The Locomotive

THE HARTFORD STEAM BOILER
INSPECTION AND INSURANCE CO.

INDEX TO VOL. 42—1938-1939

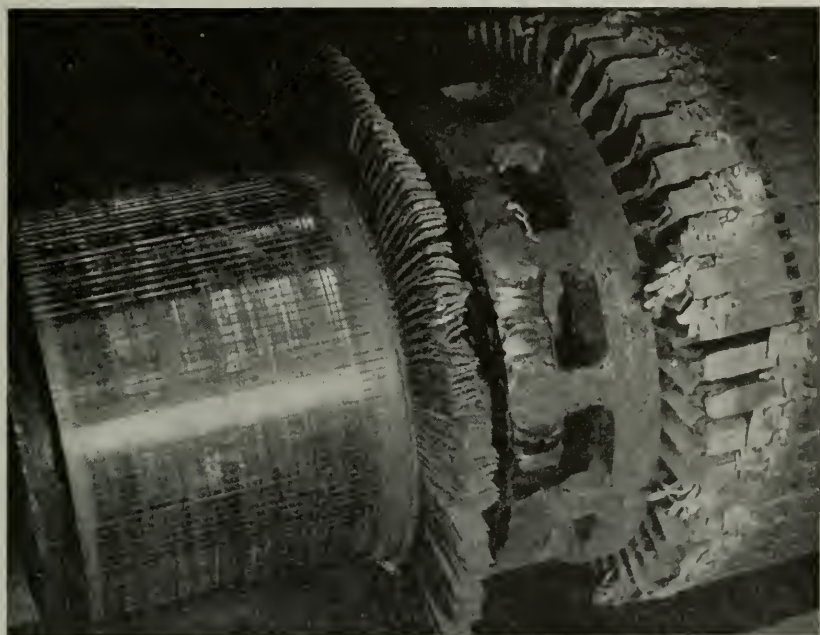
Breaking of the band wires on the commutator end was found to have caused the damage to this exciter armature of a 30,000 kw turbo-generator set. The winding between the armature core and the commutator risers was completely destroyed. The resultant arcing burned the iron and laminations of the core and also set fire to the insulation. Estimated cost of repairs, which consisted of rewinding the armature and the field, rebuilding of the commutator and replacing the burned iron and laminations in the core, was \$3,000.

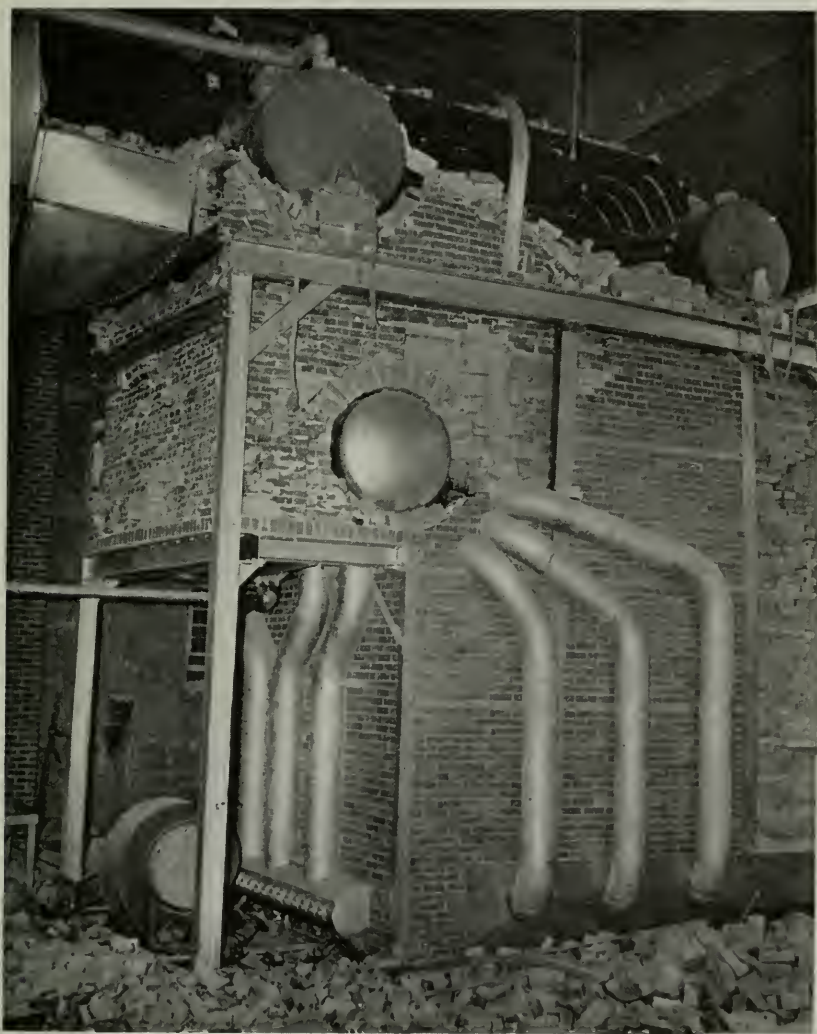
The damage to this large water tube boiler fired with natural gas was caused by a furnace explosion.

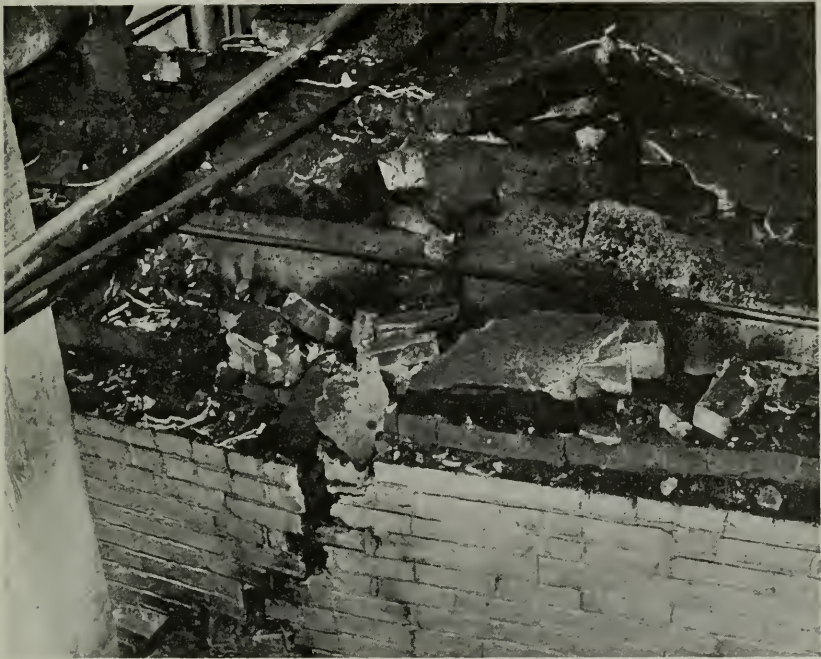
View of another watertube boiler—oil fired—showing damage from a furnace explosion.

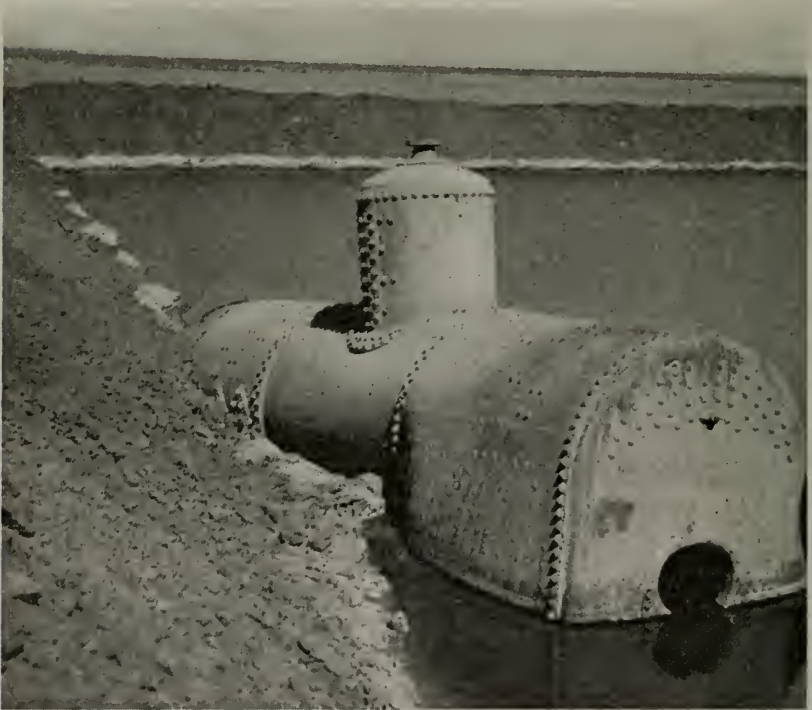
This locomotive fire box type boiler soared to the above location 250 feet from its setting in a California oil field when the crown sheet dropped because of low water and over-heating. A boiler attendant was scalded.

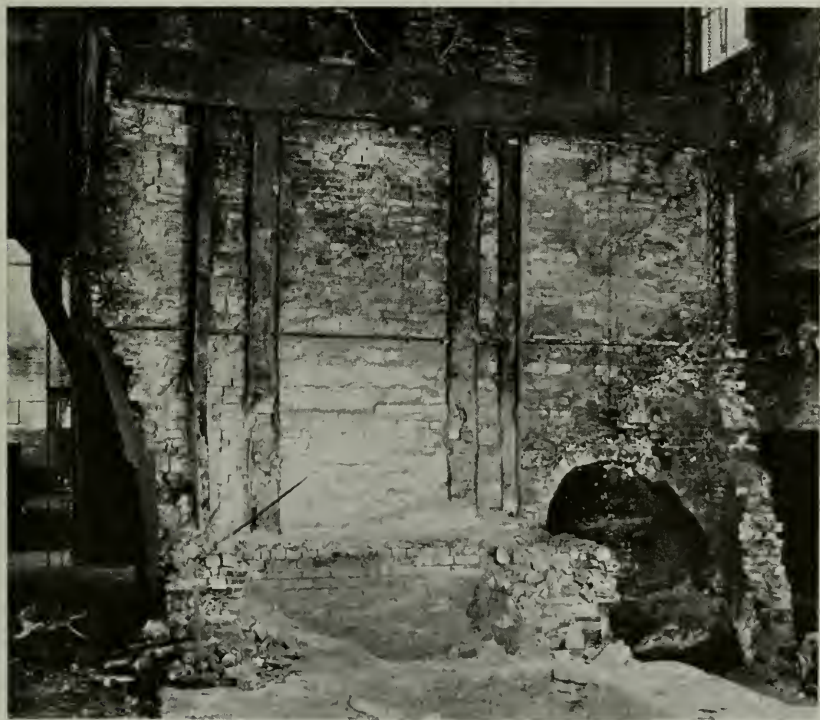
Figure 1—Boiler supporting columns, encased in intermediate brick-walls of a battery of boilers, almost entirely wasted away by oxidation from the high temperatures in the combustion chambers.

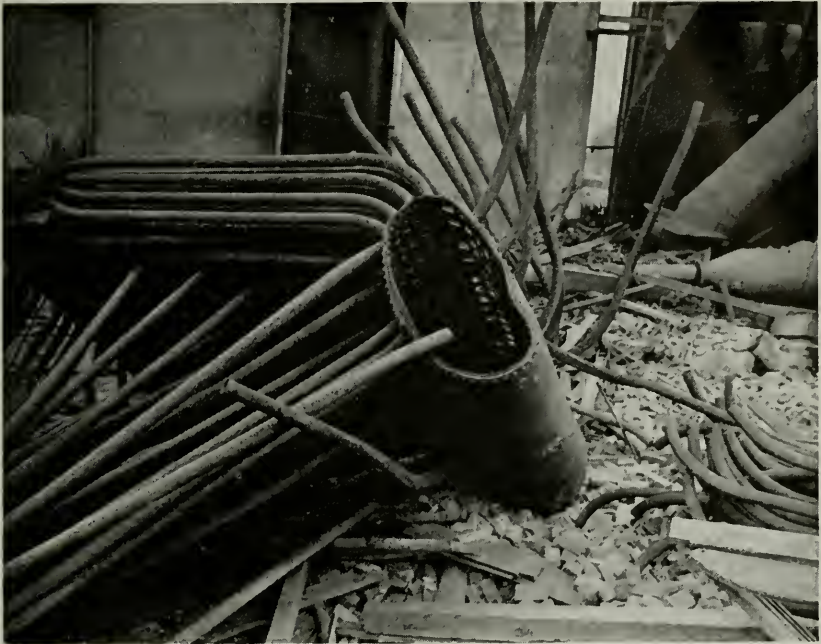
Figure 2—Weakened by corrosion, the blind head in the mud drum of this water tube boiler in a utility plant tore loose and caused the death of four people, injuries to six others and \$100,000 property loss.

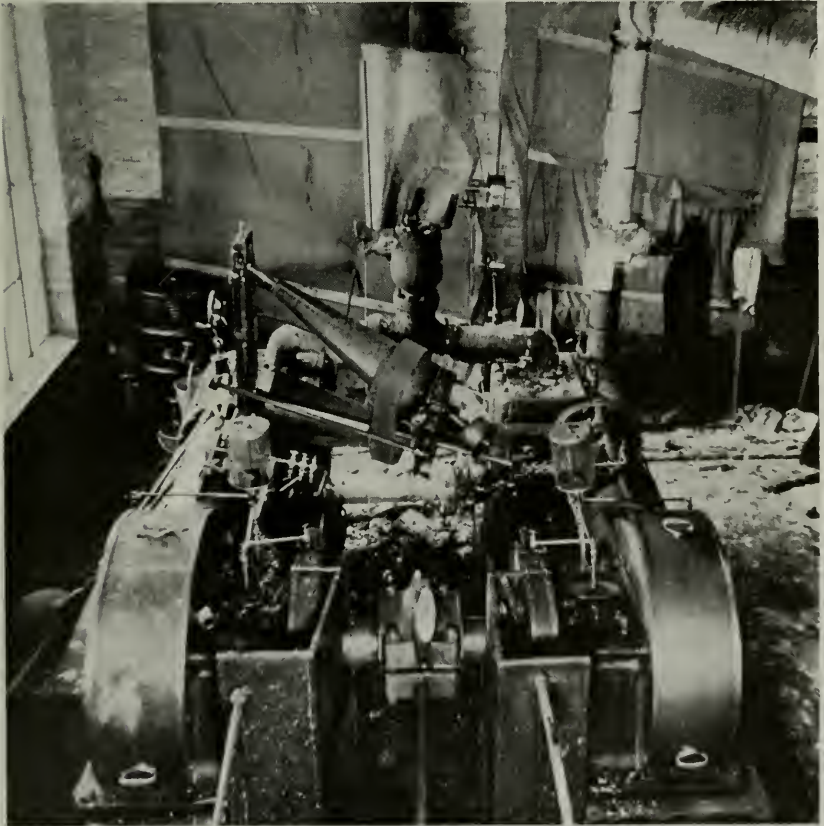
View of the steam engine showing the wreckage following the explosion.

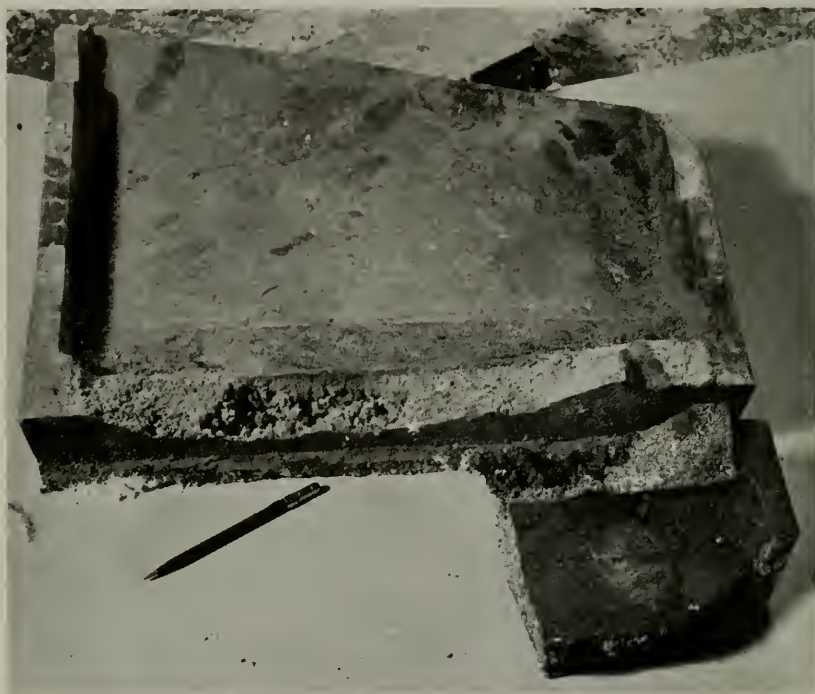
These two broken parts of the wheel, placed together as they were located in the rim, show slag and gas pockets in the casting.

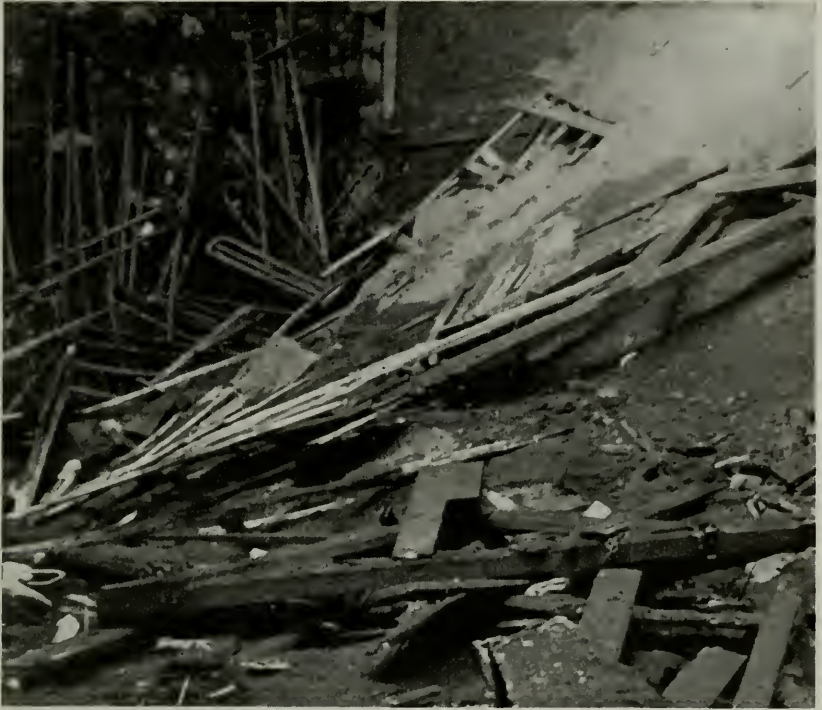
Figure 2—Some of the broken ammonia cooling coils and a section of the collapsed roof following an accident to a refrigerating system in an ice storage building.

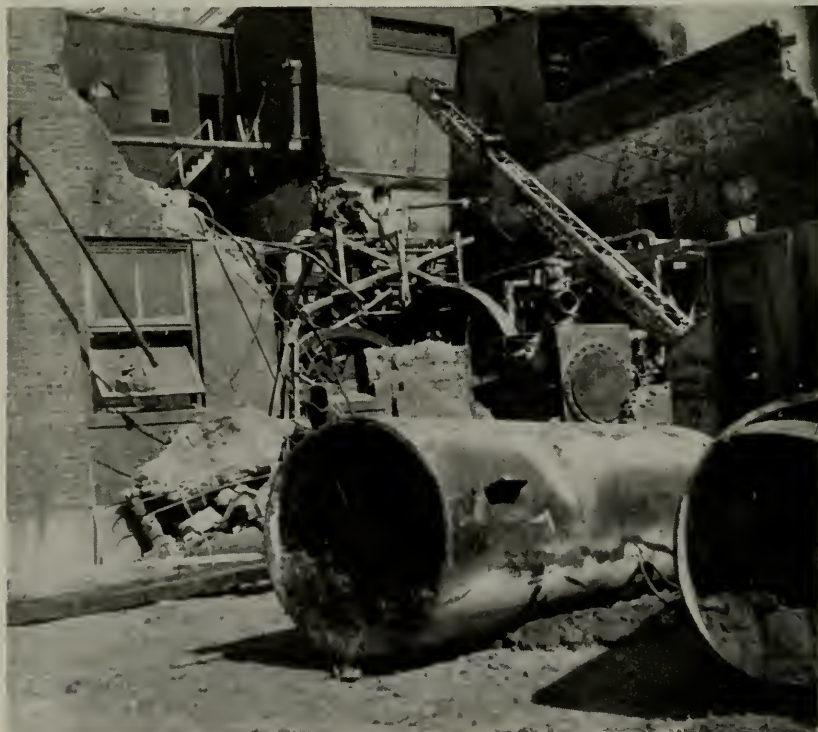
Figure 3—Power plant for a packing company wrecked by an explosion and fire after a fitting ruptured in an ammonia discharge line of a large refrigerating system.

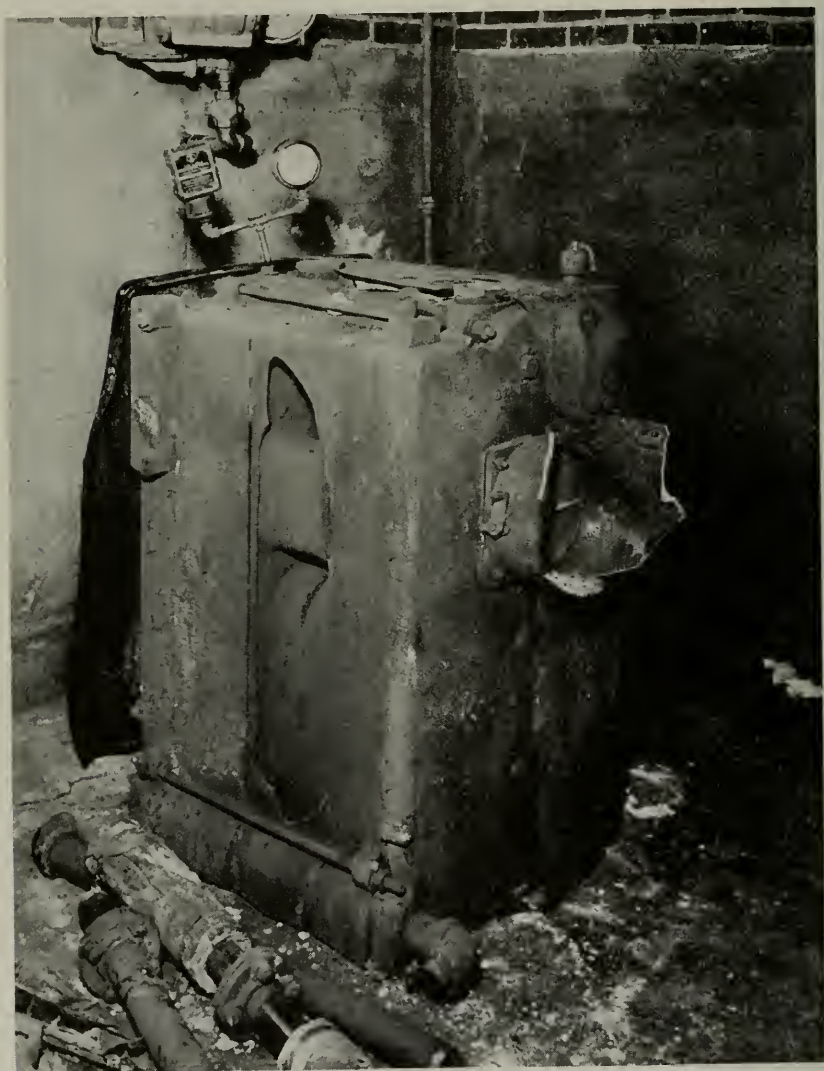
Figure 4—Failure of a pressure control device plus an inoperative safety valve caused the explosion of this cast iron steam heating boiler in a Kansas residence.

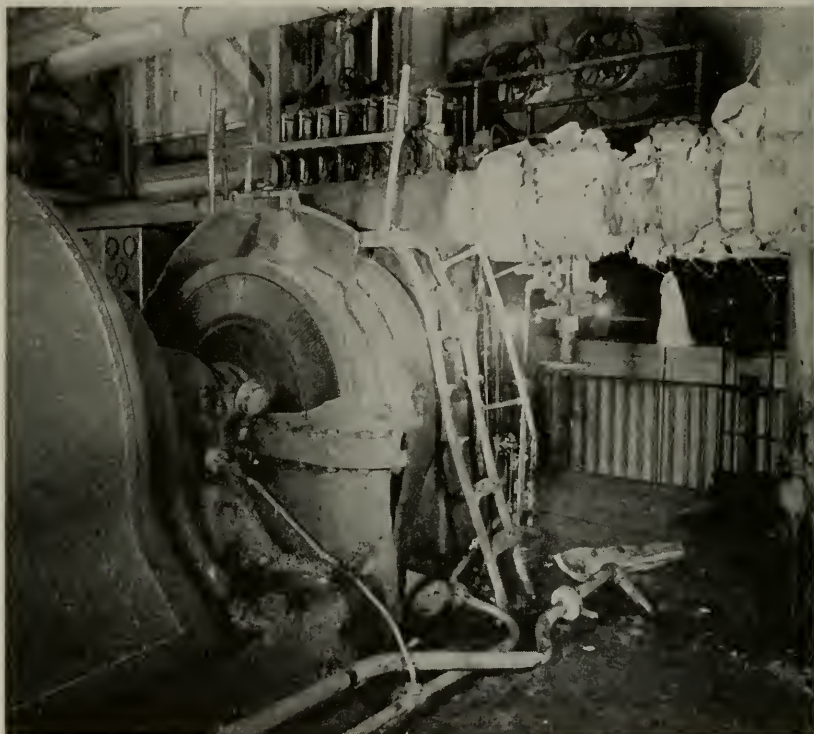
Steam turbine wrecked by an explosion when its exhaust casing burst from excessive steam pressure.

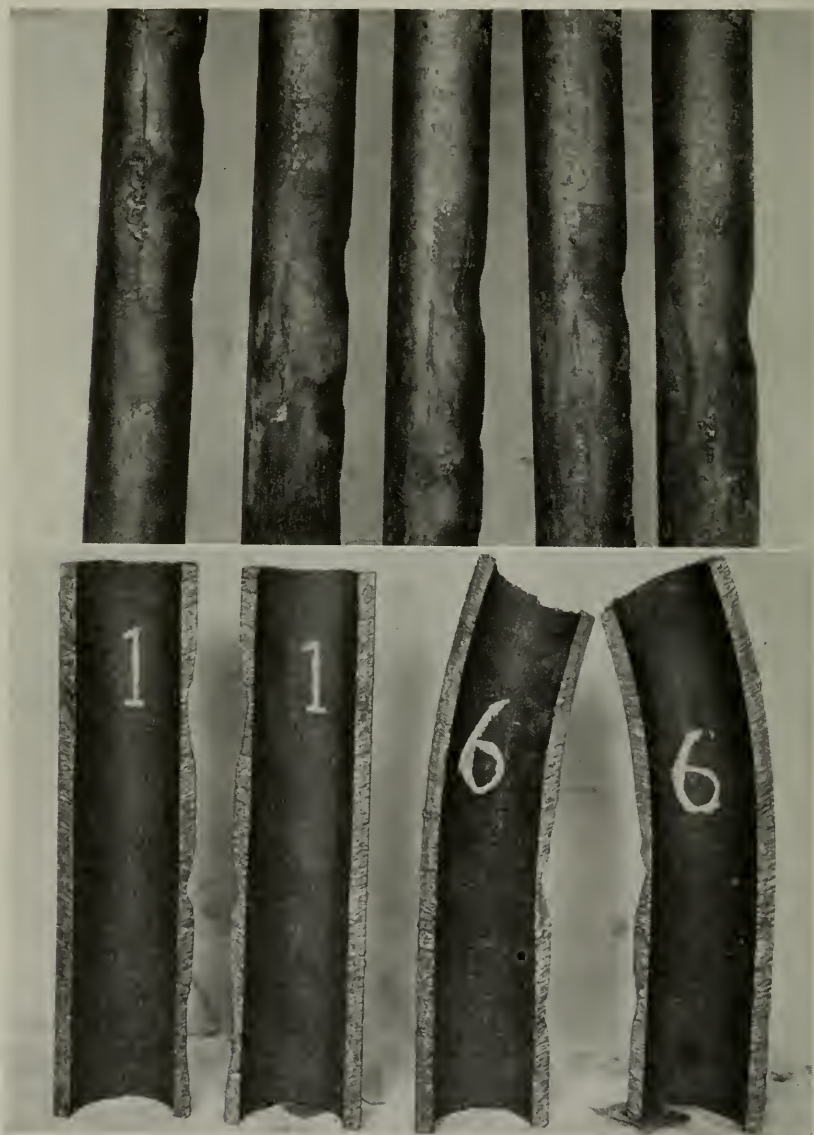
Top—Tubes in a water tube boiler eroded by steam from a soot blower. Previously, shields had been welded to these tubes to stop the erosion but they proved ineffective.

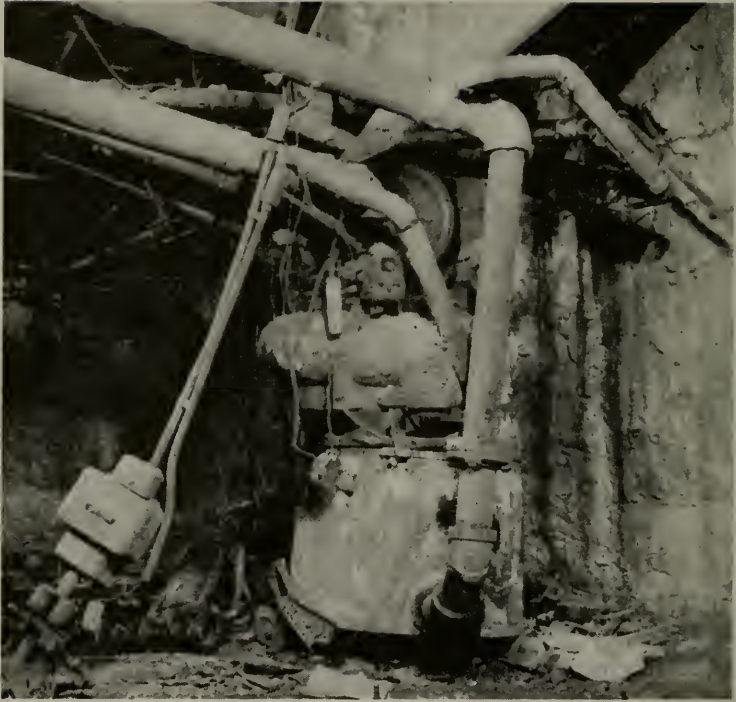
THIS cast iron boiler—uninsured—exploded from overpressure. Connected to a closed type hot water heating system, the boiler was not equipped with a dependable means to provide for expansion of the water. Electric wiring for an aquastat short circuited, the oil burner continued in operation, and as the water expanded the pressure increased. A closed valve between the boiler and a safety valve prevented release of excessive pressure.

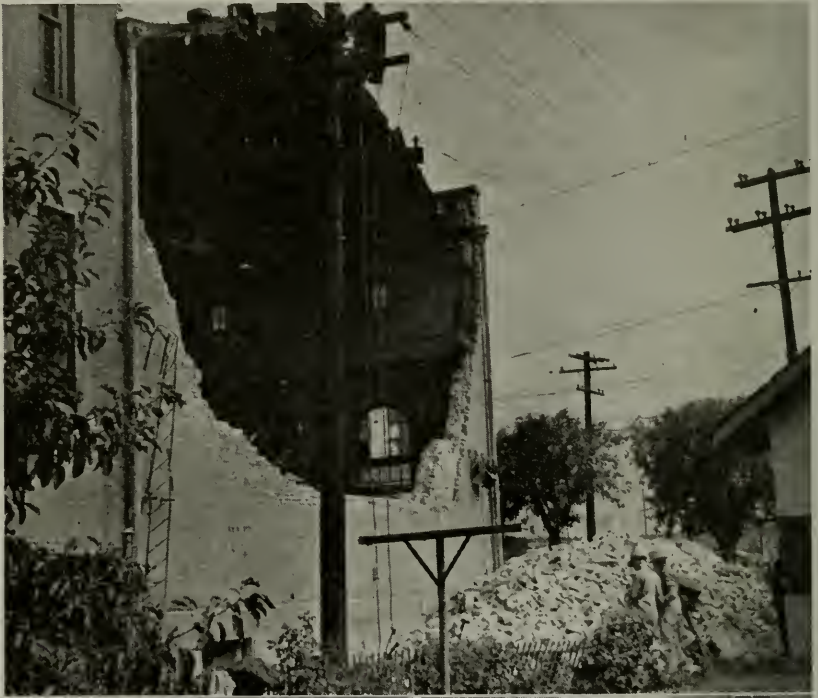
Two views of a utility sub-station after an explosion, caused by a direct stroke of lightning, blew out the end-walls.

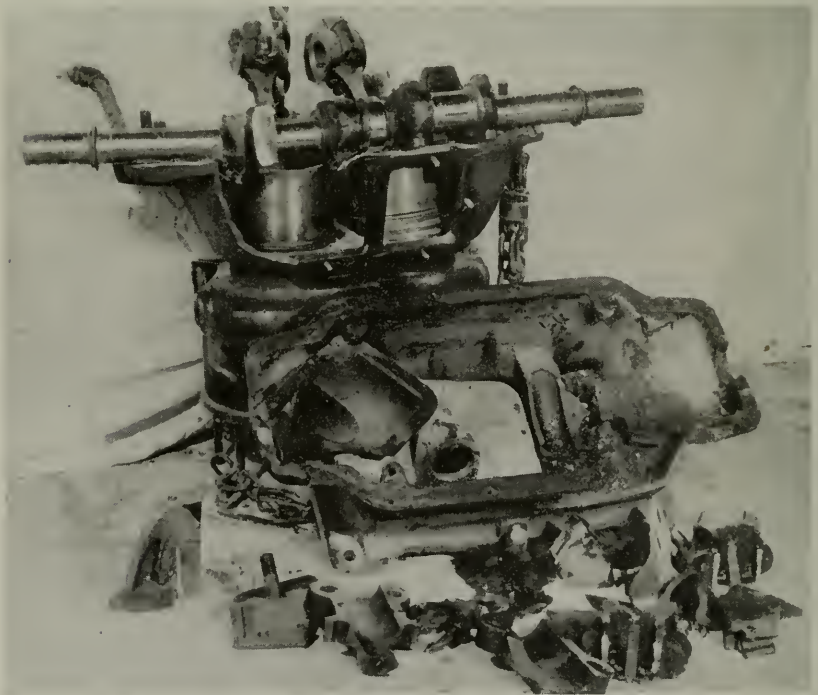
Figure 2—Vertical two-cylinder air compressor so completely wrecked when the crankshaft broke that repairs were impracticable.

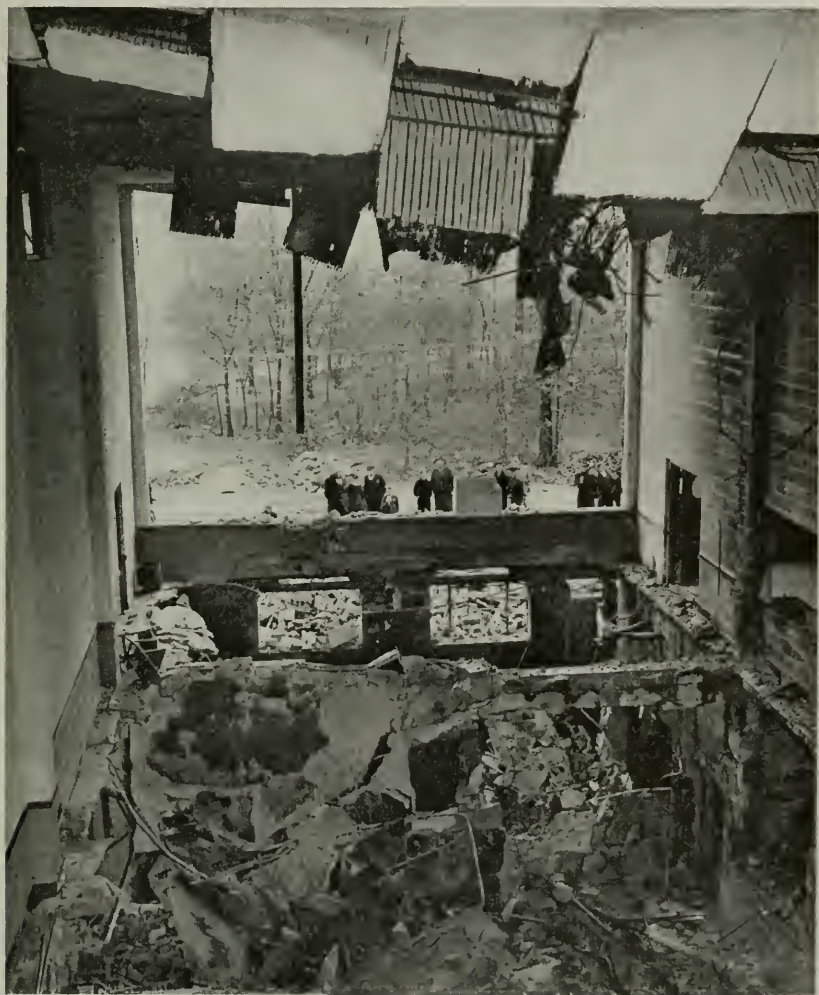
Pictured above are the ruins of a high-school study hall. An explosion of a hot water heating boiler caused this damage.

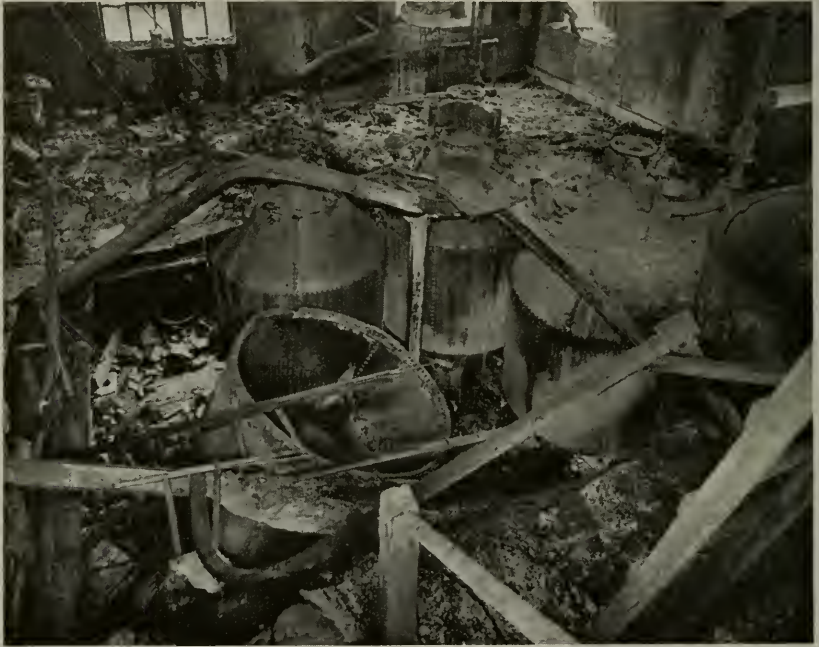
Scene in a soda recovery room at a paper pulp manufacturing plant after an explosion of a soda leaching tank.

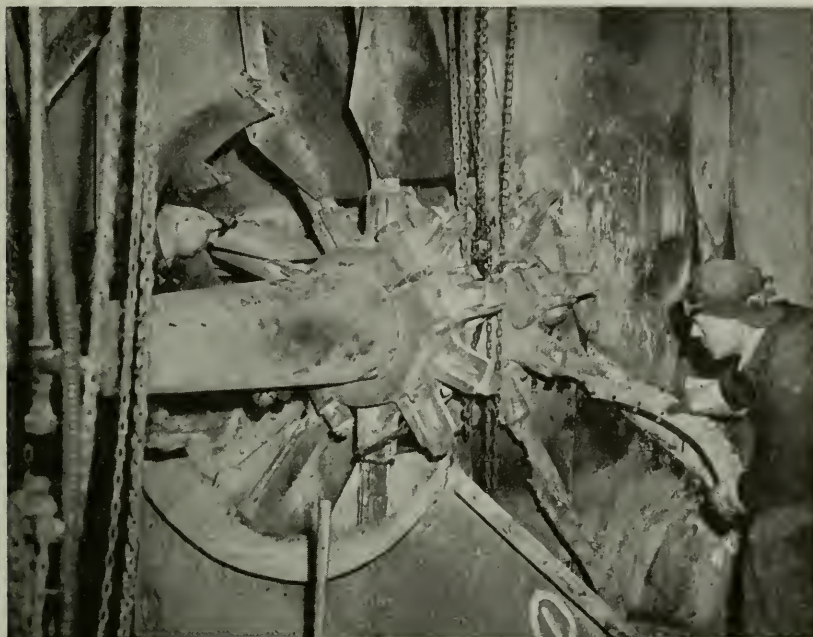
Figure 1—Part of the damage to one-half of a duplex-type induced draft fan, 450 hp capacity. Erosion of the shrouding and excessive temperature of the stack gases caused the accident.

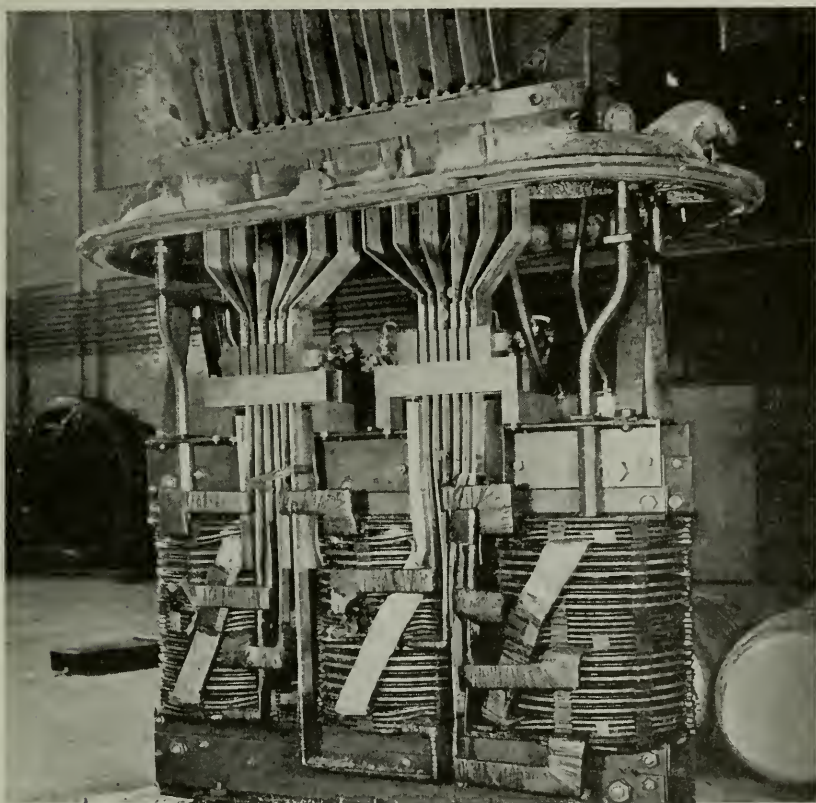
View of a three-phase, 800 kv-a transformer, removed from its casing for an examination after it had failed to operate. The source of trouble was readily determined, for as shown in the photograph the short-circuited coils in the center phase were plainly visible. Further investigation revealed that several high-tension windings had burned through completely and a number of secondary coils had been damaged as well. Intermittent excessive overloads which produced both severe mechanical stresses between the windings and excessive heating were believed to have been the cause. The cost of repairs to the transformer was about \$1,900 although production loss and extra expense incurred for a temporary transformer while repairs were being made exceeded \$12,000.

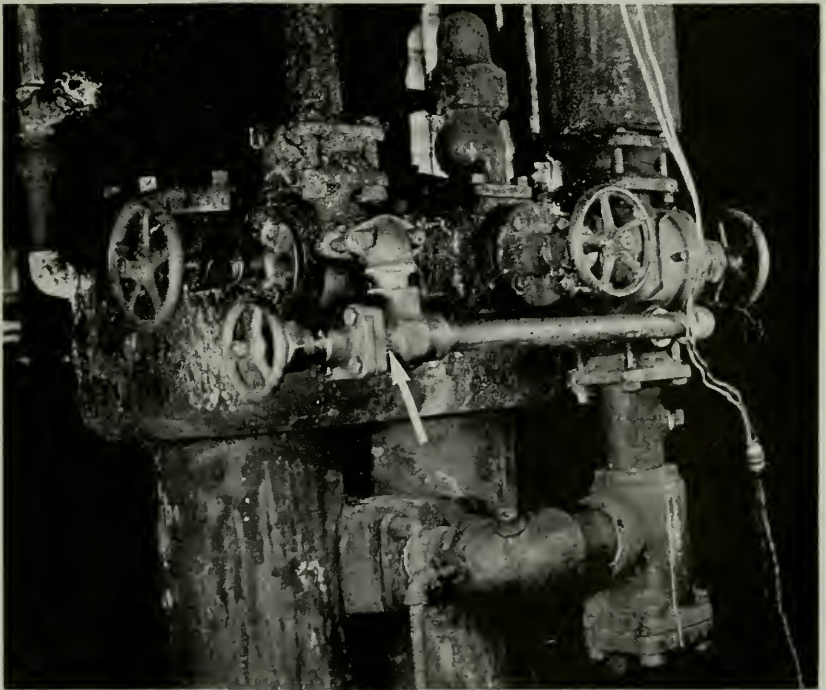
Figure 1—Four people were injured and a \$37,000 property damage loss was caused by the breaking of a by-pass valve on this ammonia compressor. Arrow indicates the point where the break occurred although a new valve had been installed when this picture was taken.

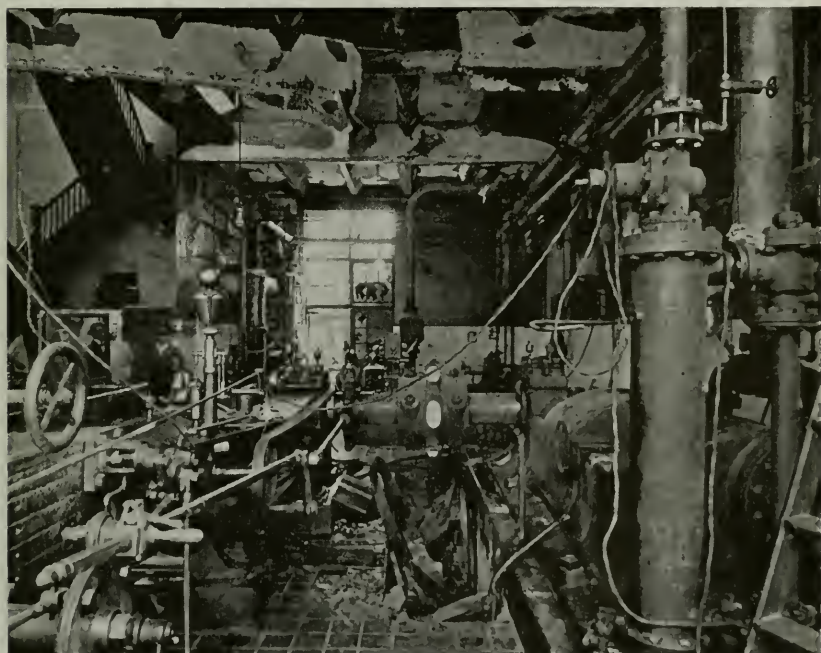
Figure 3—When a 12' flywheel on this steam-driven ammonia compressor ran away, the resultant property damage amounted to more than \$40,000.

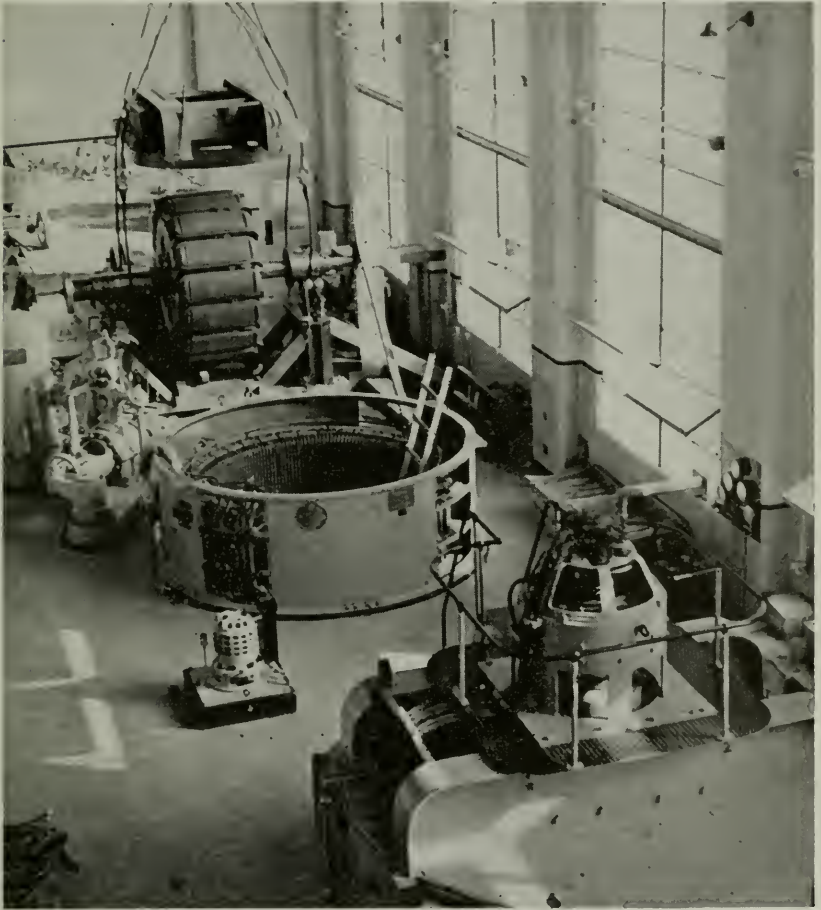
Scene in a California power plant showing the generator ends of two vertical water turbine-generator units, each of 7,500 kw capacity. One generator has been dismantled for complete rewinding of its stator, necessitated by failure during a severe electrical storm. The total loss, direct and indirect, was \$37,000.

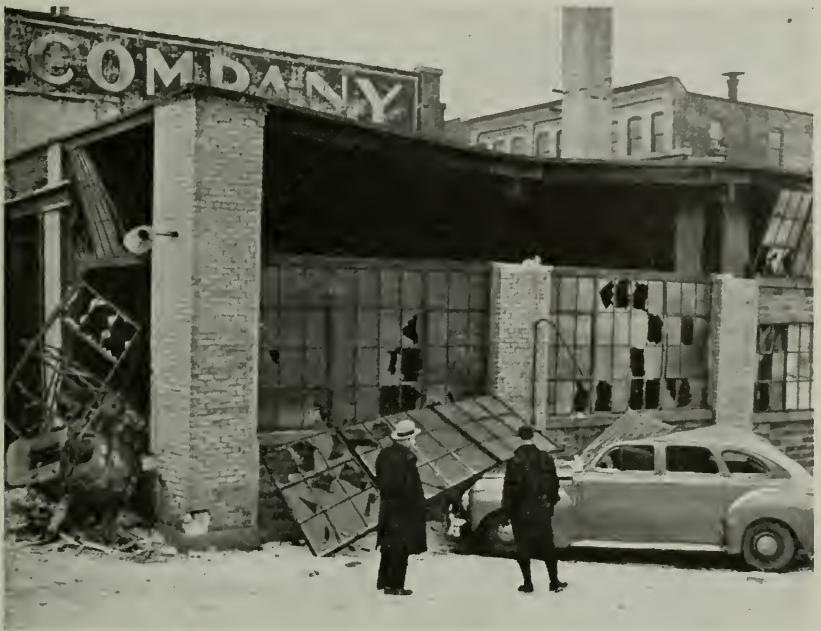
Figure 3—A check valve between a hot water heating boiler and its relief valve was reported as the cause of the explosion which wrecked this building.

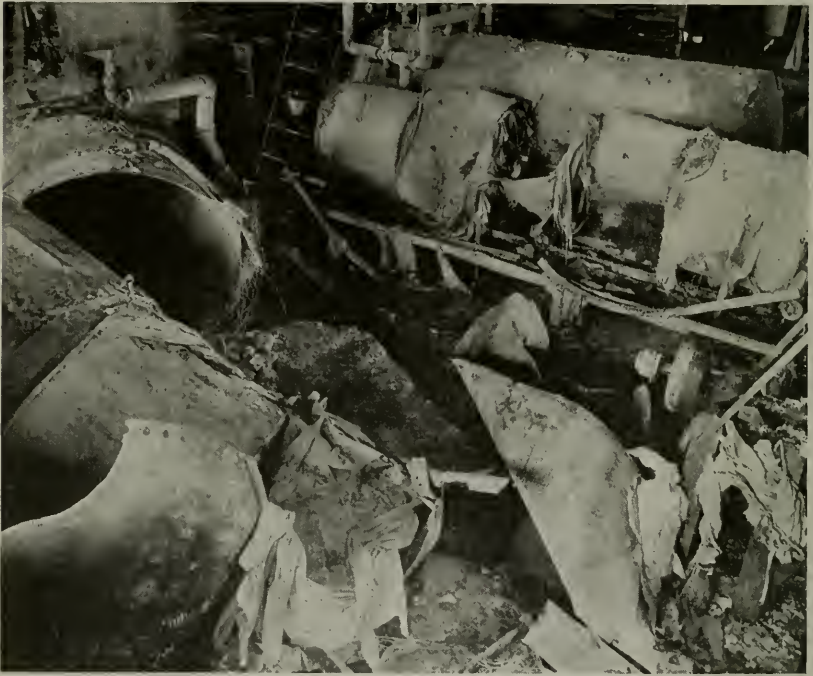
Figure 4—When a badly corroded vulcanizer exploded in a Pennsylvania plant, two persons were injured and the property damage amounted to \$6,000. This shows parts of the exploded vessel.

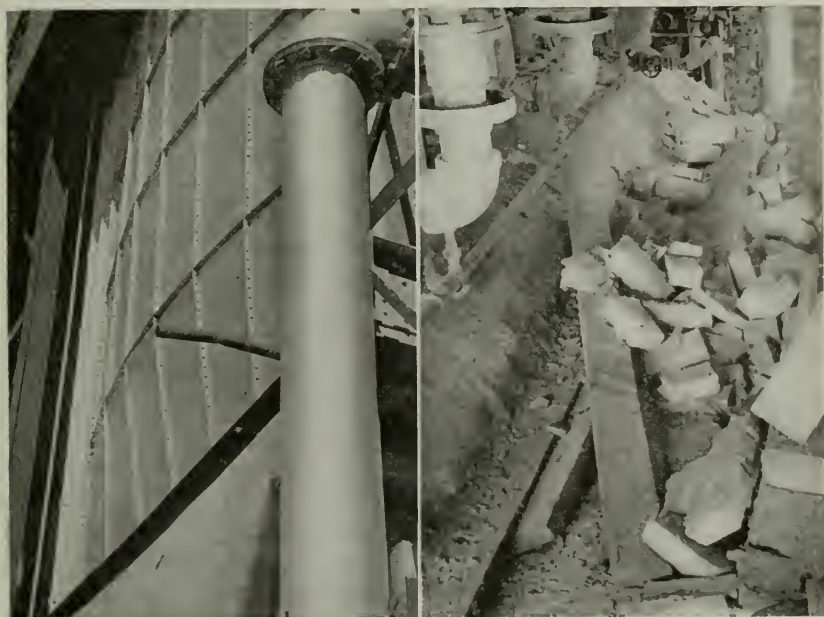
Figure 5—(Left) and 5A (Right)—Two pictures showing some of the damage caused by a furnace explosion to a large water-tube boiler in an Arizona utility power house. The one at the left shows one wall of the boiler's economizer bulged out several inches, while the other gives a view of damaged brickwork in the top of the setting.
