Aircraft Action Reports

2-d (57) USS Sangamon

A16-3/0VE26 (RR) U.S.S. SANGAMON (0VE26)  
Serial 044

**Subject:** U.S.S. SANGAMON Action Report for the Ryukyus Operation (21 March to 9 May 1945).

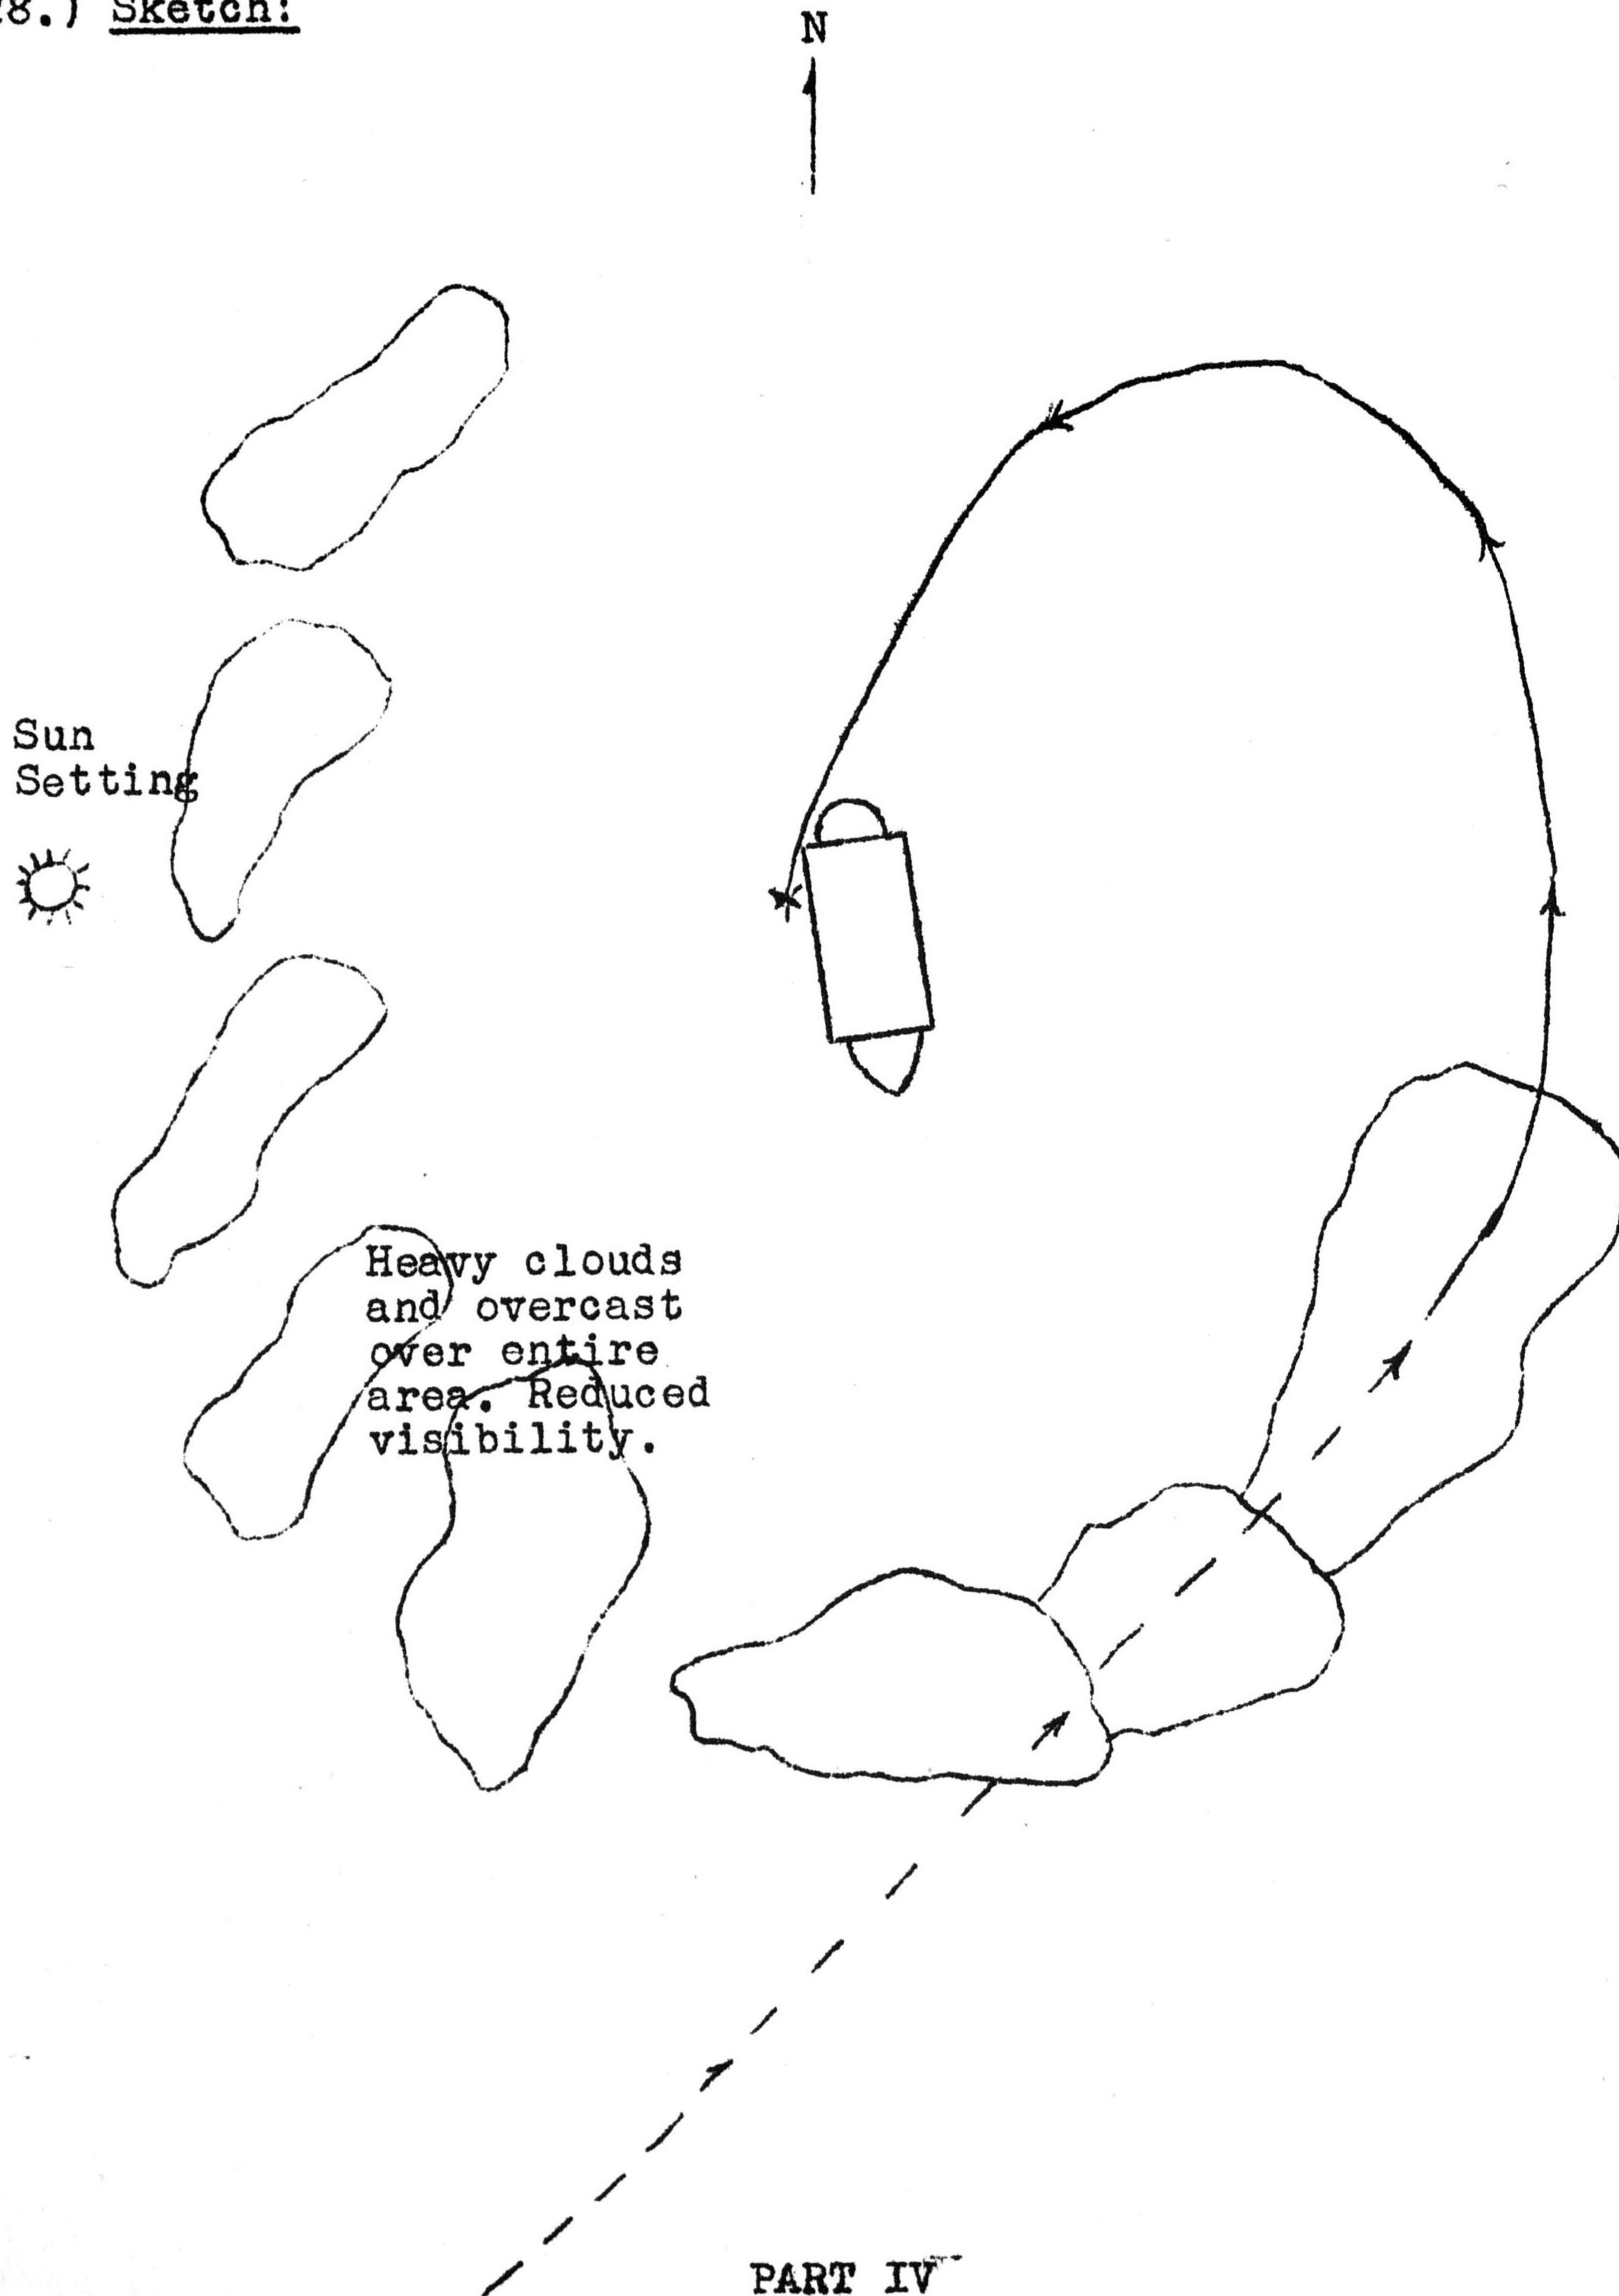
(28.) Sketch:

- (23.) Planes shot down: Sure: One. Possible: None. Damage: None.
- (24.) Details of damage to target by gunfire if available: Plane was observed to be trailing black smoke after being taken under fire; later observed to be trailing heavy white smoke as he passed over ship before crashing.

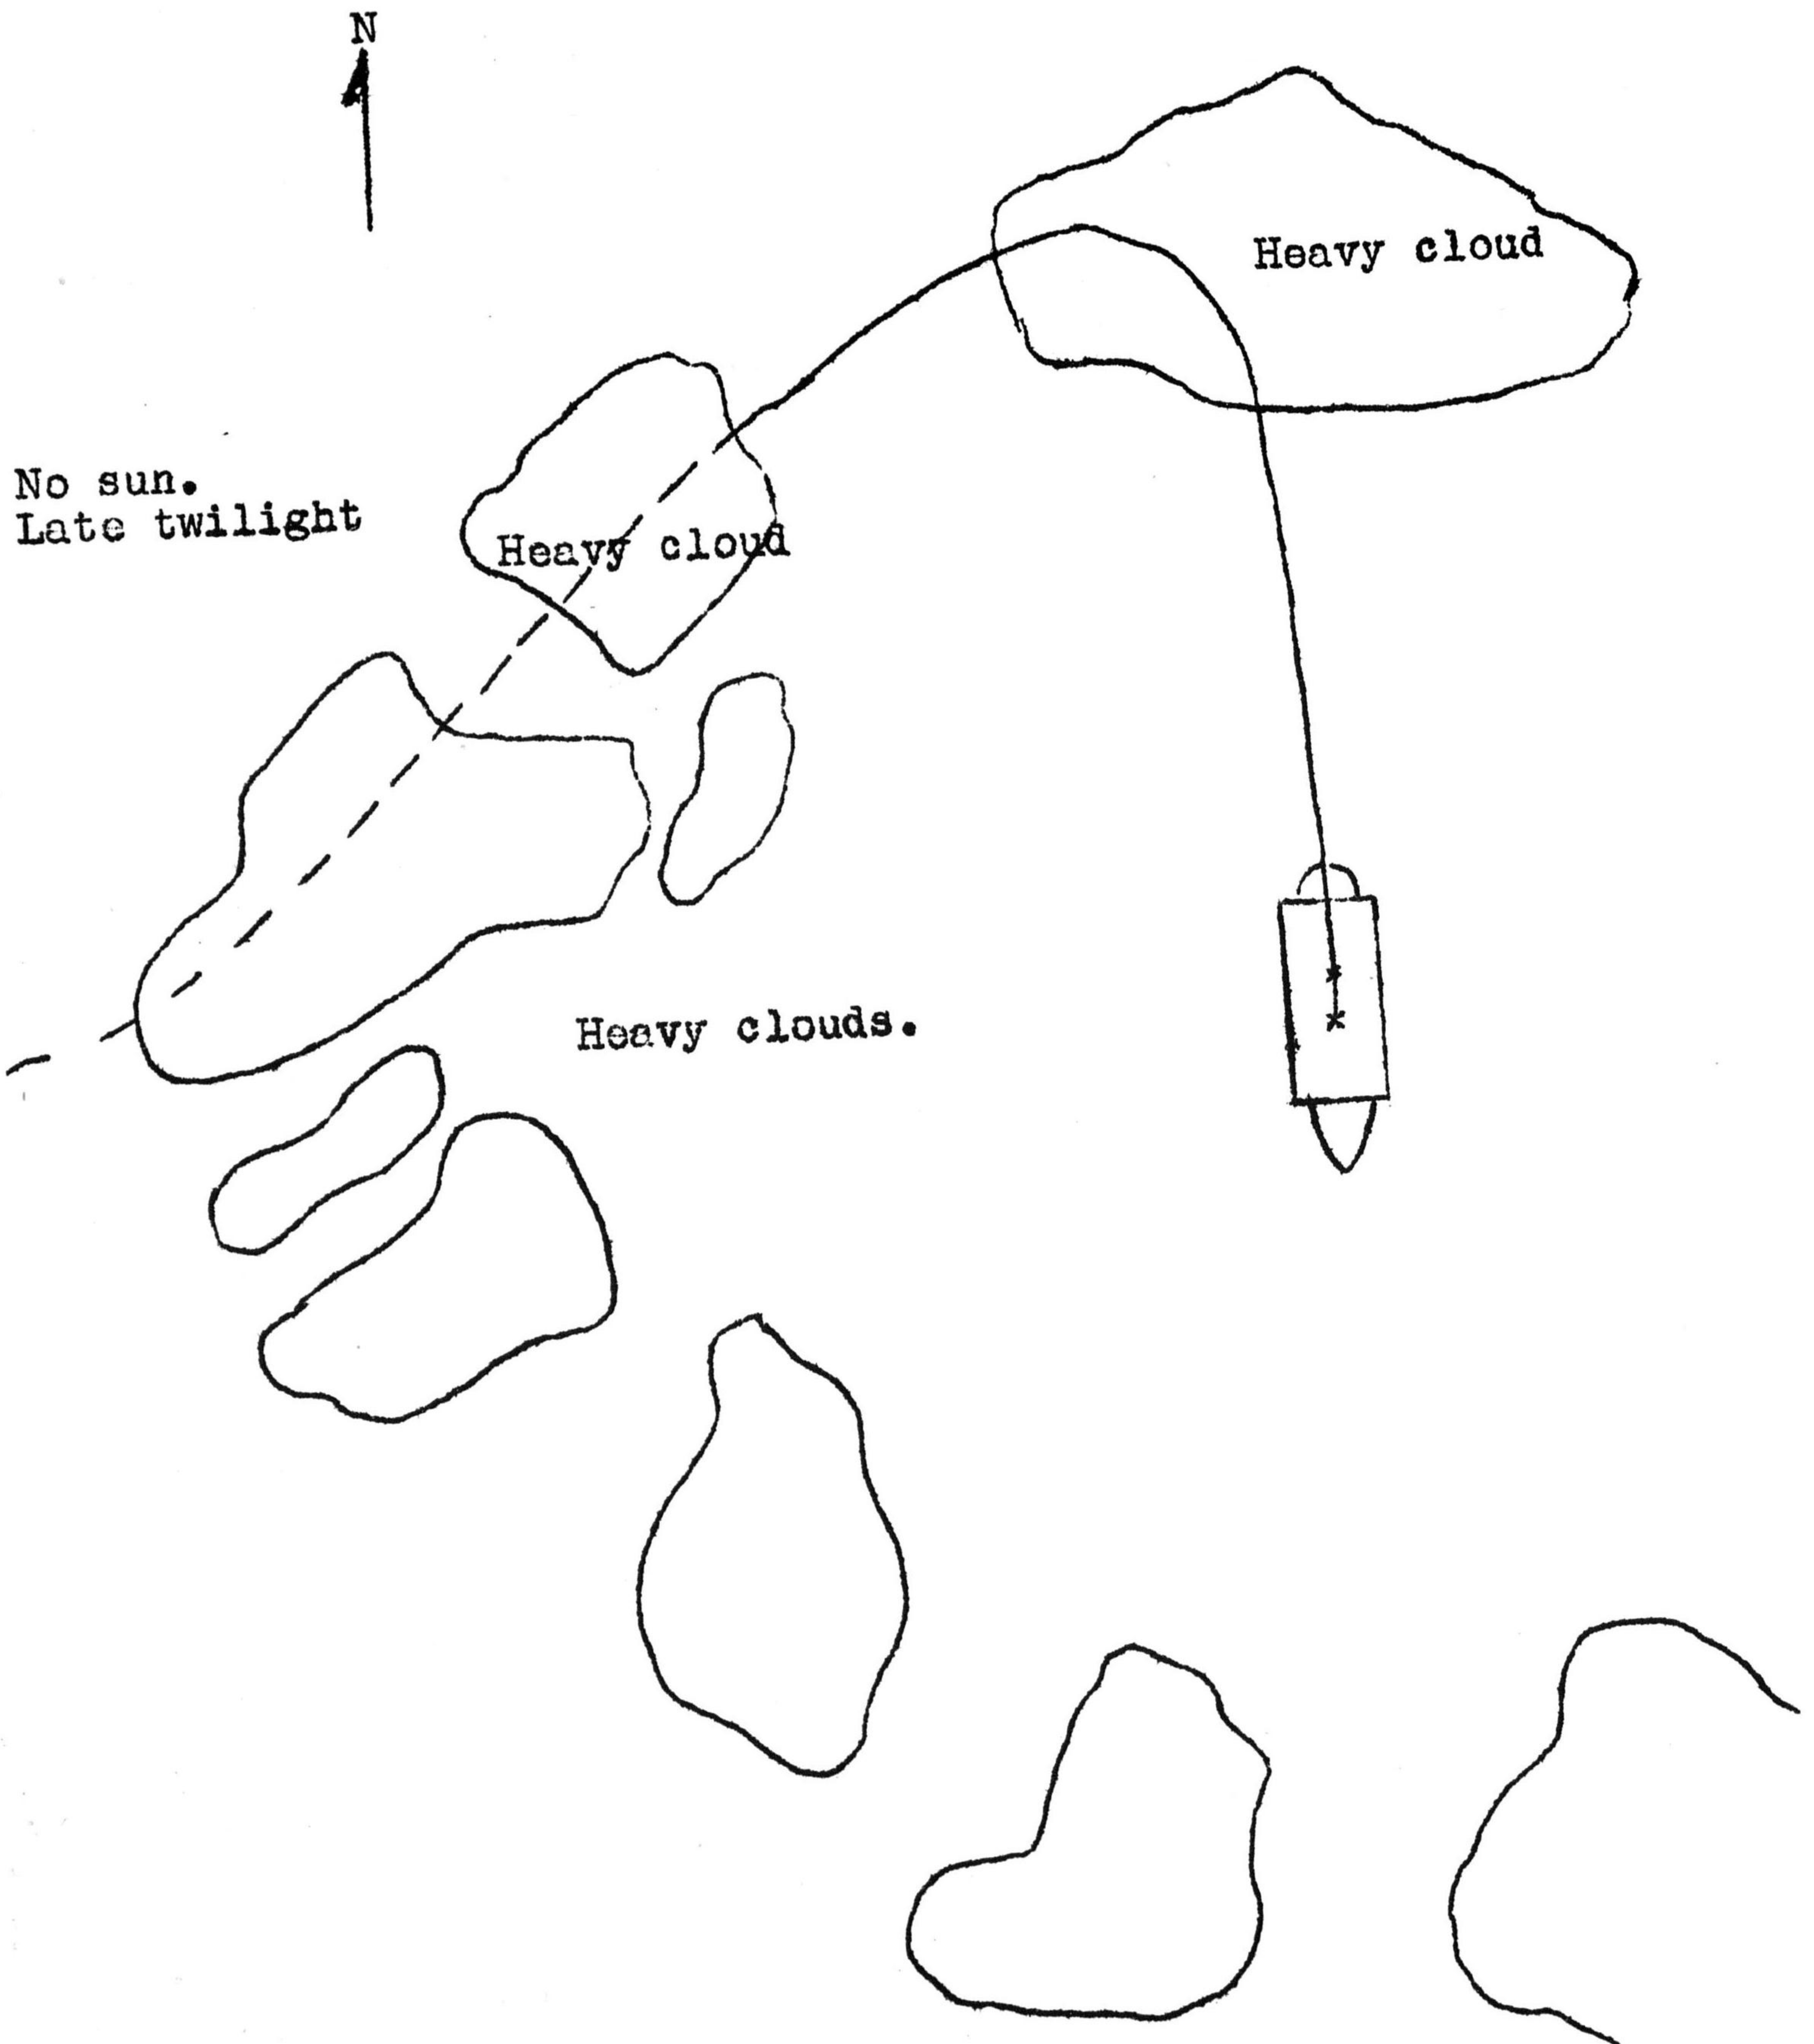
(26.) Sketch:

- (7.) Guns firing: All guns of the 40mm and 20mm battery that could bear fired on the target on the starboard quarter when given the initial commence firing order, and as target became obscured in cloud cover, a check fire cease firing gong was sounded in order to clear up visual cover of the sector. Visibility was so low, because of the period of twilight that tracer illumination would have cause loss of target vision for new open fire designation when target closed to attack again out of clouds. All guns which could bear again reopened fire immediately as soon as target came through cloud directly astern at a low angle.

- (22.) Number near bomb misses: None. Casualties from near misses: None.
- (23.) Planes shot down: Sure: One. Possible: None. Damage: None.
- (24.) Details of damage to target by gunfire if available: This plane was on fire from engine to engine and dropped part of his wing before crashing on flight deck. Plane was seen to receive hits in forward part at a range of about 600 yards.
