Docket No. SA-66

REPORT OF THE CIVIL AERONAUTICS BOARD

On the investigation of an accident involving aircraft of United States Registry NC 21714 which occurred near Miles City, Montana, on May 12, 1942.

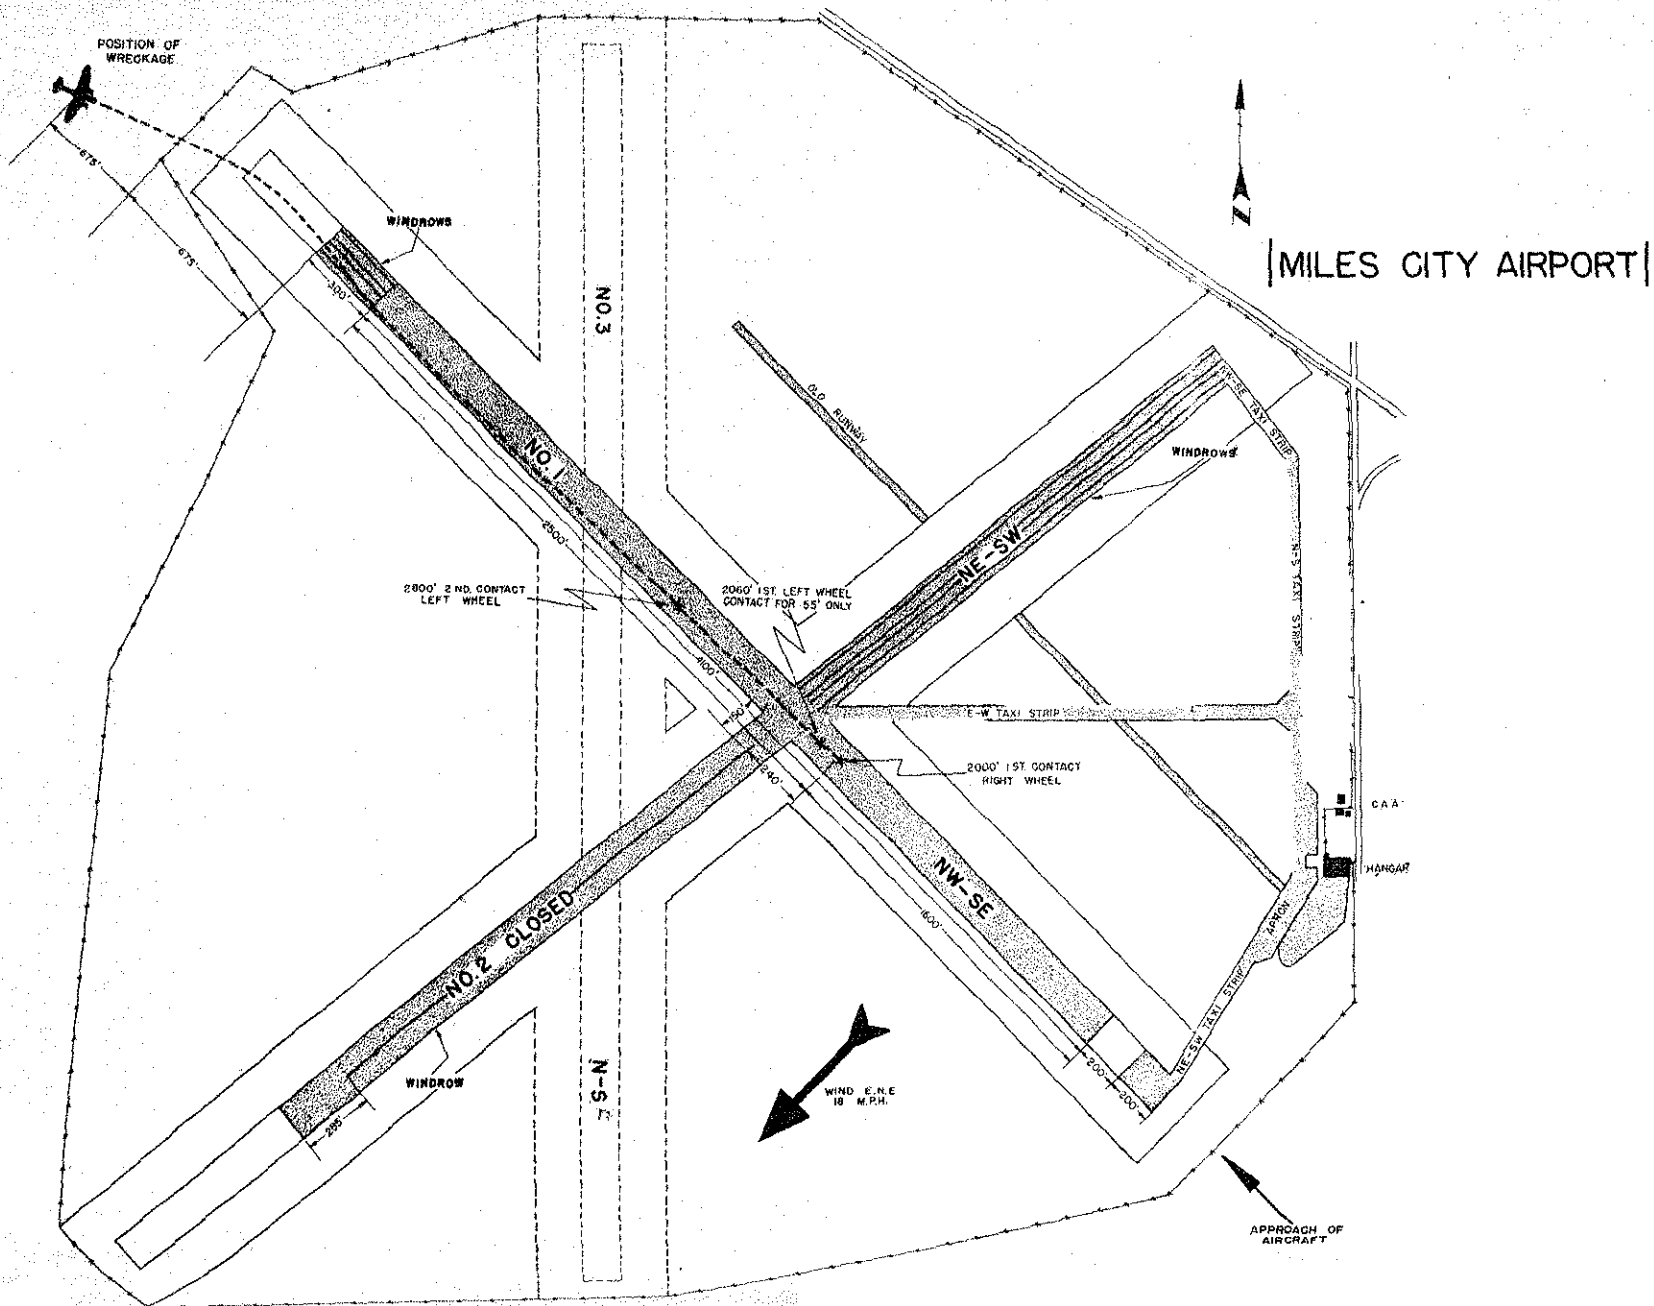
Miles City Municipal Airport is located on a plateau 2626 feet above sea level. It is a square sod field of 160 usable acres with two 200 by 4600-foot asphalt runways. (See map, opposite page.) At the time of the accident, extensive construction work was in progress necessitating the closing of the field except for its northwest-southeast runway. This runway was in good condition

except for 300 feet of the northwest end and 200 feet of the southeast end, the paving material was placed in parallel windrows about 30 inches high. The remaining 4100 feet of the runway had been completed except for the final seal coat. The ends of this usable part were properly marked by red lights and flags. On the uncompleted northeast-southwest runway there were four windrows of paving material, extending from the northeast end to the edge of the northwest-southeast runway, and one windrow extending from a point 285 feet from the southwest end of the runway to a point 150 feet from the intersection.
