NBS TECHNICAL NOTE 807

Building Performance in the 1972 Managua Earthquake

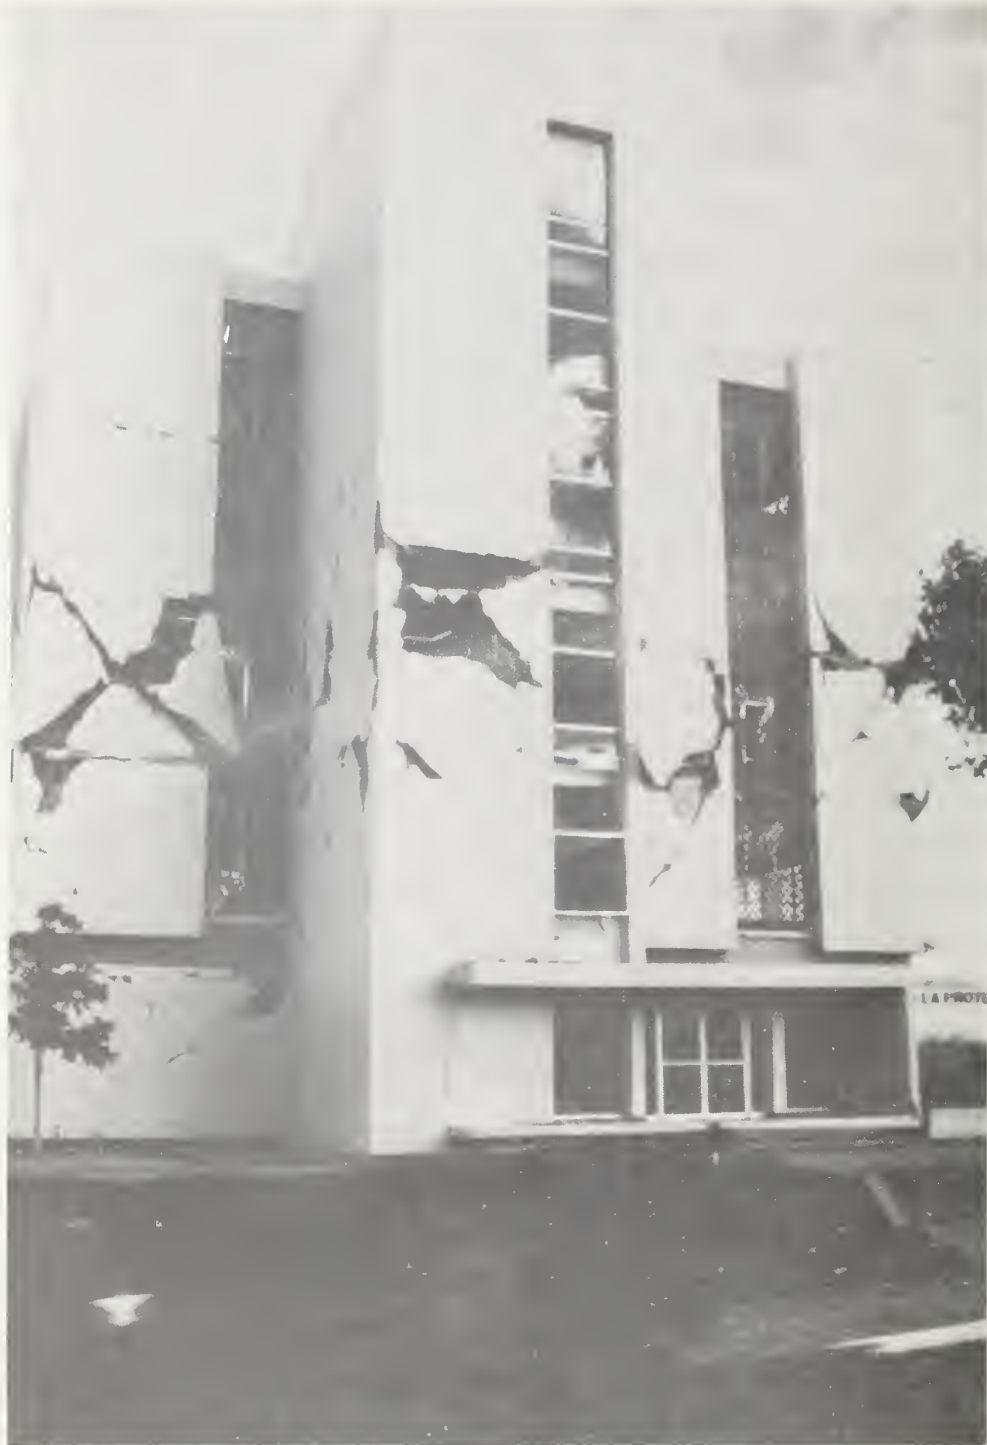
Figure 19 Severe exterior nonstructural damage in unbraced frame building, Seguros La Protectora.

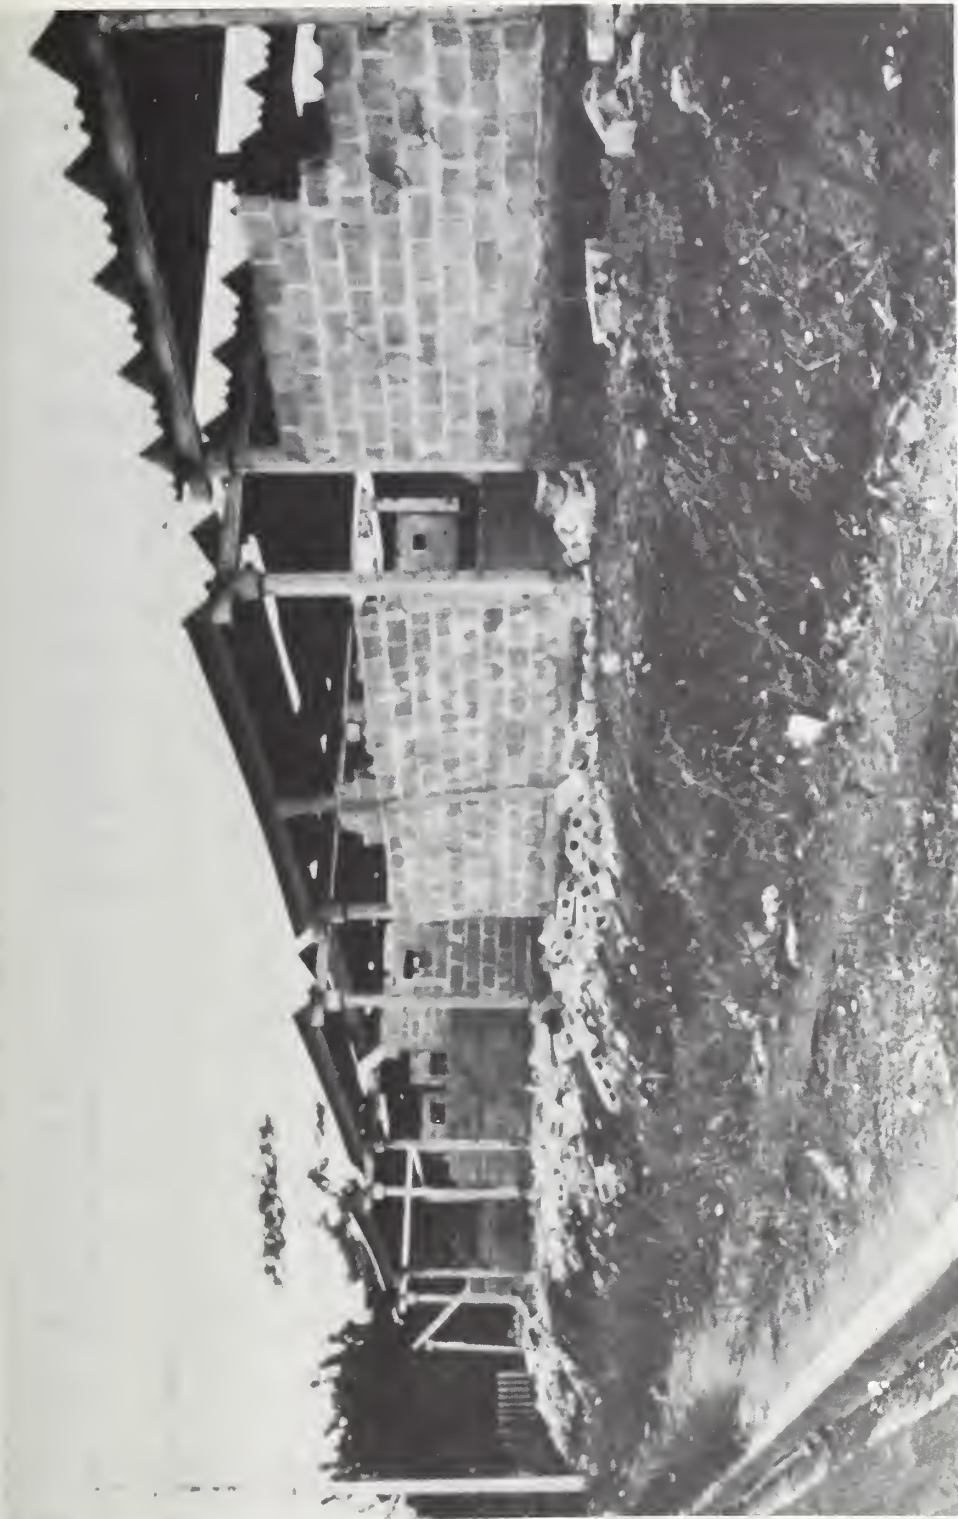
Figure 21 Failures of inadequately anchored walls of houses under construction.

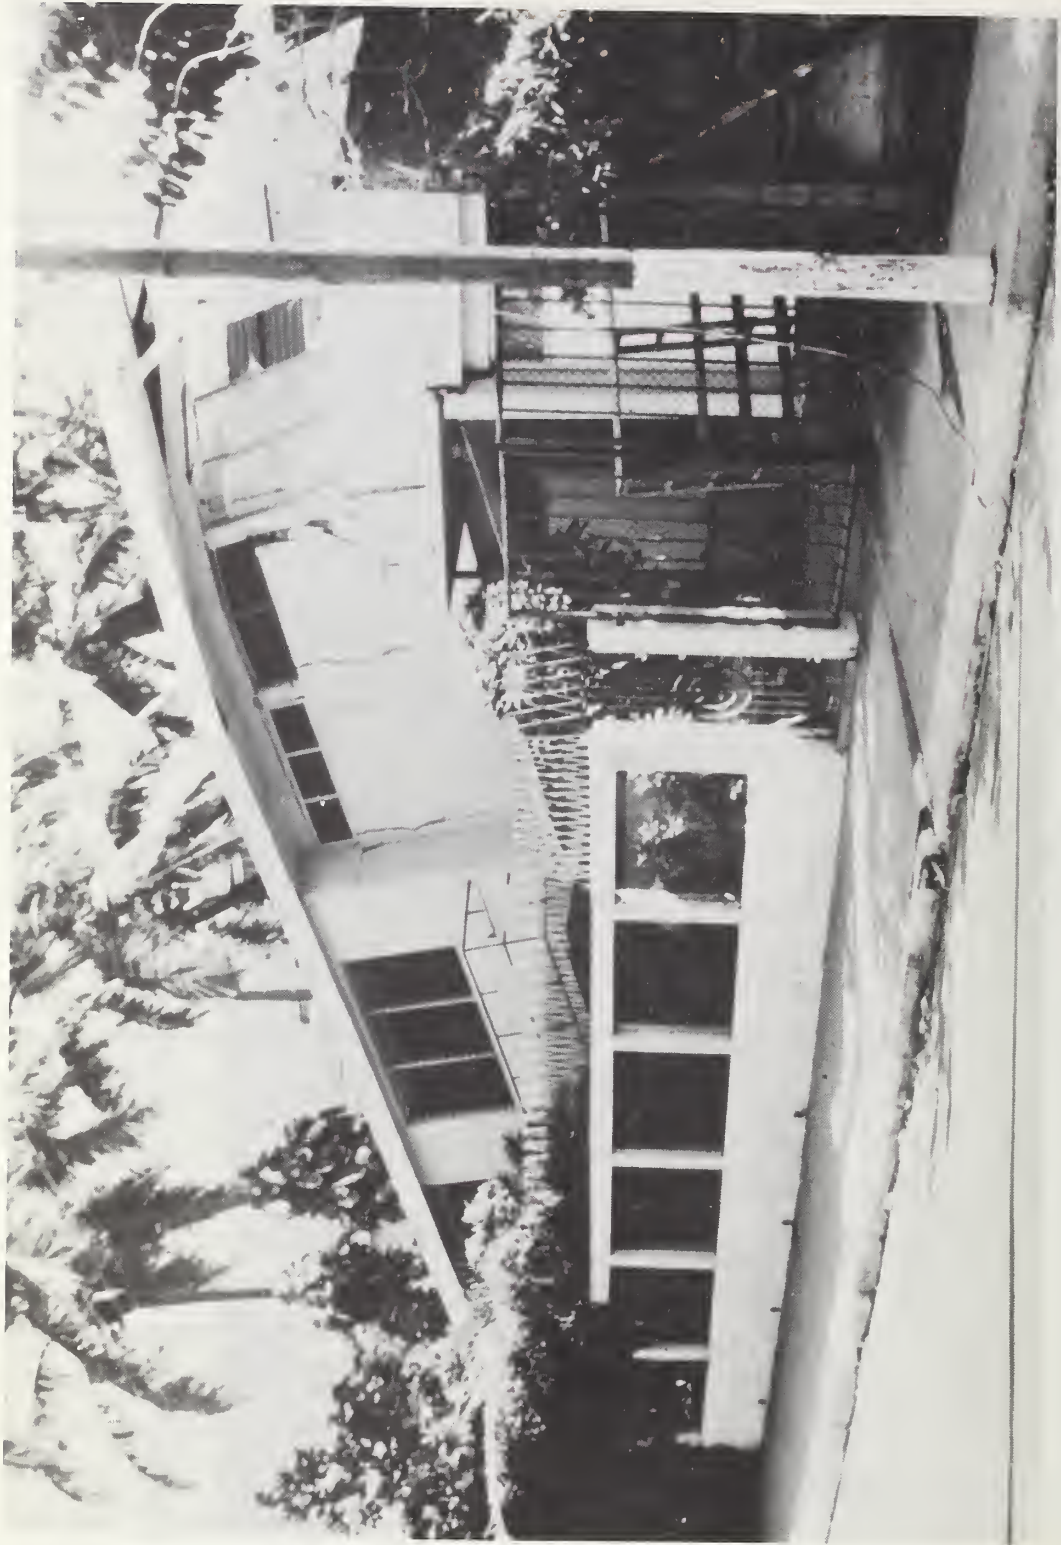
Figure 22 Collapse of modern house of "good quality."

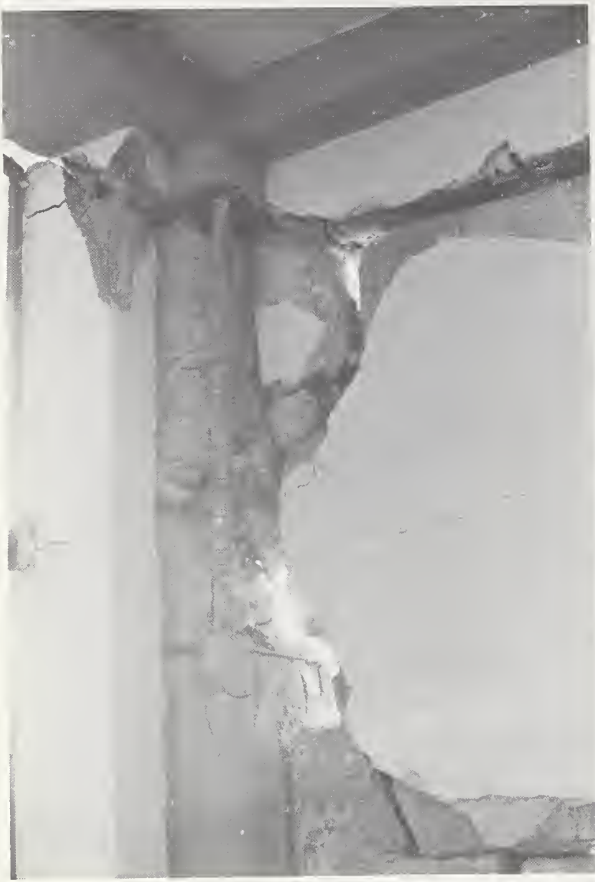
Figure 4-1 Column failure at construction join in nursery building, Mercado Periferico Oriental.

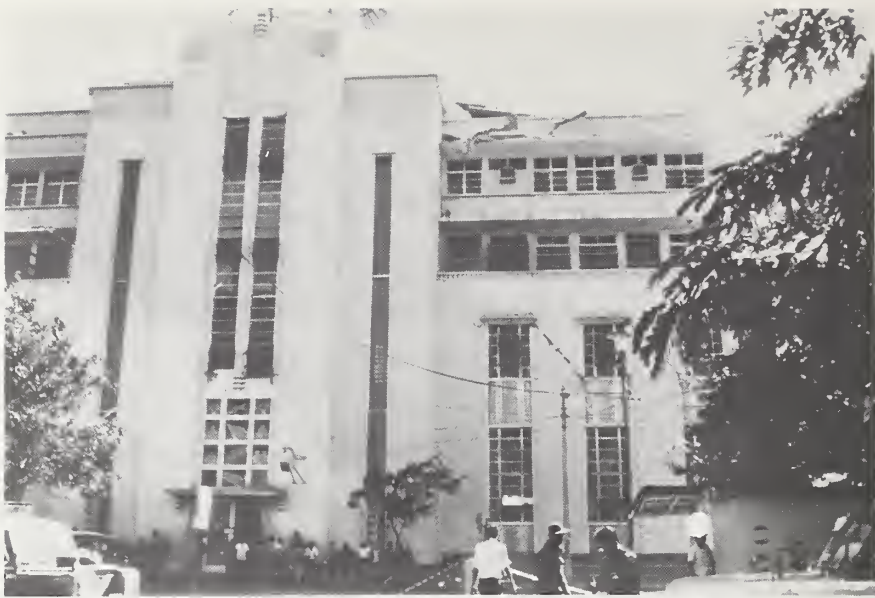
Figure 5-1 Front of the Palacio de Comunicaciones, limited damage except at fourth floor.

It was recommended immediately to personnel of the Palacio de Comunicaciones that measures be taken to protect people in the streets adjacent to the east and west sides of the building. It is also recommended that valuable communications equipment installed on the fourth floor be relocated to eliminate hazards to the equipment and personnel using it, since the roof structure easily could fail from a strong wind or an earthquake aftershock. It is further recommended that the new construction on the fourth floor be removed and reconstructed appropriately. Elsewhere, repair should eliminate glass, blocks, walls, and other elements showing nonstructural damage. It is important to remove glass panels from the third floor which are particularly dangerous to people working nearby.

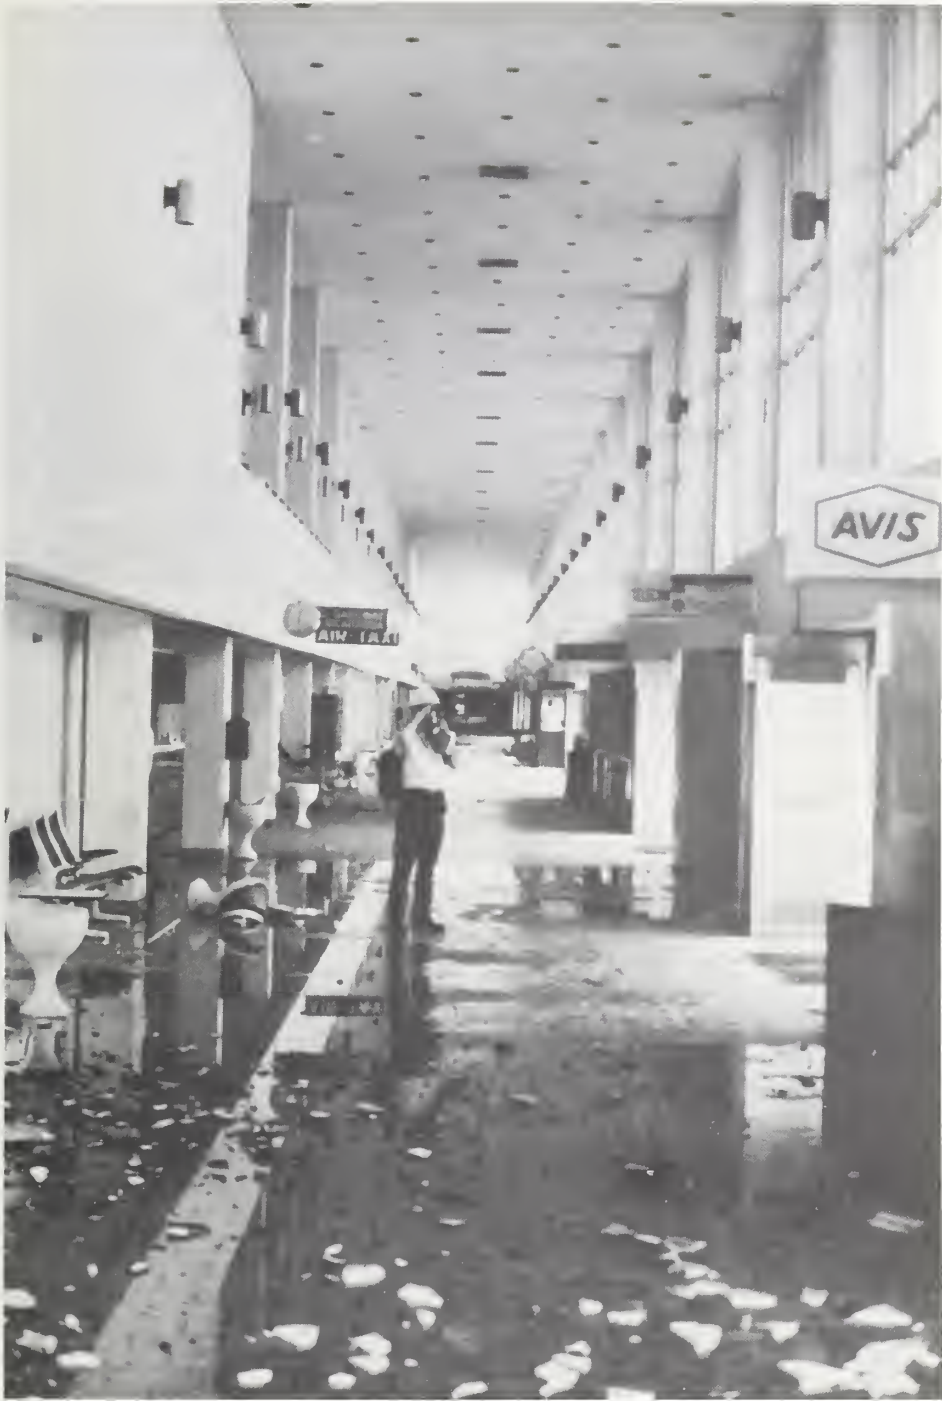
Figure 13-1 Aisle on the ground transportation side showing superficial damages, Terminal de Pasajeros Aeropuerto Internacional.

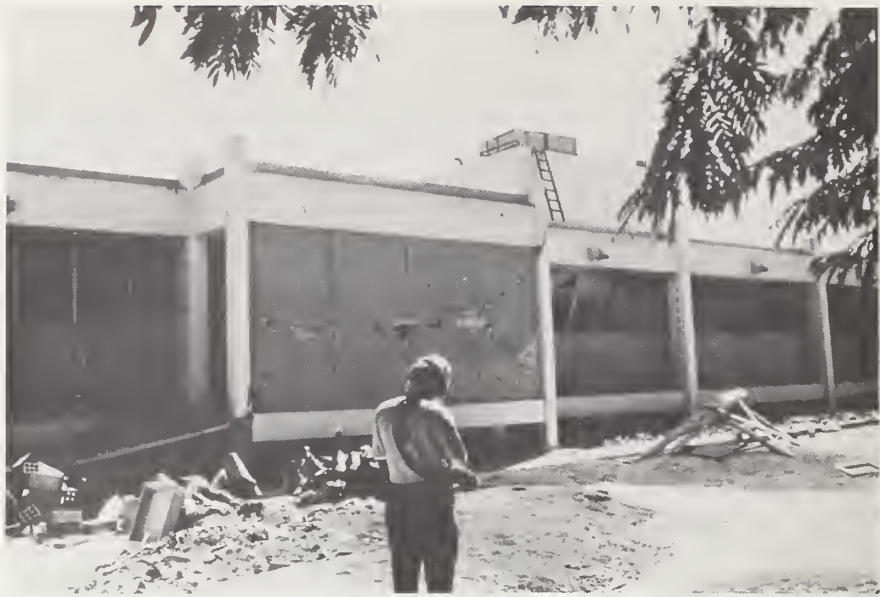
Figure 16-1 Severely damaged modern reinforced concrete frame building, INCEI administration building.

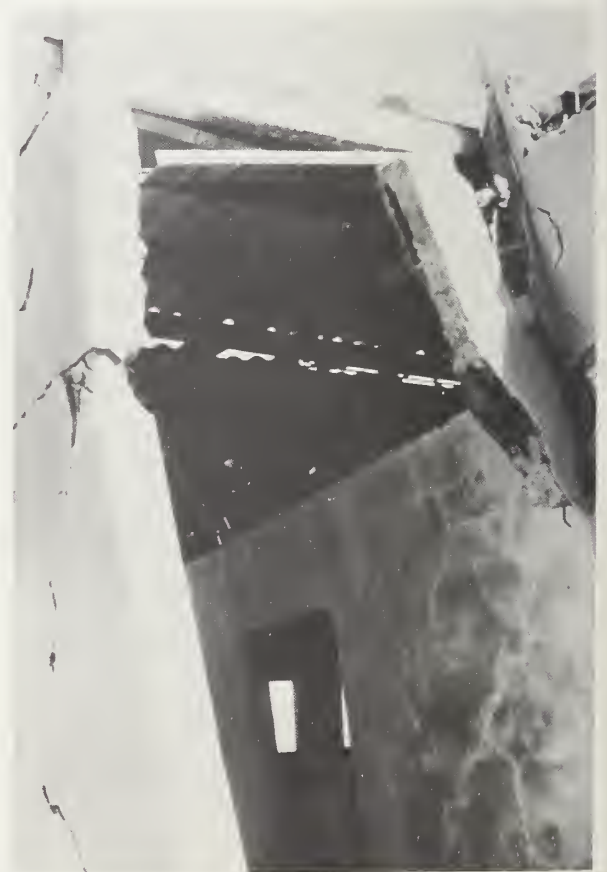
Figure 16-2 Damage from movement of inadequately braced roof, INCEI laboratory.

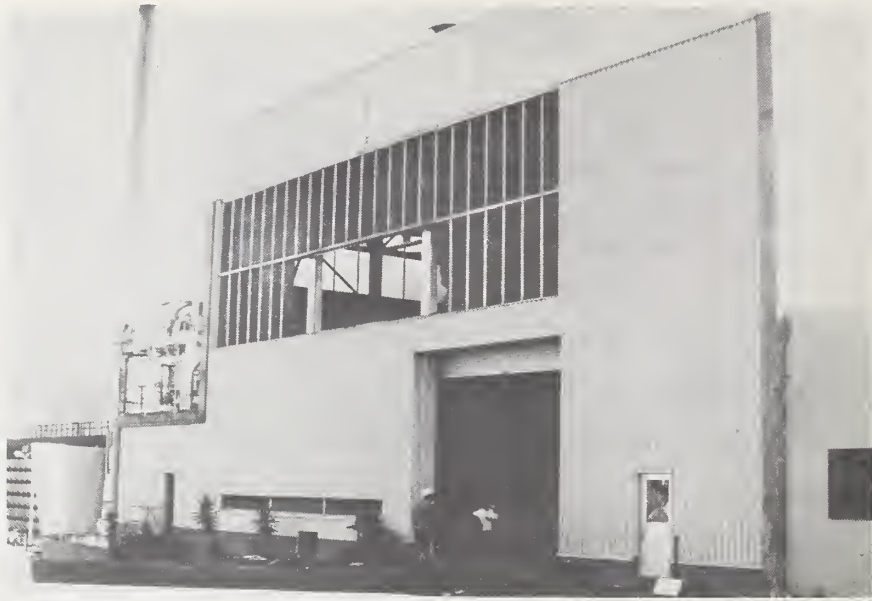
Figure 22-1 Only window damage notable in the main turbine building, Planta Eléctrica ENALUF

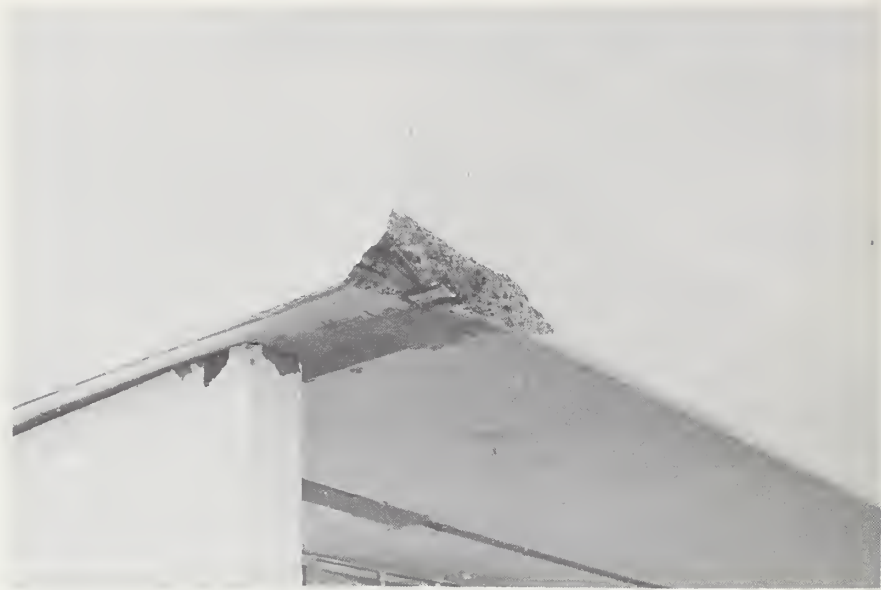
proper anchorage and energy absorbing capacity beyond maximum load probably contributed to the collapse. Careful attention to anchorage is needed for the reinforcement at corner connections between bond beams and columns for reinforced masonry walls; damages in the Salvadore Mendieta School, figure 25-2, appear to have been caused by such absence of anchorage. Elements of masonry intended to resist lateral forces should be confined by reinforced columns rather than having the masonry elements outside of the reinforcement as in the new, unused and unusable, Simon Bolivar School, figure 35-5. Attention must be given to construction joints to assure that planes of weakness are not developed in the structure as they were in the nursery school of the Mercado Oriental, figure 4-1. Cavity infill walls must be tied across the cavity and keyed to the frame beams and columns to avoid the failures occurring at the Geographical Institute, figure 75-2. Careful attention must be placed on achieving adequate continuity for precast elements as exemplified by the Bello Horizonte development, figure 24-3.

Figure 24-3 Broken weld at connection of roof channel, Bello Horizonte.

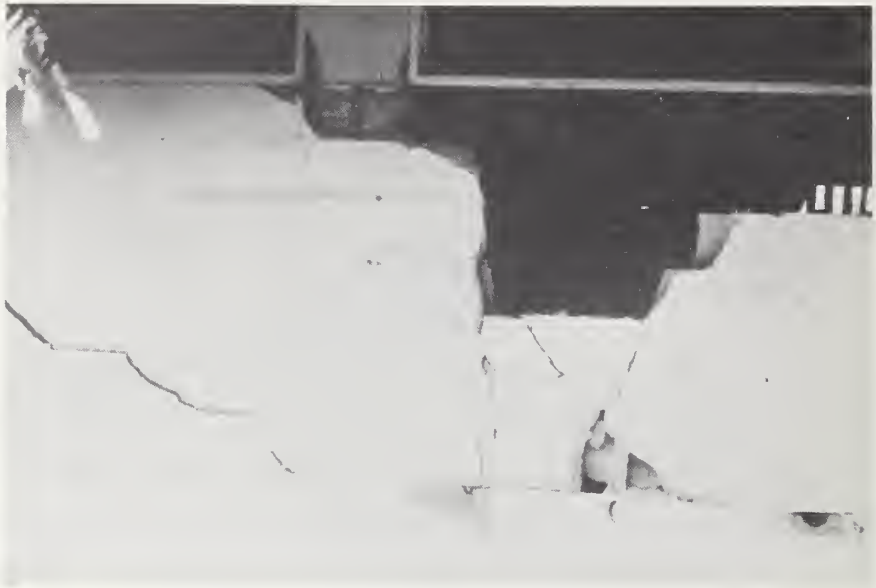
Figure 25-1 New damage over repaired cracks from the 1968 earthquake, Centro Escolar Salvador Mendieta.

Because the roof is light, reducing the earthquake forces in the structure, it appears feasible to repair these damages and return the structure to service. Attention should be given to improving the reinforcing of the block wall during the repairs.

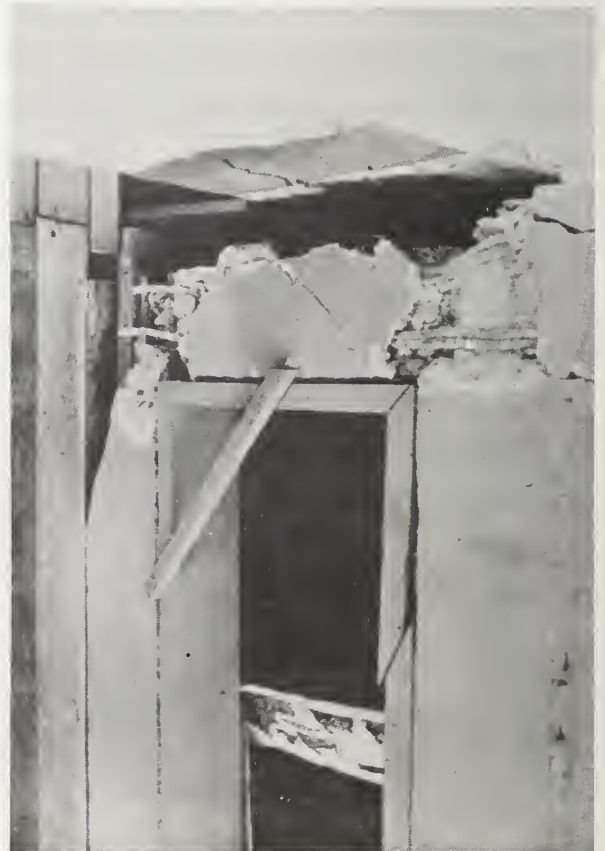
Figure 25-2 Failure of bond beam and column near aperture, note inadequacy of anchorage of reinforcement at corner.

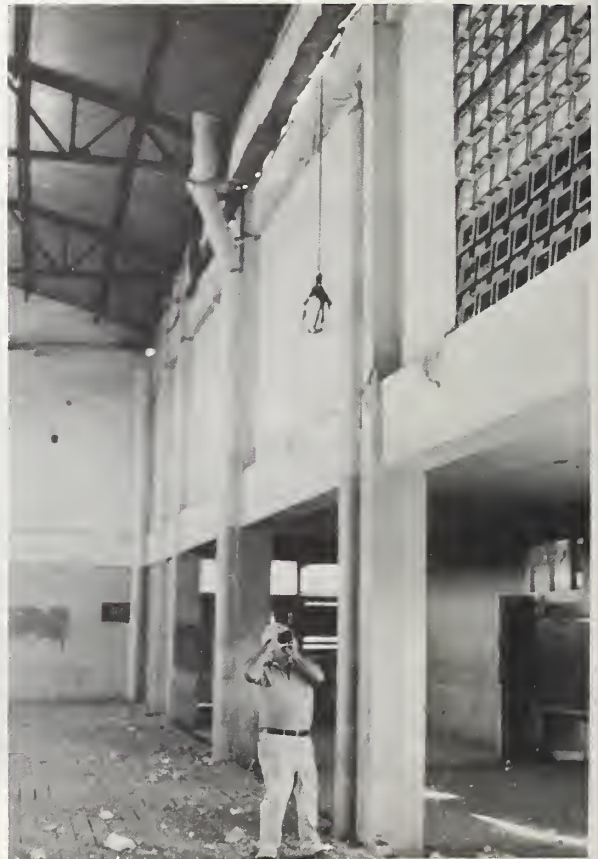
The need for proper horizontal distribution of the lateral forces induced by the earthquake also was evident in many situations. Trussed roof systems without lower chord bracing did not provide adequate horizontal diaphragm action. In a laboratory addition to the INCEI administration building, figure 16-2, the roof trusses severely displaced the end walls of the building. A similar failure occurred for the same reasons in the gymnasium of the Ramirez Goyena School, figure 38-4.

Figure 38-4 Broken wall on south side of gymnasium where school wing connects, Instituto Nacional Ramirez Goyena.

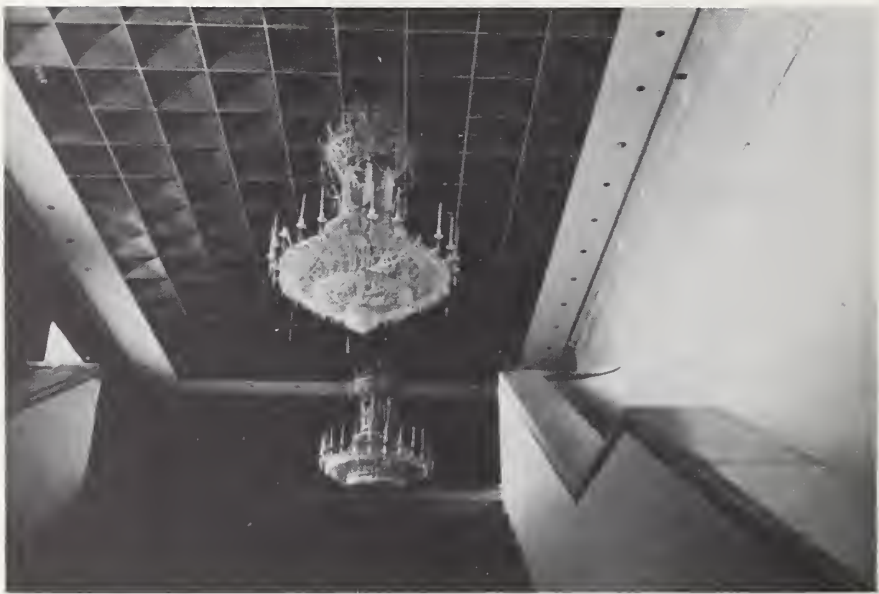
Figure 41-3 Minor finish damage amounted to fallen ceiling panels and some chips from the chandeliers, Teatro Ruben Dario.

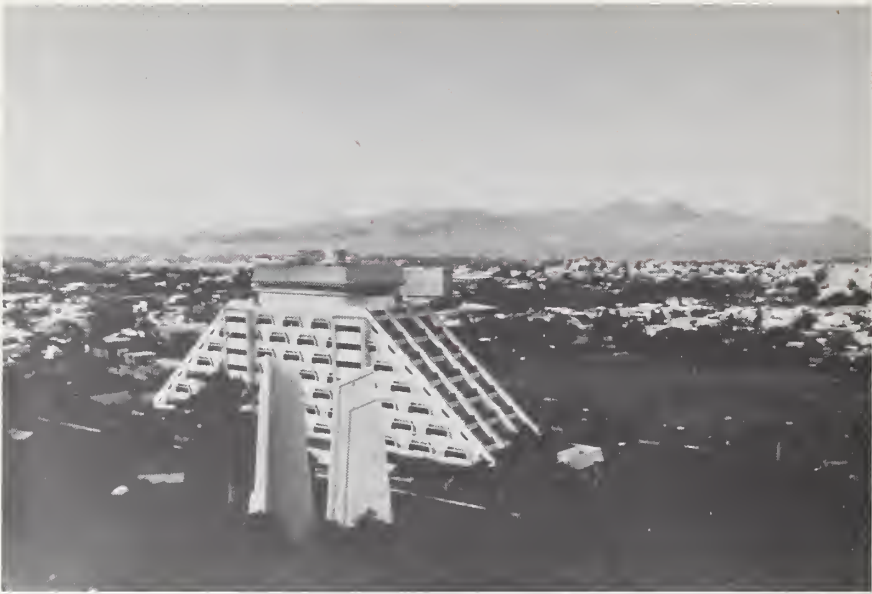
Figure 42-1 General view of Hotel Intercontinental.

- A. All beam-column connections (currently covered by architectural details) be inspected.
- B. The building reanalyzed before repairs for ground motion 1.5 times that measured at the Esso refinery or for ground motion resulting from a site study.

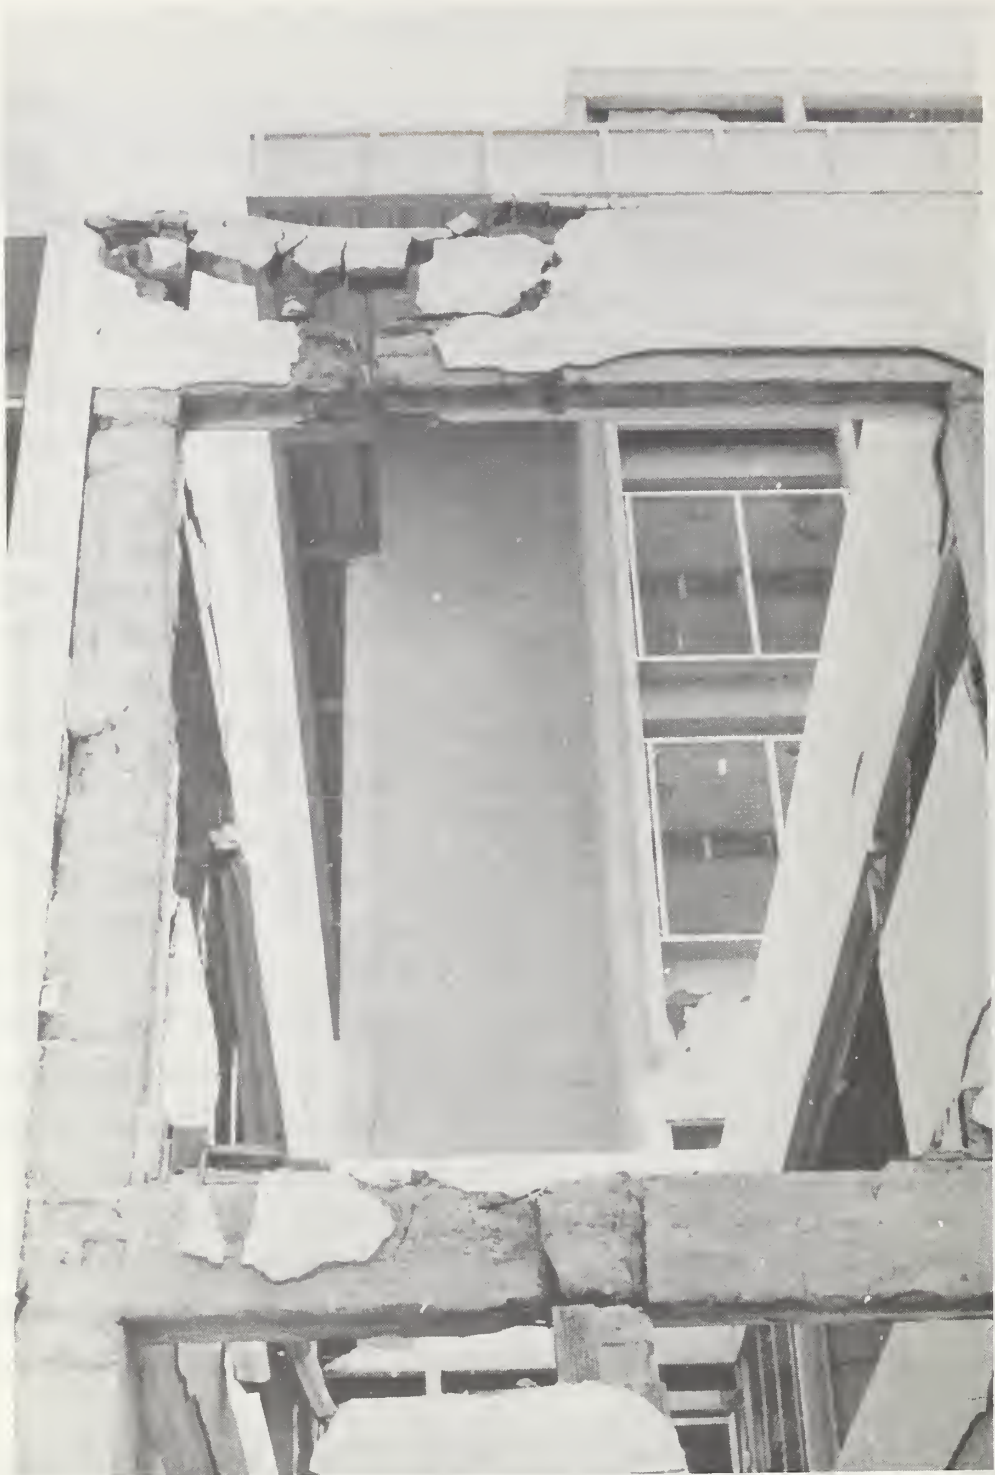
Figure 43-1 Ruptured beams connecting building elements across a courtyard, Corte Suprema de Justicia.

In general, it appears that these buildings can be returned to service following appropriate repairs which will include moderate repairs of damaged structural elements and major repairs of the non-structural elements of the buildings.

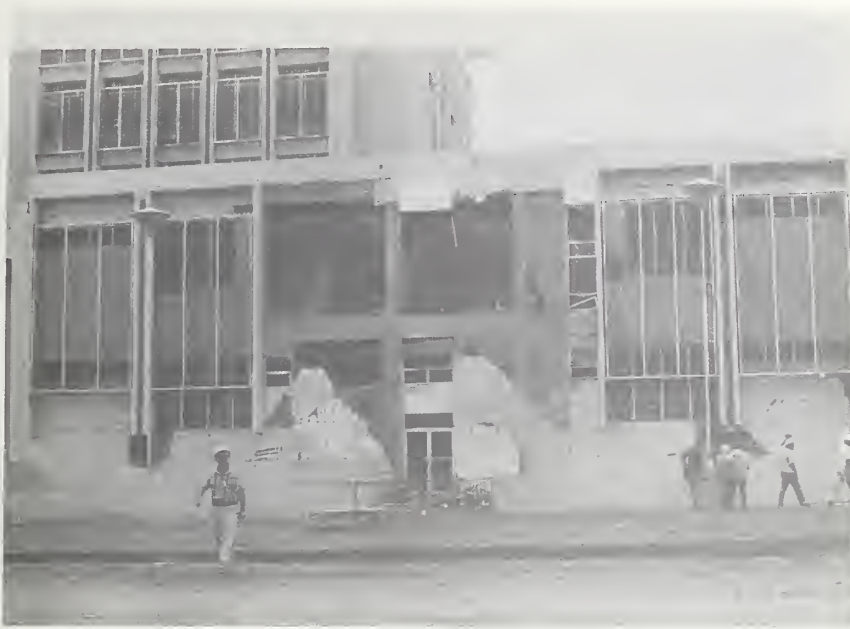
masonry partitions and curtain walls as in the INCEI warehouse, figure 16-3, and the Supreme Court building, figure 43-2; falling shelving, as in the insurance building, figure 20; displaced light fixtures as in the Central Bank, figures 52-3 and 52-4; parapets as in the Social Security Clinic, figure 71-1; and inadequately attached exterior finishes as in the Supreme Court, figure 43-4.

Figure 43-2 Extensive nonstructural damage in two story wing, Corte Suprema de Justicia.

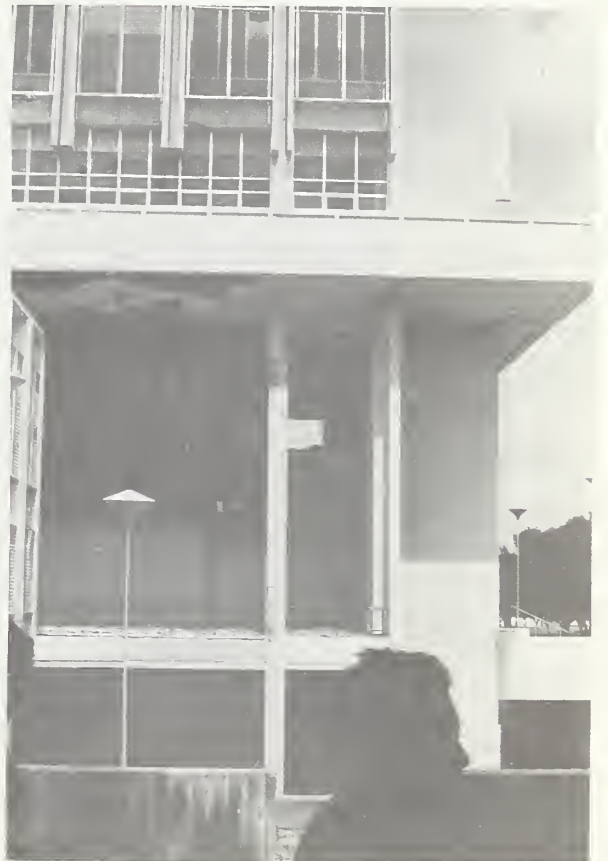
Figure 43-3 Nonstructural damage on 6 story wing, Corte Suprema de Justicia.

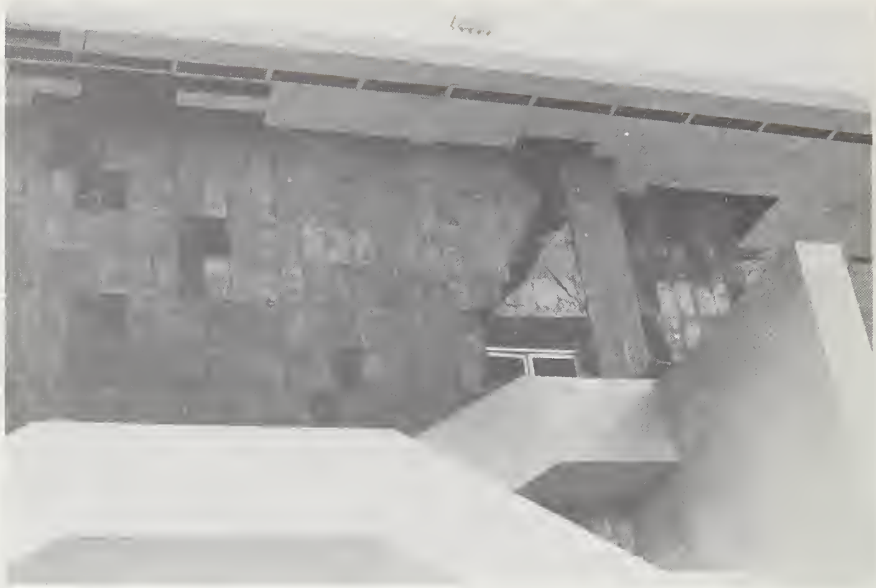
Figure 43-4 Extensive loss of exterior finish panels on 6 story wing, Corte Suprema de Justicia.

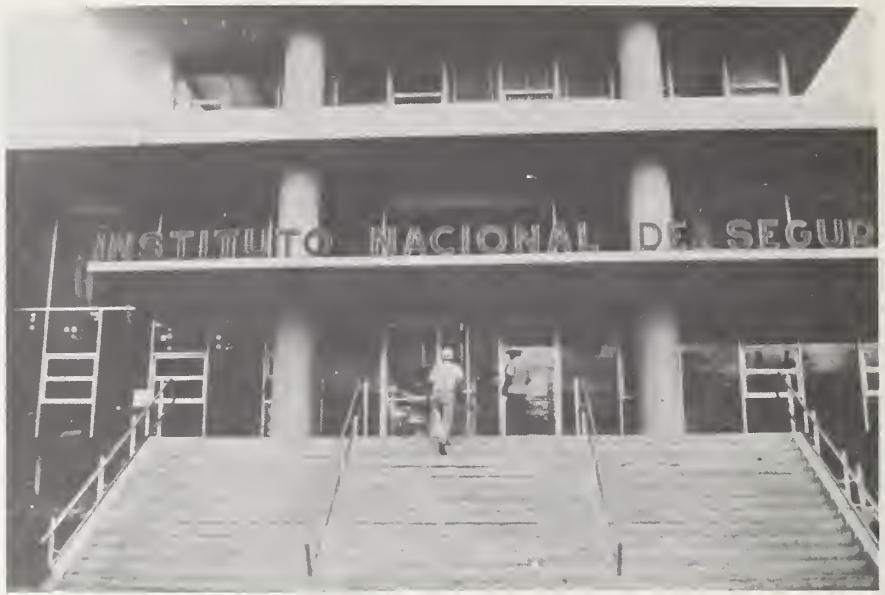
Figure 44-1 Main entrance to nine story frame showing absence of structural damage, Edificio Administrativo INSS.

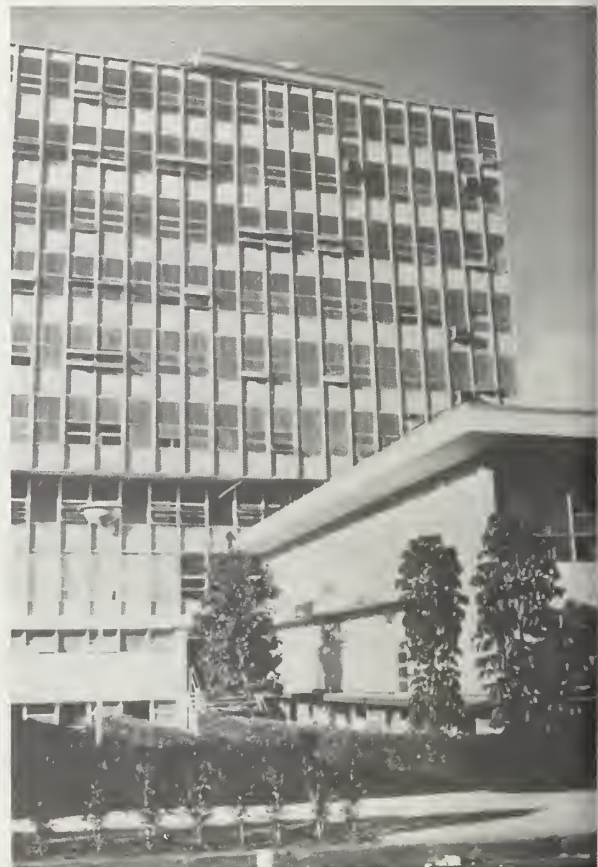
Figure 44-2 Facade shows limited nonstructural damage and collapsed mechanical penthouse, Edificio Administrativo INSS.

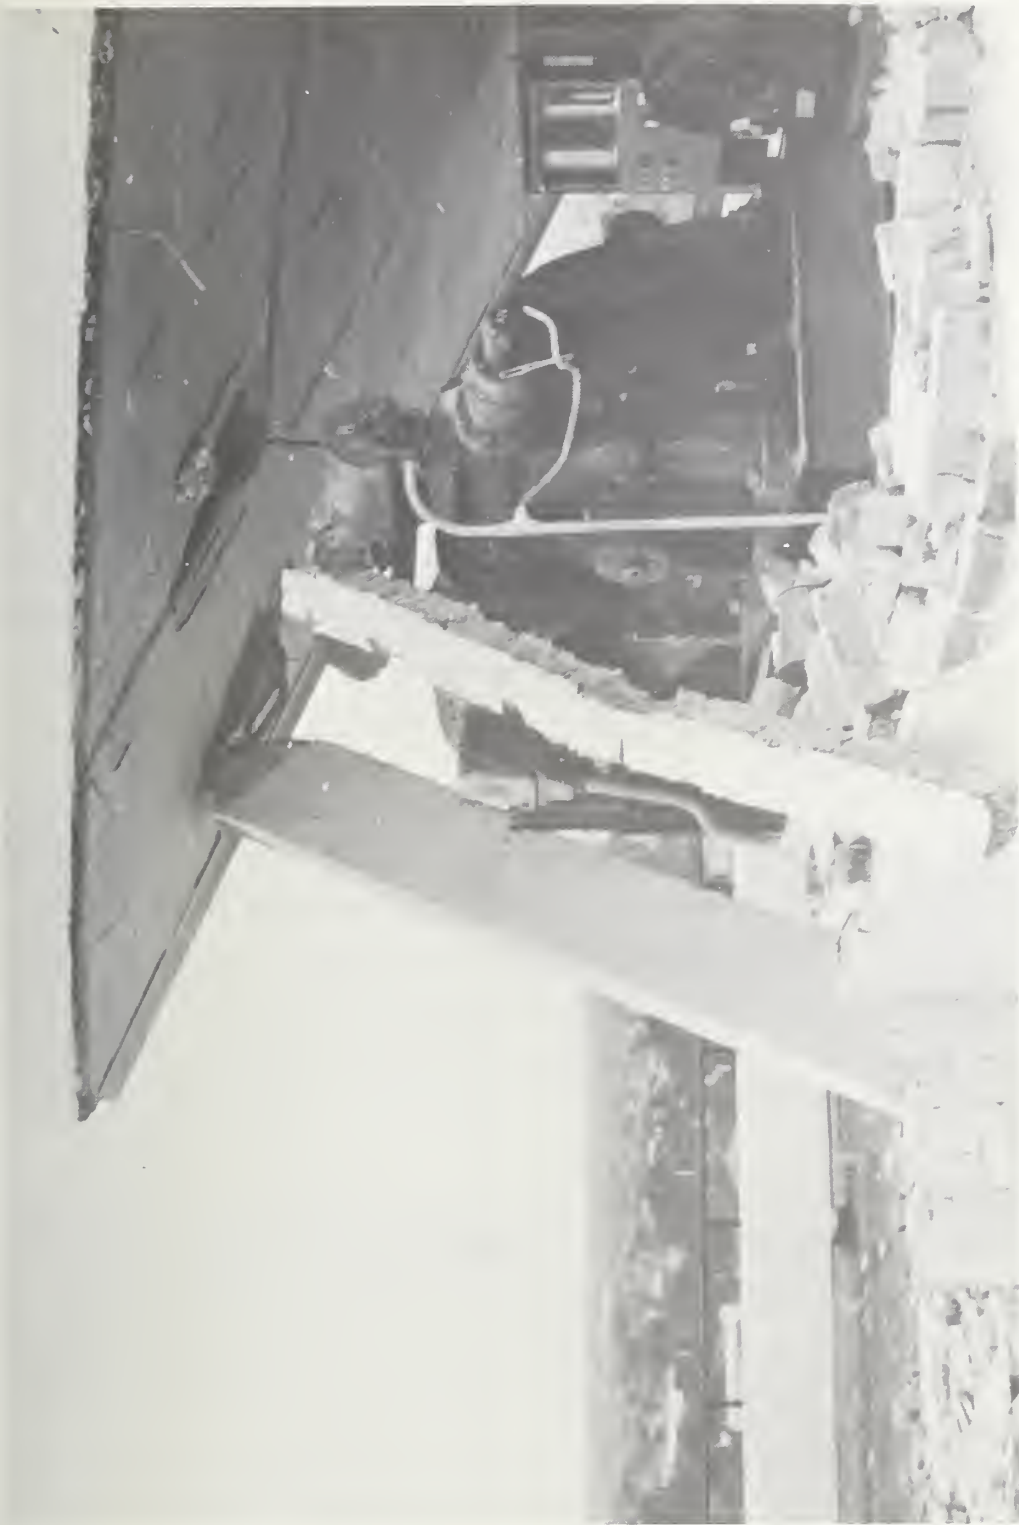
Figure 44-3 Collapsed mechanical penthouse, Edificio Administrativo INSS.

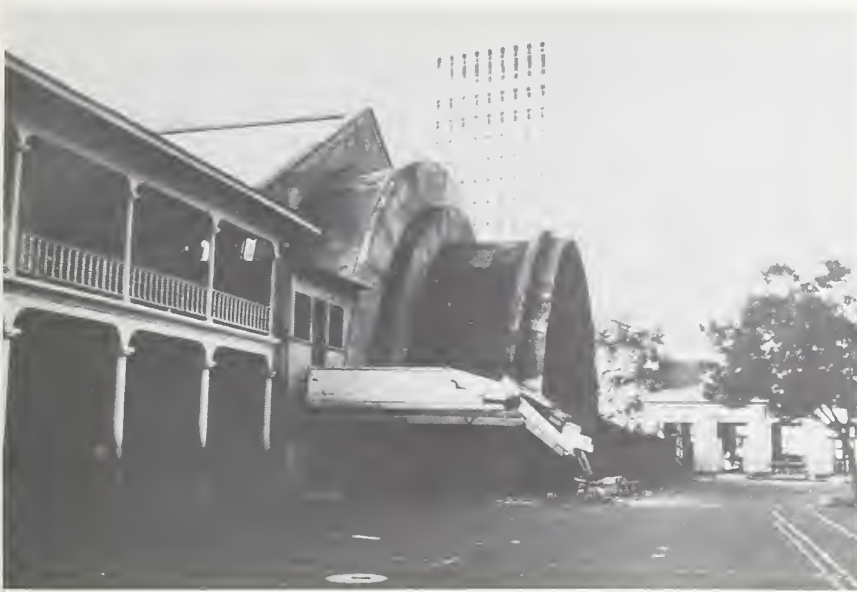
Figure 46-1 Old building and chapel of the Instituto Pedagógico.

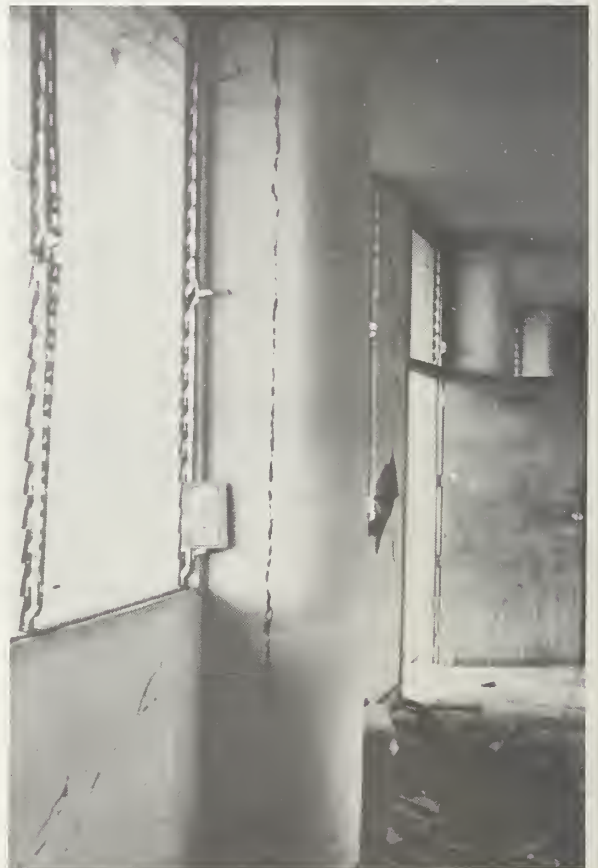
Figure 46-4 Cracking of columns,
Instituto Pedagogico.

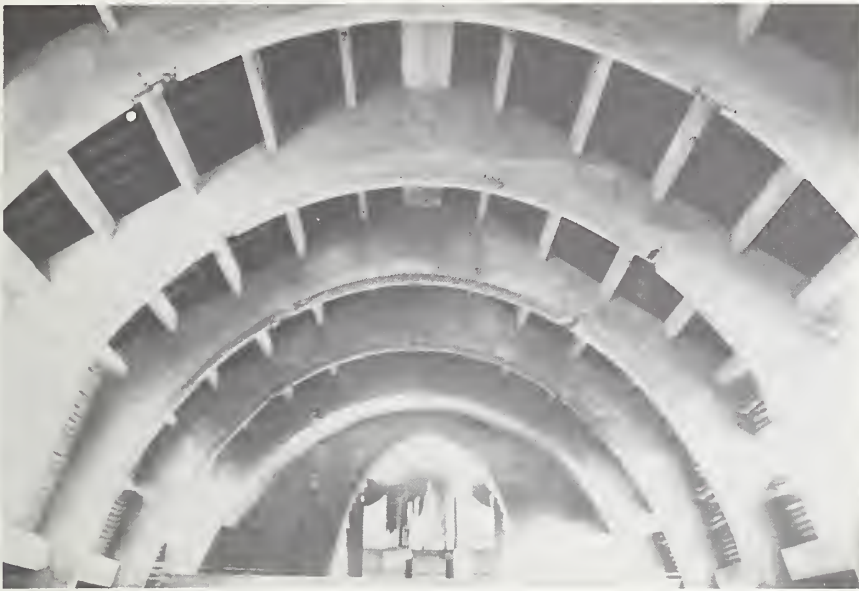
Several arches were structurally damaged by transverse motion, as well as the structure near the east end, figures 46-5 and 46-6. The building is not in danger of collapse but should be repaired (after an appropriate analysis) as soon as possible. It should be closed until repaired.

Figure 46-5 Cracking in arches of chapel, Instituto Pedagógico.

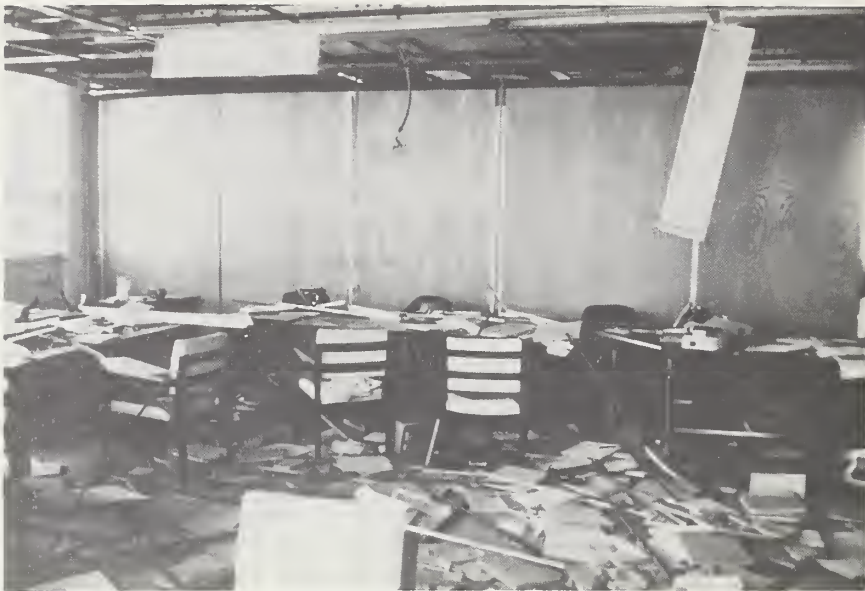
Figure 52-3 Nonstructural damage in an office, Banco Central.

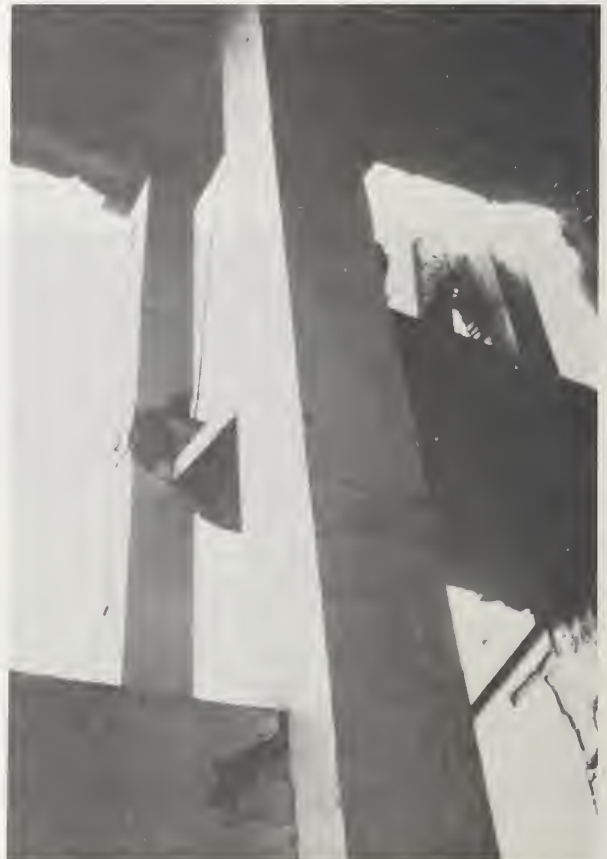
Figure 53-2 Damaged framing of gymnasium, Seminario Catolico.

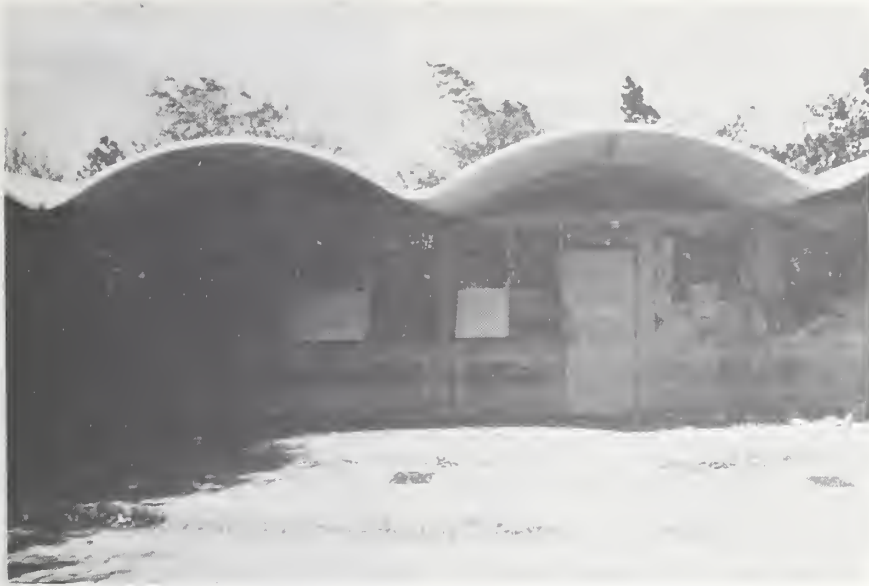
A one story building with a shell roof exhibits failures of the supporting columns, figure 53-3. A multistory reinforced concrete frame building, under construction and partially infilled shows frame failures in unfilled stories, figure 53-4.

Figure 53-3 Severely damaged columns supporting shell roof, Seminario Catolico.

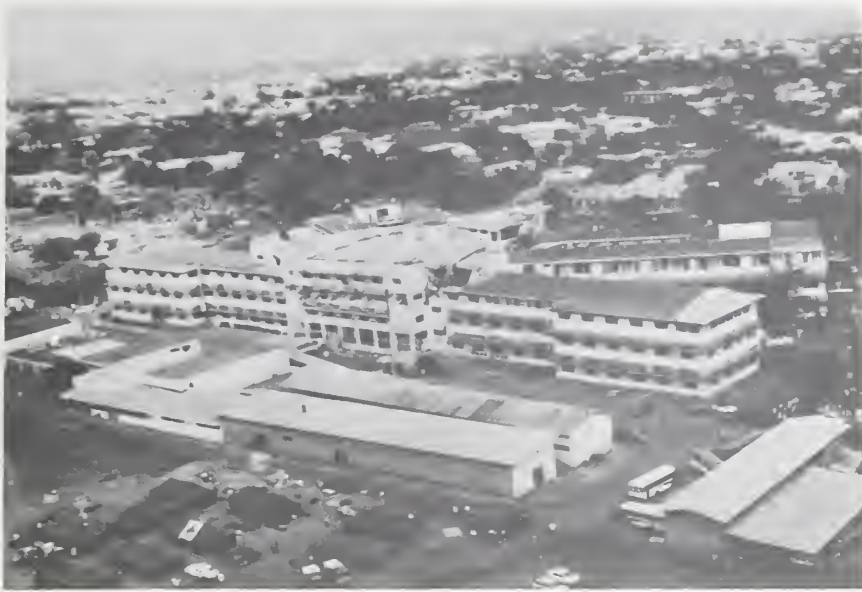
Figure 55-1 Aerial view from the rear, Hospital General El Retiro.

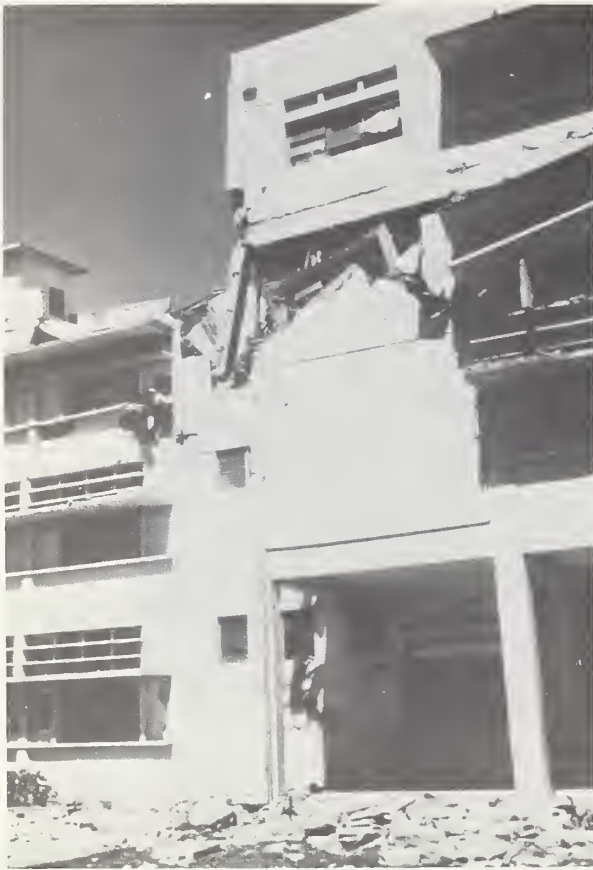
Figure 55-7 Third floor of the Hospital General El Retiro near collapse at rear.
