NBS TECHNICAL NOTE 807

Building Performance in the 1972 Managua Earthquake

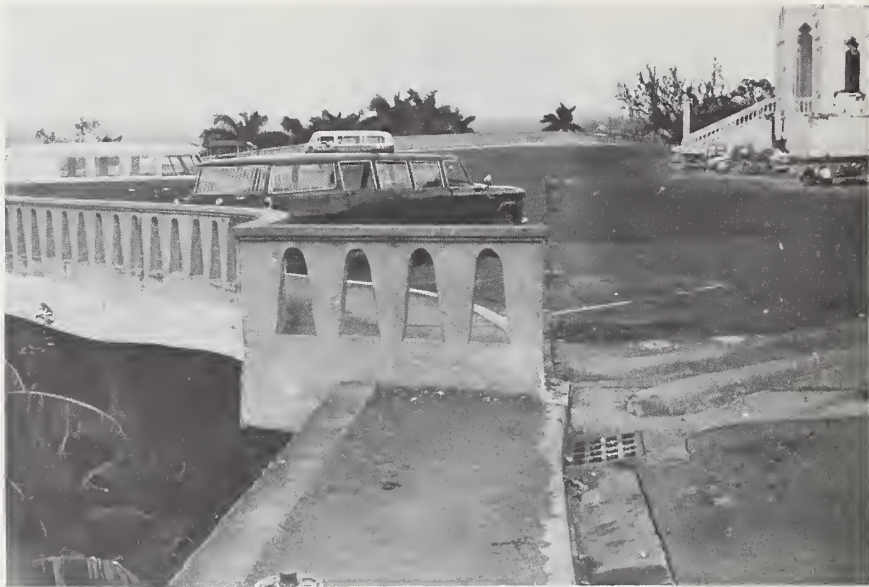
Figure 57-2 Cracking in road in front of house above retaining wall of the Storeroom of the Pines, Casa Presidencial.

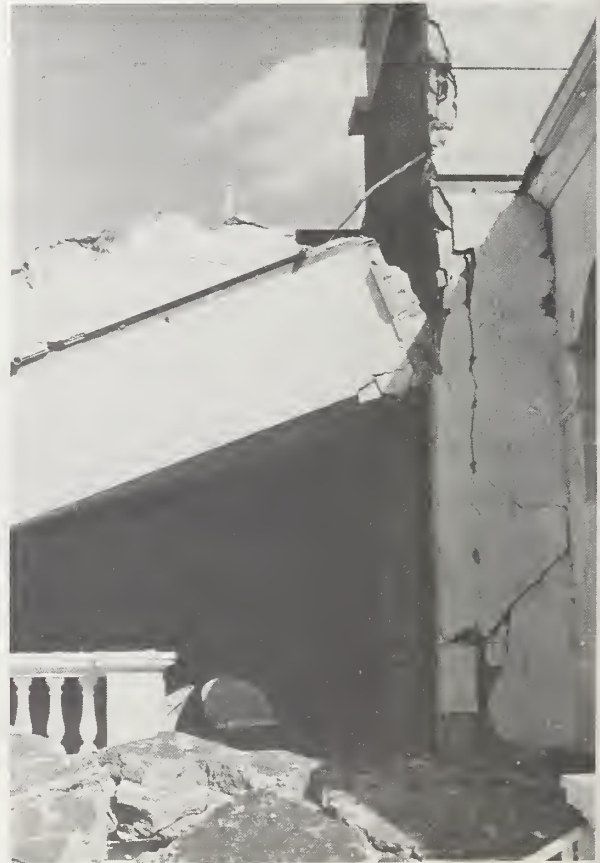
Figure 60-2 Detail of collapsed terrace roof, Casa Presidencial.

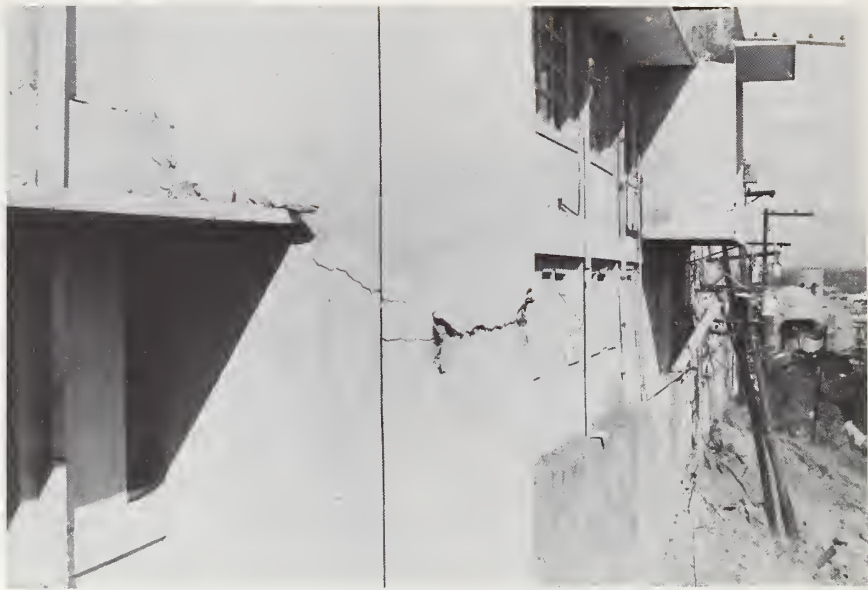
Figure 60-5 Cracking of walls at rear of building, Casa Presidencial.

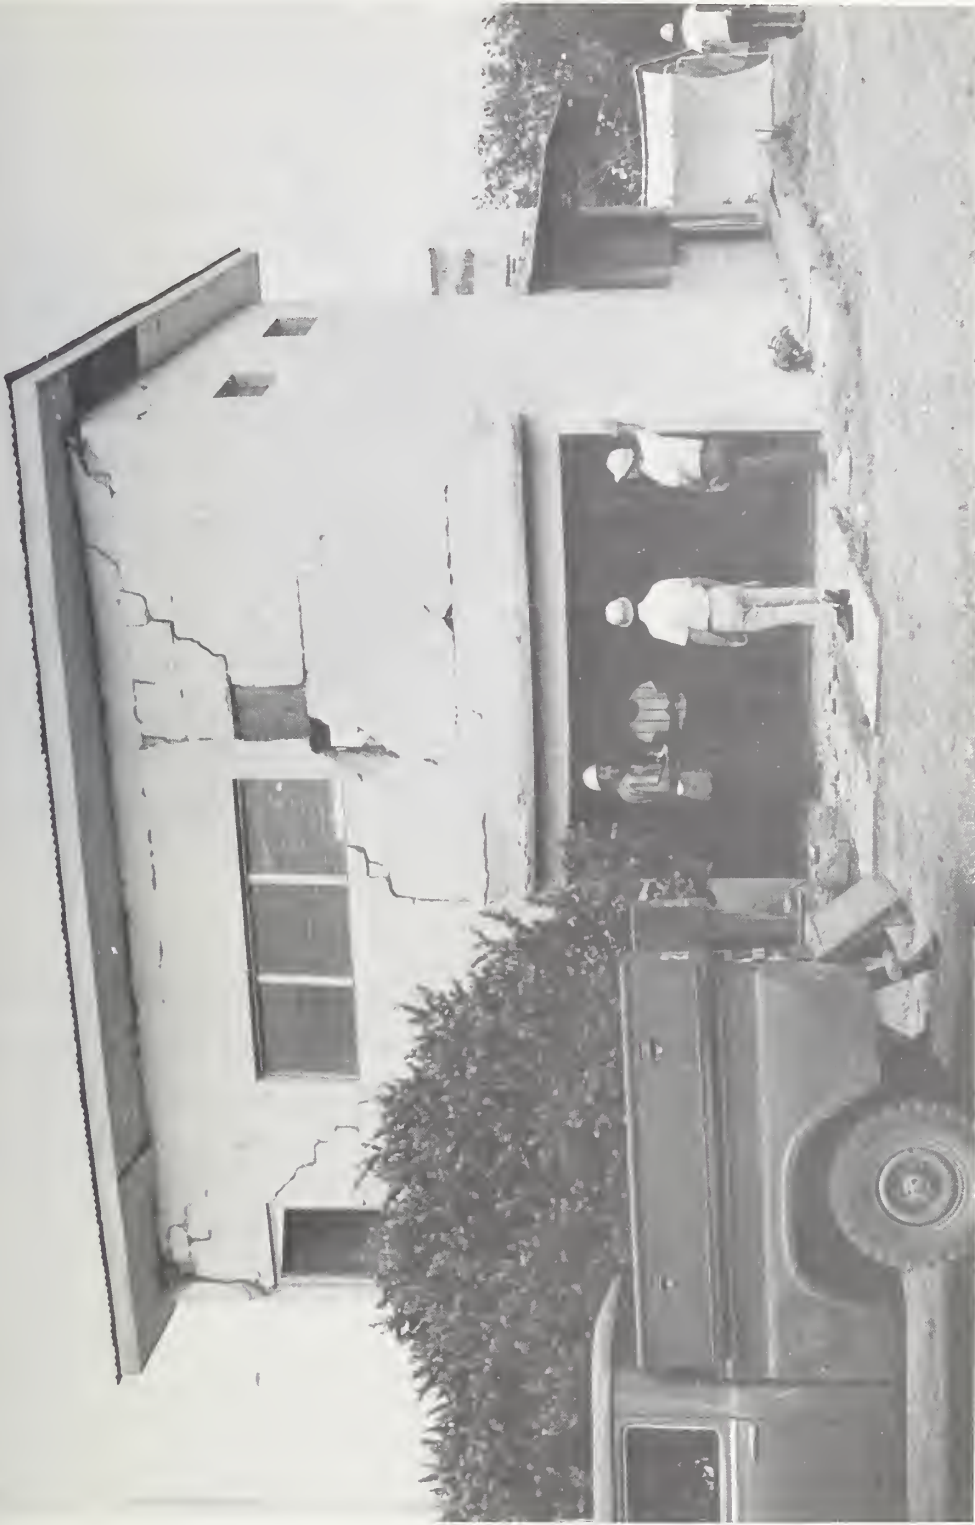
Figure 62-1 A very fragile building housing the country's radio transmission equipment, Radio-Difusora Nacional.

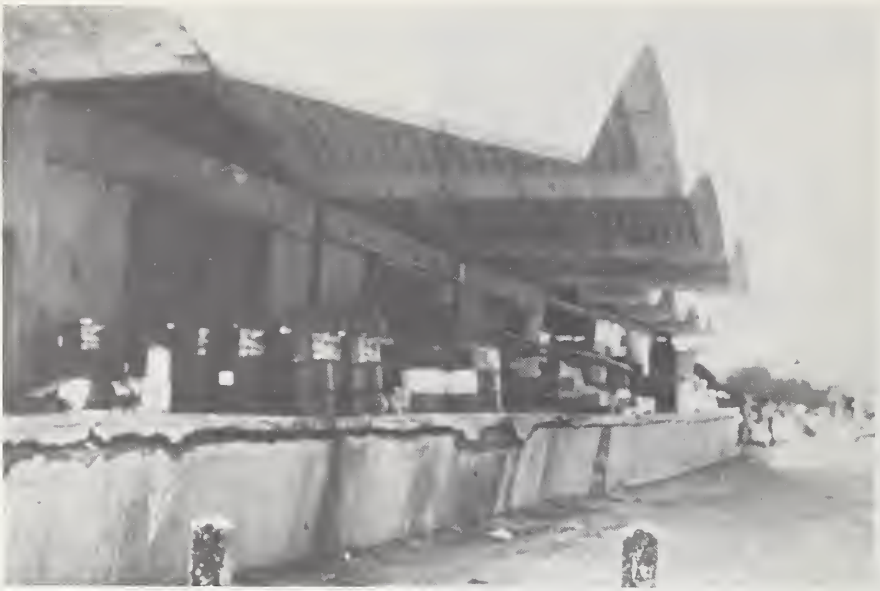
Many of the structural failures in Managua can be attributed to inadequacy of the structural systems for the lateral forces imposed by the earthquake. Heavy barrel shell roofs such as that of the Aduana (Customs House), figure 68-3, sheared their columns, figure 68-4, and collapsed or came to rest upon the contents of the building. Many multistory reinforced concrete buildings collapsed such as the Guerrero Pineda five story building, figure 74-2. Some modern one story buildings such as the INCET (National Granary) administration building, figure 16-1, appear to have been constructed with unnecessarily heavy roofs and framing systems inadequate for the resulting lateral forces. There was evidence in the Instituto Pedagogico, figure 46-3, that flat slabs showed some distress in functioning as the horizontal framing member between columns.

Figure 68-3 General view of damaged barrel shed,
Aduana General de Managua.

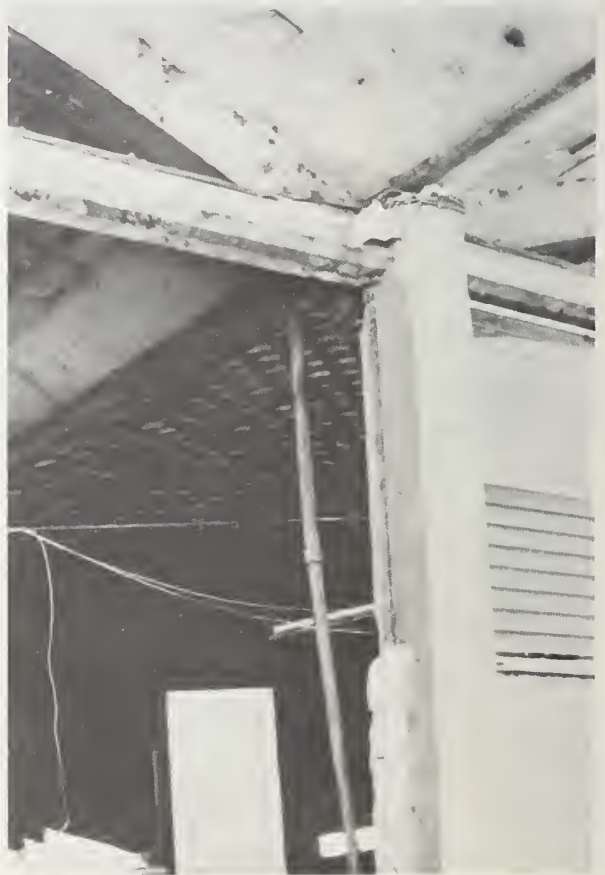
Figure 68-4 Close up of sheared
exterior columns,
Aduana General de
Managua.

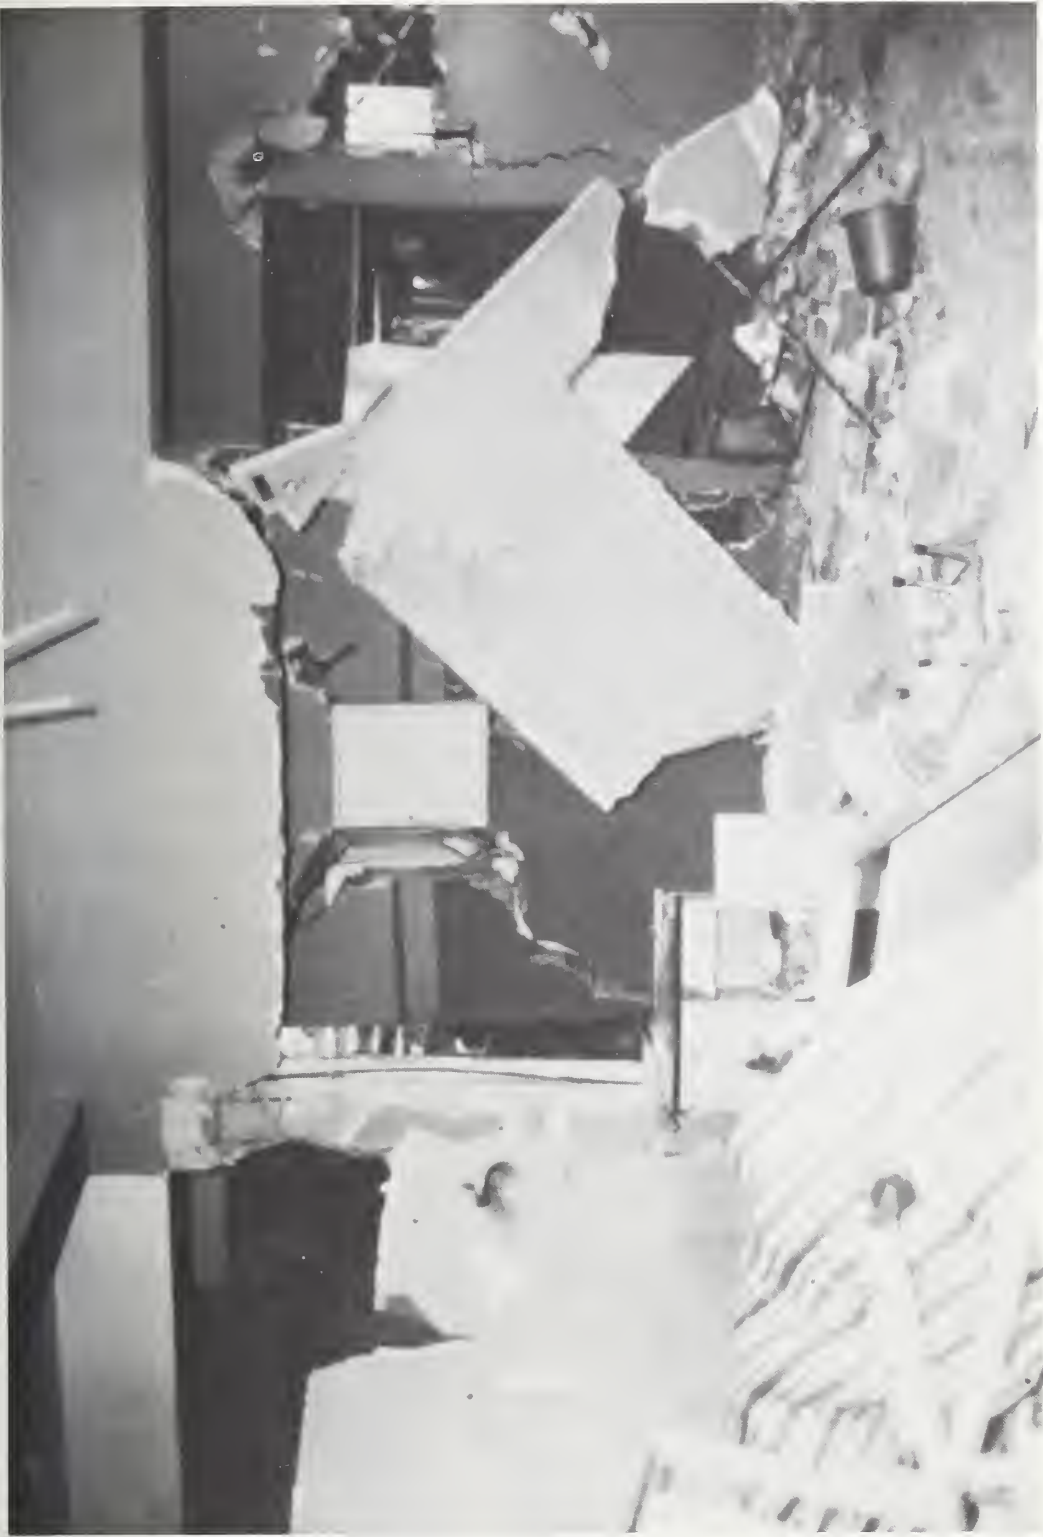
Figure 70-5 Structural and nonstructural damage in wards, Hospital del INSS.

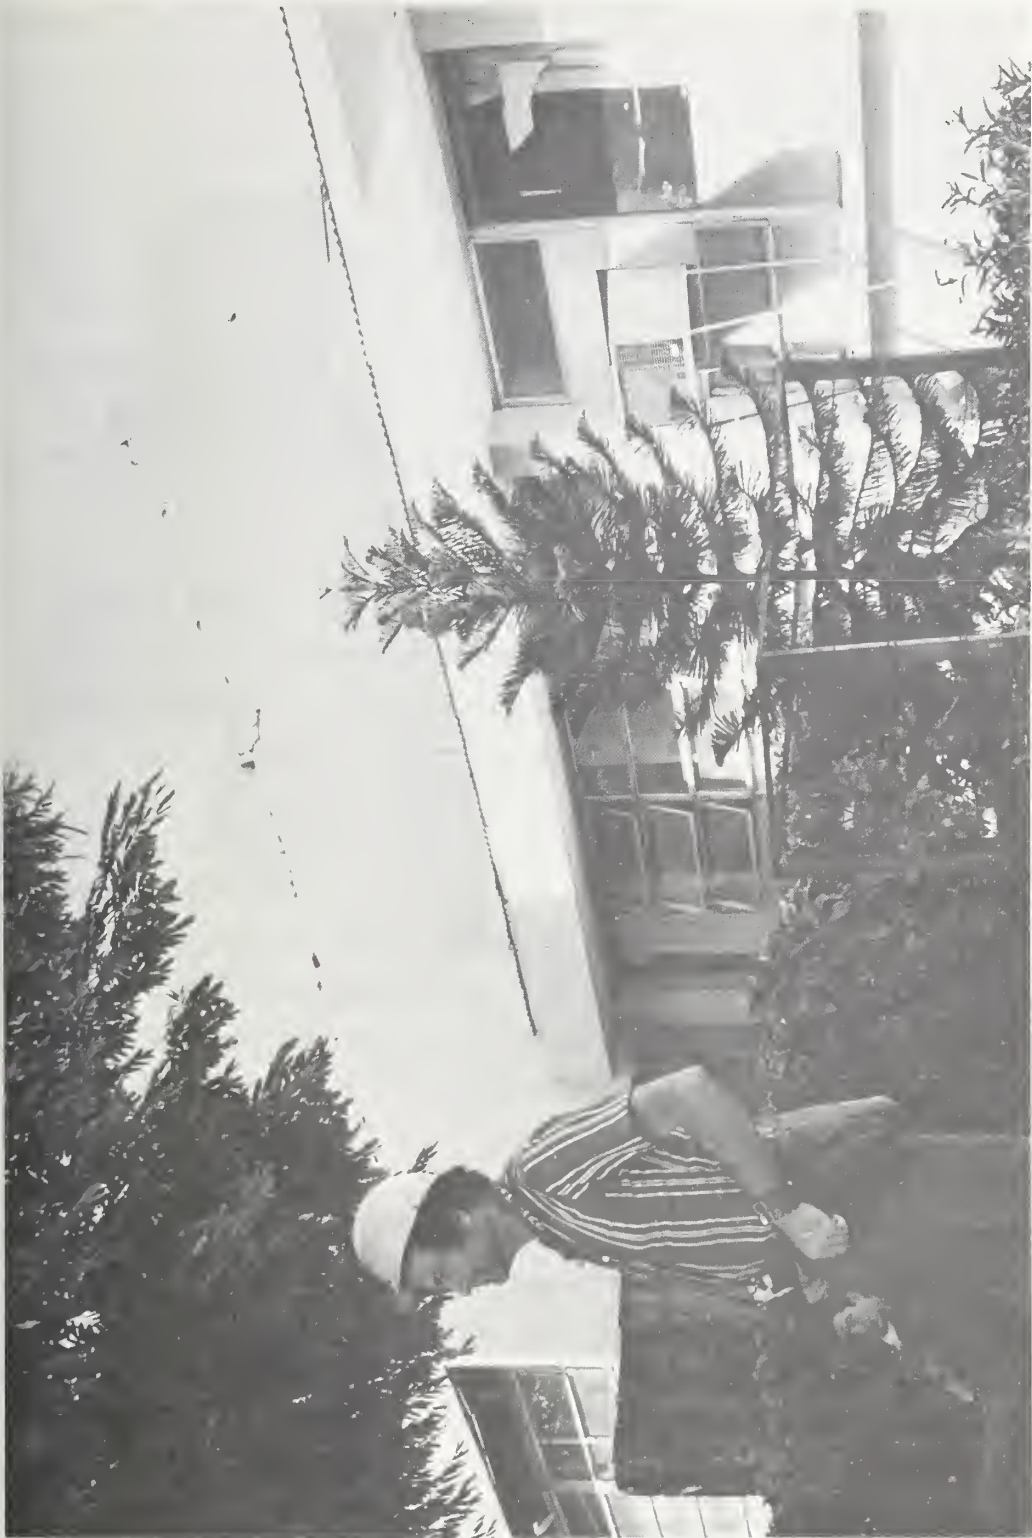
Figure 71-1 Cracked parapet walls, Policlínica Central del INSS.

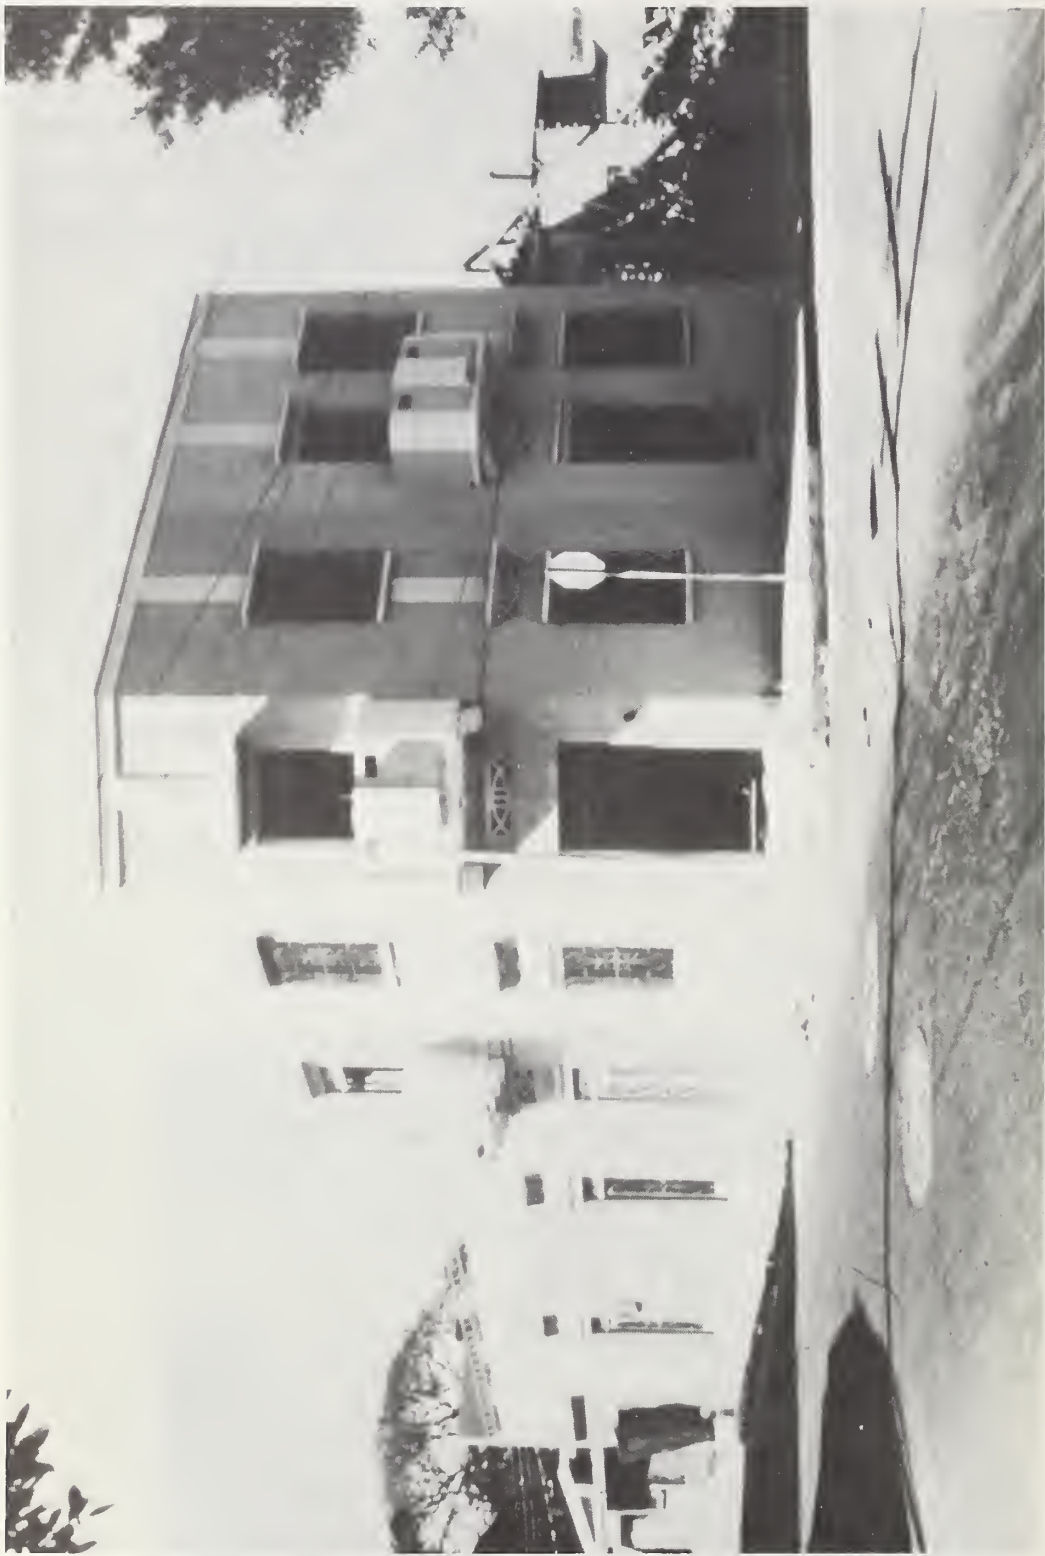
Figure 74-3 Building across from Guerrero Pineda shows little damage.
