AAIB Bulletin S1/2017

SPECIAL

ACCIDENT

Aircraft Type and Registration:	Sikorsky S-92A, G-WNSR
No & Type of Engines:	2 General Electric Co CT7-8A turboshaft engines
Year of Manufacture:	2014 (Serial no: 920250)
Location:	West Franklin wellhead platform, North Sea
Date & Time (UTC):	28 December 2016 at 0844 hrs
Type of Flight:	Commercial Air Transport (Passenger)
Persons on Board:	Crew - 2 Passengers - 9
Injuries:	Crew - None Passengers - None
Nature of Damage:	Left outer mainwheel rim distortion, seized tail rotor pitch change shaft bearing, servo piston fracture and minor damage to helideck
Commander's Licence:	Airline Transport Pilot's Licence (H)
Commander's Flying Experience:	To be confirmed
Information Source:	AAIB Field Investigation

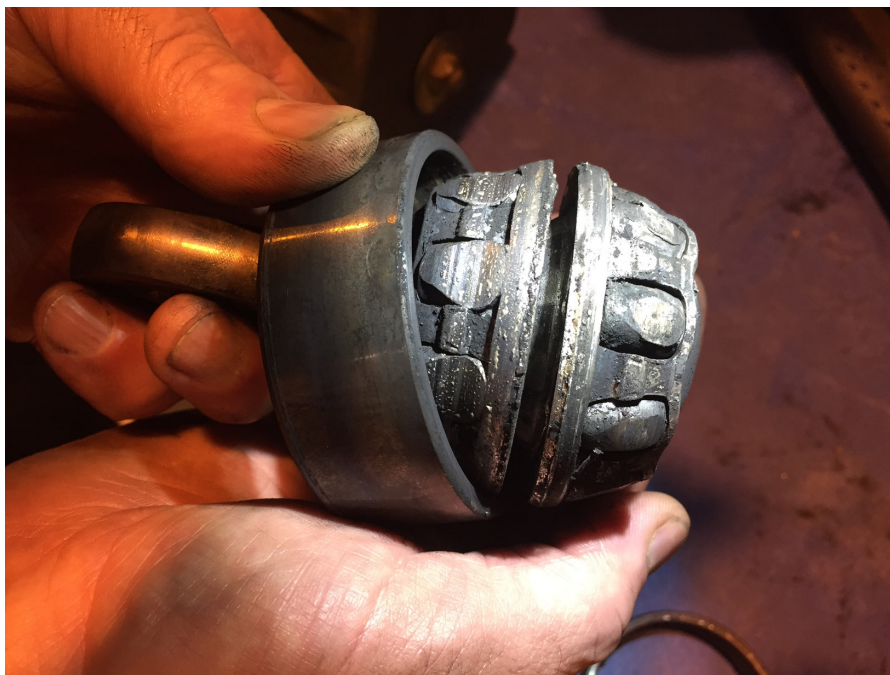
Figure 1

The technical investigation focussed on the tail rotor and associated components. Once the panels were removed it was immediately apparent that the tail rotor servo piston was damaged. The servo was removed and revealed that the tail rotor pitch change shaft (TRPCS) double row angular contact bearing was in a severely distressed condition (Figure 1).

TRPCS double row angular contact bearing from G-WNSR

Further disassembly and examination of the components found signs of severe overheating with extreme wear on the inner and outer thrust races and barrel shaped rollers of the bearing. It was found that the roller bearings seized to the inner member. The outer race roller had excessive axial play (0.5 in), such that the tail rotor driveshaft imparted a torsional load to the tail rotor servo. This torsional load caused the primary piston rod to fracture inside the servo. Due to the failure of the primary piston, the secondary piston sleeve separated axially from the primary piston adjacent to the link fitting, with the consequential total loss of control of the tail rotor.

The components were shipped to the helicopter manufacturer for forensic analysis. Initial findings indicate that the failure of this specific bearing was rapid; a period of 4.5 hours had elapsed from the first exceedance of the relevant bearing condition indicator recorded on the operator's Health and Usage Monitoring System (HUMS) to the point of failure.
