RECLAMATION SERVICE - ORPHAN MINE

GRAND CANYON NATIONAL PARK, ARIZONA

ORPHAN MINE

June 1986

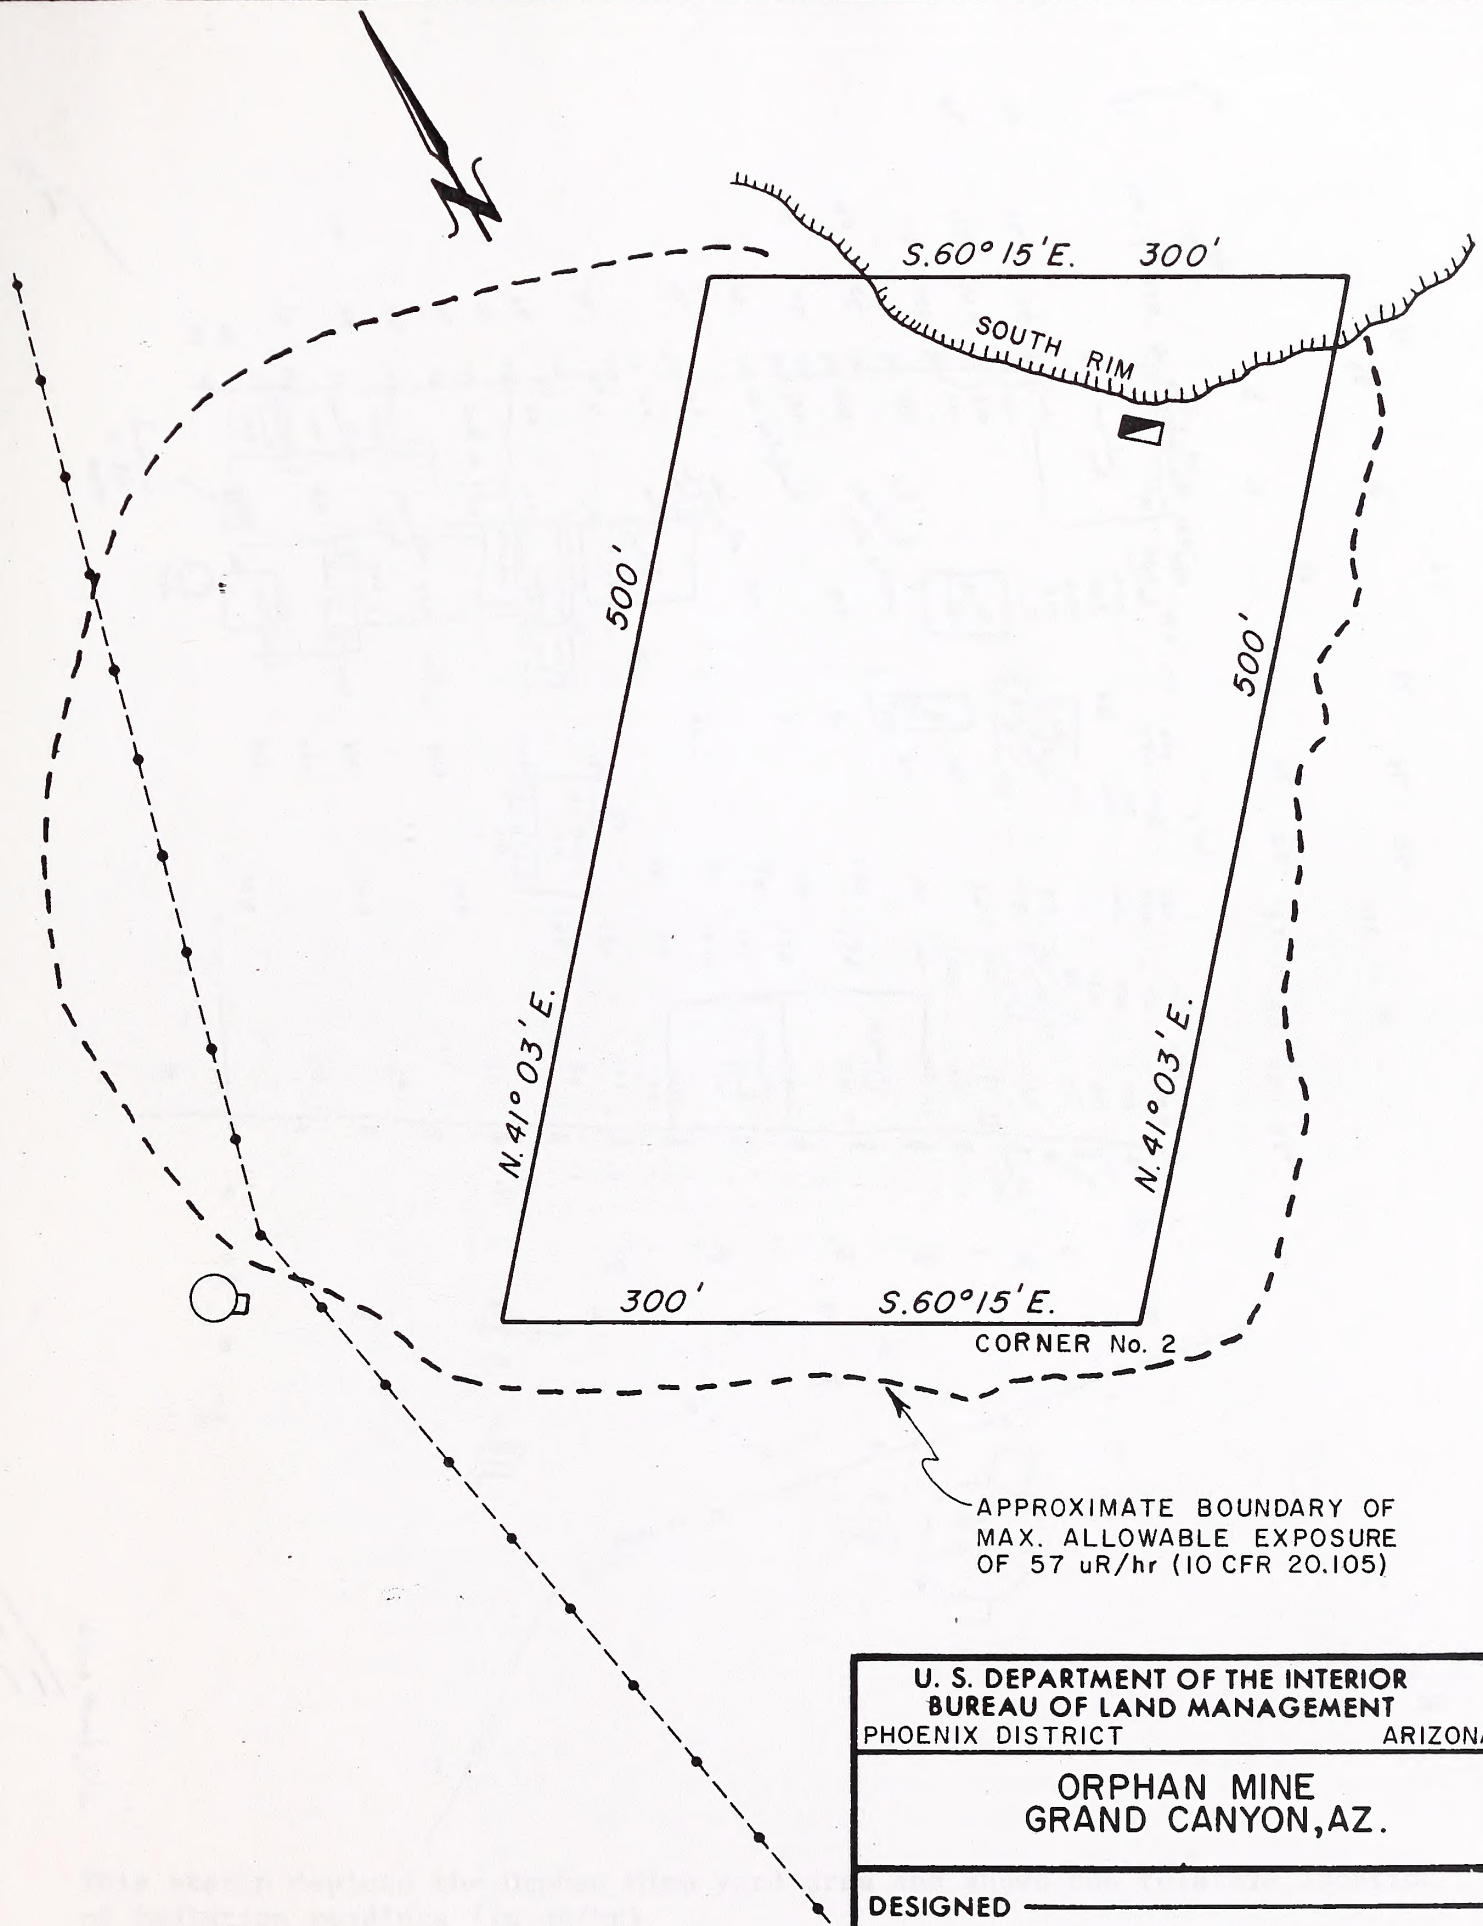
FIGURE - 4

4. **SHAFT AND CONTAMINATED MATERIALS.** Based upon the BLM radiological survey, the area in and around the mine yard is emitting low levels of radiation. Two explanations of the source of the low level radiation would be that material from the mine was used as fill when the mine yard site was being prepared and/or the random scattering of uranium ore by men and equipment during the active mining periods. In addition, it appears that low level radioactive material was transported by wind and water action to the Park lands adjacent to the fenced mine yard. Please refer to Figure 4 which shows the area, approximately 5.6 acres in size, where contamination has occurred. Figure 5 is a sketch copy of the mine yard area which shows the readings taken during the radiological survey.

APPROXIMATE BOUNDARY OF
MAX. ALLOWABLE EXPOSURE
OF 57 uR/hr (10 CFR 20.105)

In order to minimize the exposure from this hazard, it is recommended that the area showing radiation levels greater than the amount specified by Part 20 of Title 10 of the Code of Federal

Regulations, 10 CFR 20.105(a), be removed and properly disposed of by burial. The limit of 0.5 rem per year exposure or 57 microrem per hour (57 uR/hr) contained in the above cited regulation and recommended in this report is the limit allowed by the Nuclear Regulatory Commission for areas where unrestricted uses are anticipated. Therefore, the achieving of this permissible radiation level or a lower level would be a reasonable expectation for the Orphan Mine site in light of the easy access into the mine yard area by Park visitors.

It is recommended that the contaminated material with the highest radiation readings in and around the fenced mine yard be deposited down into the mine shaft which still contains radioactive materials. The use of the mine shaft would minimize any hazards associated with transporting the material to a remote burial site. The contaminated materials will consist of soil and concrete. However, based on a preliminary estimate which assumes no interference from the shaft support structure or from any mine support equipment such as air and water lines, the total volume of contaminated material will exceed the volume of the mine shaft by 100 to 200%. Therefore, the material with lower radiation readings will either have to be transported to a remote burial site or buried on site. Contaminated material located off the edge of the rim should also be recovered but may be difficult to reach with

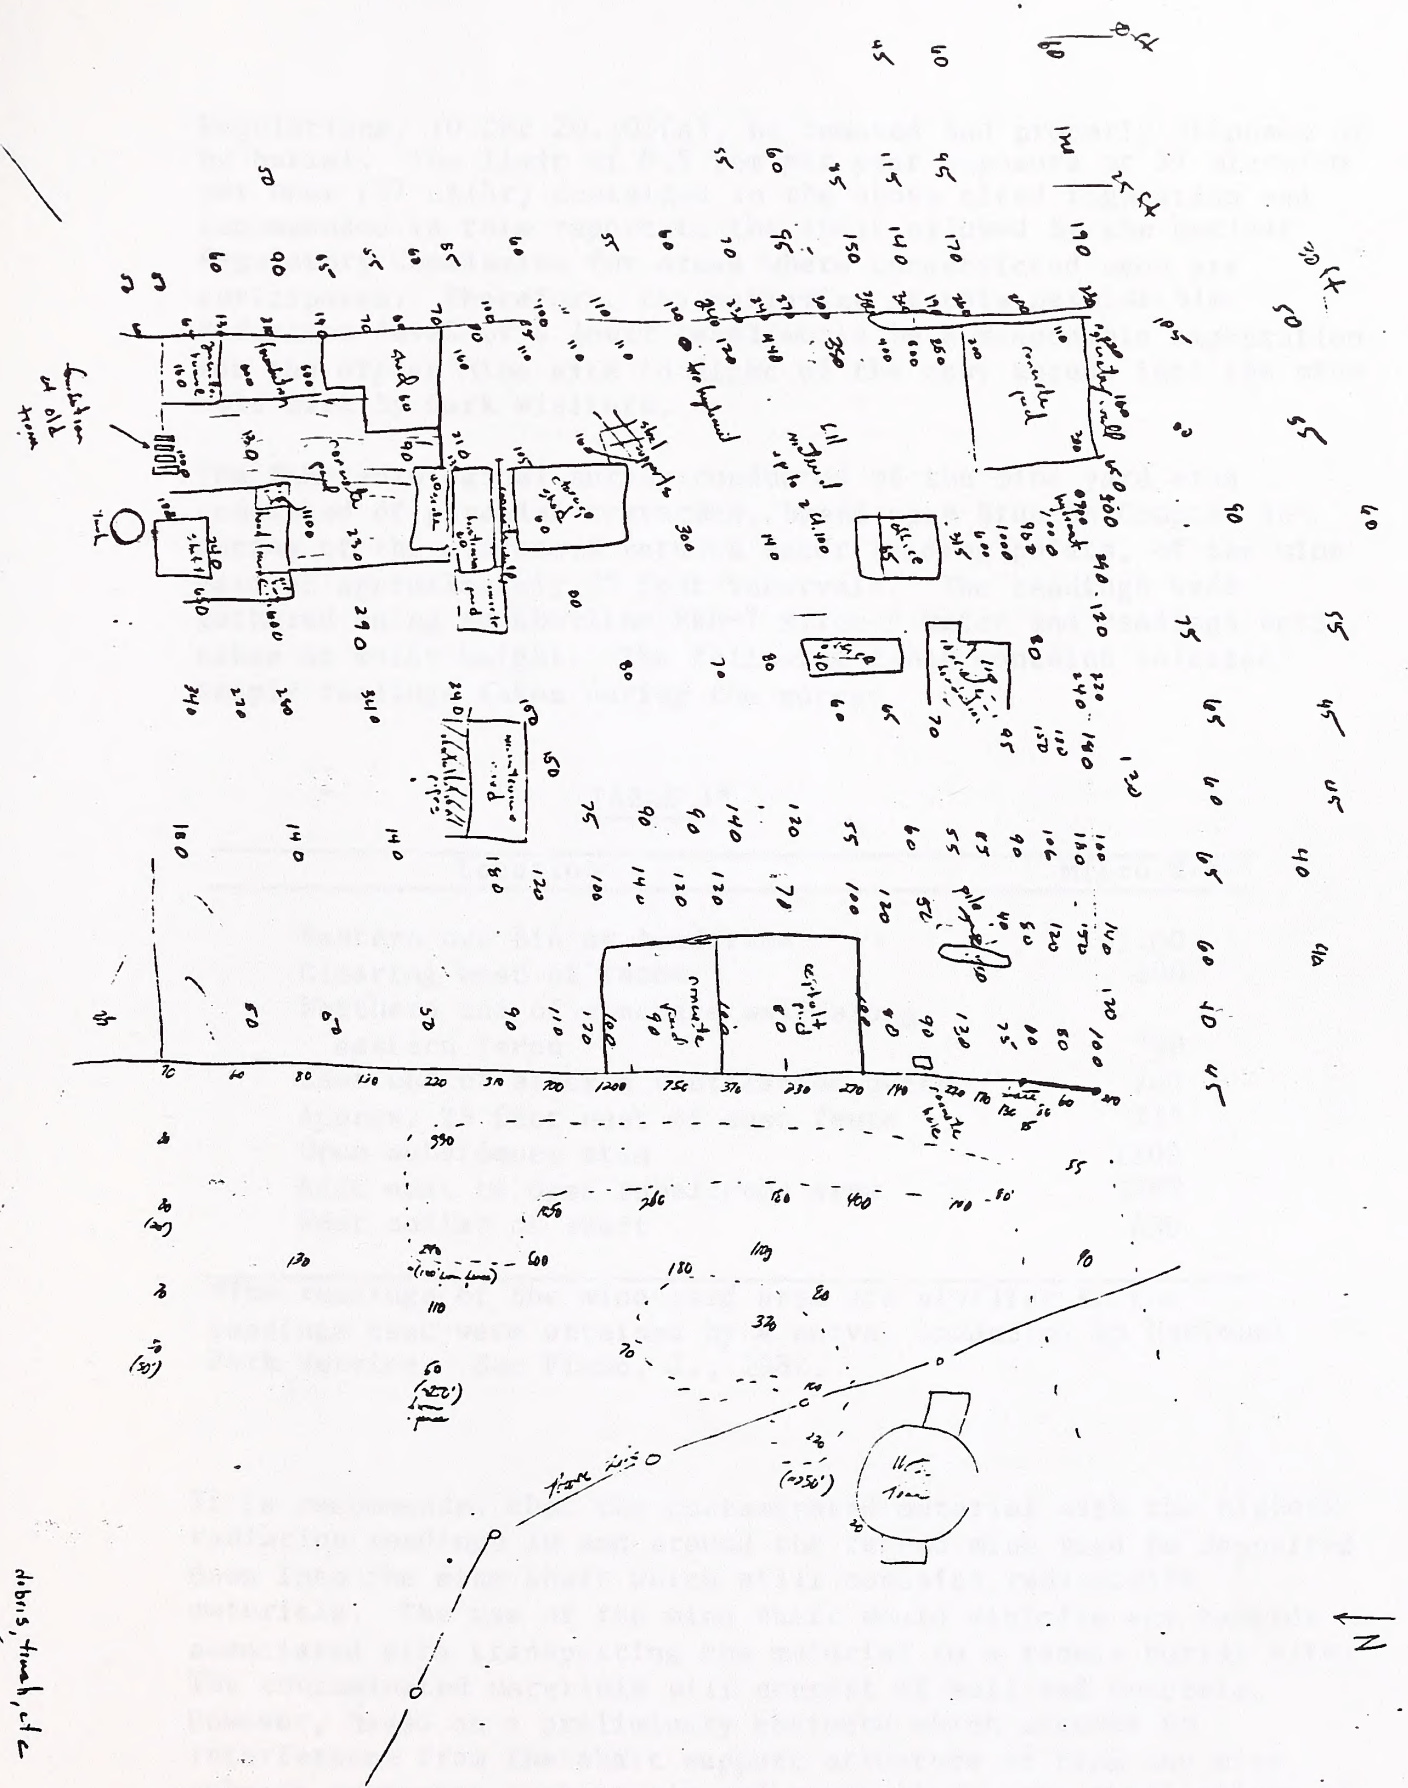
FIGURE 5

This sketch depicts the Orphan Mine yard area and shows the relative location of radiation readings (in uR/hr).

The BLM radiological survey conducted of the mine yard area consisted of parallel traverses, based upon Brunton Compass and pacing of the distances between meter reading points, of the mine yard at approximately 25 foot intervals. The readings were gathered using an Eberline PRM-7 Micro R meter and readings were taken at waist height. The following table contains selected sample readings taken during the survey.

Location	Micro R/hr.
Eastern ore bin at headframe	1100
Clearing west of fence	800
Northern end of concrete wall along eastern fence	380
East end of stacked ventilation ducts	240
Approx. 25 feet east of east fence	115
Open subsidence area	1100
Adit next to open subsidence area	3200
West collar of shaft	650

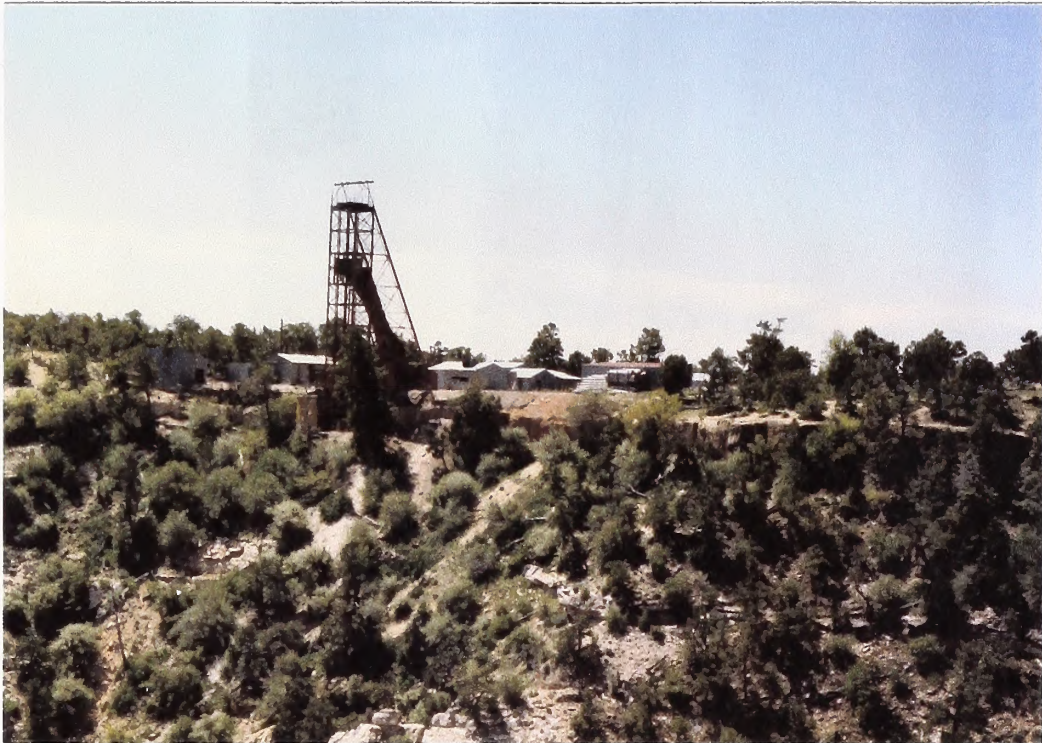
PHOTO #1: The view of the Orphan Mine facilities located on the South Rim of the Grand Canyon. The photo is taken from the Powell Memorial.

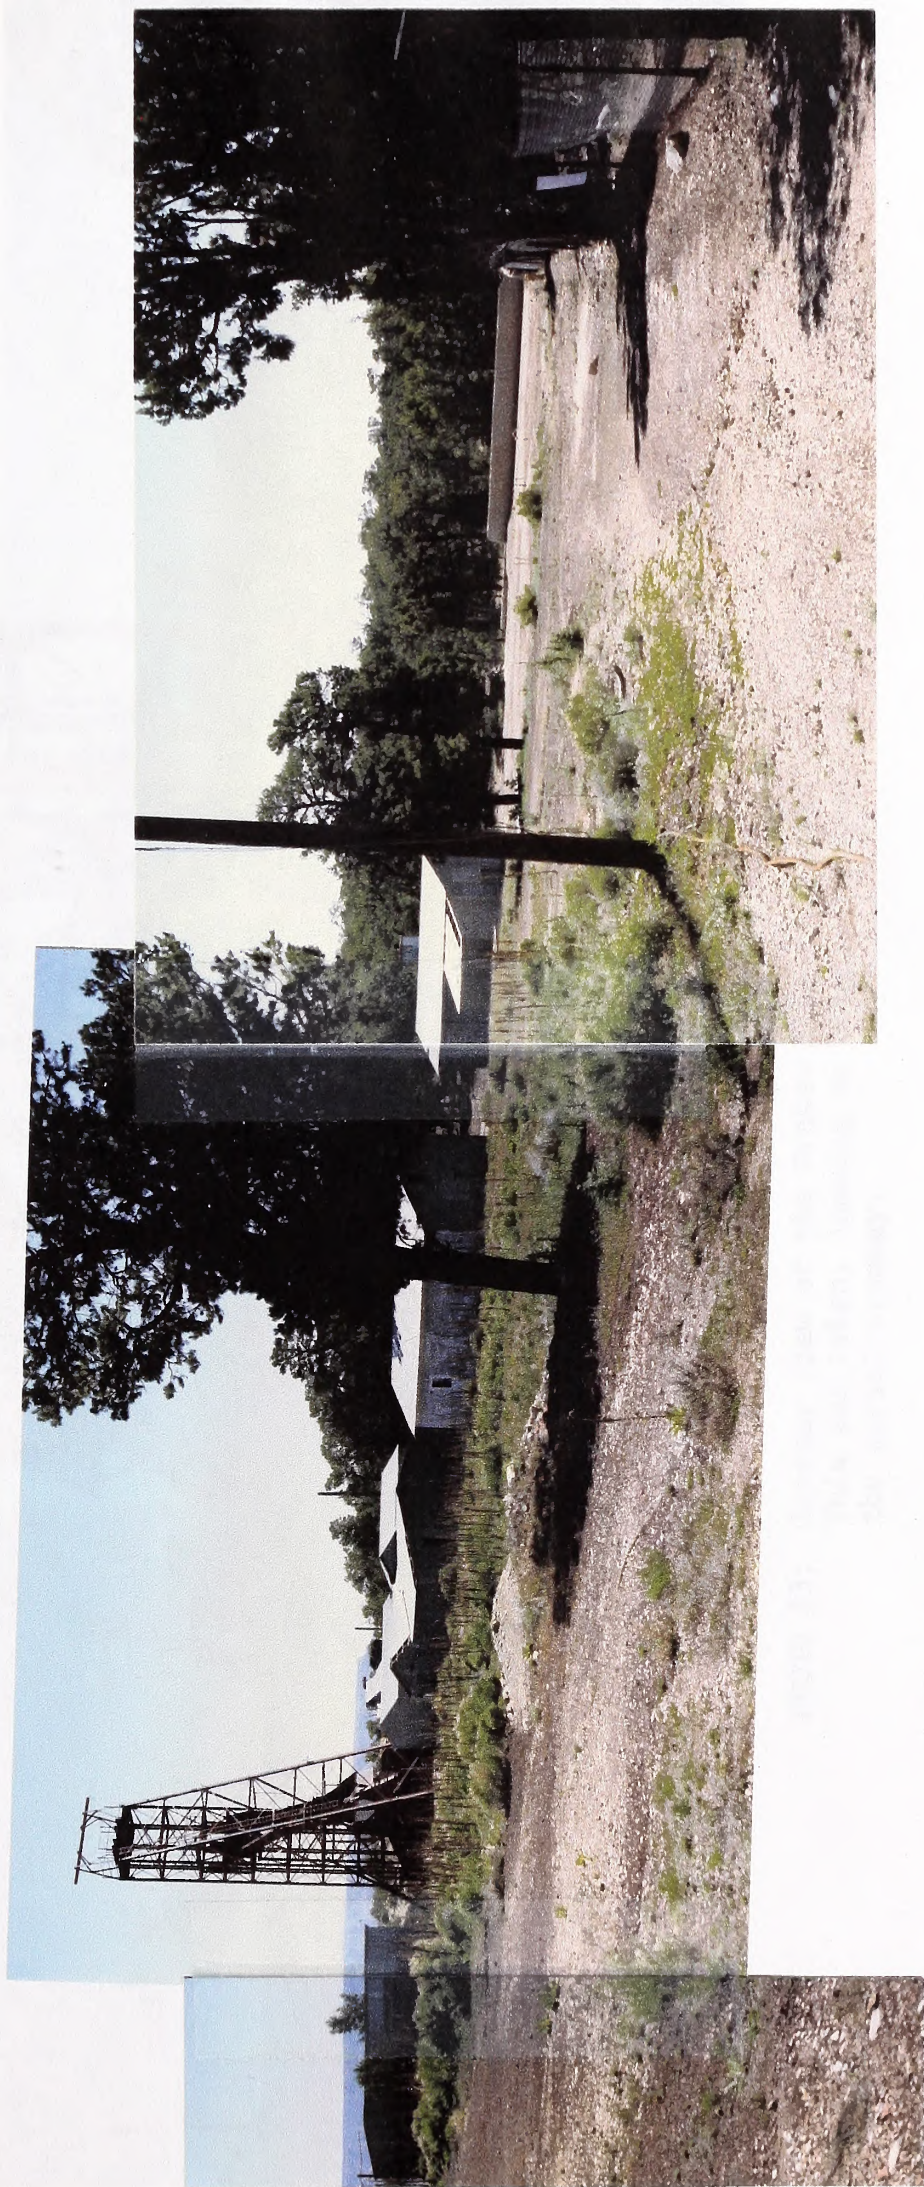
PHOTO #2: A view of the Orphan Mine facilities located on the South Rim. The photo was taken from the mine yard gate and is looking to the North.

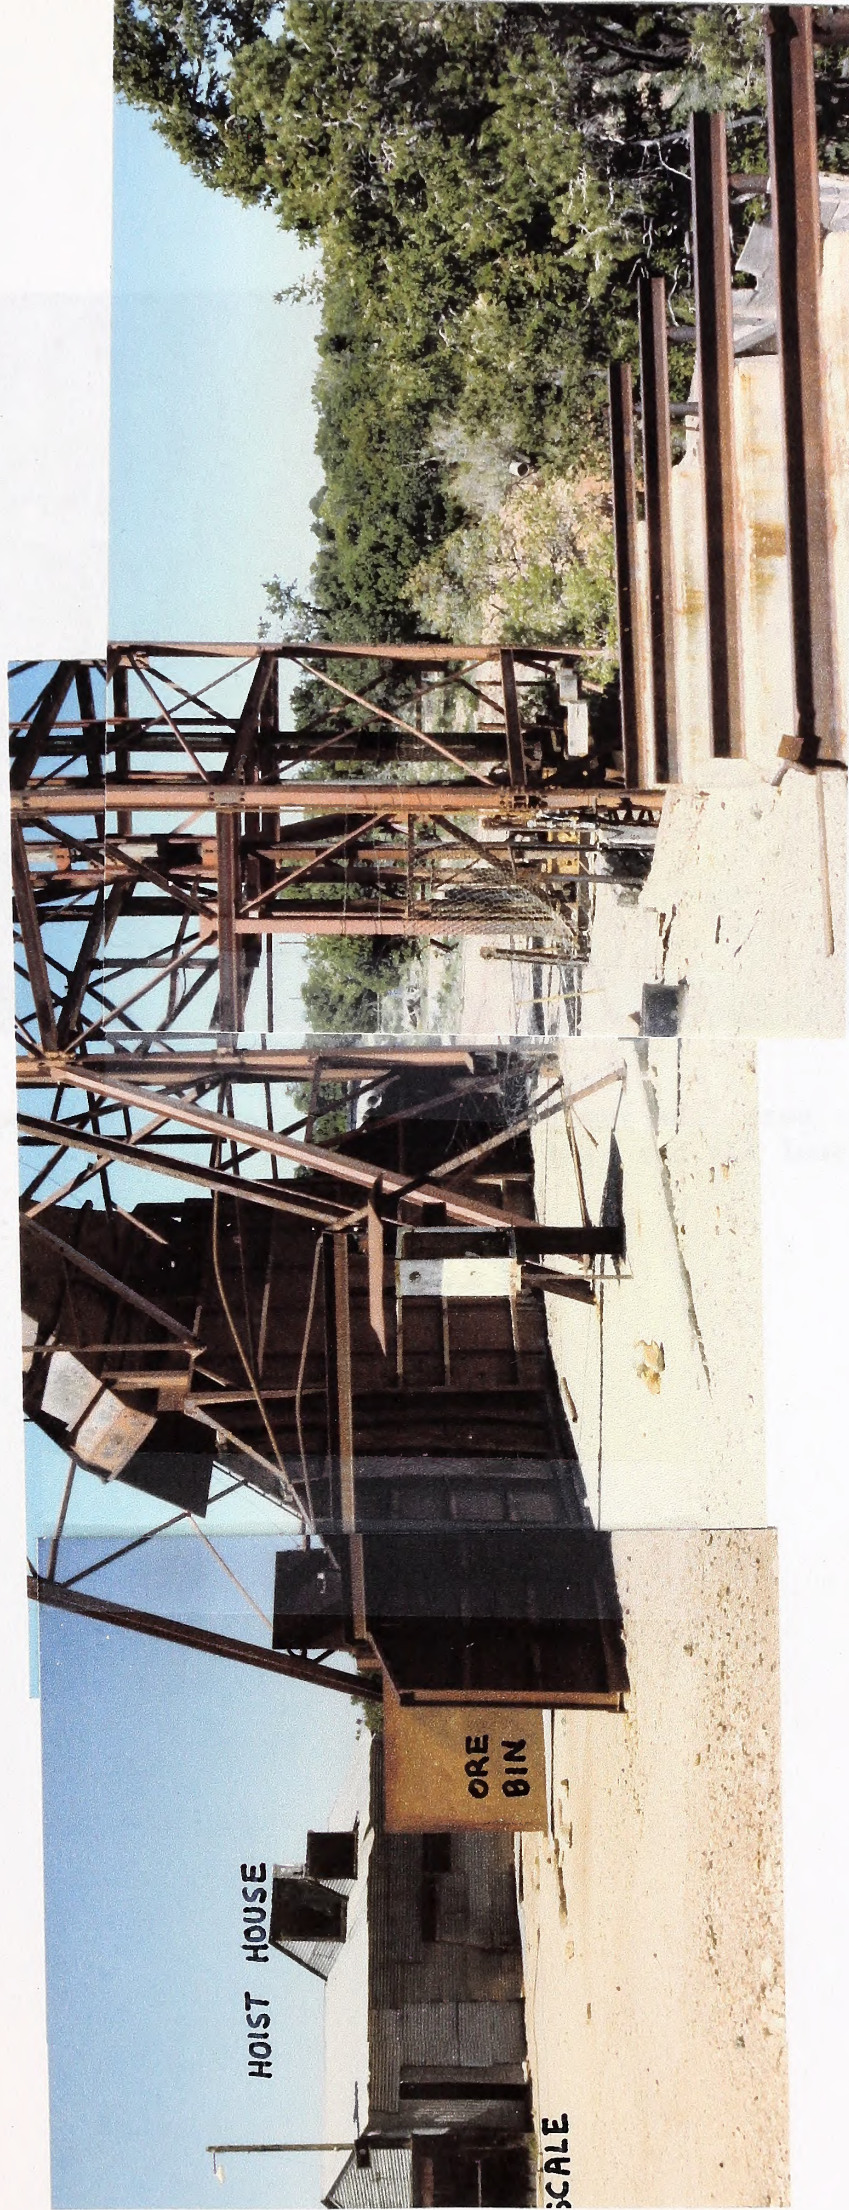
PHOTO #3: Another view of the Orphan Mine facilities on the South Rim. This was taken, looking to the south, from the foundation of the aerial tramway.

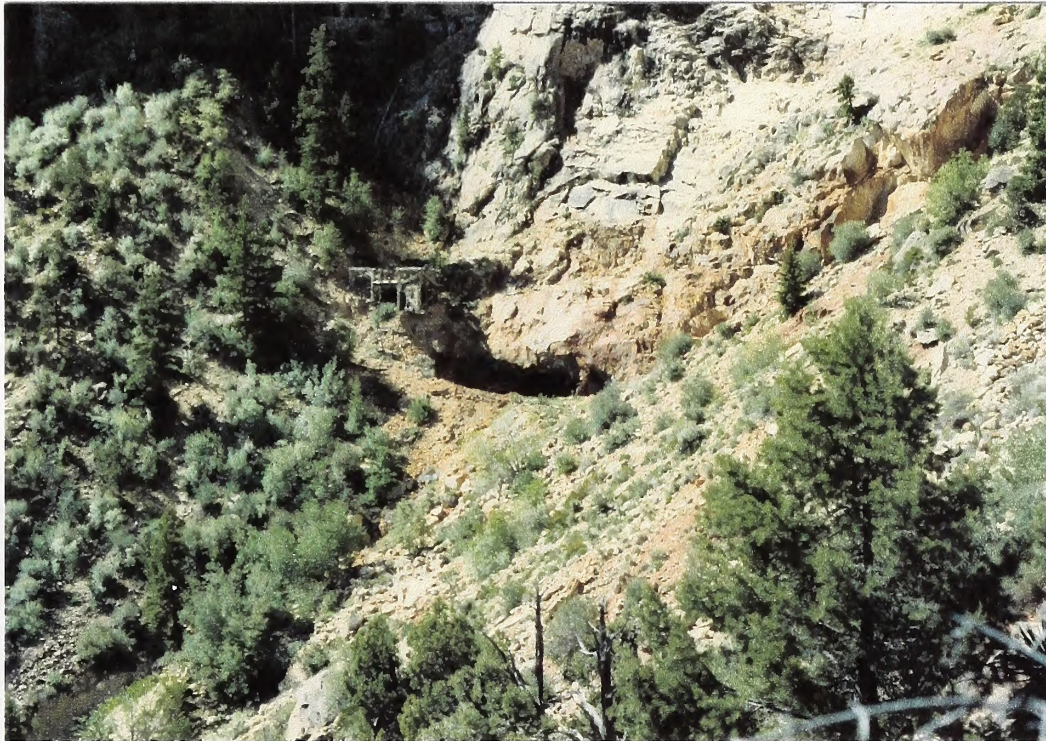
PHOTO #4: This photo show the lower adit area which includes the open subsidence hole and the lower aerial tramway tower.

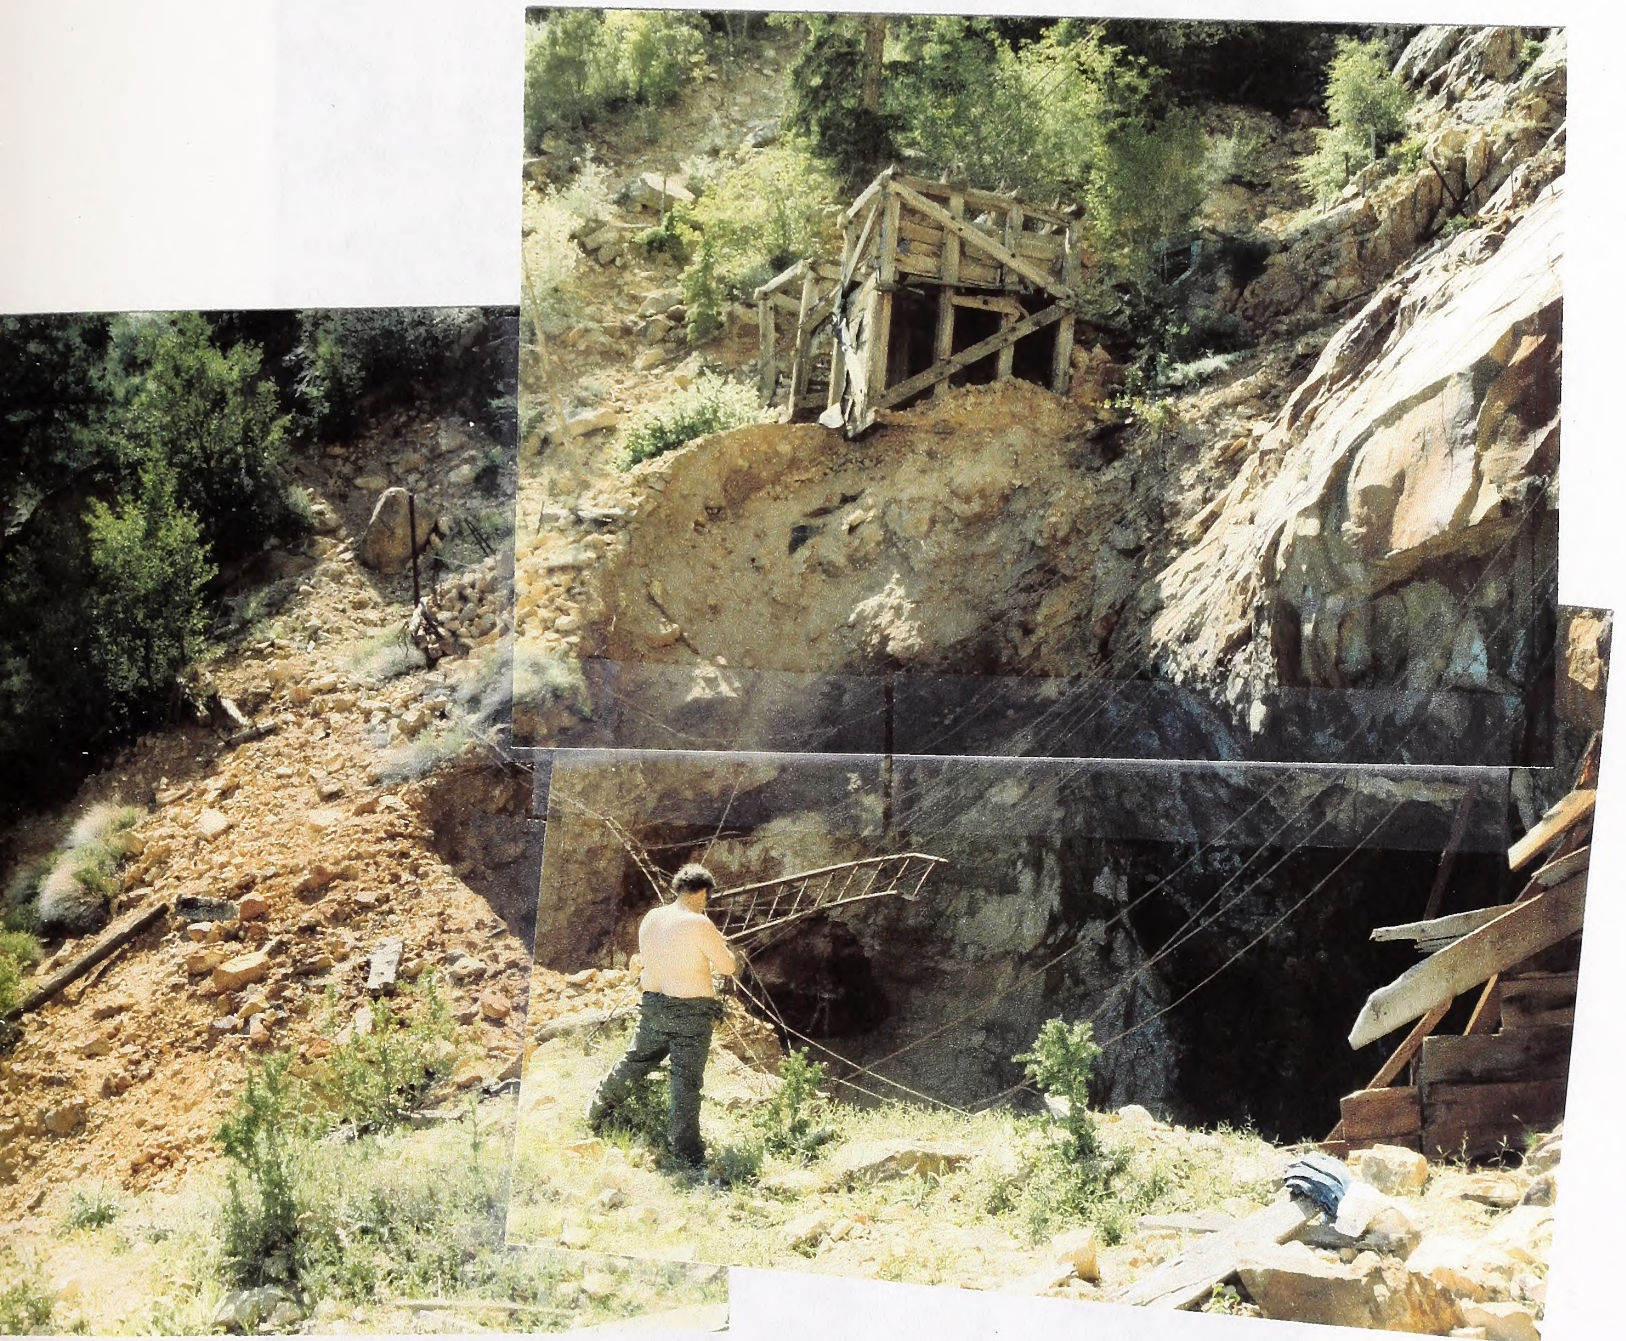
The surface disturbance in the area of the breccia pipe is confined to an area that is smaller than the mine yard. The most prominent feature in this area is the open hole, approximately 30 feet in diameter and 200 to 300 feet in depth, that resulted when the surface subsided into the old underground mine workings. The adit is located on the western edge of the opening. The open hole appears to be getting larger at the surface. This is due to the fact that loose unconsolidated material that surrounds the hole on the down slope is being washed into the opening or material is sloughing off the slope of the opening into the hole at other times.

PHOTO #5: This photo is a closeup view of the open subsidence hole and low aerial tramway tower shown in Photo #4. The cables and wooden planks were an apparent attempt to isolate the open hole from men and equipment in the area.

5. **SUBSIDENCE AREA.** Due to the remoteness and size of the open hole that was created when the surface subsided into the old underground mine workings, the only practical recommendation to reclaim the area would be to construct a heavy duty chain link fence so that wildlife and hikers would be kept a safe distance from the subsidence hole. The location of the fence must take into account that the top of the hole has not yet completely stabilized. Danger and radiation warning signs should be posted on the fence to warn Park visitors who may venture into the area of the dangerous situation.

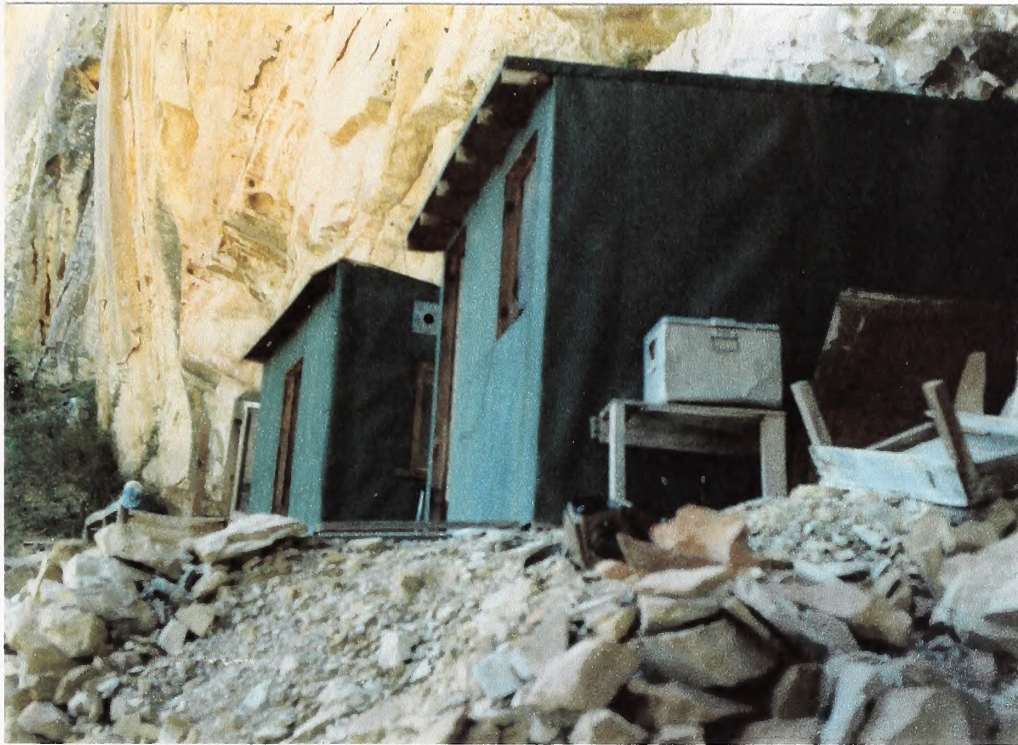
PHOTO #6: A view of the bunkhouses located at the lower adit area of the Orphan Mine. The ledge that these structures sit on is located at the left of top center of Photo #4.

The structures, including the bunkhouses and the return tramway tower, located in the adit area have no salvage value because of their remote location and should be dismantled and disposed of by depositing into the open subsidence hole. This recommendation would be more cost effective than transferring the material by

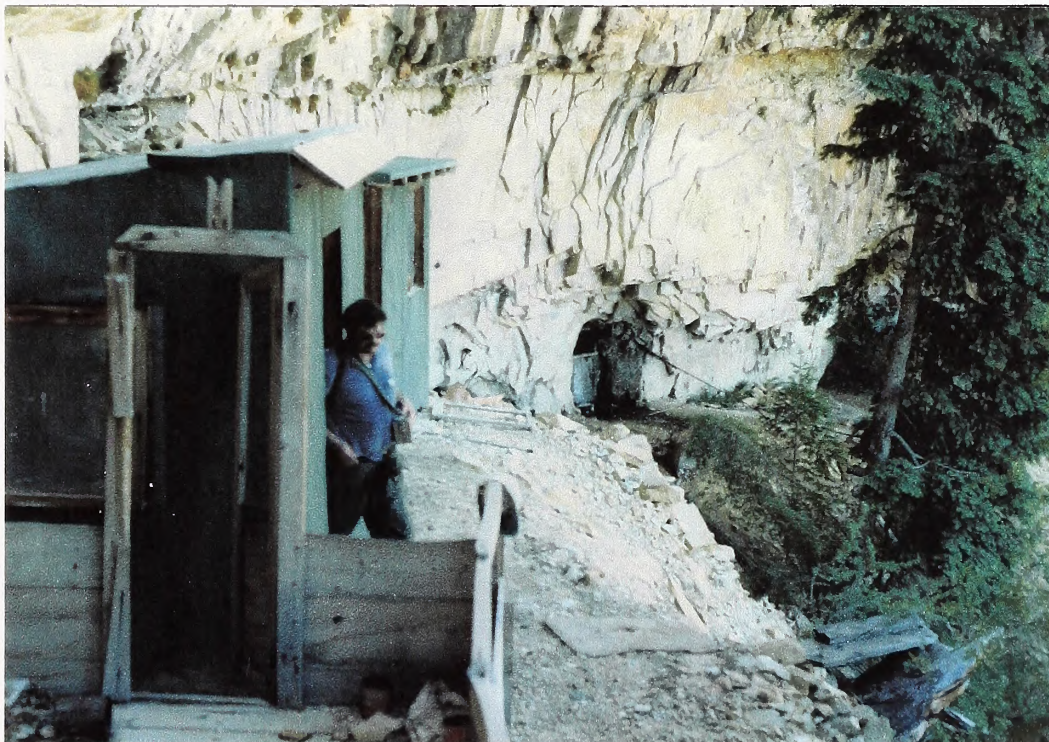
PHOTO #7: This photo is looking back to the area where Photo #6 was taken. Two adits, with the near one partially bulkheaded, are seen in this photo.

6. **ADITS AND RAISES.** All adits and raises should be sealed to prevent entry into the underground mine workings. Sealing these mine entries can be accomplished by either the construction of a concrete seal or the use of an explosive charge to blast in the sides of the entry. This recommendation includes the adit at the open subsidence hole even though it will be located within the fenced off area identified in Recommendation Number 5. The sealing of this adit is necessary because it would prevent someone from

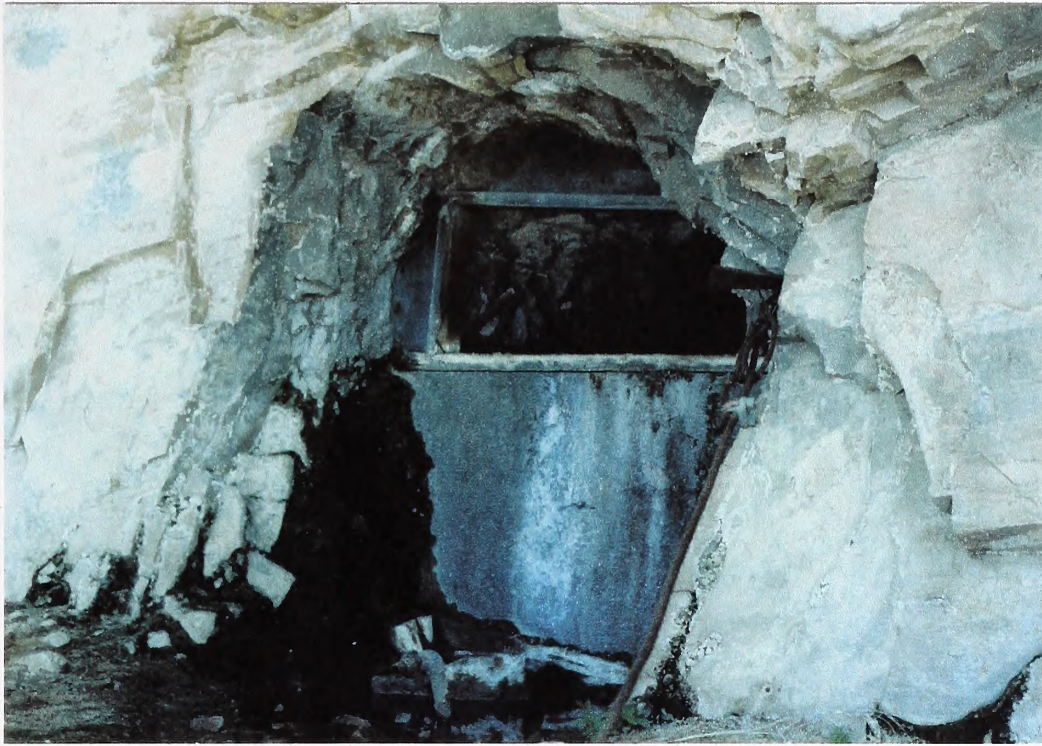
PHOTO #8: A closer view of the partially bulkheaded adit seen in Photo #7.

The adit that has been partially bulkheaded off should be blasted shut in order to prevent the buildup of water in the adit. Since the water is naturally occurring in the Coconino Sandstone, the destruction of the bulkhead will allow the water to seep down and dissipate over the naturally occurring outslope of the Hermit Shale at that location. The quality of the water is within acceptable standards except for the detectable levels of dissolved uranium, radium-26, and radon-222. Results of the water sample taken from the pool are shown in Tables 2 and 3, however, additional sampling of the water will be needed to determine any health impacts to consumption by humans and wildlife. It may be unwise to completely seal off the adit because of the possibility of the seal failing at a future date.

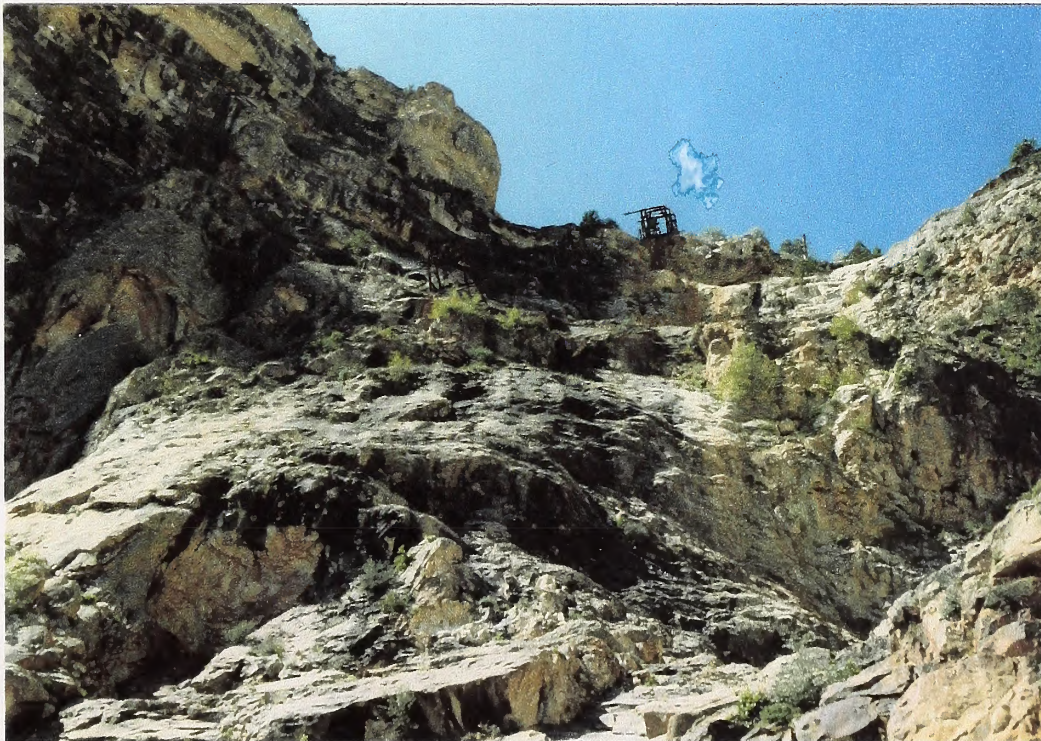
Finally, the structures that remain are the two intermediate support towers for the aerial tramway that had been put in place in order for the tramway to accommodate the terrain. The towers are constructed with wooden beams and are cantilevered out into the Canyon at locations where the terrain changes sharply. The upper of the two towers is located at the top of the Coconino Sandstone and the second tower is located approximately halfway down the Coconino Sandstone. The condition of these towers, which are anchored with concrete into the sandstone, could not be determined without a closer inspection. The steel tramway cable is still strung from just below the rim to the return tower at the adit area.

PHOTO #9: A view of the two intermediate aerial tramway towers from the lower adit area.

7. TRAMWAY. Due to the type of construction materials used on the tramway towers, natural deterioration will eventually cause the towers to collapse. Access to the intermediate tramway towers will be more difficult than the lower adit area. For this reason, it will be cost effective to leave the intermediate towers in place.

However, the decision can be made to remove the tramway towers. This option will require extensive helicopter support and a large labor force to dismantle and remove the intermediate tramway towers and to gather up the cable which will probably have to be cut into shorter lengths in order to be handled by the helicopter. The structural material of the towers, after dismantling, and the cable may either be airlifted to the South Rim for disposal at a remote site or to the lower adit area for disposal in the open subsidence hole. The final method of disposal can only be determined after an evaluation of the ability of the helicopter to safely deposit the material directly into the open subsidence hole or adjacent to the hole. Such factors as wind conditions or steepness of the terrain will have to be taken into account.
