RAILROAD ACCIDENT REPORT

REAR END COLLISION OF TWO
CHICAGO TRANSIT AUTHORITY TRAINS

CHICAGO, ILLINOIS

REPORT NUMBER: NTSB-RAR-77-10

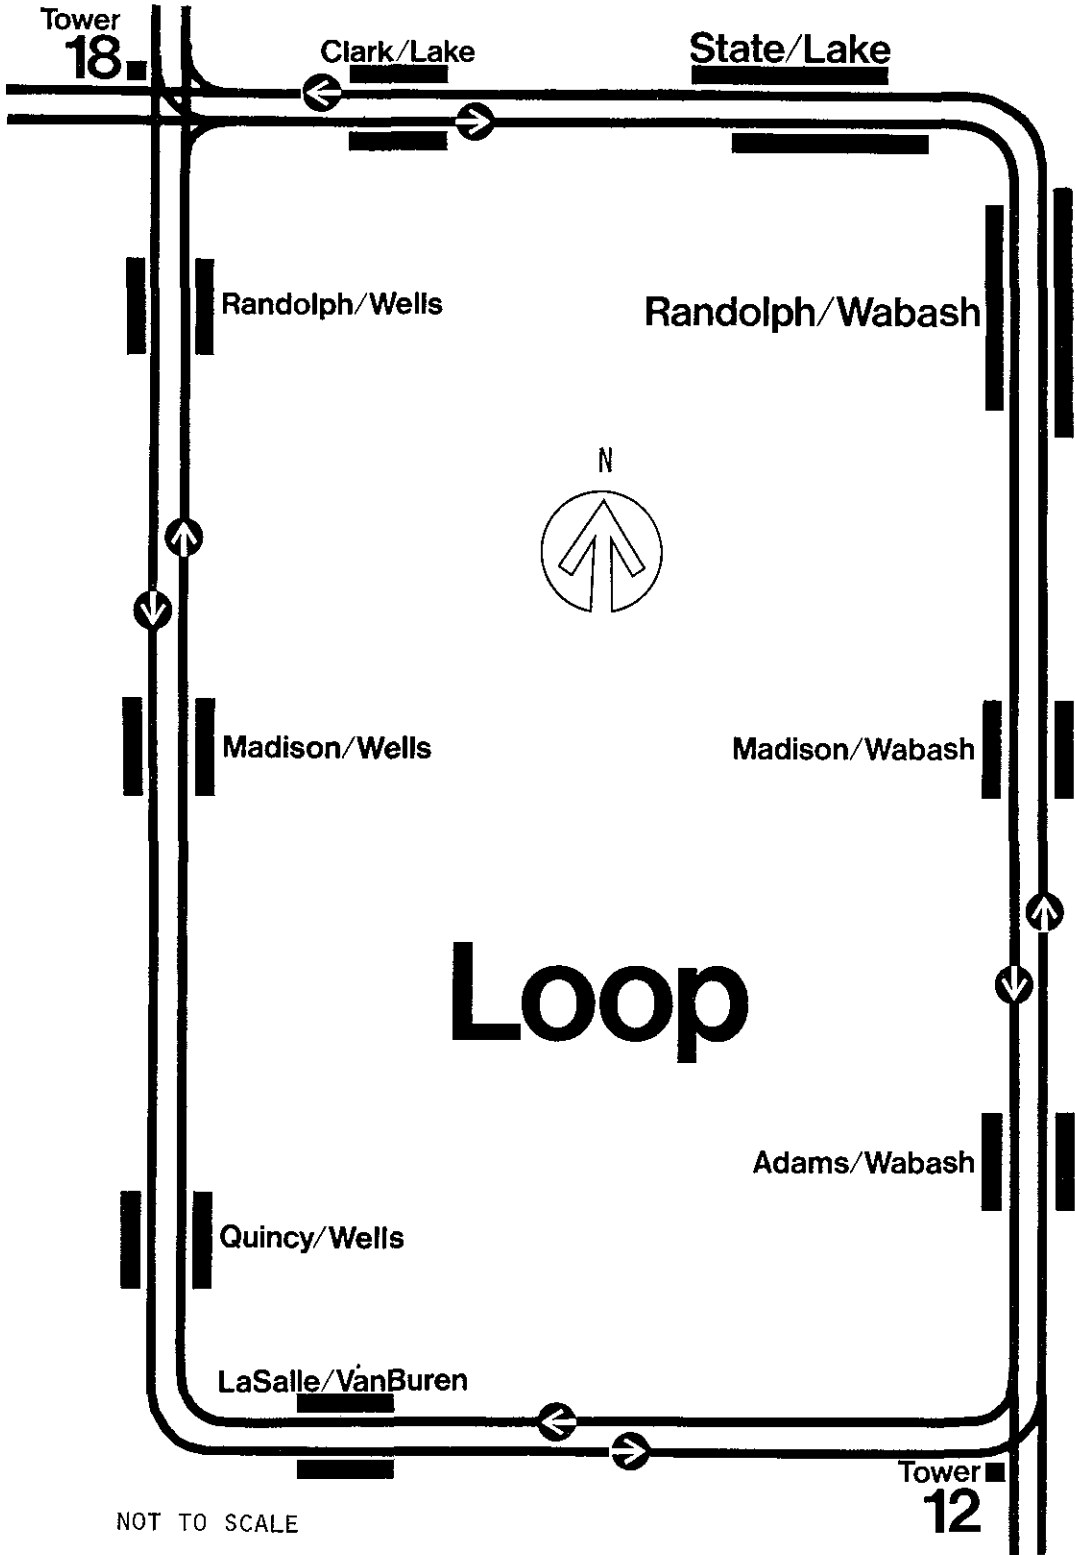
Figure 1. Plan of elevated track structure.

The accident occurred at the northeast corner of the "loop" where the elevated track structure turns west from Wabash Avenue to Lake Street. (See figure 1.)

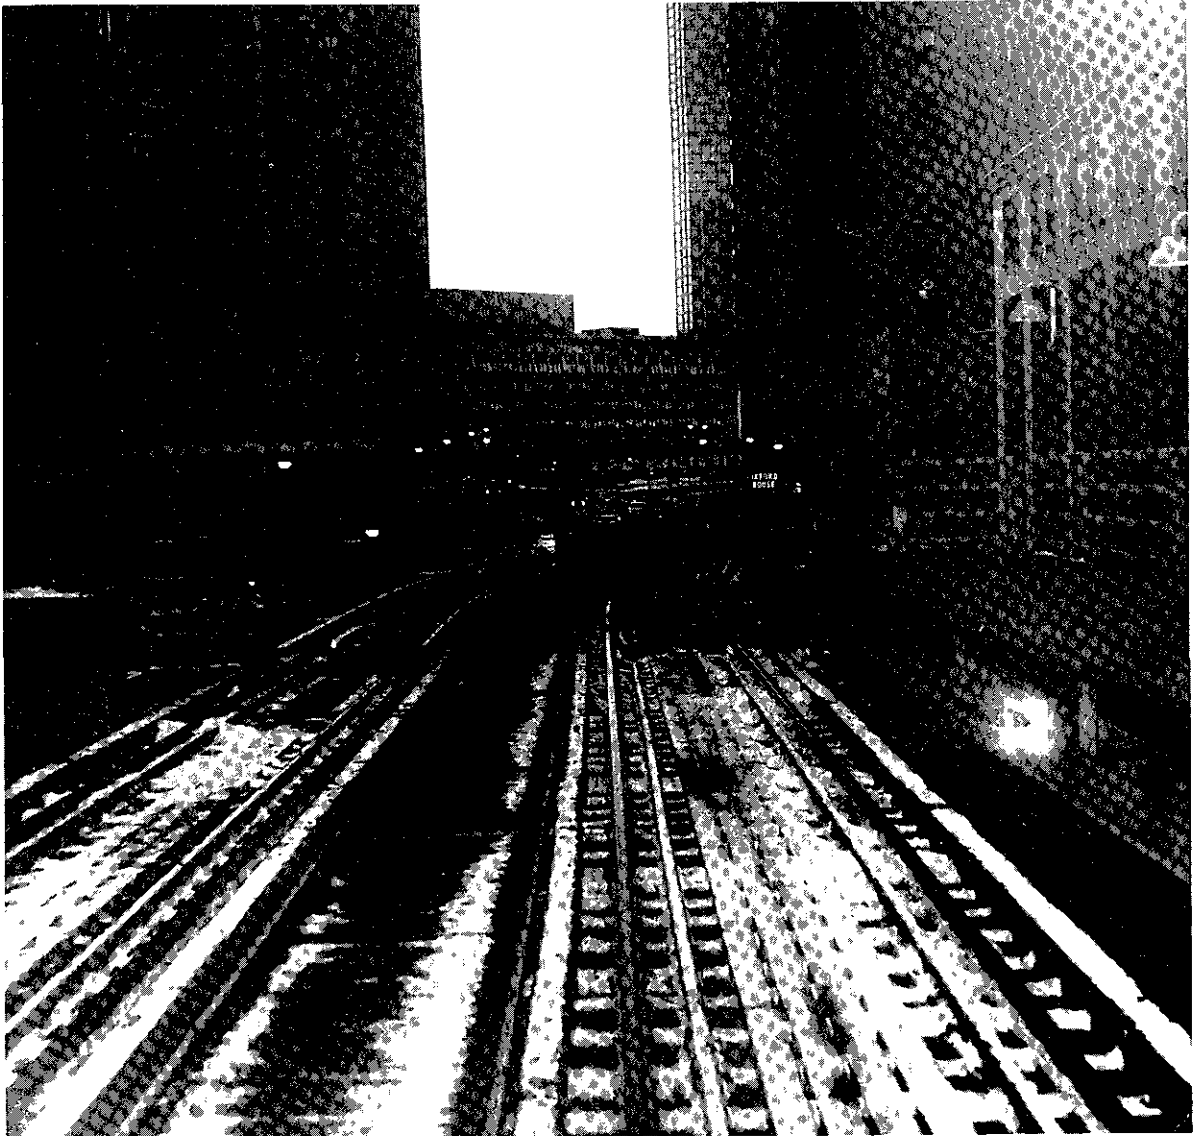
Figure 2. View of curve at Lake and Wabash from 250 feet south of collision point.

When the Lake-Dan Ryan train entered the offset curve (see figure 2) to the right at a speed of about 10 mph, the motorman moved the cineston ^{2/} to the coast position. This is a normal operating procedure. He was standing at the car controls, as CTA operating rules required. When the train entered the curve to the left, the motorman saw the rear car of the standing Ravenswood train. He claimed that this was his first view of the train since before he entered the Randolph Street Station. He also said that his view from within the operating compartment was obstructed by the windshield wiper motor, the door at his left, and the trainphone equipment. He further stated that he could not have seen the rear of the Ravenswood train from his location in the cab before he entered the curve, because the train was hidden from his view by a building in the southwest corner of the intersection. (See figure 2.) When he sighted the train, he testified that he immediately applied the maximum service brakes; he claimed they were not effective, however. He then applied the emergency brakes. He said he heard the magnetic track brakes drop but that the train still did not seem to slow, and it struck the Ravenswood train at 7 to 9.5 mph. (See appendix B.)

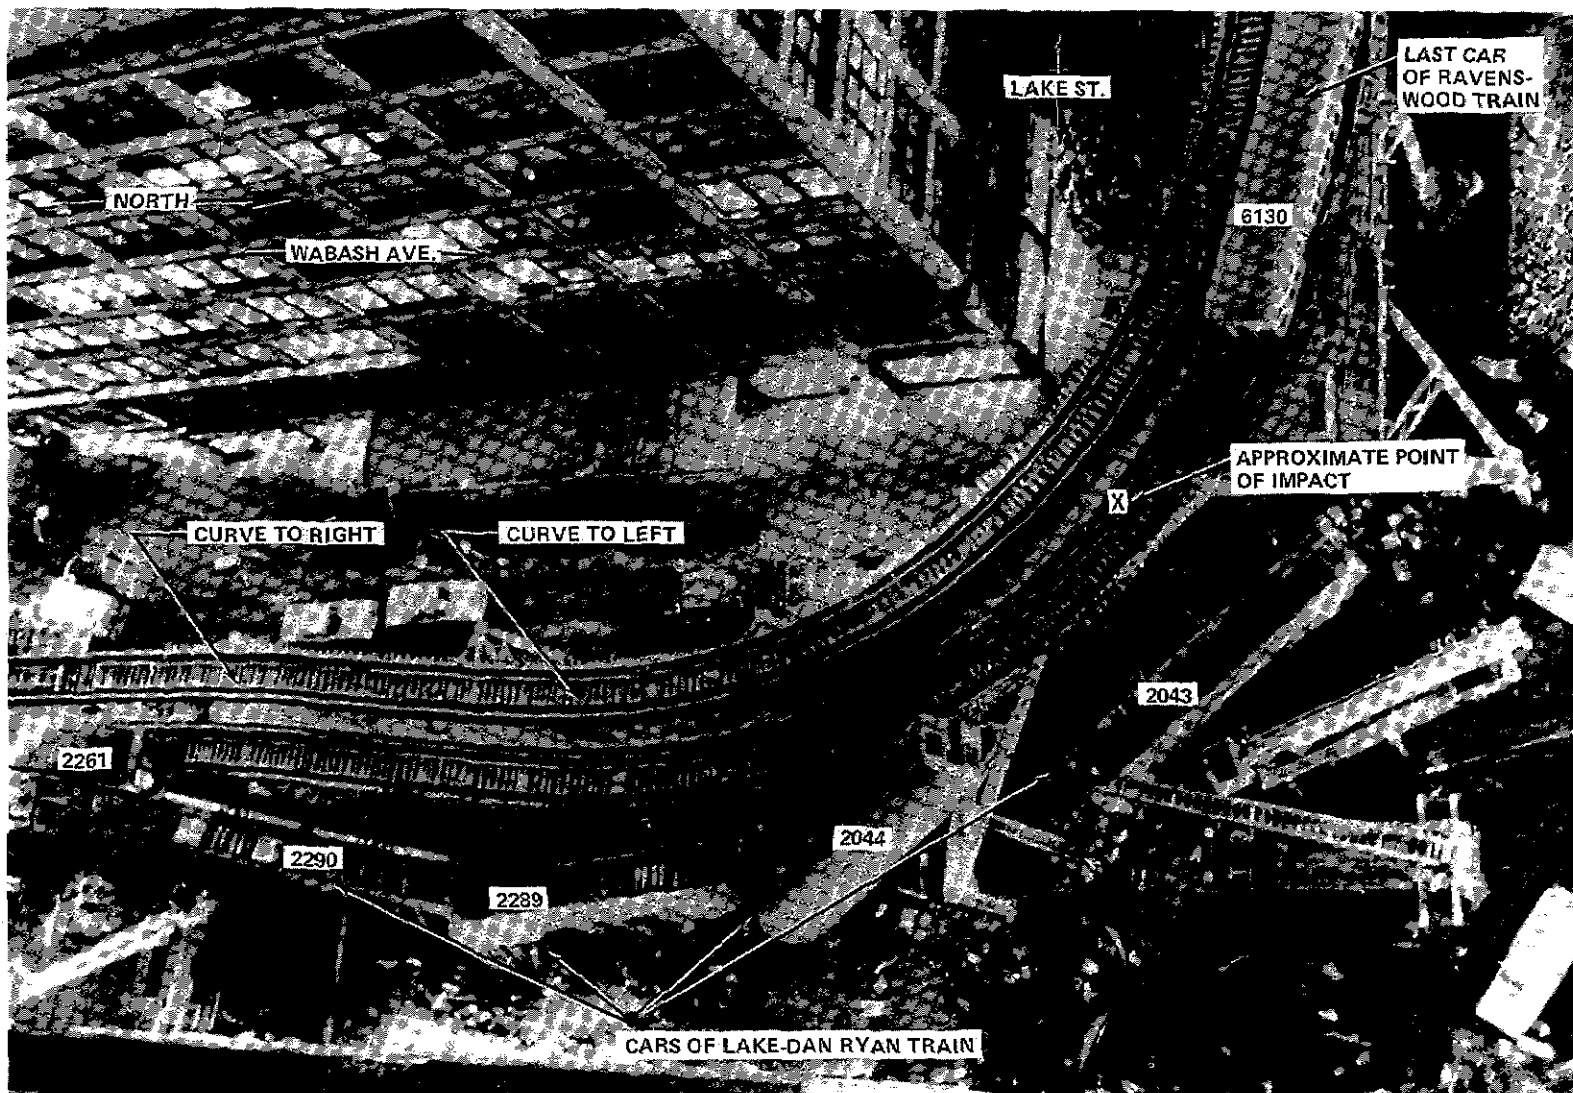
Figure 3. Aerial view of accident site.

Upon impact, about 5:27 p.m., the first car of the Lake-Dan Ryan train began rocking slowly from side to side, moved slightly back, and then fell from the track structure. Several witnesses reported seeing a high-intensity, electrical arc flash and hearing a loud noise at that time. The next three cars reportedly stopped and then turned over slowly and fell from the elevated structure. (See figure 3.)

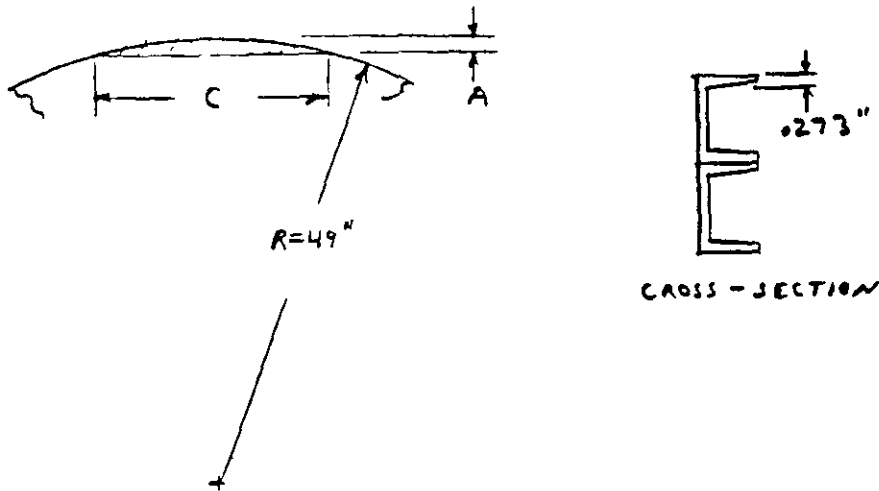
Figure 1. Anticlimber Geometry

Figure 1 is a representation of the anticlimbers.
