MARINE CASUALTY REPORT

SS MARINE ELECTRIC,
O.N. 245675,

CAPSIZING AND SINKING
IN THE ATLANTIC OCEAN
ON 12 FEBRUARY 1983
WITH MULTIPLE LOSS OF LIFE

REPORT NO. 16732/0001 HQS 83

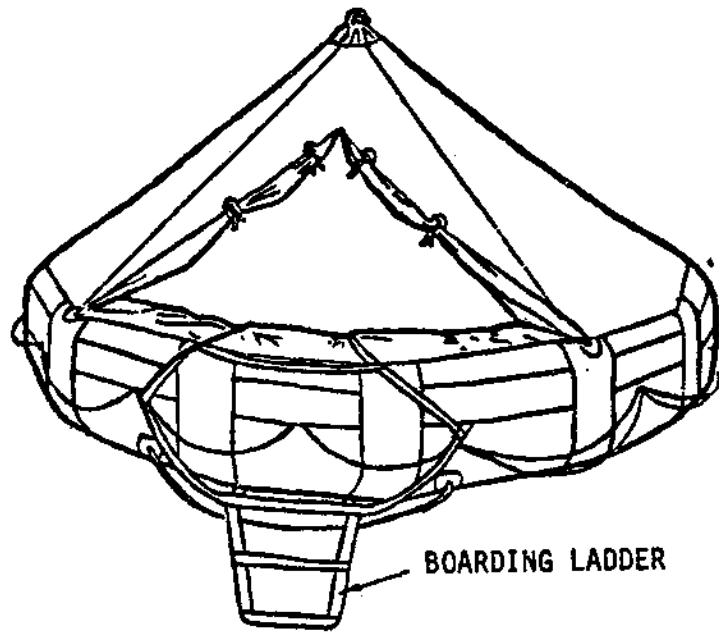
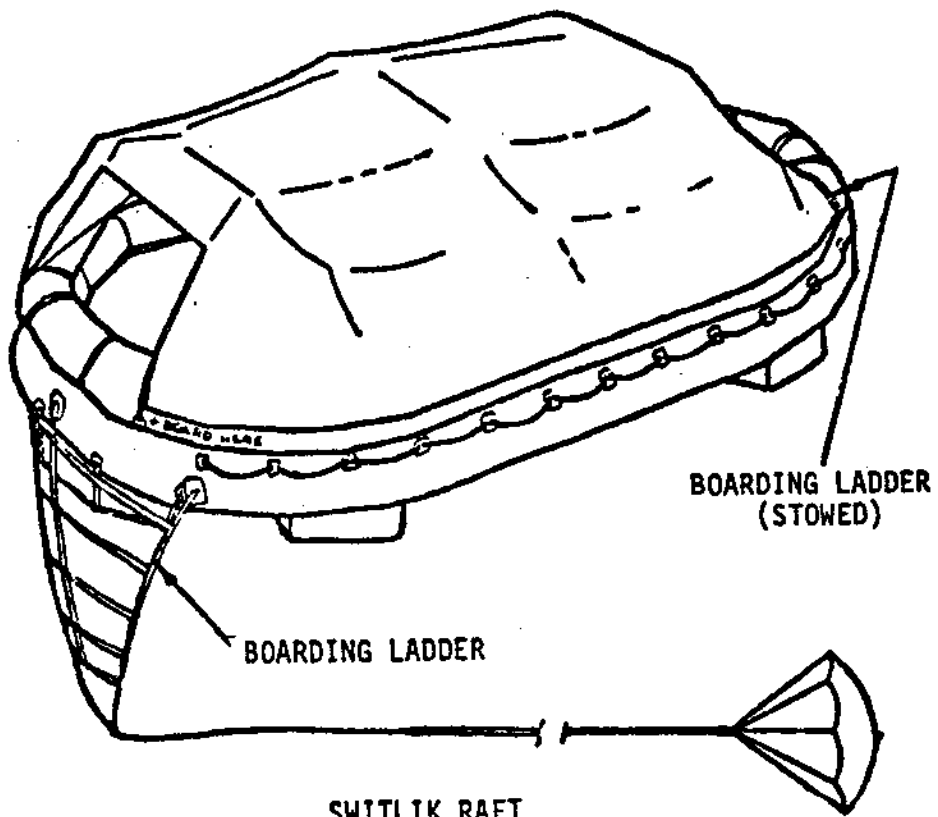
412. It was not determined which raft the 12-4 Able Seaman was able to climb into. Both types are represented in the figure below in order to describe the boarding ladder arrangements. With each type, two boarding ladders were provided, each fabricated of polyester fabric belts. One ladder was designed to deploy automatically when the raft was inflated, and had the sea-anchor drogue attached to it. Another web-belt boarding ladder was folded and stowed inside the raft, and designed to be cast over the side of the raft by an occupant.

10. Recommendation 10: This recommendation is concurred with. As part of the present regulatory project concerning SOLAS 74/83, the Coast Guard will propose that new inflatable liferafts be equipped with a boarding ramp. Further, the Coast Guard intends to propose that existing inflatable liferafts be retrofitted with boarding ramps, or stiffeners with standoffs for boarding ladders, or both.
