DUTCH
SAFETY BOARD

Gear collapse during landing

The Hague, May 2018.

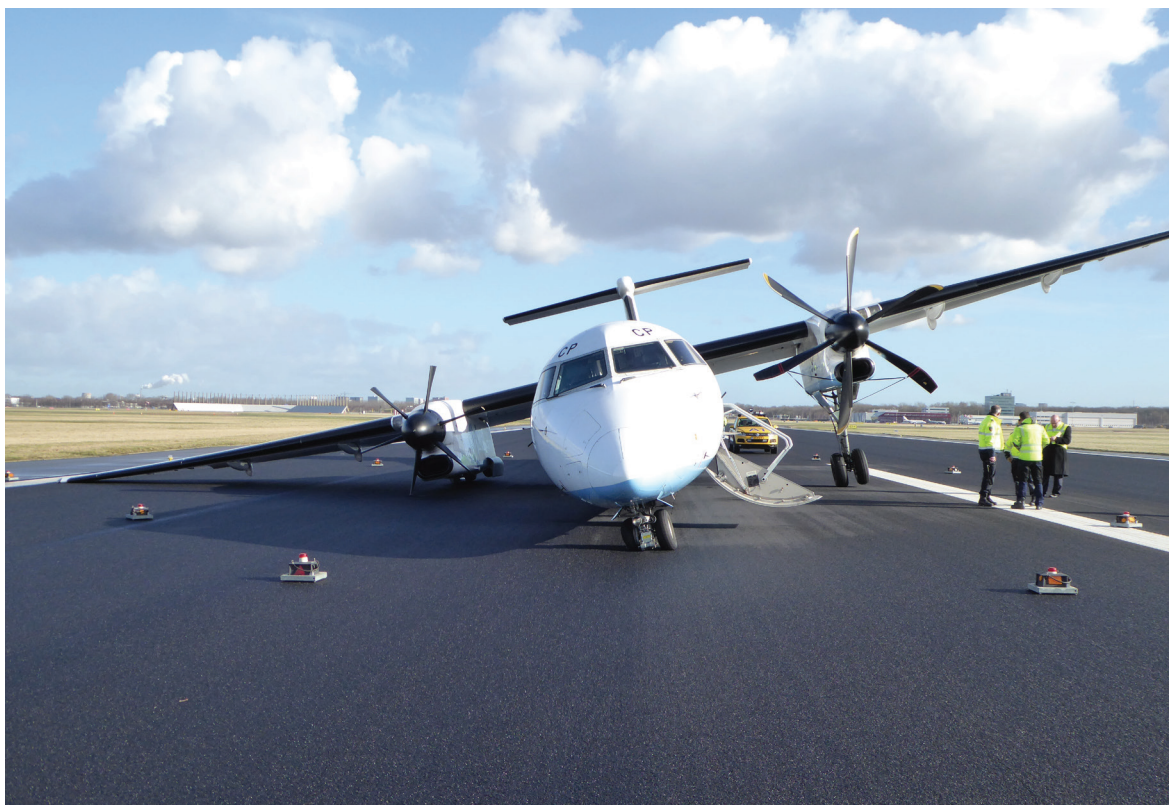
Figure 1: aircraft on runway after occurrence. (source: Dutch Safety Board)

The right-hand propeller, right-hand engine nacelle, lower fuselage, wing tip and aileron collided with the runway and the aircraft continued for several hundred meters before coming to a complete stop. This resulted in damage to the right hand propeller, the lower fuselage structure and right-hand outboard wing tip. The right-hand fuselage was also damaged due to fragments from the right-hand propeller and stone strikes. The left-hand main landing gear and nose gear remained extended.

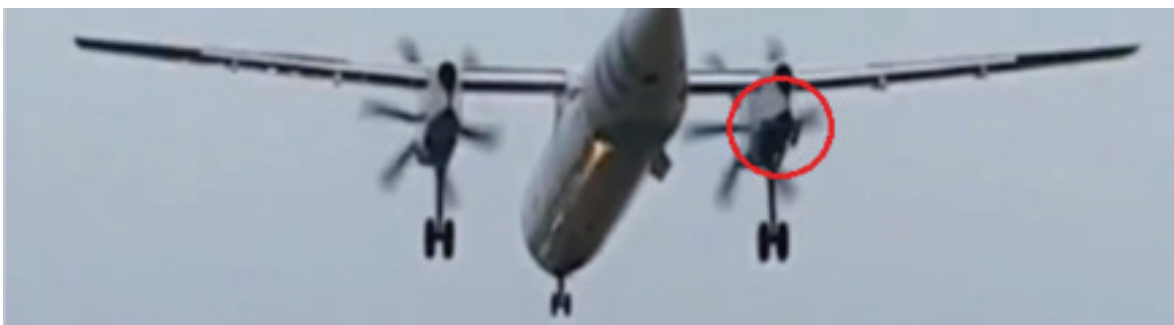
The landing of the aircraft was filmed from several different positions. One of the passengers sitting close to the RH engine and landing gear filmed the RH MLG aft doors just prior to landing, two local TV stations recorded the landing as part of two separate television documentaries on the hard winds on the day of the accident. All video evidence indicates that the right hand MLG aft doors were open at the time of the landing.

Figure 2: moment just before landing, viewed from rear, showing aft doors open on RH MLG. (still of video)

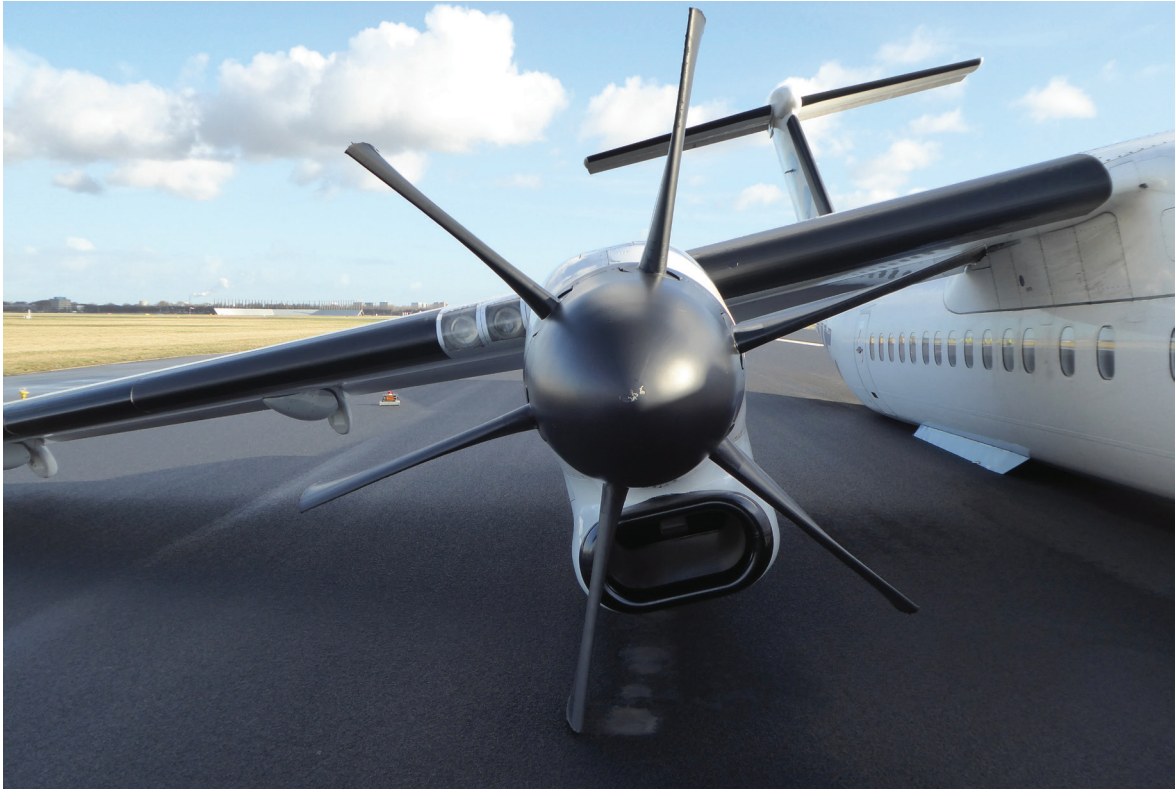
The nose landing gear right-hand tire was damaged during the incident. There were no visible signs of deformation to the nose gear, except for damage to the right-hand tire and outer wheel hub. The right-hand main landing gear was found to be partially within the nacelle.

The right-hand (number 2) engine propellers contacted the runway surface, causing all blades to be ground down to approximately half their original length. The nacelle did not make contact with the ground, except at the outboard, aft MLG door. The engine nacelle centre and aft sections were not damaged. No damage was noted on the nacelle frames.

Figure 4: right-hand nacelle and MLG after occurrence. (source: Dutch Safety Board)

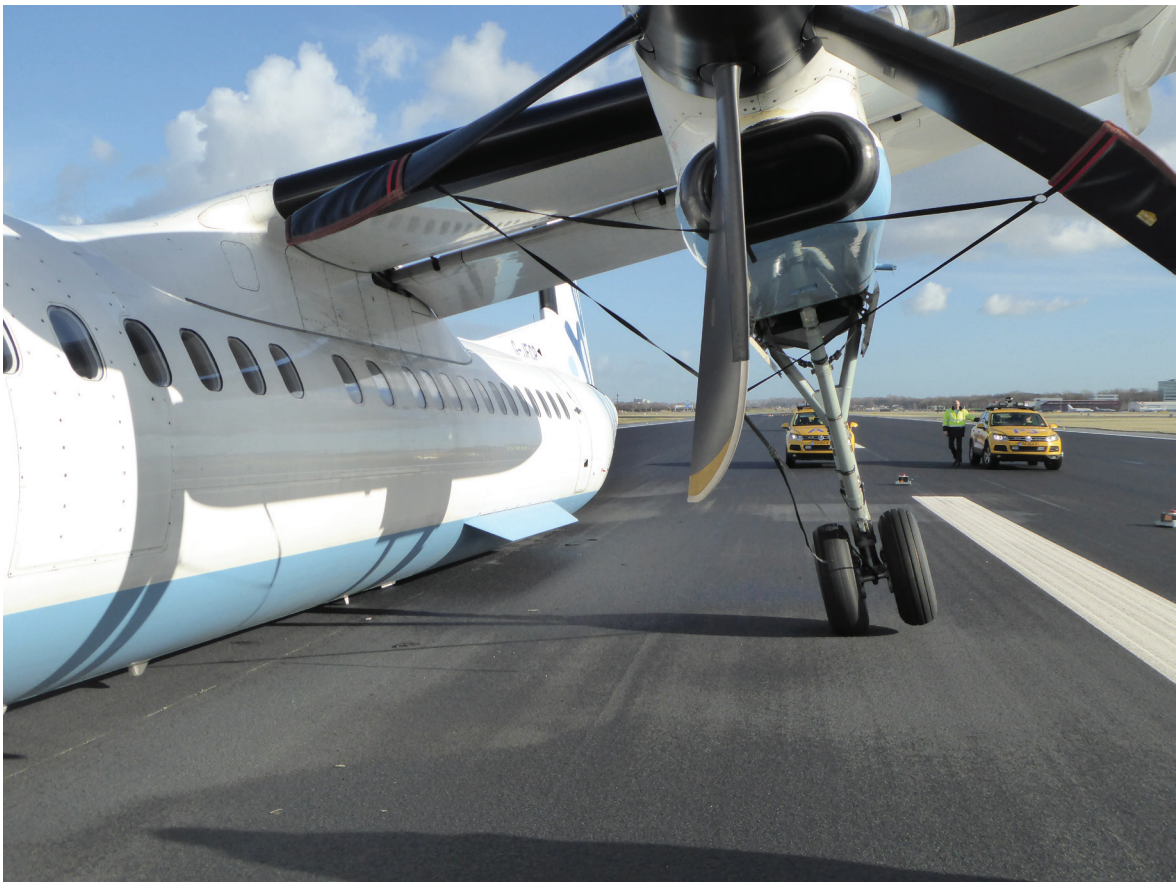
The left-hand MLG was extended and supported the weight of the aircraft at an angle. There was no visible damage to the gear attachment points.

Figure 5: left-hand nacelle and MLG after occurrence. (source: Dutch Safety Board)

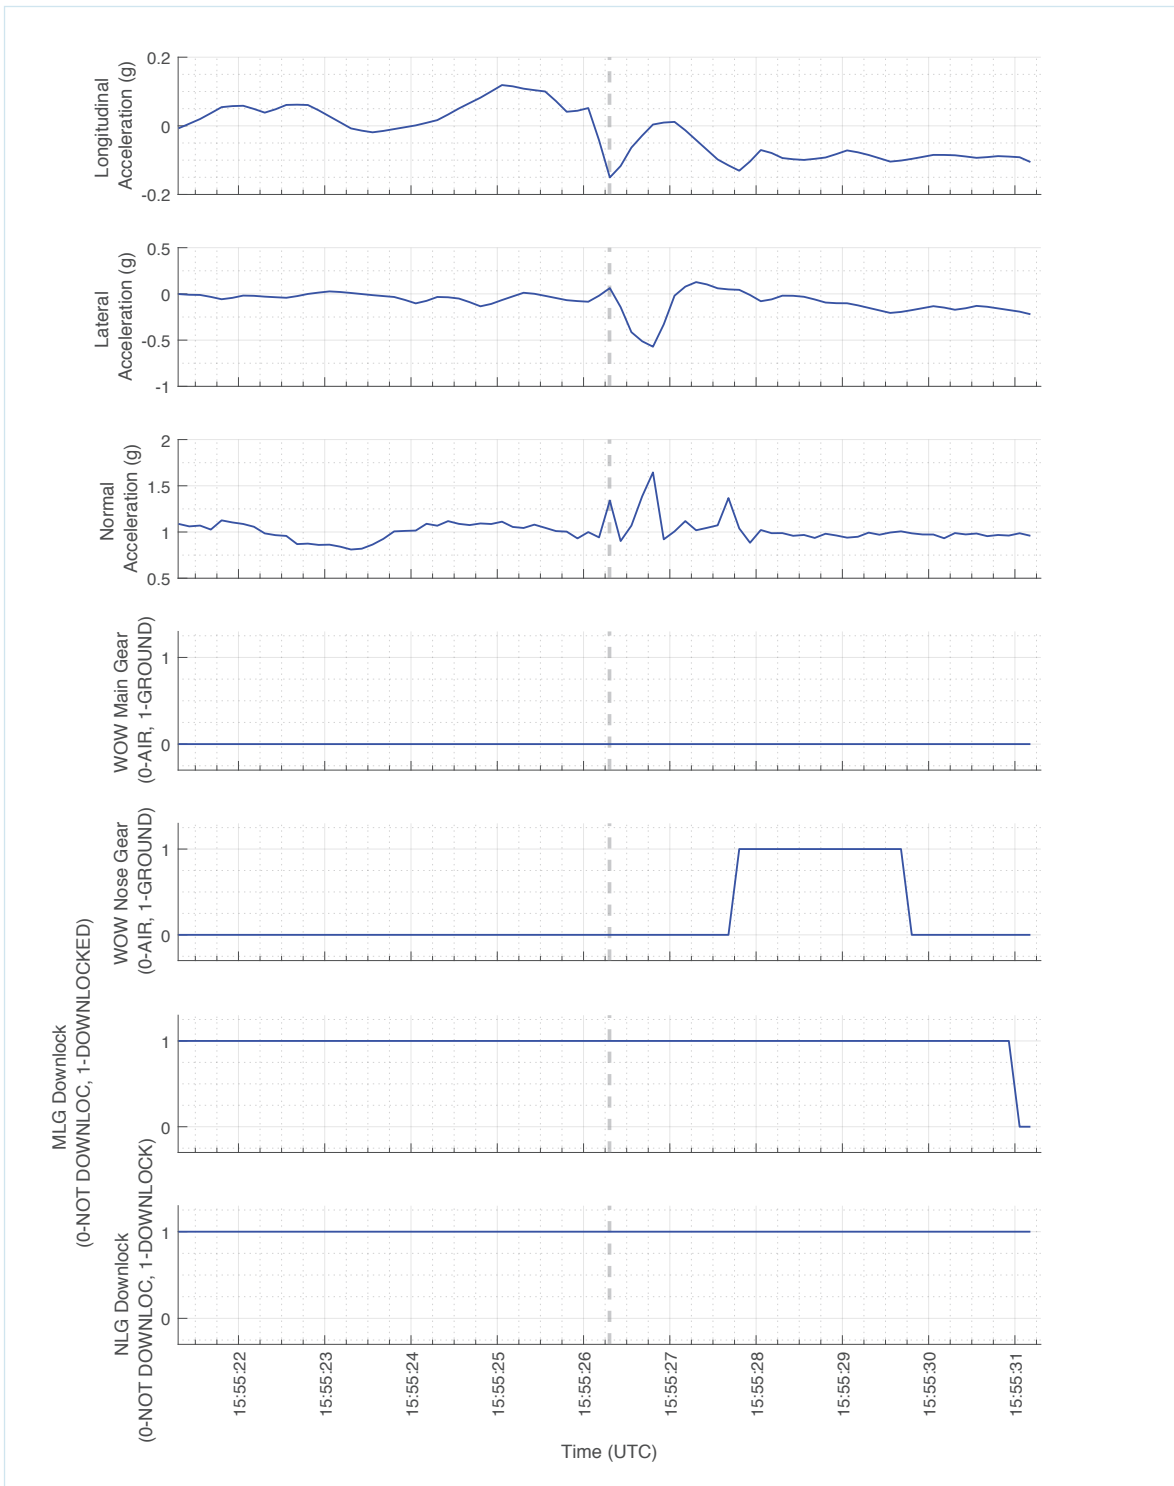
A close-up of the linear accelerations and weight on wheels (WOW) sensor information at touchdown is depicted in Figure 10. Initial point of contact with the ground occurred at approximately 15:55:26.3 UTC. At this time, a vertical acceleration of 1.367 g⁴ was measured. Shortly after this, at 15:55:26.8 UTC, a large magnitude peak of 1.66 g in normal (vertical) acceleration was observed. At the same time, a lateral acceleration of approximately -0.571 g⁵ was recorded. Consecutively, a third larger magnitude peak of 1.387 g in normal acceleration was observed at 15:55:27.7 UTC.

Considering the WOW sensor signal and MLG and NLG down-lock sensor signals in Figure 22, it was observed that the MLG WOW sensor unit indicated AIR during the complete approach and landing. The MLG WOW sensor unit is composed of two sensors. If one of the sensors indicates AIR, the MLG WOW parameter will indicate AIR. It is not possible to derive the AIR/GROUND state of each of the sensors separately. In contrast to the MLG, the NLG WOW sensor switched to GROUND at 15:55:29 UTC, switched back to AIR until 15:55:31 UTC and finally remained at GROUND. The MLG down lock parameter indicated DOWNLOCKED up to approximately 4 seconds after initial ground contact. After that, the parameter switch to NOT DOWNLOCKED. The NLG down-lock parameter indicated DOWNLOCKED during the whole landing run. WOW sensor parameters are sampled at a frequency of 1 Hz, down-lock sensor values are sampled at 0.25 Hz.

Figure 10: Time-history plot of the linear accelerations in the direction of the aircraft body axes, weight on wheels sensor information and the MLG and NLG down lock parameter. The dotted grey line indicates the point of initial contact with the ground ⁷.

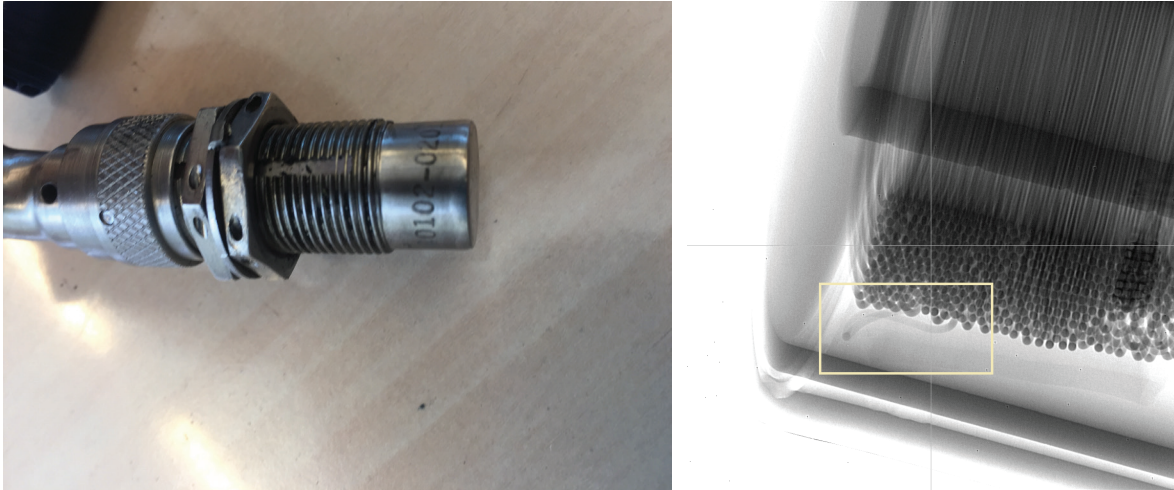
During the investigation the proximity sensors were removed from the brace and were tested separately. X-ray photography showed that one of the sensors’ wire spools showed a irregularity in the wire. When tested under room temperatures, the sensors did not show any malfunction or erratic readings. The sensors were then exposed to sub-zero temperatures and slowly warmed up to room temperature, comparative to the situation the aircraft was in coming down from altitude during the approach, when temperatures changed from -19° C to +8° C.

Figure 18: proximity sensor, and x-ray of sensor showing irregularity in loom.

During testing, one of the sensors showed indications out of the normal spectrum. This is in line with the PSEU fault readings initiated during the approach. The fault most likely caused the doors to remain open and the down lock actuator not activated after the MLG was fully down during the approach. This is in line with the PSEU logic described earlier.

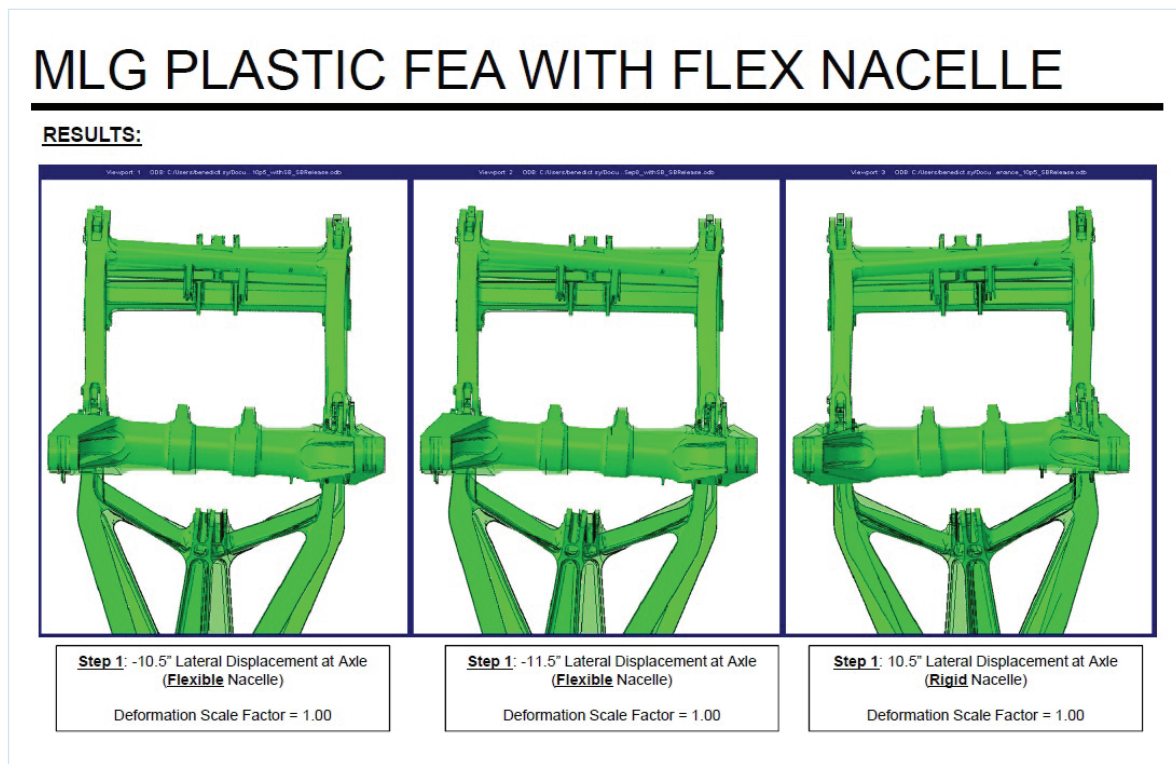
Figure 19: results of plastic deformation analyses. (source: landing gear manufacturer)

Further testing predicted that if a stabilizer brace assembly was installed at the time the yoke was deformed to the extent it was observed, the aft stabilizer brace should also have suffered permanent deformation. From the graph shown above, the aft stabilizer brace would have experienced permanent plastic strain even at relatively low lateral displacements. No permanent deformation was found in the aft stabilizer brace of the accident aircraft. If the aft stabilizer brace would have been deformed, it could not have been installed properly in the fixture as shown above. From the statements from the maintenance crew, there was no issue installing the brace assembly in the fixture. It is therefore highly unlikely that the aft stabilizer brace assembly from the accident was installed when the deformation of the yoke occurred.

Analyses predicts that if a stabilizer brace assembly was installed at the time the yoke was deformed to the extent it was observed, the yoke attachment lugs for the aft stabilizer brace should also have suffered permanent deformation. No deformation was found on the lugs for the aft brace on the accident yoke. It is therefore highly unlikely that ANY stabilizer brace assembly was installed when the deformation of the yoke occurred. This leads to the conclusion that the deformation of the yoke took place when the aircraft was not in a flying condition.

Based on the analysis conducted by the landing gear manufacturer, and the fact there was no deformation or damage found on the stabilizer or yoke attachment lugs, the deformation on the yoke most likely was present prior to touchdown at Schiphol. This deformation was caused when NO stabilizer brace assembly was installed.

- Investigate the possibility to incorporate into the AMM:
 - Possible change in task for the stab brace change to identify a possible yoke distortion,
 - Possibility to incorporate common checks for the stab brace change to verify down lock sensor serviceability in both the near and far configuration,
 - Incorporate a caution "with the stabilizer brace removed, do not induce any side loads to the MLG shock strut while in the retracted position, damage to the yoke can result.

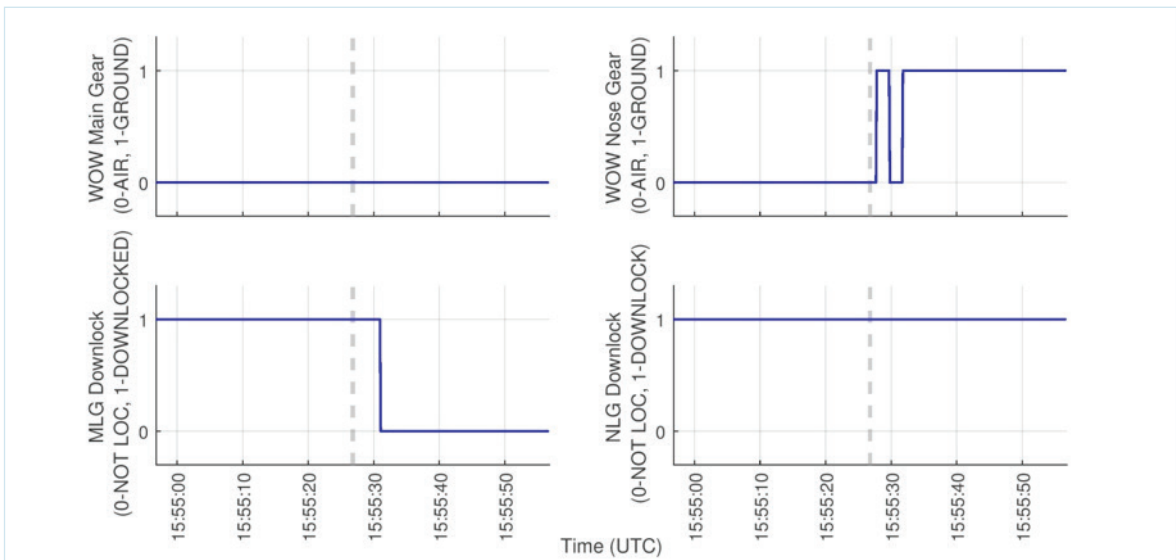
Figure 22: Time-history plot of weight on wheels sensors and gear downlock parameters as obtained from the decoded FDR data.
