Name of Target SHIZUOKA A/C PLANT

Location of Target SHIZUOKA

Team No. VI PDD - Job #2

Date 4 Nov 45 **Team Comdr.** Guill

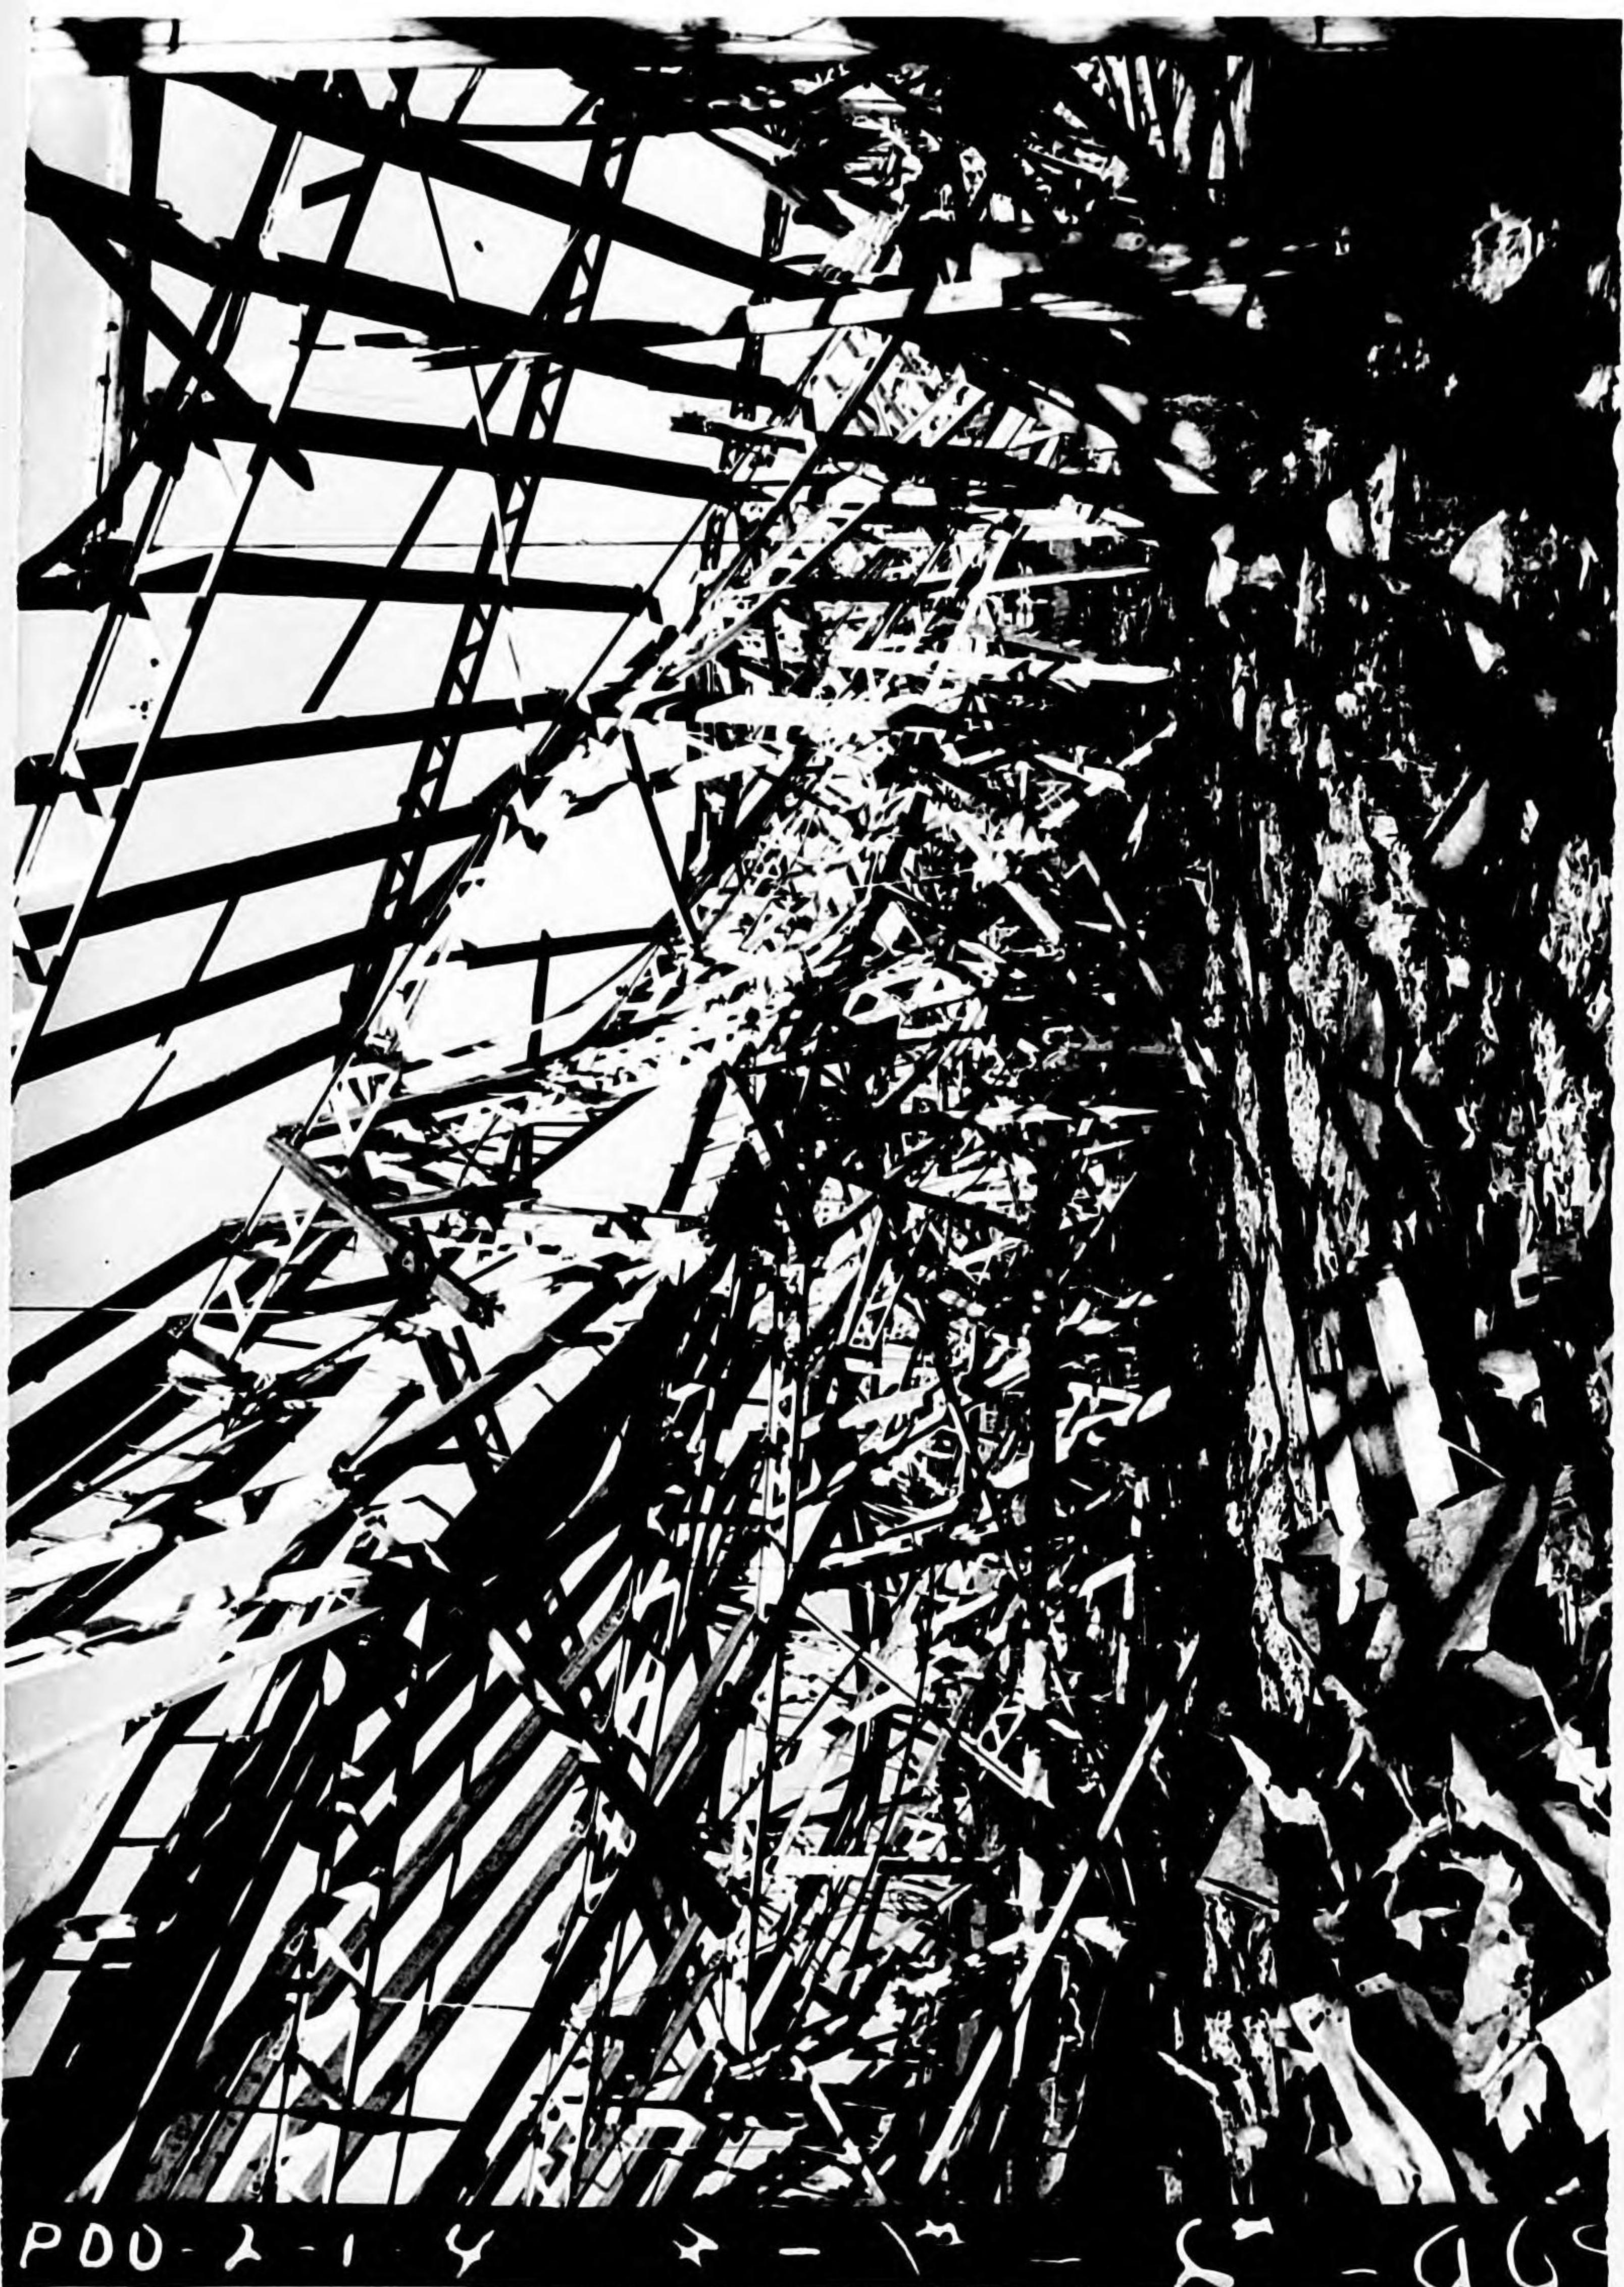
Photo 1 - Typical roof construction in Bldg 1, showing details in roof which has not been disturbed by bombing.

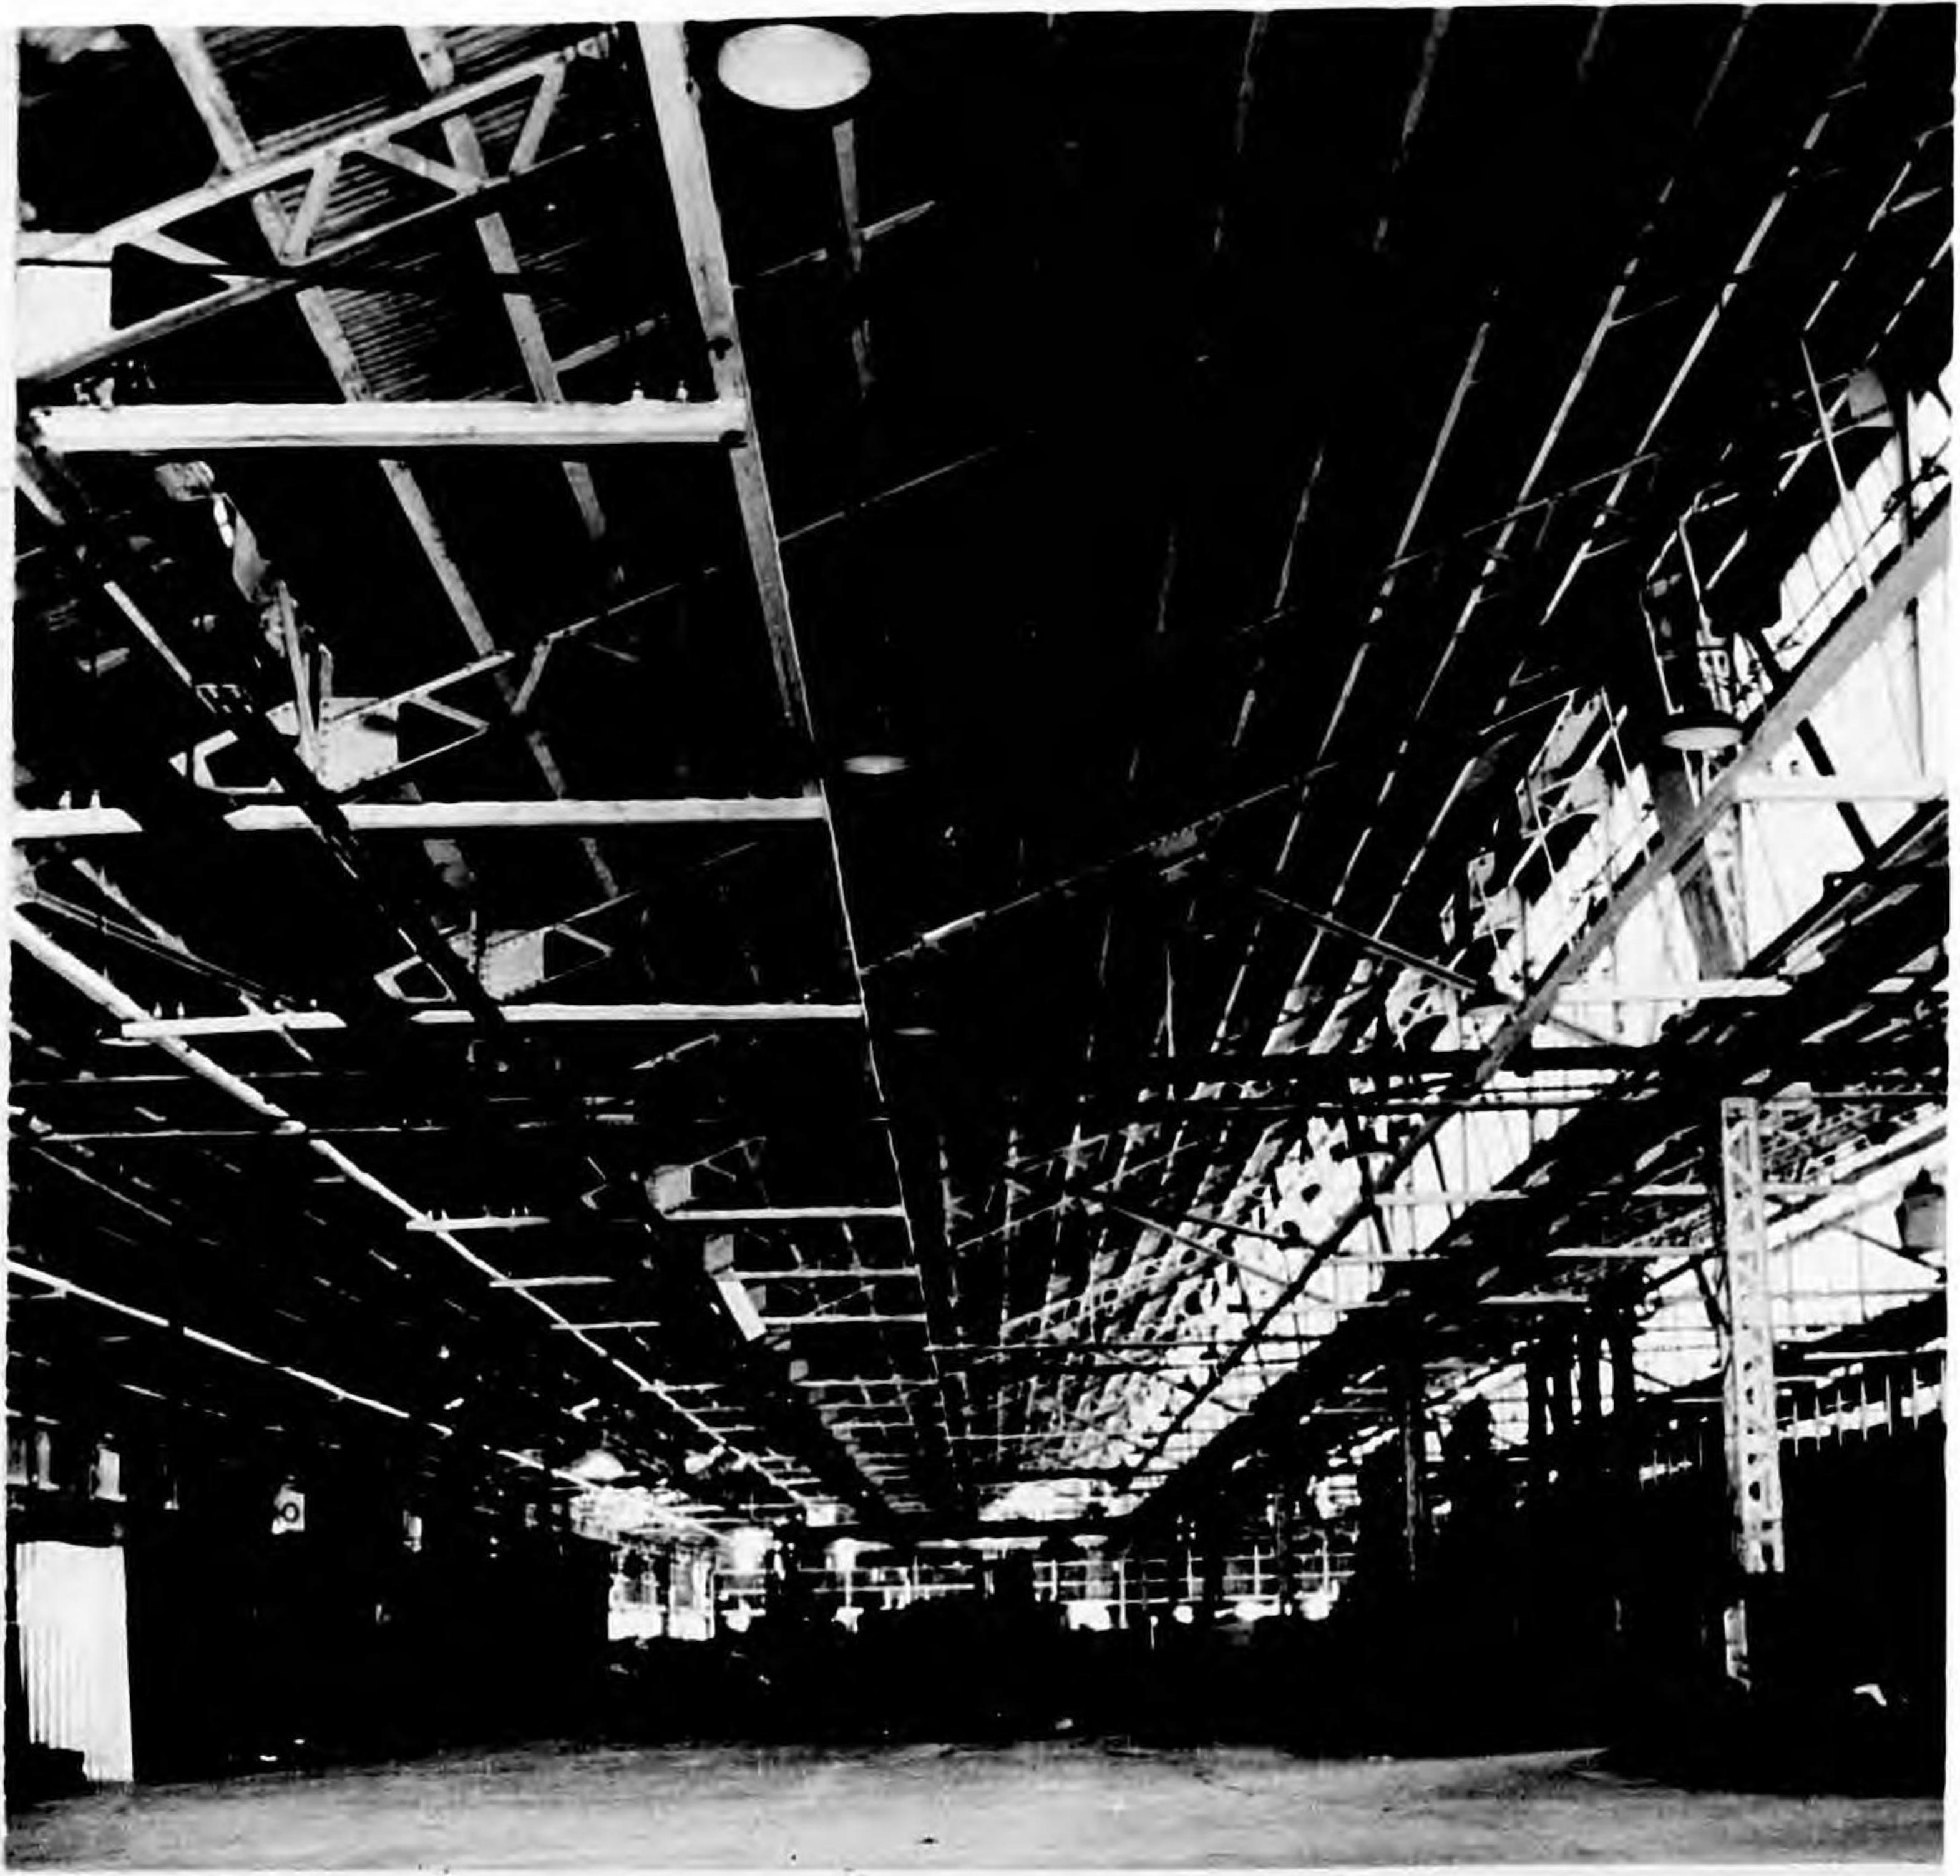
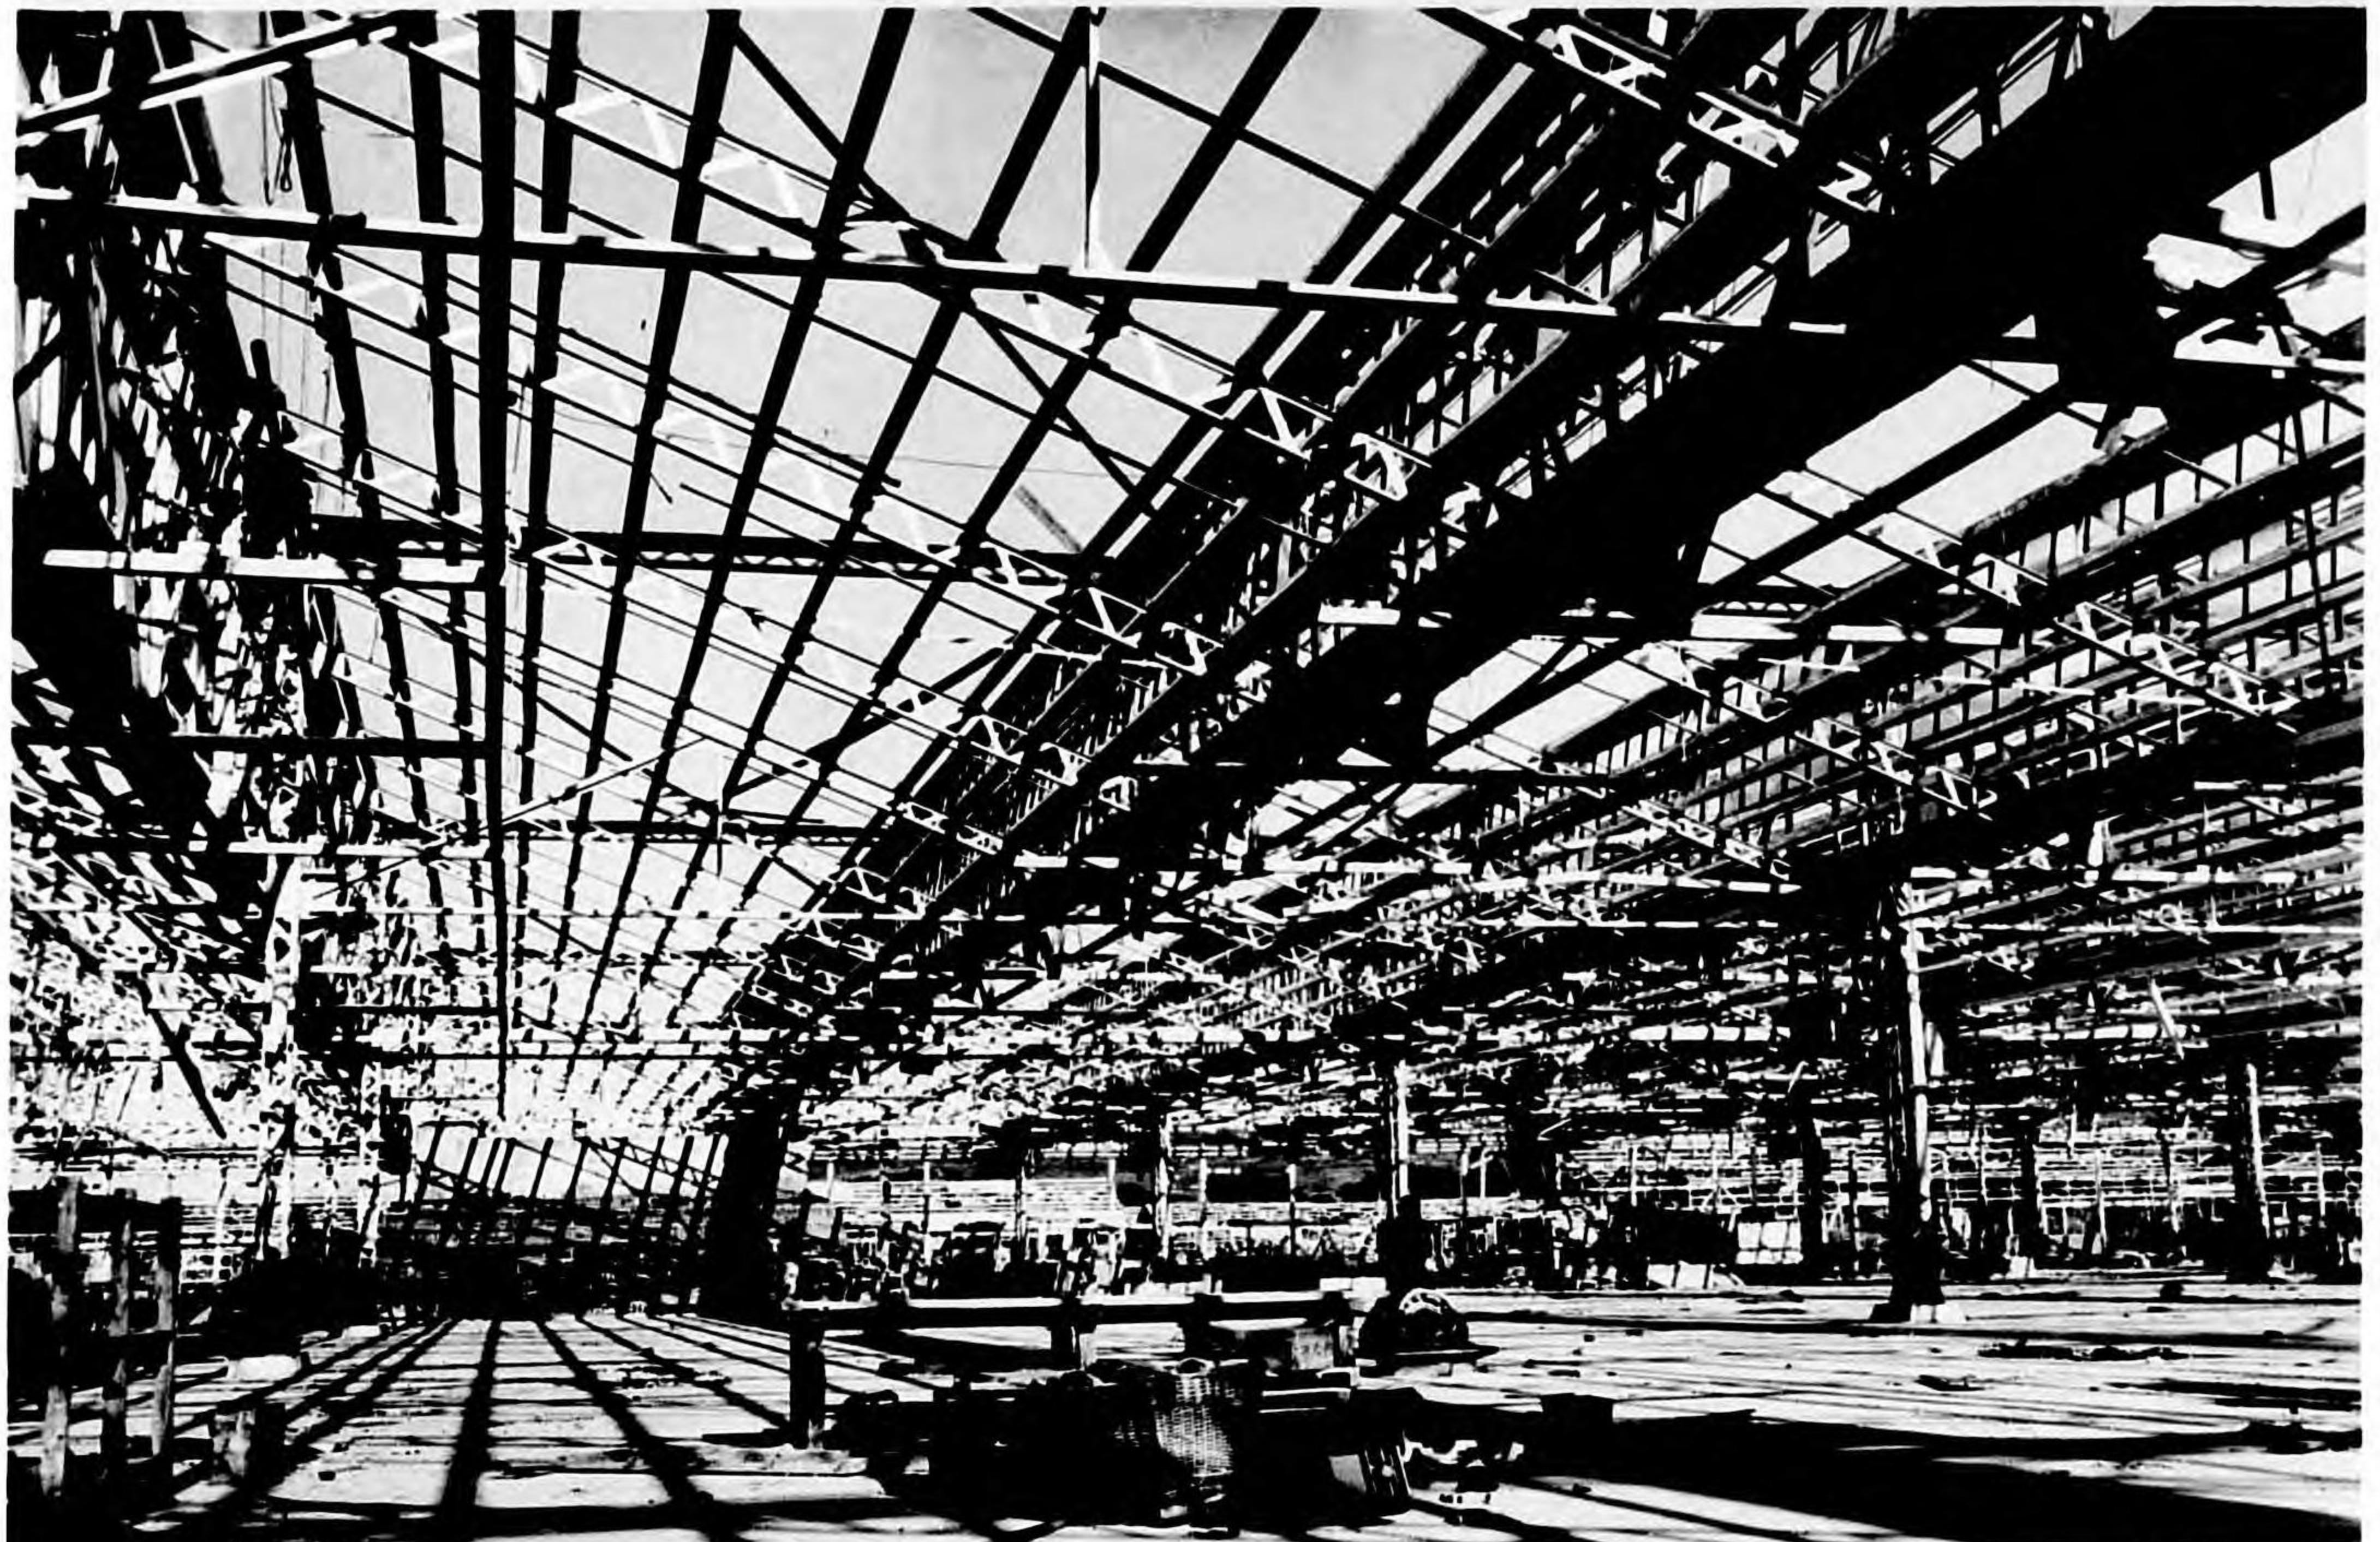
Photo 2 - Roof construction in Bldg 1, showing bare trusses where roof covering and glass have been completely removed.

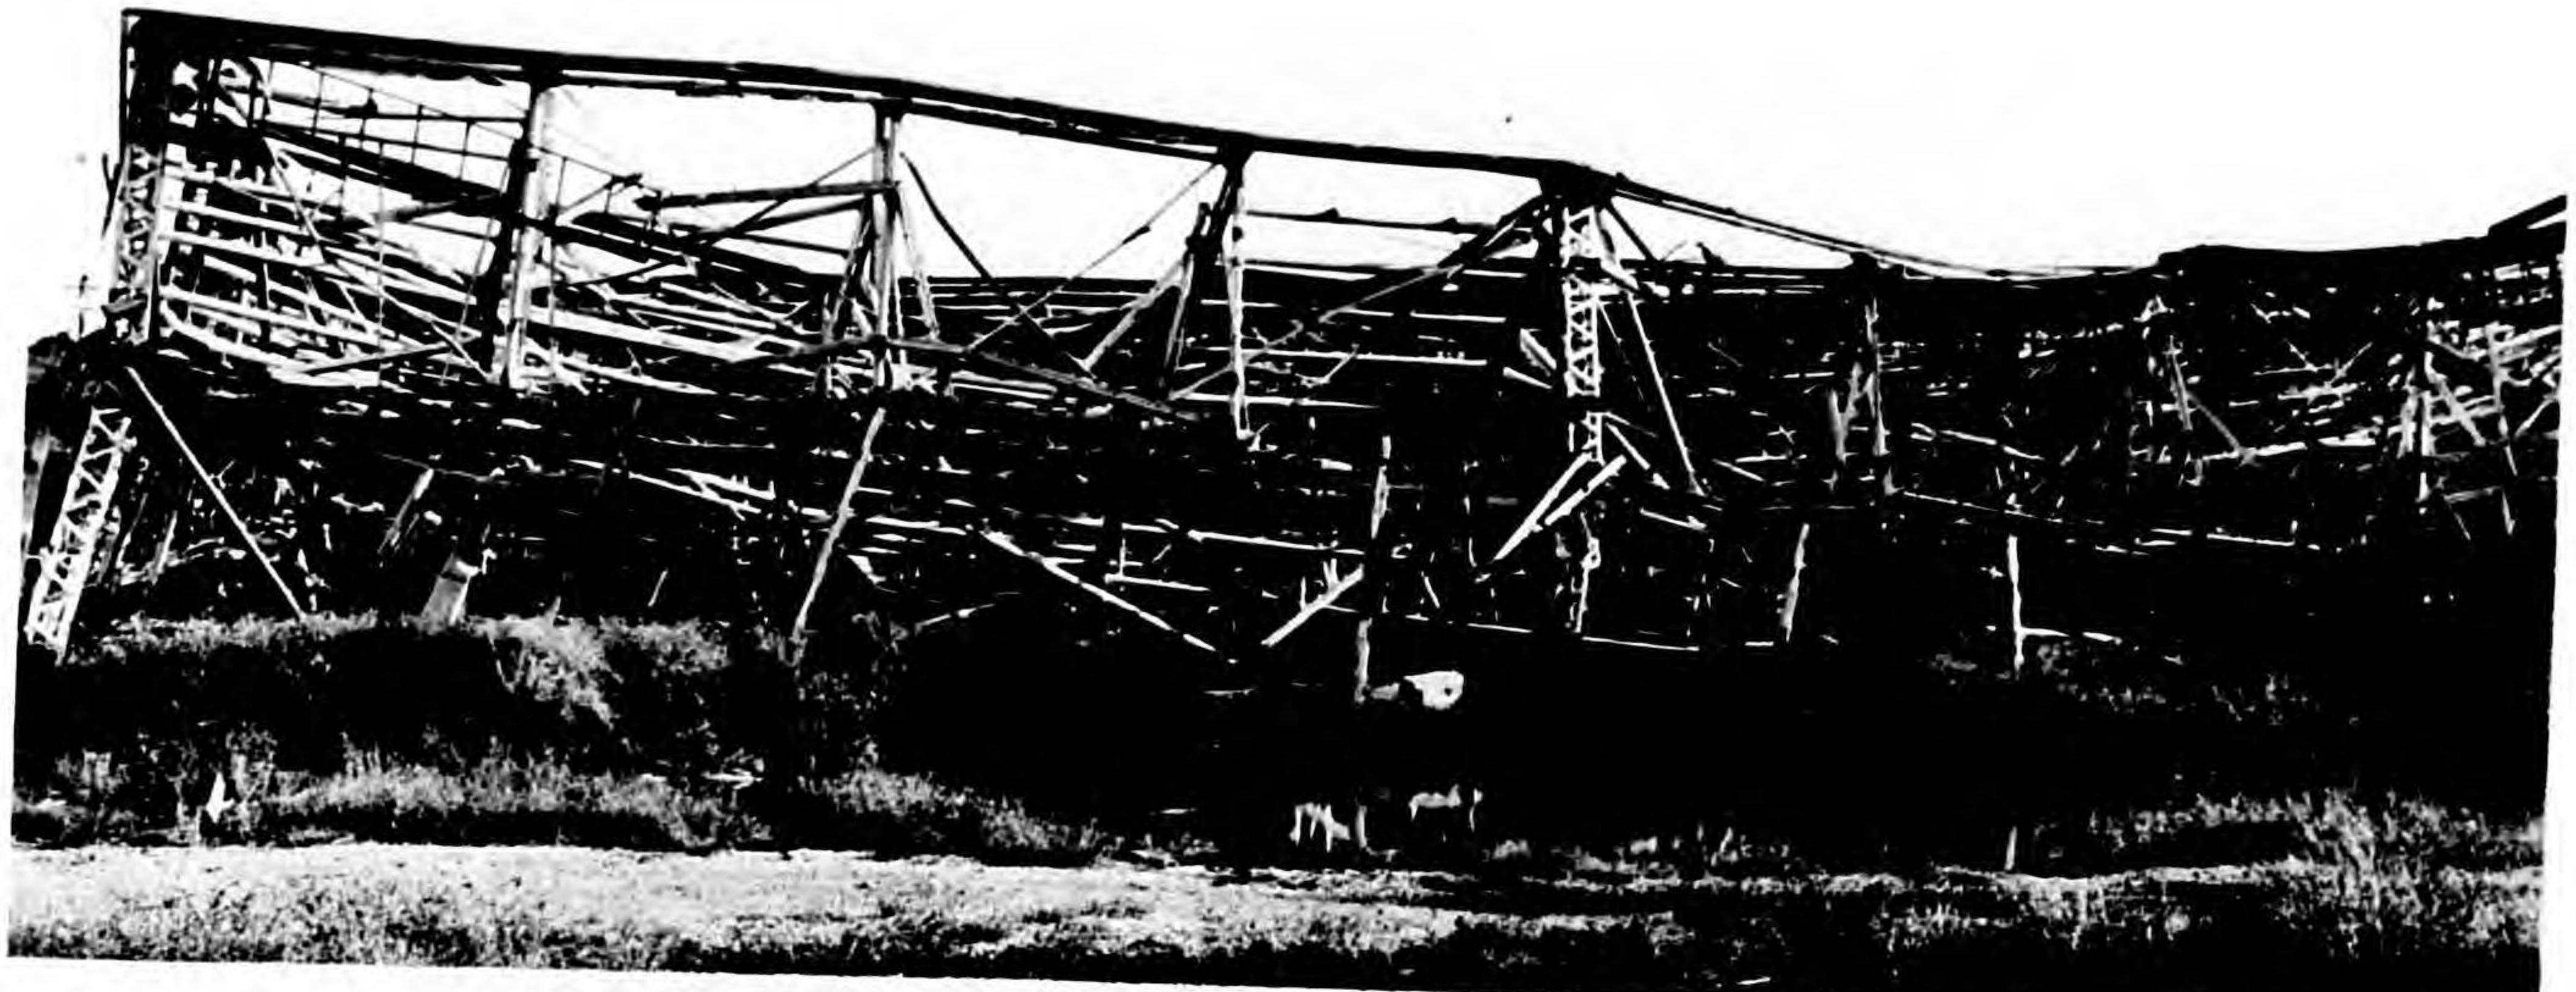
Photo 3 - General view of NE corner of Bldg 1 showing damage inflicted by Bombs 8 and 9, craters of which may be seen in the foreground.

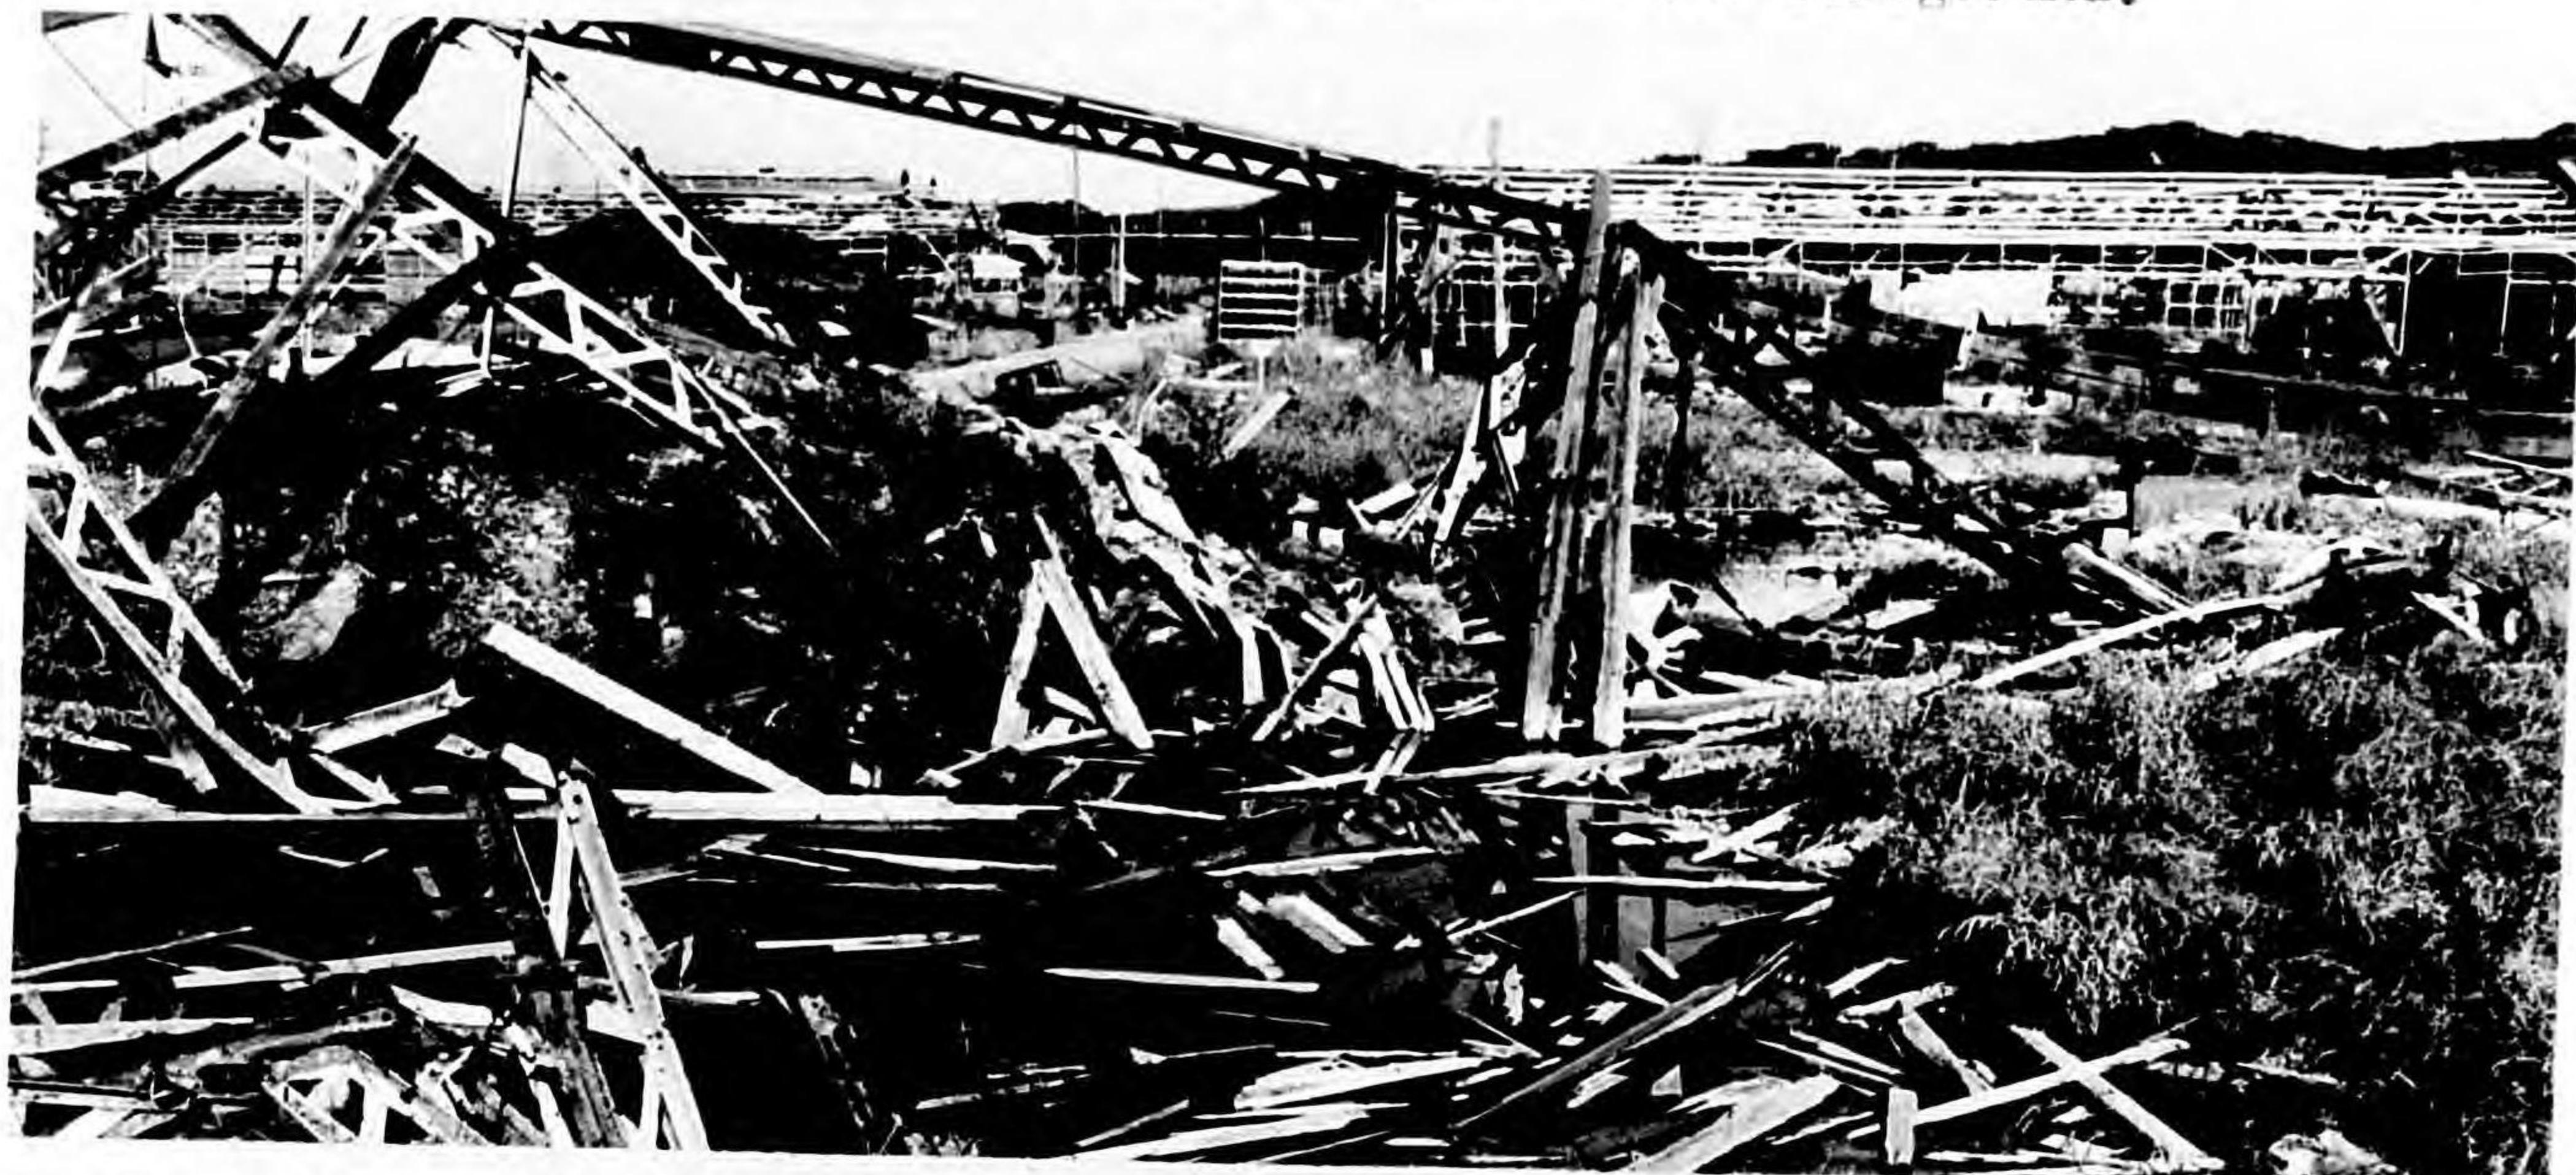
Photo 4 - Damage from Bomb 11 (foreground), a direct hit, and Bomb 10 (background), a near miss. This portion of Bldg 1 was destroyed.

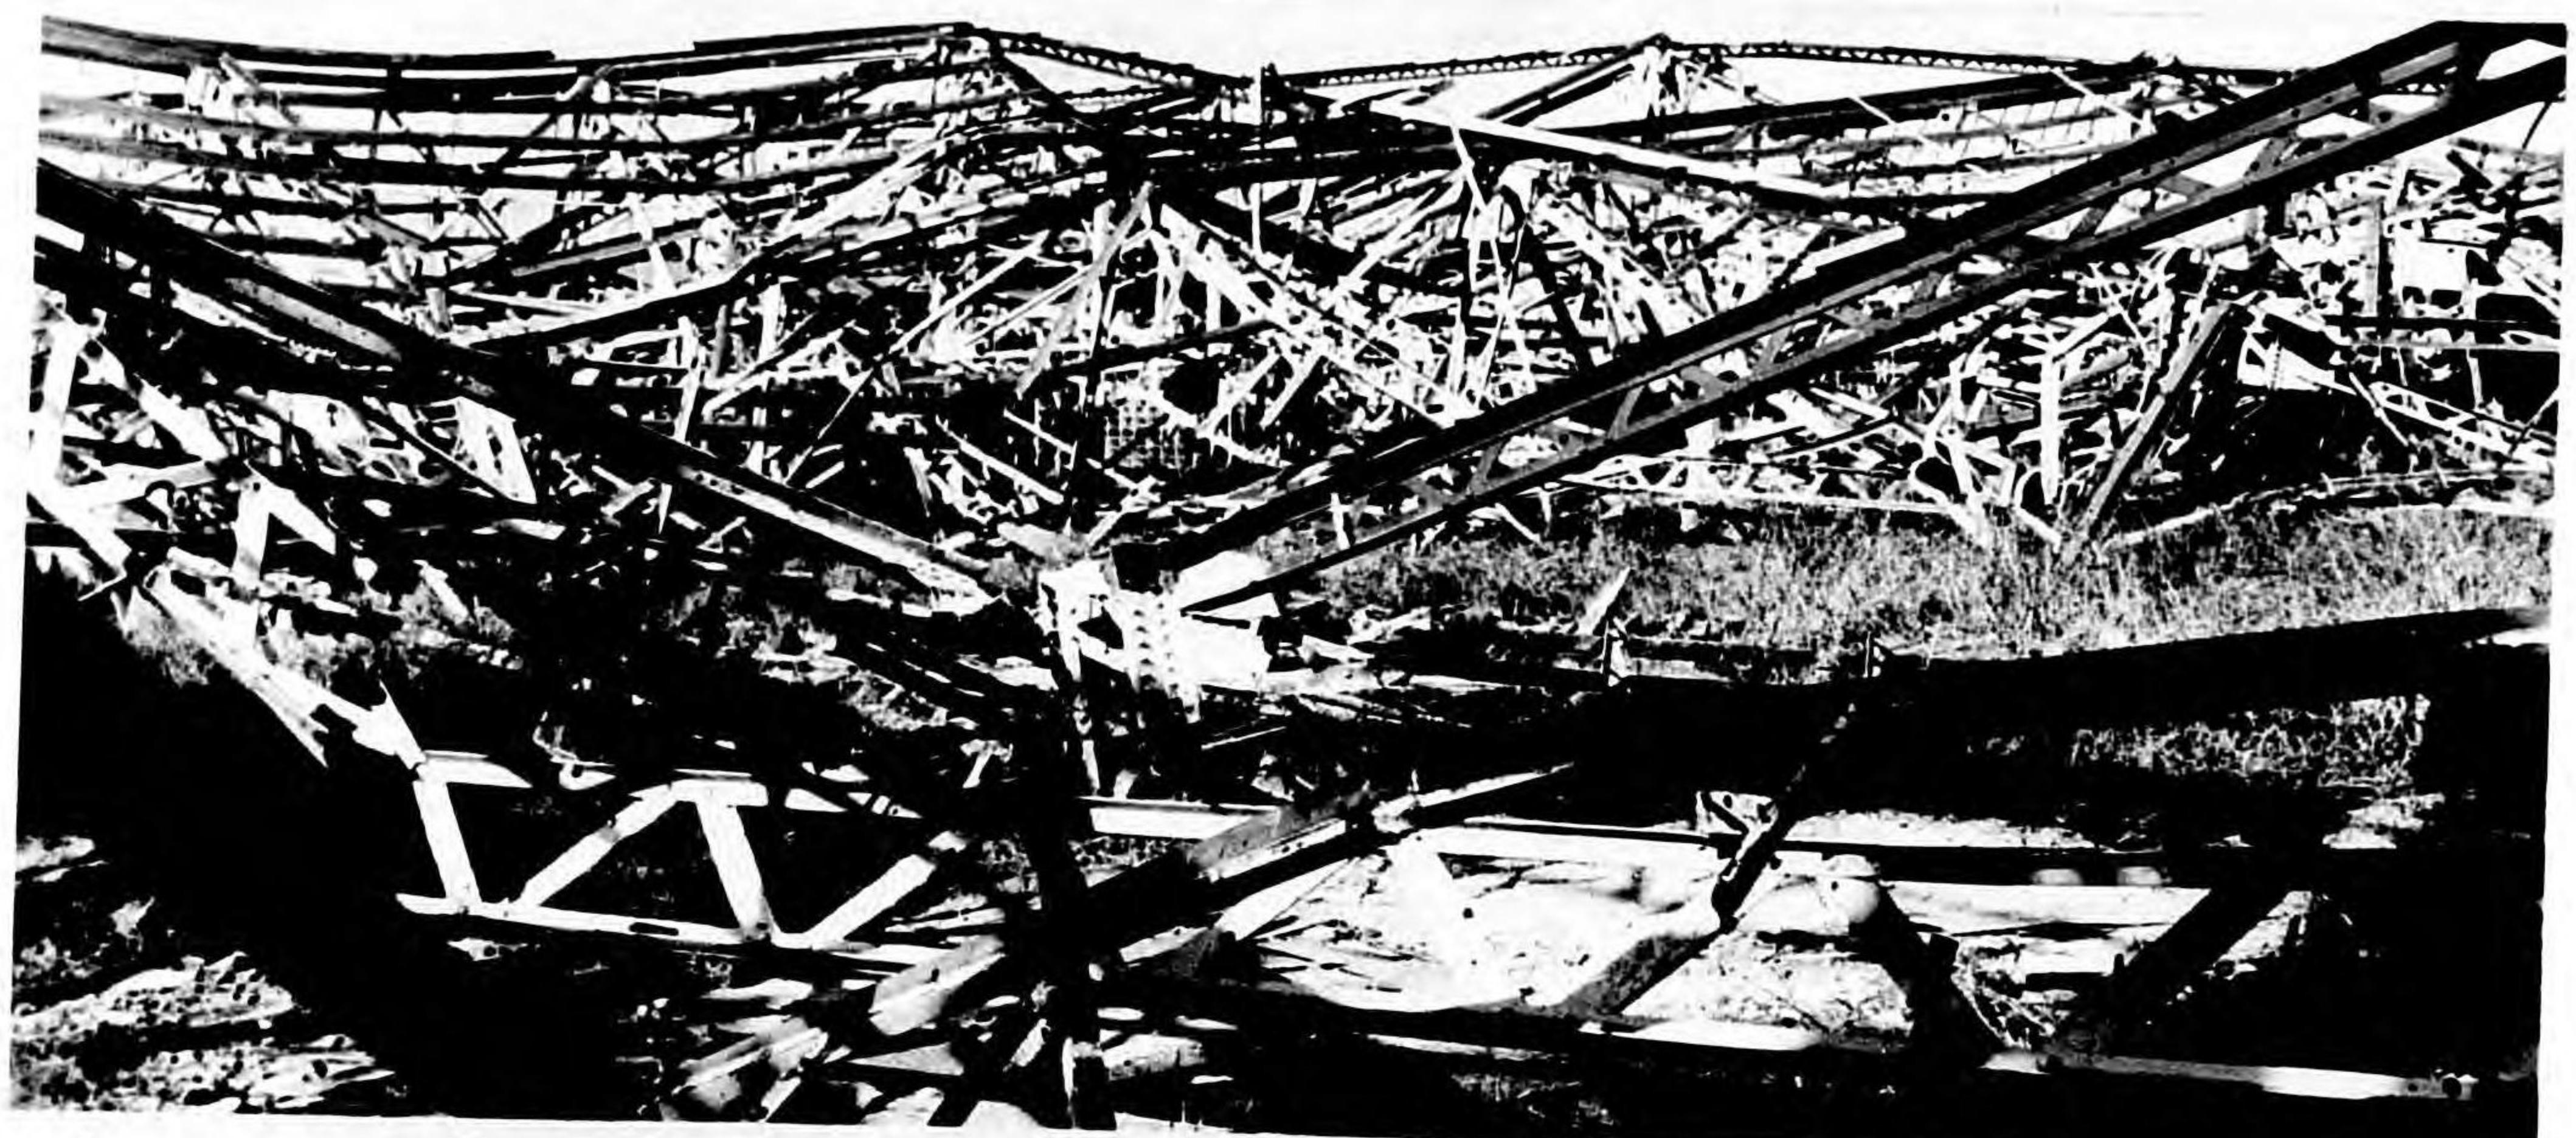
Photo 5 - Collapse of the shop roof occasioned by the direct hit of Bomb 12. This damage was increased by effects of Bombs 10 and 11, which detonated to the right of the picture.
