Name of Target SHIZUOKA A/C PLANT

Location of Target SHIZUOKA

Team No. VI PDD - Job #2

Date 4 Nov 45 **Team Comdr.** Guill

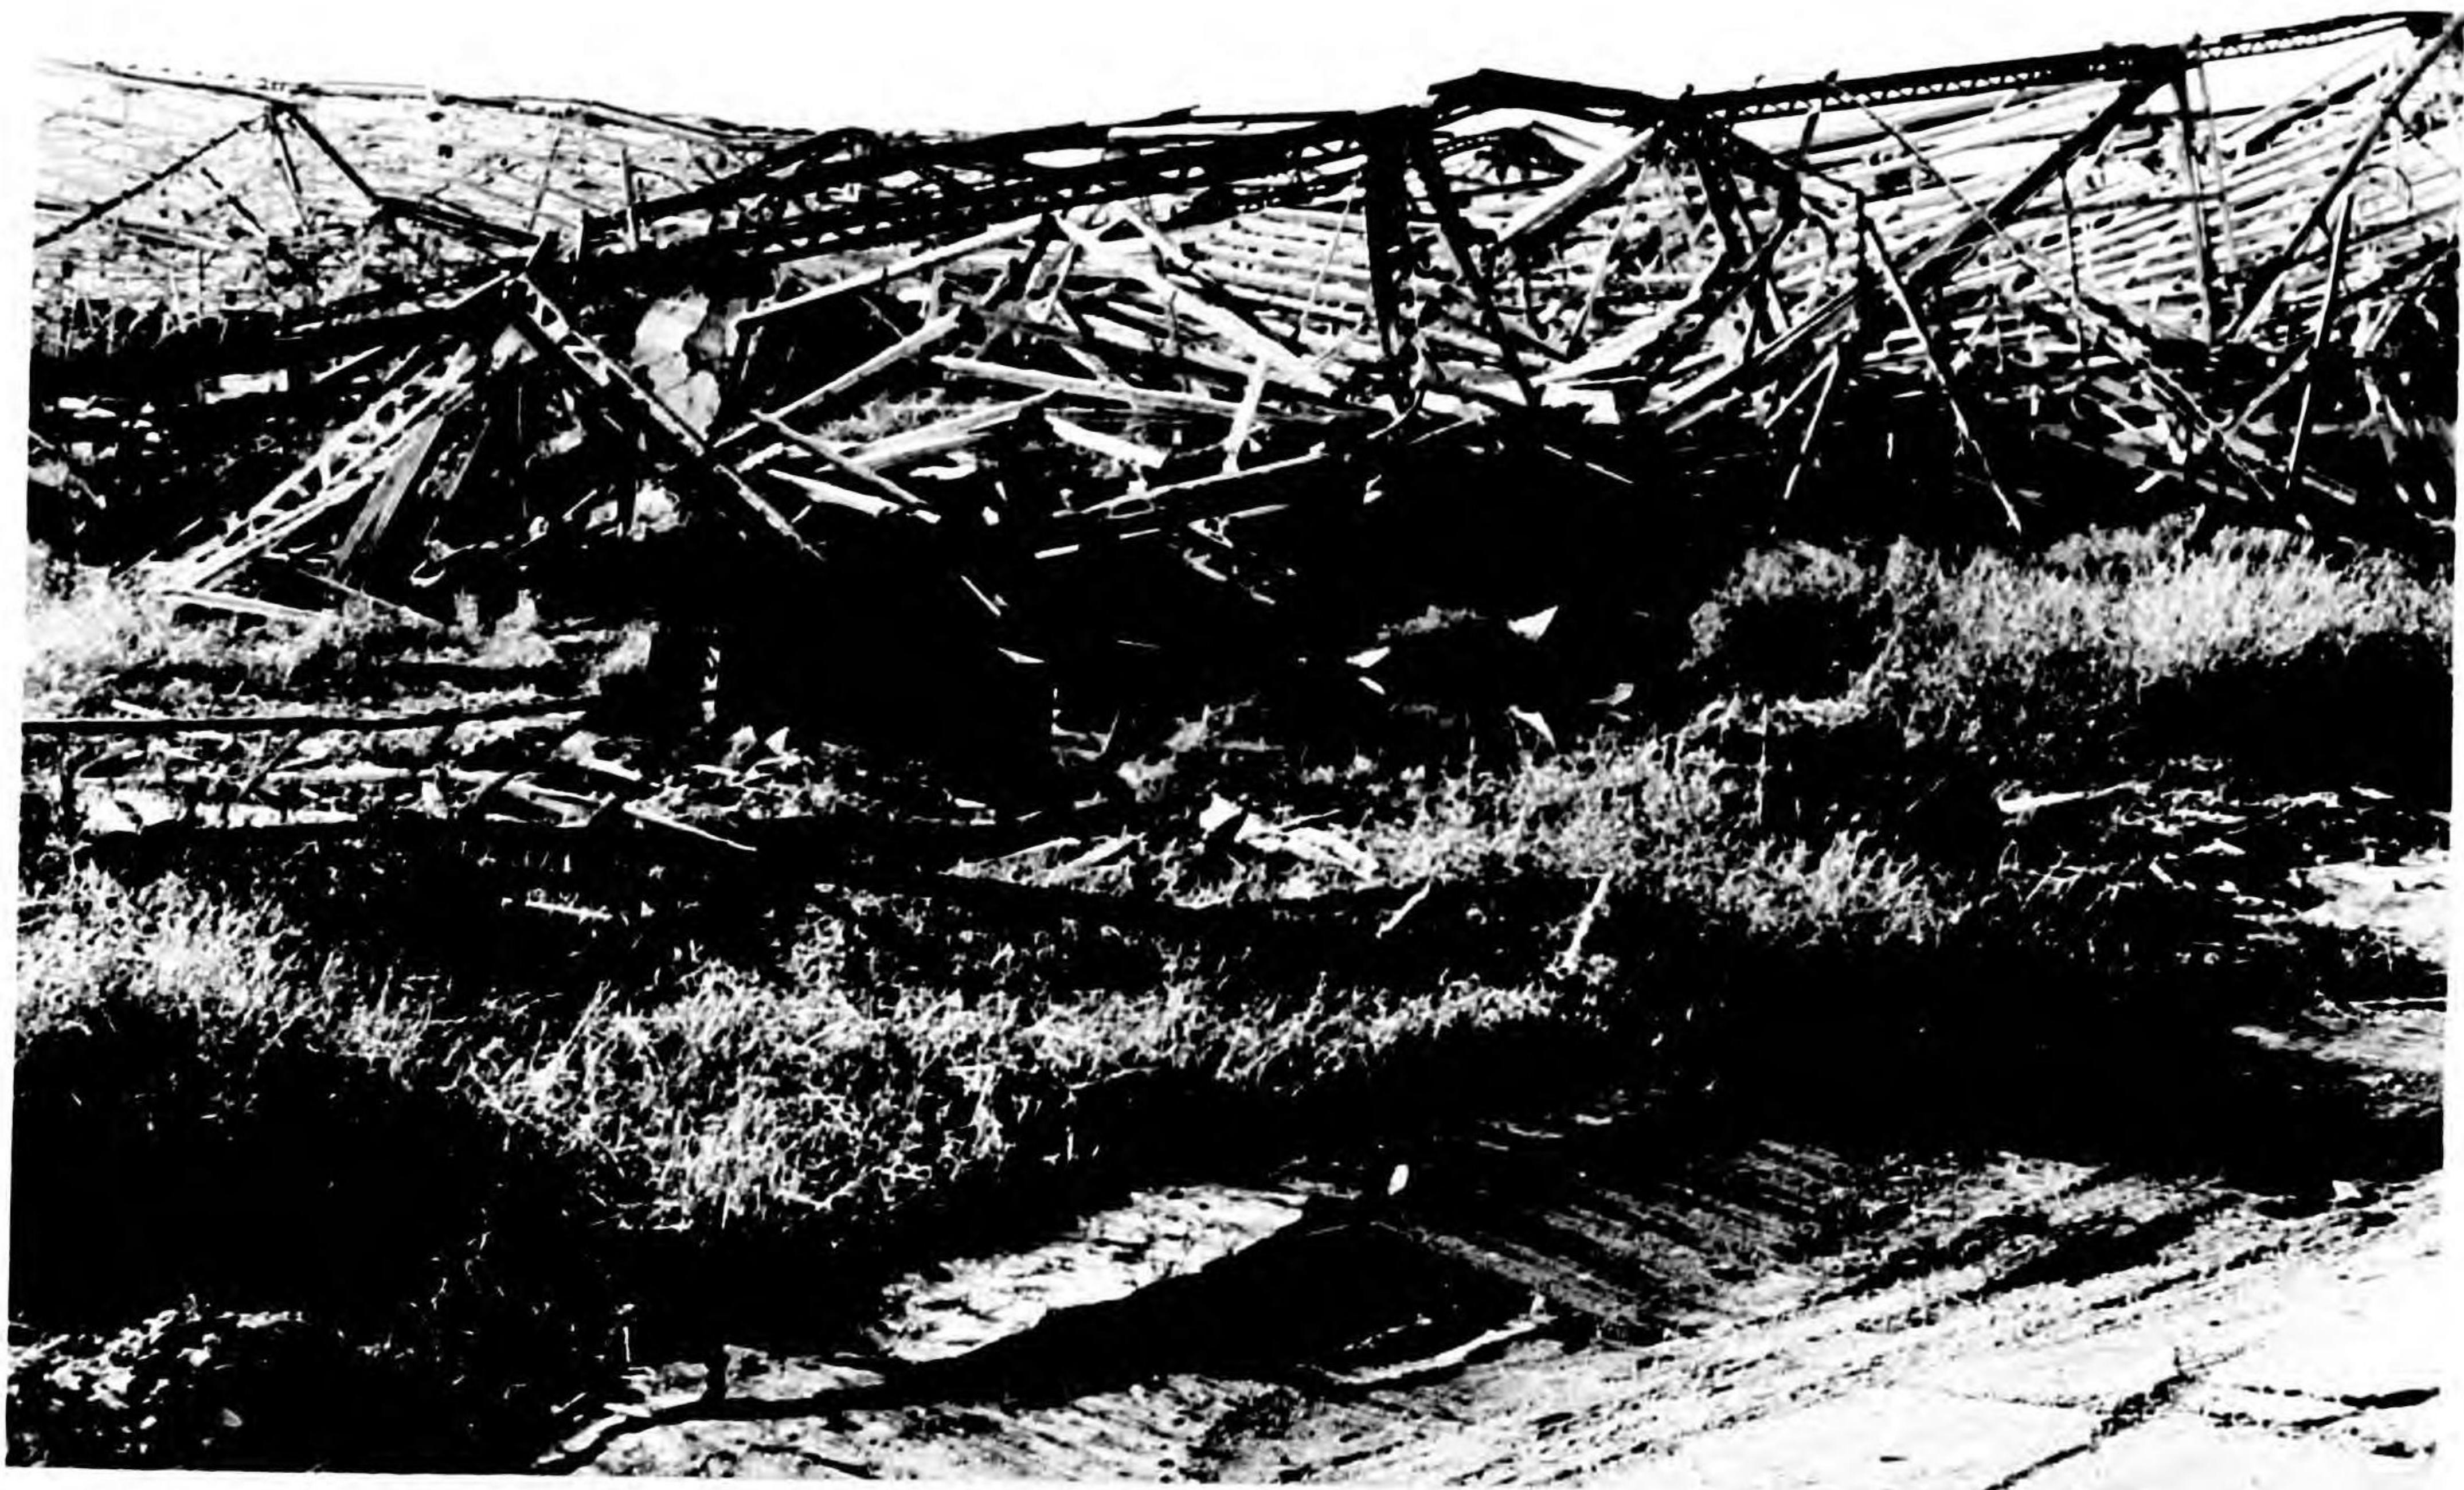
Photo 6 - General view of the effects of Bombs 10, 11 and 12, showing complete collapse of the building at this point.

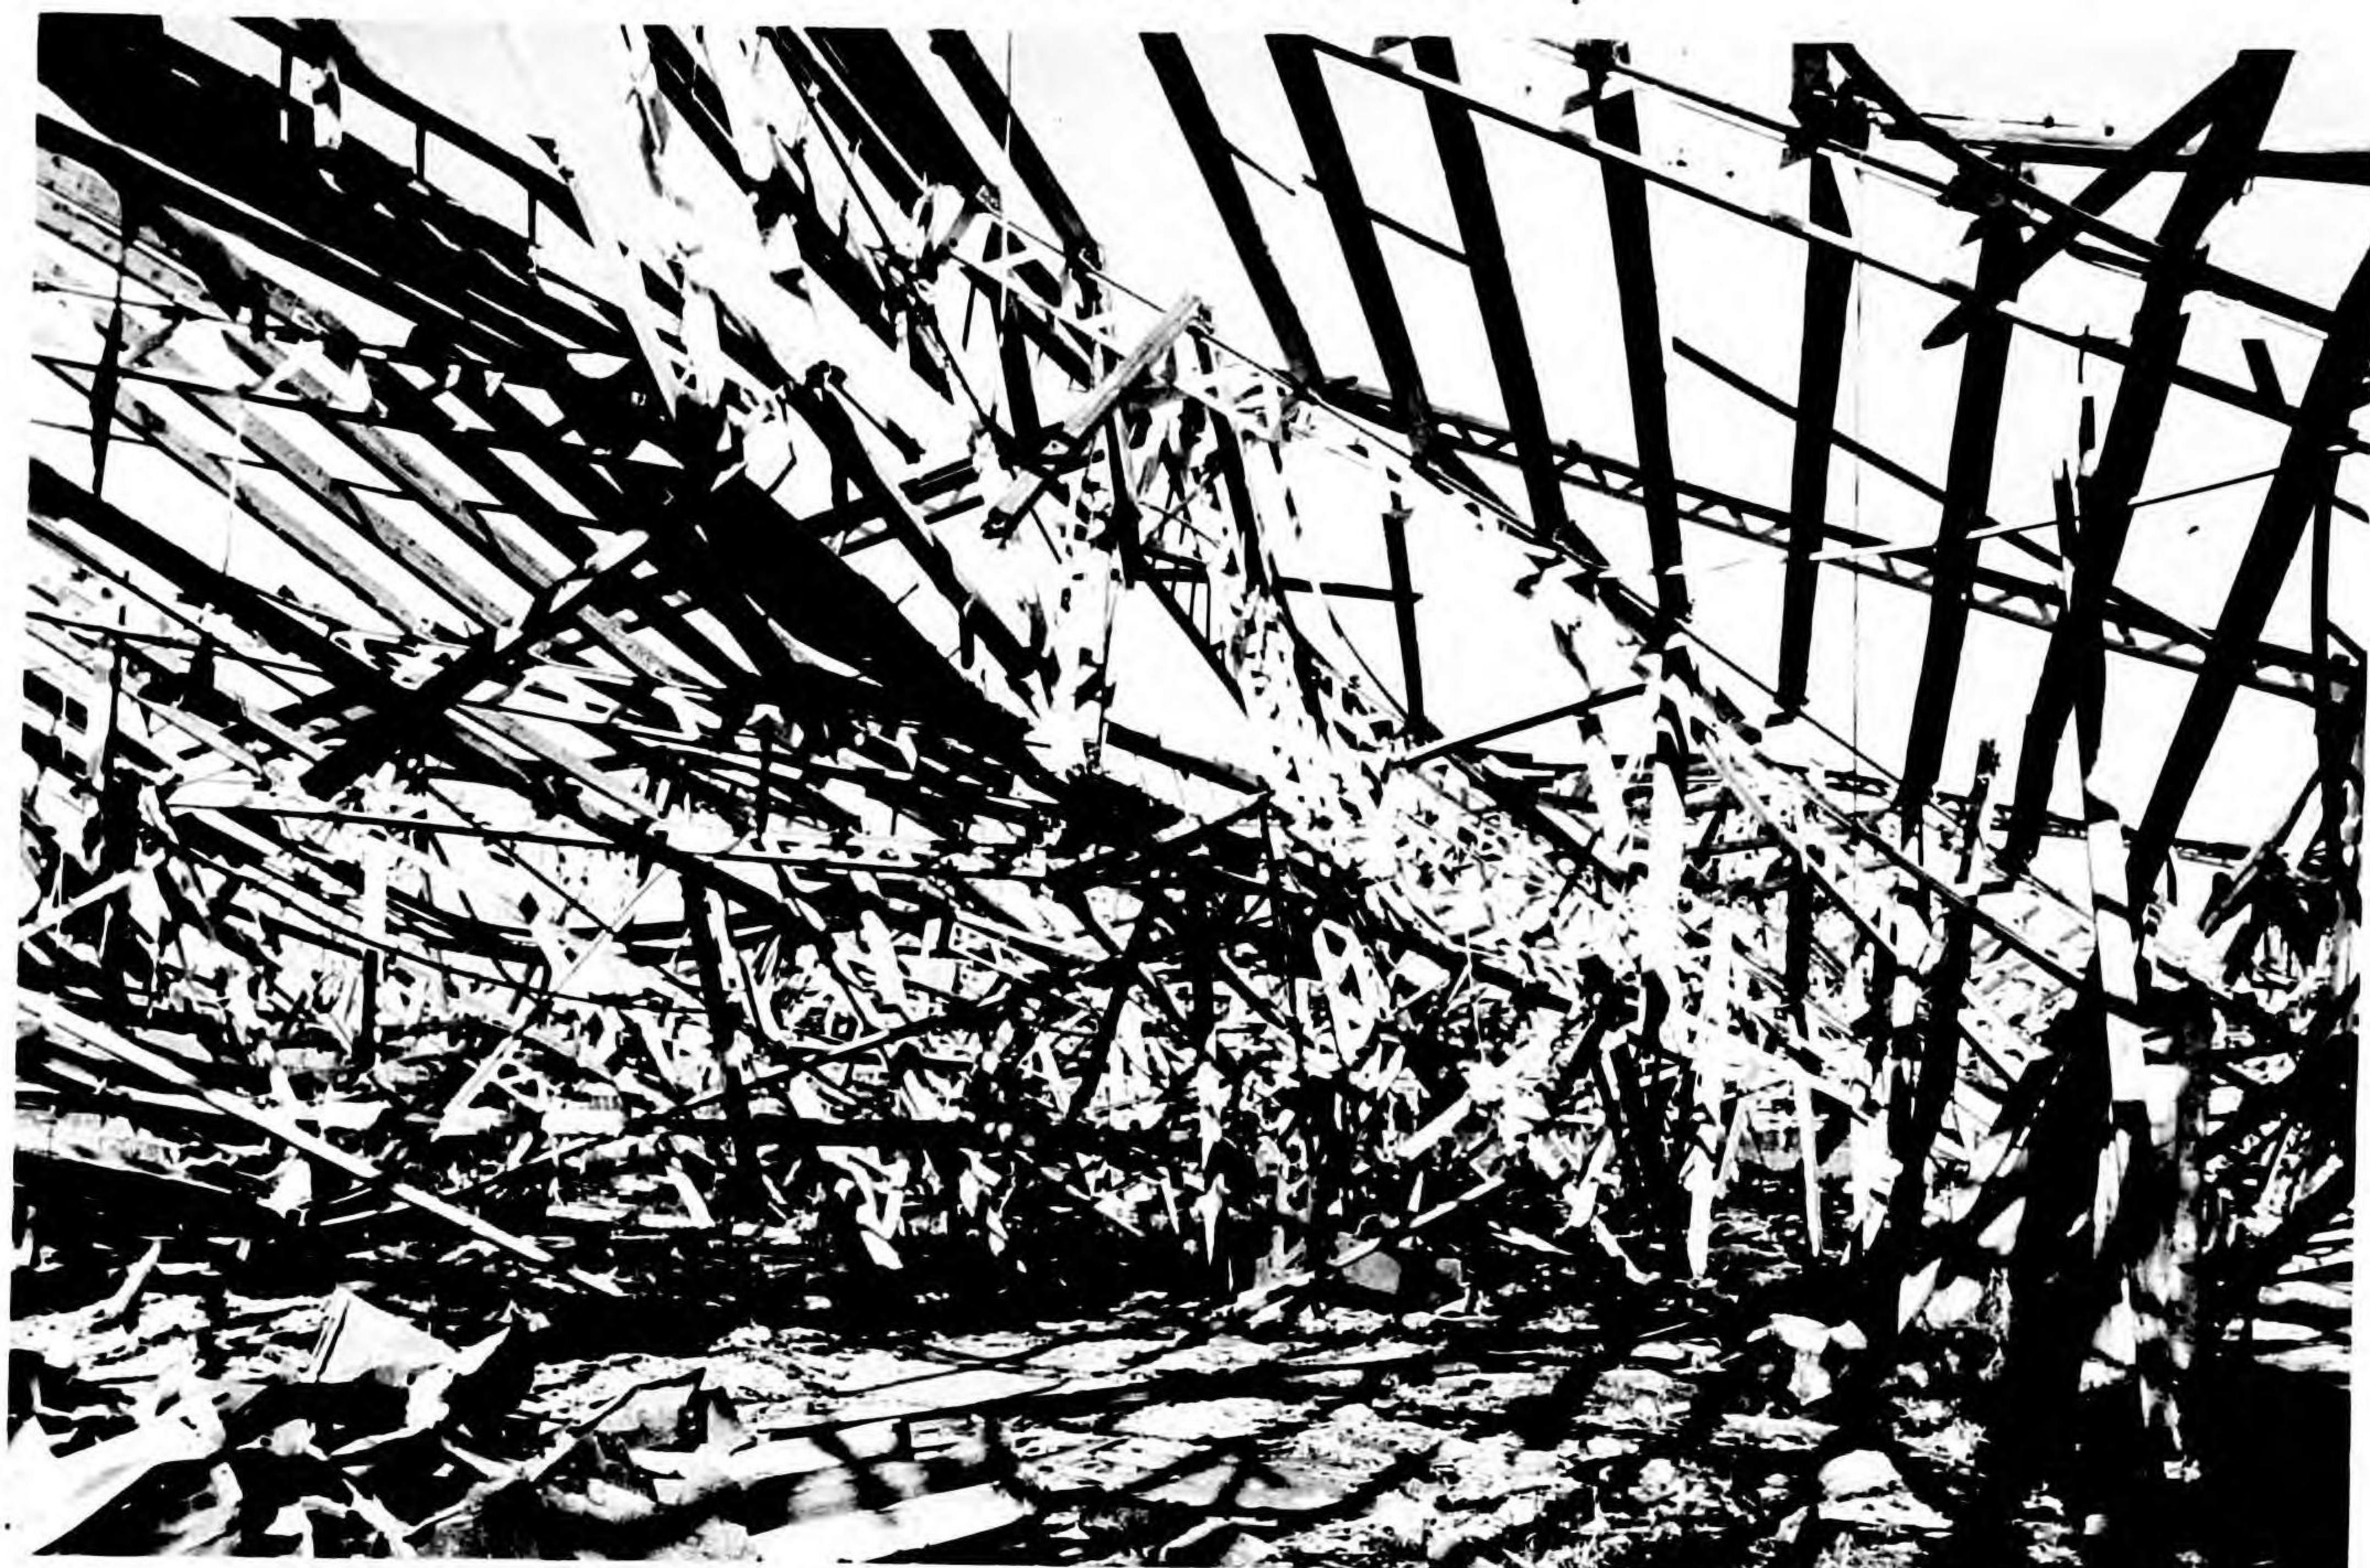
Photo 7 - In the foreground, tangled wreckage caused by Bomb 12. In the background, damage caused by Bombs 8 and 9.

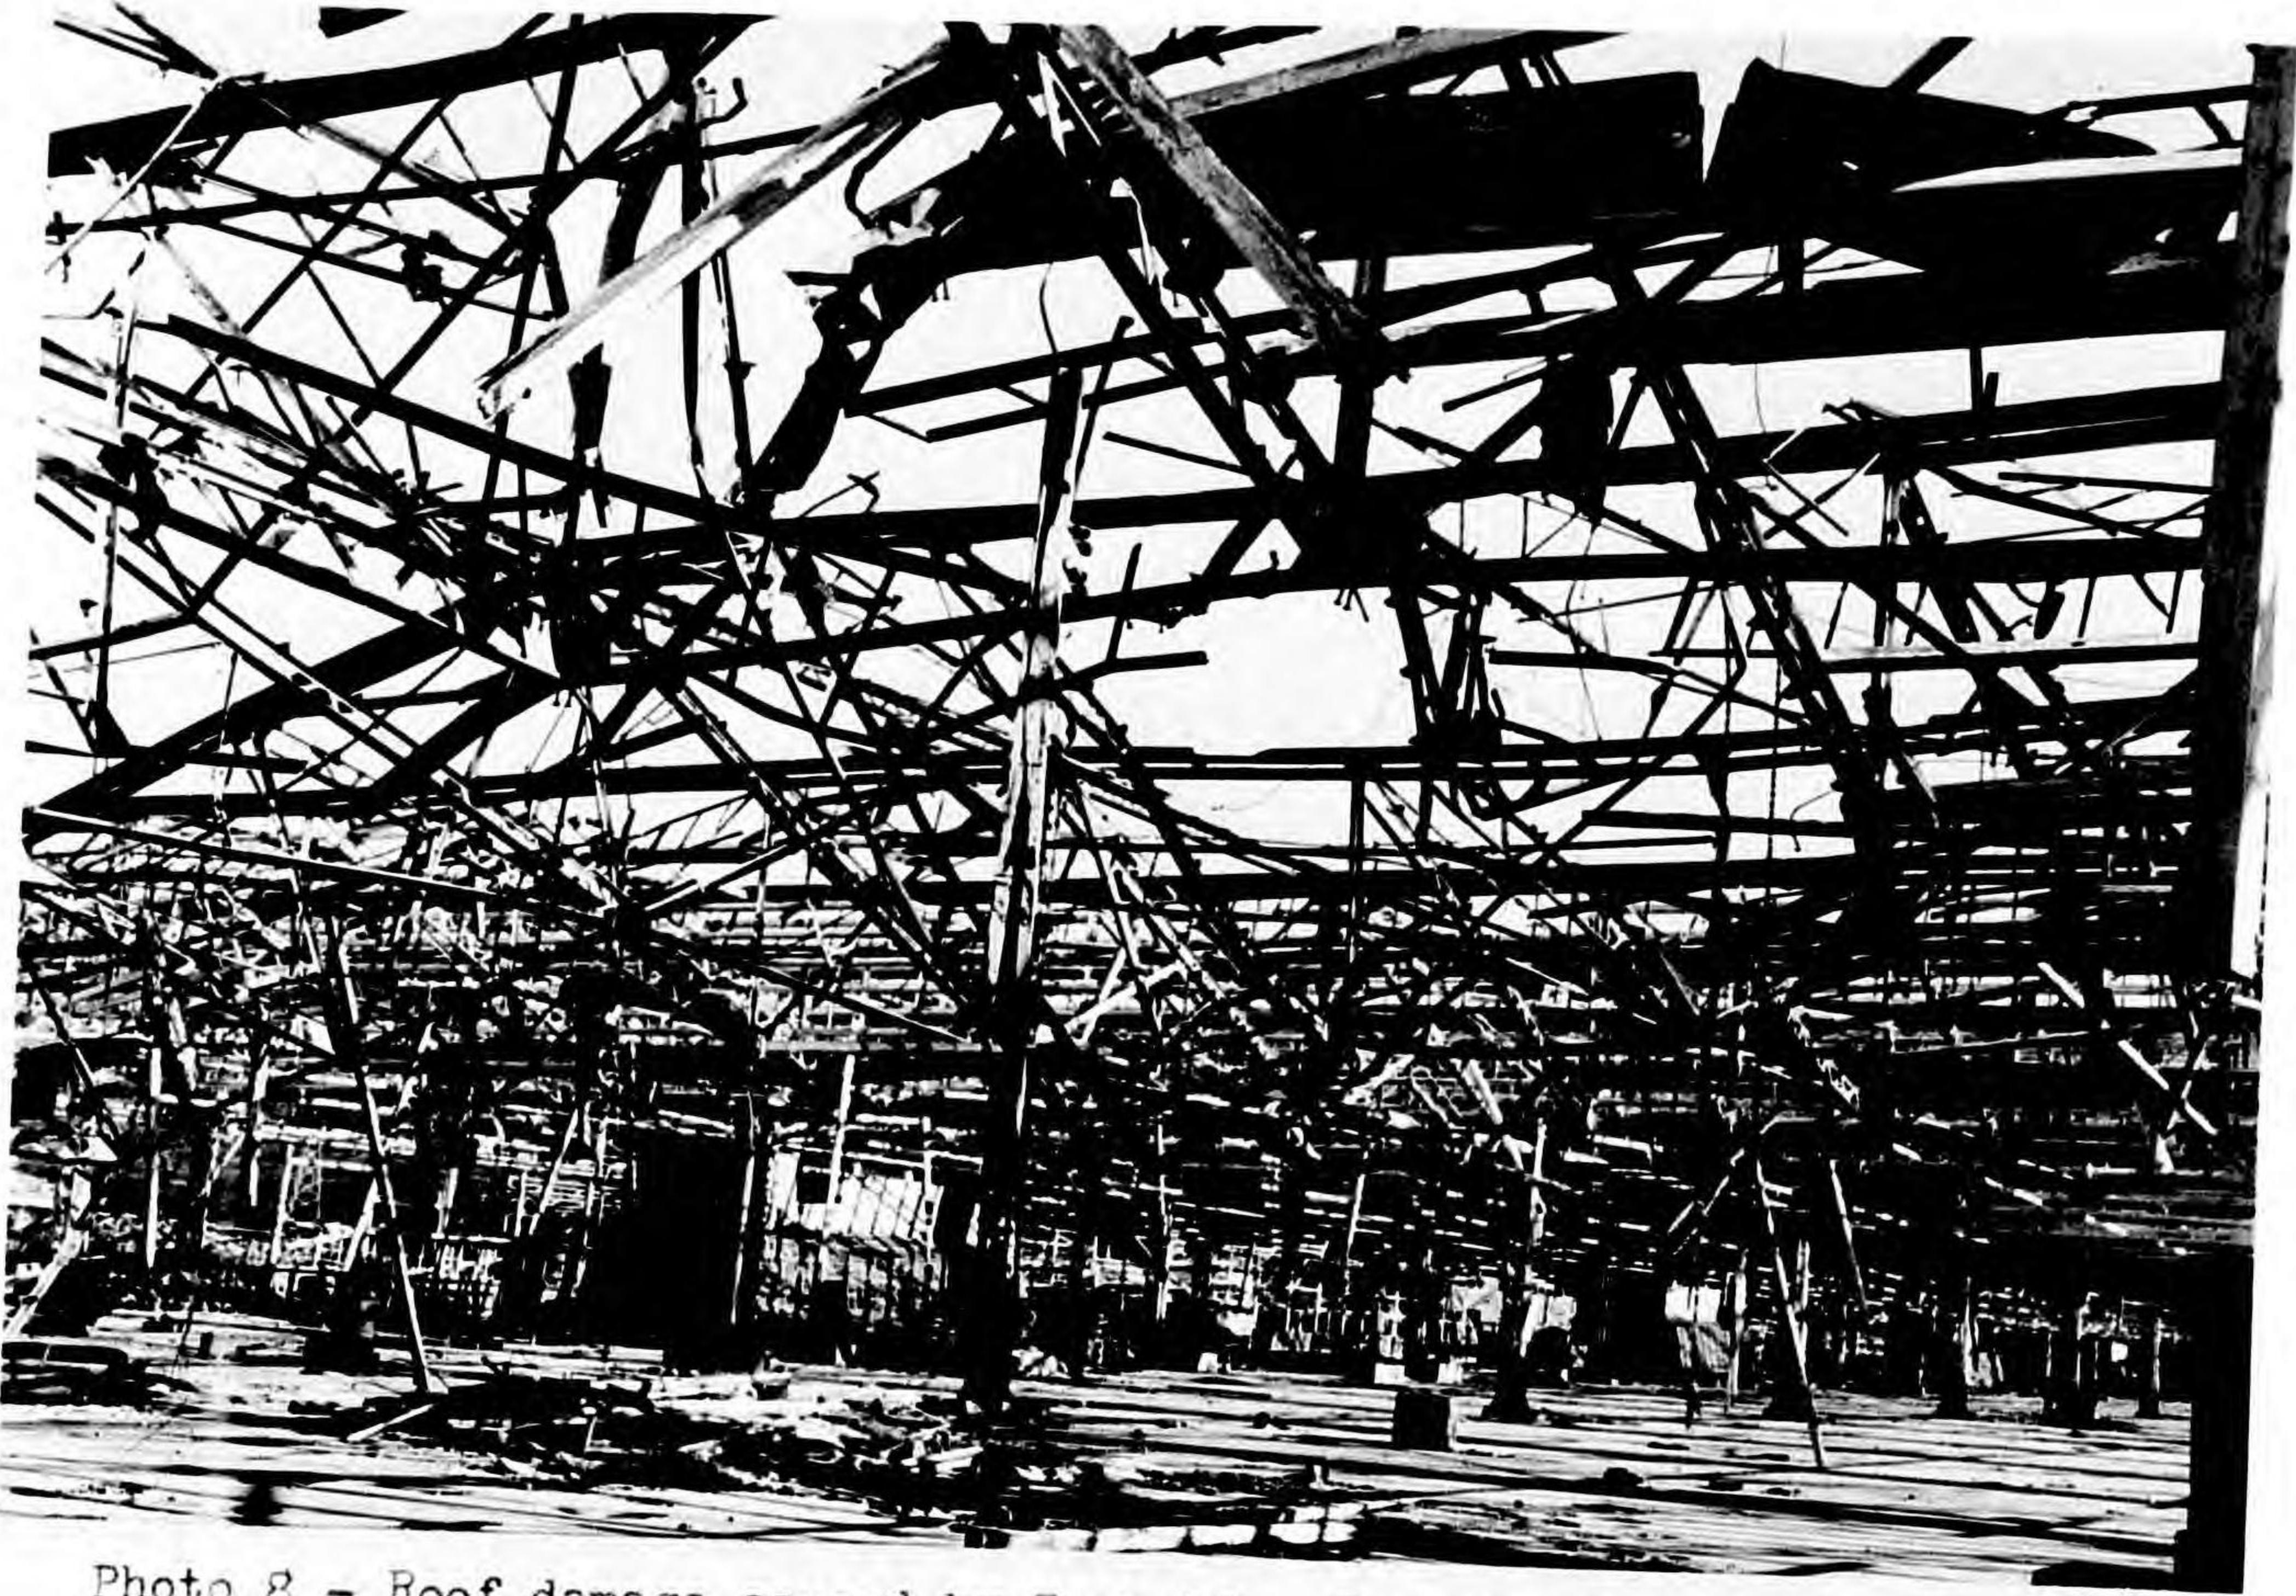
Photo 8 - Roof damage caused by Bomb 15. Structural damage was minor compared to that caused by bombs which detonated at ground level.

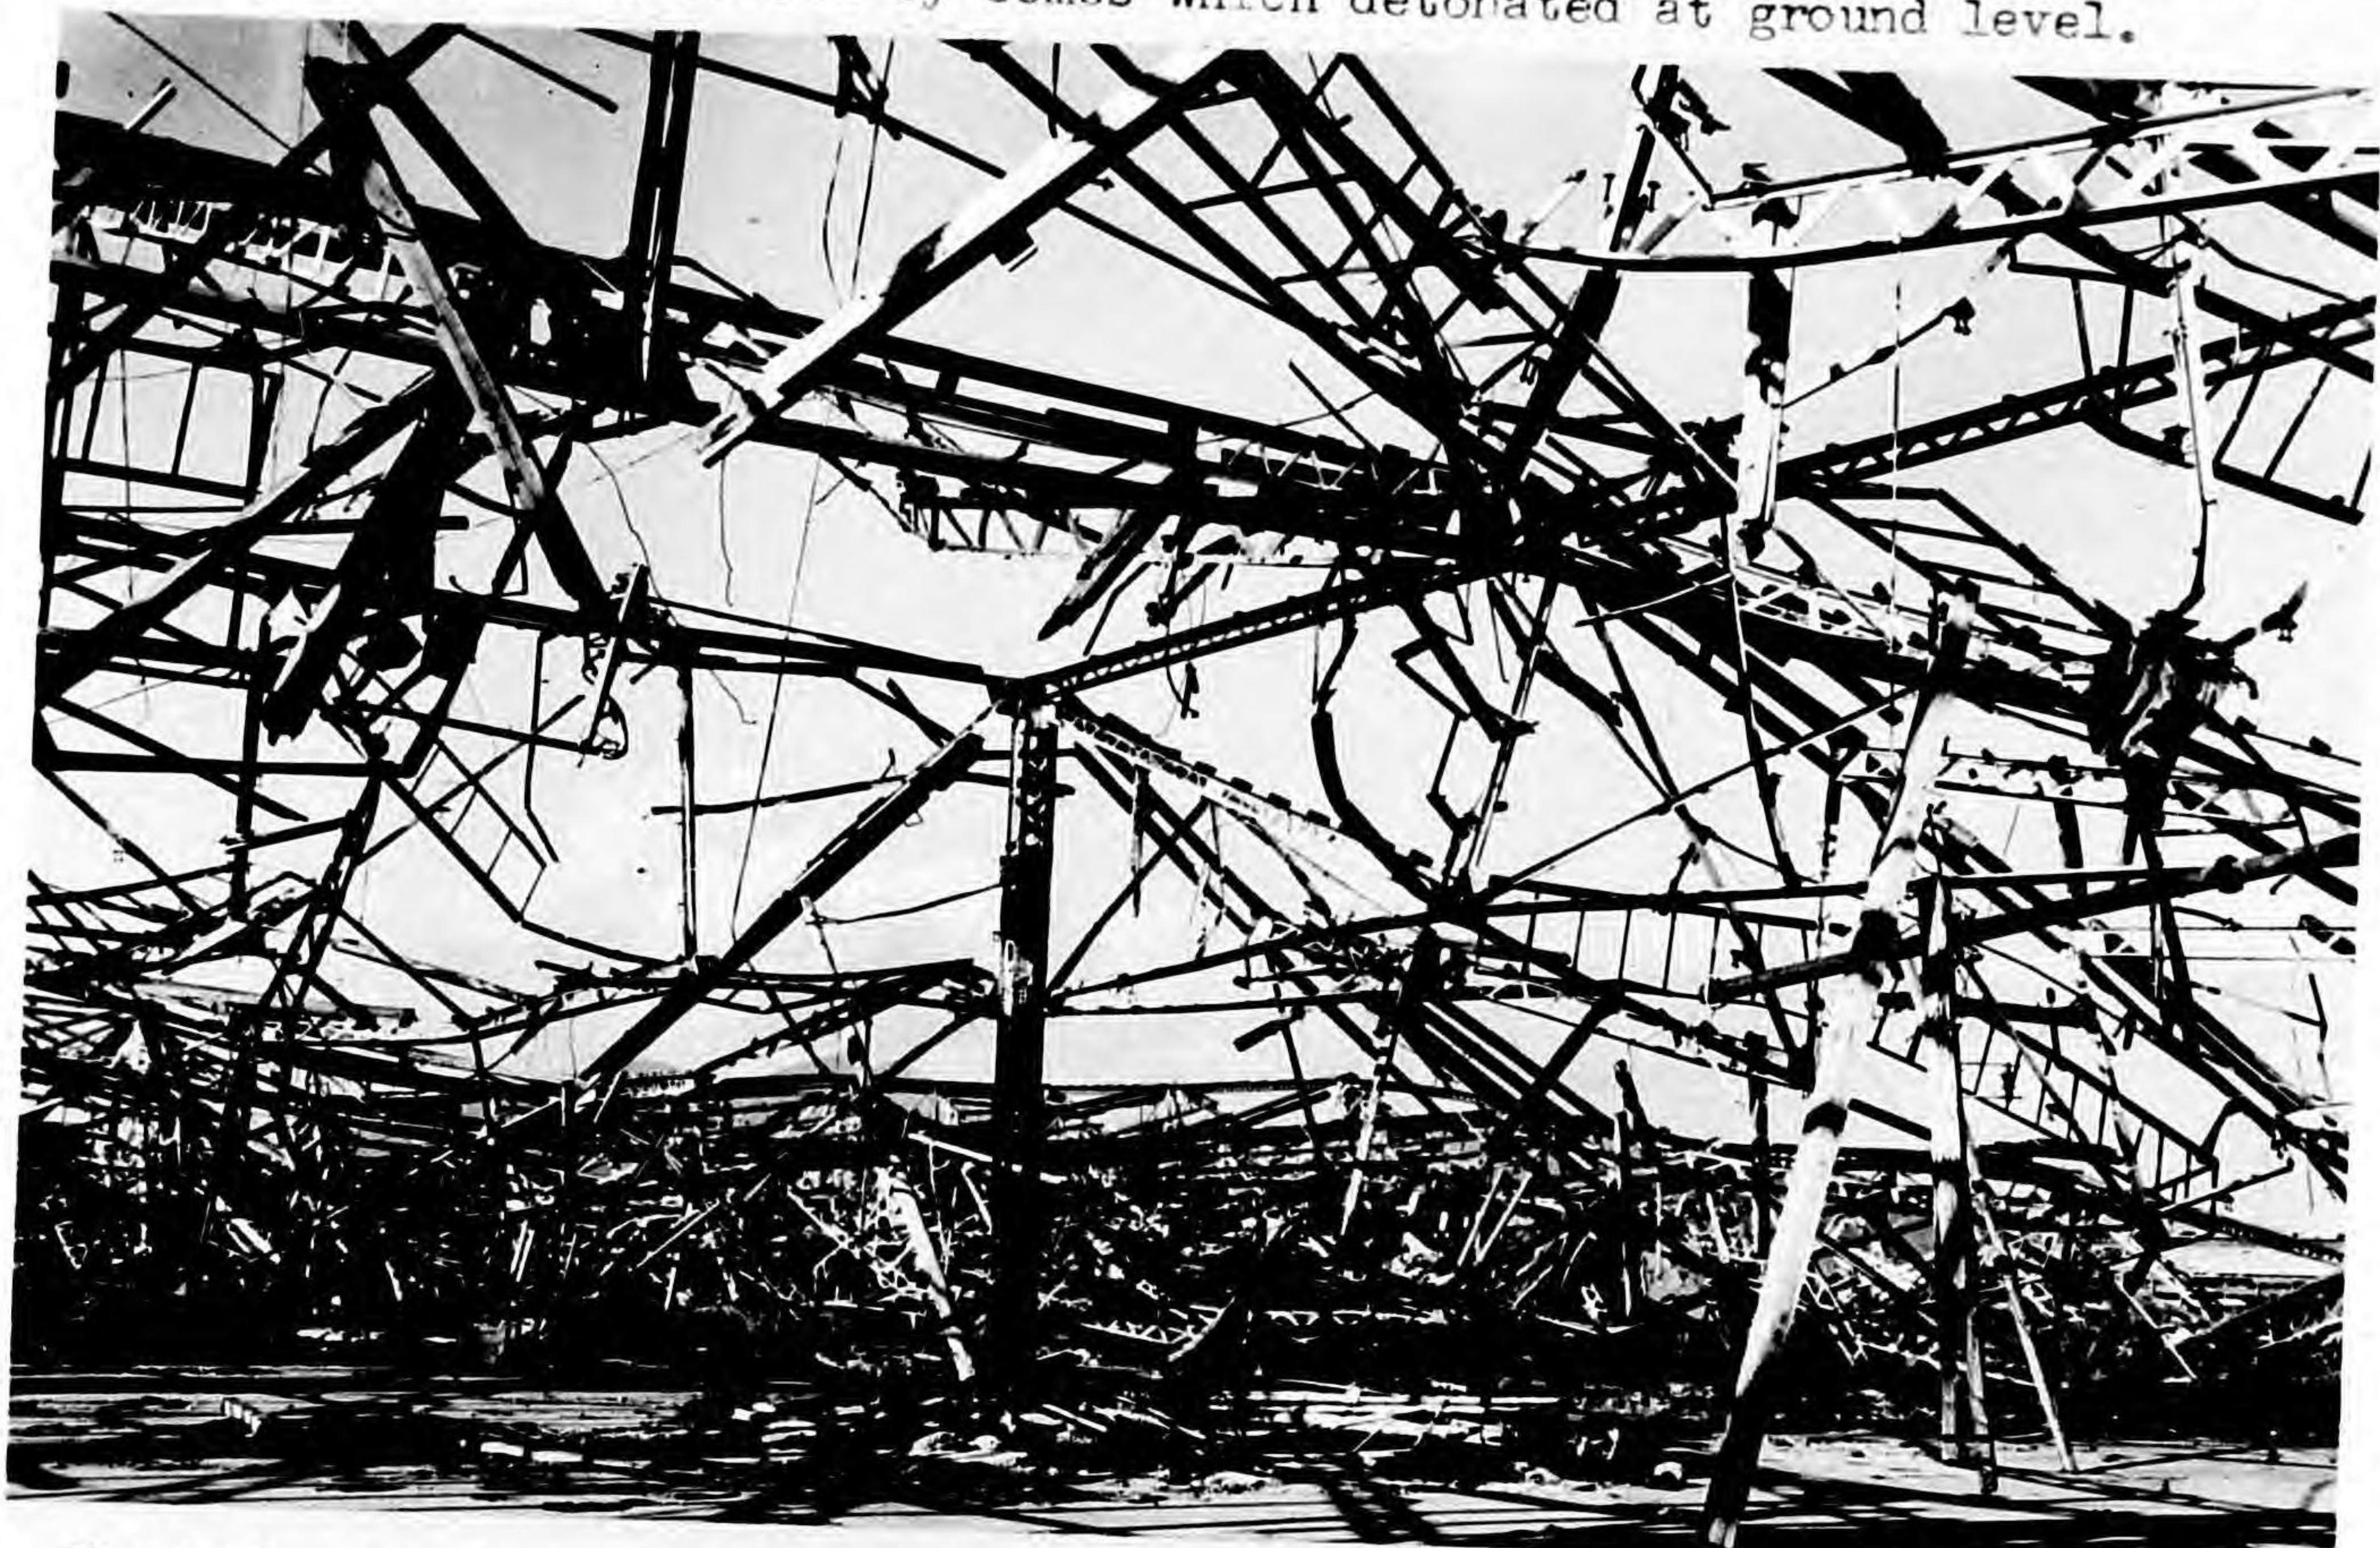
Photo 9 - At top of photo, a view of the collapsed roof and superficial damage caused by Bomb 15. Damage in background was caused by Bombs 11 and 12.

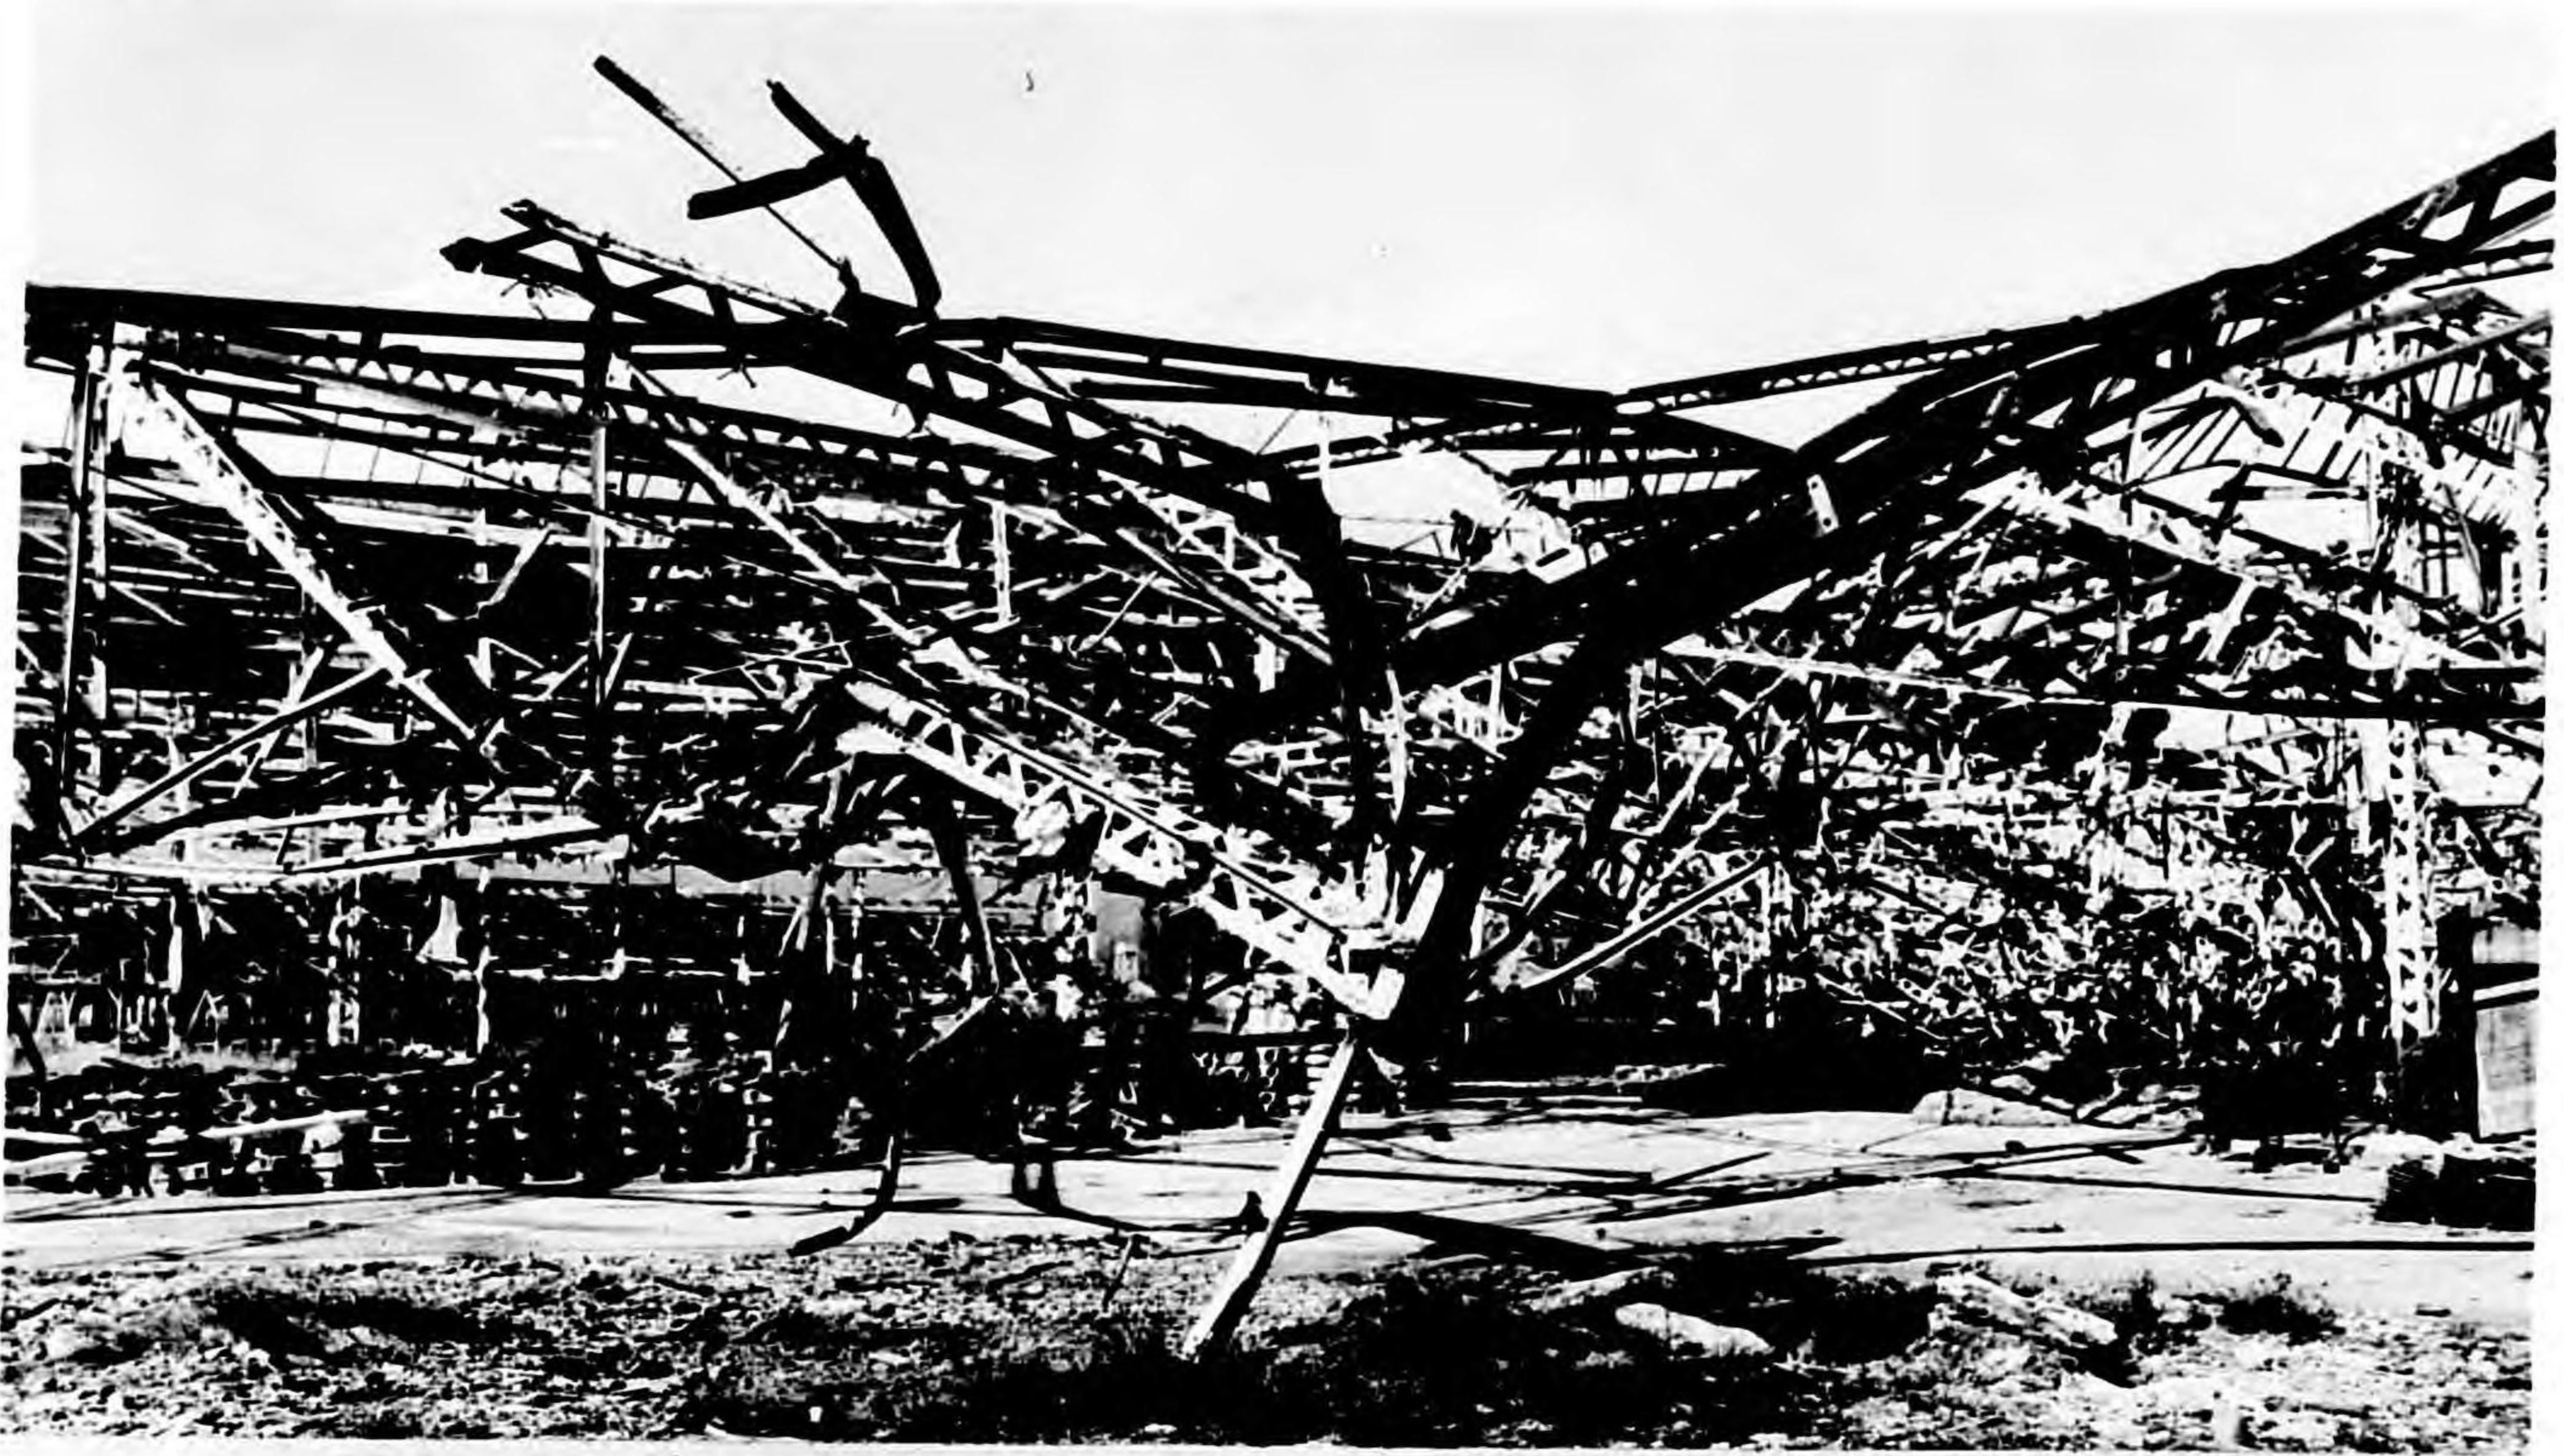
Photo 10 - Superficial damage (at top of building) was caused by Bomb 13 which exploded in the roof. The crater at the bottom of the picture, as well as most of the other damage shown, was caused by Bomb 14.

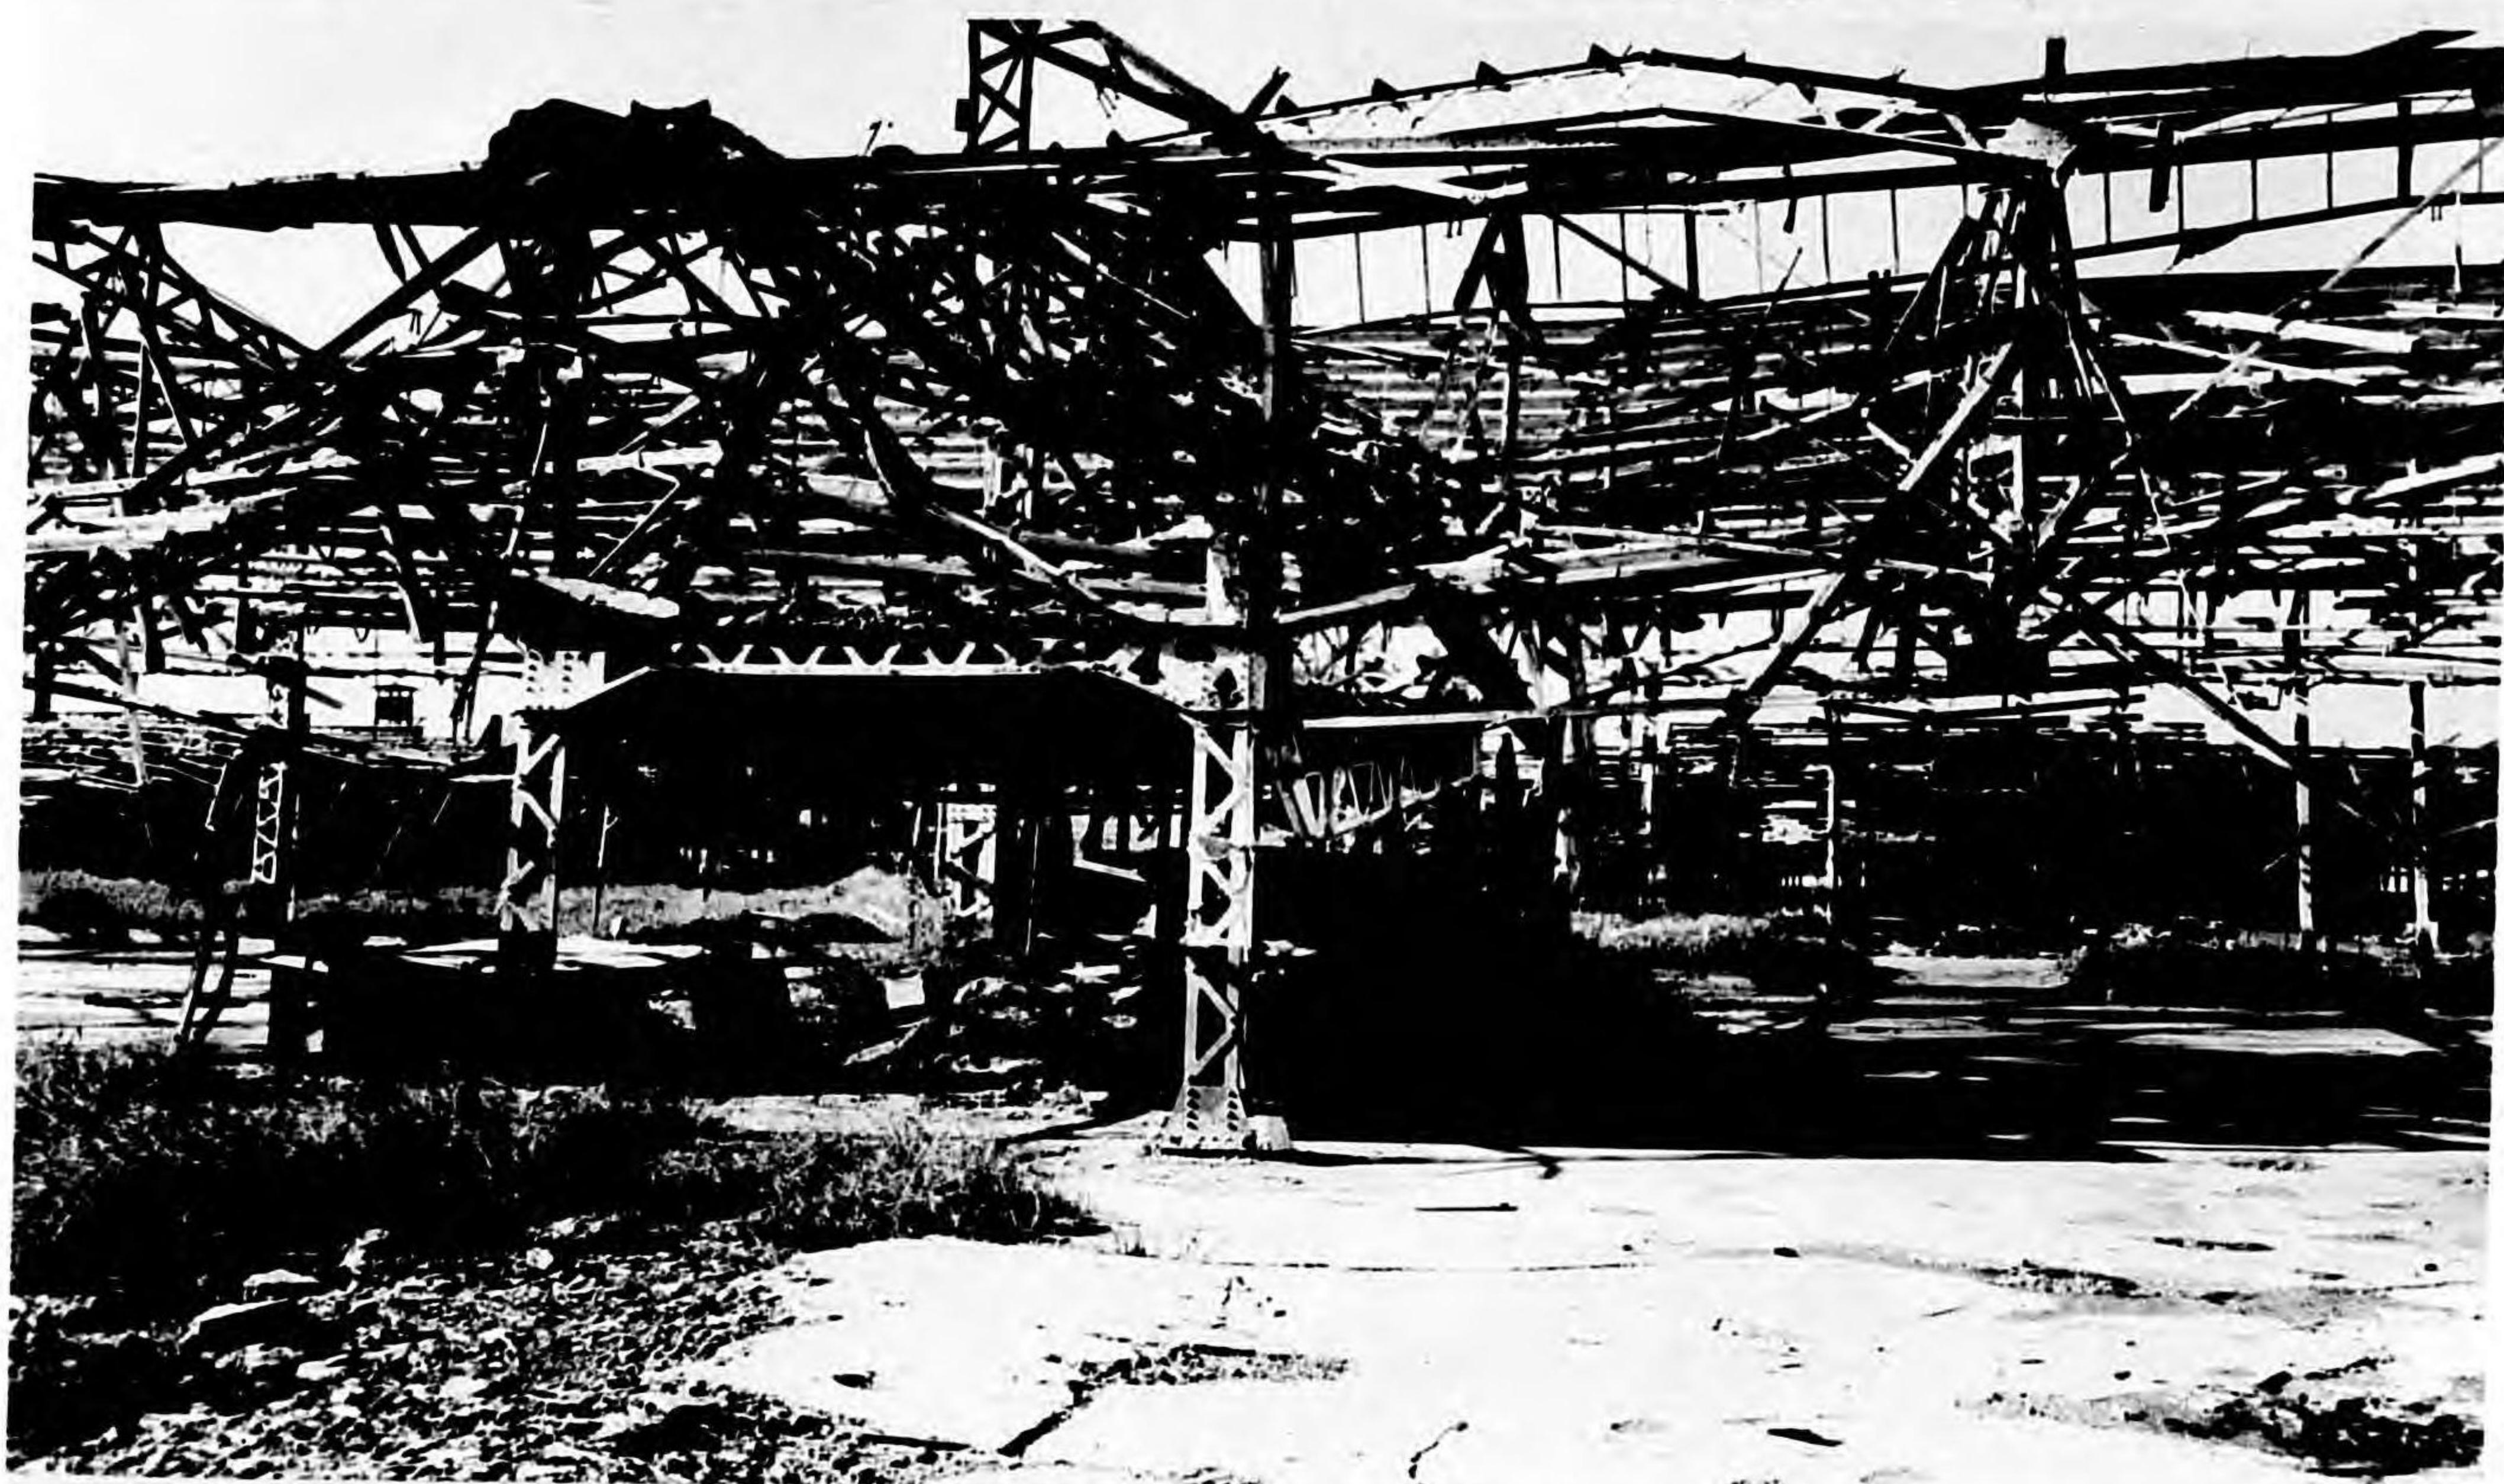
Photo 11 - Structural damage caused by Bomb 14. Column 3-F (left center photo) was sheared approximately two feet above floor level. The column was thrown in an arc of 270 degrees, up and over a transformer stand.
