Name of Target SHIZUOKA A/C PLANT

Location of Target SHIZUOKA

Team No. VI PDD - Job #2

Date 4 Nov 45 **Team Comdr.** Guill

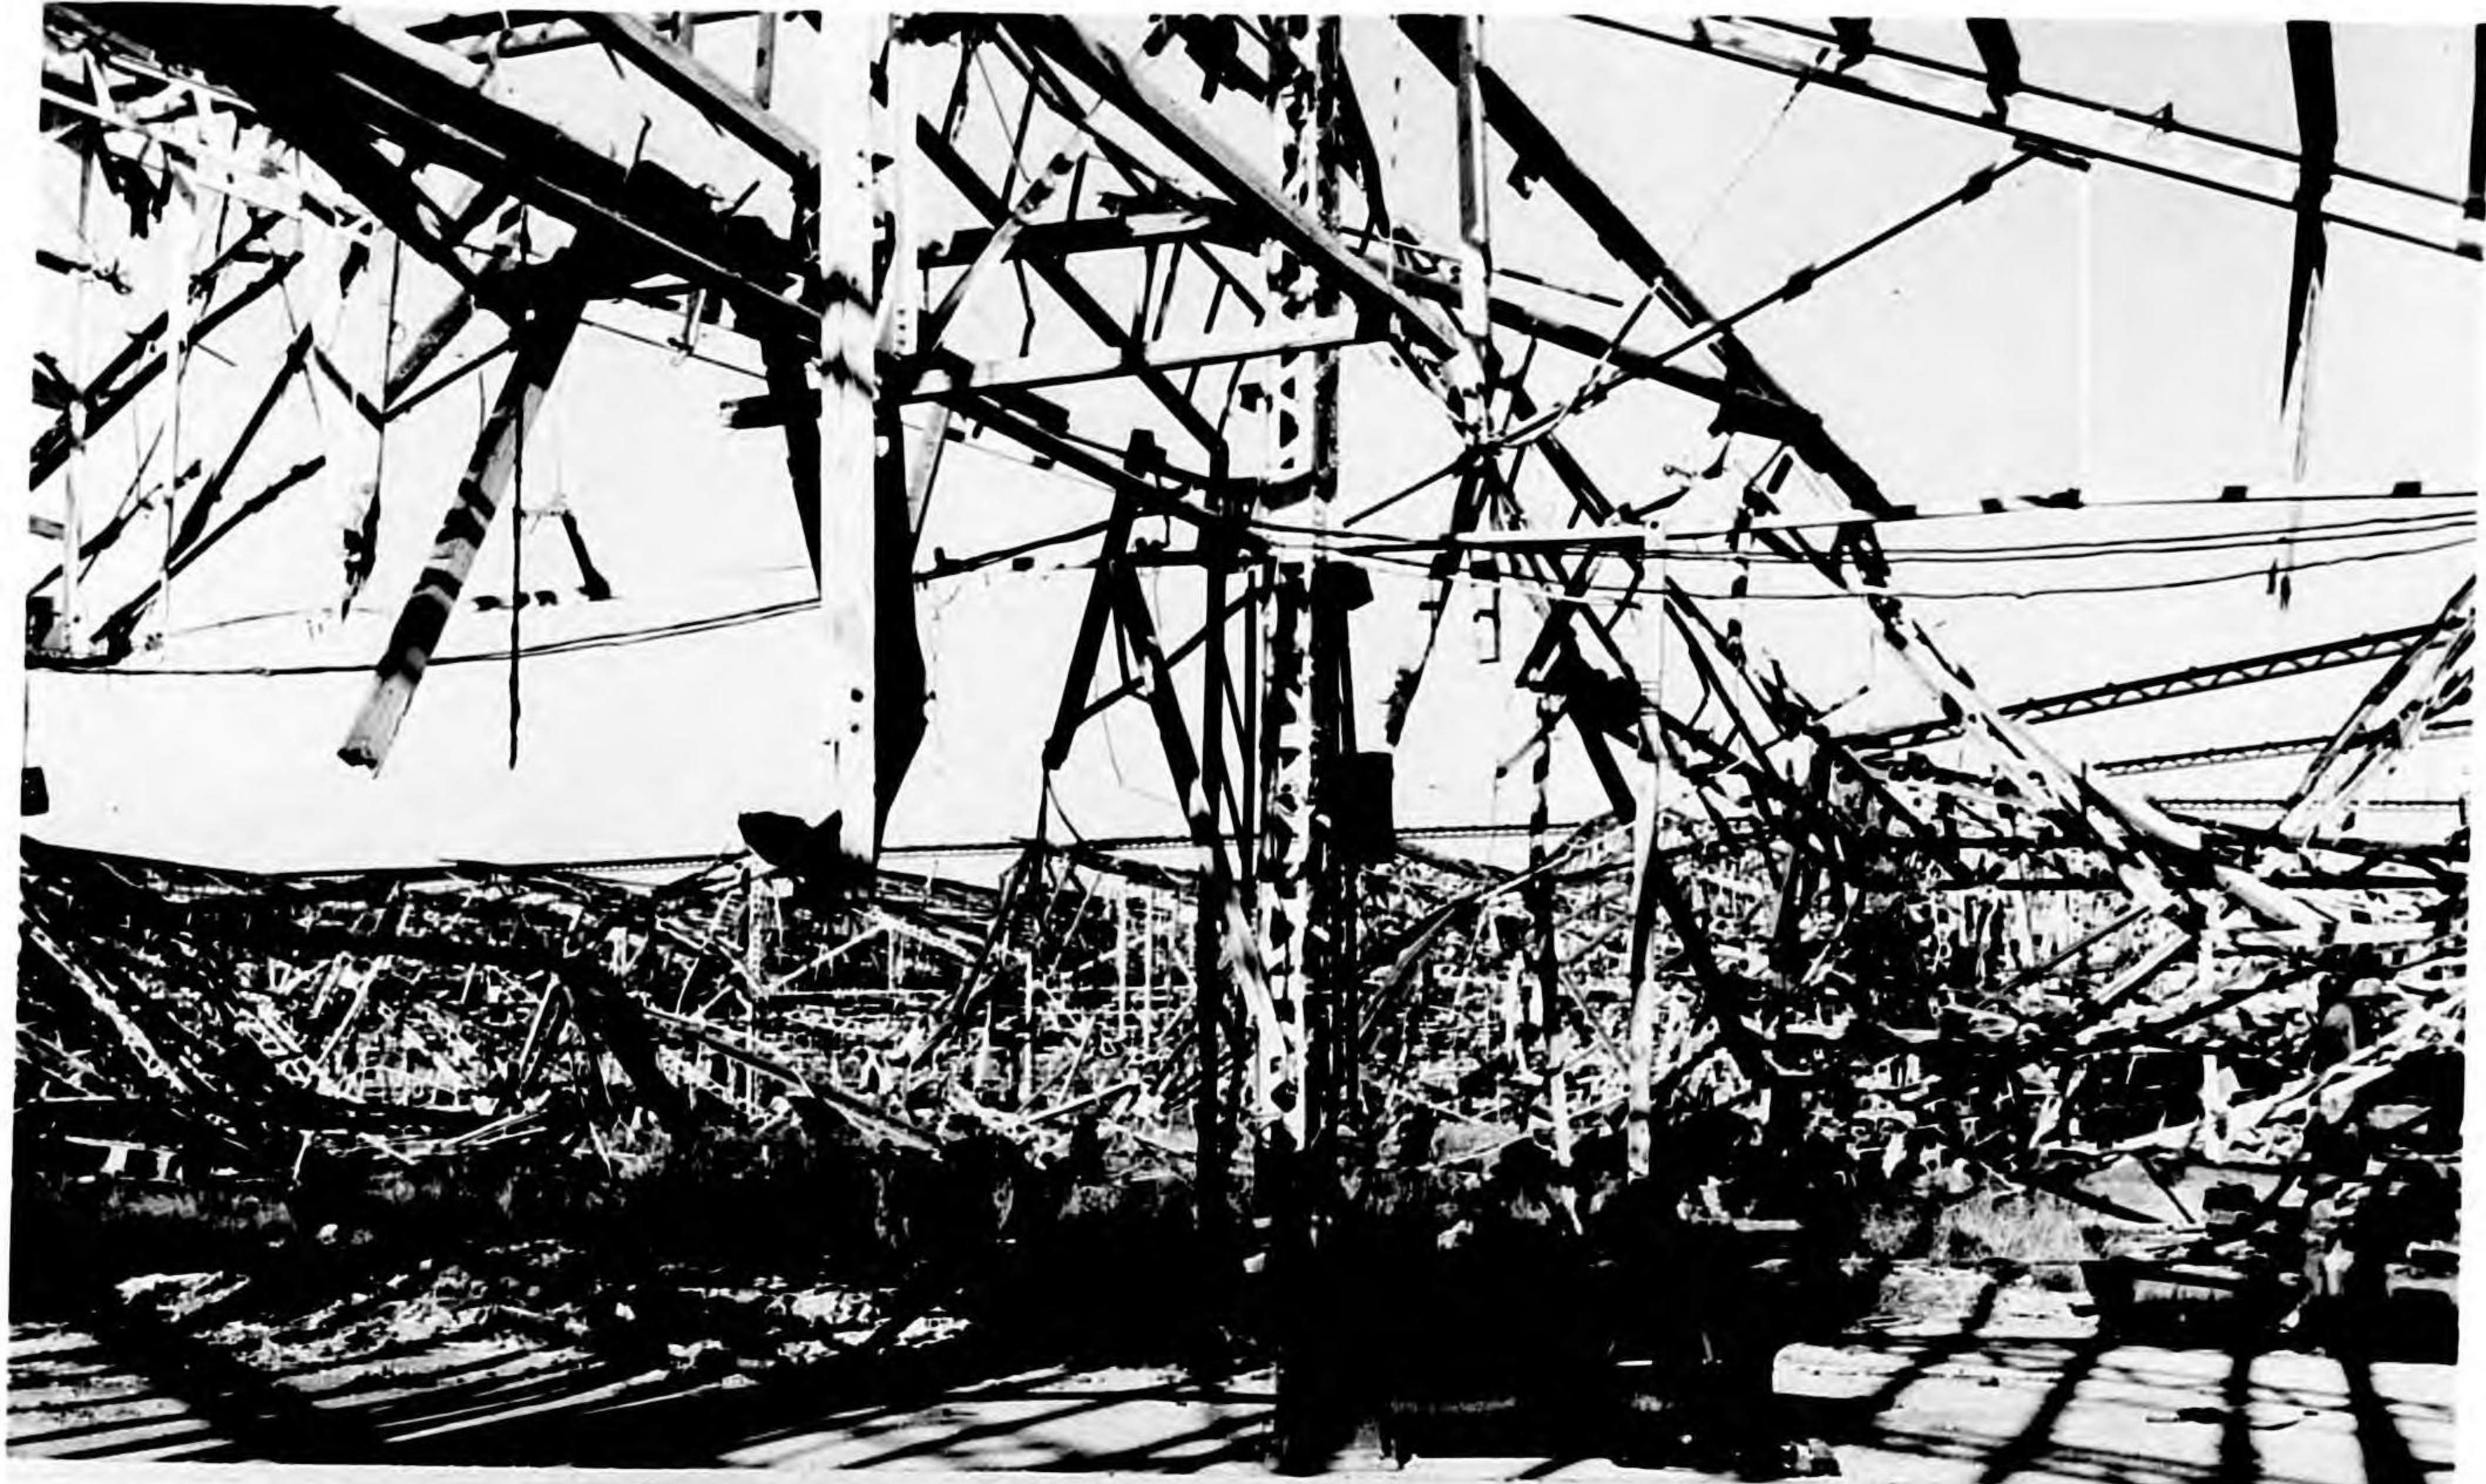
Photo 12 - A general view of the complete collapse of the shop structure caused by Bombs 16, 17, and 18.

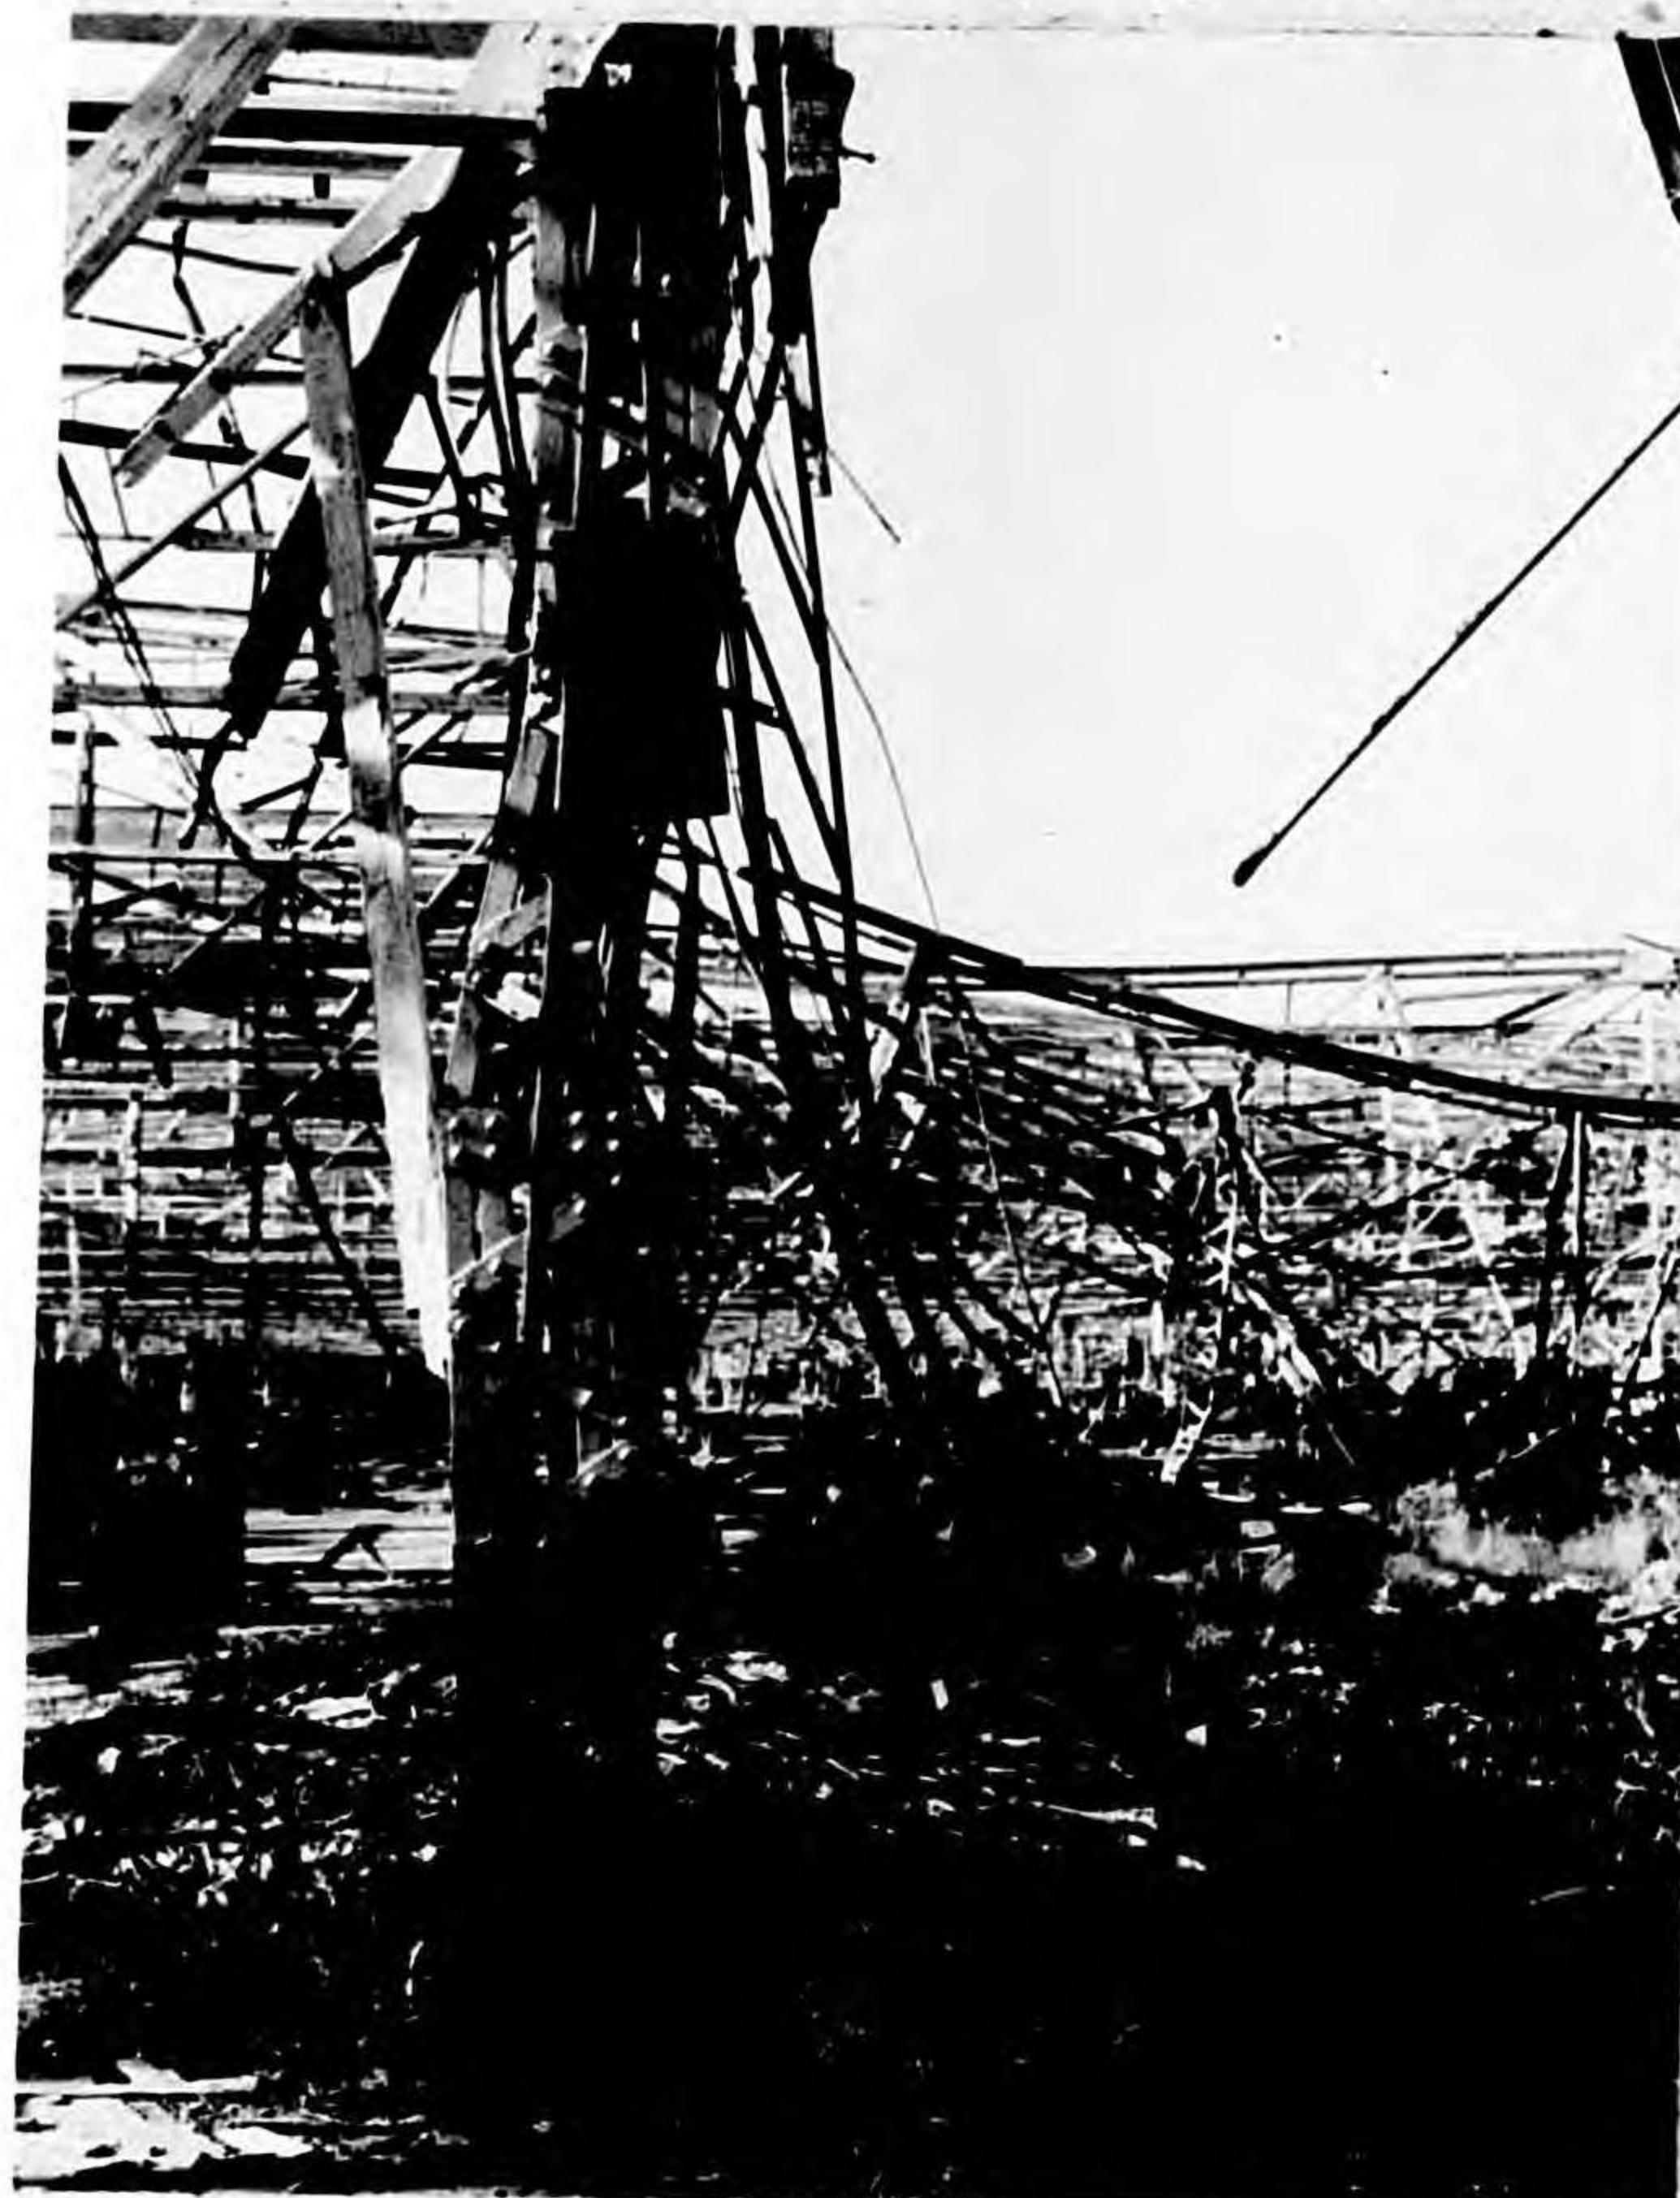
Photo 13 - In the foreground is Column 11-D, showing the effect of earth shock, blast and strain on a typical supporting column.

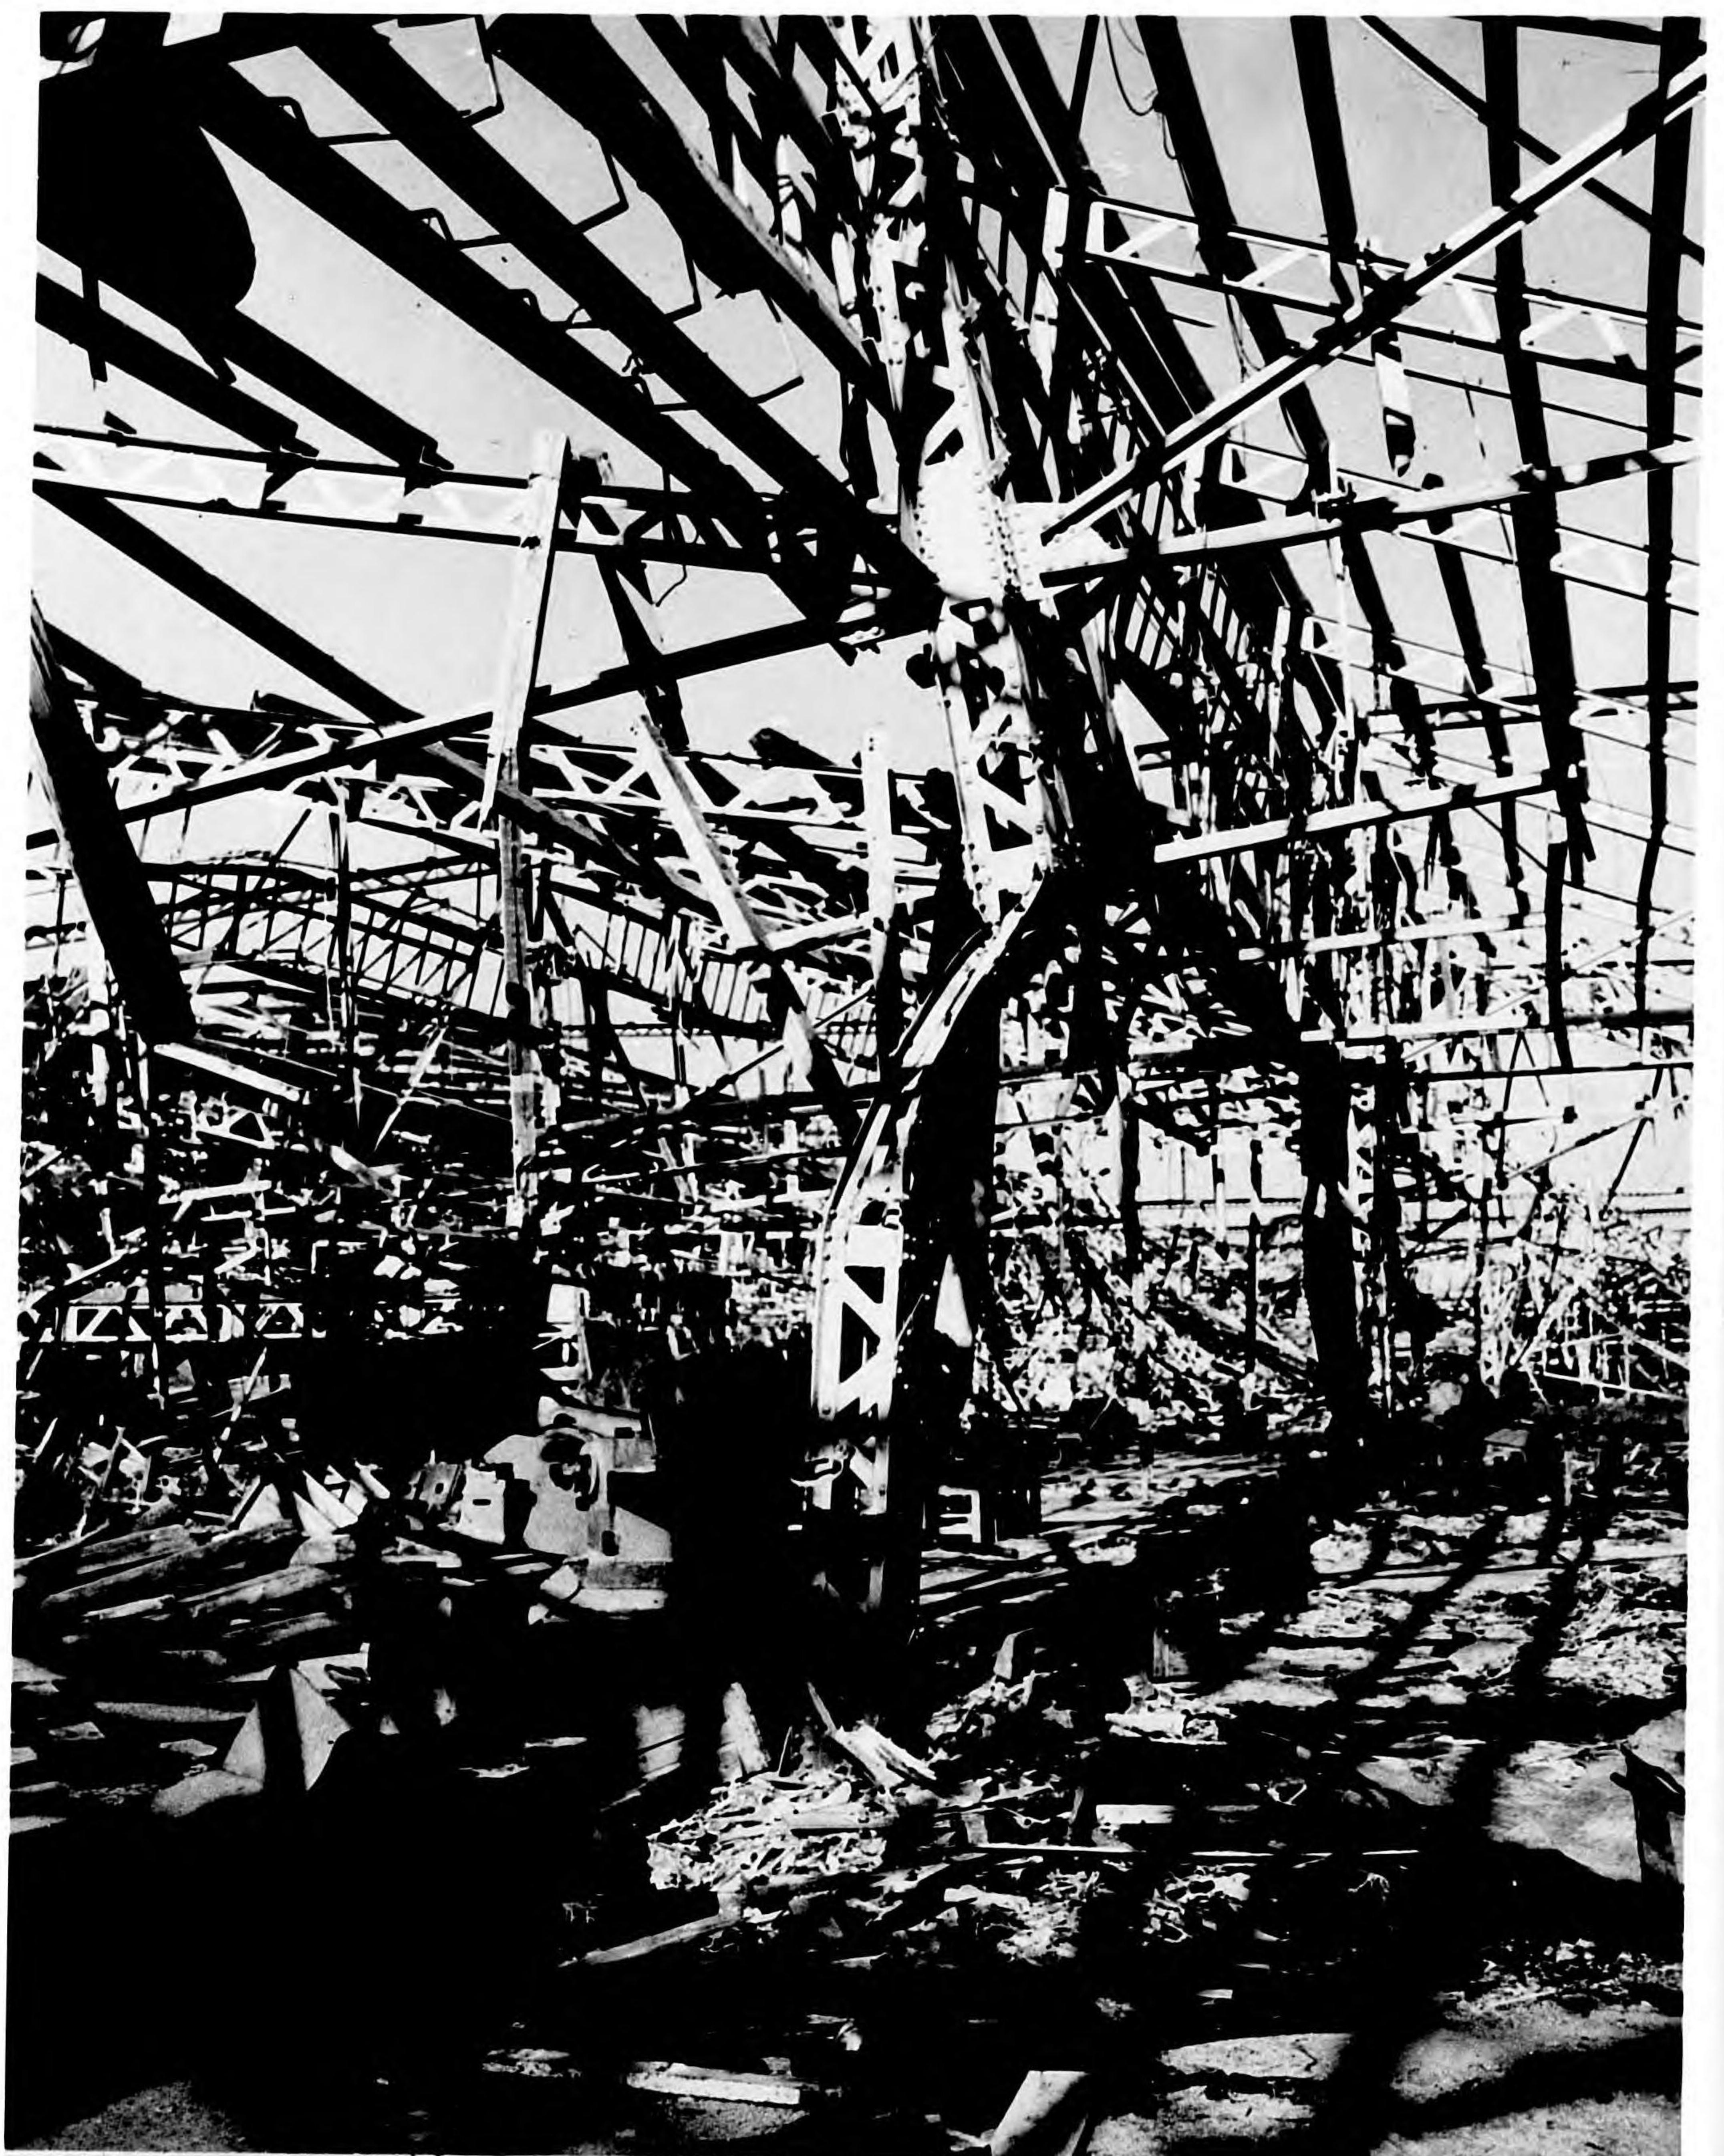
Photo 15 - Column 12-E shows the effect of earth shock and shifting of column footing as the column failed under compression.

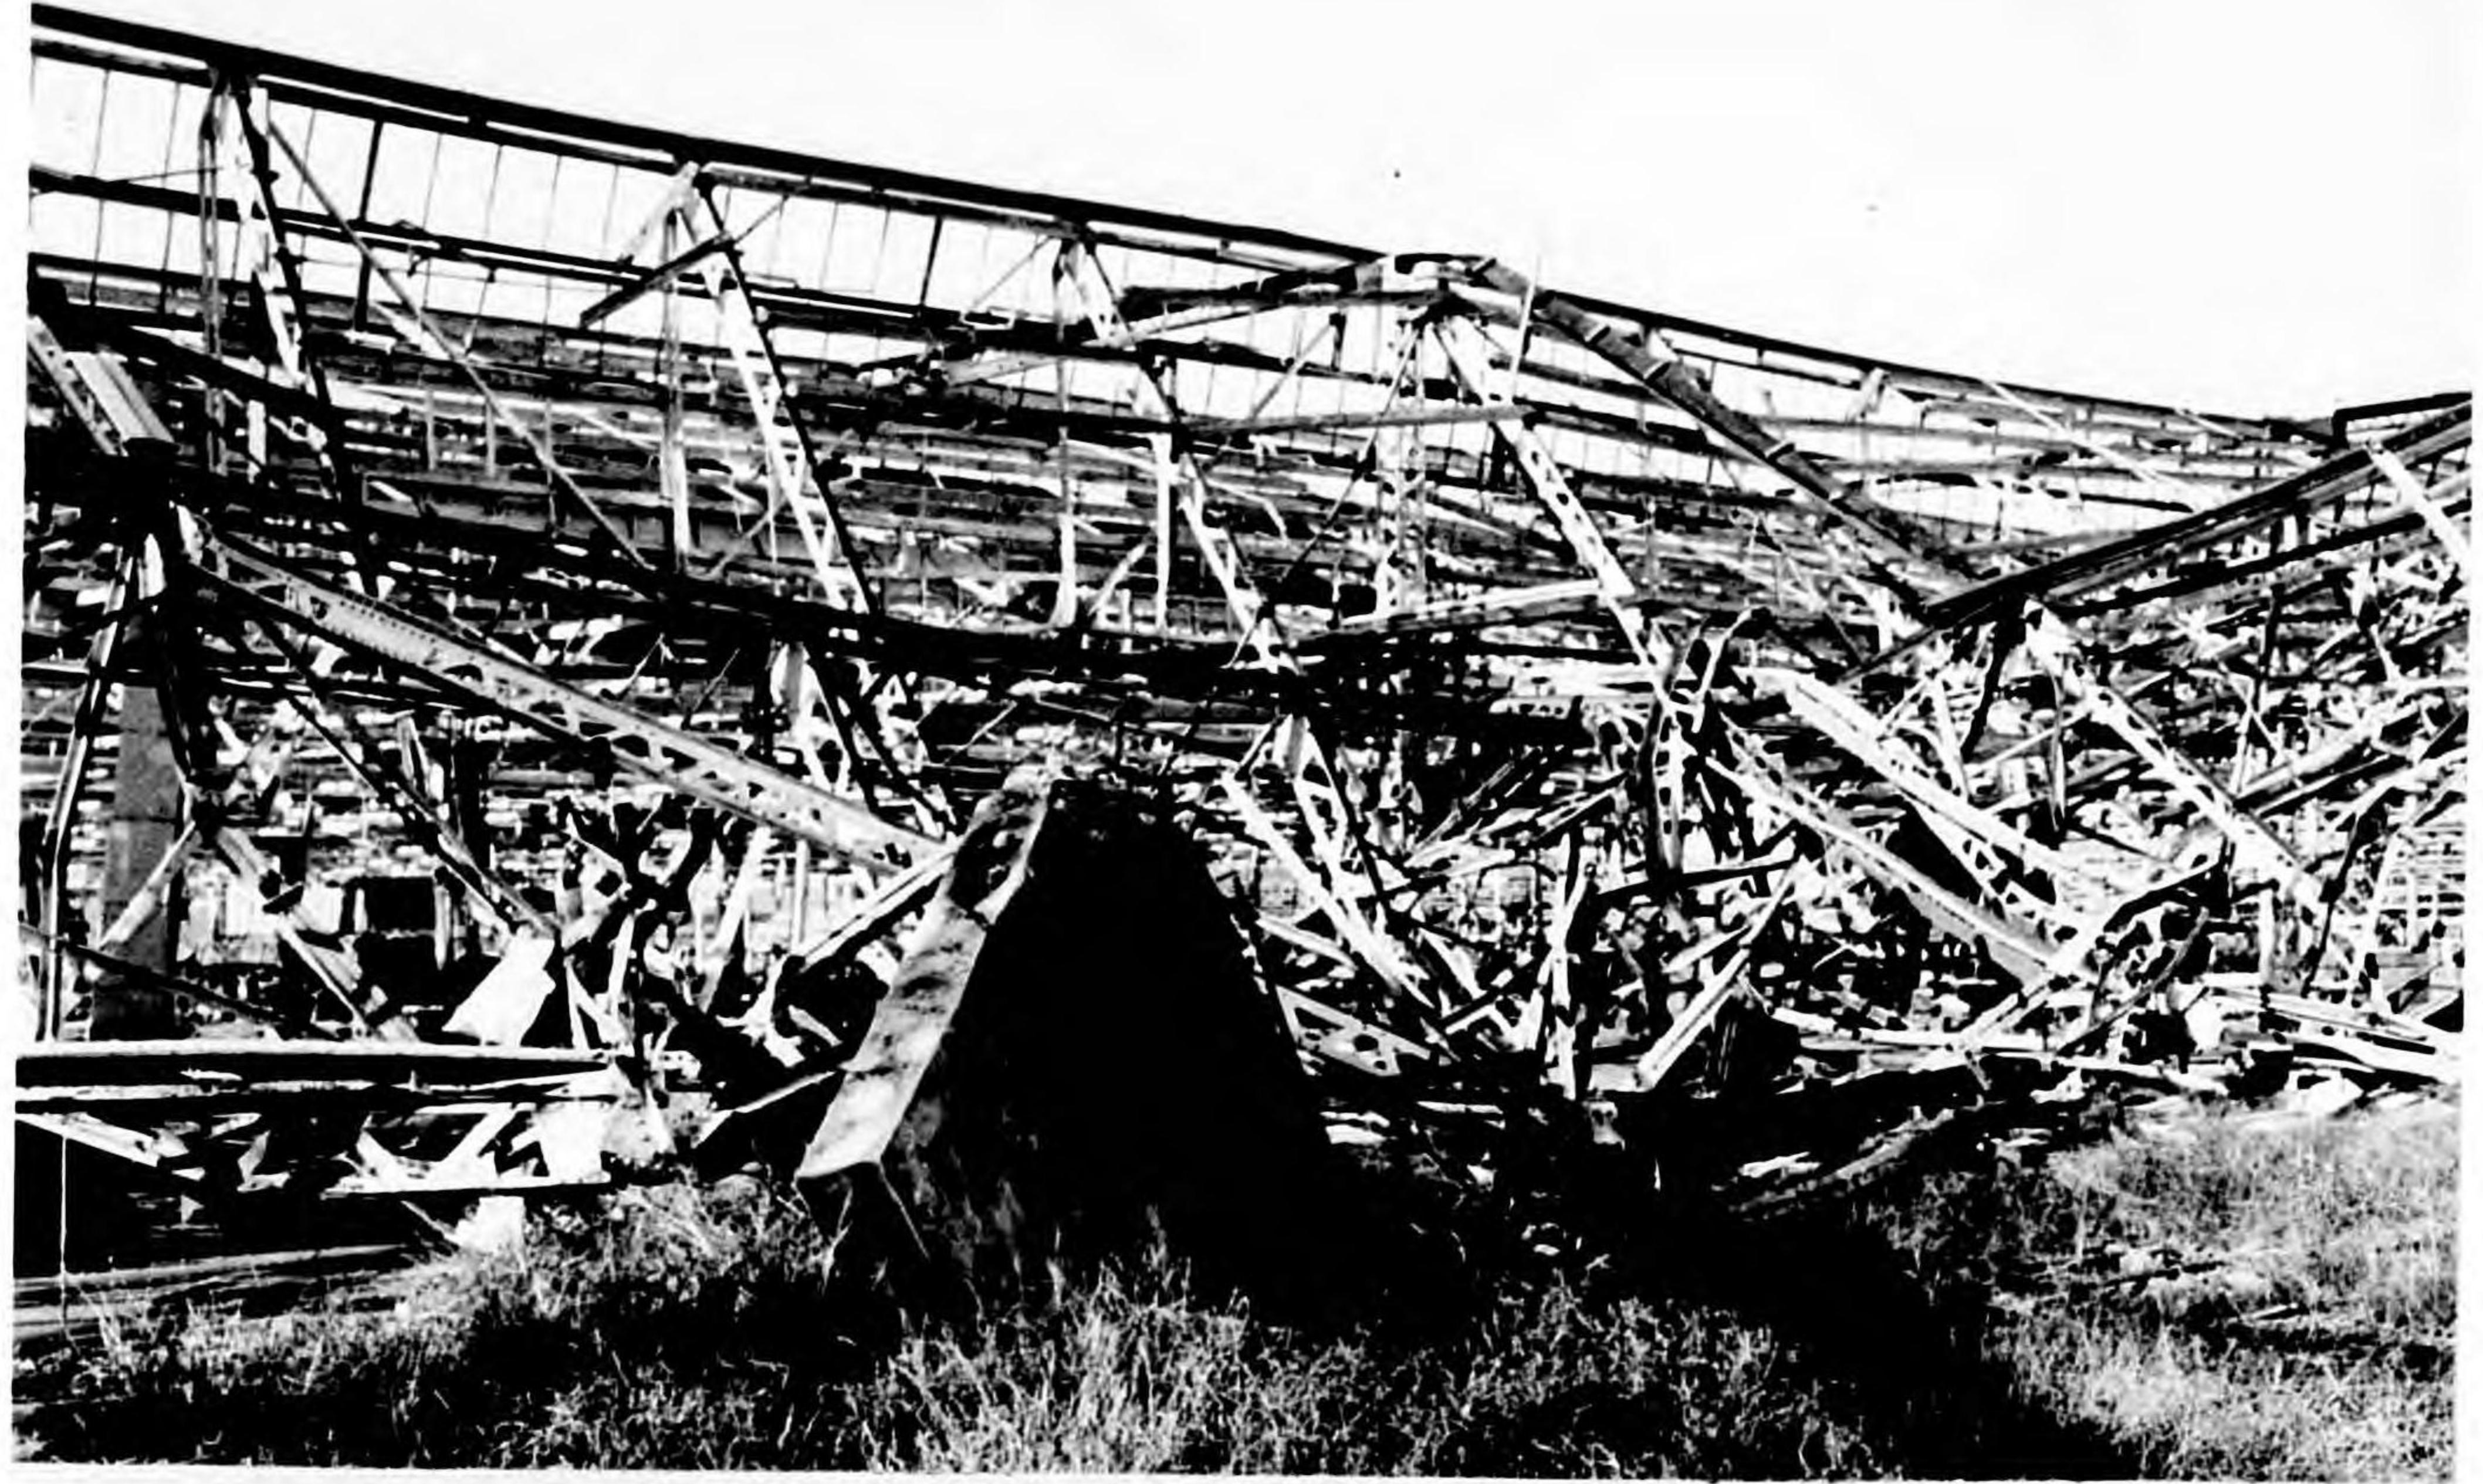
Photo 16 - In the center foreground is the footing of Column 11-E, up-turned by Bomb 18, indicating the disruptive effect of this bomb. The background shows more of the overall damage effect of Bombs 16, 17, and 18.

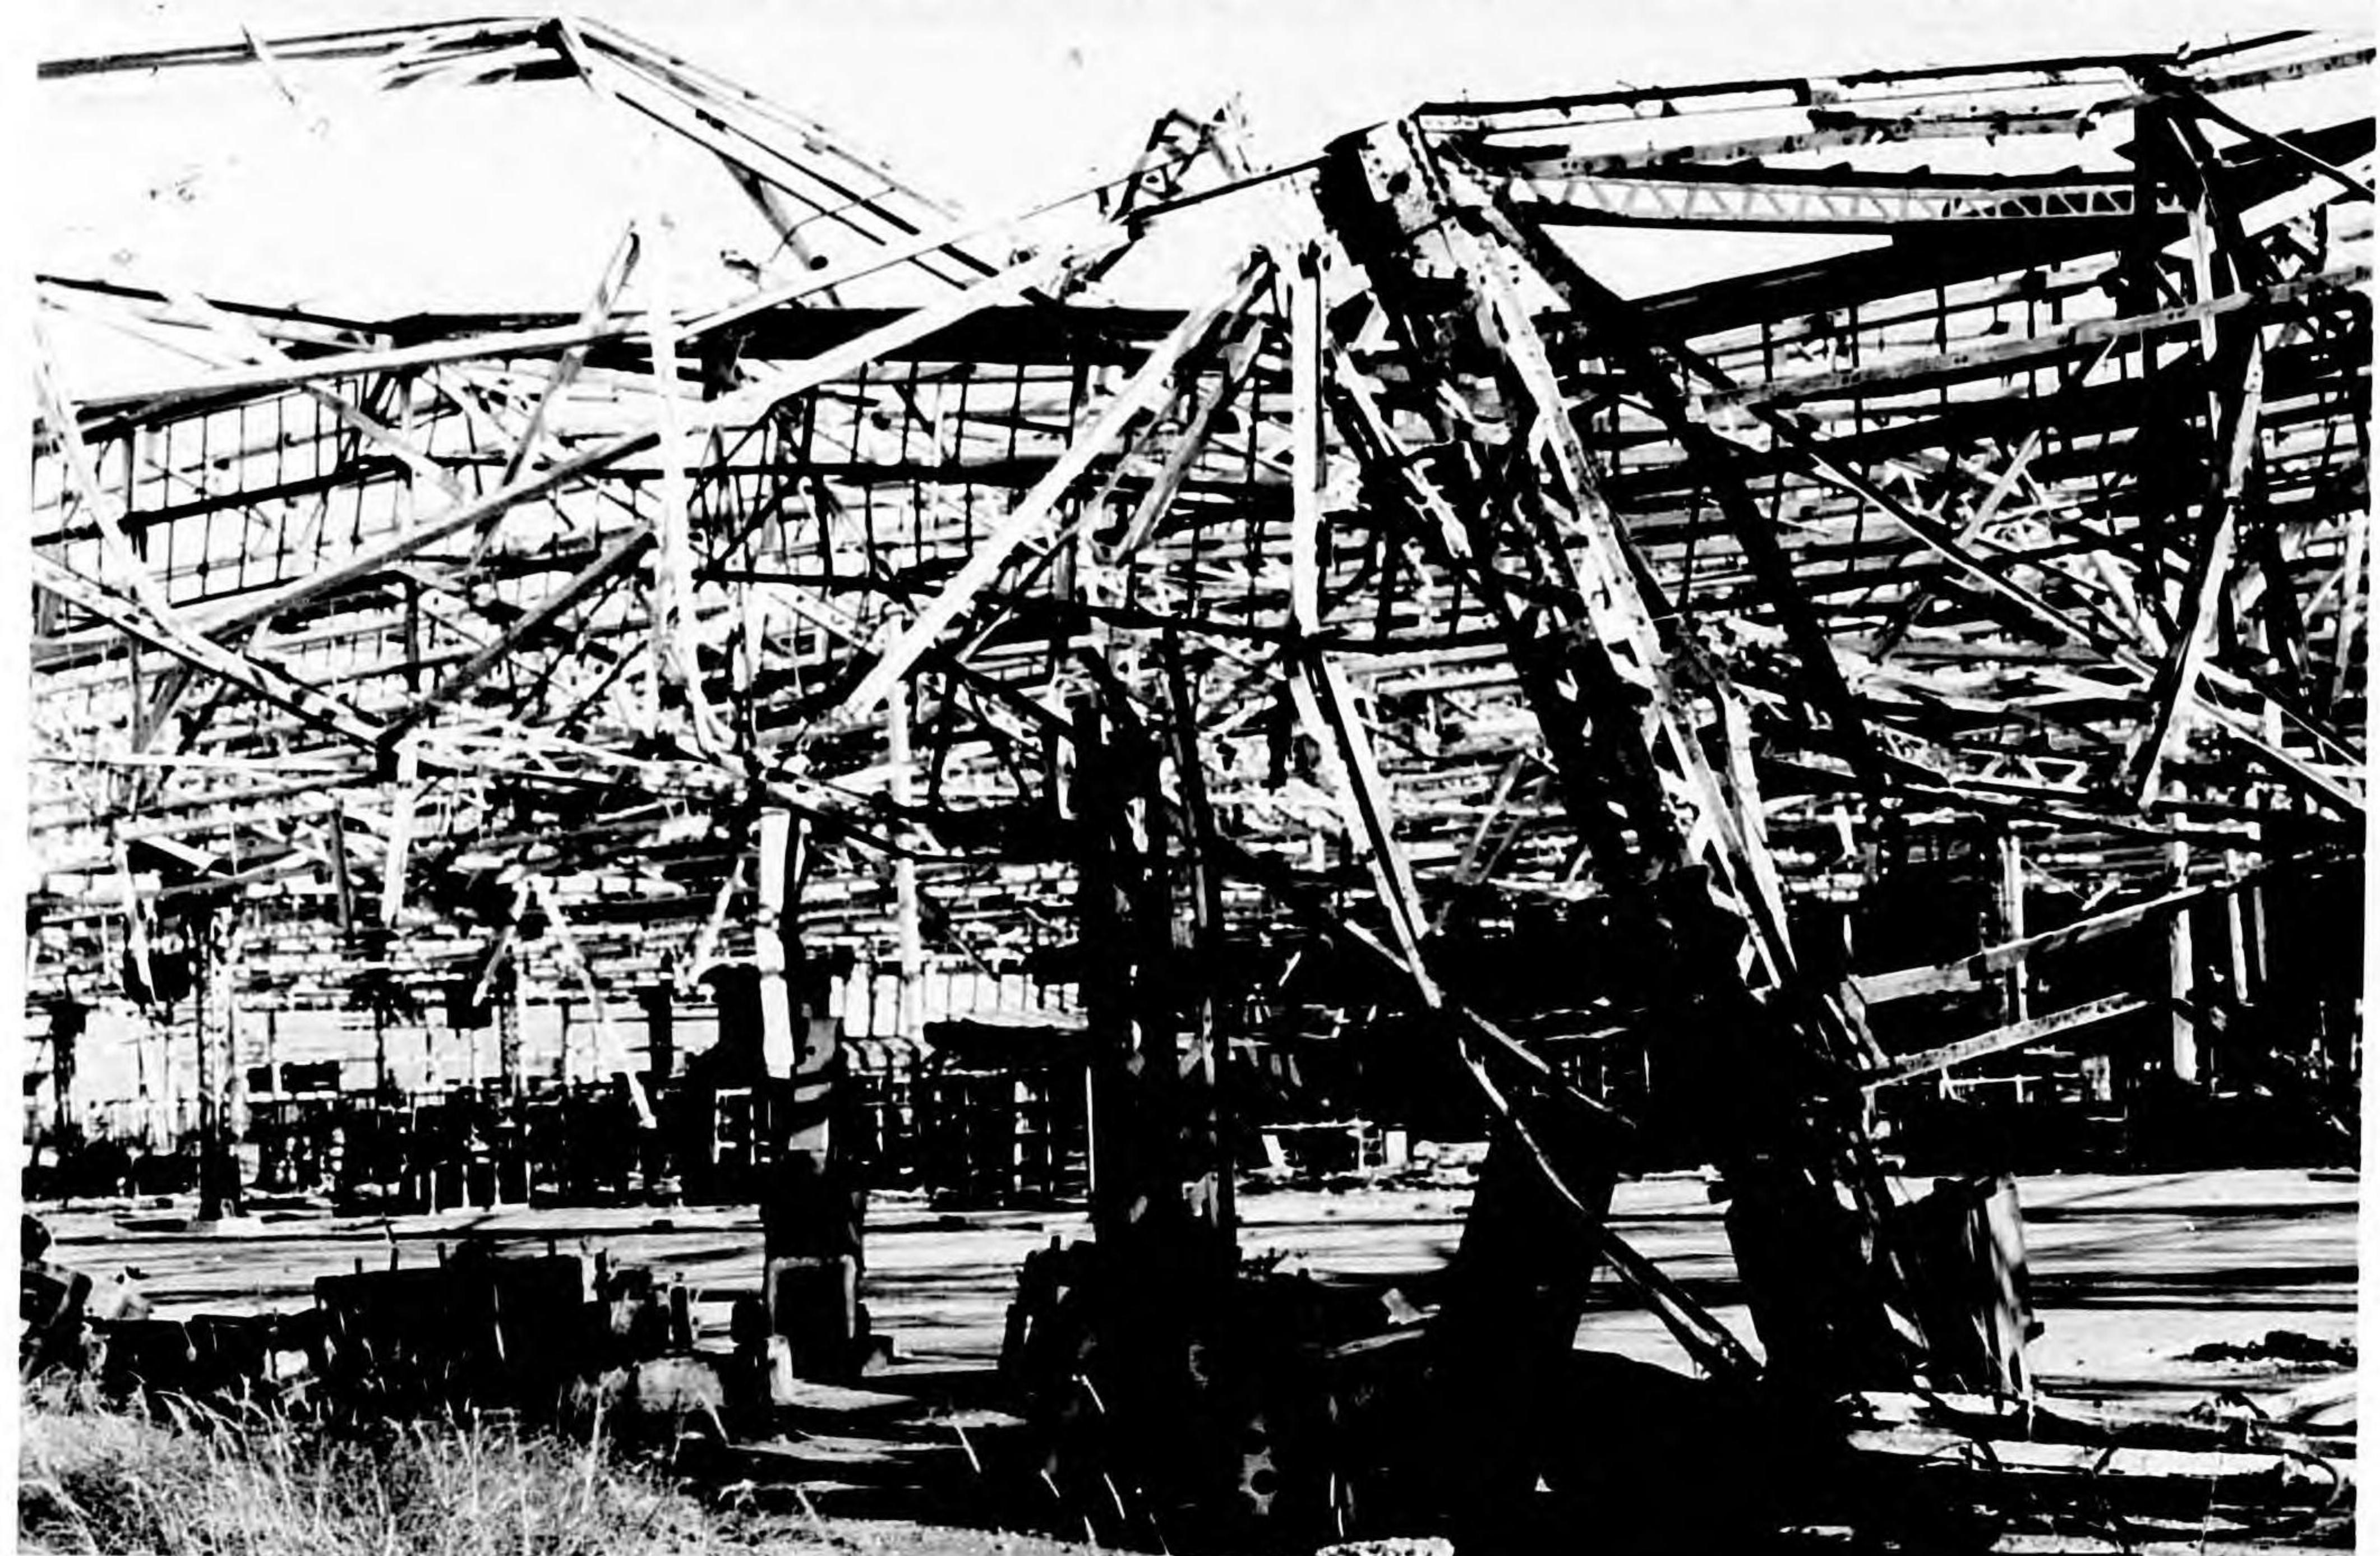
Photo 17 - Column 13-I, sheared in the center and blown to one side by Bomb 19, contributing to a great extent to the general roof collapse.

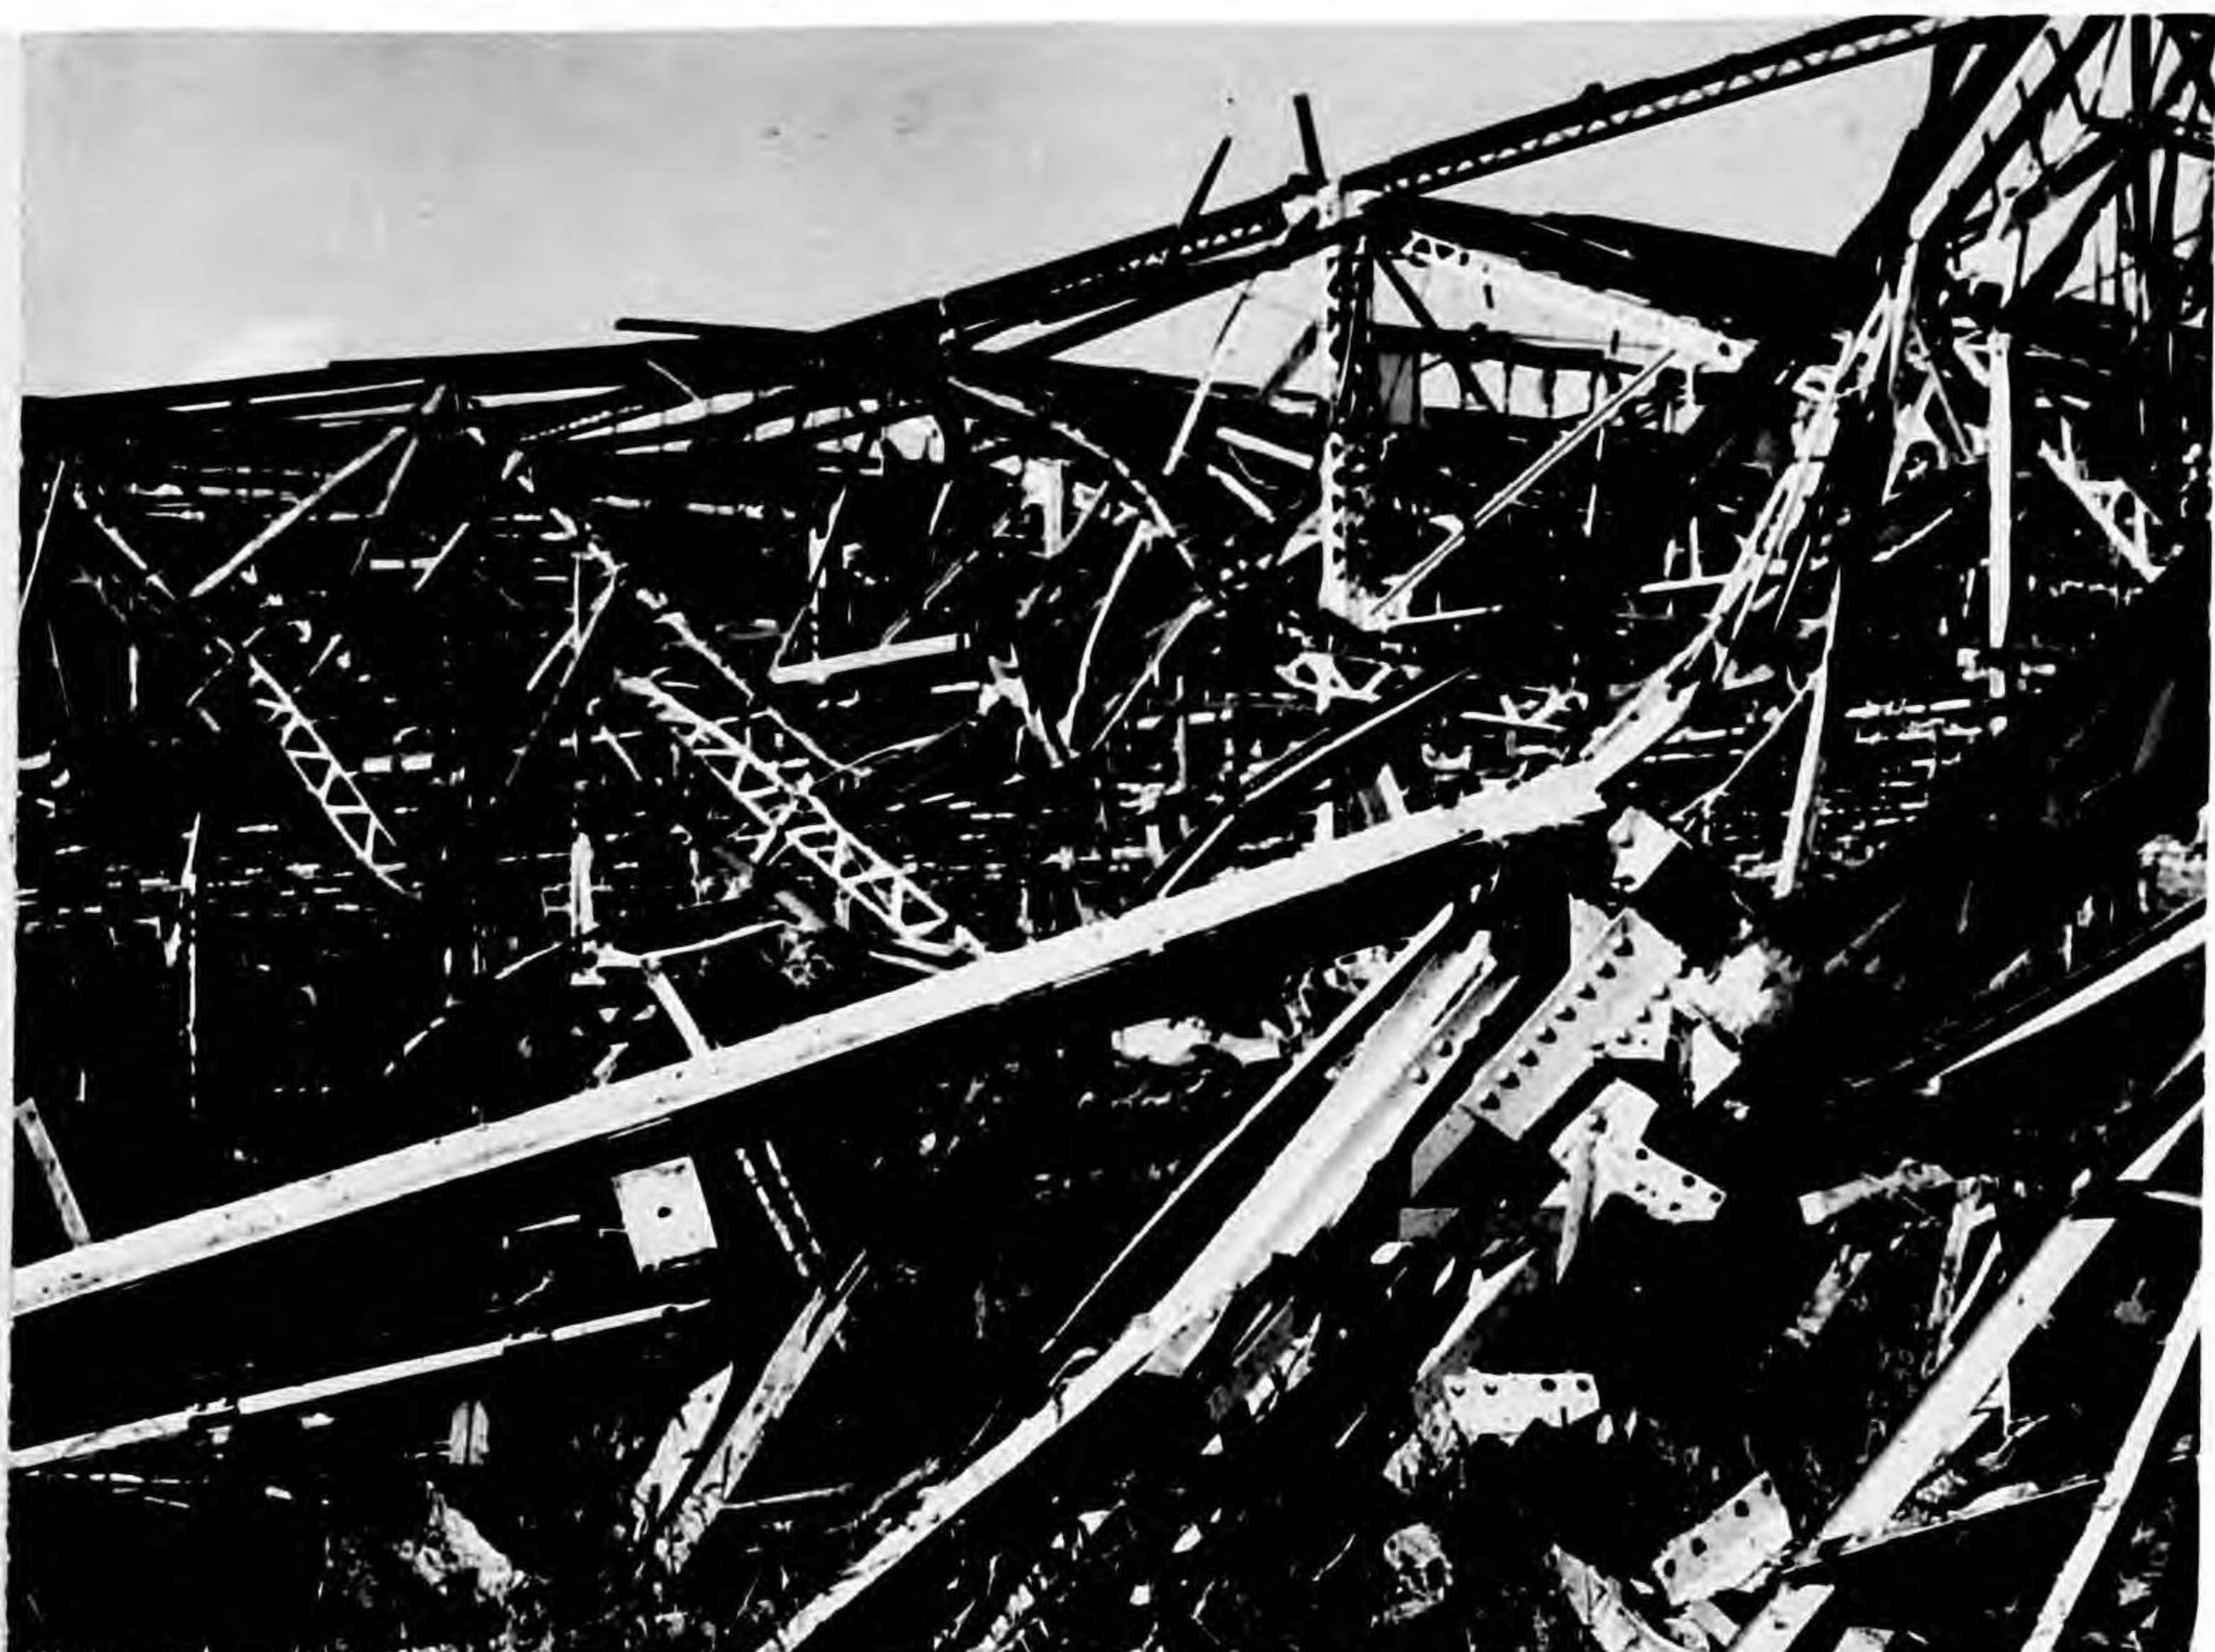
Photo 18 - Detail of failure of Column 10-F which was sheared approximately 4 inches from its base and shattered into scrap.
