Name of Target SHIZUOKA A/C PLANT

Location of Target SHIZUOKA

Team No. VI PDD - Job #2

Date 4 Nov 45 **Team Comdr.** Guill

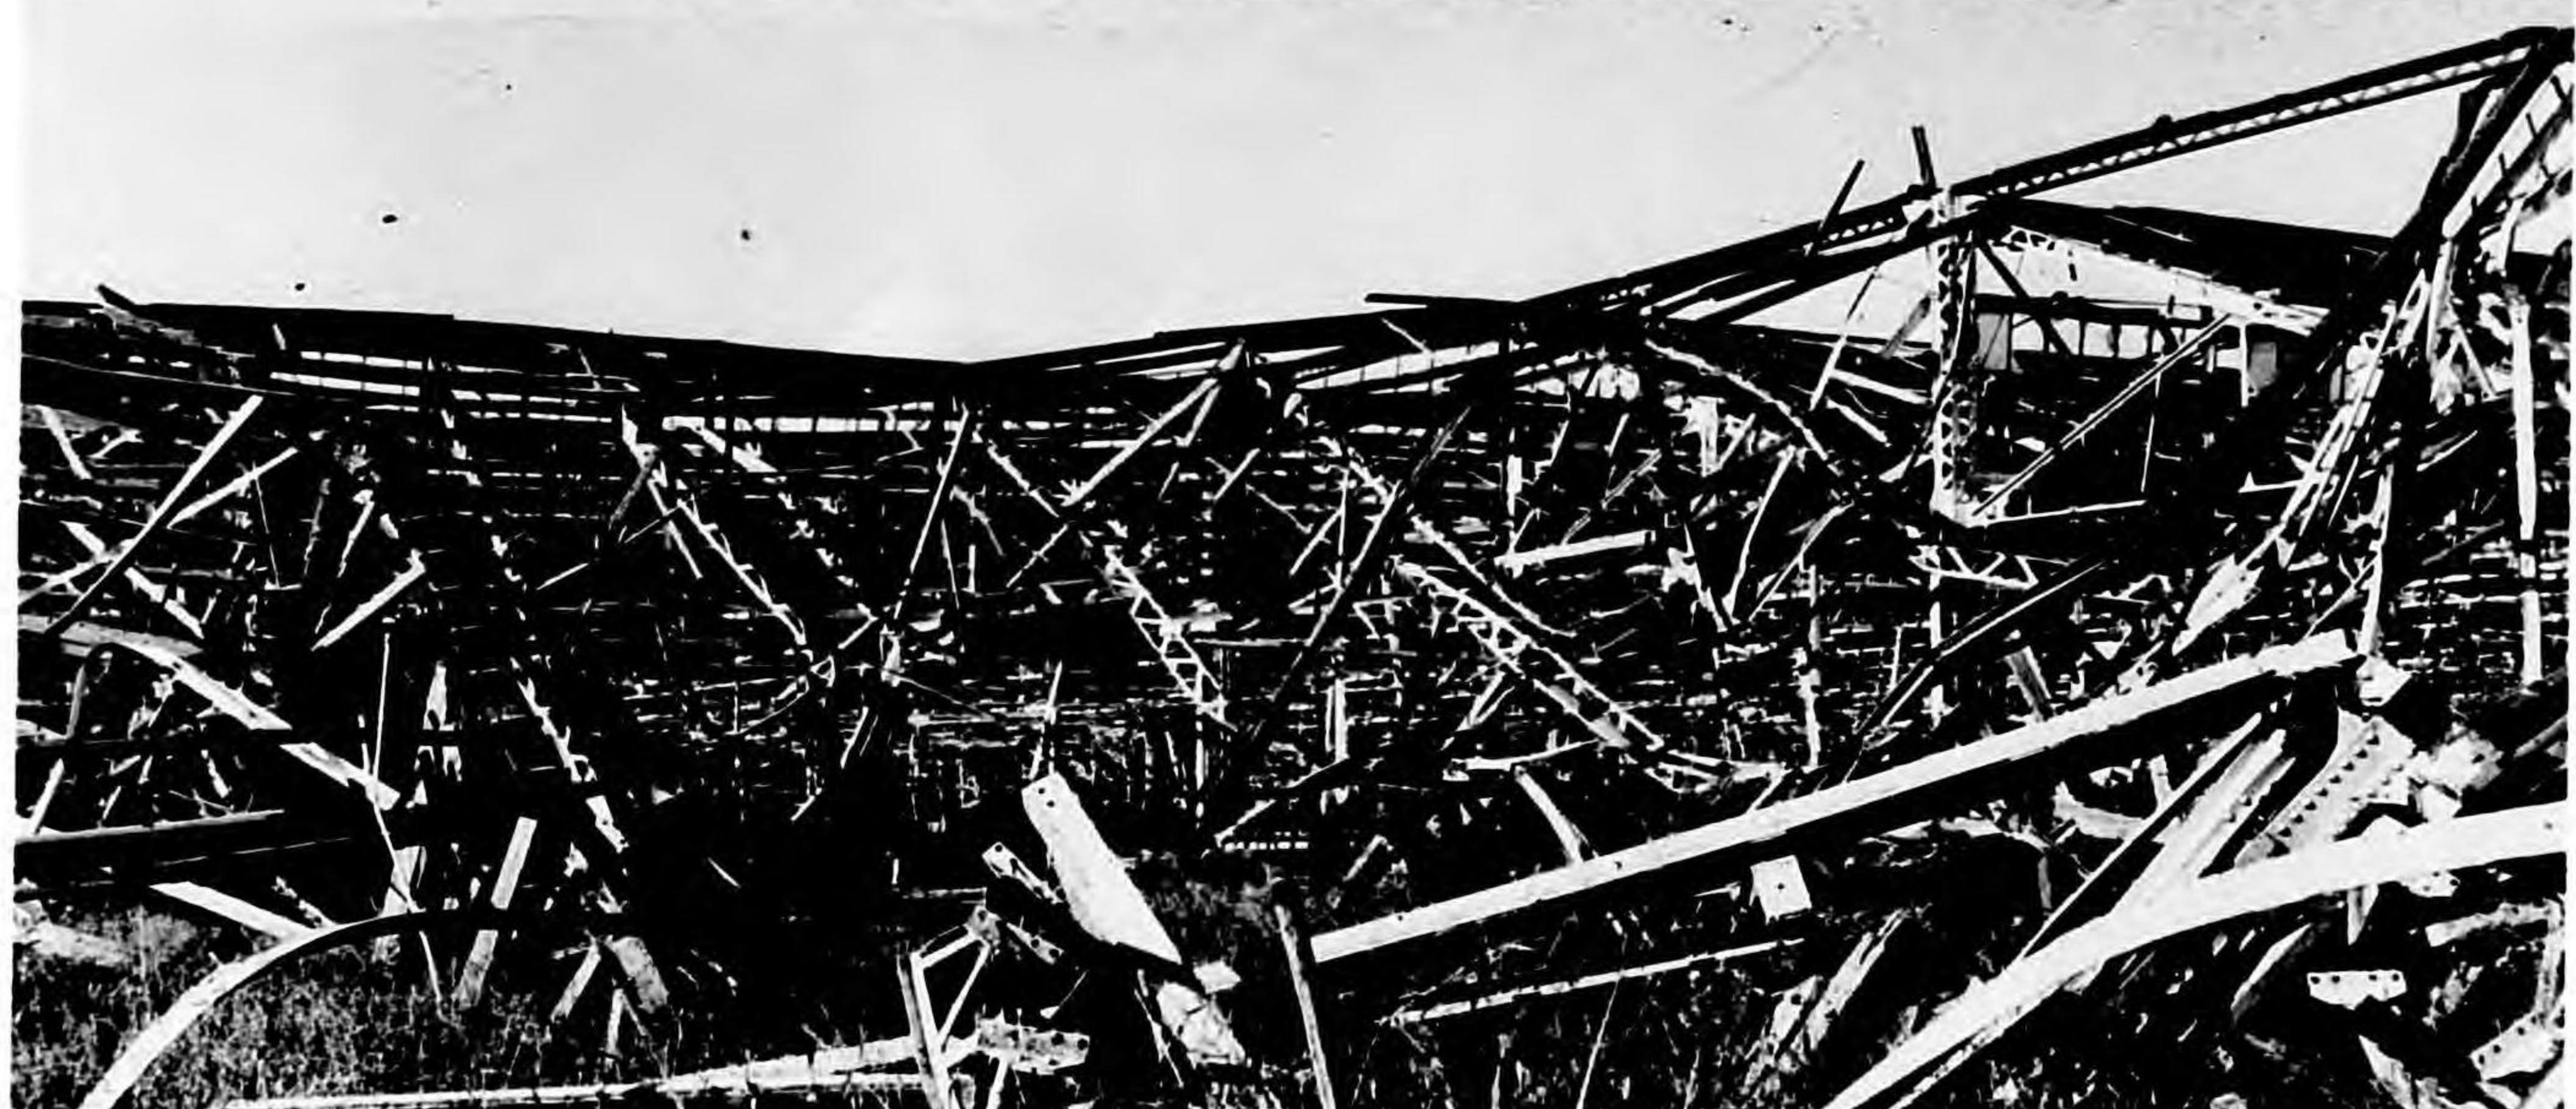
Photo 19 - A partial view of damage caused by Bombs 16 and 17. Weeds and grass tend to obscure craters and detail of damage at crater level.

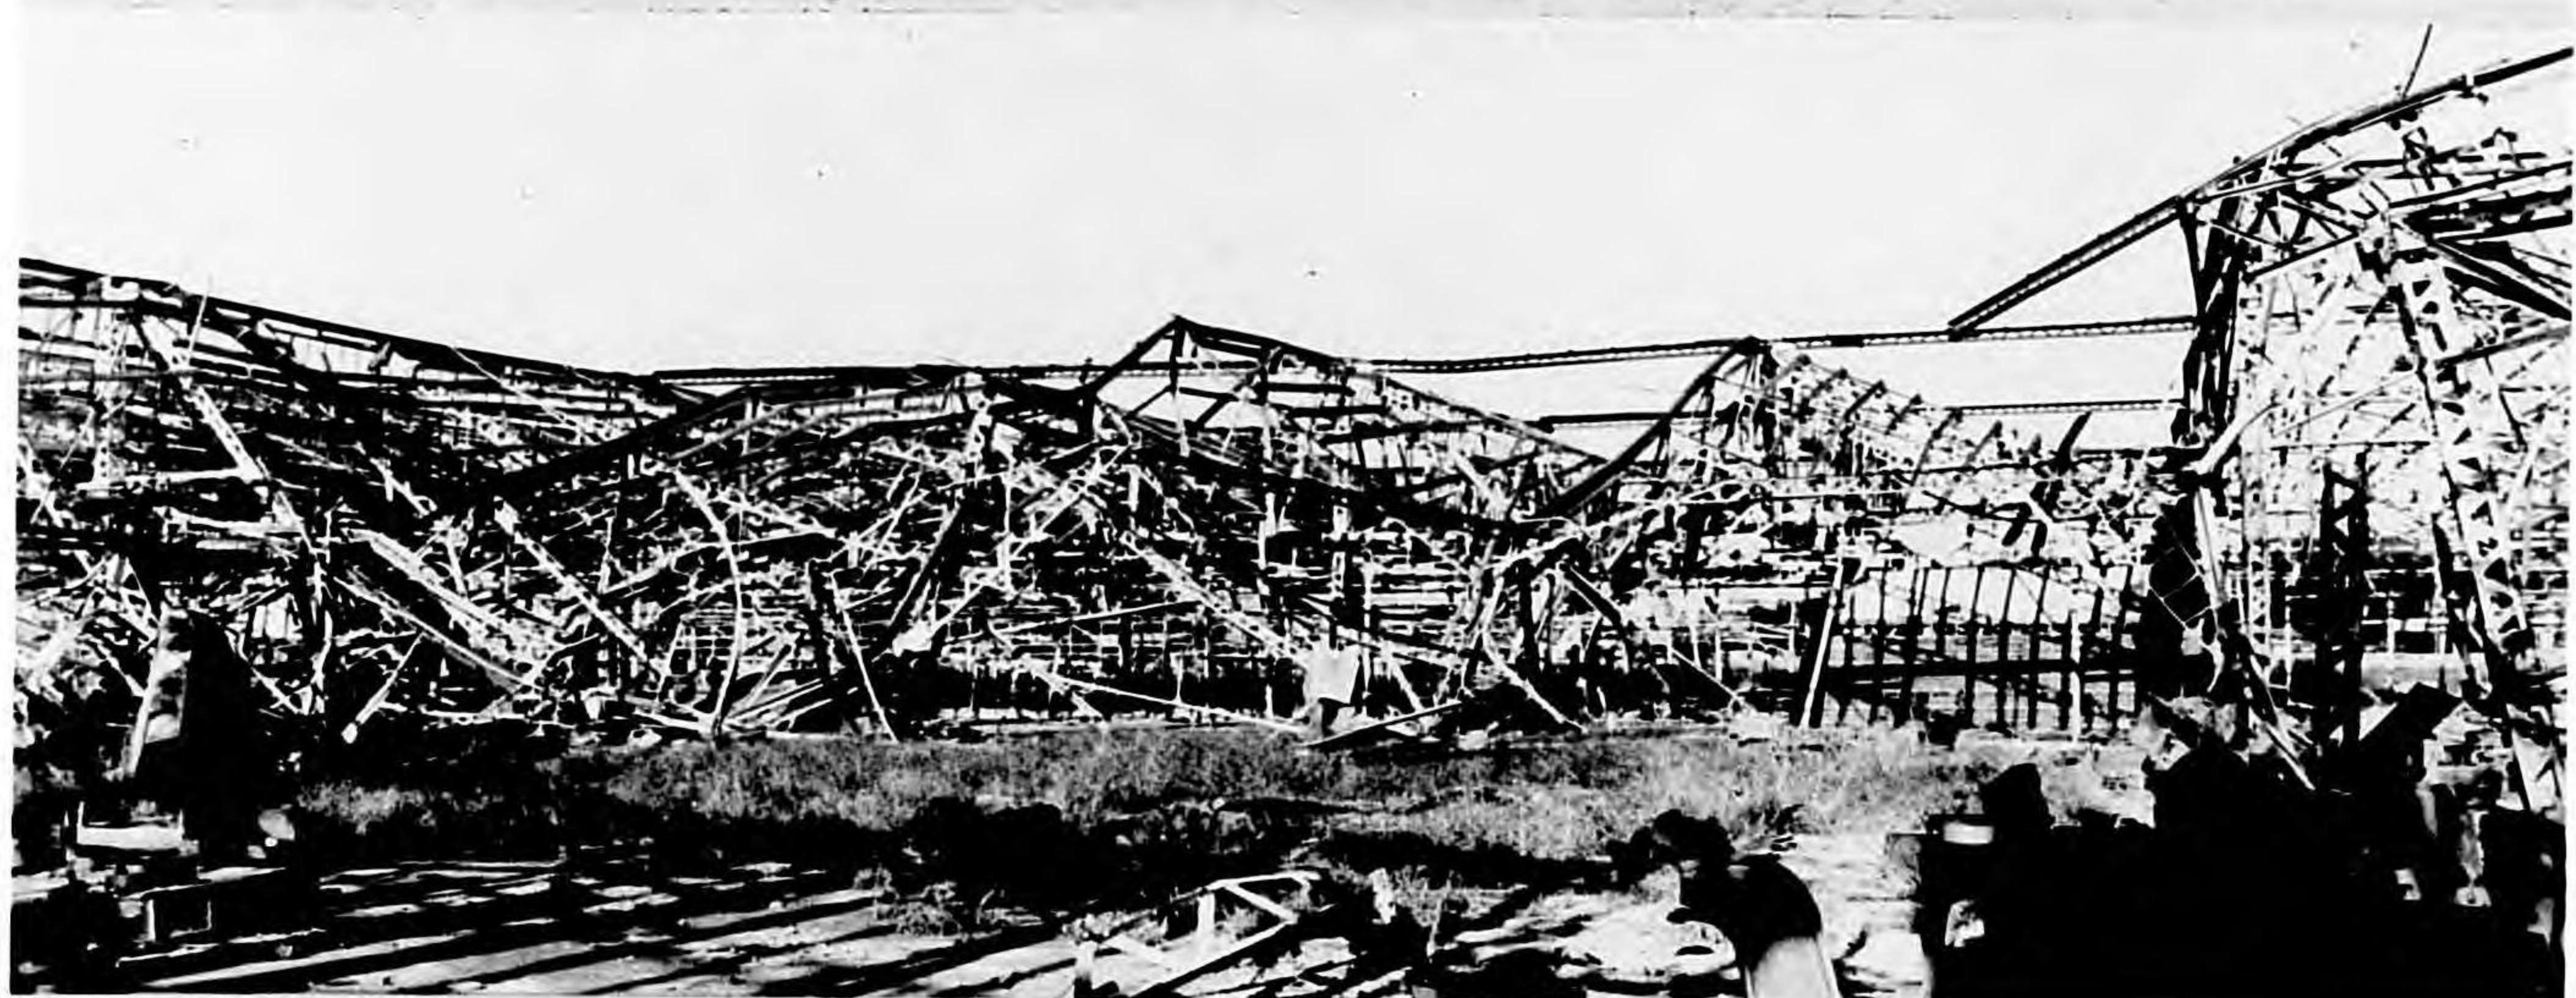
Photo 20 - Damage caused by Bomb 19, indicating very clearly the effect of a well placed, correctly fuzed bomb. The entire roof structure collapsed, and the strain of this collapse extended well into the remaining structure.

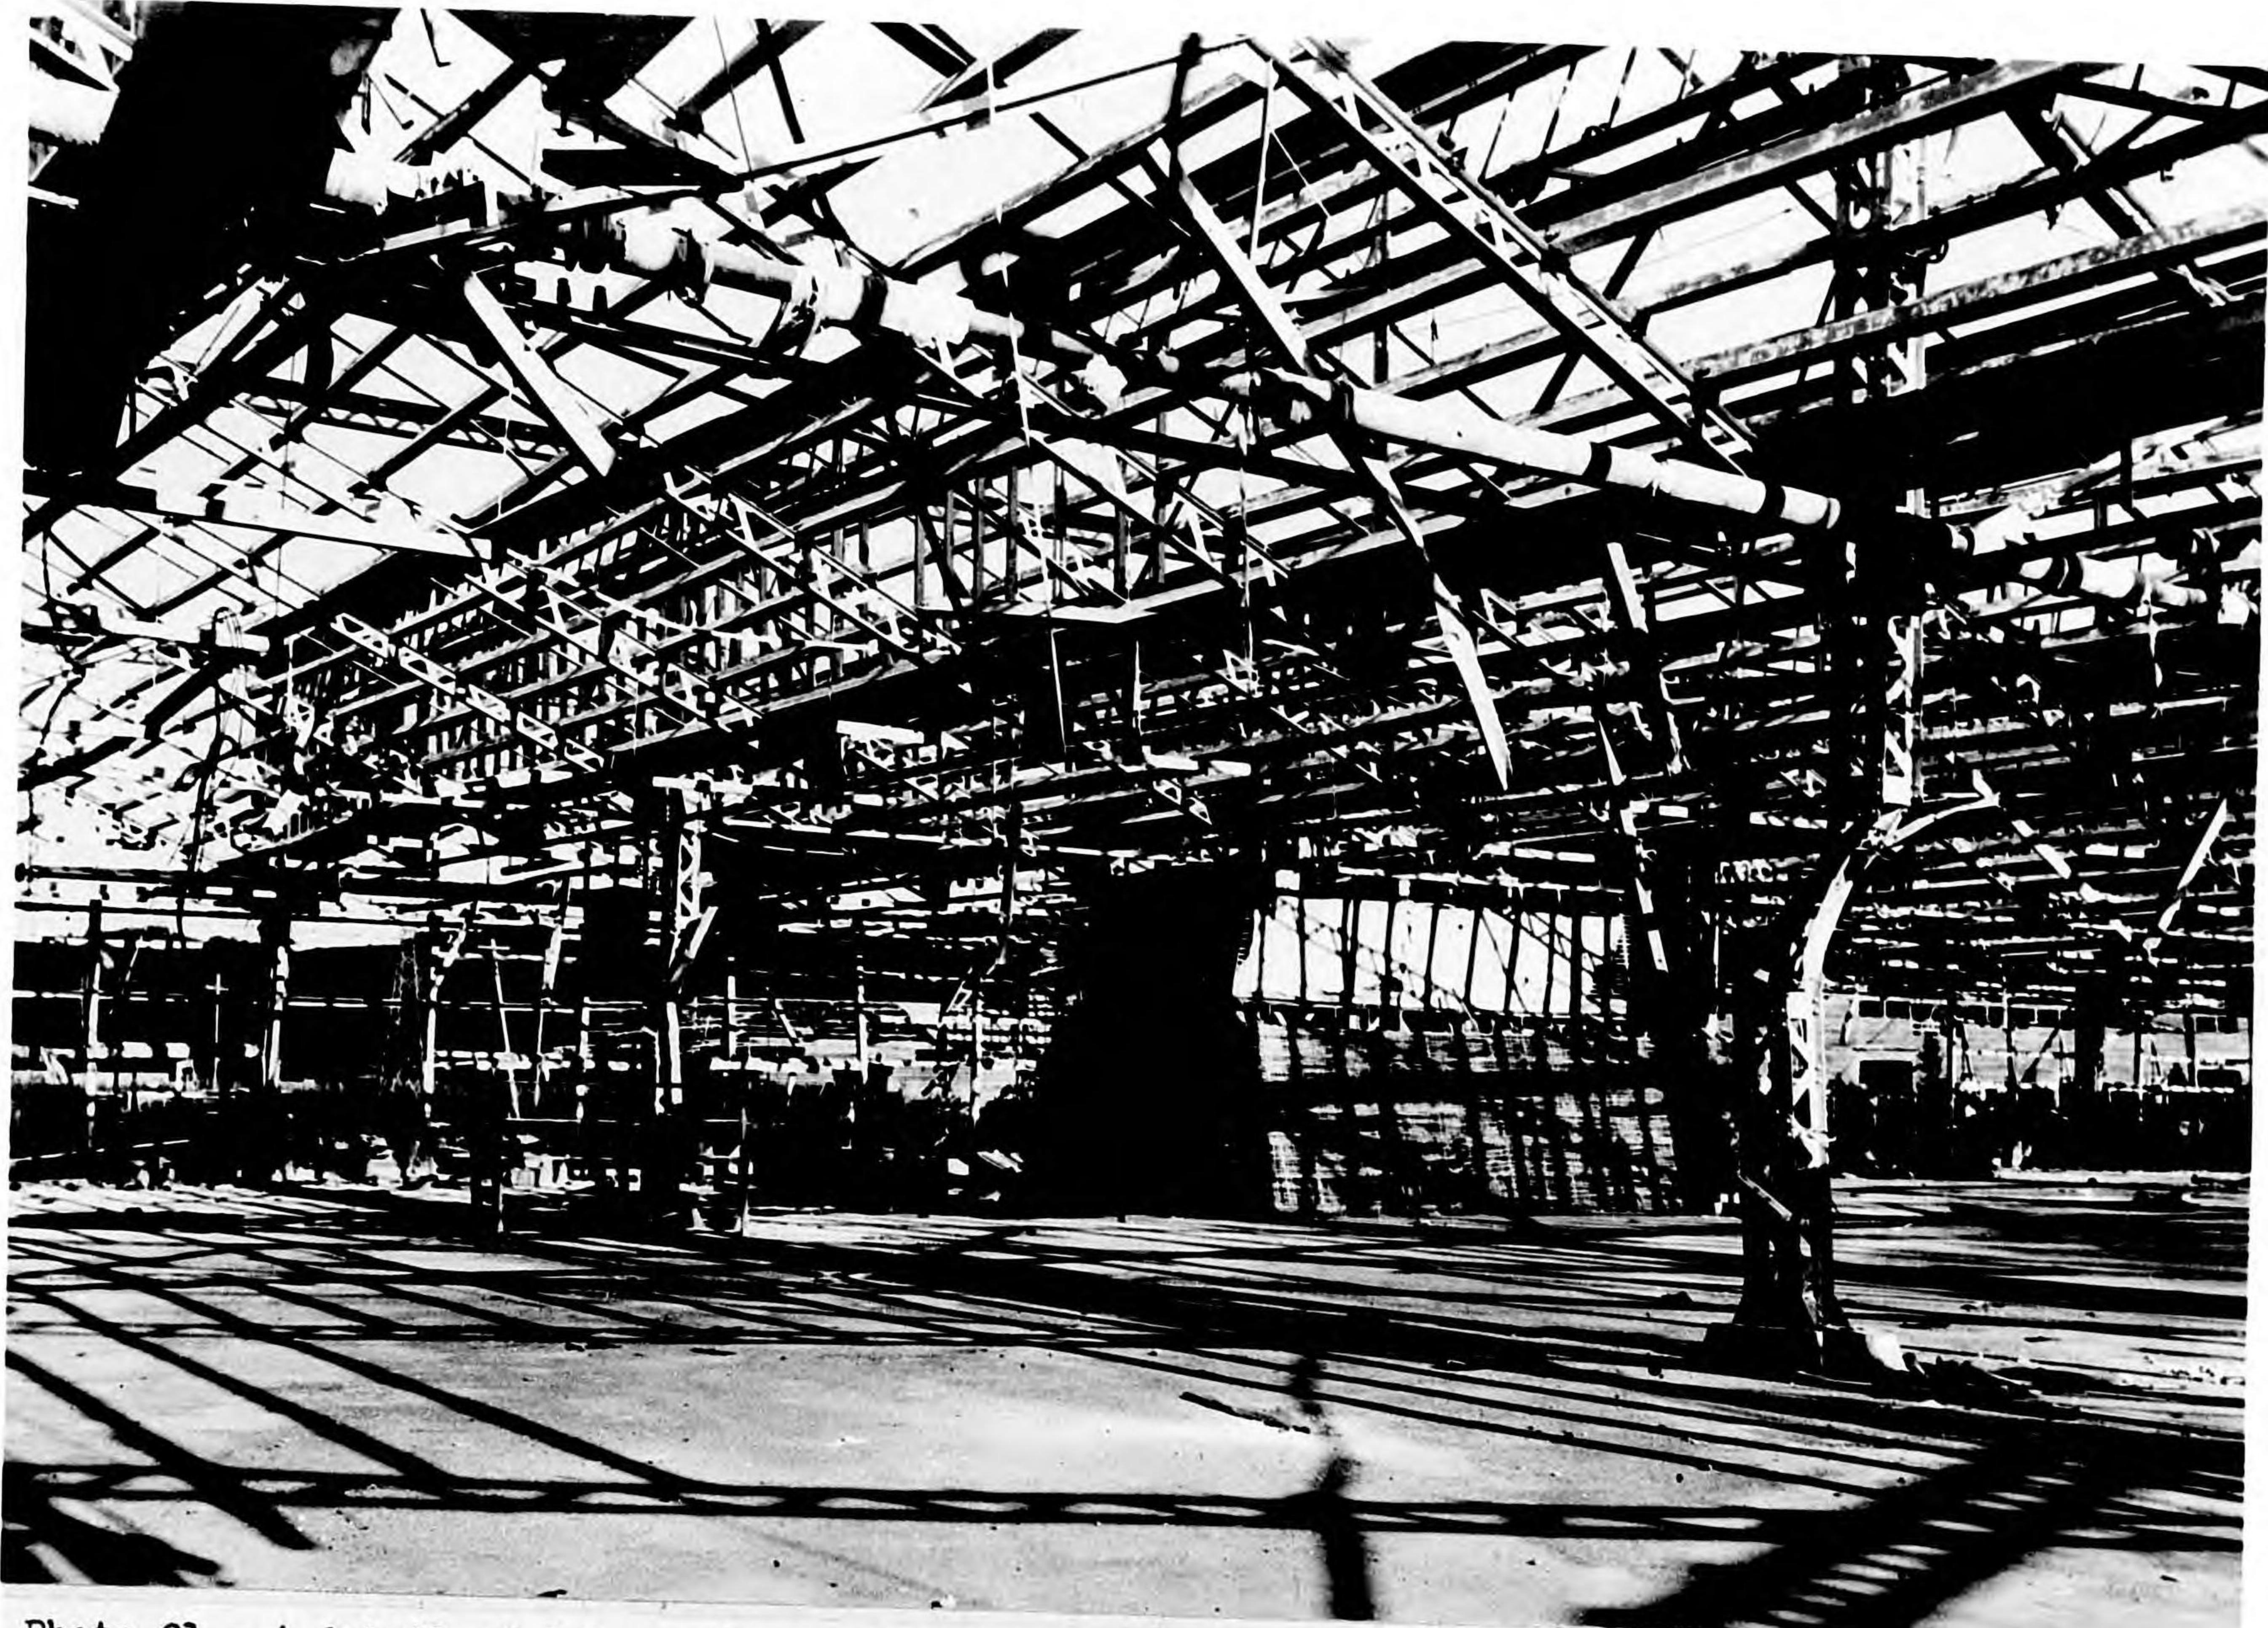
Photo 21 - A detail of Columns 10-J, 10-K and 10-L, showing how the collapse of the roof structure caused by Bomb 19, which detonated out of the picture to the right, racked the structural members and pulled these columns toward the collapsed section. Although not damaged directly by blast, these columns are useless as load-bearing members.
