THE
ONTARIO WATER RESOURCES
COMMISSION

GROUND AND SURFACE WATER
INVESTIGATIONS

TOWNSHIP OF EAST WHITBY

INDUSTRIAL DISPOSAL (OSHAWA) LIMITED

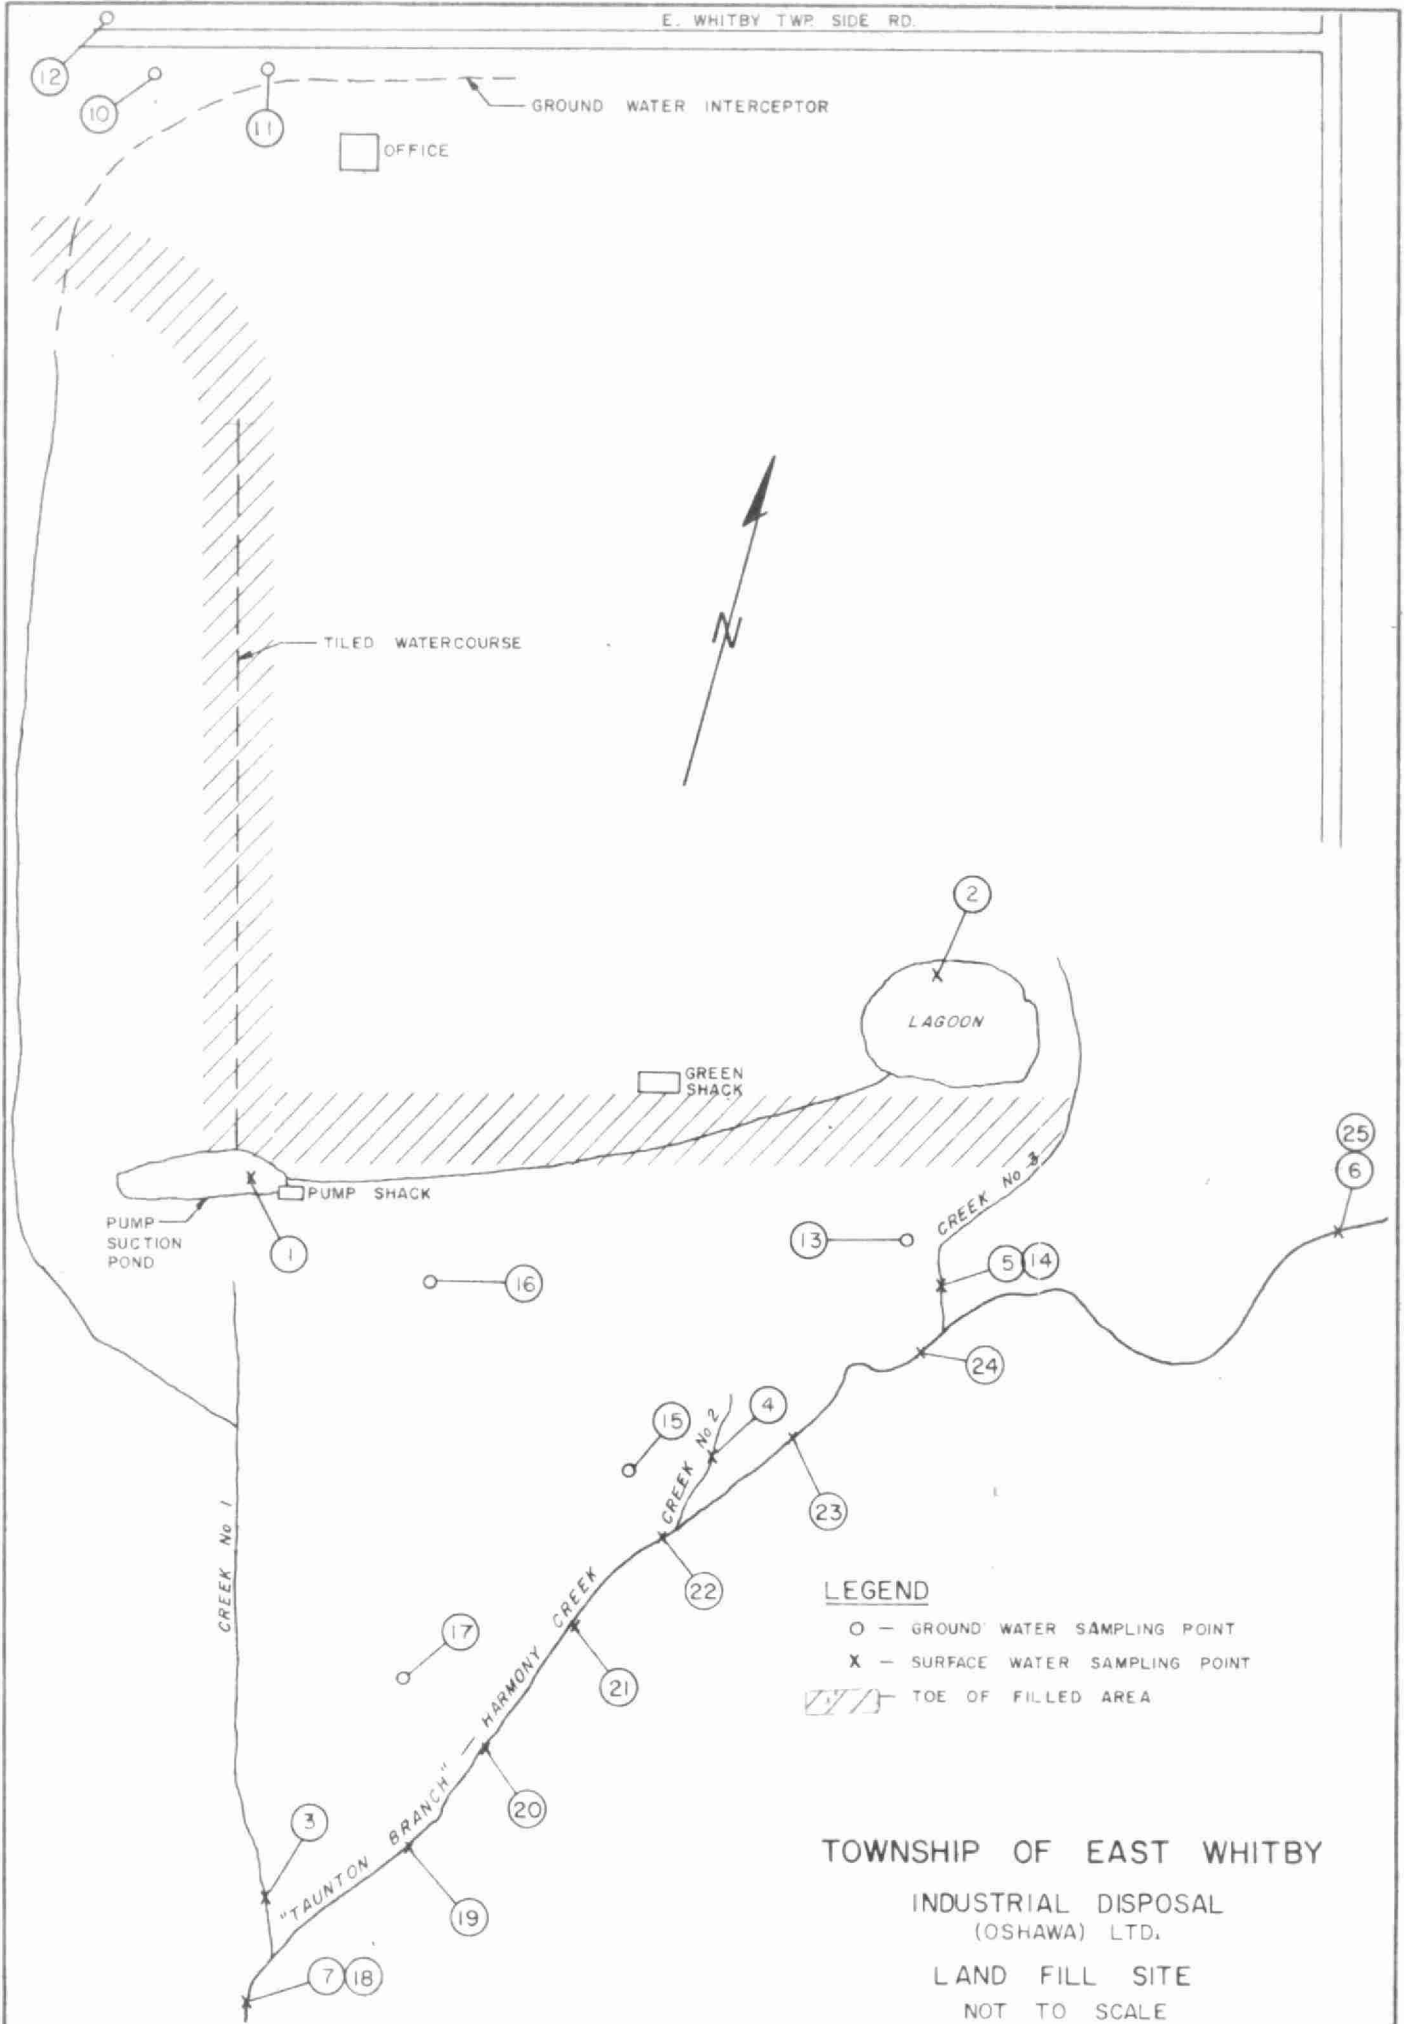
LAND FILL SITE
NOT TO SCALE

A map, which includes the information pertinent to this report, is appended.

The laboratory results of the surface water samples, collected on May 25, exceed the Commission objectives with respect to; 5-day BOD and iron at stations 3 and 4; phenols at stations 3 to 7 inclusive; and coliforms at station 4.

The seepage into test holes 10, 11, and 12 was observed to come mainly from the north. The laboratory results of the samples indicate that a ground water pollution problem exists in this area and that the degree of pollution is most severe at the test hole closest to the filled area.

The samples from the test holes south of the filled area are numbered 13, 15, 16, and 17. The laboratory results of these samples indicate that the pollution of ground waters resulting from the landfill operation is most significant in the area south of the toe of the filled area between Creek No. 1 and Creek No. 2.

On the basis of the laboratory results it may be concluded that a ground water pollution problem exists north of the site and that the pollution south of the site is most significant in the area between Creek No. 1 and Creek No. 2.

1. Continued efforts should be expended in the exploration, interception, and diversion of ground water in the vicinity of the existing disposal site.

2. Continued efforts should be made to prevent leachate, from the existing landfill site, from entering ground and surface waters.
