ENERGY DISSIPATORS FOR FLUMES AND CULVERTS

EQUIPMENT DEVELOPMENT AND TEST REPORT 7700-12

Ted L. Pickett, Mechanical Engineer

APRIL 1977

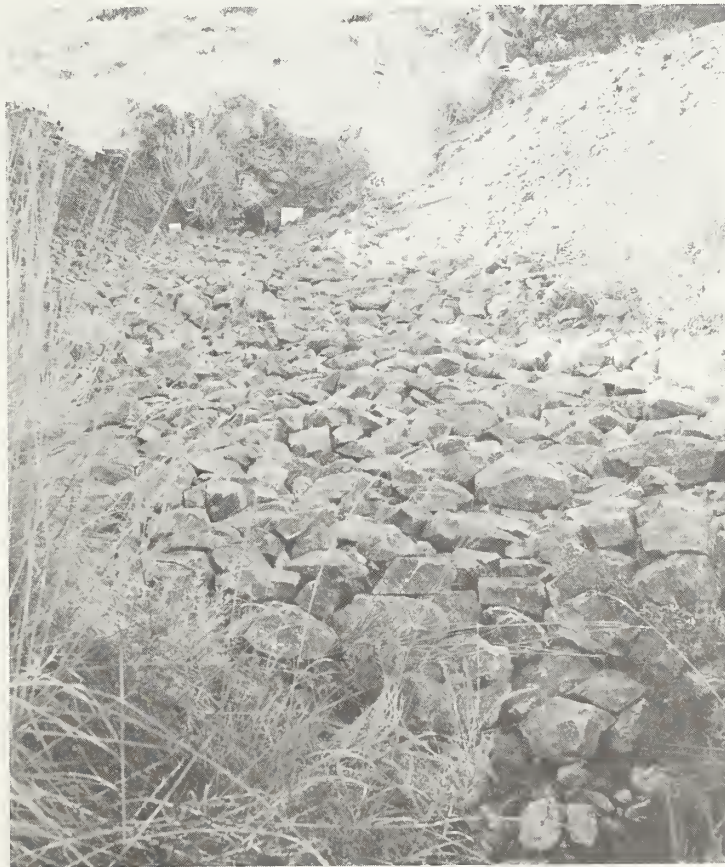
In an attempt to dissipate the energy of the water carried by specified drainage devices and thus reduce the potential for erosion, engineers have placed rocks, concrete posts, or similar material ("rip-rap") at the outlets of the flumes and culverts. Usually the material for these rip-rap sites (fig. 1) has to be imported and the ground at the outlet has to be trenched out to hold the material. The material is then placed, frequently by hand, in a very irregular manner in an attempt to interrupt and deflect water flow and spread the flow stream. These efforts are often frustrated because either the rip-rap itself is washed away or sediment, carried by the water flow, is deposited at the rip-rap site, causing the rip-rap to be less irregular, thus reducing its energy dissipating capability.

Figure 1. Typical rip-rap site, Toiyabe National Forest, Calif.

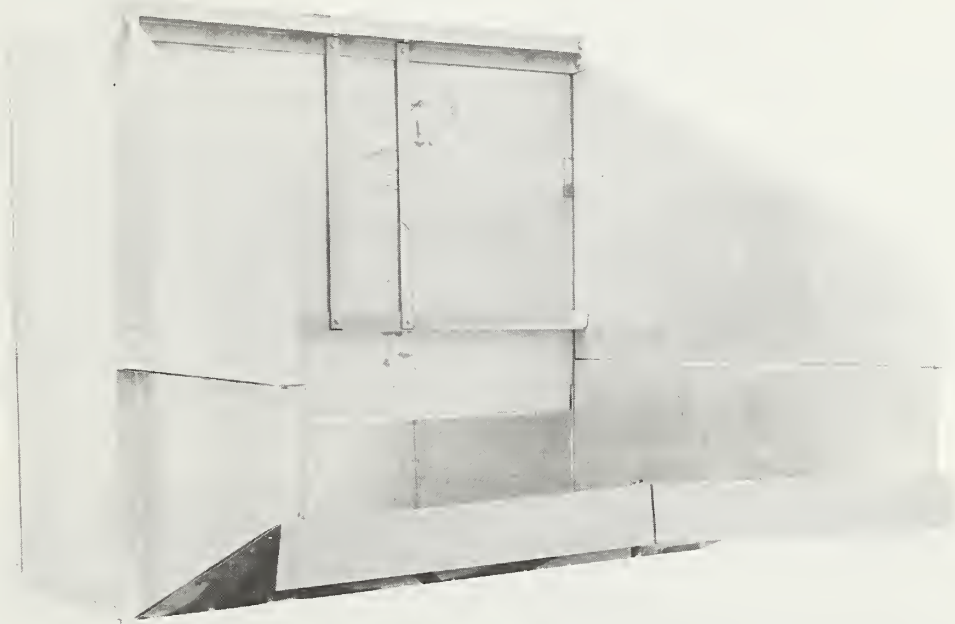
A full-size dissipator, fabricated by scaling up the Bureau's design (fig. 2) was tested by SDEDC engineers in the bed of the San Gabriel River on the Angeles National Forest, Calif. The results looked promising; it was effective at reducing flow energy and exhibited self-cleaning action, even for rocks up to 8 in in diameter. Fabrication of 20 of these dissipators proceeded at SDEDC, and Forest Service Regions were asked to select locations for dissipator placement.

Figure 2. Energy dissipator based on results of hydraulic model studies.

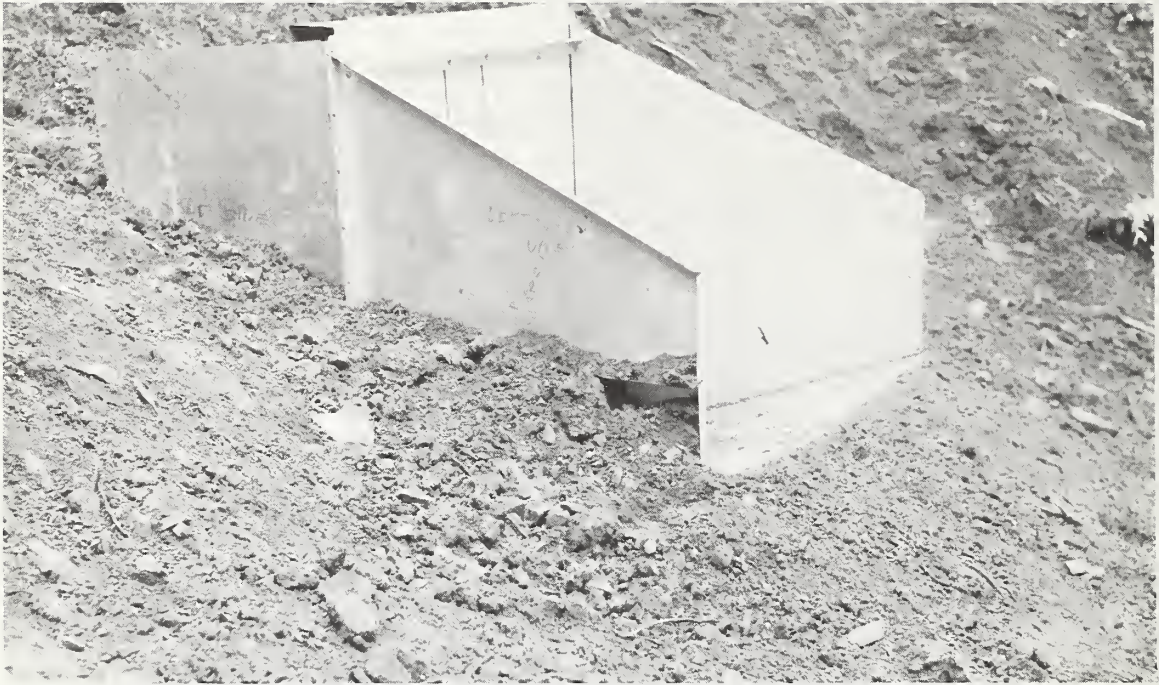
Figure 3. Dissipator installed at "severe" location.

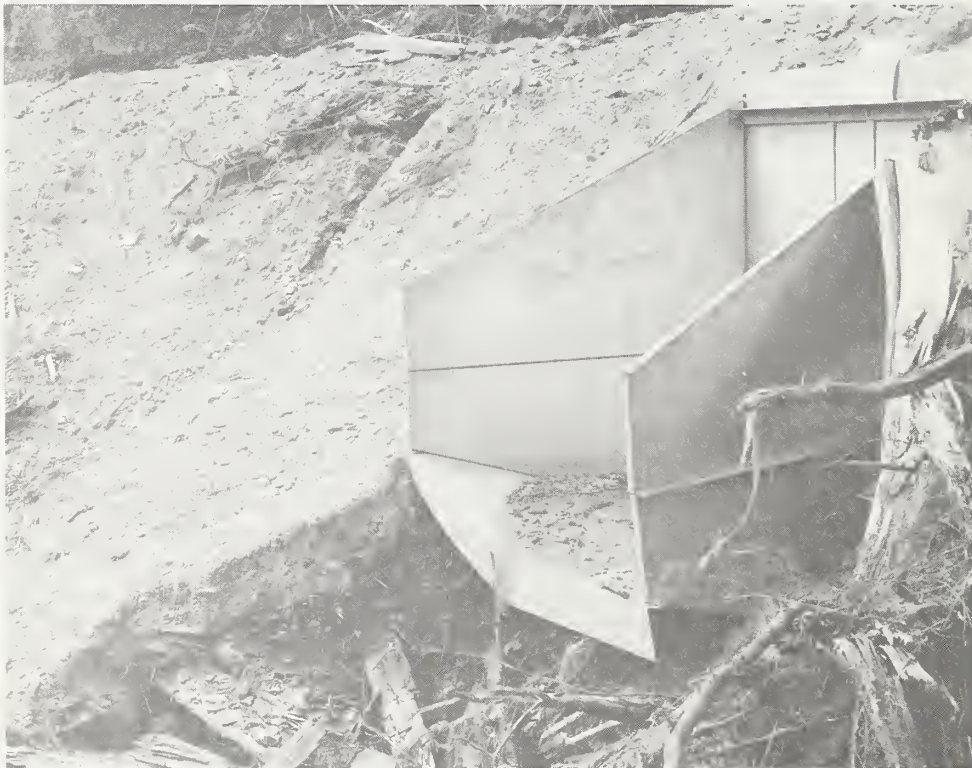
Figure 4. "Severe" site shows signs of much erosion.

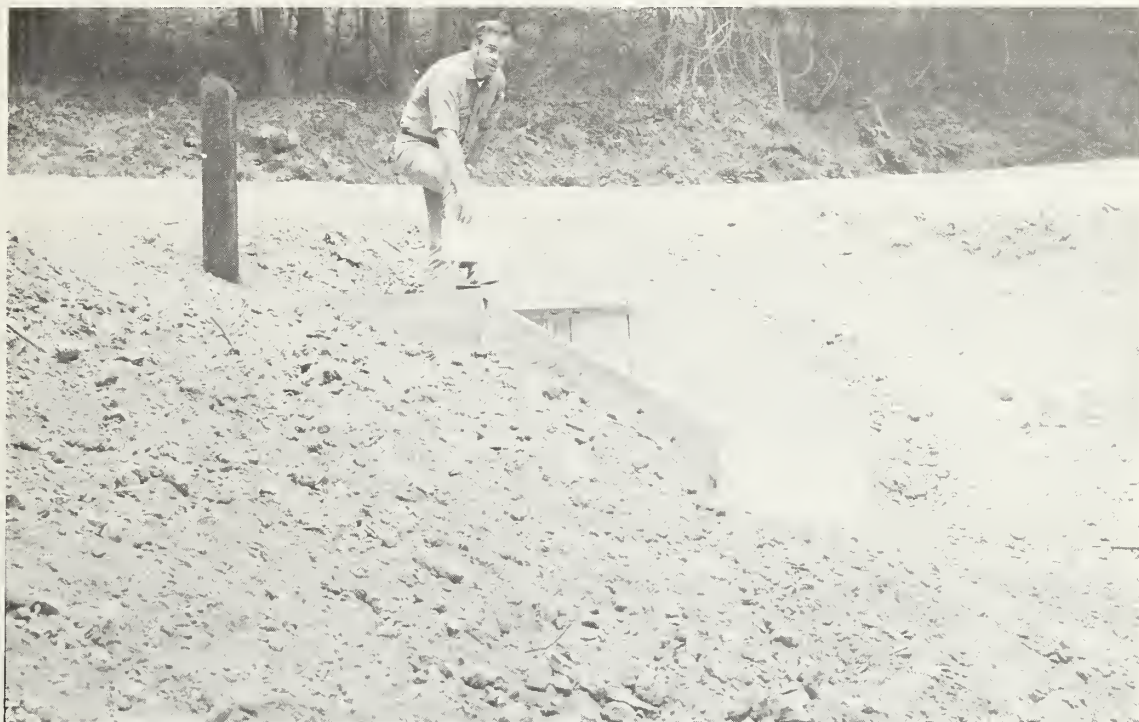
Figure 5. Dissipator right after being installed at relatively "stable" site.

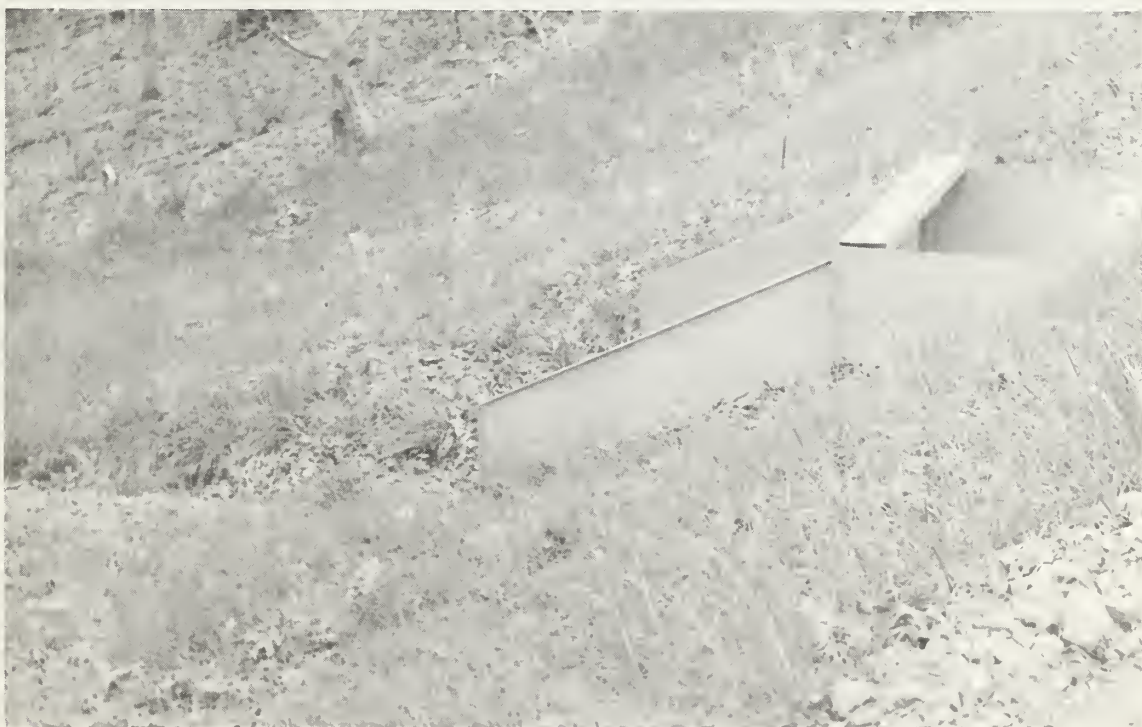
Figure 6. Dissipator has successfully stemmed erosion at the "stable" site.
