**KOMITE NASIONAL KESELAMATAN TRANSPORTASI
REPUBLIC OF INDONESIA**

Aircraft Accident Investigation Report

PT Sriwijaya Air

Boeing 737-500; PK-CLC

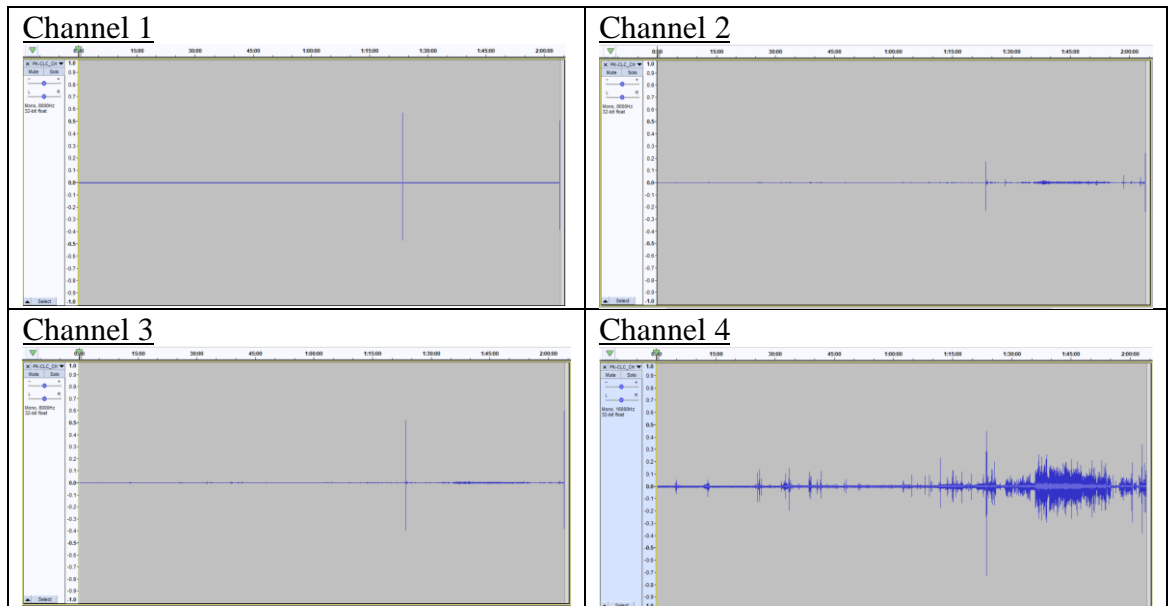
Figure 15: The downloaded CVR data in 2020

On 9 April 2020, the CVR was downloaded at the Sriwijaya Air facility while the aircraft was grounded for maintenance. There was no recording on Channels 1, 2 and 3, while Channel 4 recorded conversation between engineers while performing maintenance. The result of the download stated that the CVR was functioning correctly.

The investigation was unable to determine the reason on why Channel 4 recorded a prominent tone with a frequency of about 400 Hz in the downloaded CVR data in 2019 but was not in the downloaded CVR data in 2020.

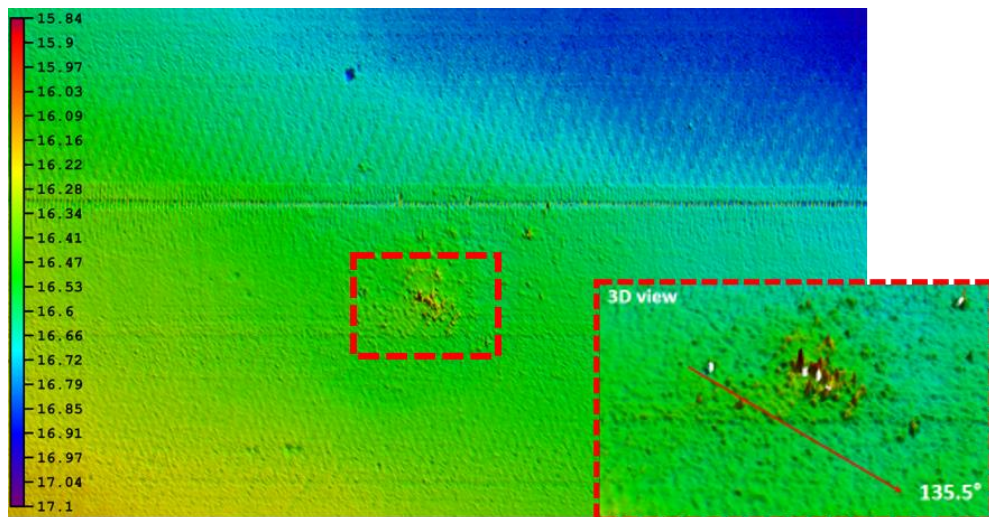
Figure 18: Scanning result from multibeam echosounder

The accident site was located about 11 Nm northwest of Jakarta, and about 80 meters southeast of the last known aircraft position recorded by the ADS-B. The wreckage distributed over an area of about 80 by 110 meters on the seabed at a depth of approximately 16 meters.

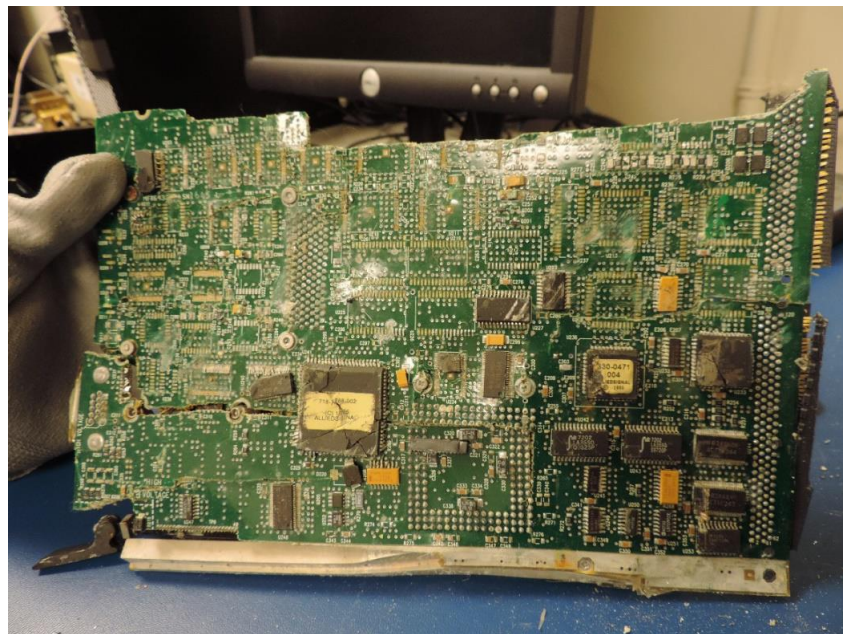
Figure 19: The EGPWS CCA

The unit was examined at the Honeywell Aerospace facility in Redmond, Washington, USA on 8 April 2021. The examination revealed that the unit was severely damaged with sections of the chassis and circuit card assemblies missing, deformed, and scratched. The mounting tray was still in place with the unit and could not be removed by hand. To remove the unit from the tray, the rivets that held the mounting tray were removed, and a section of the tray was cut to remove the EGPWS computer.

The EGPWS Circuit Card Assemblies (CCA) were removed from the chassis of the computer and inspected. The EGPWS CCA condition is shown in the following figure.

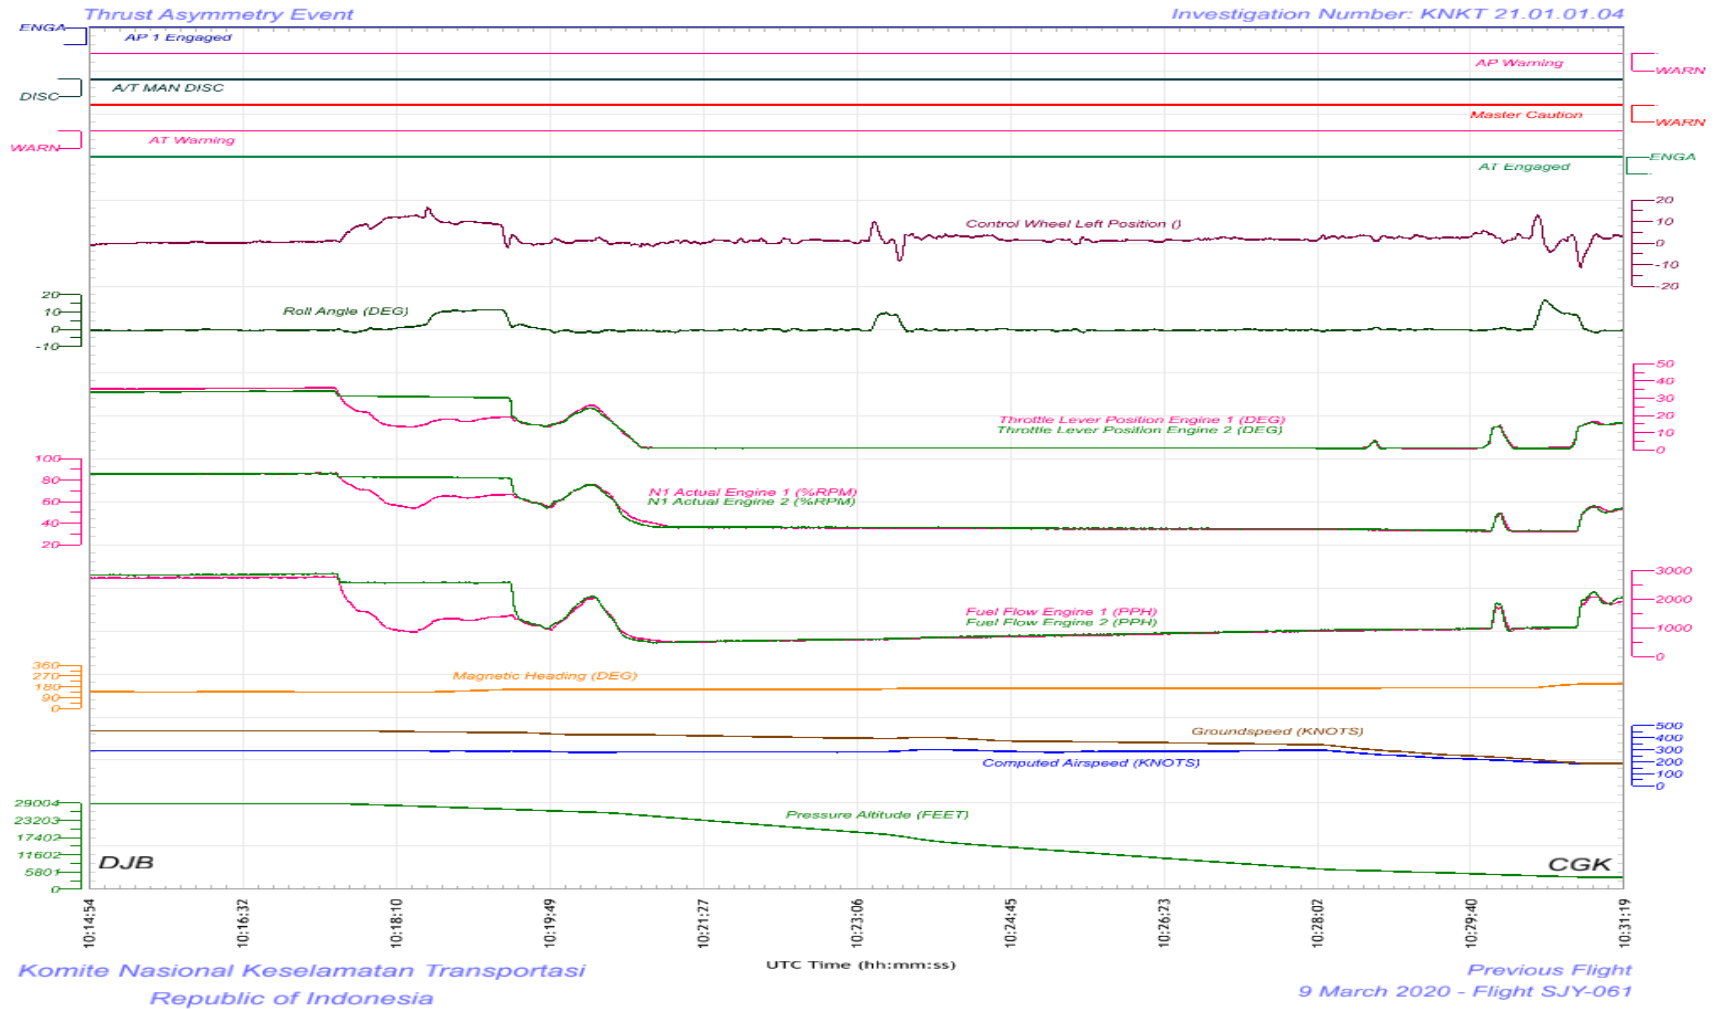
Figure 32: The QAR data of a flight on 9 March 2020

The QAR data of a flight on 9 March 2020 showed that:

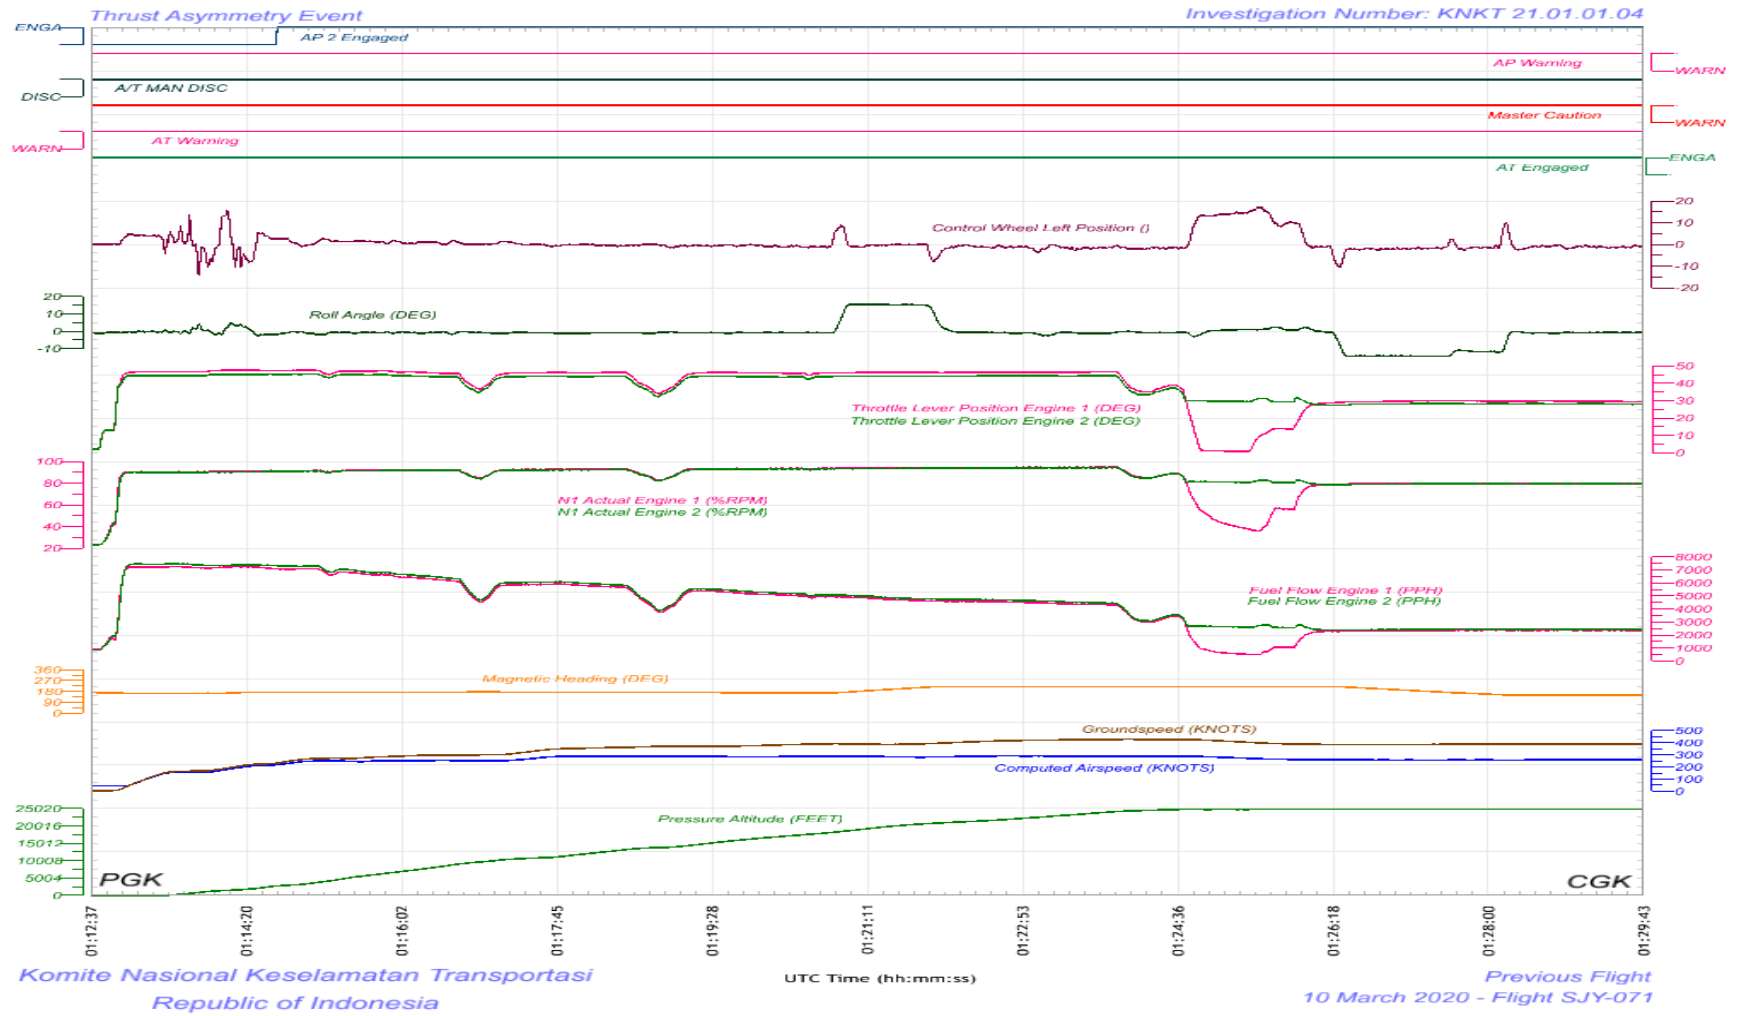
Figure 33: The QAR data of a flight on 10 March 2020

The QAR data of a flight on 10 March 2020 showed that:

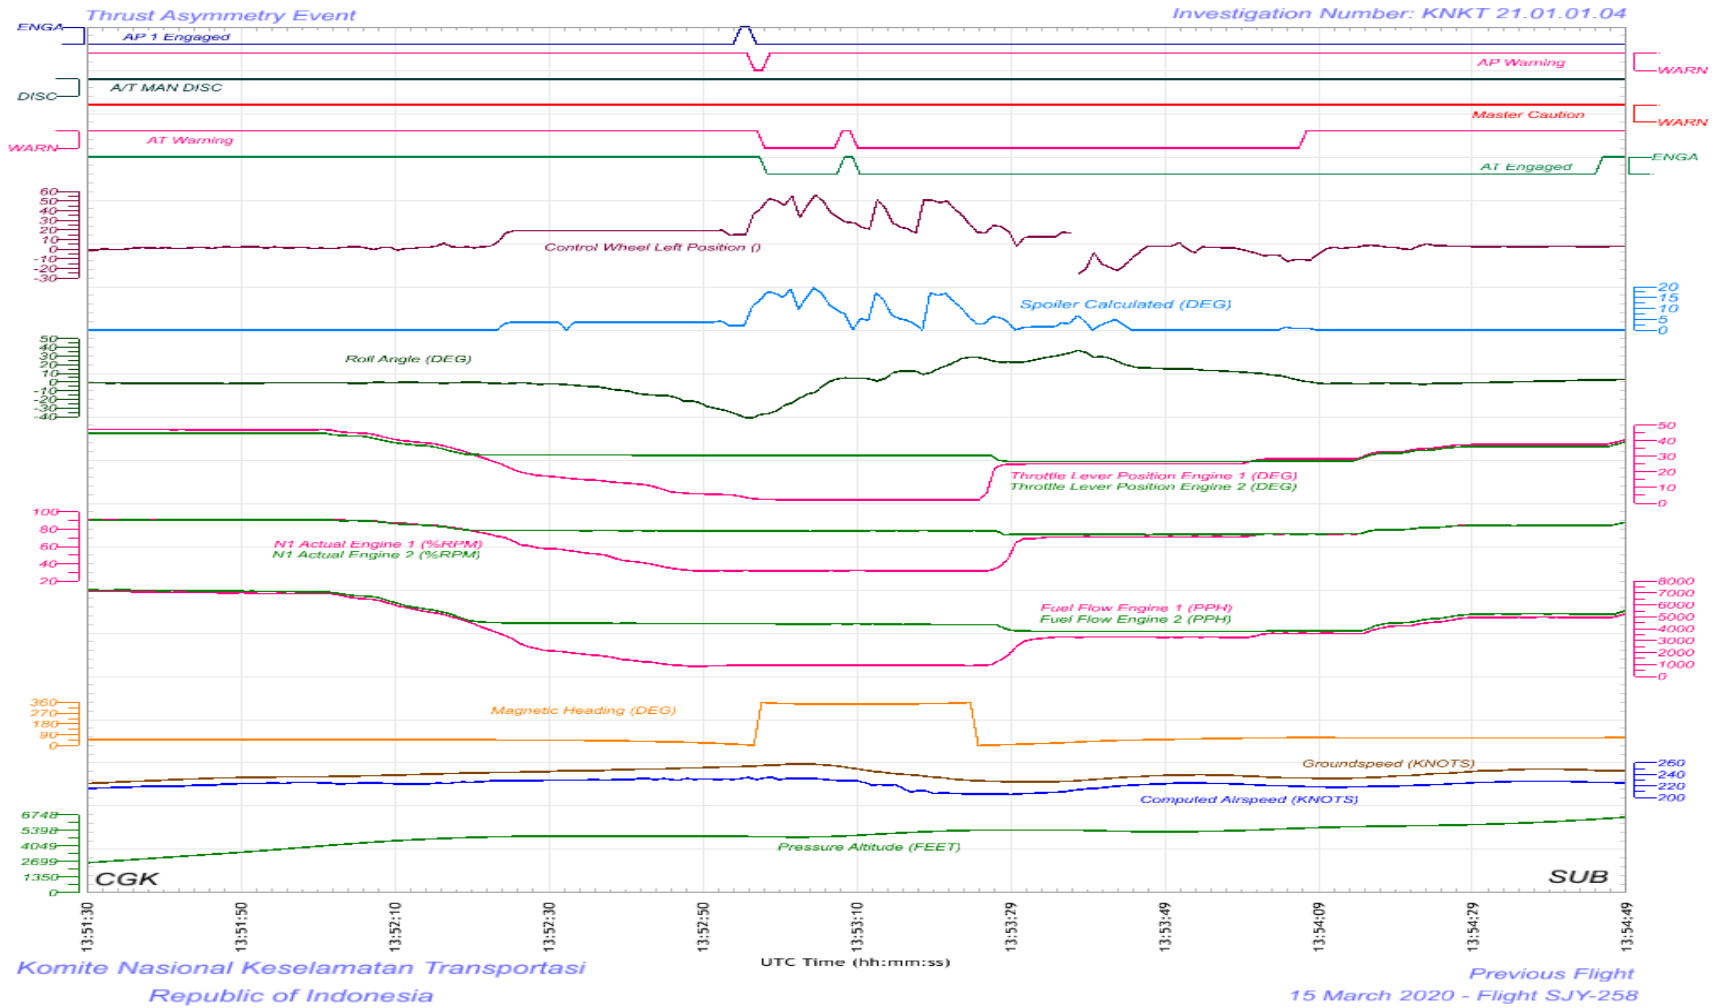
Figure 34: The QAR data of a flight on 15 March 2020 with additional parameter of spoiler deployment calculation

The QAR data of a flight on 15 March 2020 showed that:

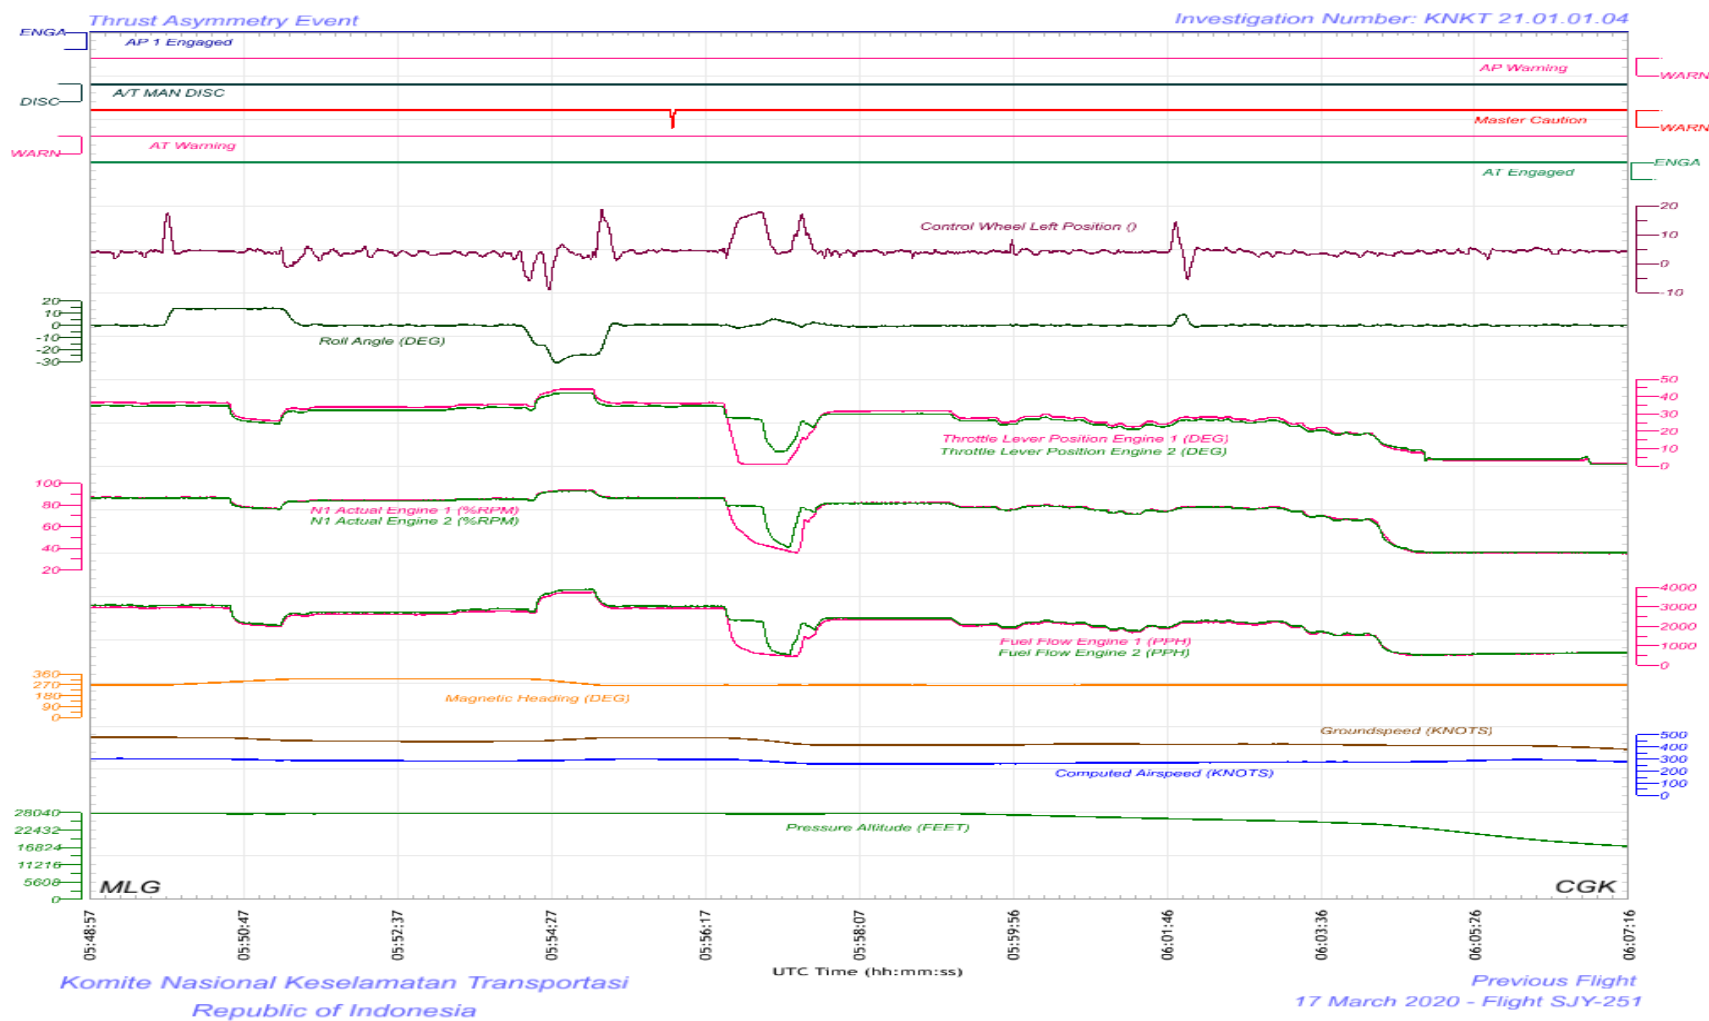
Figure 35: The QAR data of a flight on 17 March 2020

The QAR data of a flight on 17 March 2020 showed that:

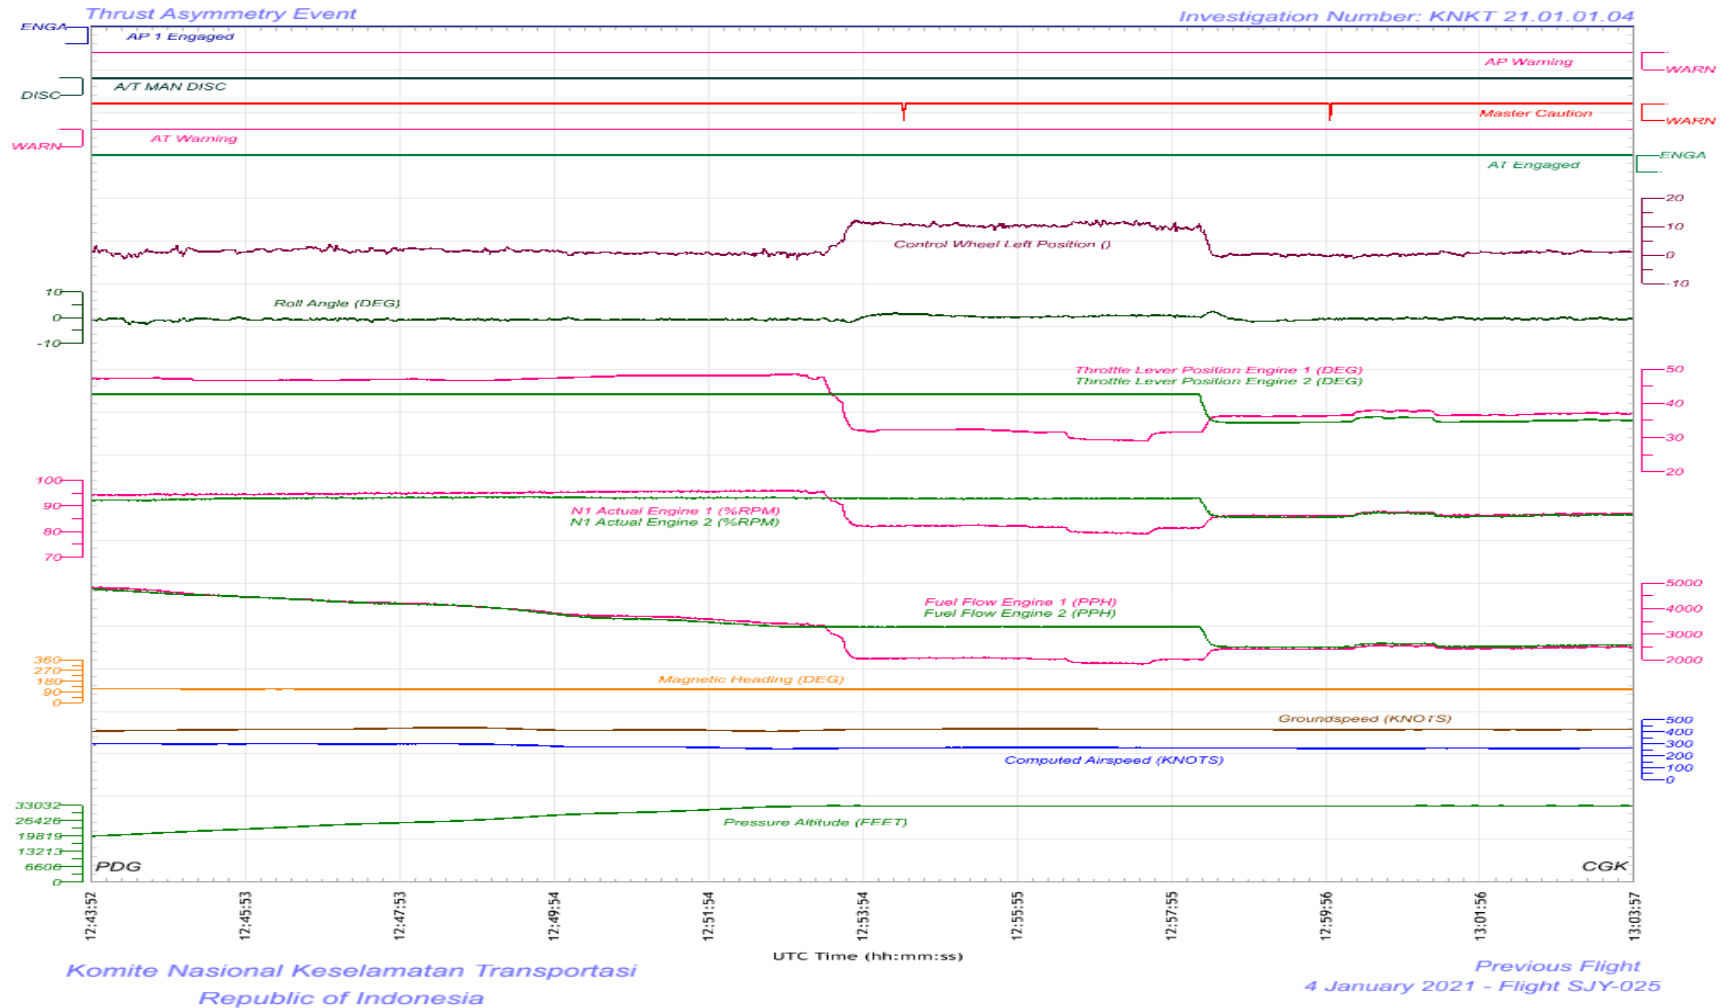
Figure 36: The QAR data of a flight on 4 January 2021

The QAR data of a flight on 4 January 2021 showed that:

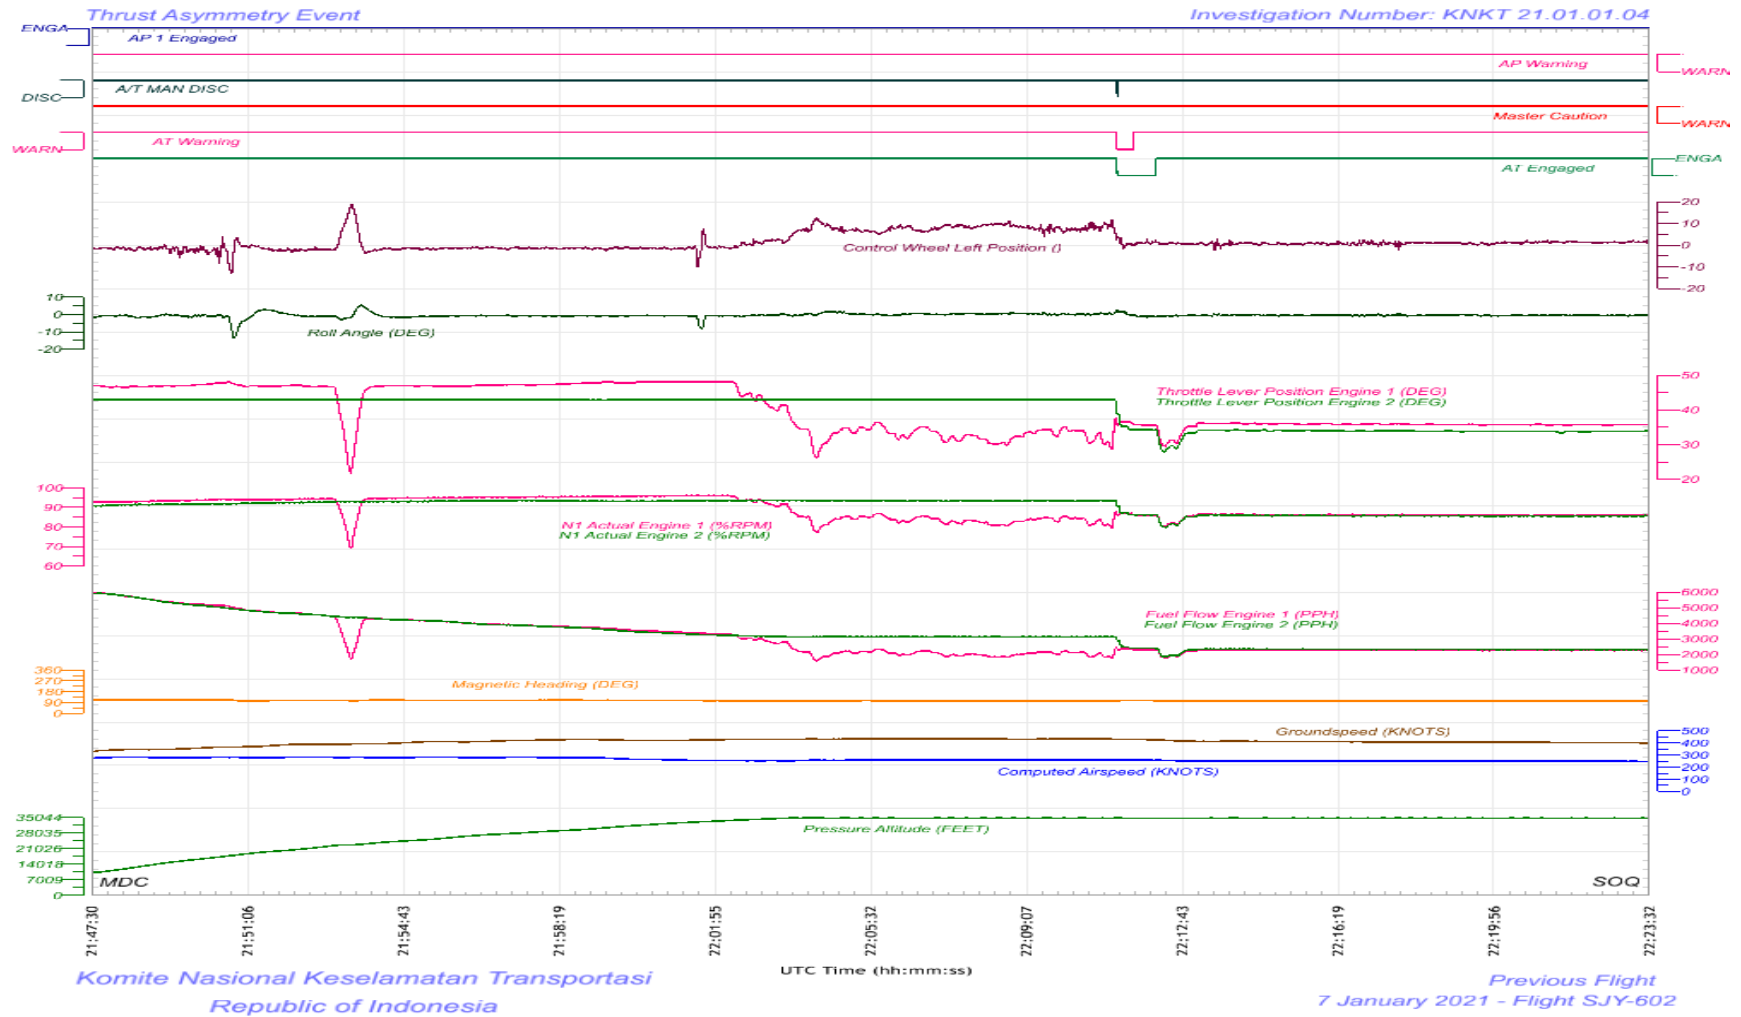
Figure 37: The QAR data of a flight on 7 January 2021

The QAR data of a flight on 7 January 2021 showed that:
