ROAD DESIGN GUIDELINES FOR THE IDAHO BATHOLITH BASED ON THE CHINA GLENN ROAD STUDY

R. B. Gardner
William S. Hartsog
Kelly B. Dye

USDA Forest Service
Research Paper INT-204
April 1978

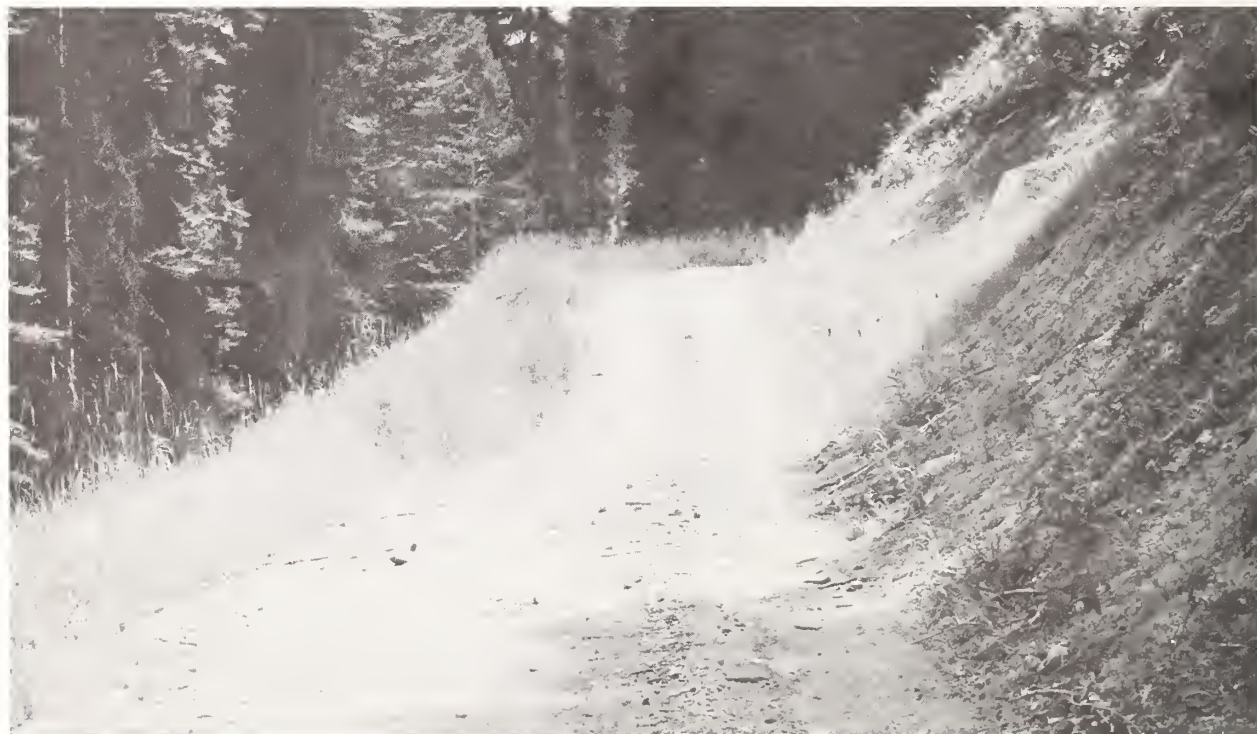
In figures 5 and 6, it is apparent that control of surface water has been maintained by the judicious use of outsloping, design dips, and breaks in grade. In figures 7 and 8, insloping was used with berms to direct surface water to the cross-drain culverts. Although the road is primarily an outsloped road, there were occasions when water could not be carried to a full bench section or transition point from fill to cut to be dispersed on natural ground. When this occurred, as shown in figures 7 and 8, insloping and berms were used. Because of the difficulty of maintaining berms, and the extra road width required for their use, they were employed only when other means could not be used.

Figure 5.--Outsloped section with dip (built after construction).

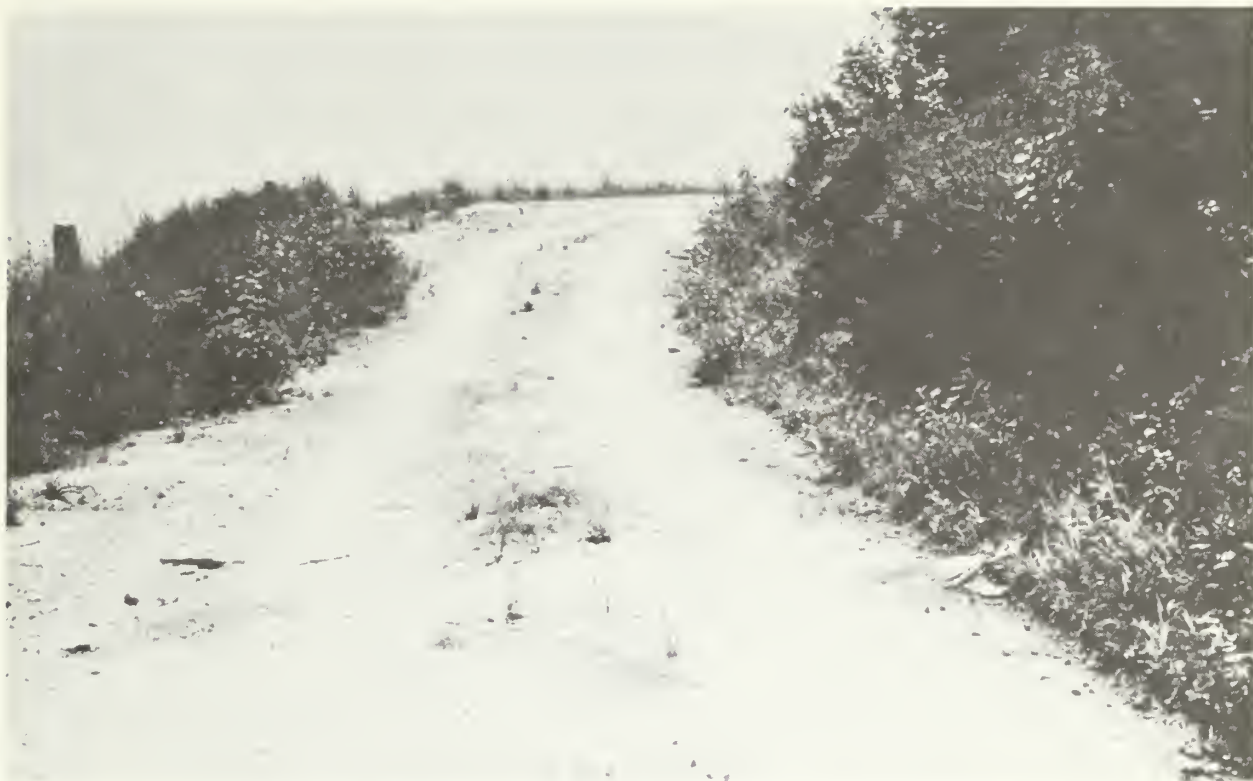
Figure 6.--Break in grade, with dip followed by turnout on outslope section.

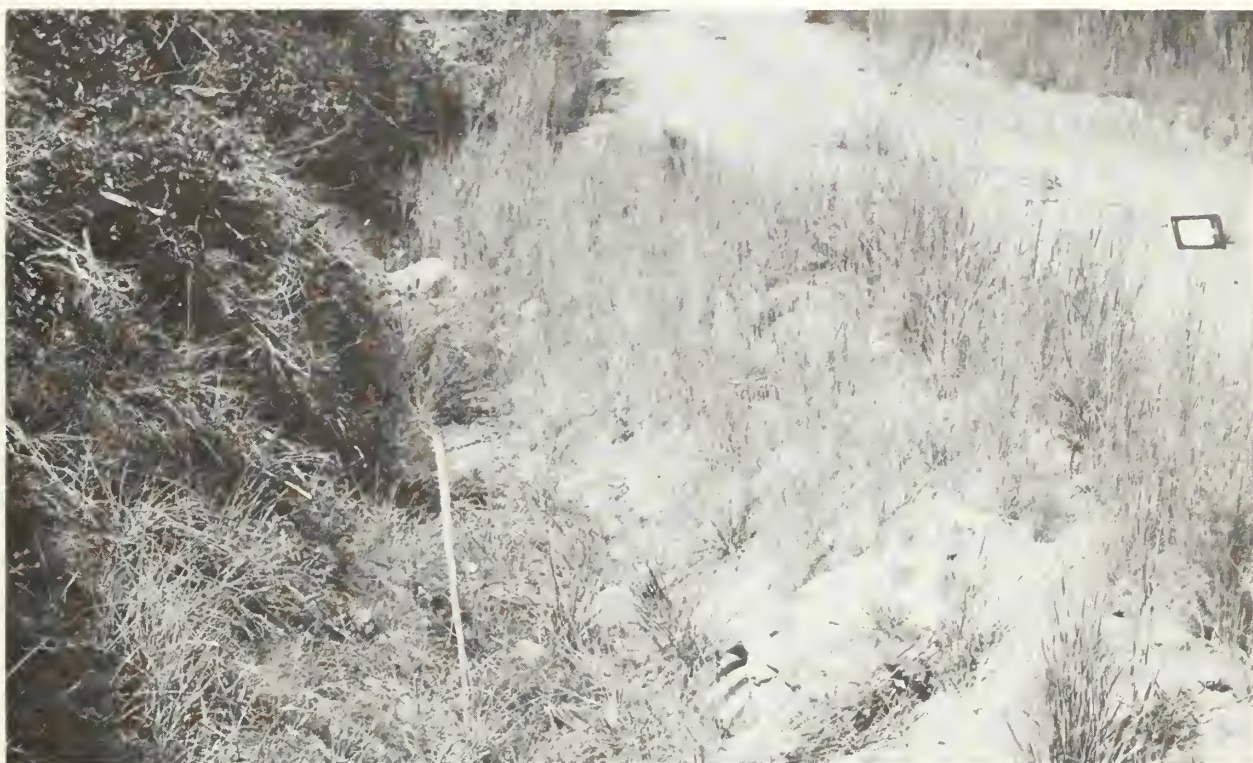
Figure 7.--Inslope to culvert for cross drainage at break in grade.

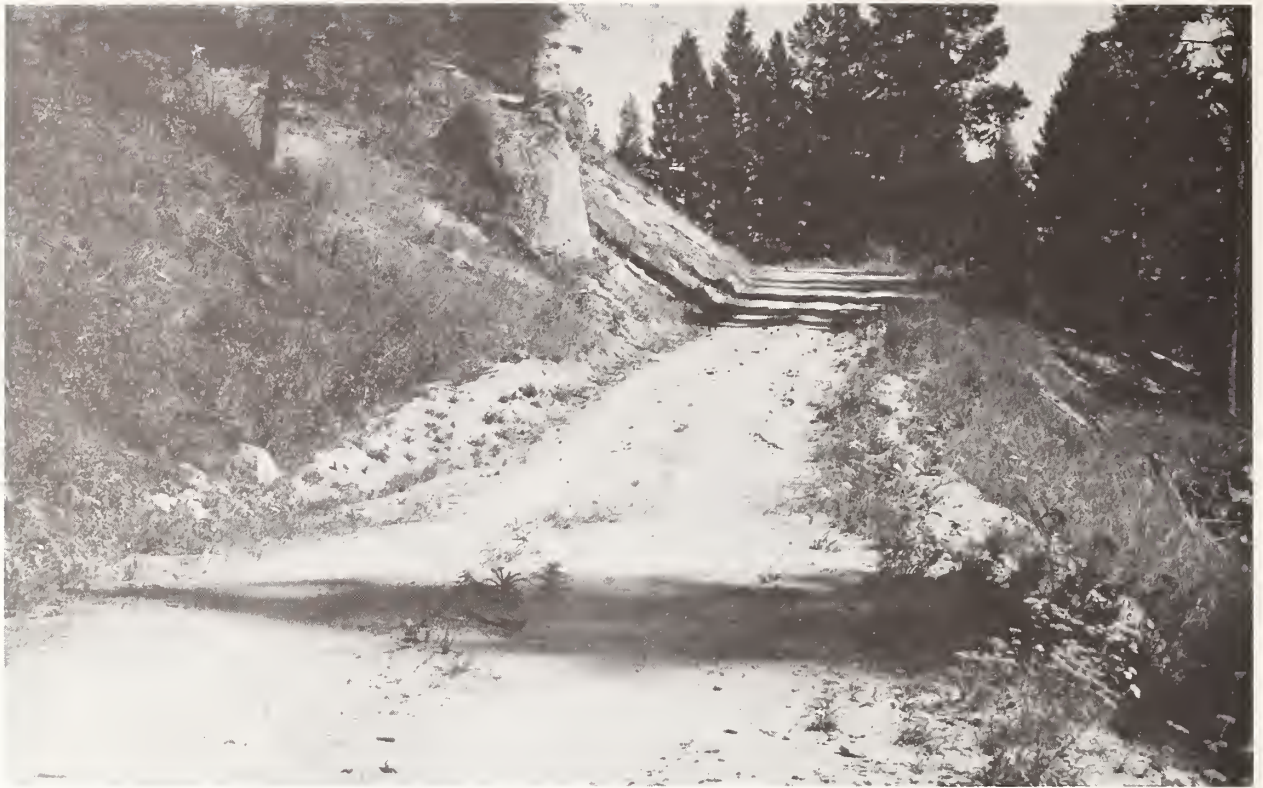
Figure 8.--Insloping to dip with berms controlling flow.

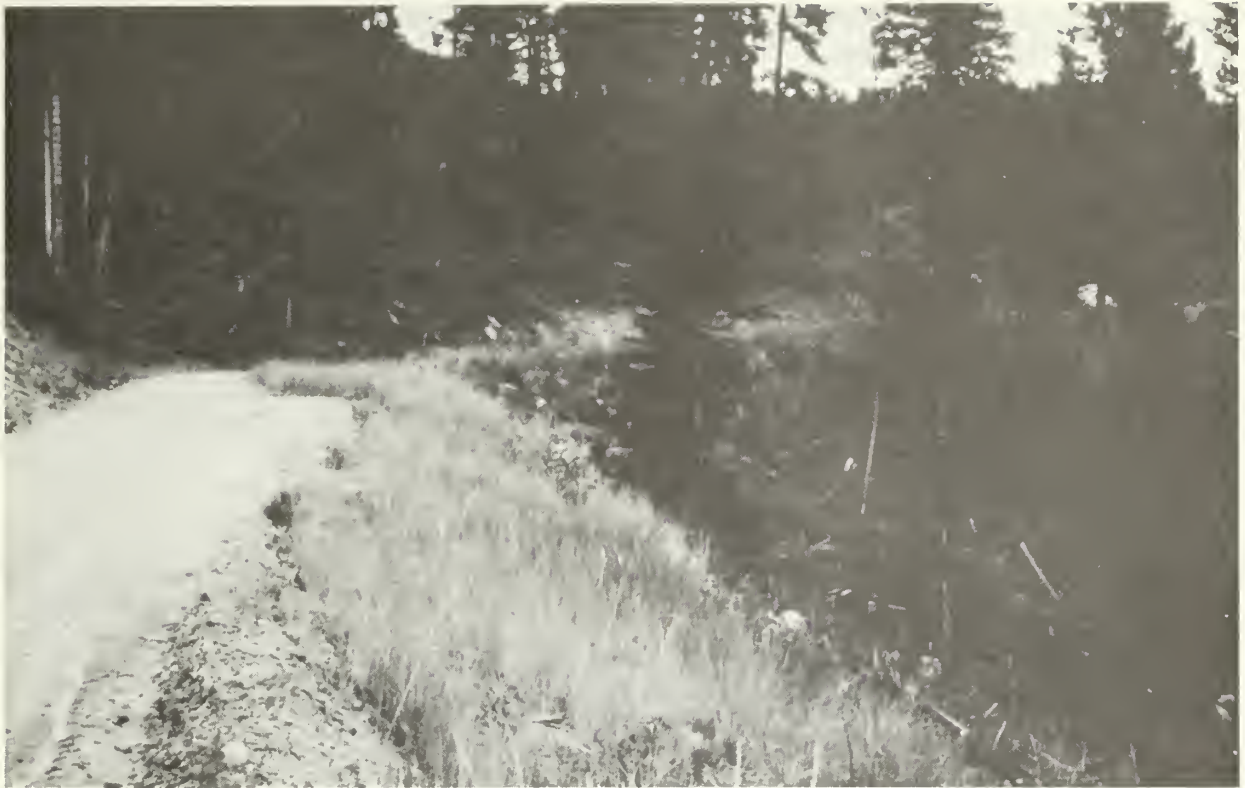
Since most of the sidecast fill slopes are short (less than 20 feet (6.10 m) long) and they are built on natural ground slopes of 50 percent or less, there have not been any failures, even through some slopes are steeper than 1-1/2:1. Part of the success of fill slope stability to date can be attributed to the fact that good drainage has prevented any of the fills from becoming saturated.

In figure 9, a typical section of stable sidecast fill is shown.

Figure 9.--Typical section of stable, sidecast fill.

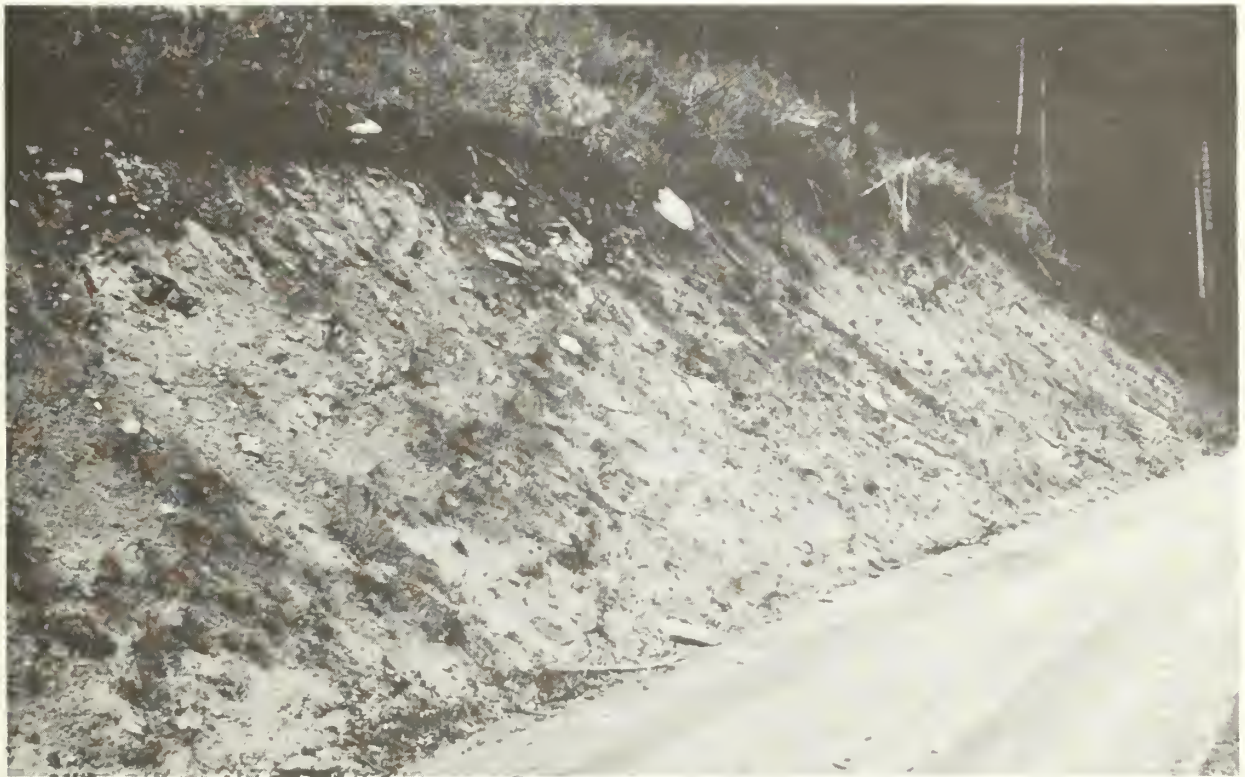
Since natural ground slope seldom exceeded 50 percent, it was generally possible to use 1:1 backslopes for cuts without opening up excessively long raw slopes. (When slopes exceeded 55 percent, full bench construction was used to eliminate sliver fills.) Figure 10 shows a typical section of cut slope that is relatively short and obviously stable.

Figure 10.--Typical section of stable 1:1 cut slope.

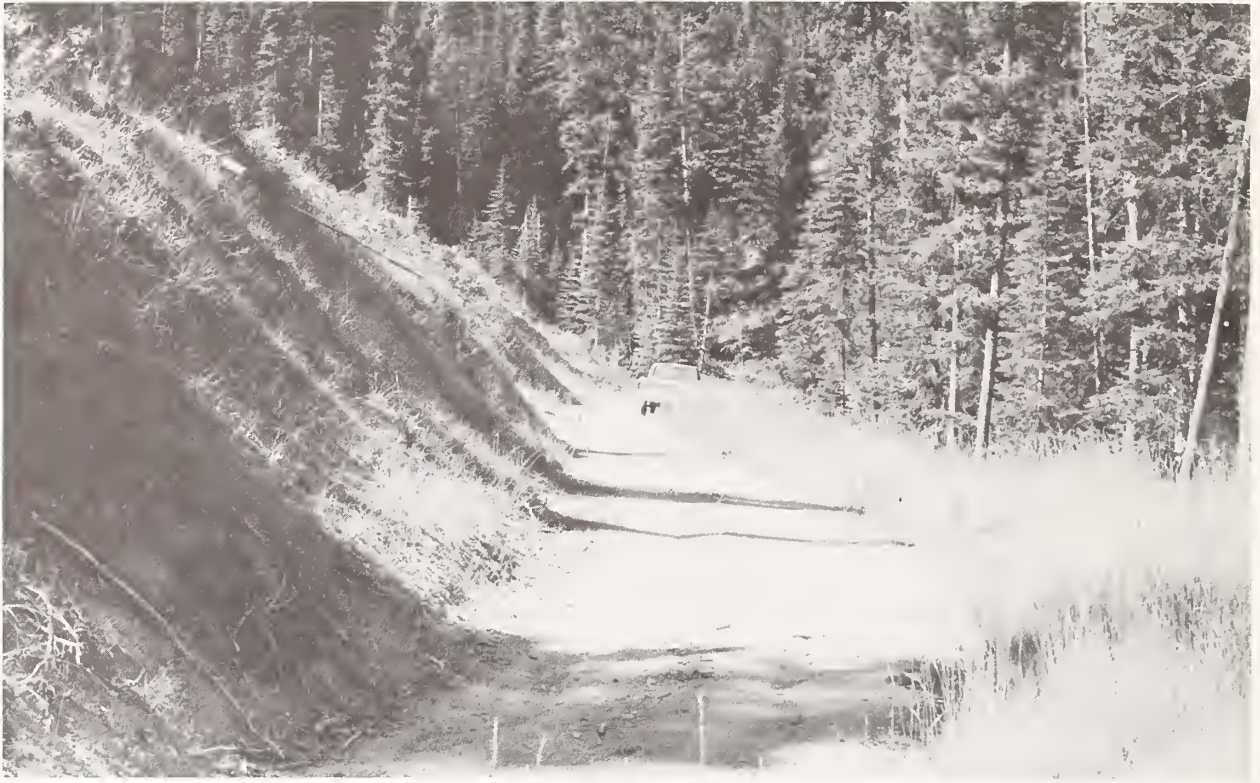
The revegetation success with cut slopes has been generally good, and fill slopes excellent (fig. 9 and 11). Seeding specifications are given in the following tabulation:

Figure 11.--Revegetation of cut-and-fill slopes.

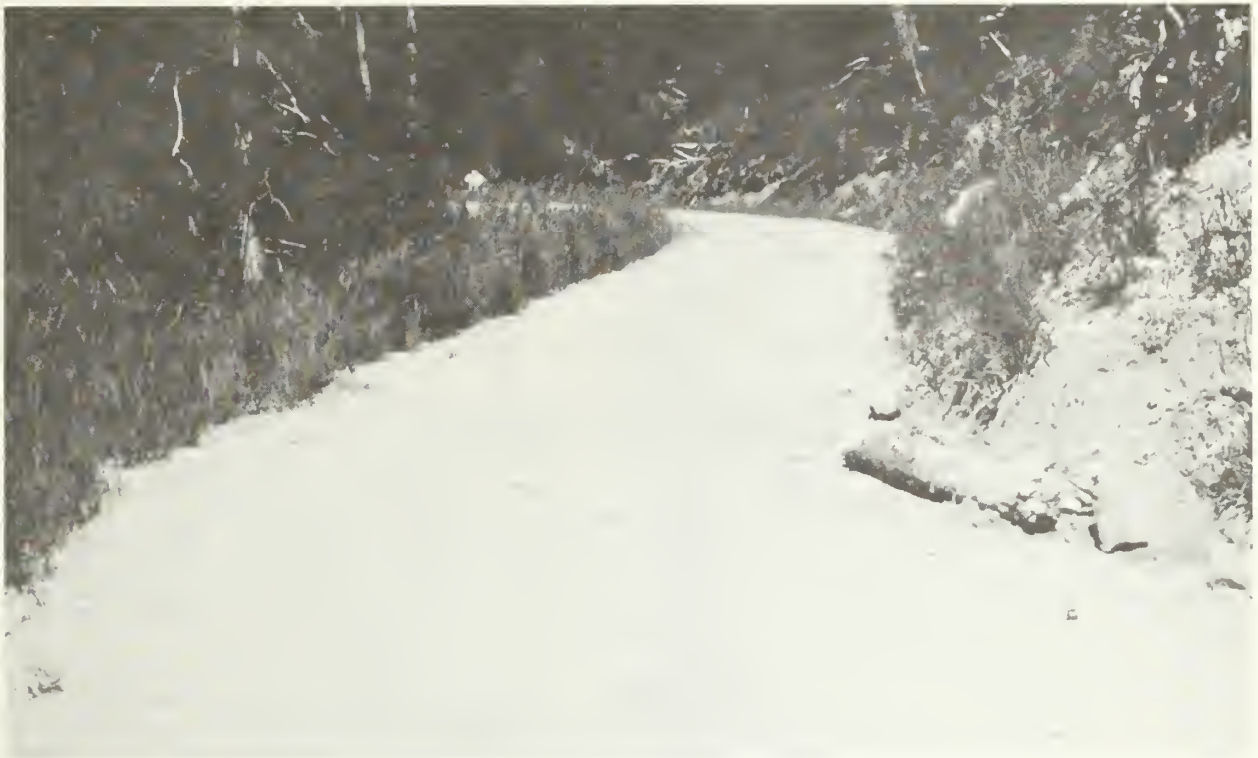
The difference between the two sections of road in these categories is primarily the use of grade rolling and the dip design in the second section discussed earlier. In figure 13, a transition section (inslope to outslope) is shown. This is an example of good design working well, controlling flow. Figure 14 shows a dip in a section of sustained outsloped grade. The appearance of the unmaintained road surface shows that drainage has been adequately controlled.

Figure 13.--Transition from outslope to inslope just past the curve is an example of good design functioning well.

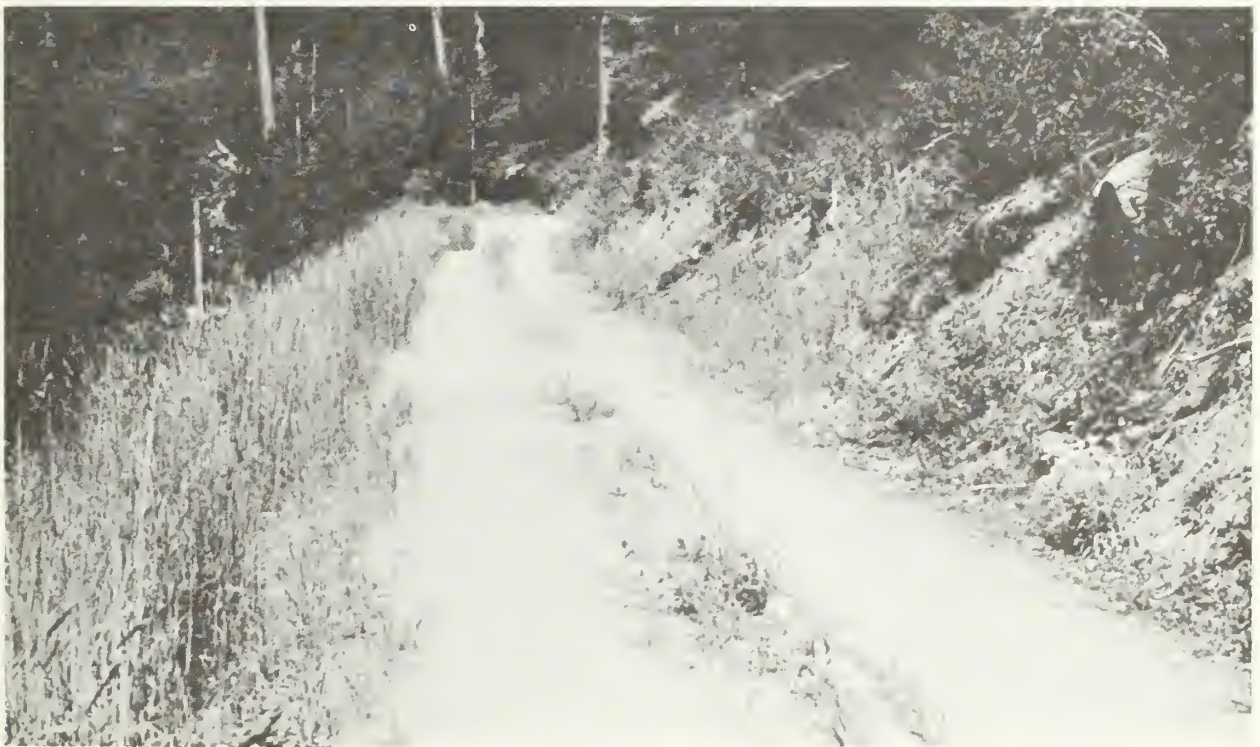
Figure 14.--Dip near the end of a section of outsloped road on a sustained grade.

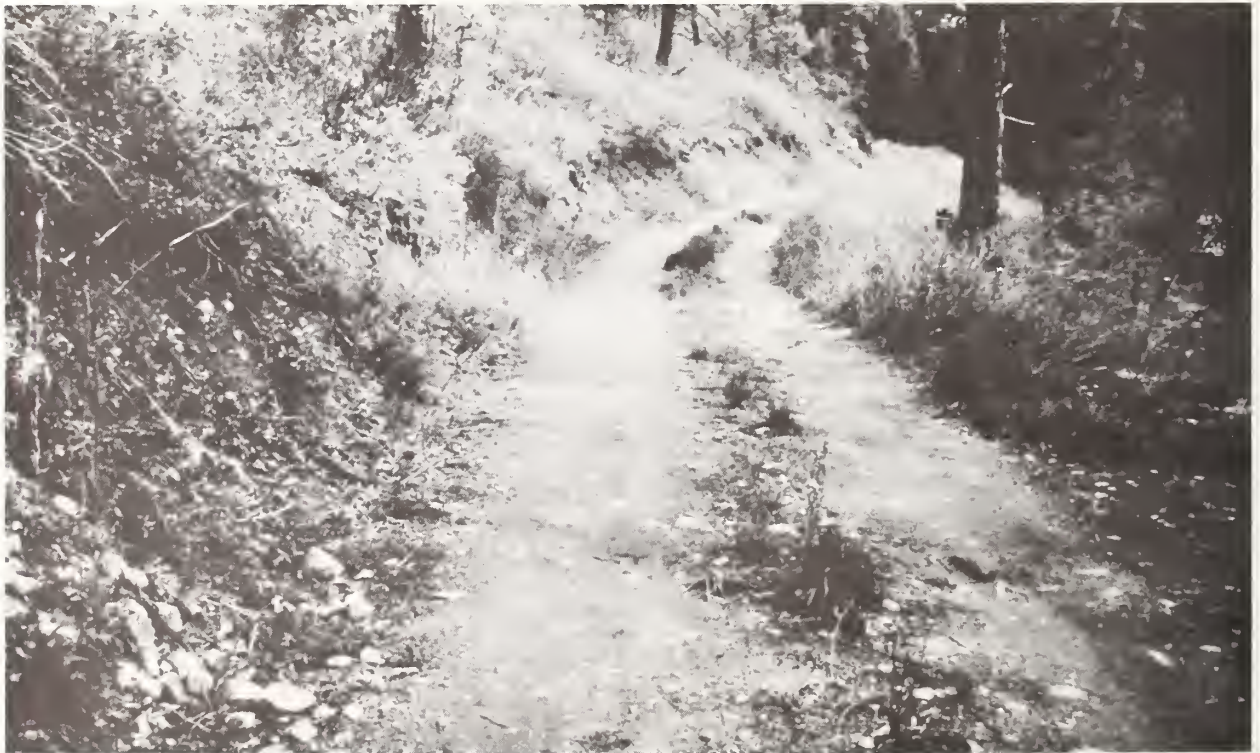
When cut heights are very short on uniformly sloping sidehills, vertical slopes generally work well, as seen in figure 15. In situations that are obviously well drained, but when soil depths are fairly deep, they may still work satisfactorily, as seen in figure 16. For cuts steeper than 1:1 in some of the deeper, well-drained slopes, structural stability may be retained, but sloughing can become a problem, especially when cornice conditions begin to form at the interface of the cut and natural ground, as seen in figure 17. Figure 18 shows what can happen to cuts steeper than 1:1 in the deeper soils that are not as well drained. The crack seen in the picture is a planar failure that has resulted in a section of the cut slumping toward the road.

Figure 15.--Short, stable vertical backslopes on uniformly sloping terrain.

No changes were made in revegetation, and the success was good for fill slopes on both sections. One of the disadvantages of vertical backslopes is that they cannot be seeded or planted. However, for the short slopes, natural vegetation usually invades from above as seen in figure 15.

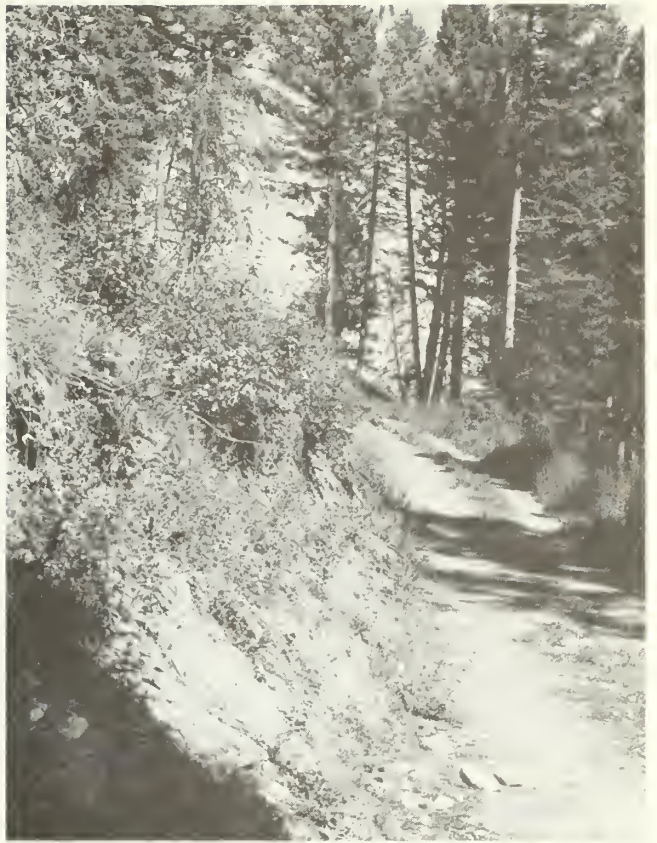
*Figure 16.--Transition
from 3/4:1 to vertical
backslopes going away
from the camera.*

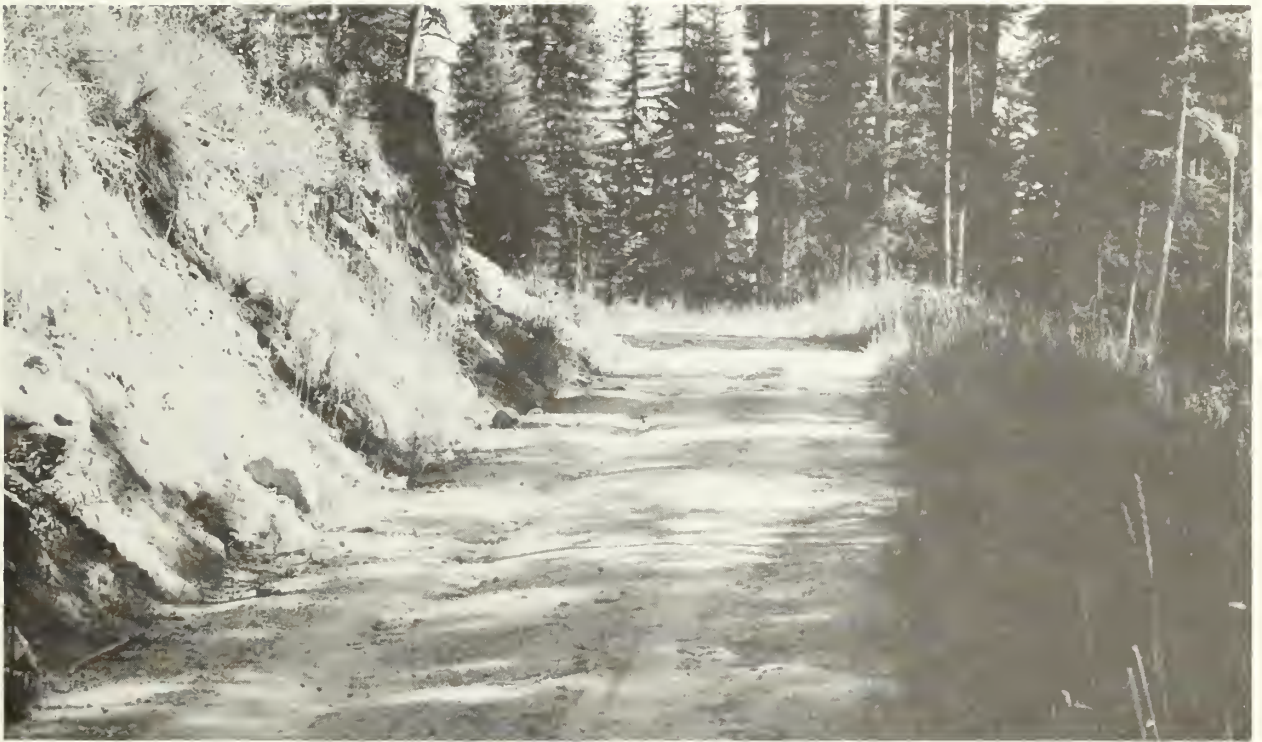
*Figure 17.--Cut slope near maximum height of 6 feet (1.83 m)--structurally stable, but
prone to sloughing. A cornice is beginning to build at the top of the cut.*

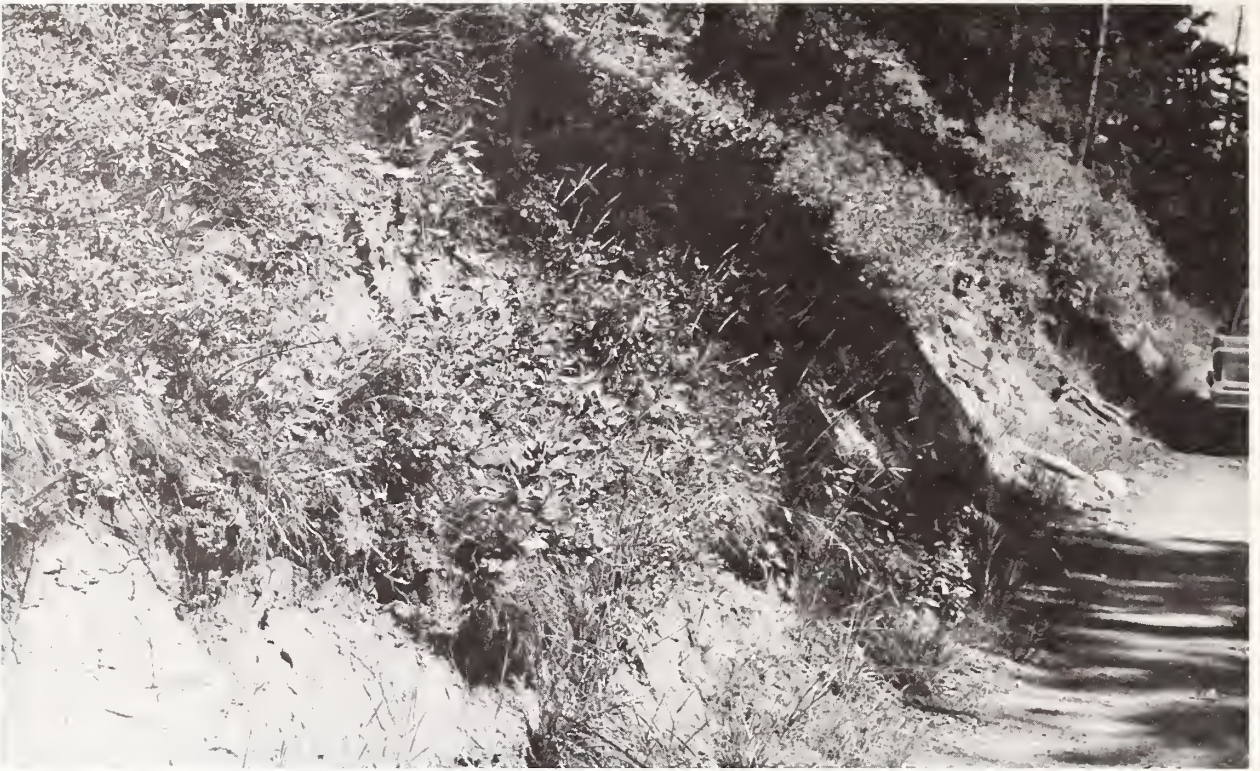
Figure 18.--Crack in a cut slope that is near the 6-foot (1.83-m) maximum height.
