# AIRCRAFT ACCIDENT REPORT

PAN AMERICAN WORLD AIRWAYS, INC.  
B-707-321B, N761PA  
SAN FRANCISCO, CALIFORNIA  
JUNE 28, 1965

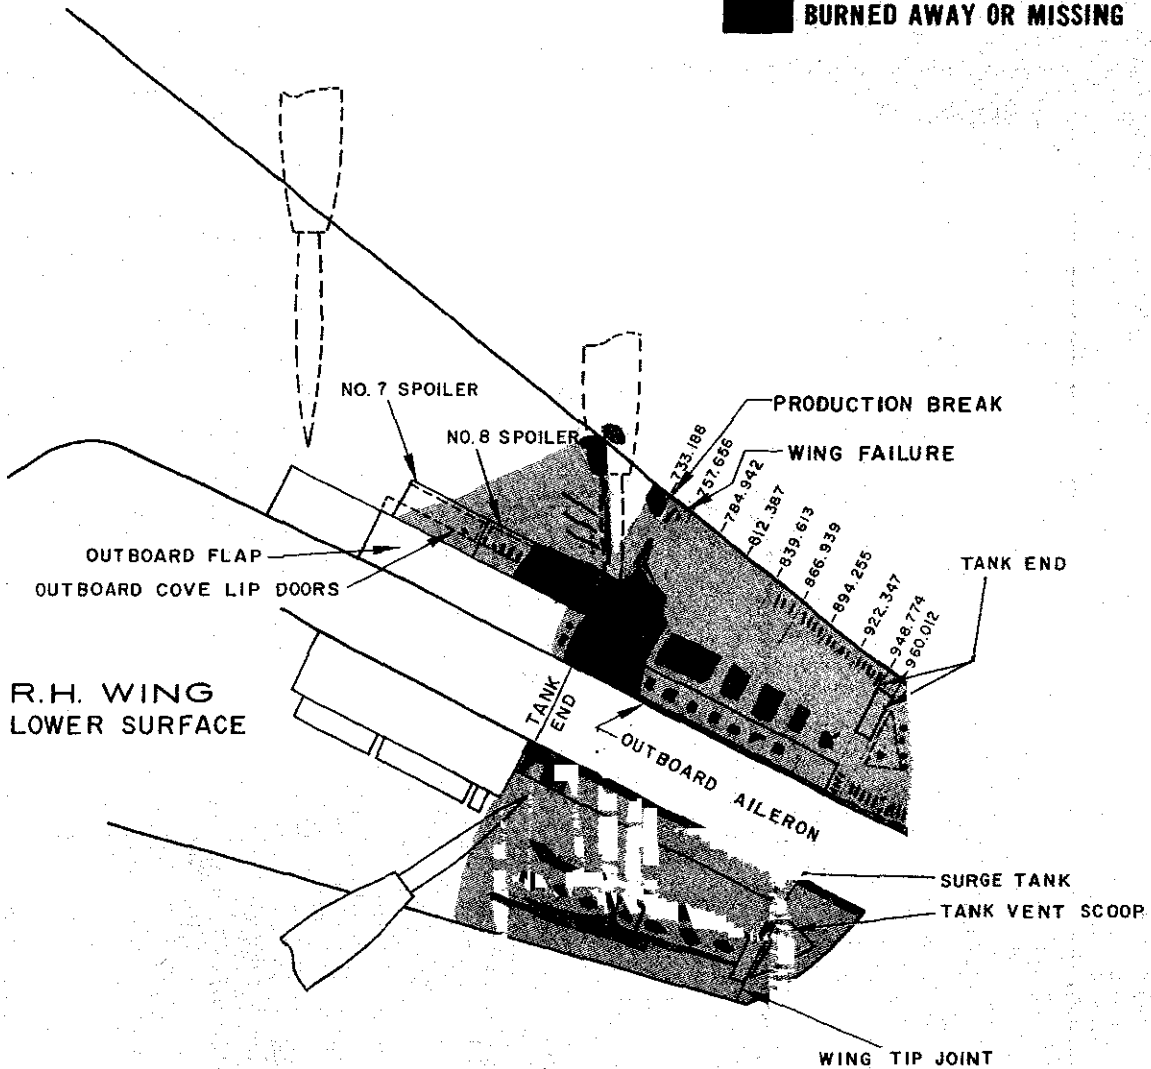
**ATTACHMENT 1**

There were three distinct fire patterns on the part of the wing which remained on the aircraft. (See Attachment No. 1.) One originated on the inboard gap cover area, followed the outboard nacelle upper surface support outboard to the trailing edge of the upper surface, and inboard to the inboard end of the outboard flap. The wing skin over all three fuel tank vent lines in this area was burned away or cracked for lengths ranging from 44 inches over the forward vent line to 26 inches over the aft vent line. In this same area there were three holes, located in buckled skin, through the upper skin over the No. 4 main fuel tank.

The second fire pattern was in the area of the wing separation outboard of station 733. This fire consumed much of the portion of the aft spar remaining outboard of the production break and the centers of the access doors remaining with the attached lower skin. The fracture surfaces inboard of this area were extensively burned and metal sprayed while those on the separated panel had little heat damage and no soot deposits.

The third fire area was defined by heavy sooting and/or consumption of much of the outboard skin and ribs along the entire length of the nacelle strut trailing edge fairing. Finally, metal droplets were found on the right horizontal stabilizer and on the outboard three wing vortex generators in the aft row.
