# NAVAL POSTGRADUATE SCHOOL

A-10/GAU-8 LOW ANGLE FIRINGS VERSUS  
SIMULATED SOVIET TANK BATTALION  
(HONEYWELL LOT NUMBER 0L78D043-016)  
(ARRAY 3)

2 FEBRUARY 1979

R.H.S. STOLFI  
R.R. MCEACHIN

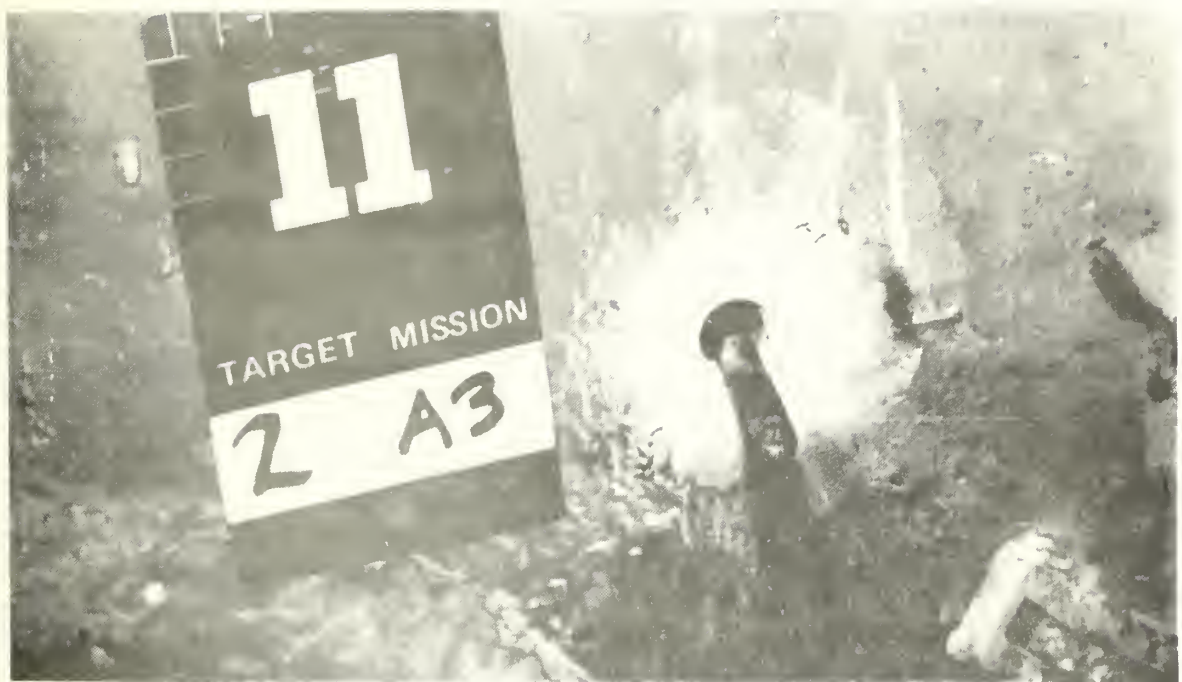
FIGURE 12. Impact Eleven, Target 2, Perforation of Rear Hull Armor (Transmission Oil Cooler Line was Penetrated, Causing Oil Leak).

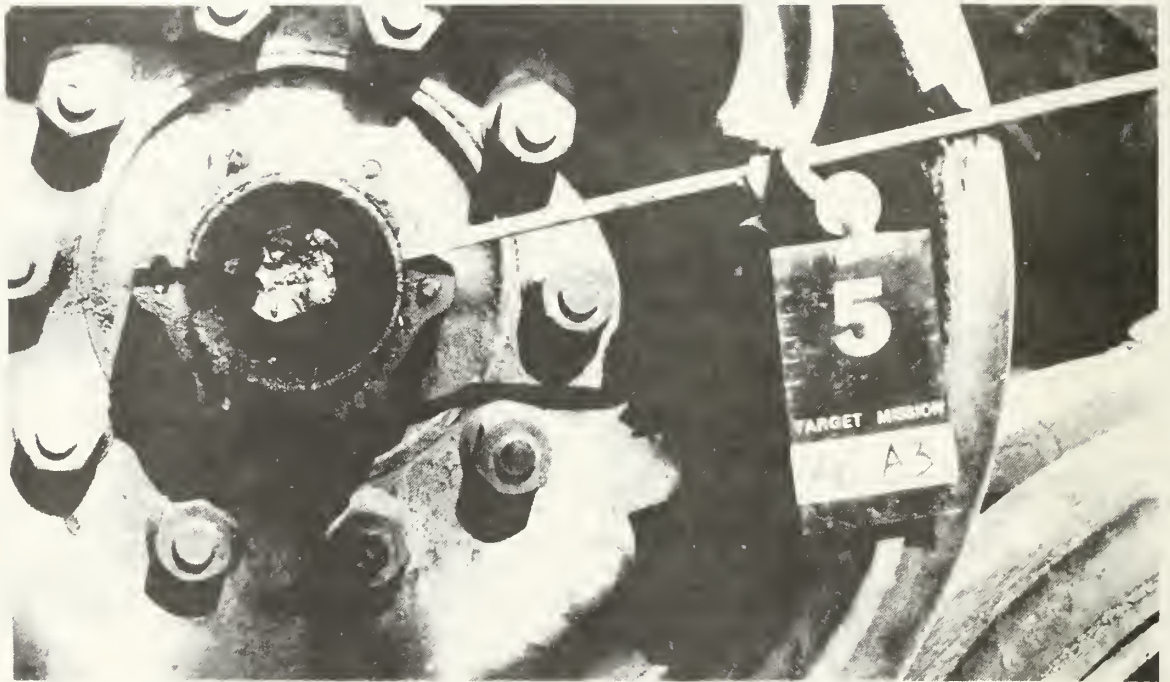
FIGURE 14. Impact Five, Target 4, Showing Destroyed Adjusting Idler Hub in the Left Track.

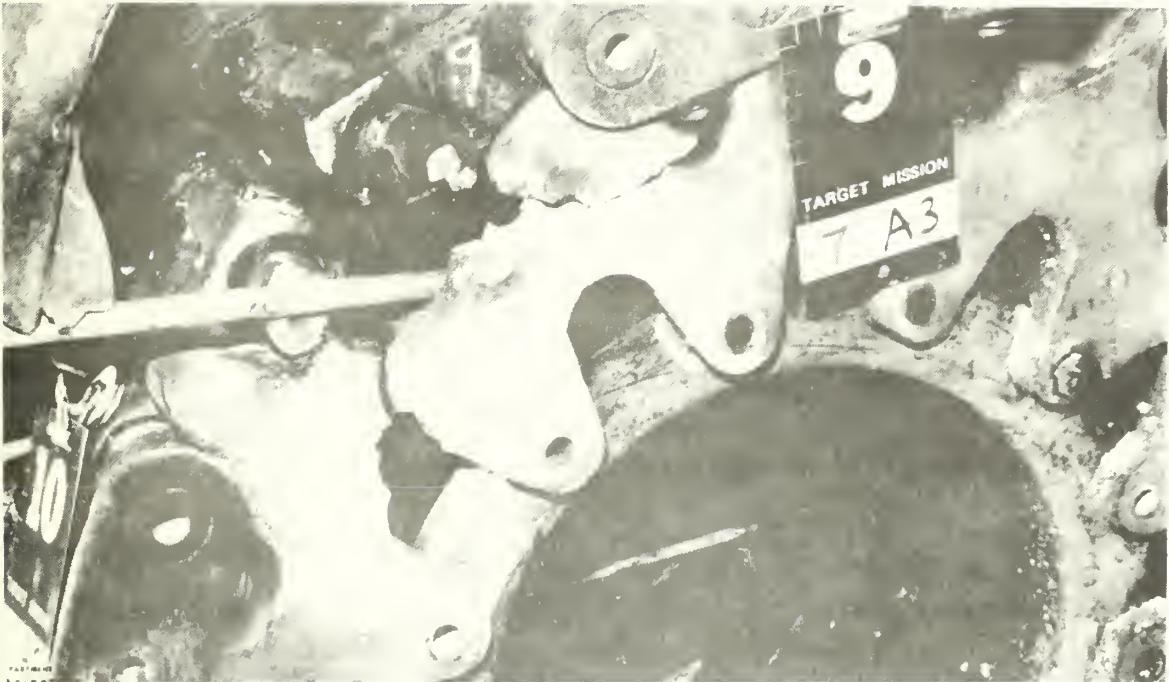
Mobility was estimated to have been degraded by 20%, due to cumulative damage to the track and suspension system resulting from seven hits. Impact 9, shown in Figure 16, is representative of the most severe damage inflicted during this attack pass.

FIGURE 16. Impact Nine, Target 7, Showing Destroyed End Connector, Damaged Track Shoe Pins, and Broken Right Drive Sprocket.

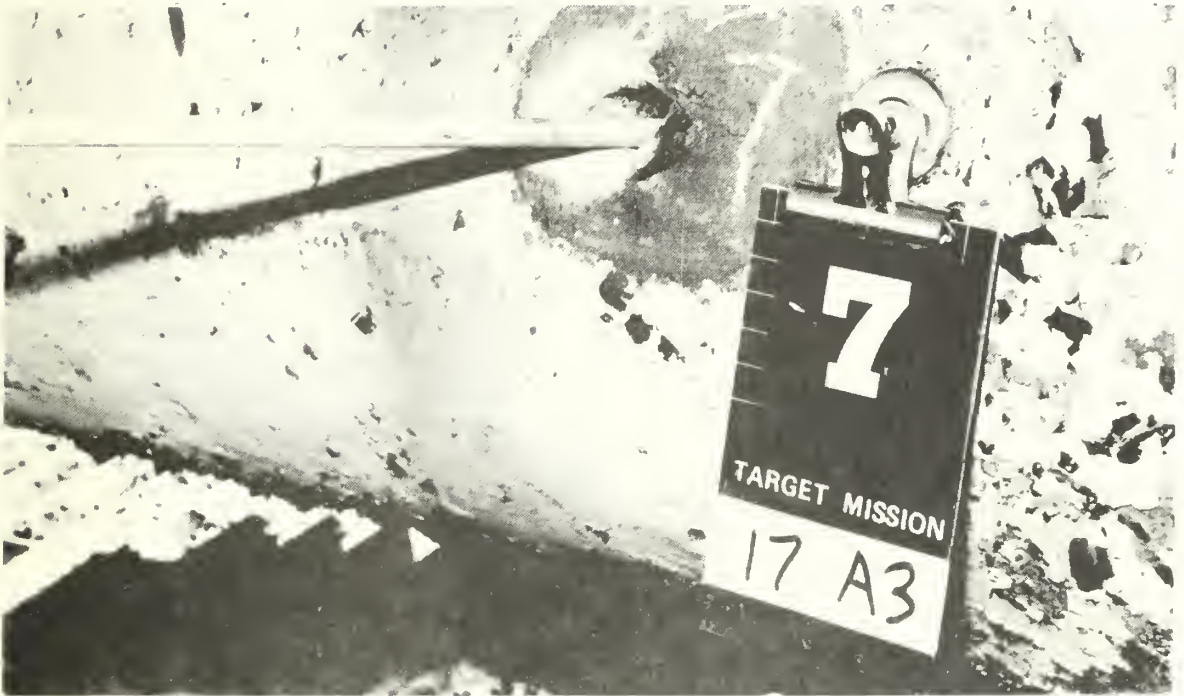
FIGURE 20. Impact Seven, Target 17, Perforation of Right Side of Turret.

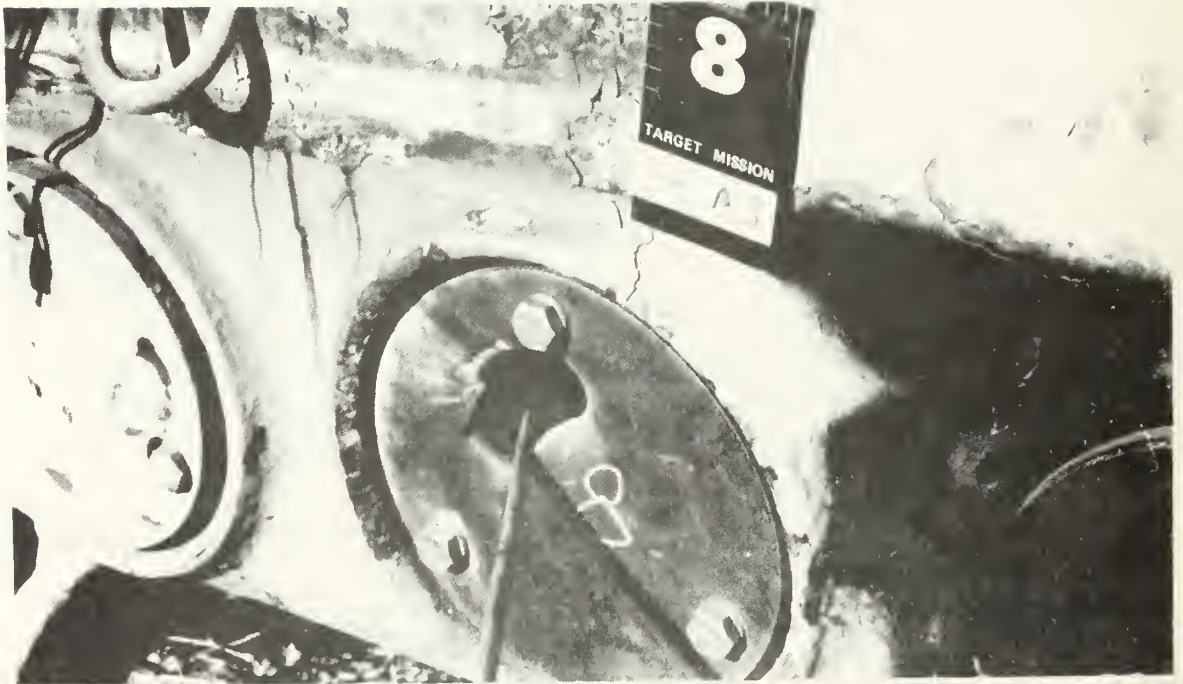
FIGURE 22. Impact Eight, Target 19, Perforation of Center Access Door into Transmission Compartment, and Penetration into the Transmission Case.

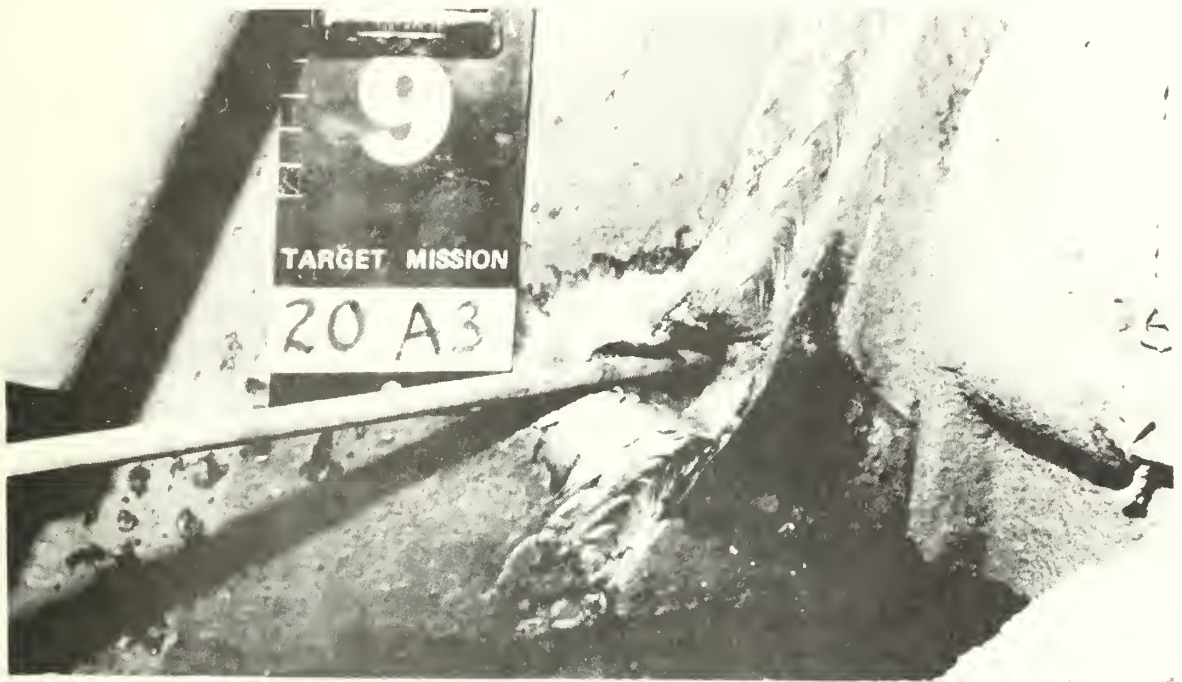
Impact 9 (Figure 24) perforated the right hull and penetrated the right fuel tank, causing a leak. Impacts 7, 8, 13, 14, 15, and 17 contributed to the kill through minor damage to the track and suspension system. In the judgement of the Combat Damage Assessment Team, the hole through the fuel tank, which was located only inches from the bottom would have filled the space under both the engine and fighting compartments with fuel and forced the evacuation of the tank.

FIGURE 24. Impact Nine, Target 20, Perforation of the Hull Armor and Penetration into the Right Fuel Tank.

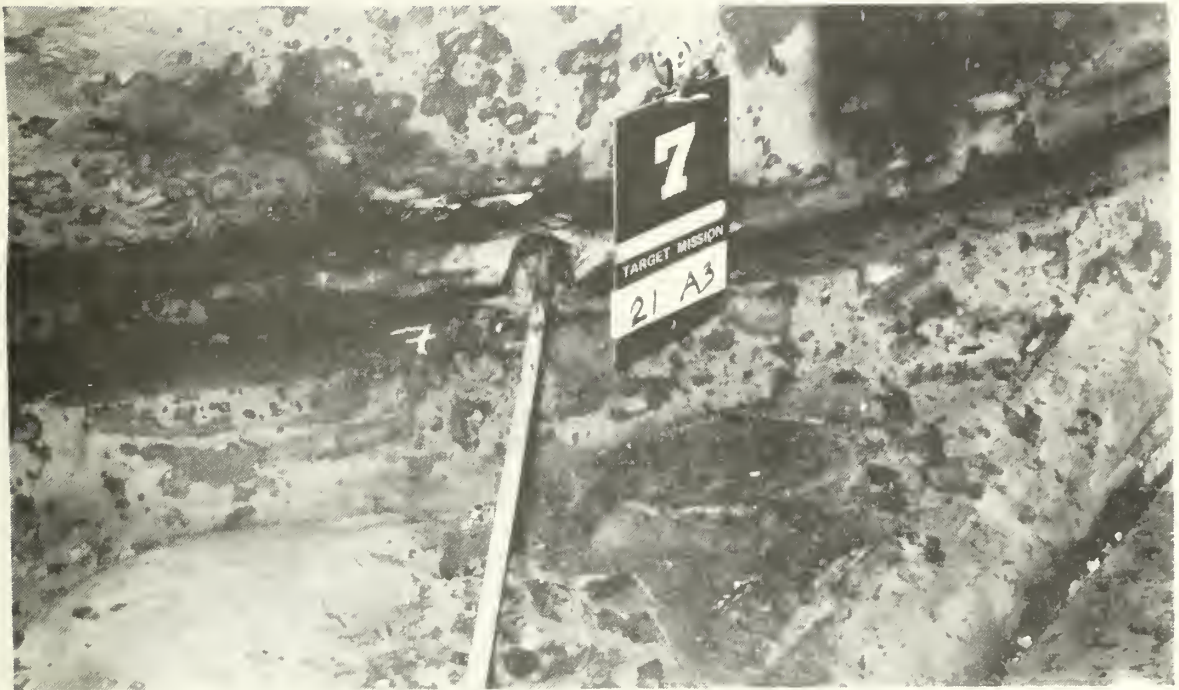
FIGURE 28. Impact Seven, Target 21, Showing Location of Strike Which Jammed the Turret.

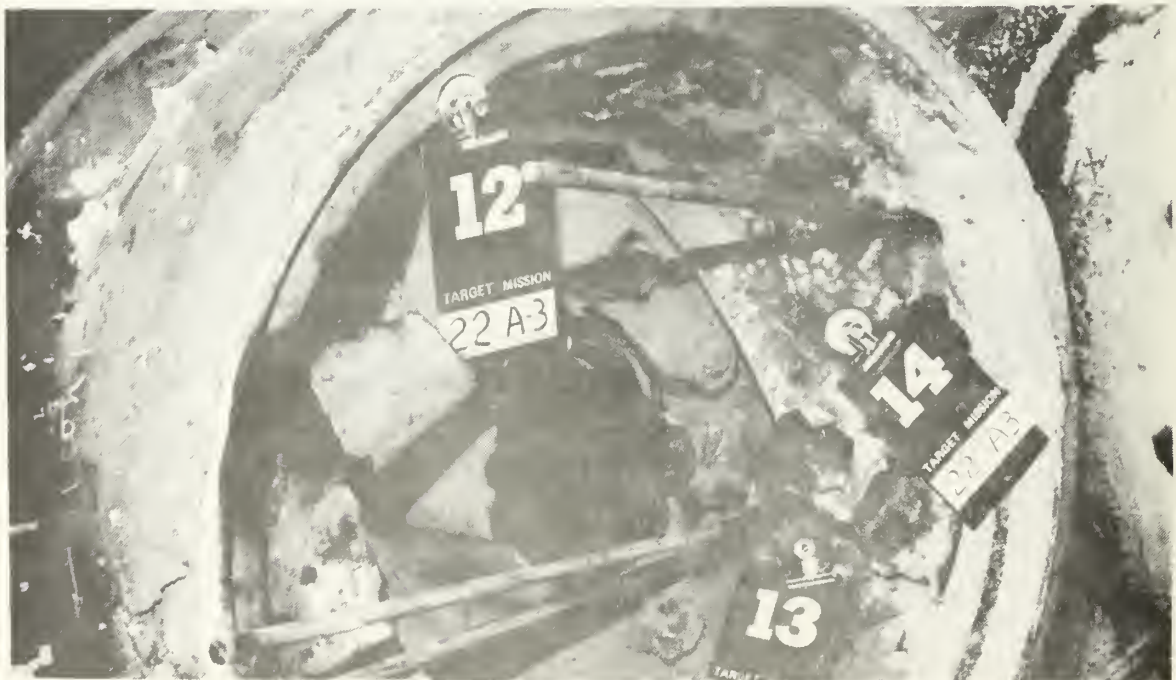
The primary contributors to the kill were impacts 10 and 12, shown in Figures 30 and 31, respectively, which destroyed the right #4 roadwheel bearing spacer and hub, damaging the spindle; and impacts 6 and 25, shown in Figures 32 and 33, respectively, which severely damaged the right drive sprocket. Cumulative damage from four other impacts contributed to the kill.

FIGURE 31. Impact Twelve, Target 22, Which Destroyed the Right Number 4 Roadwheel Hub and Outer Bearing.

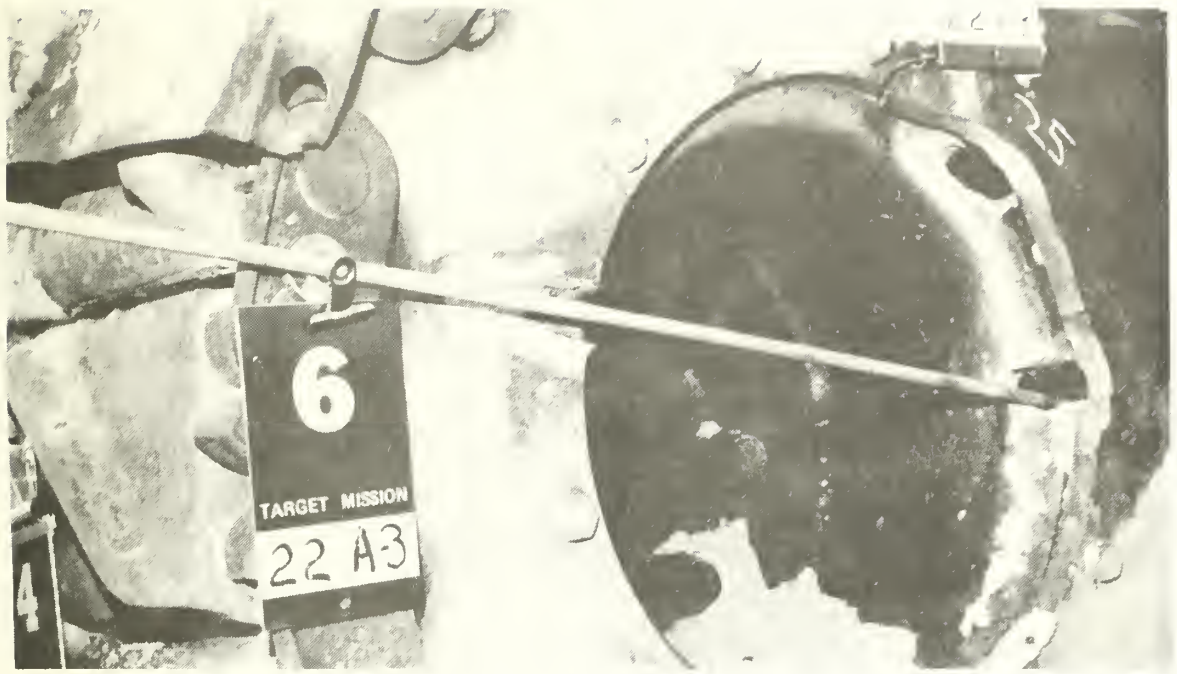
FIGURE 32. Impact Six, Target 22, Showing Damage to Right Drive Sprocket.

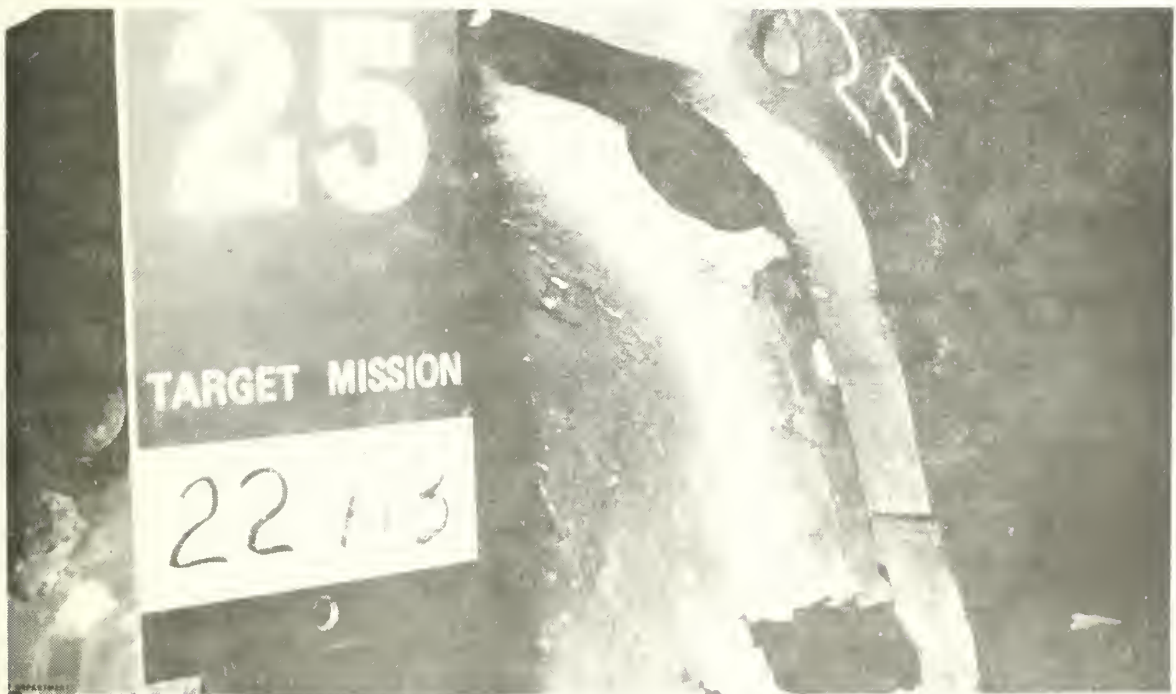
FIGURE 33. Impact Twenty-Five, Target 22, Showing Damage to Right Drive Sprocket.

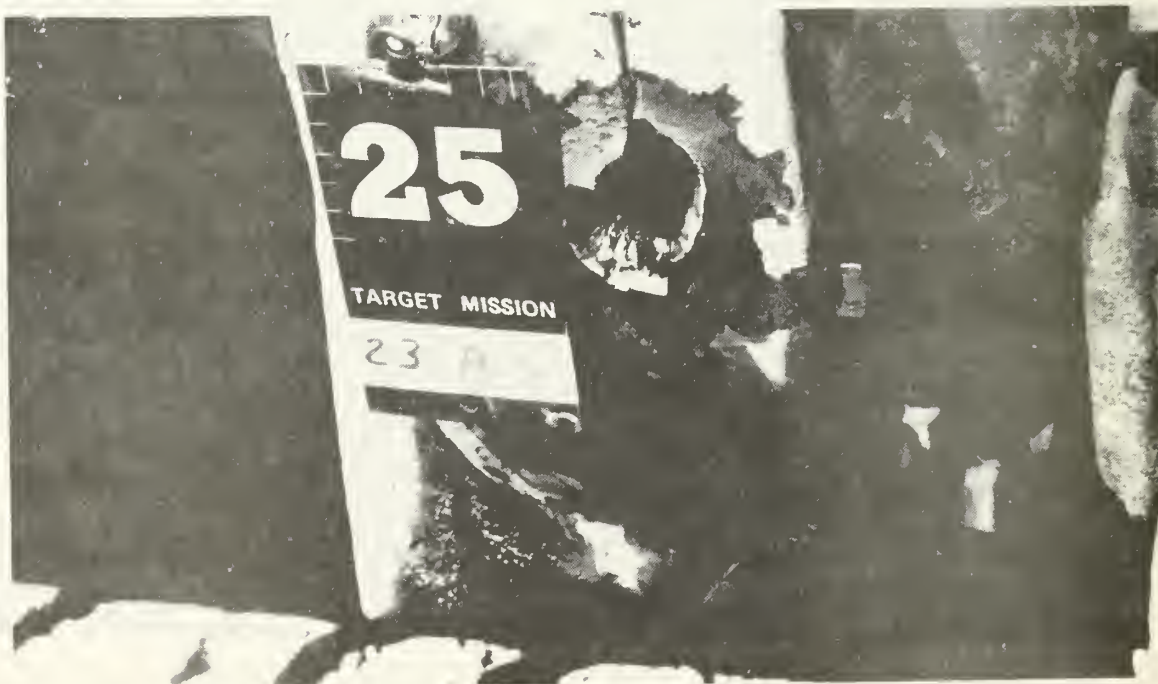
FIGURE 40. Impact Twenty-Five, Target 23, Penetration into the Right Final Drive.

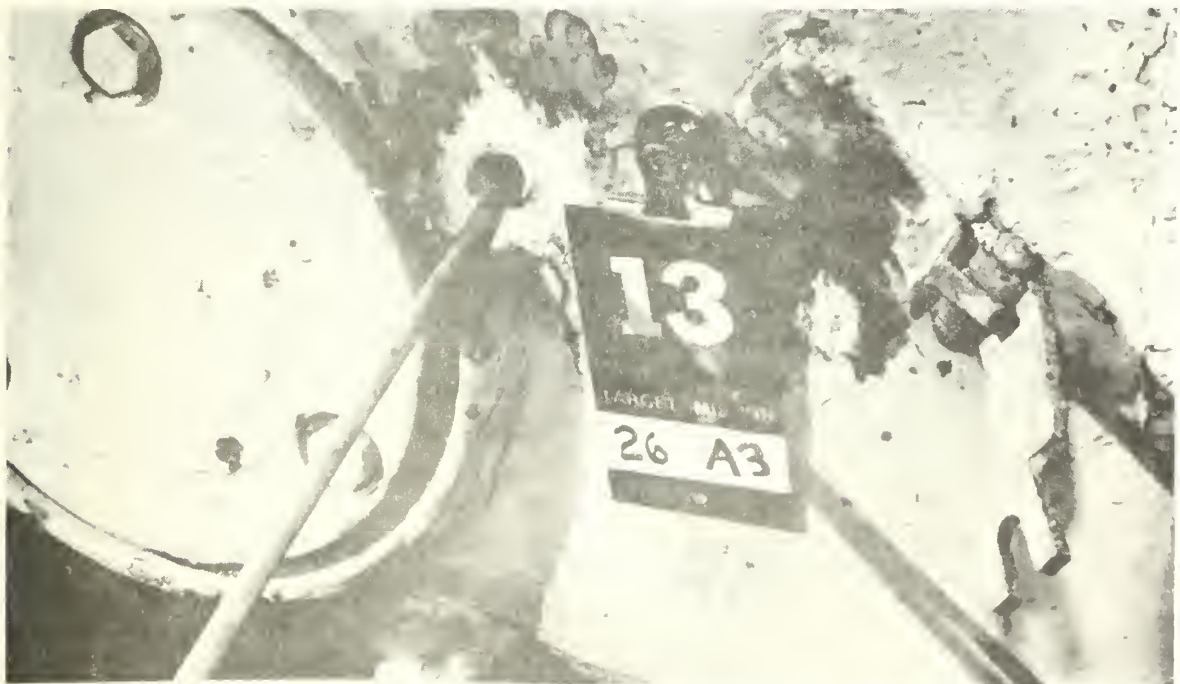
A 100% M-Kill was assessed because of Impacts 12 and 13, shown in Figures 42 and 43, respectively, which perforated the rear hull armor and penetrated the transmission case. Two other impacts (4 and 6), which caused slight damage to the track, made a minor contribution to the kill. One other hit (Impact 9) perforated the rear hull into the transmission compartment, but the extent of the damage could not be determined.

FIGURE 43. Impact Thirteen, Target 26, Perforation of Rear Hull Armor and Penetration into the Transmission Case.

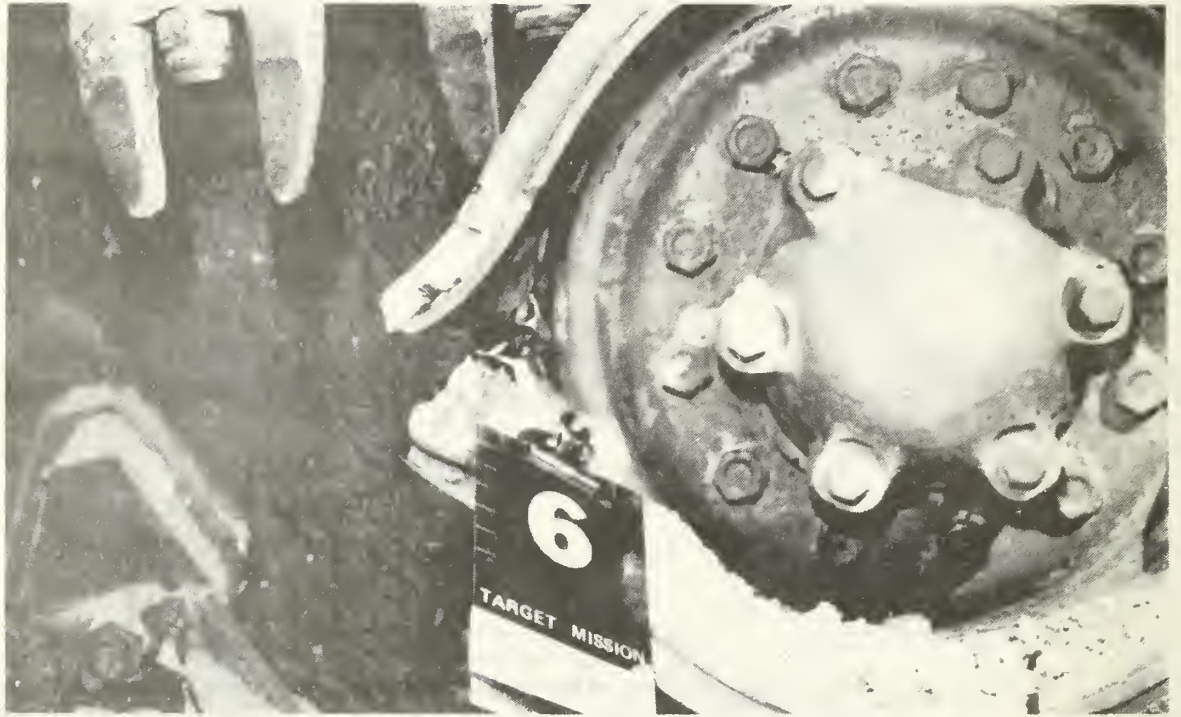
A 10% M-Kill was assessed due to the impacts on the track and suspension system. Impact 6, shown in Figure 45, is representative of the most severe damage inflicted during this attack.

FIGURE 45. Impact Six, Target 27, Showing Damage to Left Number 2 Track Support Roller.

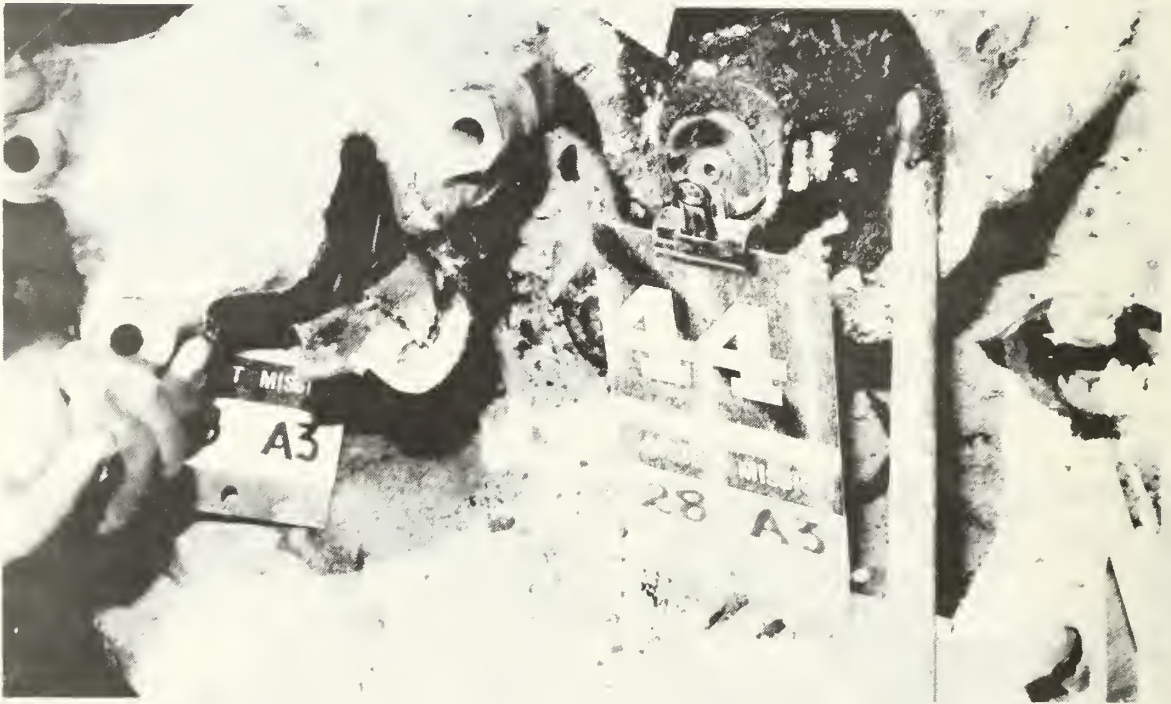
- a. M-Kill: A 100% M-Kill was assessed because of Impact 38 (Figure 47) which perforated the left hull and penetrated the left fuel tank, and to Impacts 34 and 44, shown in Figures 48 and 49, respectively, which destroyed the left #5 and #6 roadwheel hubs. Cumulative damage to the track and suspension system from 10 other impacts contributed to the M-Kill.
- b. F-Kill: A 95% F-Kill was assessed because of casualties caused to all crewmen in the fighting compartment by eight perforations of the hull and turret armor. One additional perforation had no behind-the-plate effects.

FIGURE 49. Impact Forty-Four, Target 28, Which Destroyed the Left Number Six Roadwheel Hub.

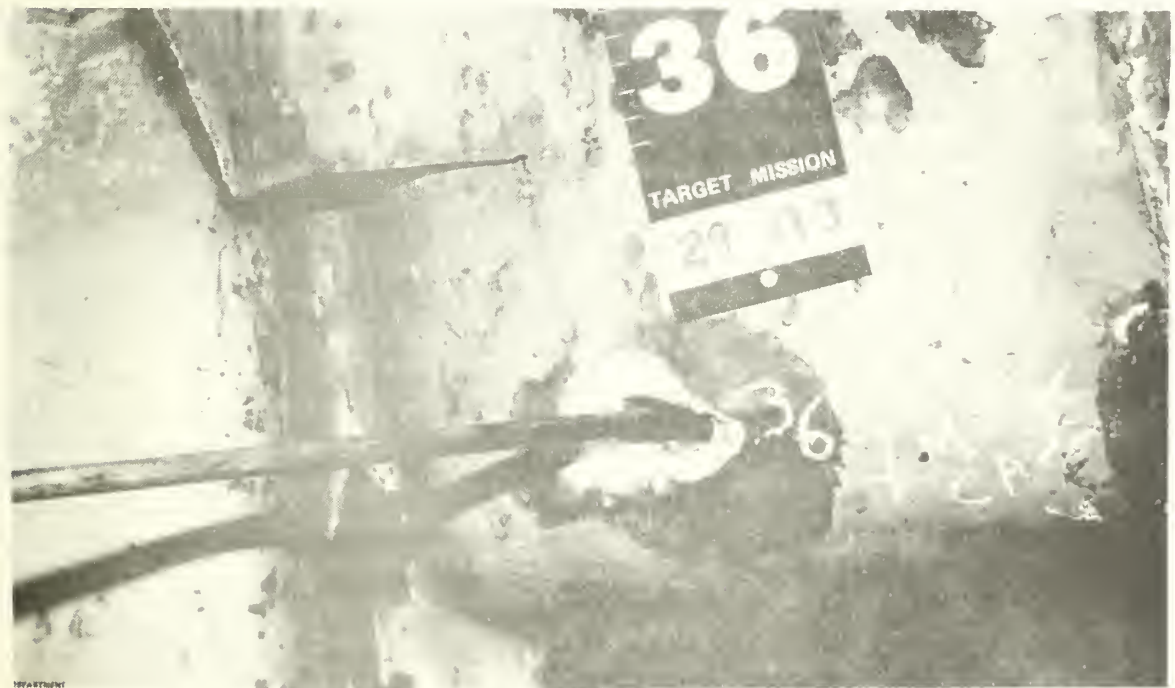
FIGURE 52. Impact Thirty-Six, Target 29, Perforation of Rear Hull Armor and Penetration into the Transmission Case.

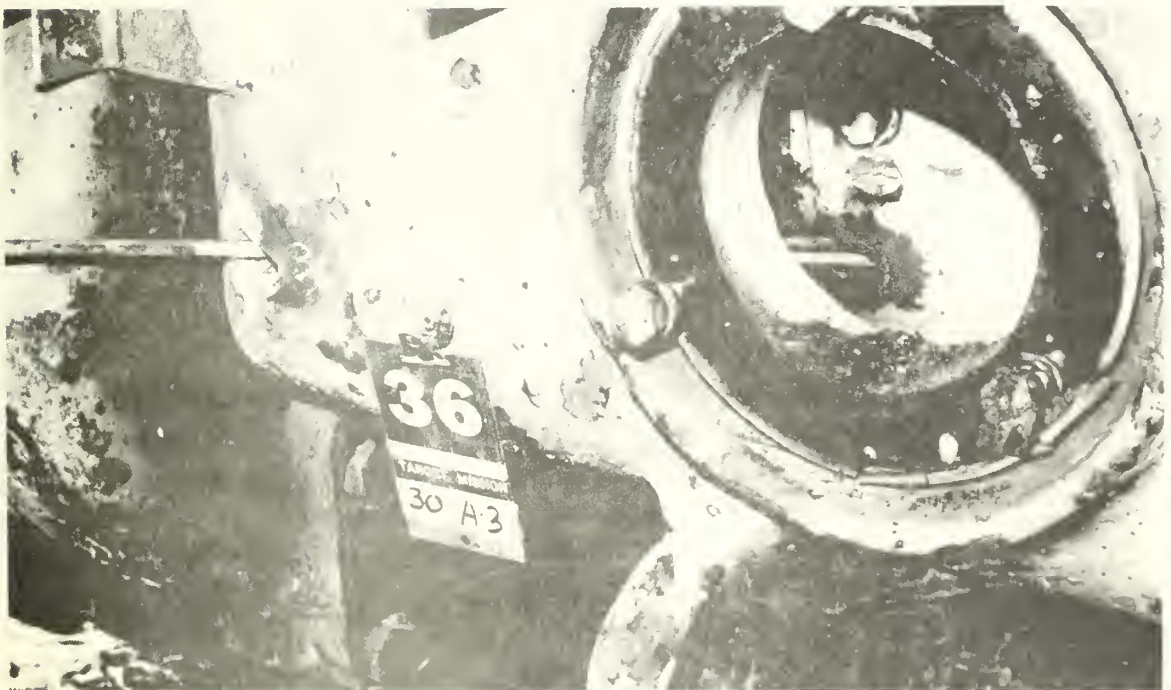
FIGURE 57. Impact Thirty-Six, Target 30, Perforation of Left Hull Armor and Penetration into the Transmission Case.

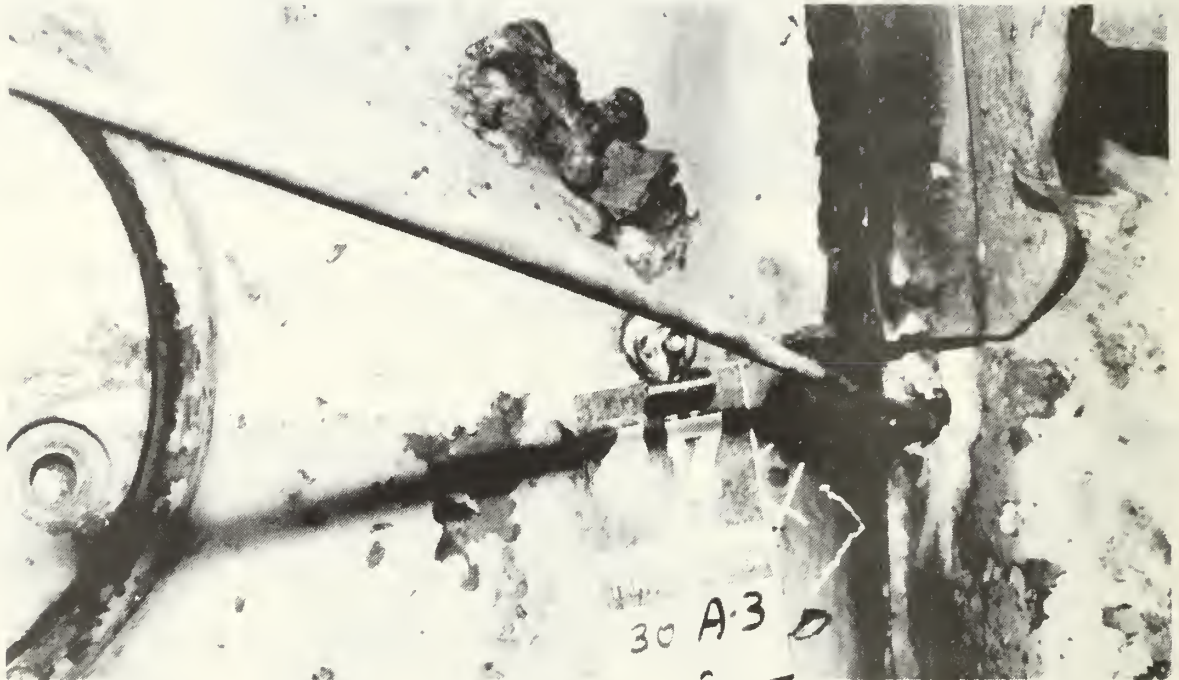
FIGURE 58. Impact Forty-Seven, Target 30, Penetration into the Right Final Drive.

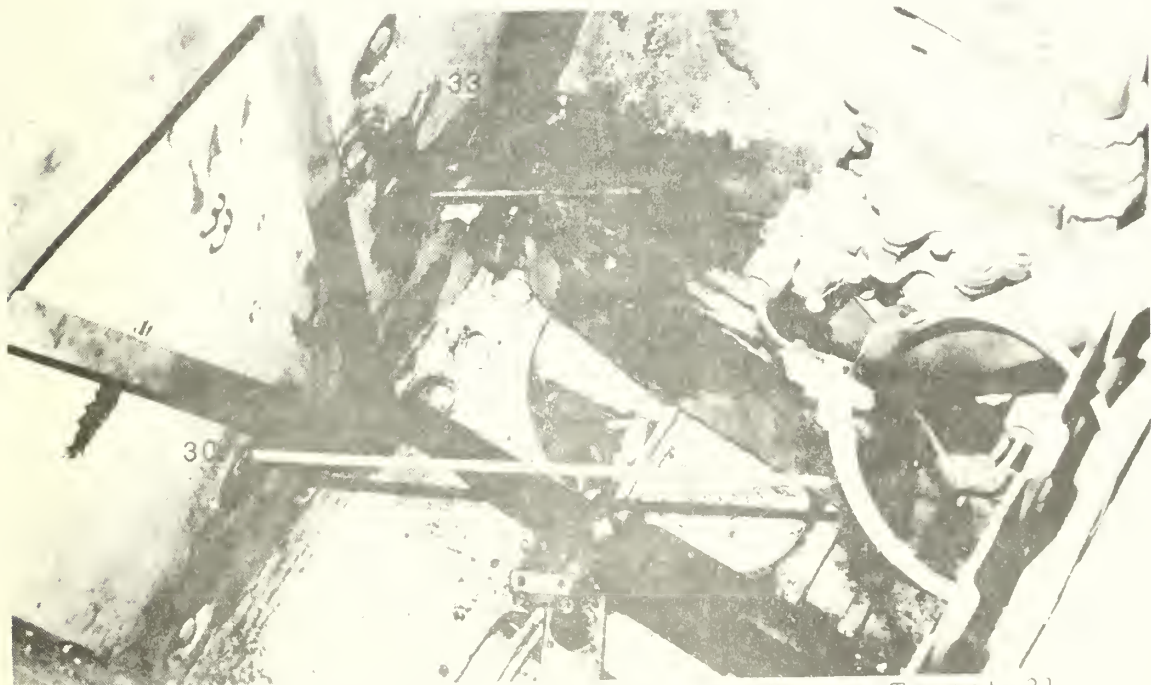
FIGURE 61. Impacts Thirty and Thirty-Three, Target 31, Impact 30 Perforated the Hull Armor and Penetrated the Left Fuel Tank. Impact 33 Perforated the Hull Armor into the Engine Compartment.

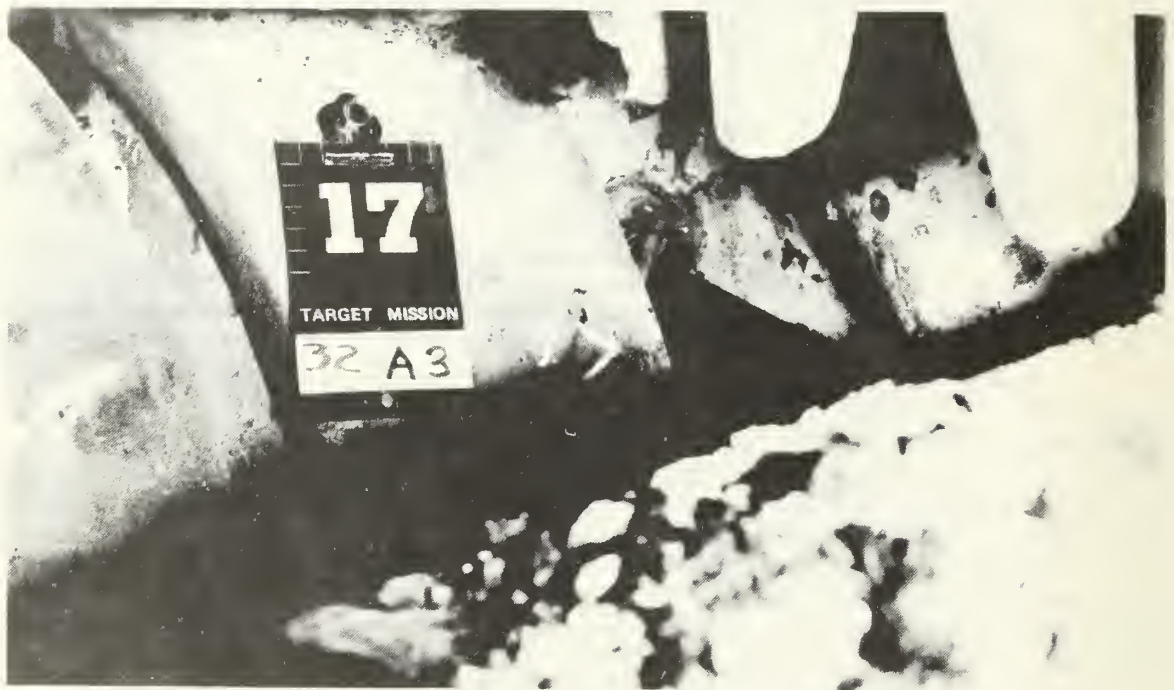
FIGURE 63. Impact Seventeen, Target 32, Perforation of the Hull Armor and Penetration into the Left Fuel Tank.

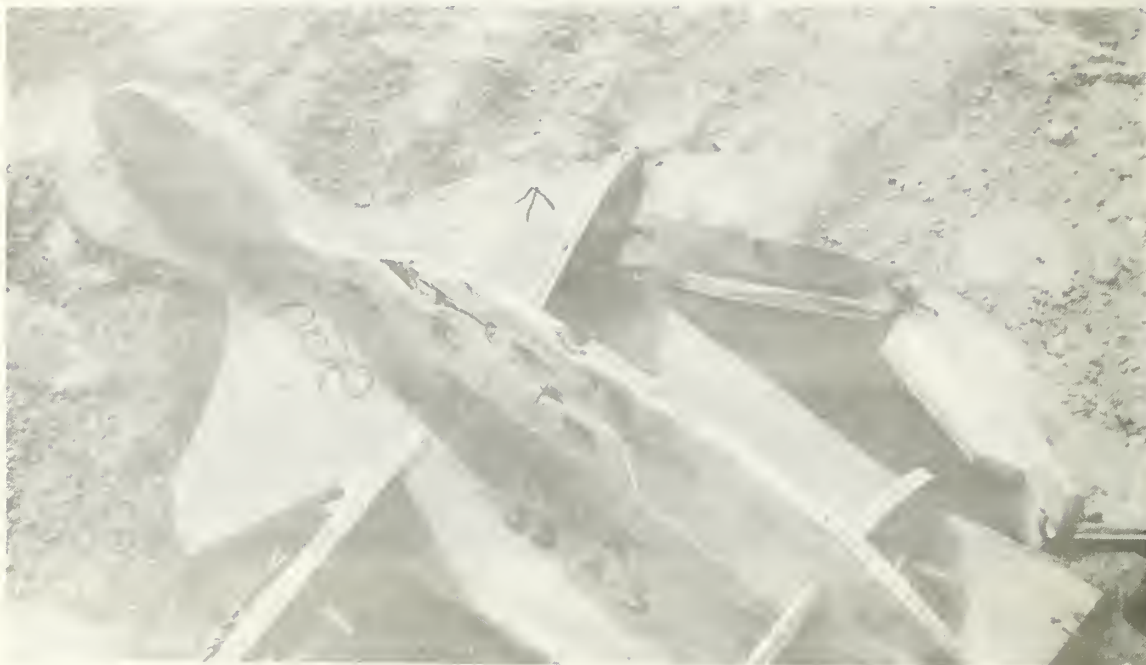
FIGURE 67. Commander Manikin, Target 33, Showing Damage from Impacts 6 and/or 8, which Perforated the Left Side of the Turret.

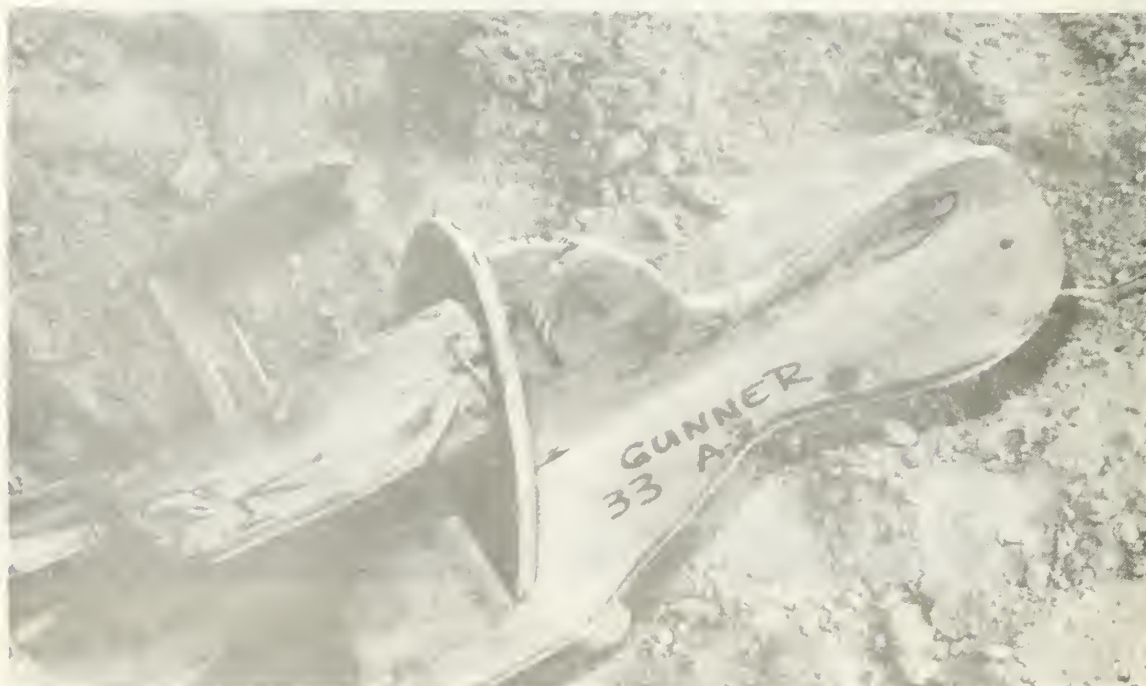
FIGURE 68. Gunner Manikin, Target 33, Showing Damage from Impacts 6 and/or 8, which Perforated the Left Side of the Turret.

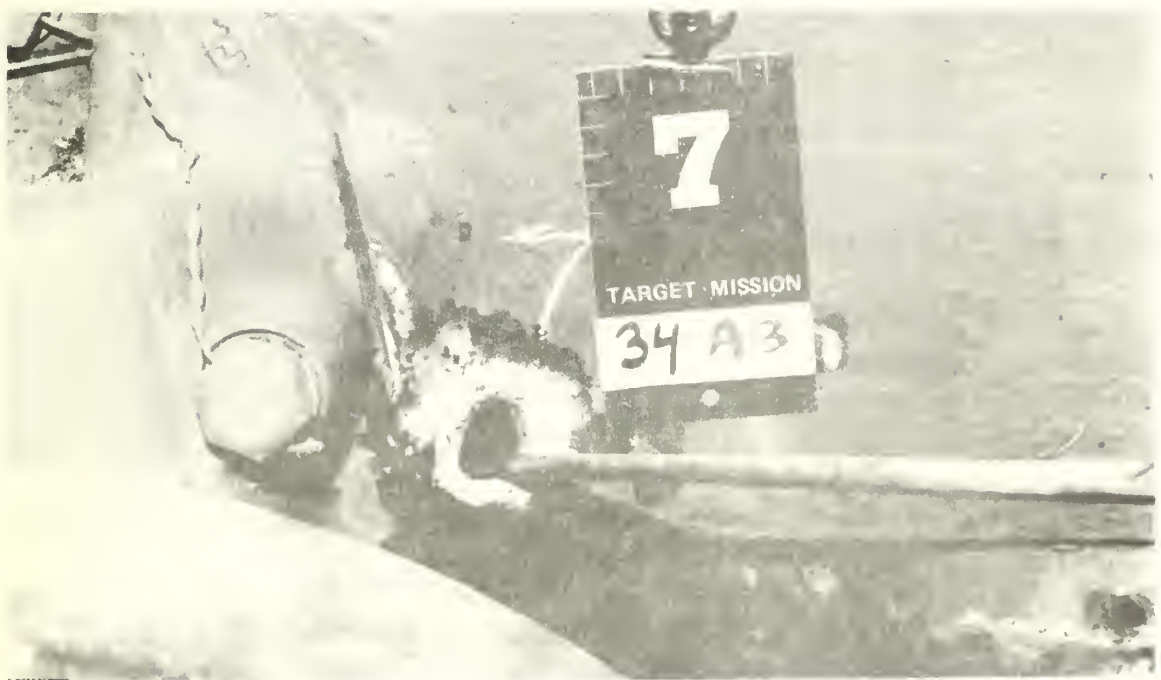
FIGURE 71. Impact Seven, Target 34, Perforation of the Left Hull Armor into the Bulkhead ammunition Stowage Area

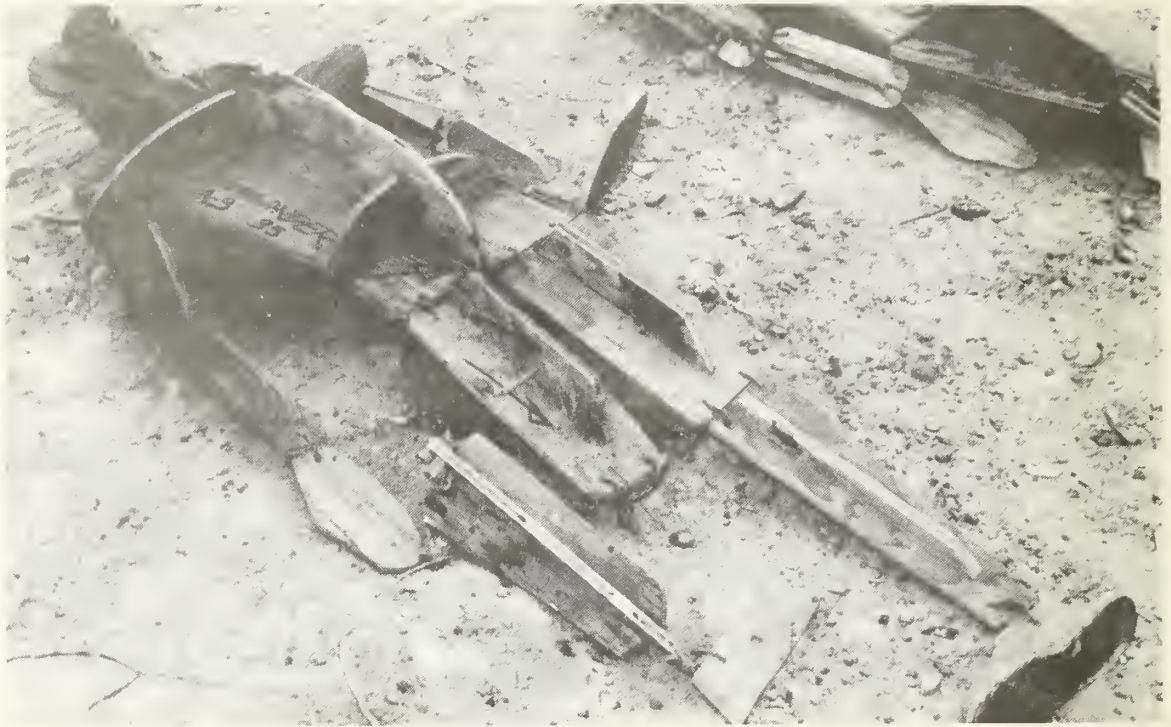
FIGURE 73. Commander Manikin, Target 35, Showing Damage from Perforations into the Fighting Compartment.

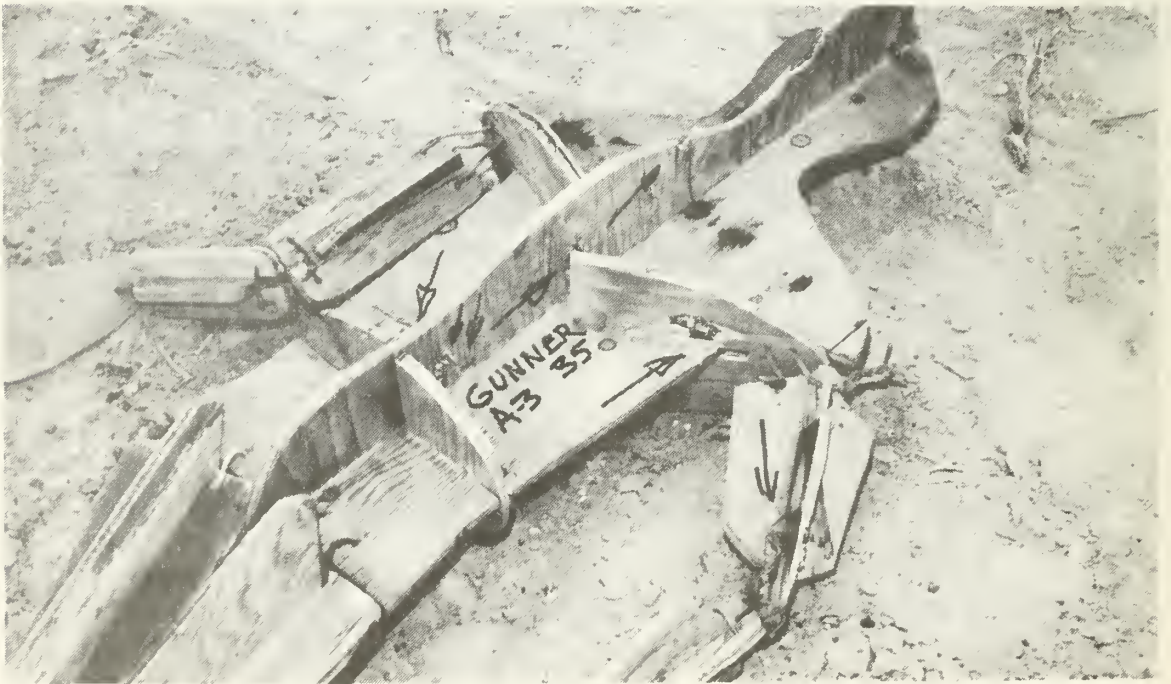
FIGURE 74. Gunner Manikin, Target 35, Showing Damage from Perforations into the Fighting Compartment.

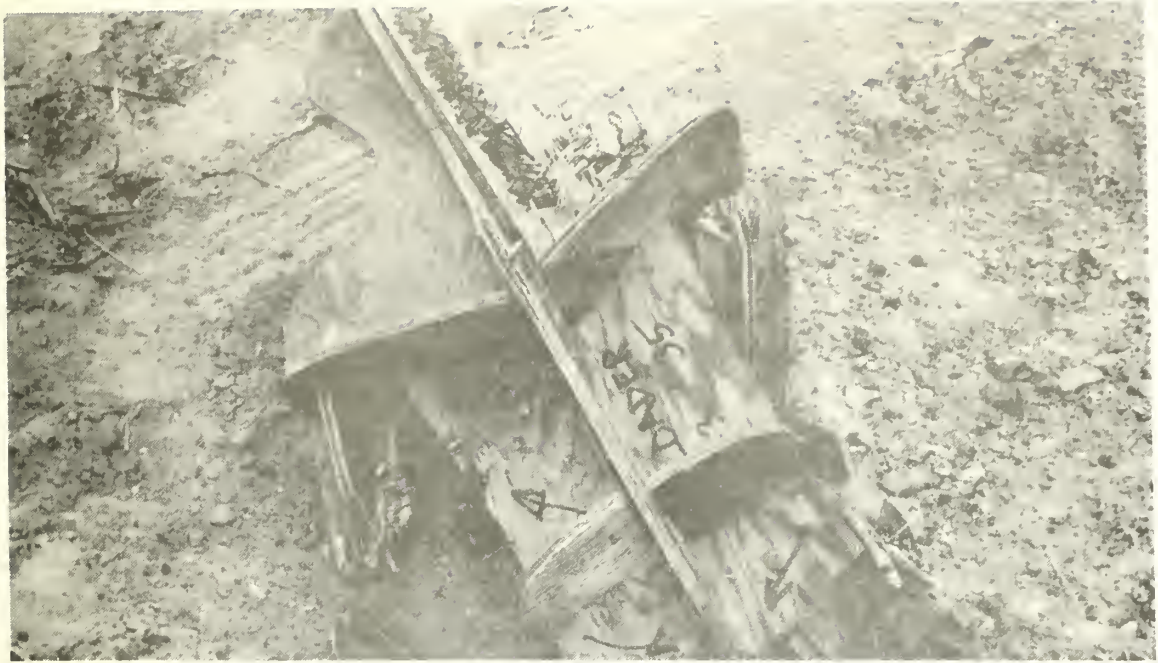
FIGURE 75. Loader Manikin, Target 35, Showing Damage from Perforations into the Fighting Compartment.

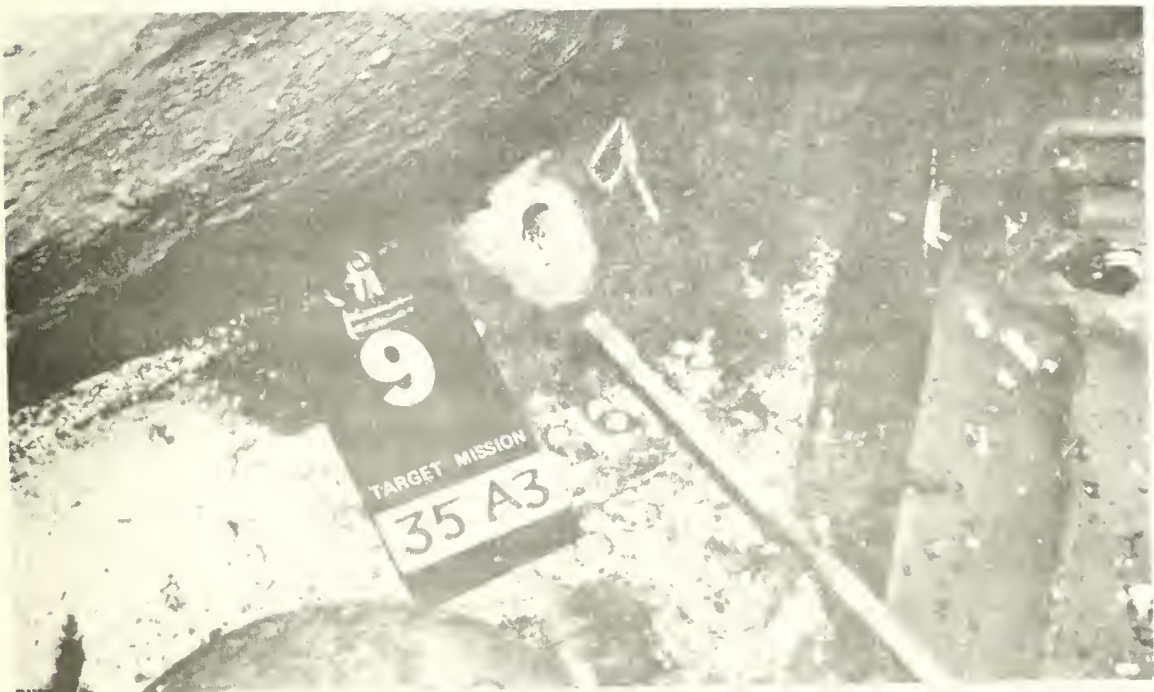
FIGURE 76. Impact Nine, Target 35, Showing Perforation of Top Hull Armor which Jammed the Turret.
