# NAVAL POSTGRADUATE SCHOOL

A-10/GAU-8 LOW ANGLE FIRINGS VERSUS  
SIMULATED SOVIET TANK BATTALION  
(HONEYWELL LOT NUMBER 0L78D043-016)  
(ARRAY 3)

2 FEBRUARY 1979

R.H.S. STOLFI  
R.R. MCEACHIN

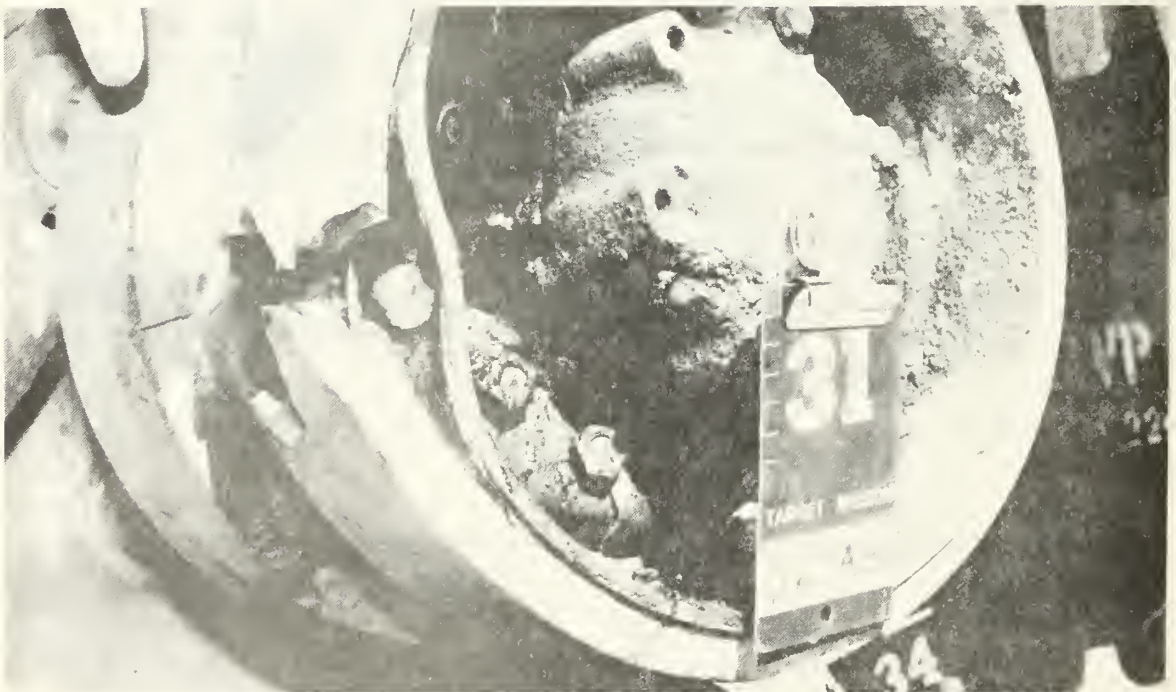
Major damage to the track and suspension system was caused by Impact 30 (Figure 78), which destroyed the left #2 roadwheel hub and bearings; Impact 31 (Figure 79), which destroyed the left #1 track support roller hub; and Impact 47 (Figure 80), which destroyed the left #5 roadwheel hub and bearings; and by twenty-two other impacts, which inflicted a high level of cumulative damage to the track and suspension system.

FIGURE 79. Impact Thirty-One, Target 36, which Damaged the Rim and Destroyed the Hub of the Left #1 Track Support Roller.

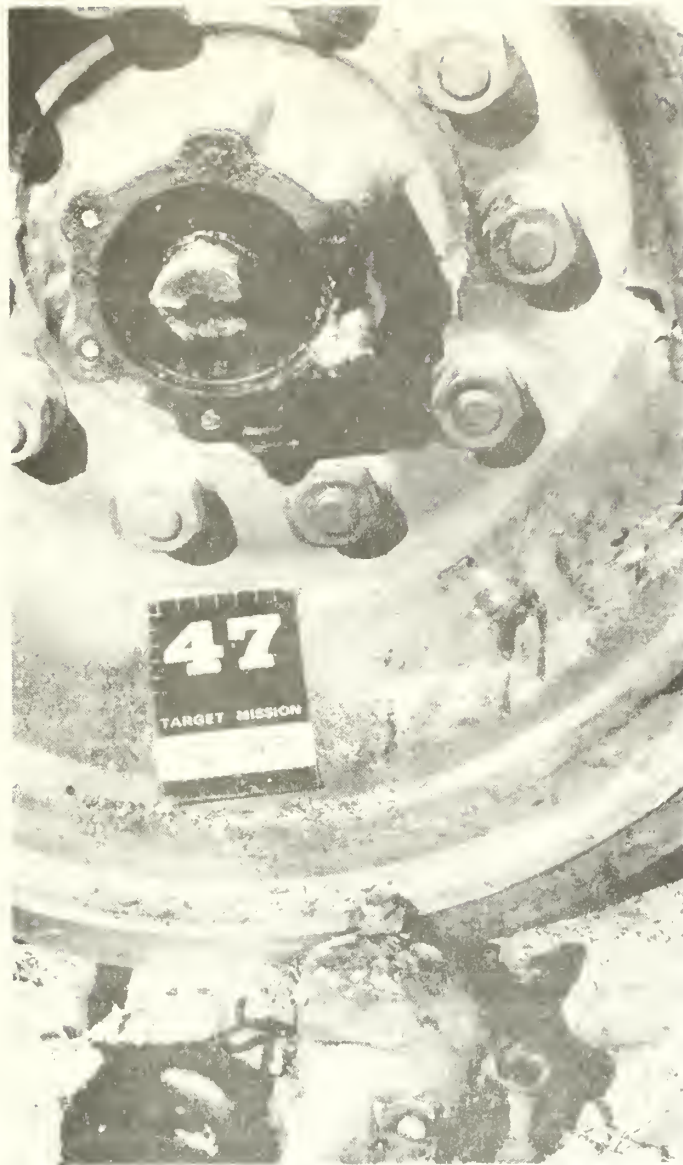
FIGURE 80. Impact Forty-Seven, Target 36, which Destroyed the Left #5 Roadwheel Hub Bearings.

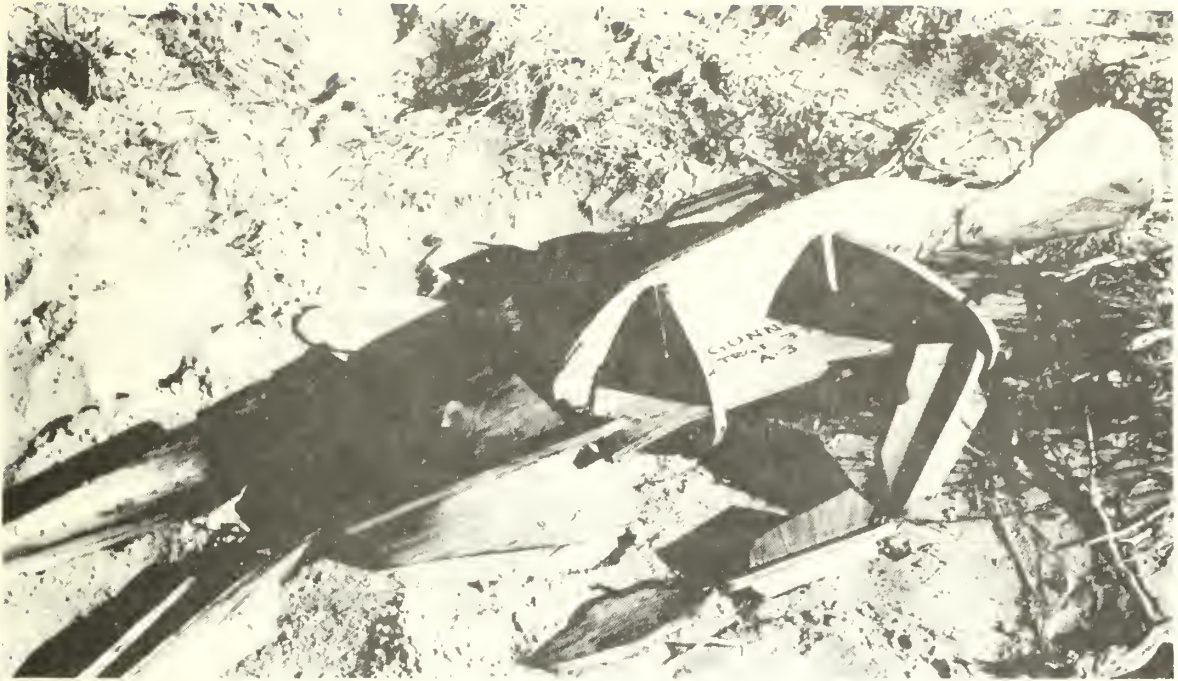
FIGURE 84. Gunner Manikin, Target 37, Showing Damage from Impact 9, Loader Fragment and burn Casualty.

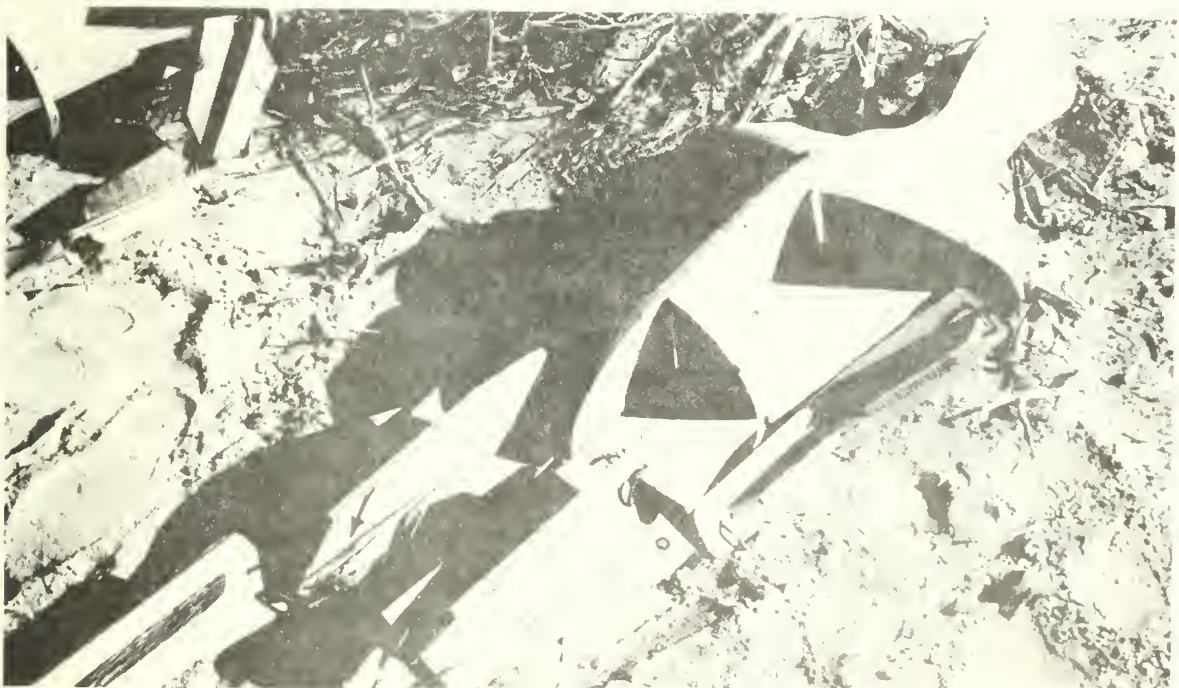
FIGURE 85. Loader Manikin, Target 37, Showing Damage from Impacts 9 and 19.

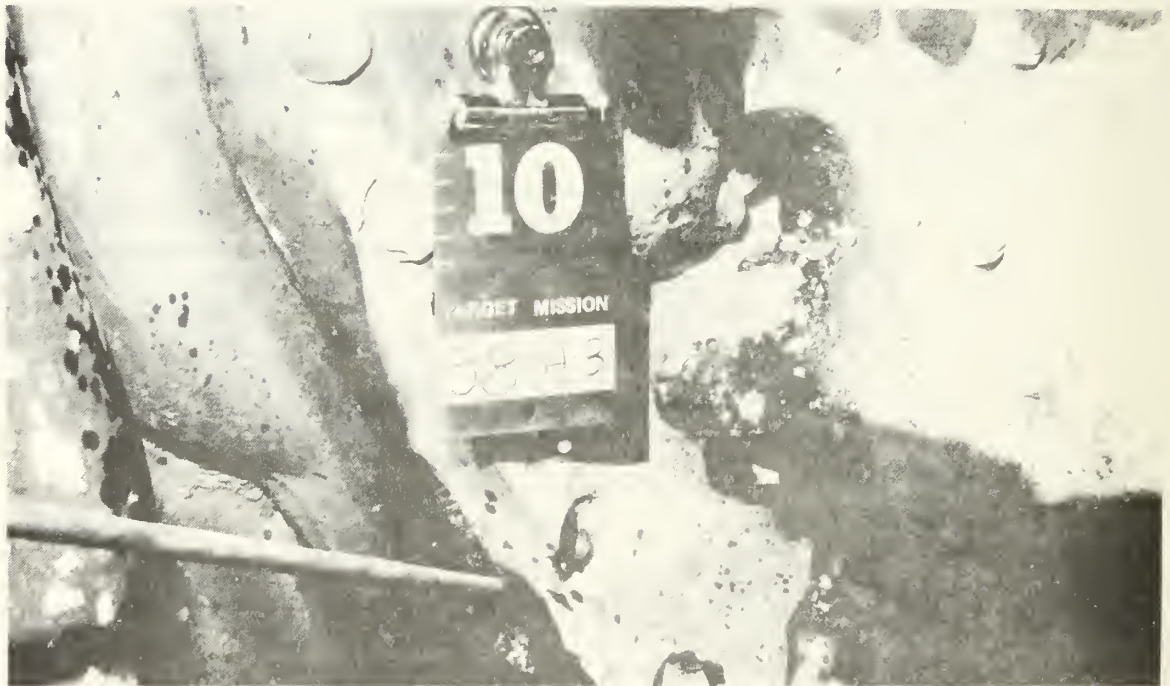
A 100% interdiction type M-Kill after 5km travel was assessed due to impact 10 (Figure 87), which penetrated the left final drive, causing an oil leak (Figure 88) and possibly projectile and/or fragment damage to the gears. Minor track and suspension damage from 4 other impacts contributed to the kill.

FIGURE 88. Impact Ten, Target 38, Showing Penetration of the Left Final Drive.

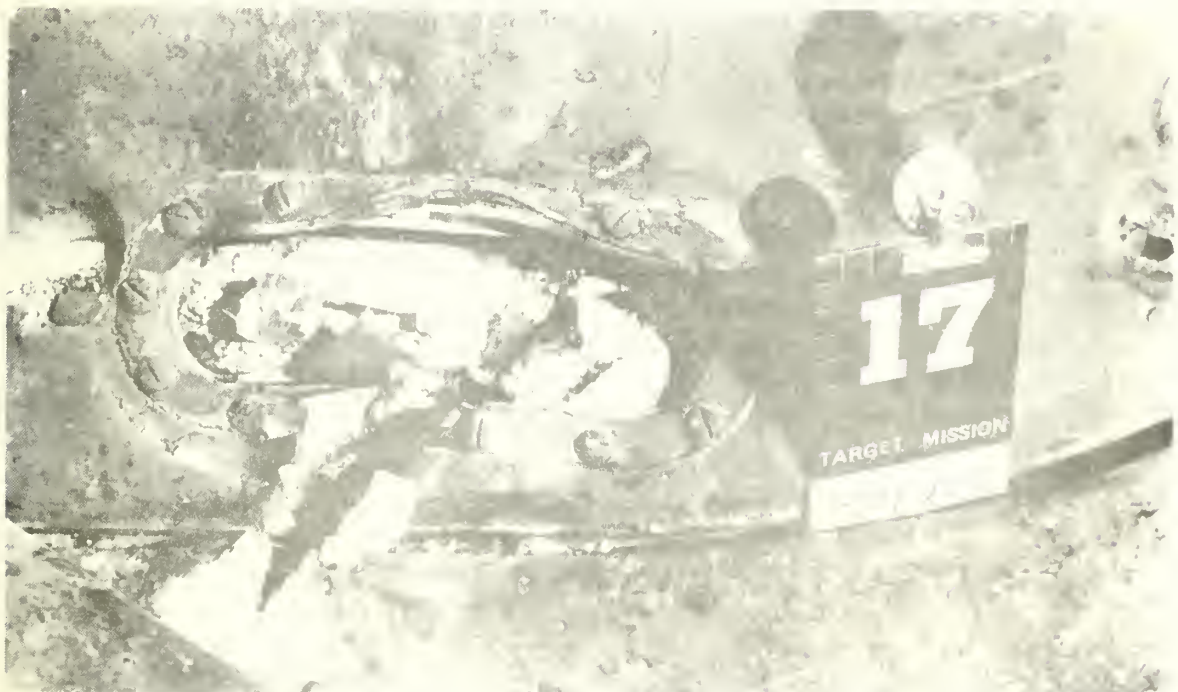
FIGURE 91. Impact Seventeen, Target 39, which Shattered a Vision Block in the Commander Cupola and wounded the Commander.

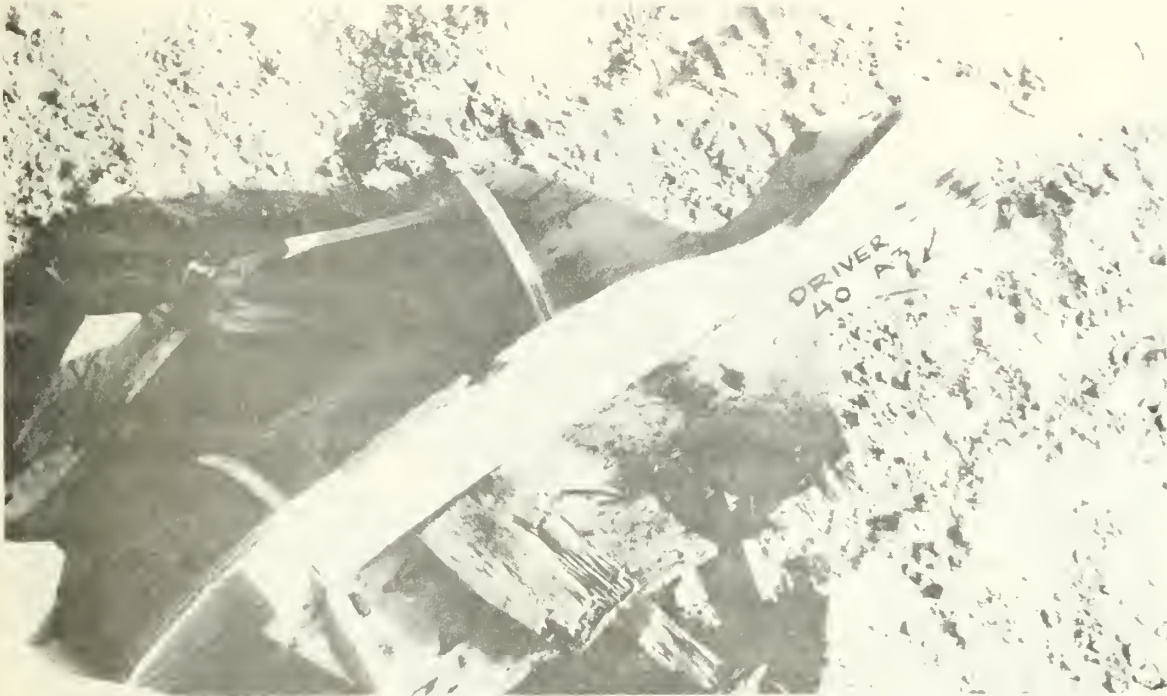
FIGURE 95. Driver Manikin, Target 40, Showing Damage from Impact 2.

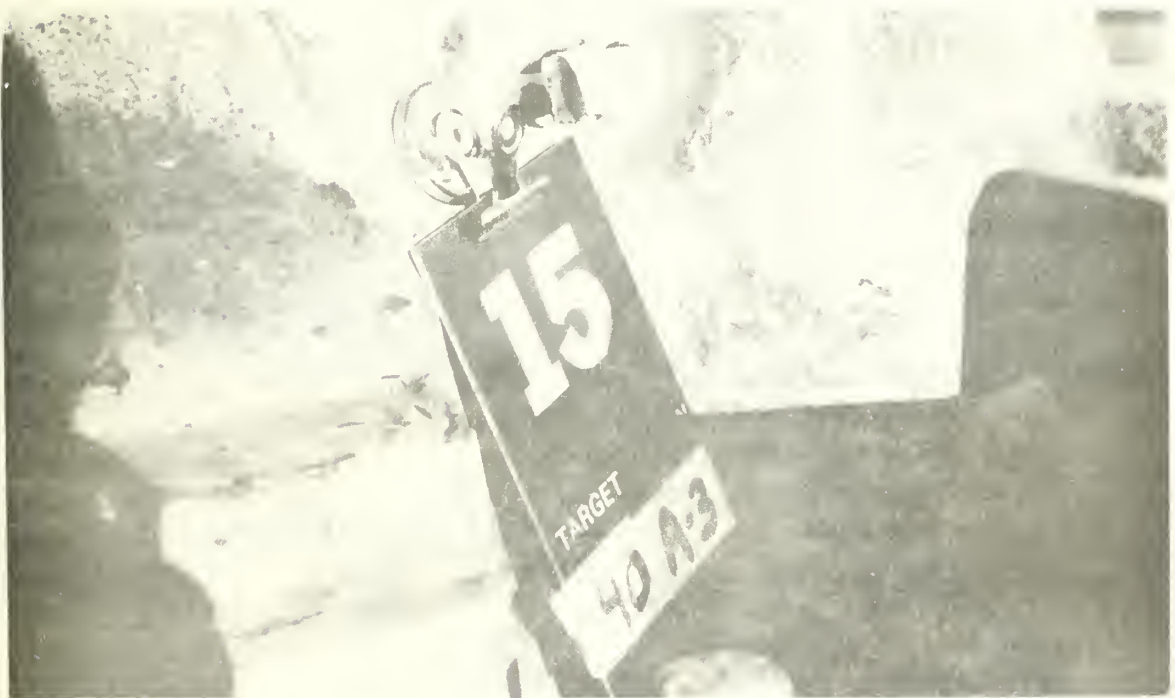
FIGURE 103. Impact Fifteen, Target 40, which Perforated the Left Side of the Commander's Cupola.

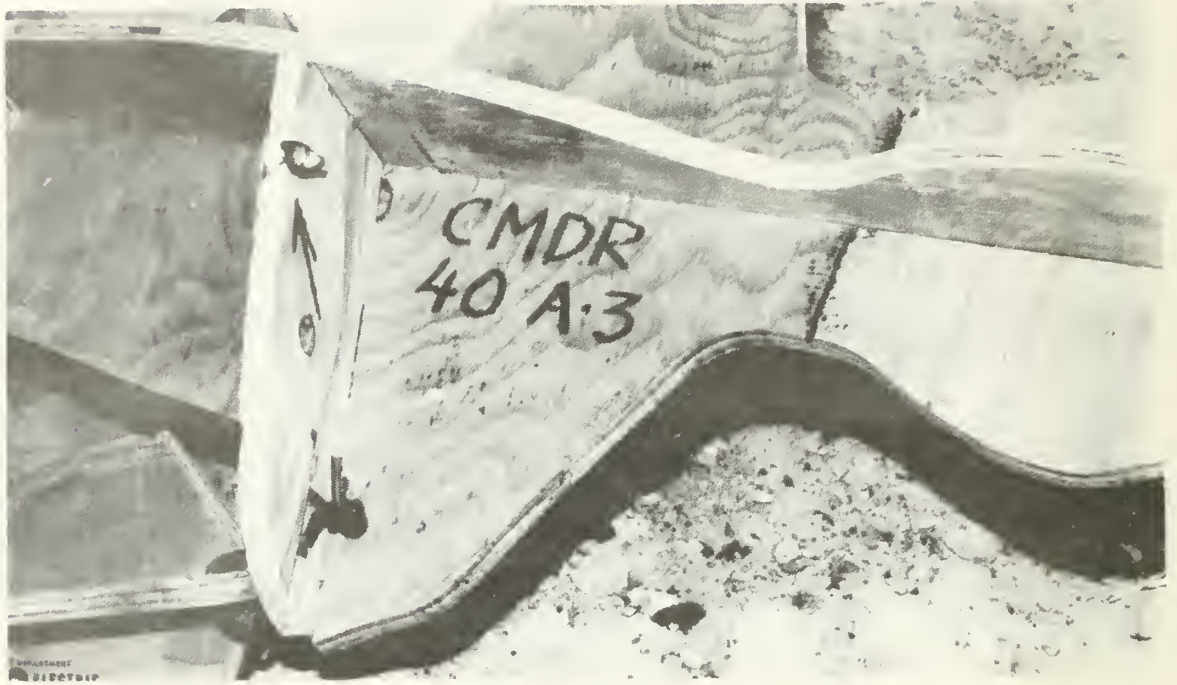
FIGURE 104. Commander Manikin, Target 40, Showing Damage from Impact 15.

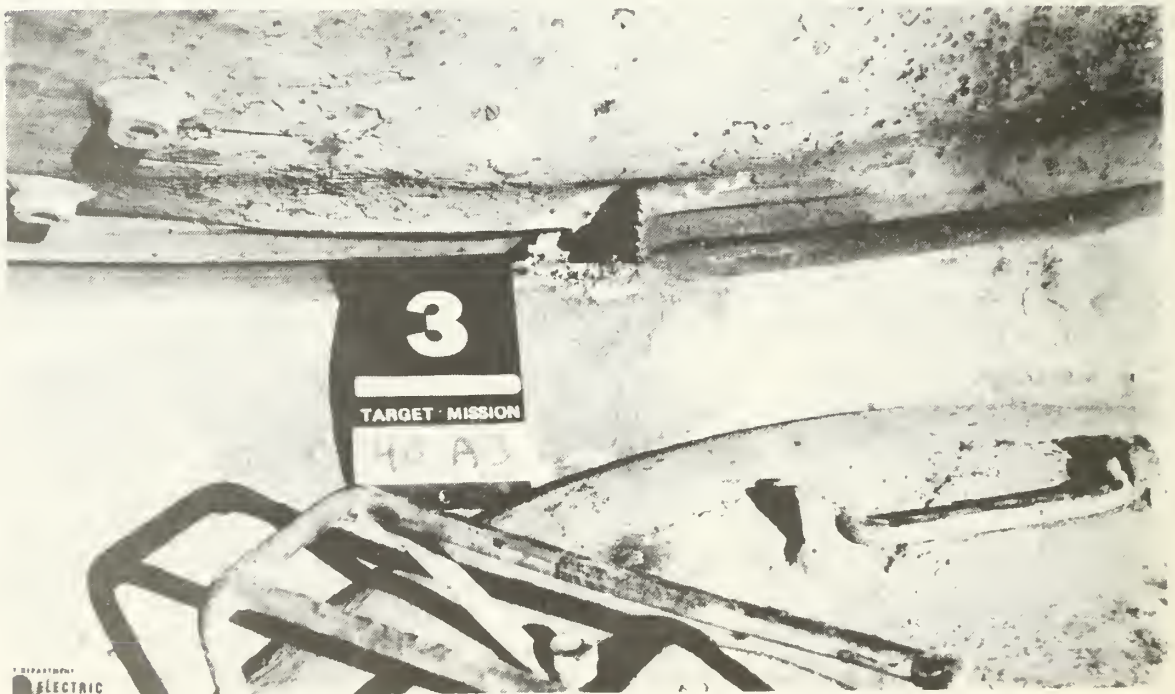
FIGURE 105. Impact Three, Target 40, which Jammed the Turret so that it would not Traverse.

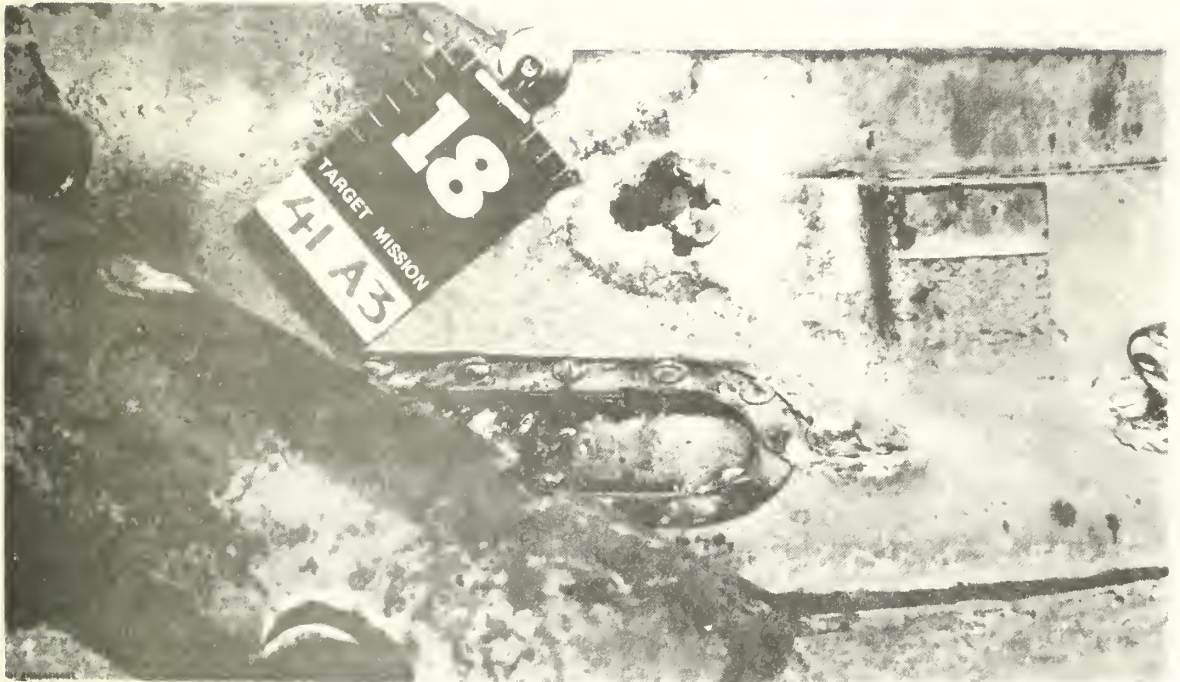
FIGURE 107. Impact Eighteen, Target 41, Perforation of Commander's Cupola, causing Casualties to Commander and Gunner.

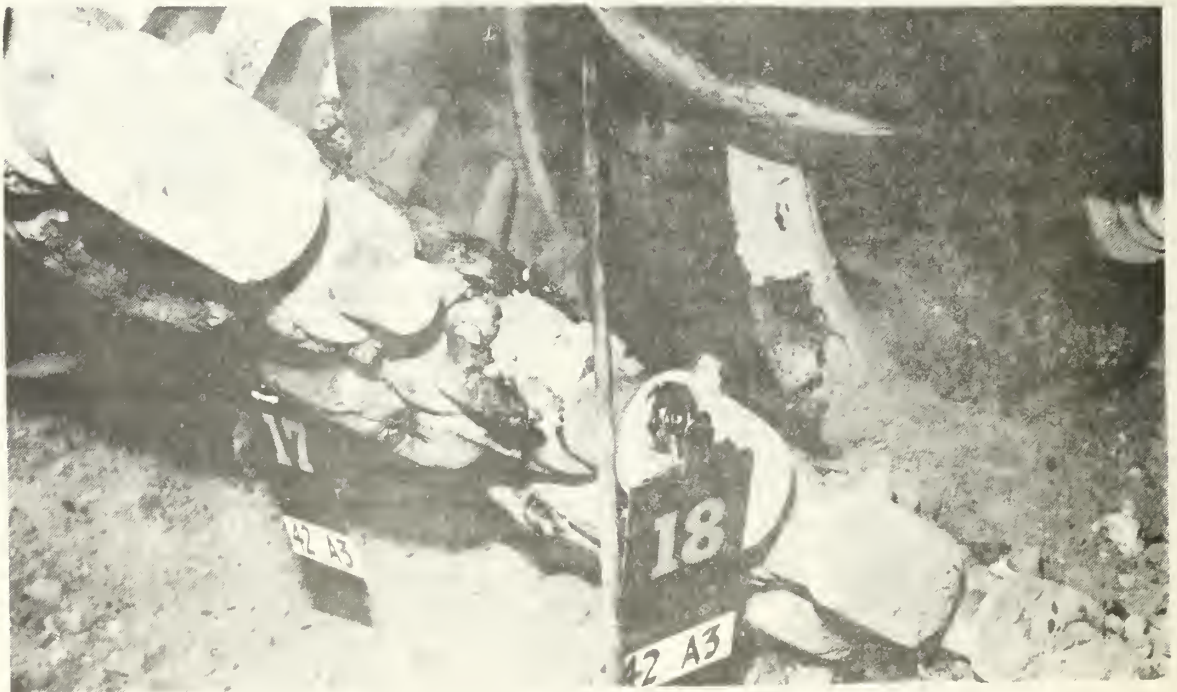
FIGURE 110. Impact Eighteen, Target 42, Showing Destroyed End Connector.

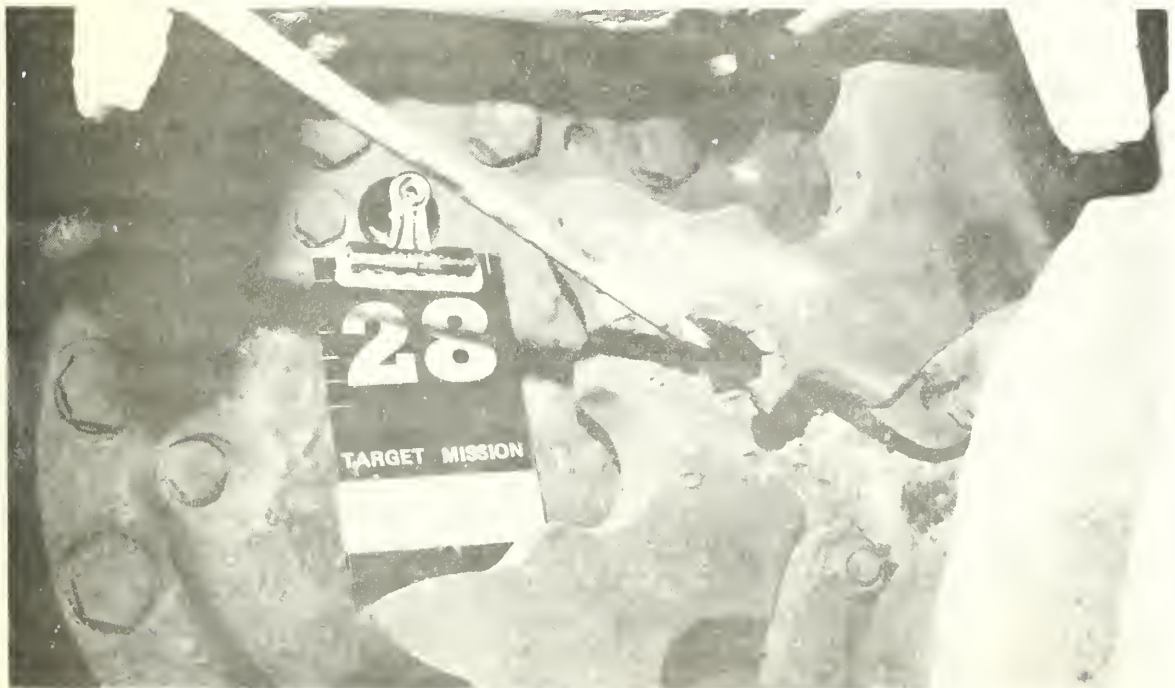
FIGURE 113. Impact Twenty-Eight, Target 43, Showing Damage to Left Inside Drive Sprocket and Penetration of Left Final Drive.

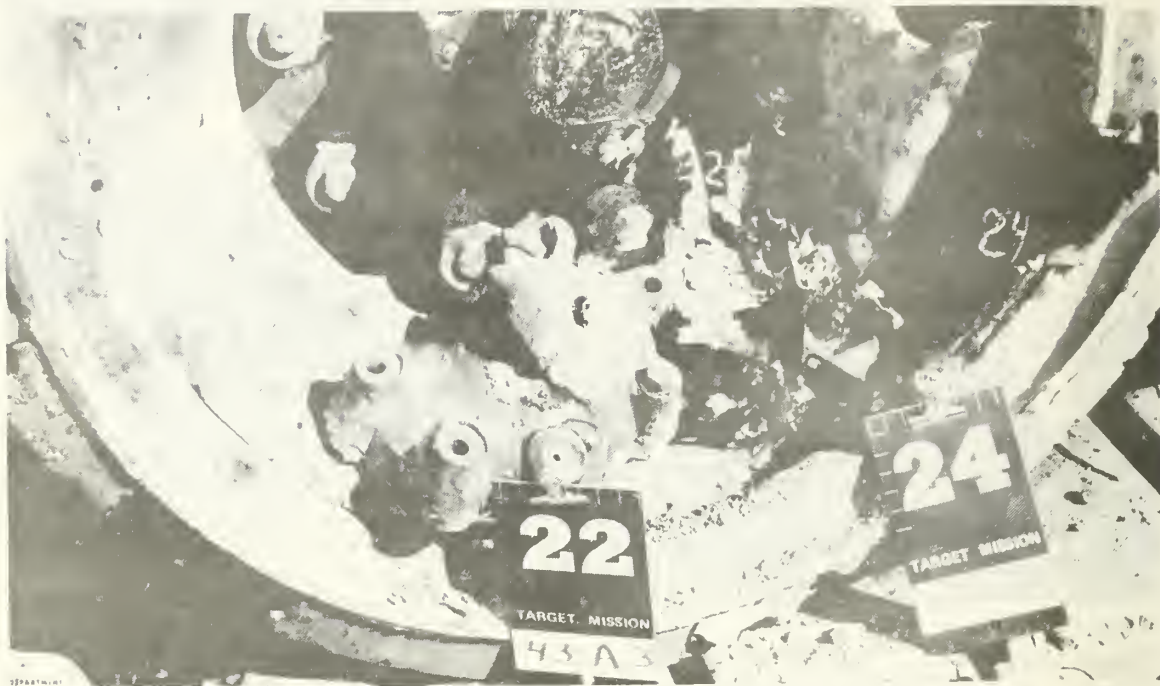
FIGURE 114. Impact Twenty-Two, Target 43, which Destroyed the Left #6 Roadwheel Hub.

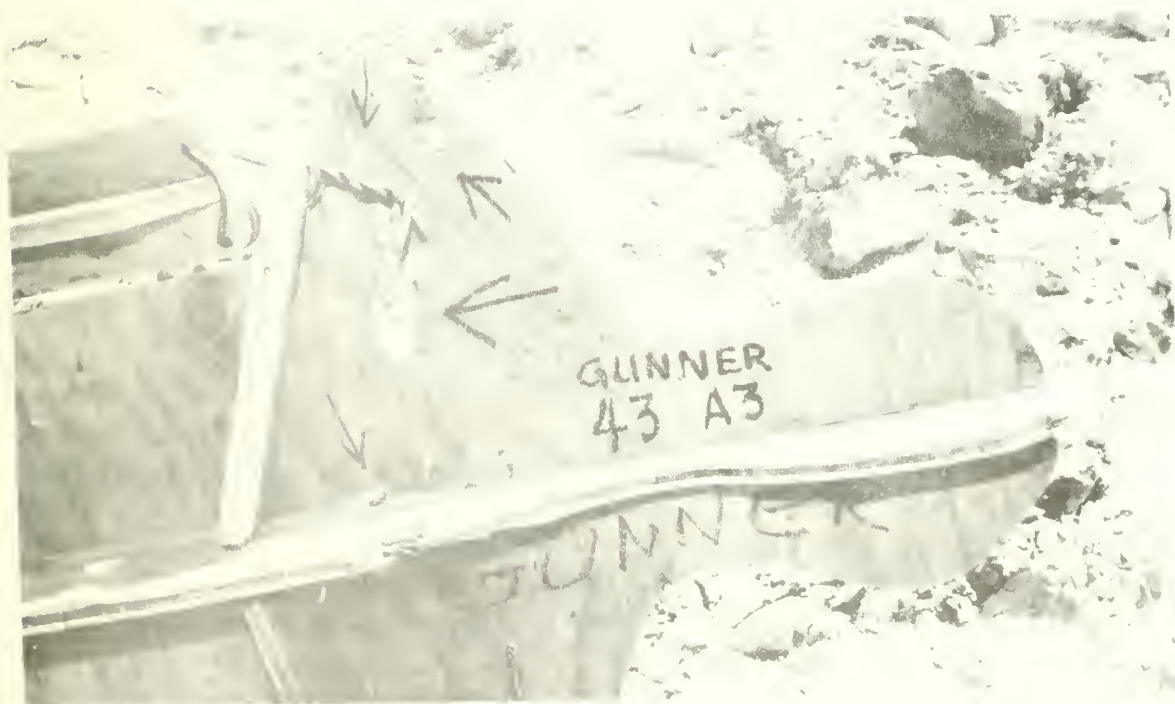
FIGURE 117. Gunner Manikin, Target 43, Showing Damage from Impact 3.

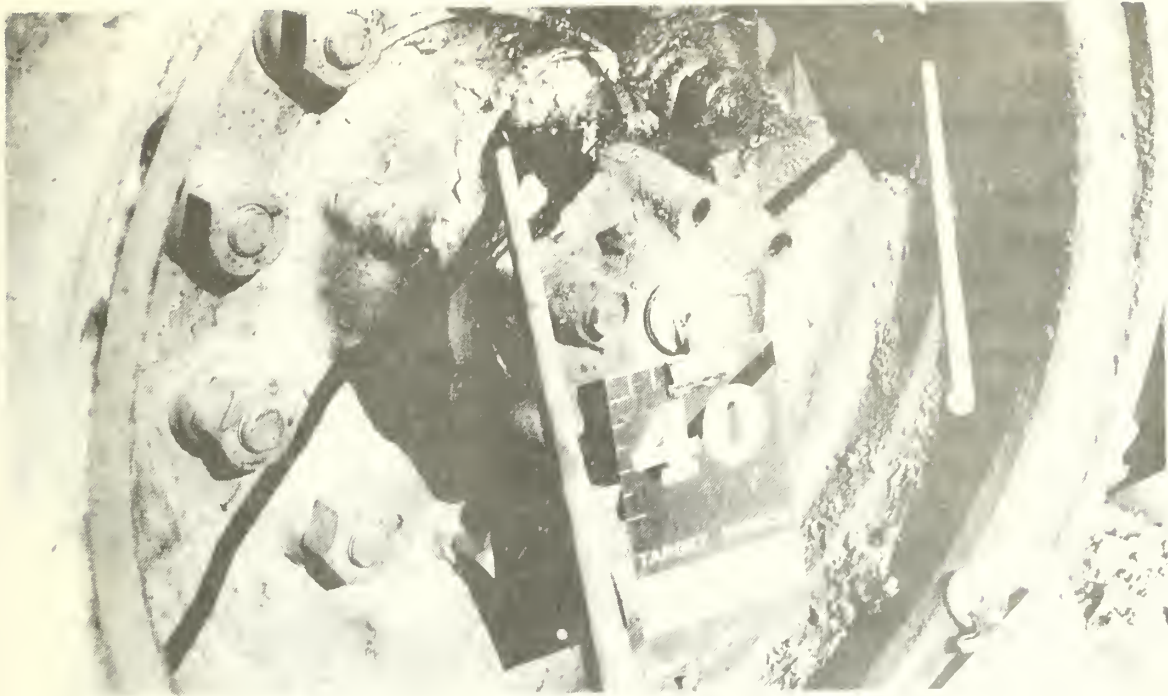
FIGURE 122. Impact Forty, Target 45, Severe Damage to Left #4 Roadwheel Hub, 100% Loss of Wheel.

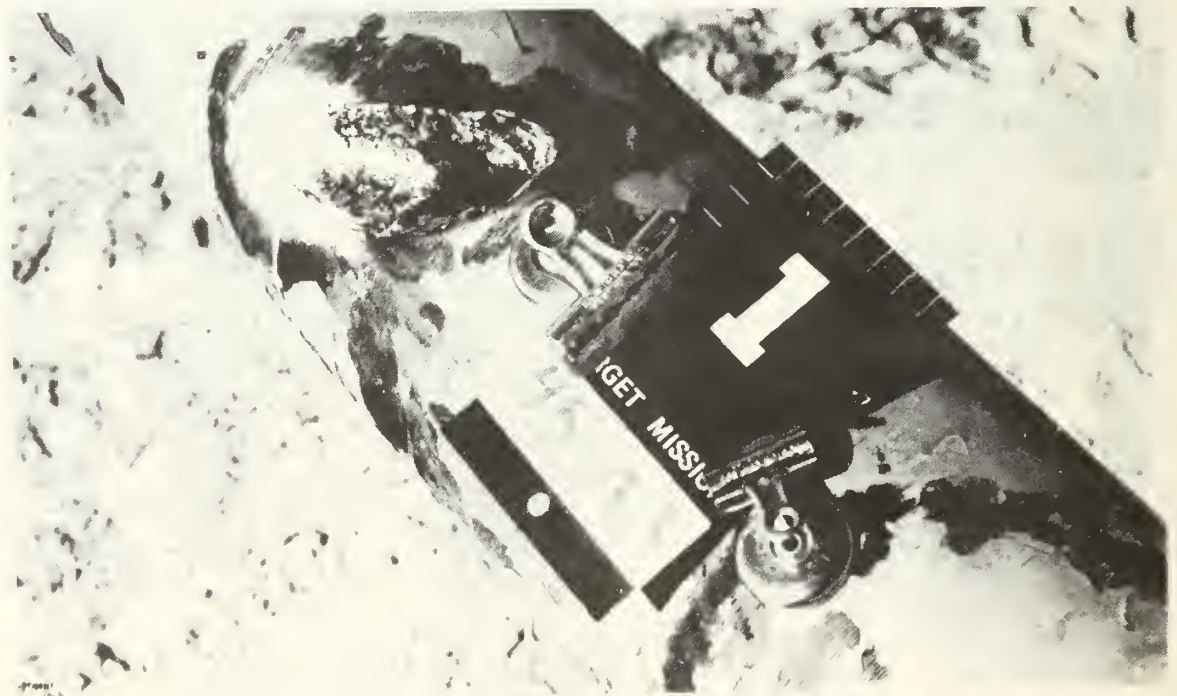
FIGURE 125. Impact One, Target 45, Top of Gun Tube Wall Perforated, Maximum Hole Dimension 37mm.
