Collision of passenger train A42 with buffer stop

Richmond, New South Wales | 22 January 2018

ATSB Transport Safety Report
Rail Occurrence Investigation
RO-2018-004
Final – 20 December 2019

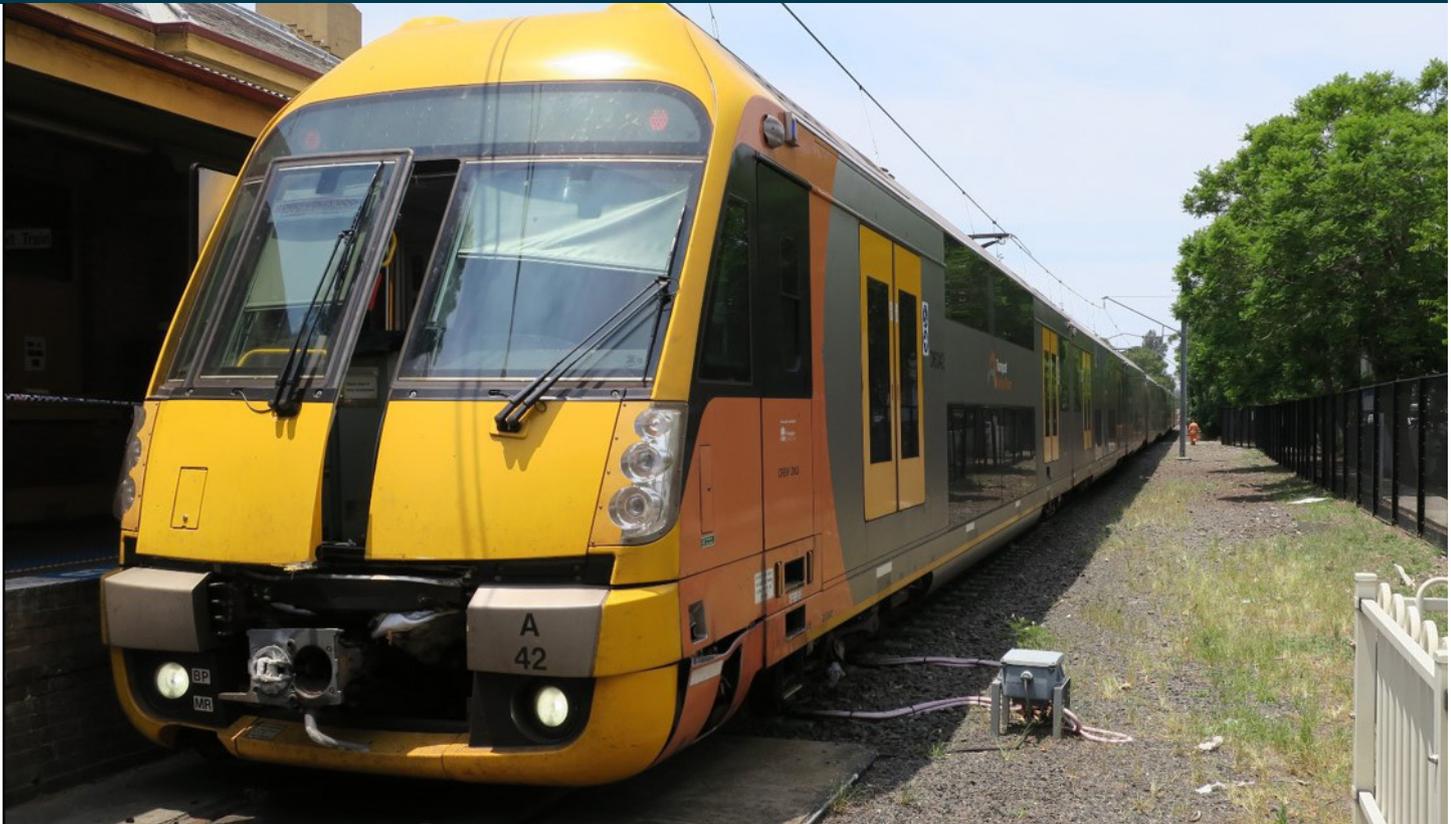
Cover photo: Front of A42 at Richmond Station after collision with buffer stop. Source ATSB.

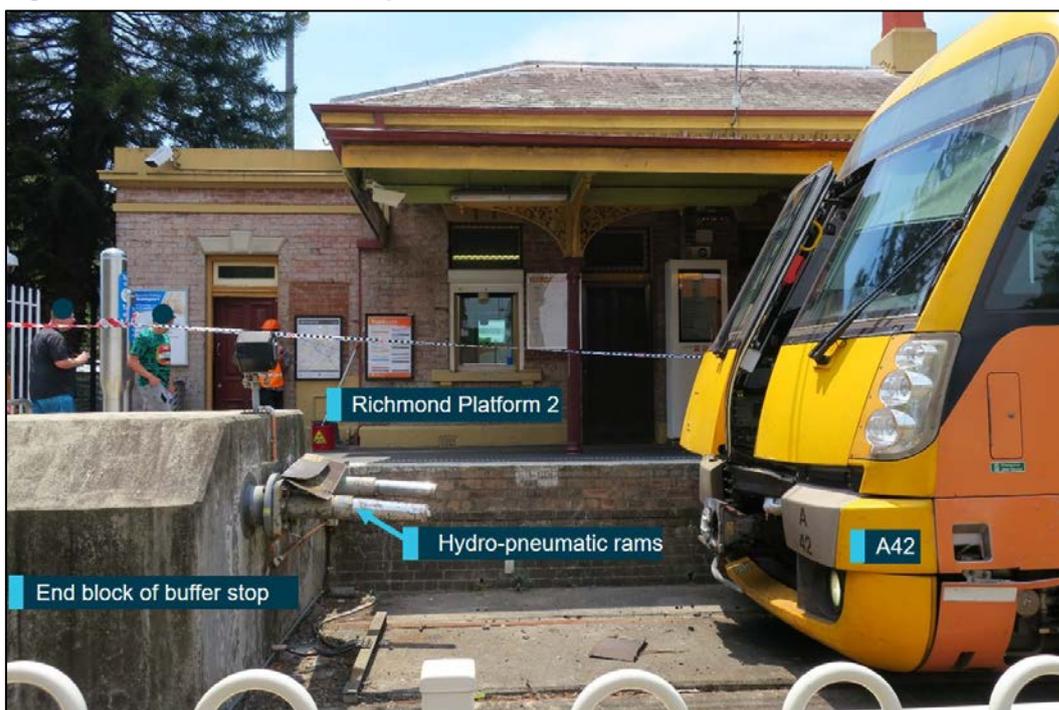
Figure 3: Platform 2 buffer stop and front of A42

The collision caused substantial damage to the end-of-track buffer stop with a significant transverse crack opening at the corner of the base and the upright. The two hydro-pneumatic rams positioned on the front of the buffer stop also sustained damage (Figure 3).

This figure shows the post-collision damage to the buffer stop on Platform 2 and the front of A42.
Source: ATSB

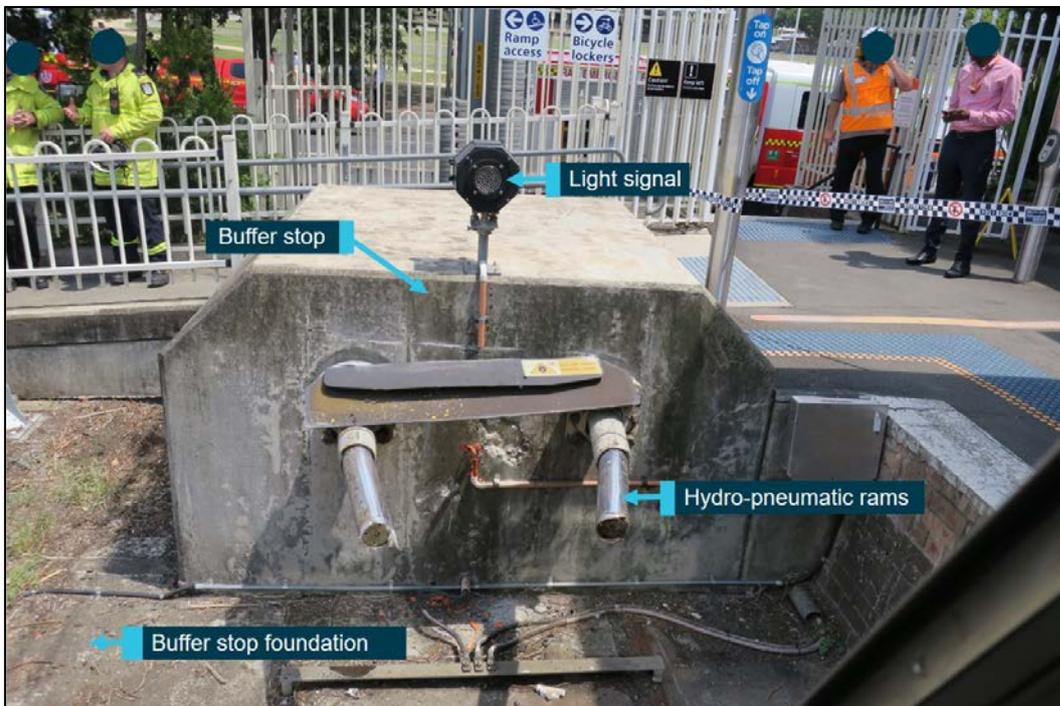
Figure 8: Platform 2 buffer stop of Richmond Station

This diagram shows the post-collision damage to the buffer stop on Platform 2, details at Richmond Station, and the light signal attached to the buffer stop.
Source: ATSB

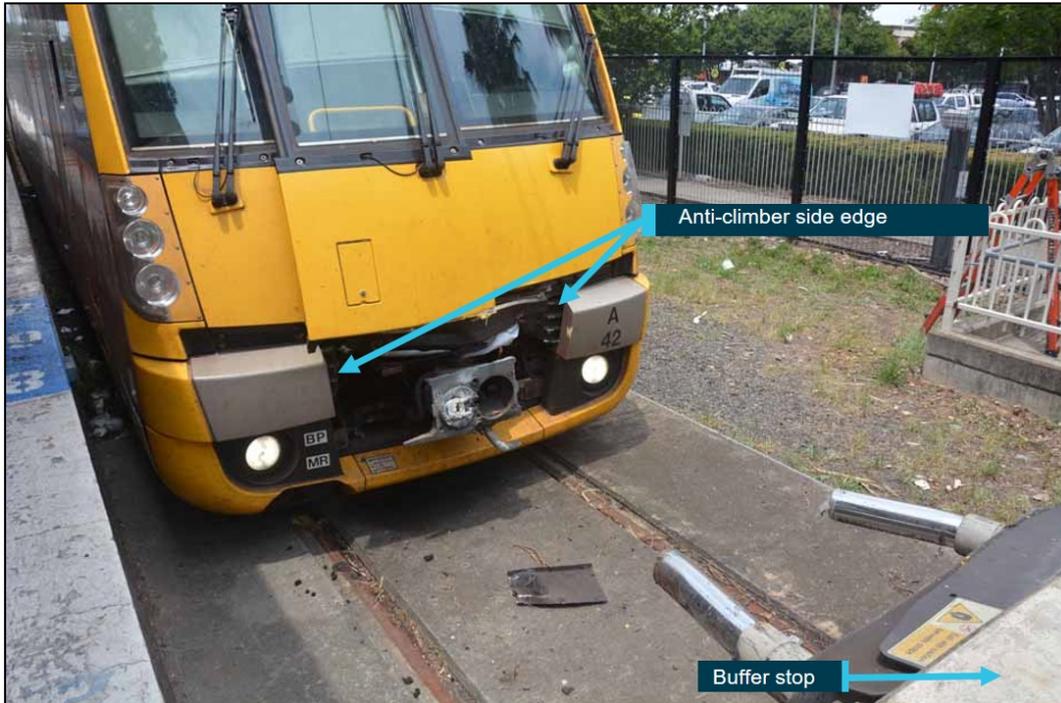
Figure 25: Position of anti-climbers on leading car

The front edge of both anti-climbers contacted the buffer tube flange on the face of the concrete buffer stop (Figures 25 and 26). The driver's side crash box activated and deformed rearwards by 50 mm; this damaged the fibreglass canopy and floor. The guard's side crash box did not activate despite the anti-climber also contacting the buffer tube flange (Figure 27). The maximum stroke for the crash box rams behind the anti-climber was 800 mm. It is possible the edge contact transferred angular force to the anti-climber, this did not allow the ram to slide and deform as designed.

*This figure shows position of the anti-climbers on the leading car of A42 and the edge which contacted the buffer tube flange.
Source: ATSB*

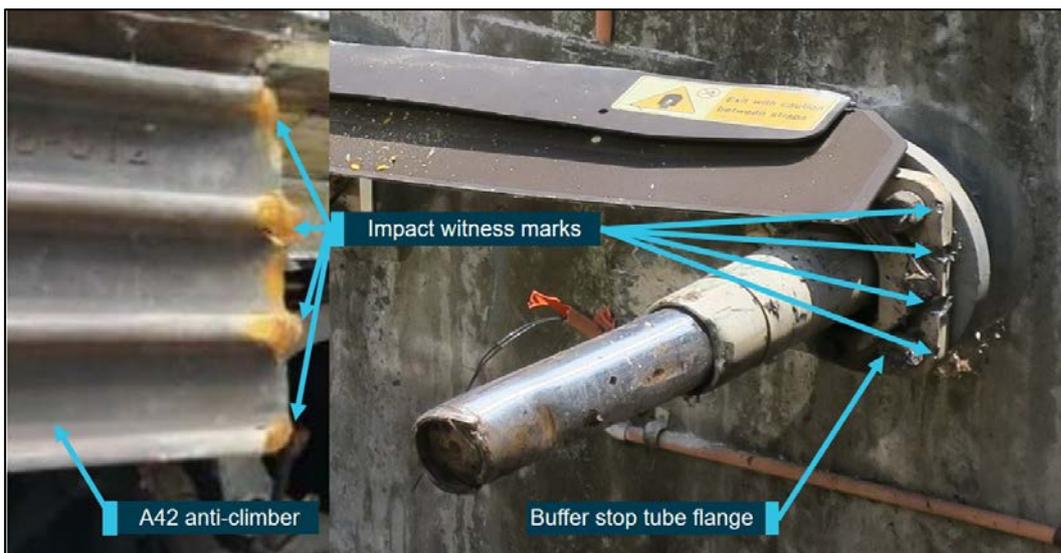
Figure 26: Damage from impact with anti-climbers

*This figure shows the damage to the buffer stop tube flange (Right side) following contact with A42's RHS anti-climber (Left side) and the corresponding damage to the RHS anti-climber edge.
Source: ATSB*

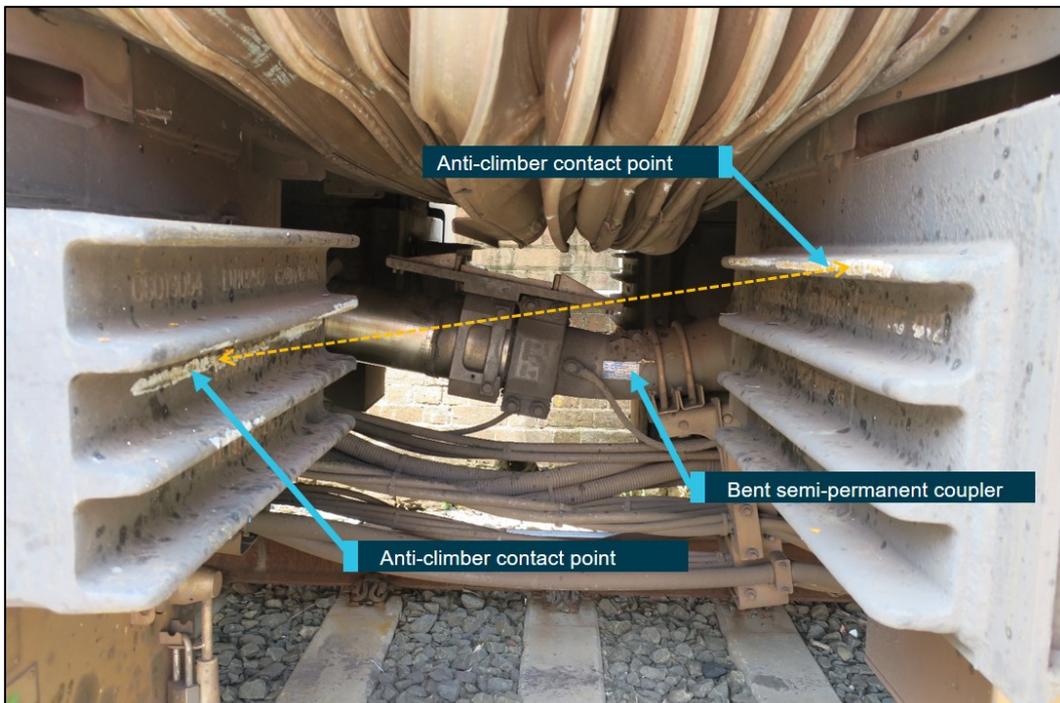
Figure 28: Bent semi-permanent coupler

The semi-permanent coupler between the first and second cars (Figure 28), and that between the second and third cars were bent and damaged. The vertical angular movement of the semi-permanent coupler is limited to 8 degrees (by design). This vertical limit was exceeded by the excessive pitching due to the CEMS not properly activating. The other four semi-permanent couplers also sustained damage. The anti-climbers between the third and fourth cars did not engage and instead one anti-climber damaged the 1500V DC junction box on the other car (Figure 29). The only semi-permanent coupler not to sustain damage was the semi-permanent coupler between the seventh and eighth cars.

This figure shows the bent coupler between the first and second cars (D6342 and N5342) and also the contact witness marks on the anti-climbers.
 Source: ATSB

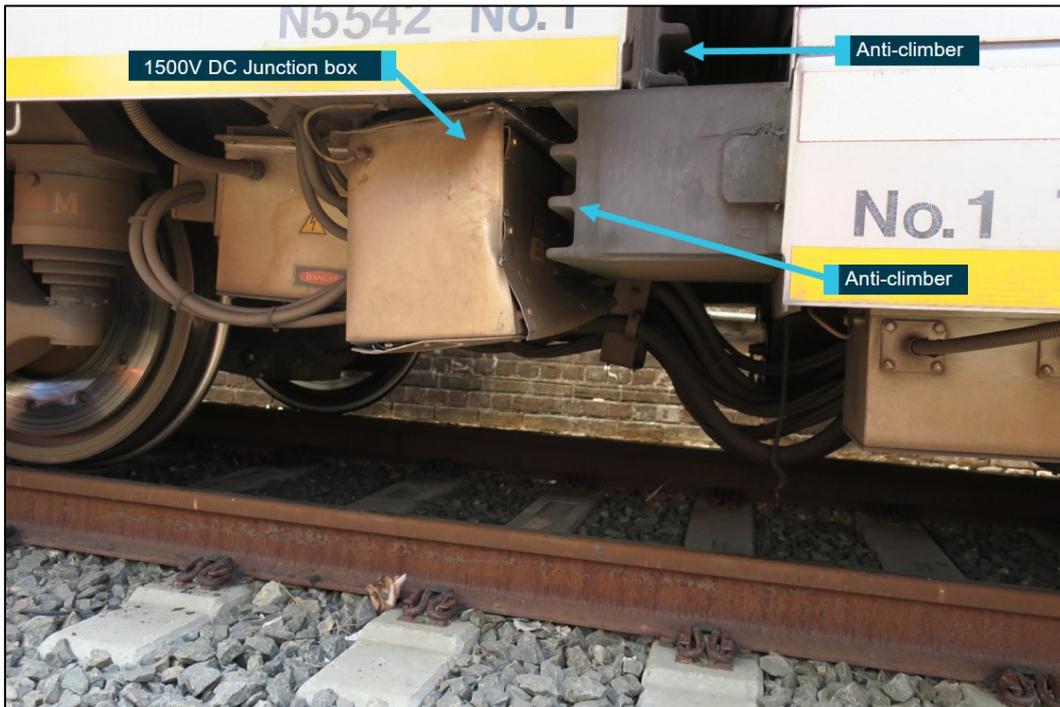
Figure 29: Anti-climber into junction box

*This figure shows the No. 1 end of motor car N5542 overriding the No. 1 end of trailer car T6542, between the third and fourth cars. The anti-climber has damaged the 1500V DC junction box.
Source: ATSB*

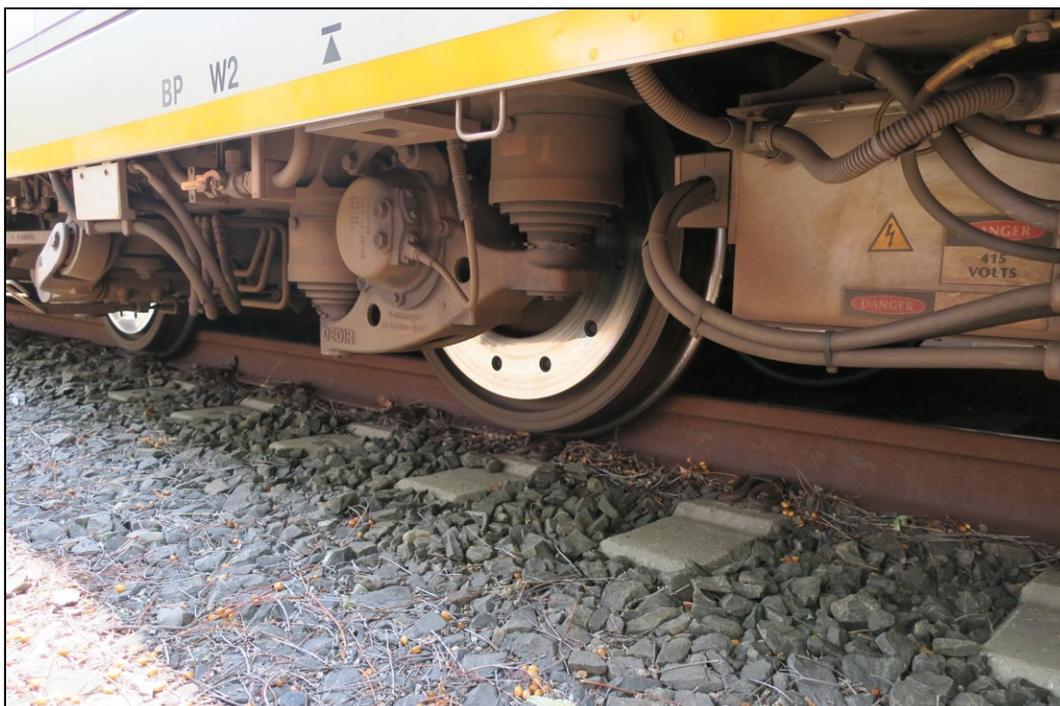
Figure 30: Derailed wheels

The bending of the couplers between the first two car interfaces, and the derailment of all wheels of a bogie (Figure 30), is indicative of vertical pitching that occurred because of the forces being transferred along the train not in a line of action close to the centreline through the couplers. This affected the alignment of the anti-climbers, which reduced their effectiveness in containing vertical movement (Figure 31).

This figure shows the derailed wheels on the bogie on the No.1 end of the fifth car (T6642) (non-platform side).
