FORT EGBERT AND EAGLE, ALASKA

❧ A PRESERVATION PLAN ❧

National Trust for Historic Preservation in the United States
740-748 Jackson Place, N.W.
Washington, D.C. 20006
Prepared Under Contract for the Bureau of Land Management

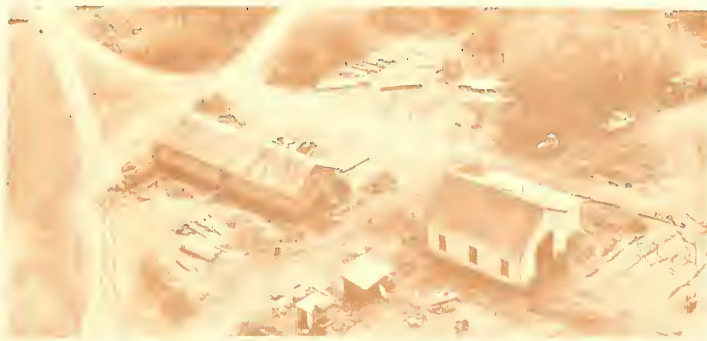
Figure 20. Stabilization of foundation of the quartermaster storehouse (left) and the firehouse (water wagon shed). (Volz)

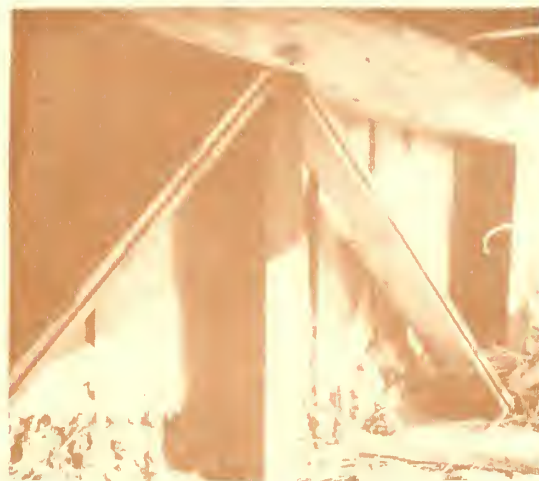
Figure 21. Deteriorated condition of siding on the granary due to direct contact with soil. Note that four to six inches of siding at ground level are totally decayed. (Volz)

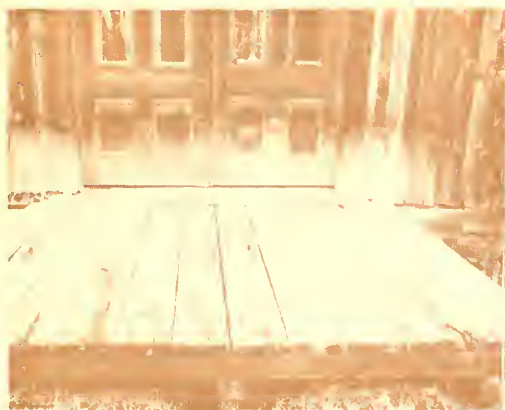
Figure 22. South porch of granary showing advanced decay in deck plank. Note decay fungus fruiting bodies on plank end-grain in foreground. (Clark)

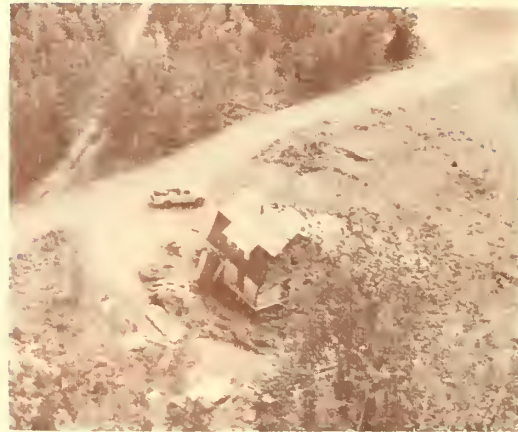
Figure 24. NCO quarters, July 1975, with foundation stabilization completed and building in process of being reroofed. Roofing and replacement of rear shed addition will take place in 1976. (Volz)

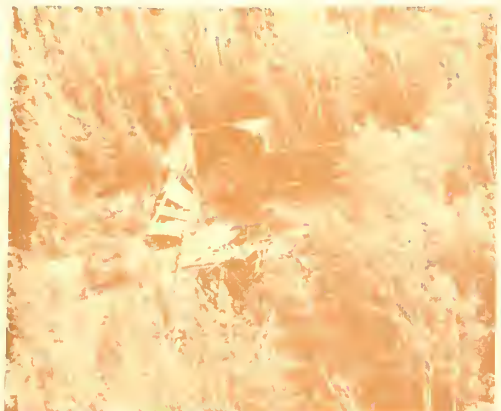
Figure 27. Ruins of second post hospital built in 1906. Remaining walls will be stabilized and potential hazards eliminated. (Volz)

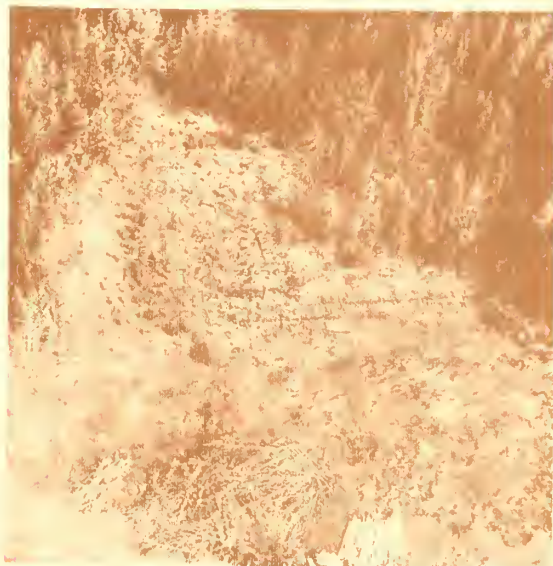
Figure 28. Ruins of enlisted men's barracks. Stringers and joists are still visible. Ruins will be stabilized and identified with interpretive markers. (Volz)

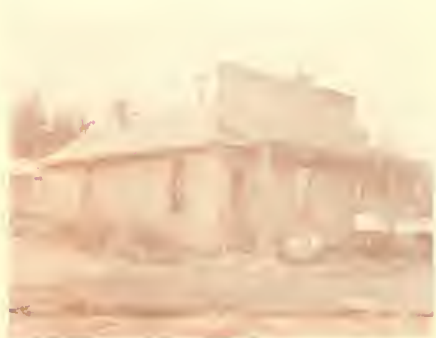
Figure 44. This building is one of two remaining false front structures in Eagle and the only historic building surviving in its block. Preservation of the structure is critical. (Scott)

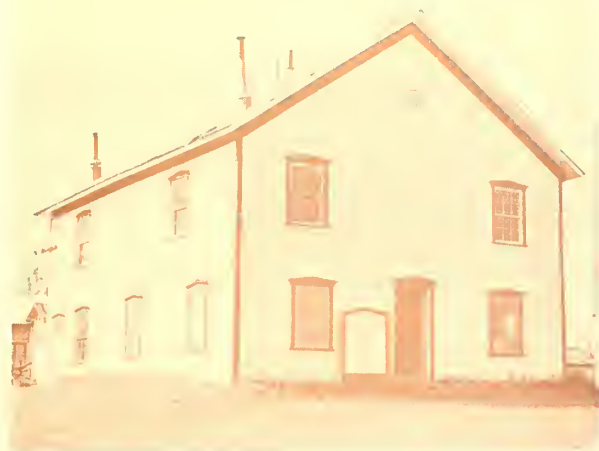
Figure 45. Today the courthouse stands without its porch and the building is used as the Eagle Public Library, a temporary jail and a museum. Plans call for its restoration in 1976. See Figure 13 for comparison. (Scott)

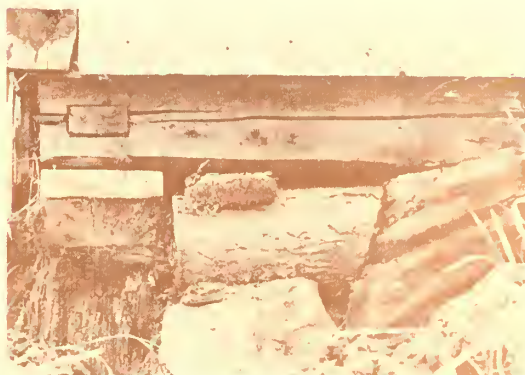
Figure 46. As the courthouse settled and its foundation deteriorated, discarded logs and lumber were used beneath sills and joists to support the structure. (Volz)

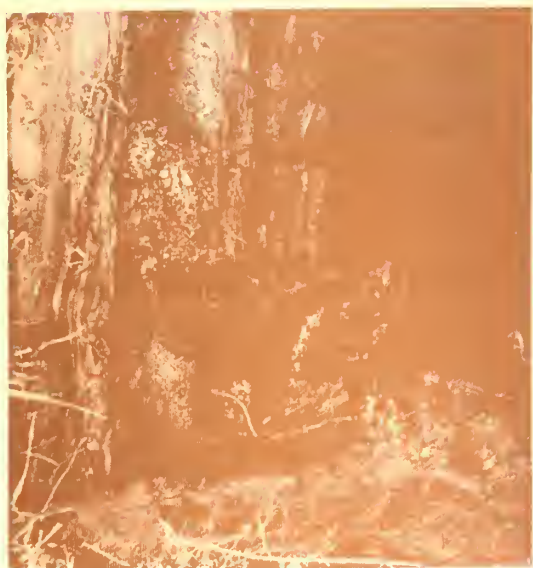
Figure 47. Supporting timbers of the courthouse were totally deteriorated and will require replacement during restoration. (Volz)
