# Southern Region Headquarters

## Smithville, Mississippi EF5 Tornado Damage

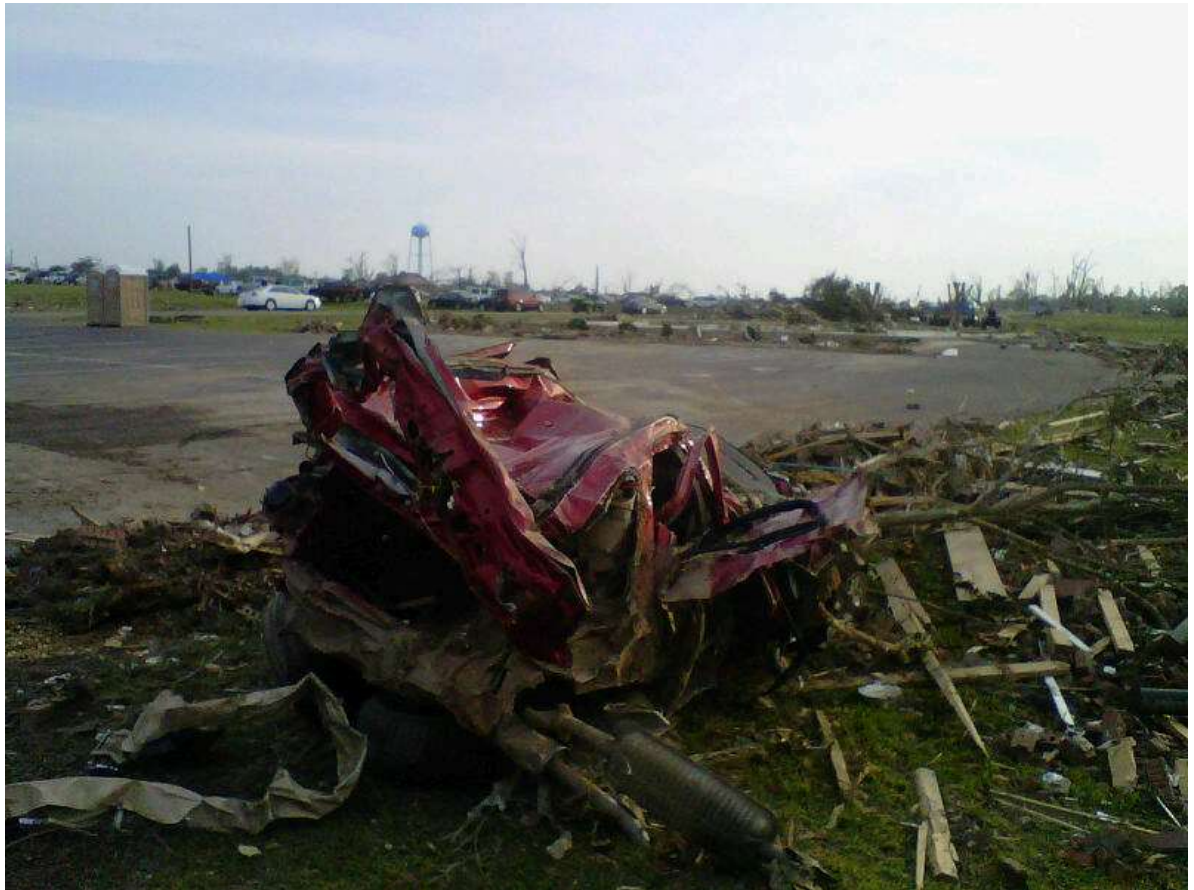
*The remains of a Ford Explorer in Smithville MS. The tornado hurled the SUV about 1/2 mile, into the town's water tower (the tower is in the picture background) and continued on another 1/4 mile until impact. (Photo: Mississippi Emergency Management Agency)*

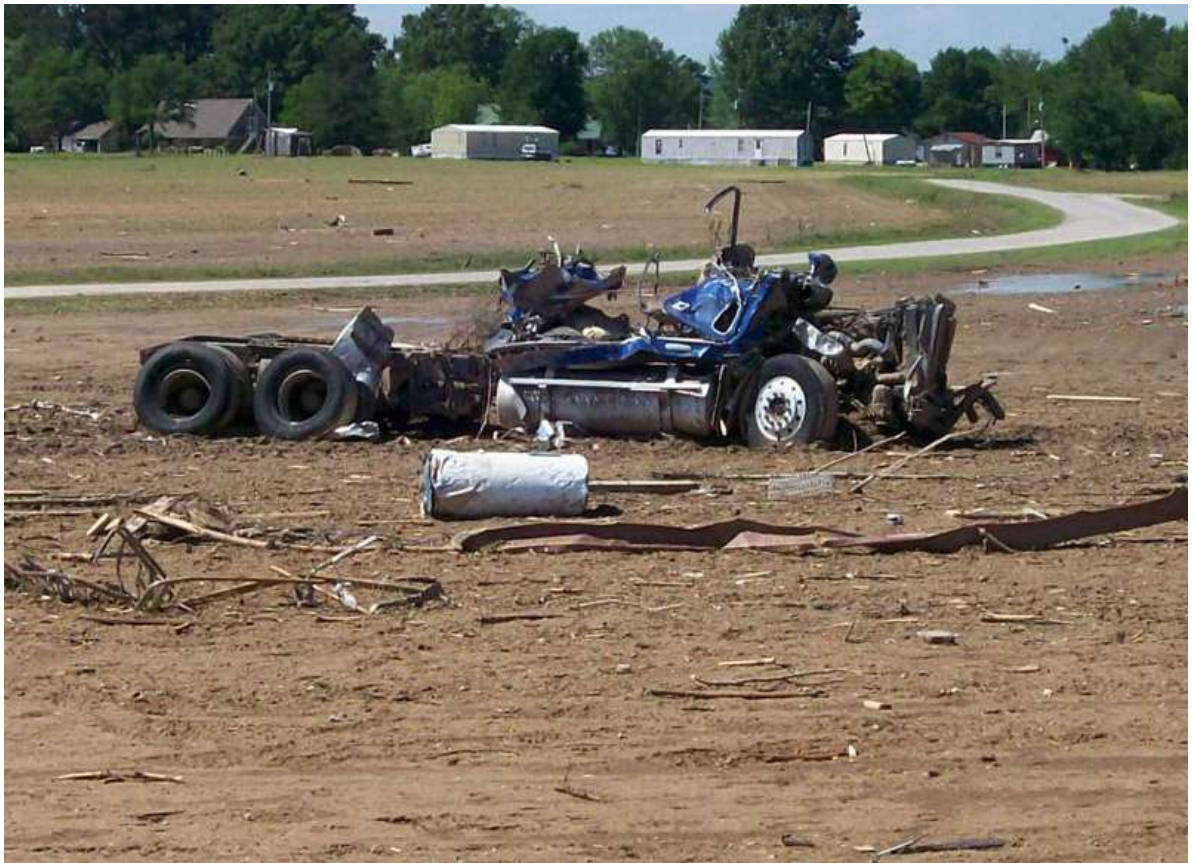
Lifted and flattened truck tractor/cab (estimated to have been tossed 1/4 to 1/2 mile). Photo location one mile west of Smithville, MS. (Photo: WFO Memphis)

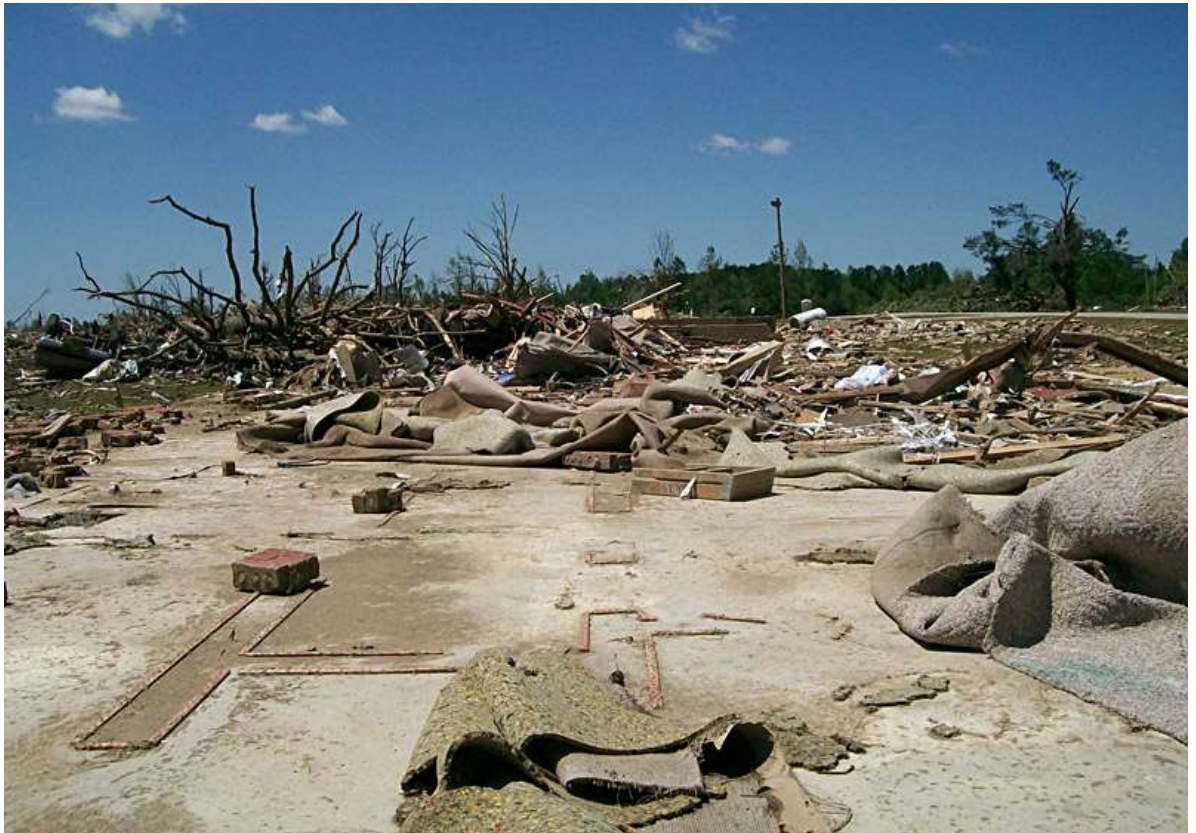
Looking north, a slab with no standing walls. Debarked hardwood trees in background. Photo location Smithville, MS. (Photo: WFO Memphis)

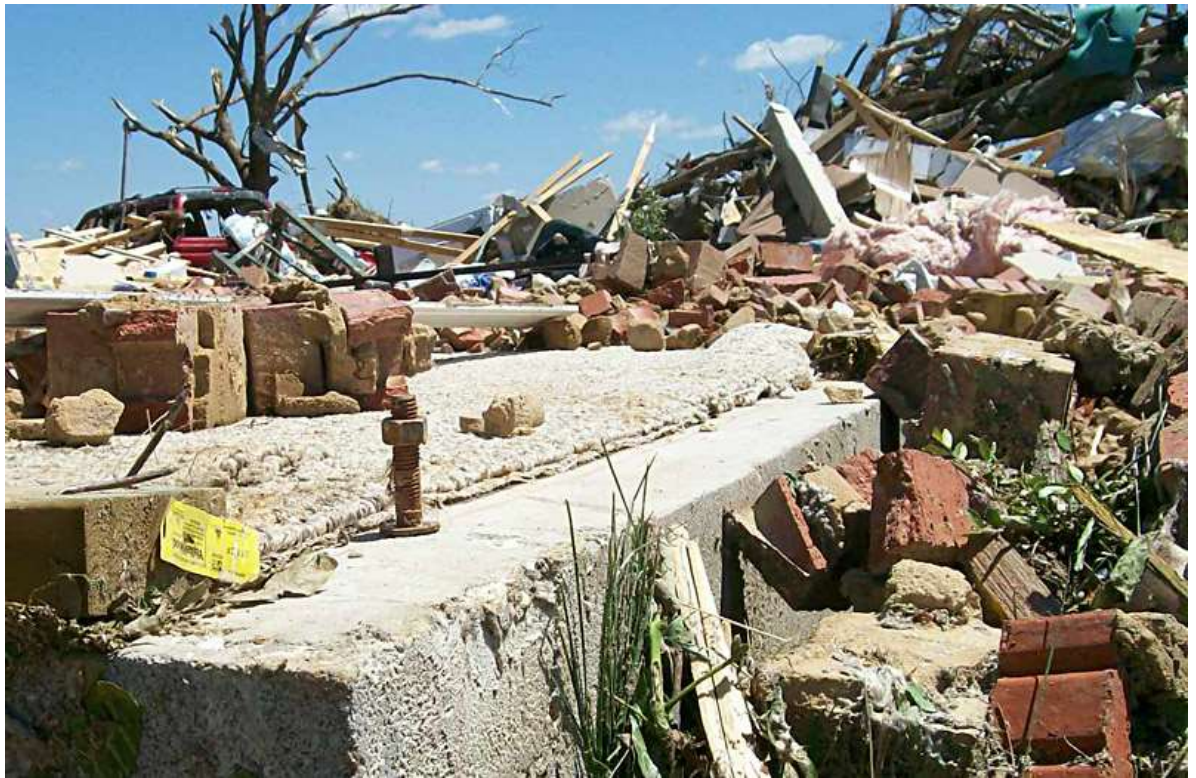
Looking south, protruding anchor bolt (washer/nut intact) from slab with base plate ripped away. No standing walls, just rubble. Debarked hardwood trees in background. Photo location Smithville, MS. (Photo: WFO Memphis)

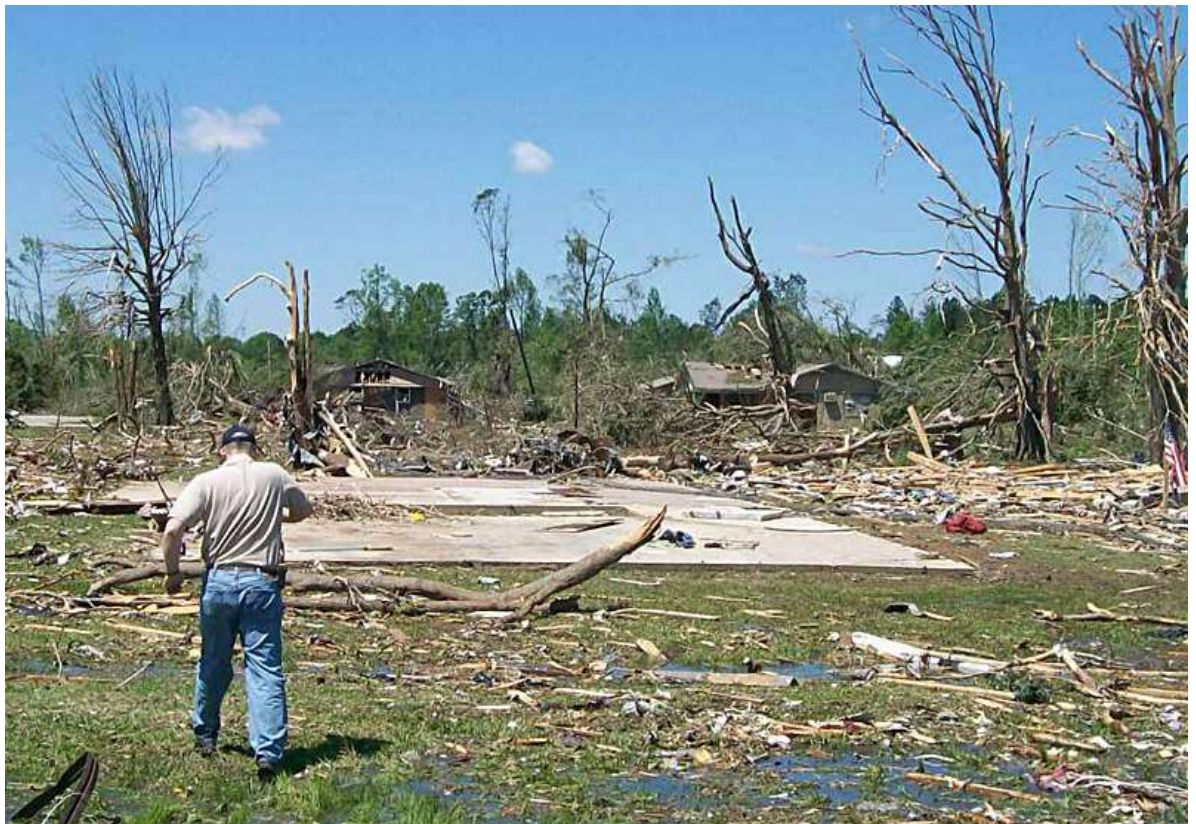
Slab wiped clean with only anchor bolts protruding from perimeter of slab. One fatality and two serious injuries at this location. Hardwood tree in background debarked. Rich Okulski, Warning coordination Meteorologist (WFO Memphis) surveying damage. Photo location one mile west of Smithville, MS. (Photo: WFO Memphis)
