CIVIL AERONAUTICS BOARD

AIRCRAFT ACCIDENT REPORT

FRONTIER AIRLINES, INC.
DOUGLAS DC-3C, N61142
MILES CITY, MONTANA
MARCH 12, 1964

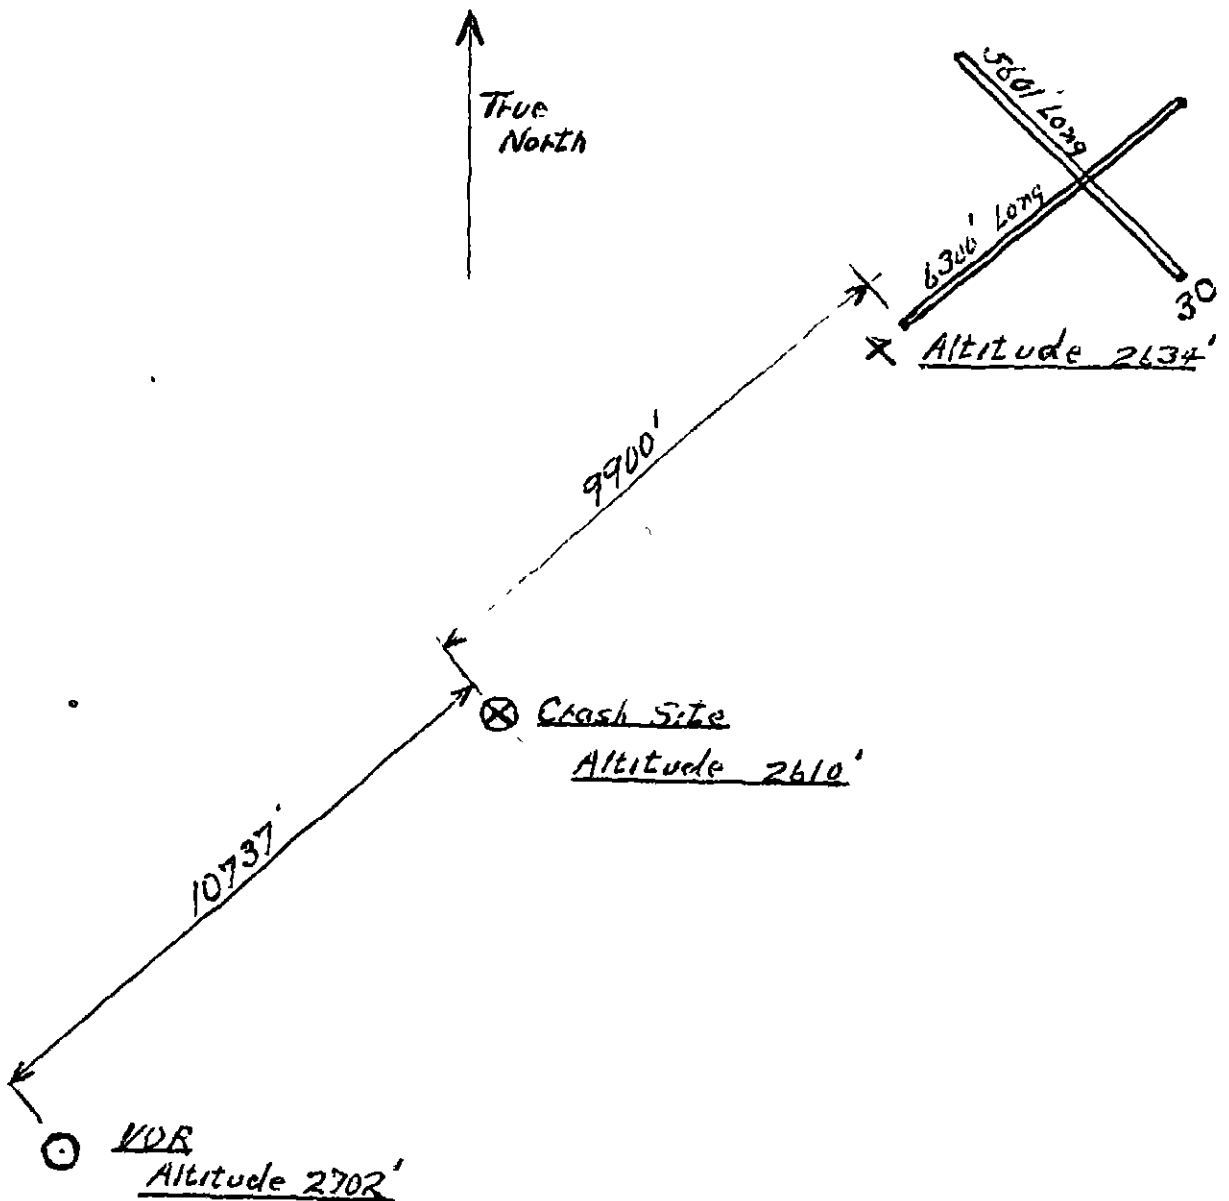
Attachment 'B'

The crash site was on a 22-degree upslope at an elevation of 2610 feet m.s.l. and 9,900 feet short of the approach end of Runway 4. The airport elevation is 2,628 feet m.s.l. and that of the VOR station is 2,702 feet m.s.l. At the time of impact the aircraft's heading was about 38 degrees magnetic and the elevation of the crest of the small rise ahead was 2,615 feet m.s.l. (See attachment "B".)
