OIL REFINERY

MISSION RESUME

Mission Number 291 3 August 1945

Target 90.17-116; Mitsubishi Oil Refinery
Target 90.17-127, Hayama Petroleum Co.

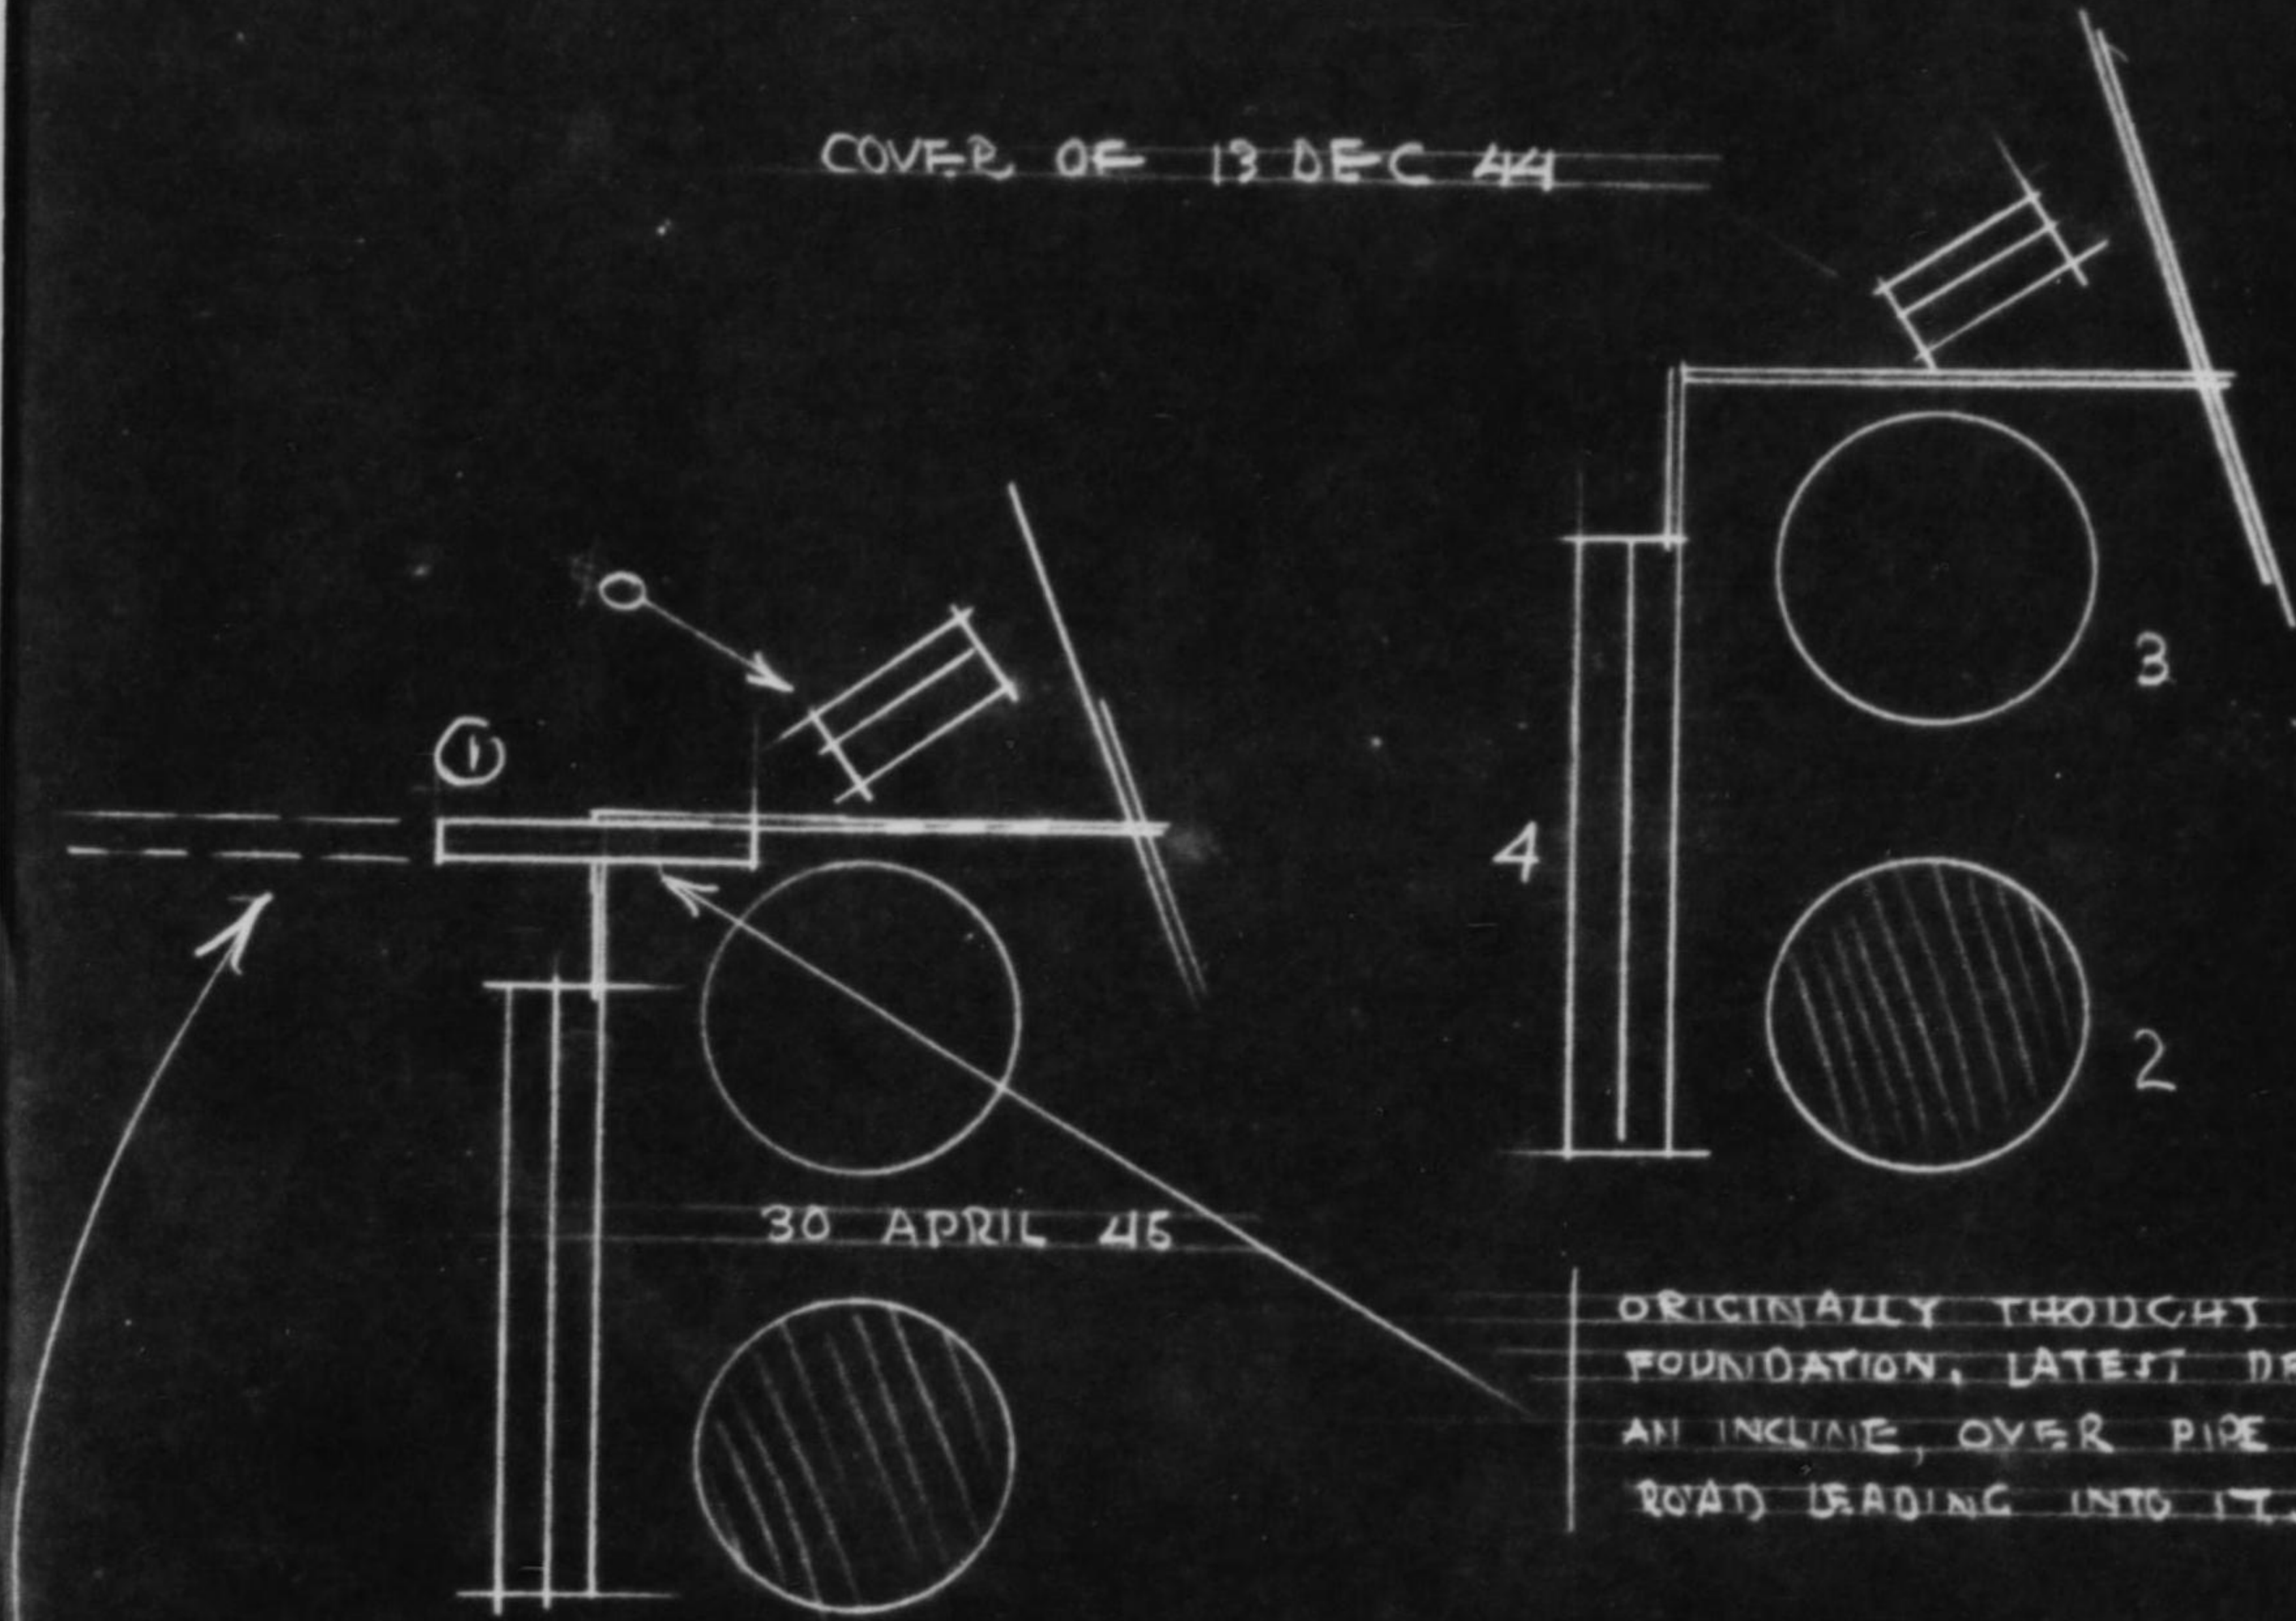
SKETCH No 1

ORIGINALLY THOUGHT TO BE A FOUNDATION, LATEST DEDUCTION IS:- AN INCLINE OVER PIPE LINE - NEW ROAD LEADING INTO IT.

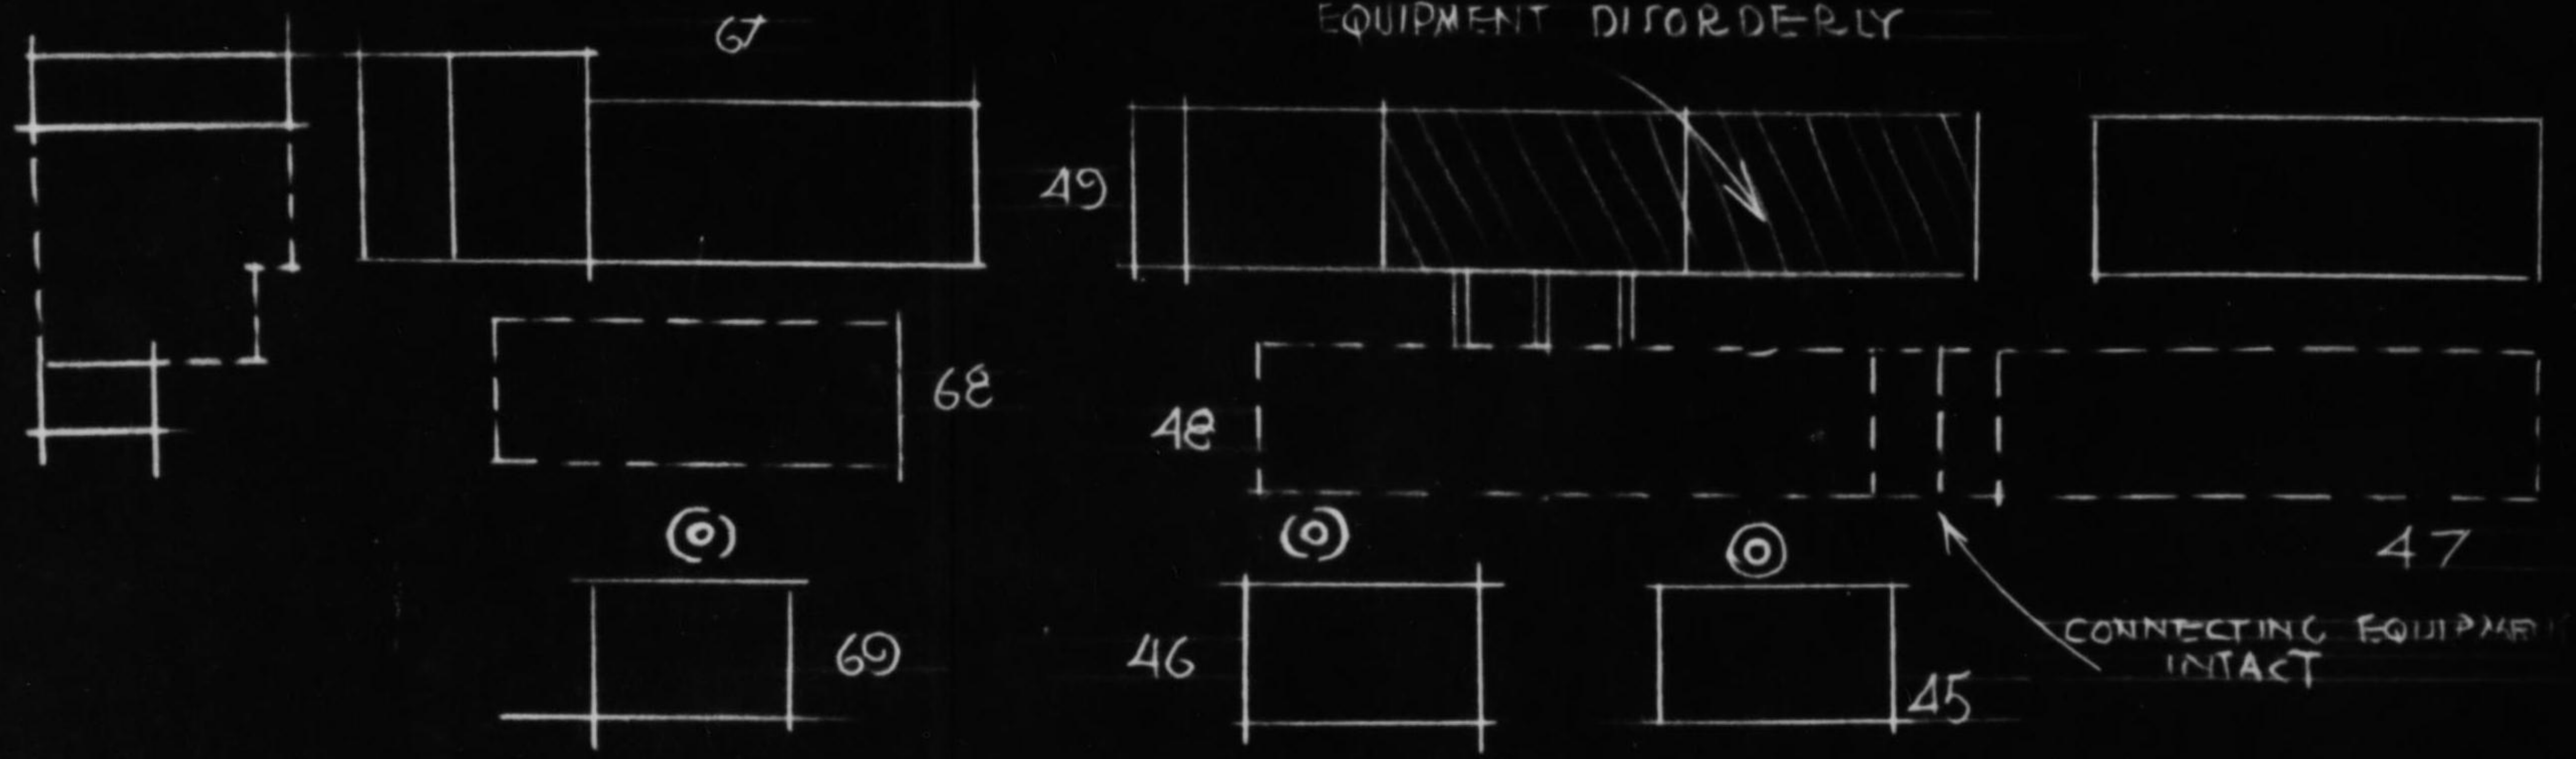
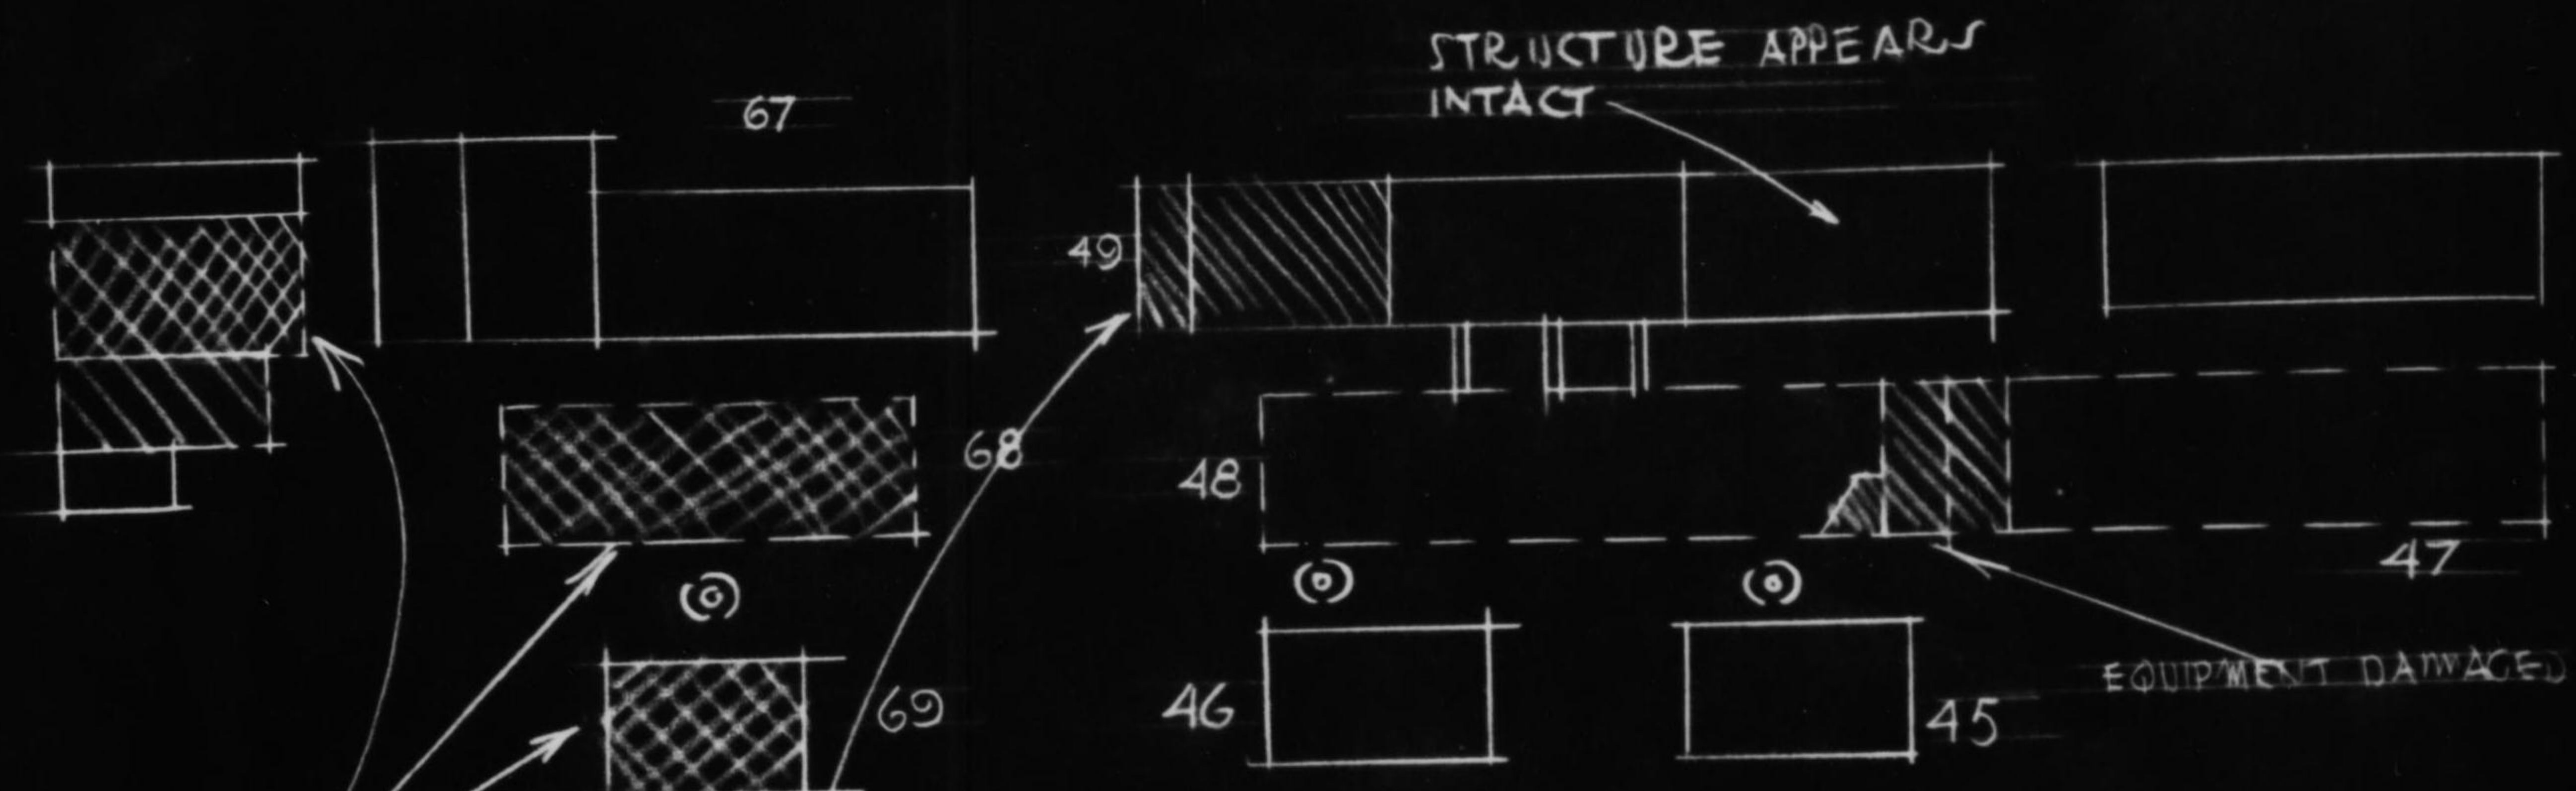
SKETCH No 2

EQUIPMENT DAMAGED

SEVERELY DAMAGED

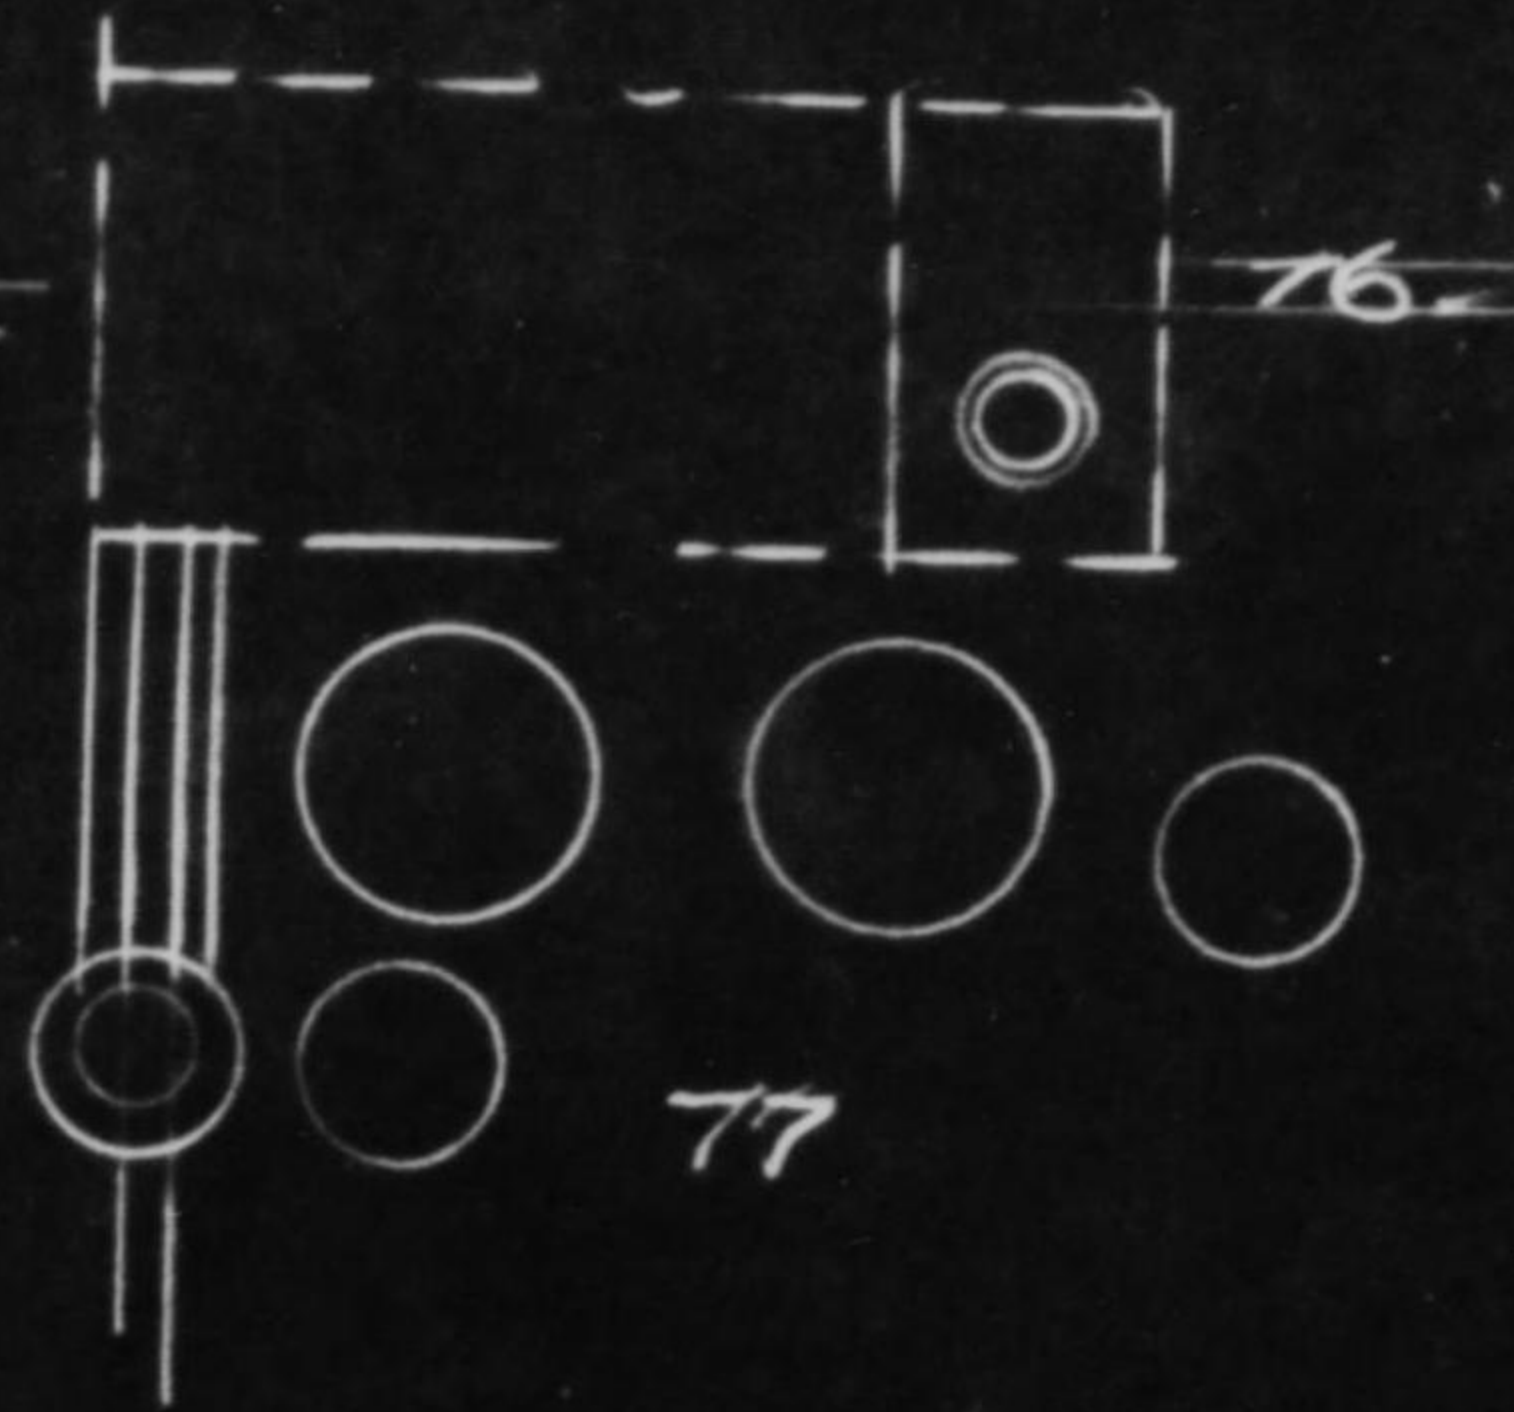
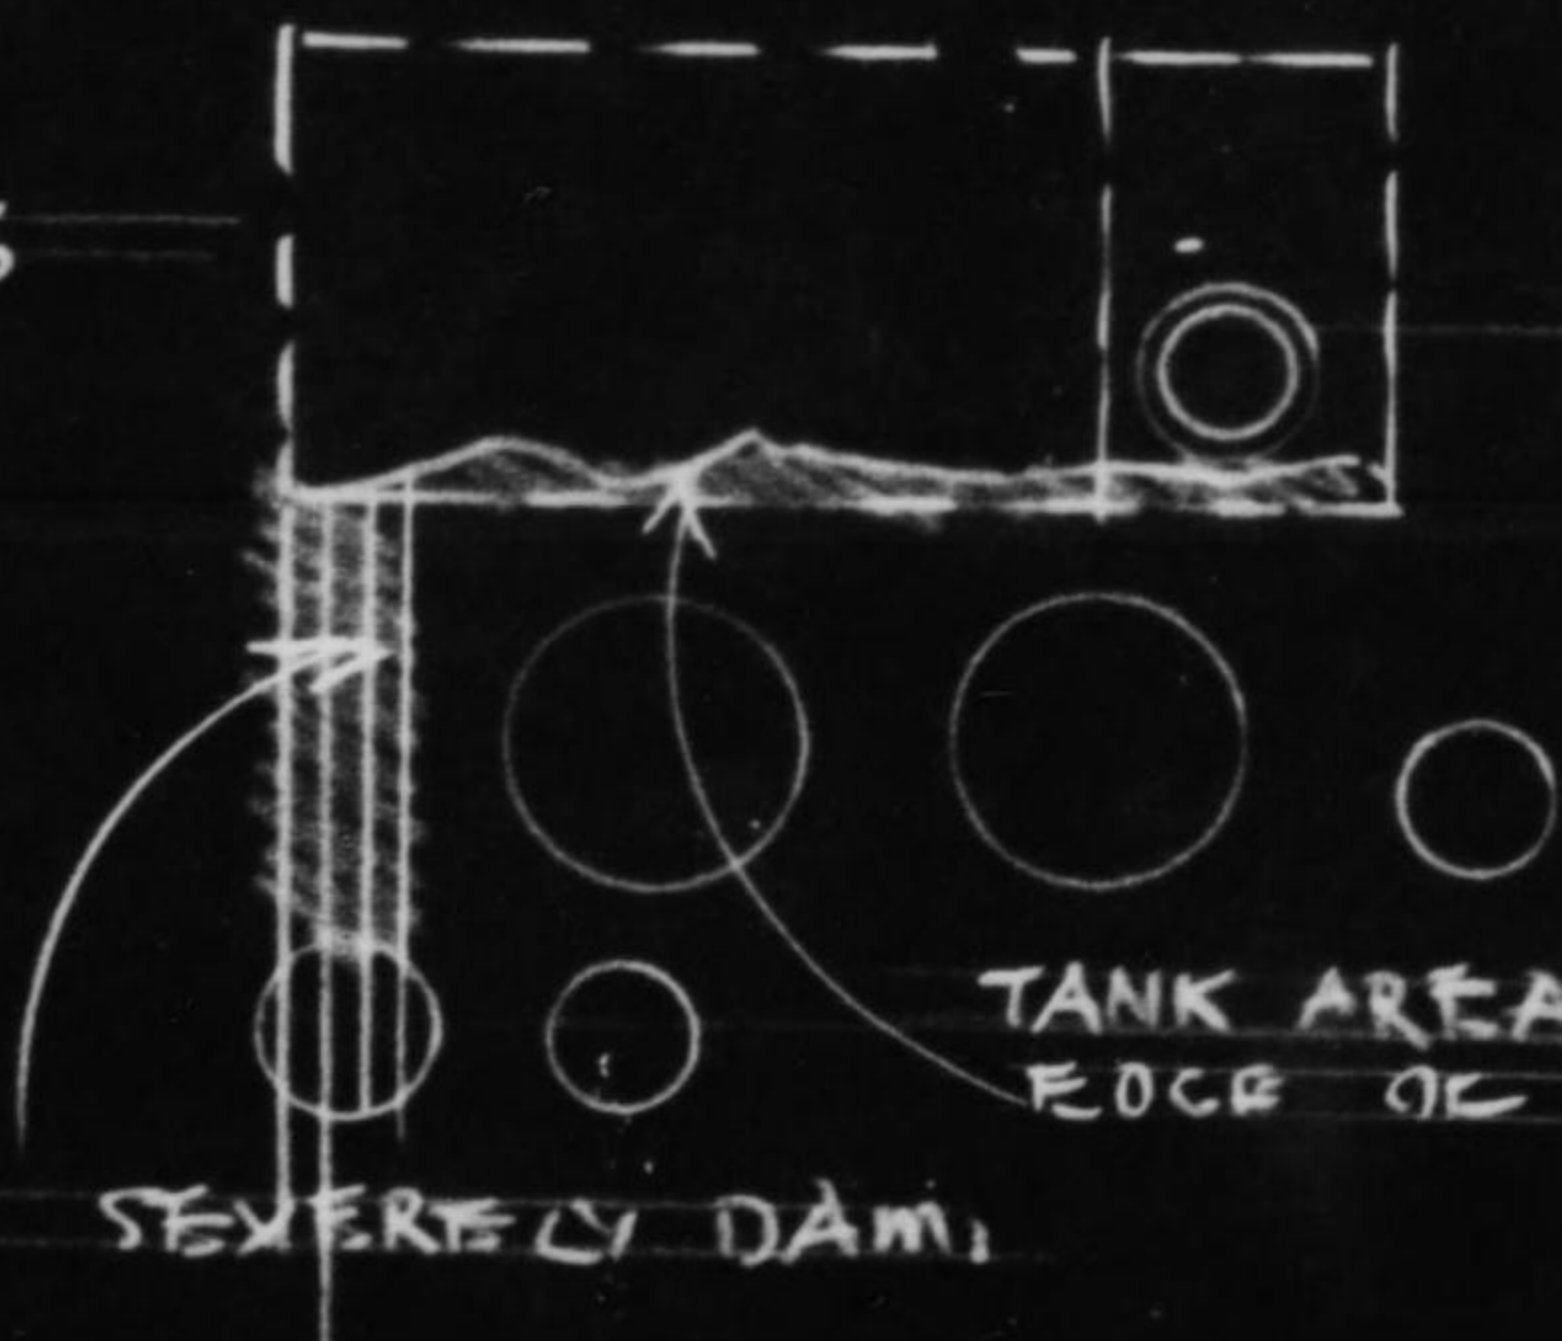
SKETCH NO. 3

65	-----	No visible damage		
66		Two tanks destroyed prior to 13 Dec 44. Three others destroyed in attack of 13/14 April 45		
67		No visible damage		
68		Demolished		
69		Demolished; chimney still standing		
	A	Small building destroyed		
	B	No visible damage		
	C	Destroyed		
70		Severely damaged		
71 to 74, incl.		No visible damage		
75		Cover is too hazy to distinguish details.		
76		Possible damage to southwest corner of unit, see sketch

PIPES SEVERELY DAM.

TANK AREA DAMAGED
EDGE OF UNIT SEEMS CHIPPED

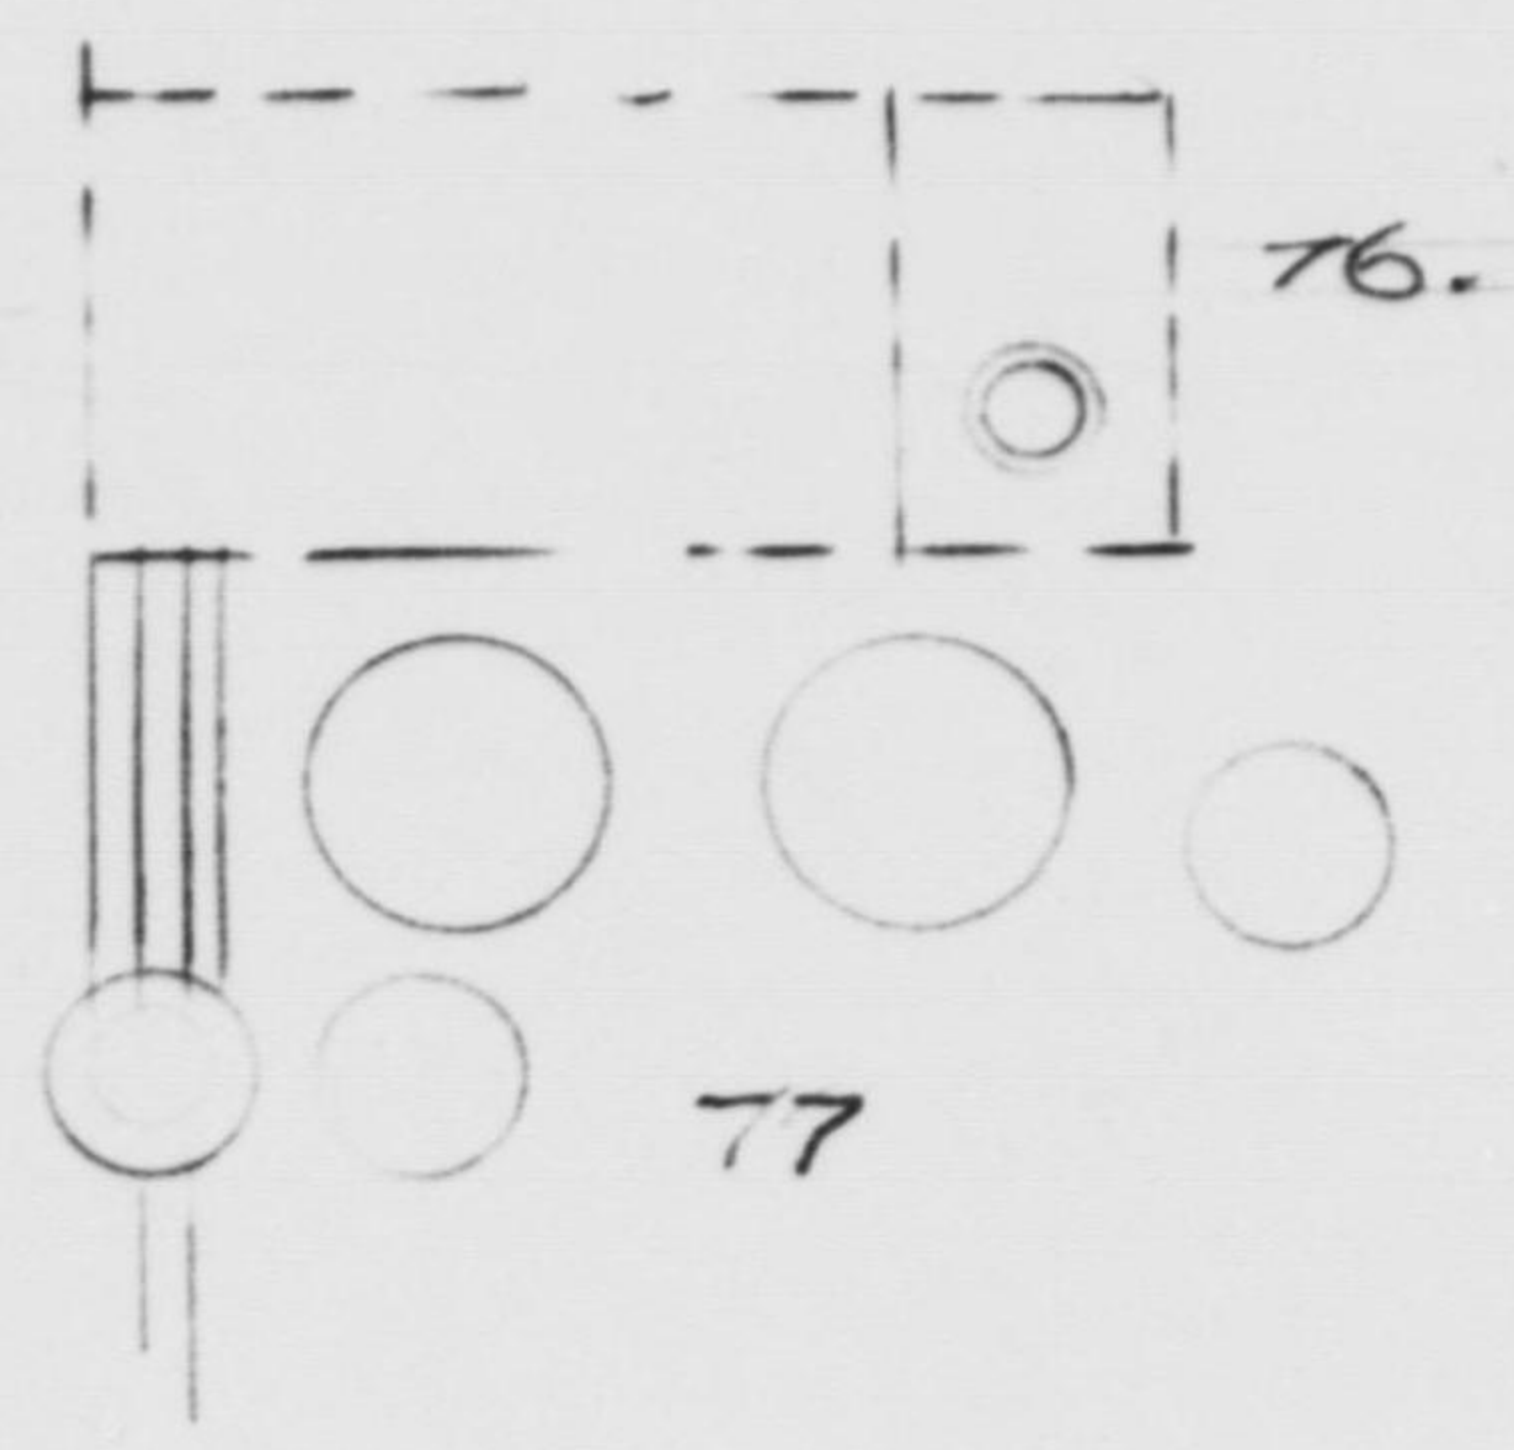
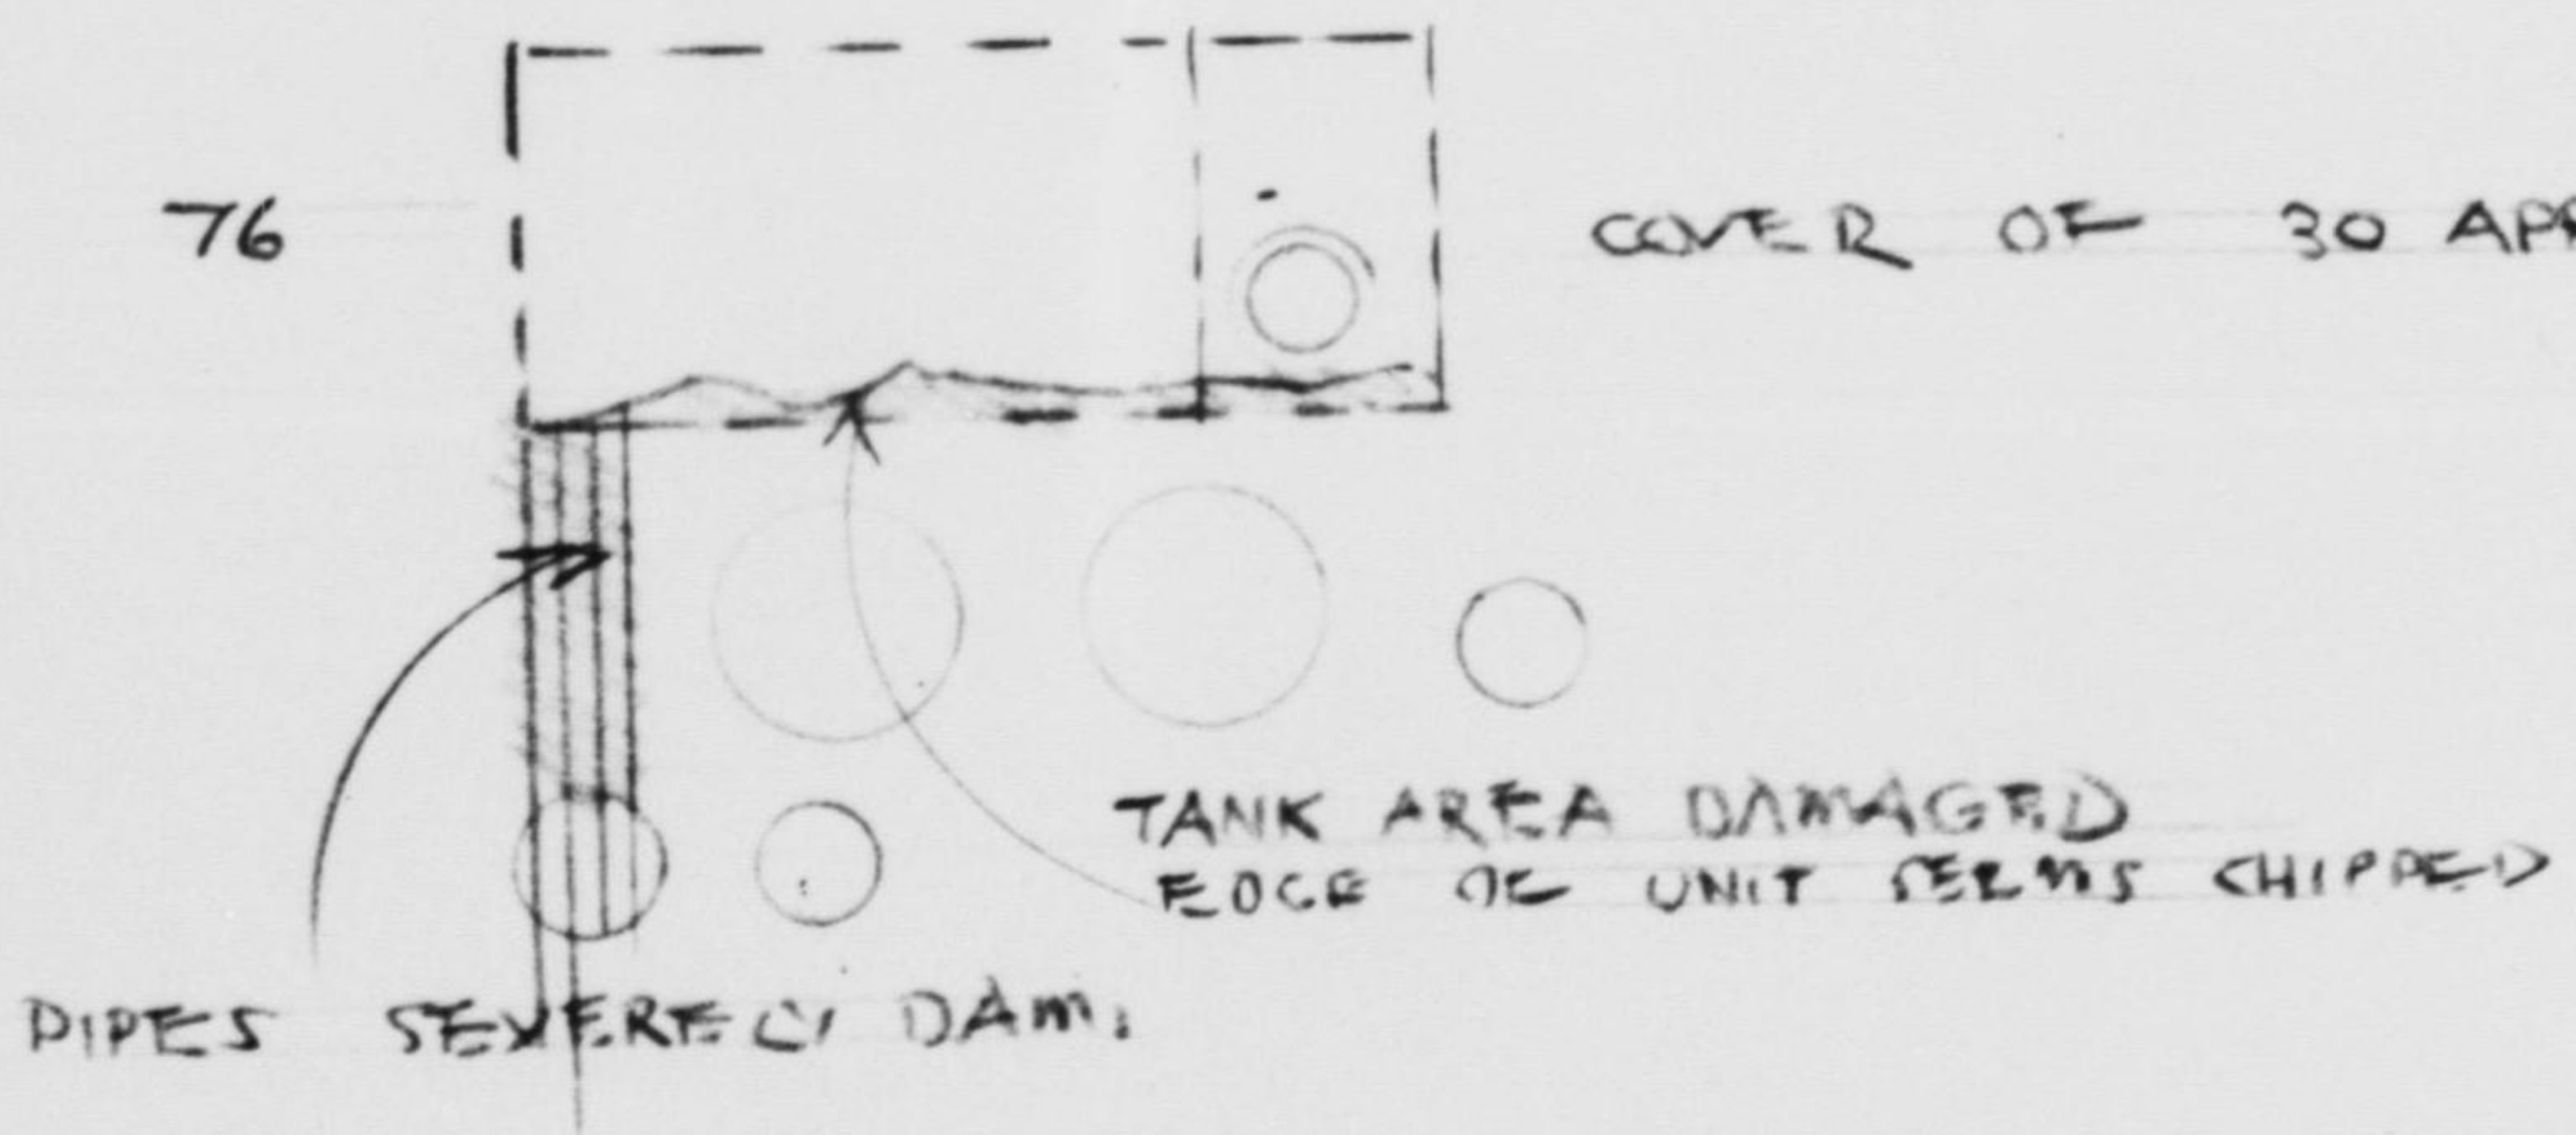
SKETCH No. 3

65	-----	No visible damage		
66		Two tanks destroyed prior to 13 Dec 44. Three others destroyed in attack of 13/14 April 45		
67		No visible damage		
68		Demolished		
69		Demolished; chimney still standing		
	A	Small building destroyed		
	B	----- No visible damage		
	C	Destroyed		
70		Severely damaged		
71 to 74, incl.		No visible damage		
75		Cover is too hazy to distinguish details.		
76		Possible damage to southwest corner of unit, see sketch

PIPES SEVERELY DAMAGED

TANK AREA DAMAGED
EDGE OF UNIT SEEMS CHIPPED

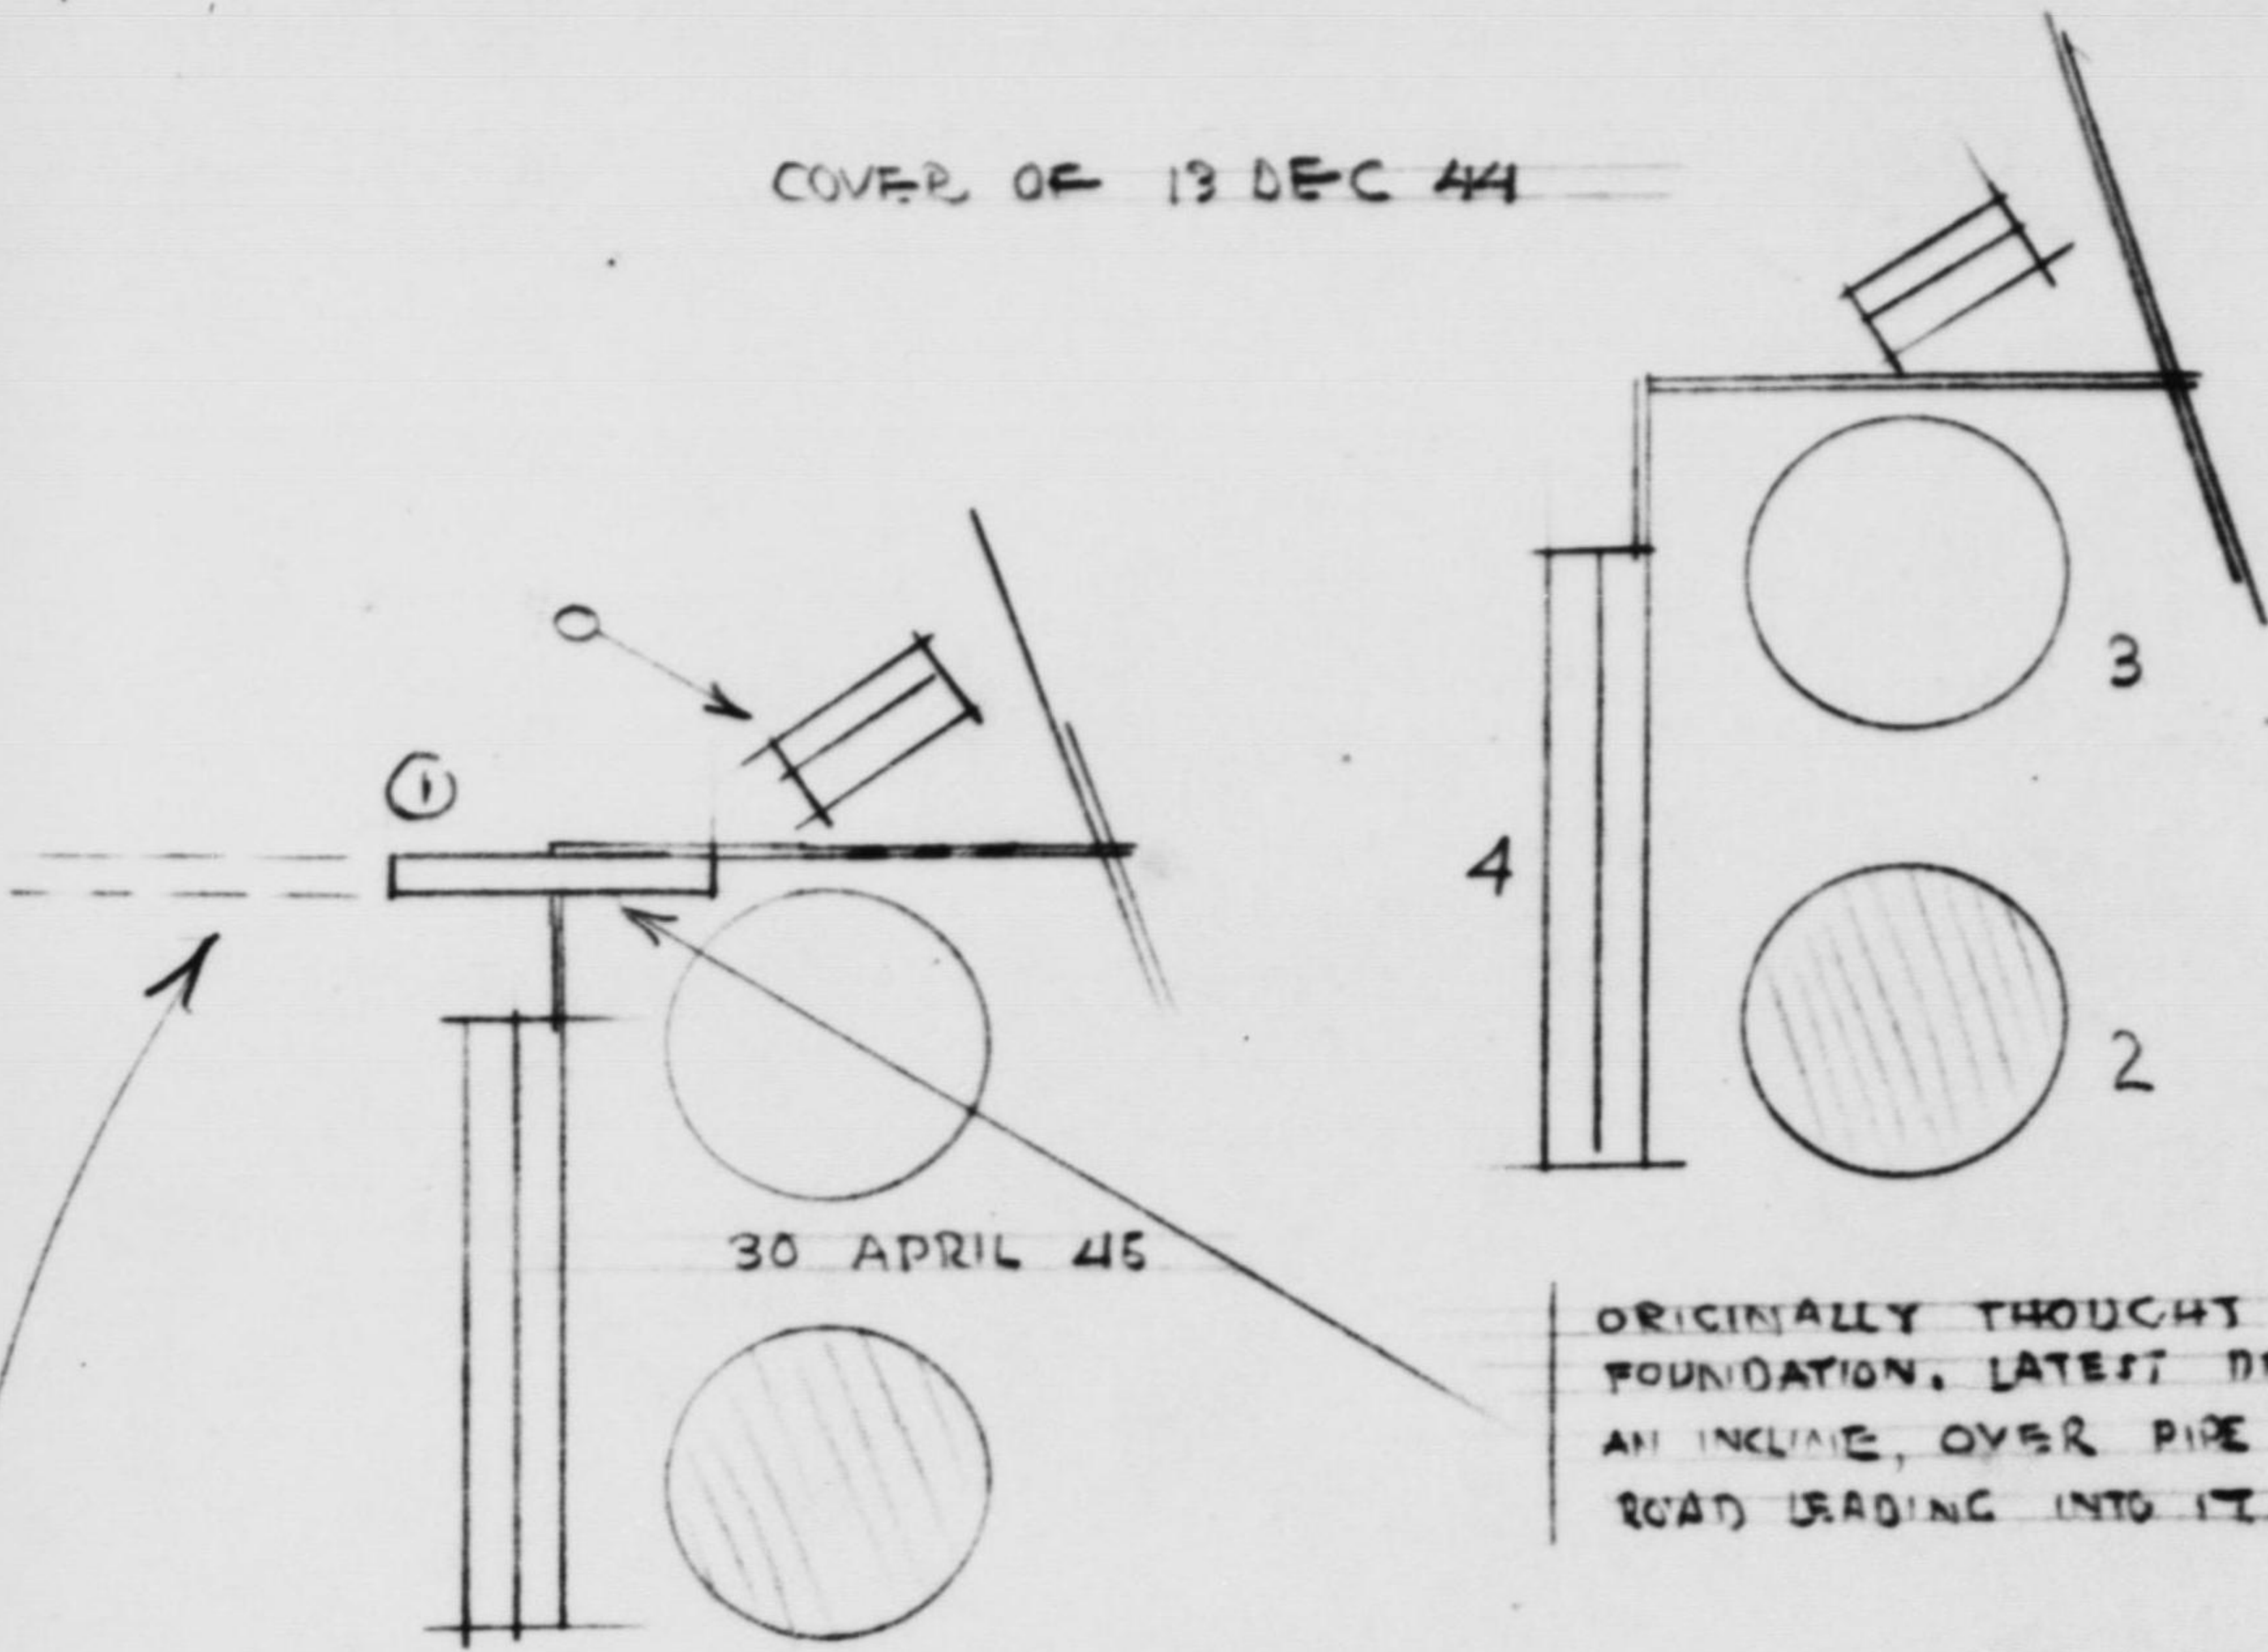
SKETCH No 1

ORIGINALLY THOUGHT TO BE A
FOUNDATION. LATEST DEDUCTION IS:-
AN INCLINE, OVER PIPE LINE - NEW
ROAD LEADING INTO IT.
