OIL REFINERY

MISSION RESUME

Mission Number 291 3 August 1945

Target 90.17-116; Mitsubishi Oil Refinery
Target 90.17-127, Hayama Petroleum Co.

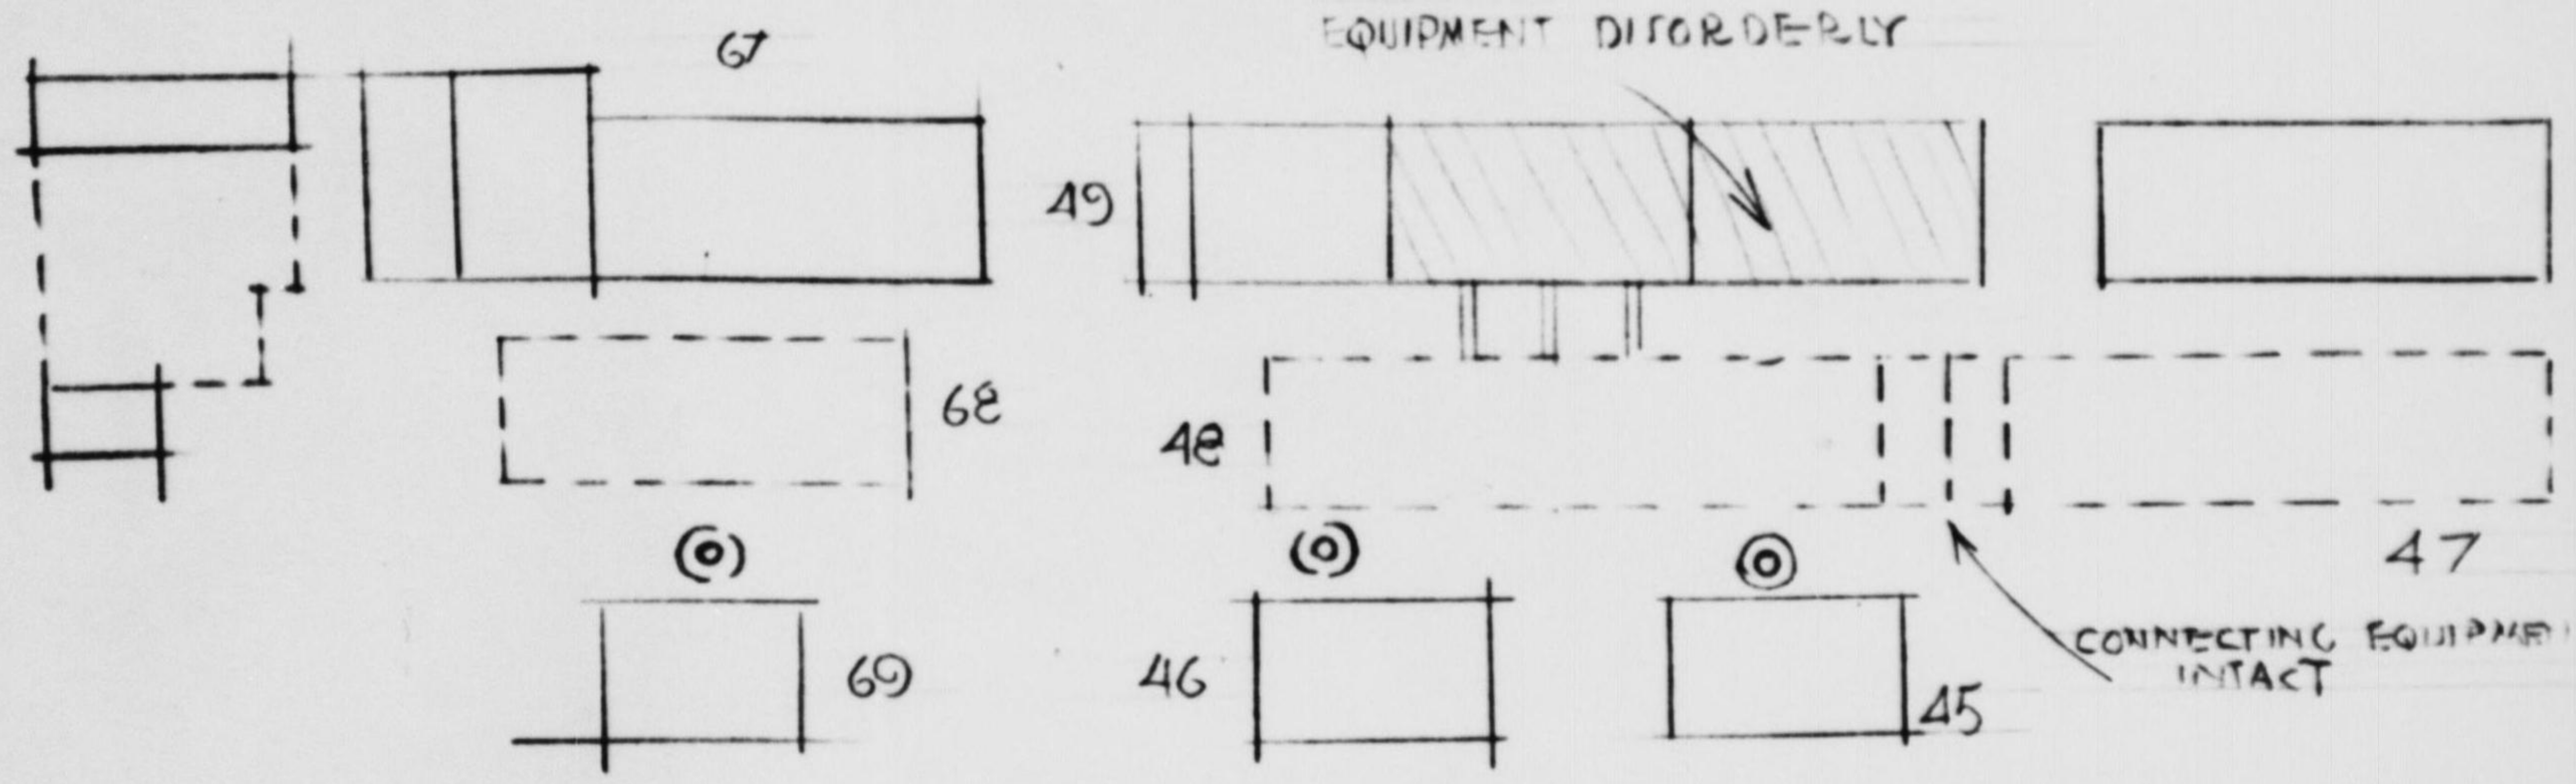
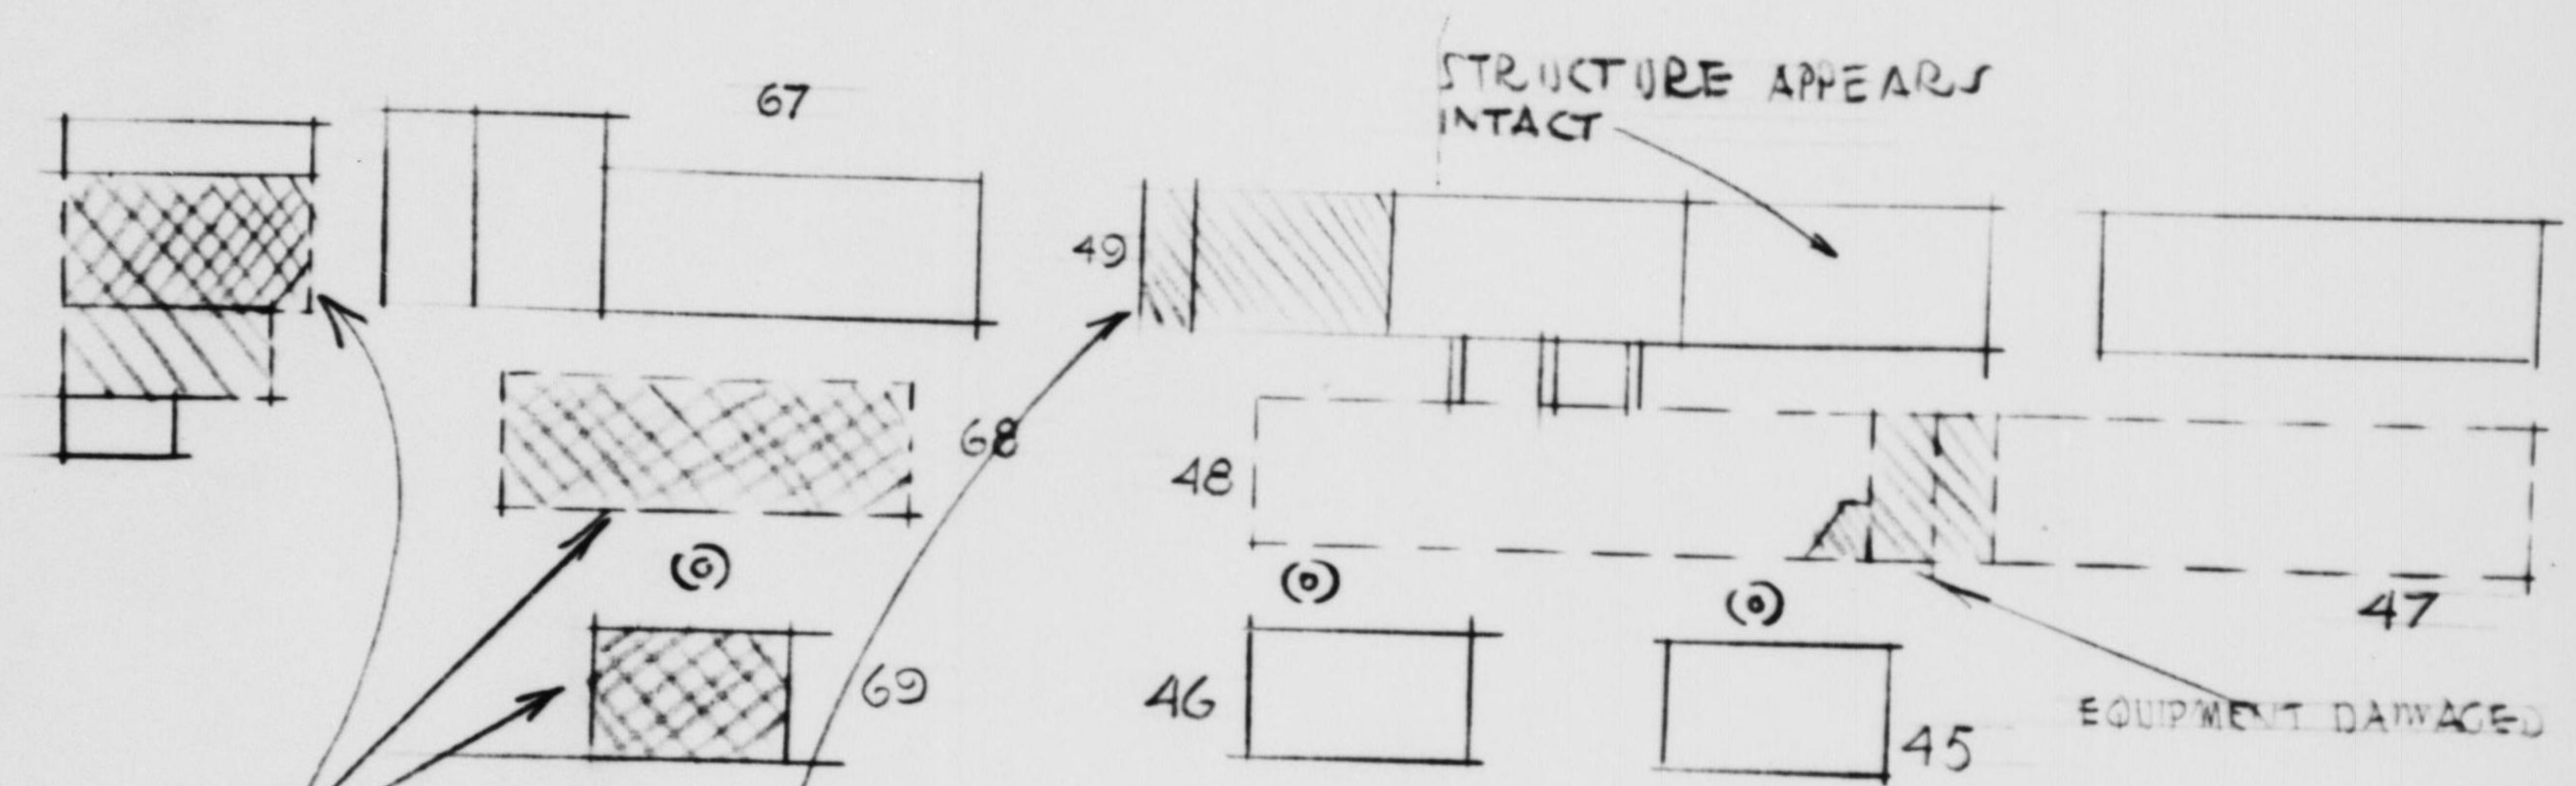
SKETCH No 2

DEMOLISHED

SEVERELY DAMAGED

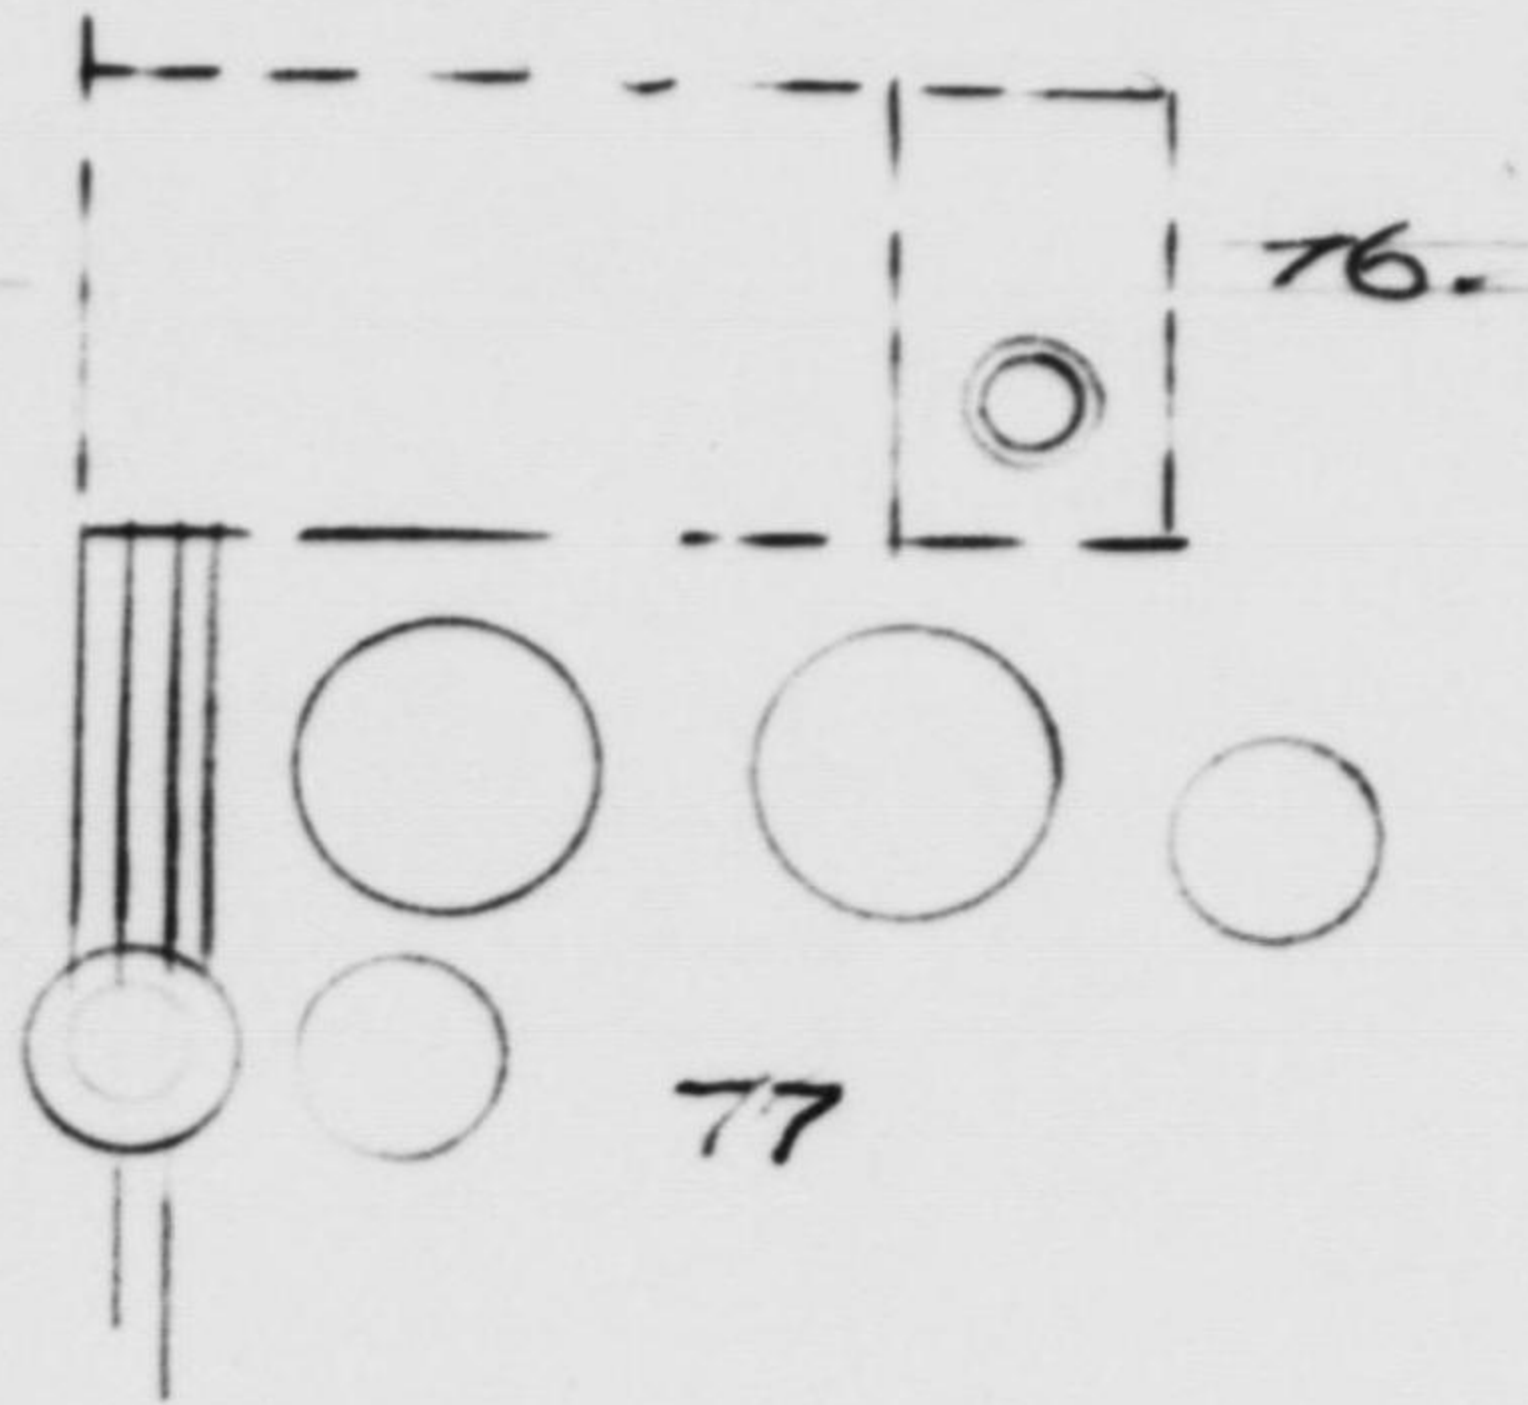
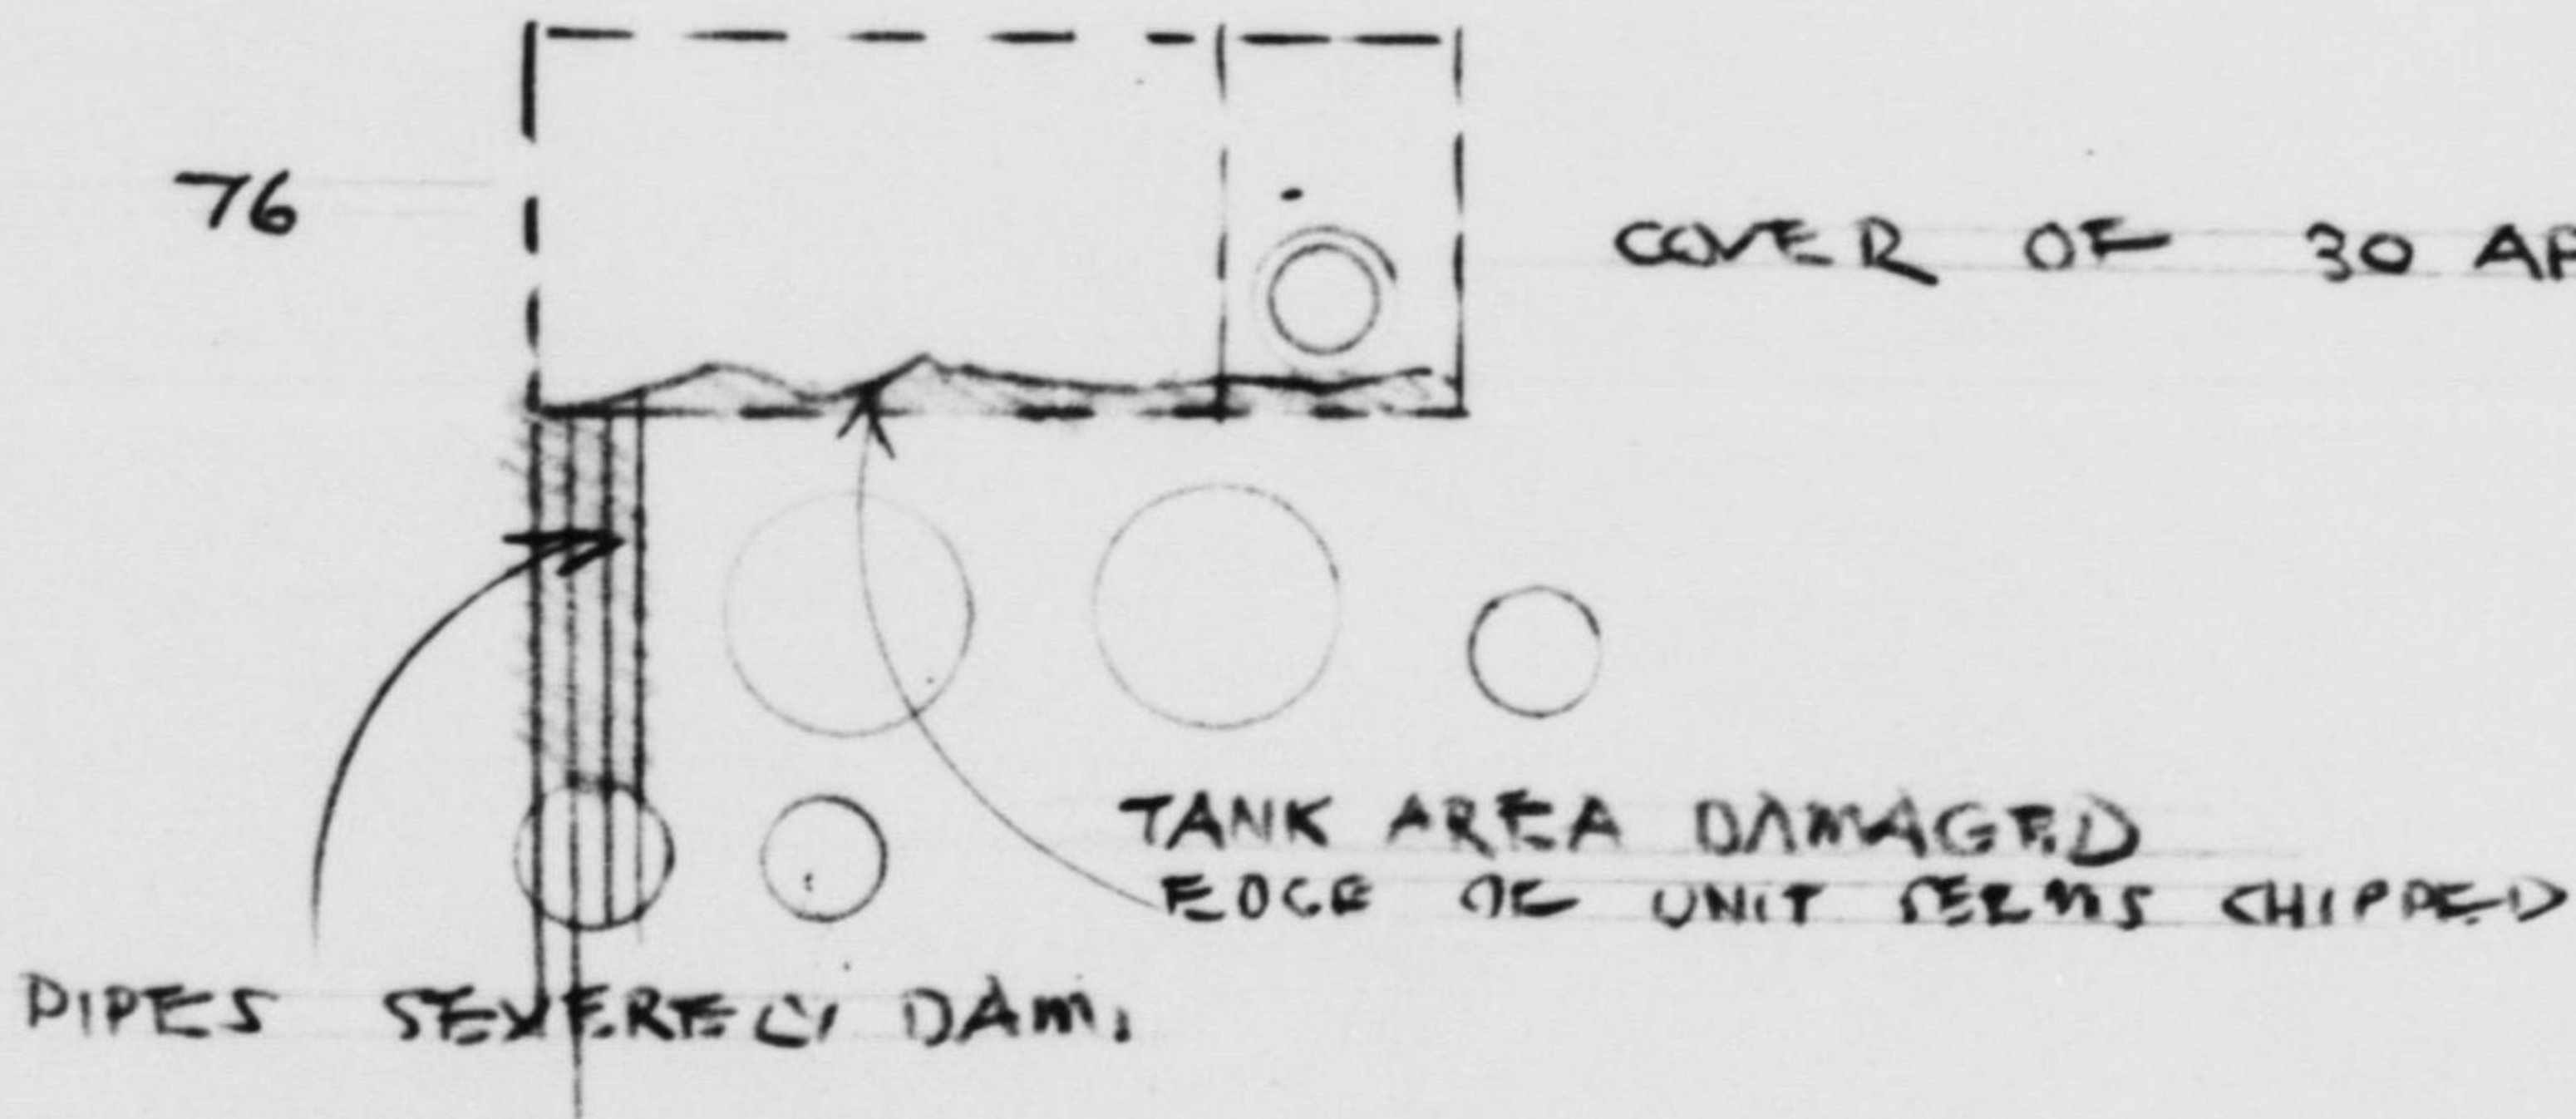
SKETCH No. 3

65	-----	No visible damage		
66		Two tanks destroyed prior to 13 Dec 44. Three others destroyed in attack of 13/14 April 45		
67		No visible damage		
68		Demolished		
69		Demolished; chimney still standing		
	A	Small building destroyed		
	B	No visible damage		
	C	Destroyed		
70		Severely damaged		
71 to 74, incl.		No visible damage		
75		Cover is too hazy to distinguish details.		
76		Possible damage to southwest corner of unit, see sketch

PIPES SEVERELY DAMAGED

TANK AREA DAMAGED
EDGE OF UNIT SEEMS CHIPPED
