INVESTIGATION NO. 2597  
THE ATCHISON, TOPEKA & SANTA FE RAILWAY COMPANY  
REPORT IN RE ACCIDENT  
NEAR CALZONA, CALIF., ON  
JUNE 25, 1942

Railroad: Atchison, Topeka & Santa Fe  
Date: June 25, 1942  
Location: Colzosa, Calif.  
Kind of accident: Derailment  
Train involved: Passenger  
Train number: 117  
Engine number: 3520  
Consist: 4 cars  
Speed: 35-40 m. p. h.  
Operation: Timetable and train orders  
Track: Single; tangent; 0.20 percent  
ascending grade westward  
Weather: Clear  
Time: About 10:30 p. m.  
Casualties: 2 killed; 31 injured  
Cause: Accident caused by bridge being  
burned out

Accident near Calzona, Calif., on June 25, 1942, caused by  
a bridge being burned out.

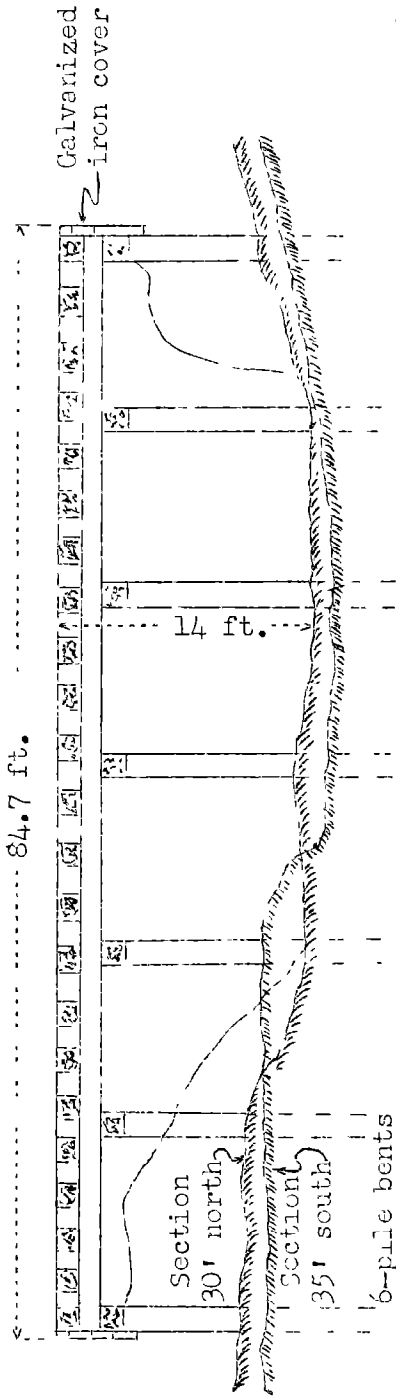
Side view of Bridge 111-B

Bridge 111-B, an open-deck 7-bent pile-and-timber trestle, 84.7 feet in length, was rebuilt during September, 1925. The bents were spaced 14 feet apart. Each bent consisted of 6 piles, which were sway-braced. The minimum penetration of the piles was 13 feet 3 inches and the maximum, 22 feet 6 inches. The caps were 12 inches by 14 inches by 14 feet. Two 4-ply chords of 7-inch by 16-inch stringers were provided. The ties were 6 inches by 3 inches by 9 feet and were spaced about 6 inches apart. The caps and the stringers were covered by No. 26 galvanized iron. The maximum height of the trestle was 14 feet. All material, except the stringers and the bulkheads, was treated wood.

The investigation disclosed that prior to the time of the accident all the deck and practically all the piles of this bridge had been destroyed by fire. The manner in which the bridge was burned indicated that the fire had started at the bottom of the bents and burned upward. Some of the piles were burned 4 to 5 inches below the ground level. Immediately after the accident occurred no flame was visible, but the abutment bents were still smouldering. Ashes had been blown away by a 35-mile-per-hour wind that had prevailed throughout the evening. Charcoal and ashes from the bridge were found at points 500 feet north of the location of the bridge. The evidence indicates that only the rails remained in place. Because of tangent track throughout a distance of 1,089 feet east of Bridge 111-B, the enginemen could have had an unobstructed view of the bridge. Since both enginemen were killed in the accident it could not be determined when they first became aware of the defective condition of the bridge, but apparently the engine was close to the east end of the bridge as the brakes were not applied until about 2 seconds before the accident occurred.
