AIRCRAFT ACCIDENT REPORT

SPECTRUM AIR, INC.
Sabre Mark 5, N275X
Sacramento, California
September 24, 1972
Adopted: March 28, 1973

NATIONAL TRANSPORTATION SAFETY BOARD
Washington, D.C. 20591
Report Number: NTSB-AAR-73-6

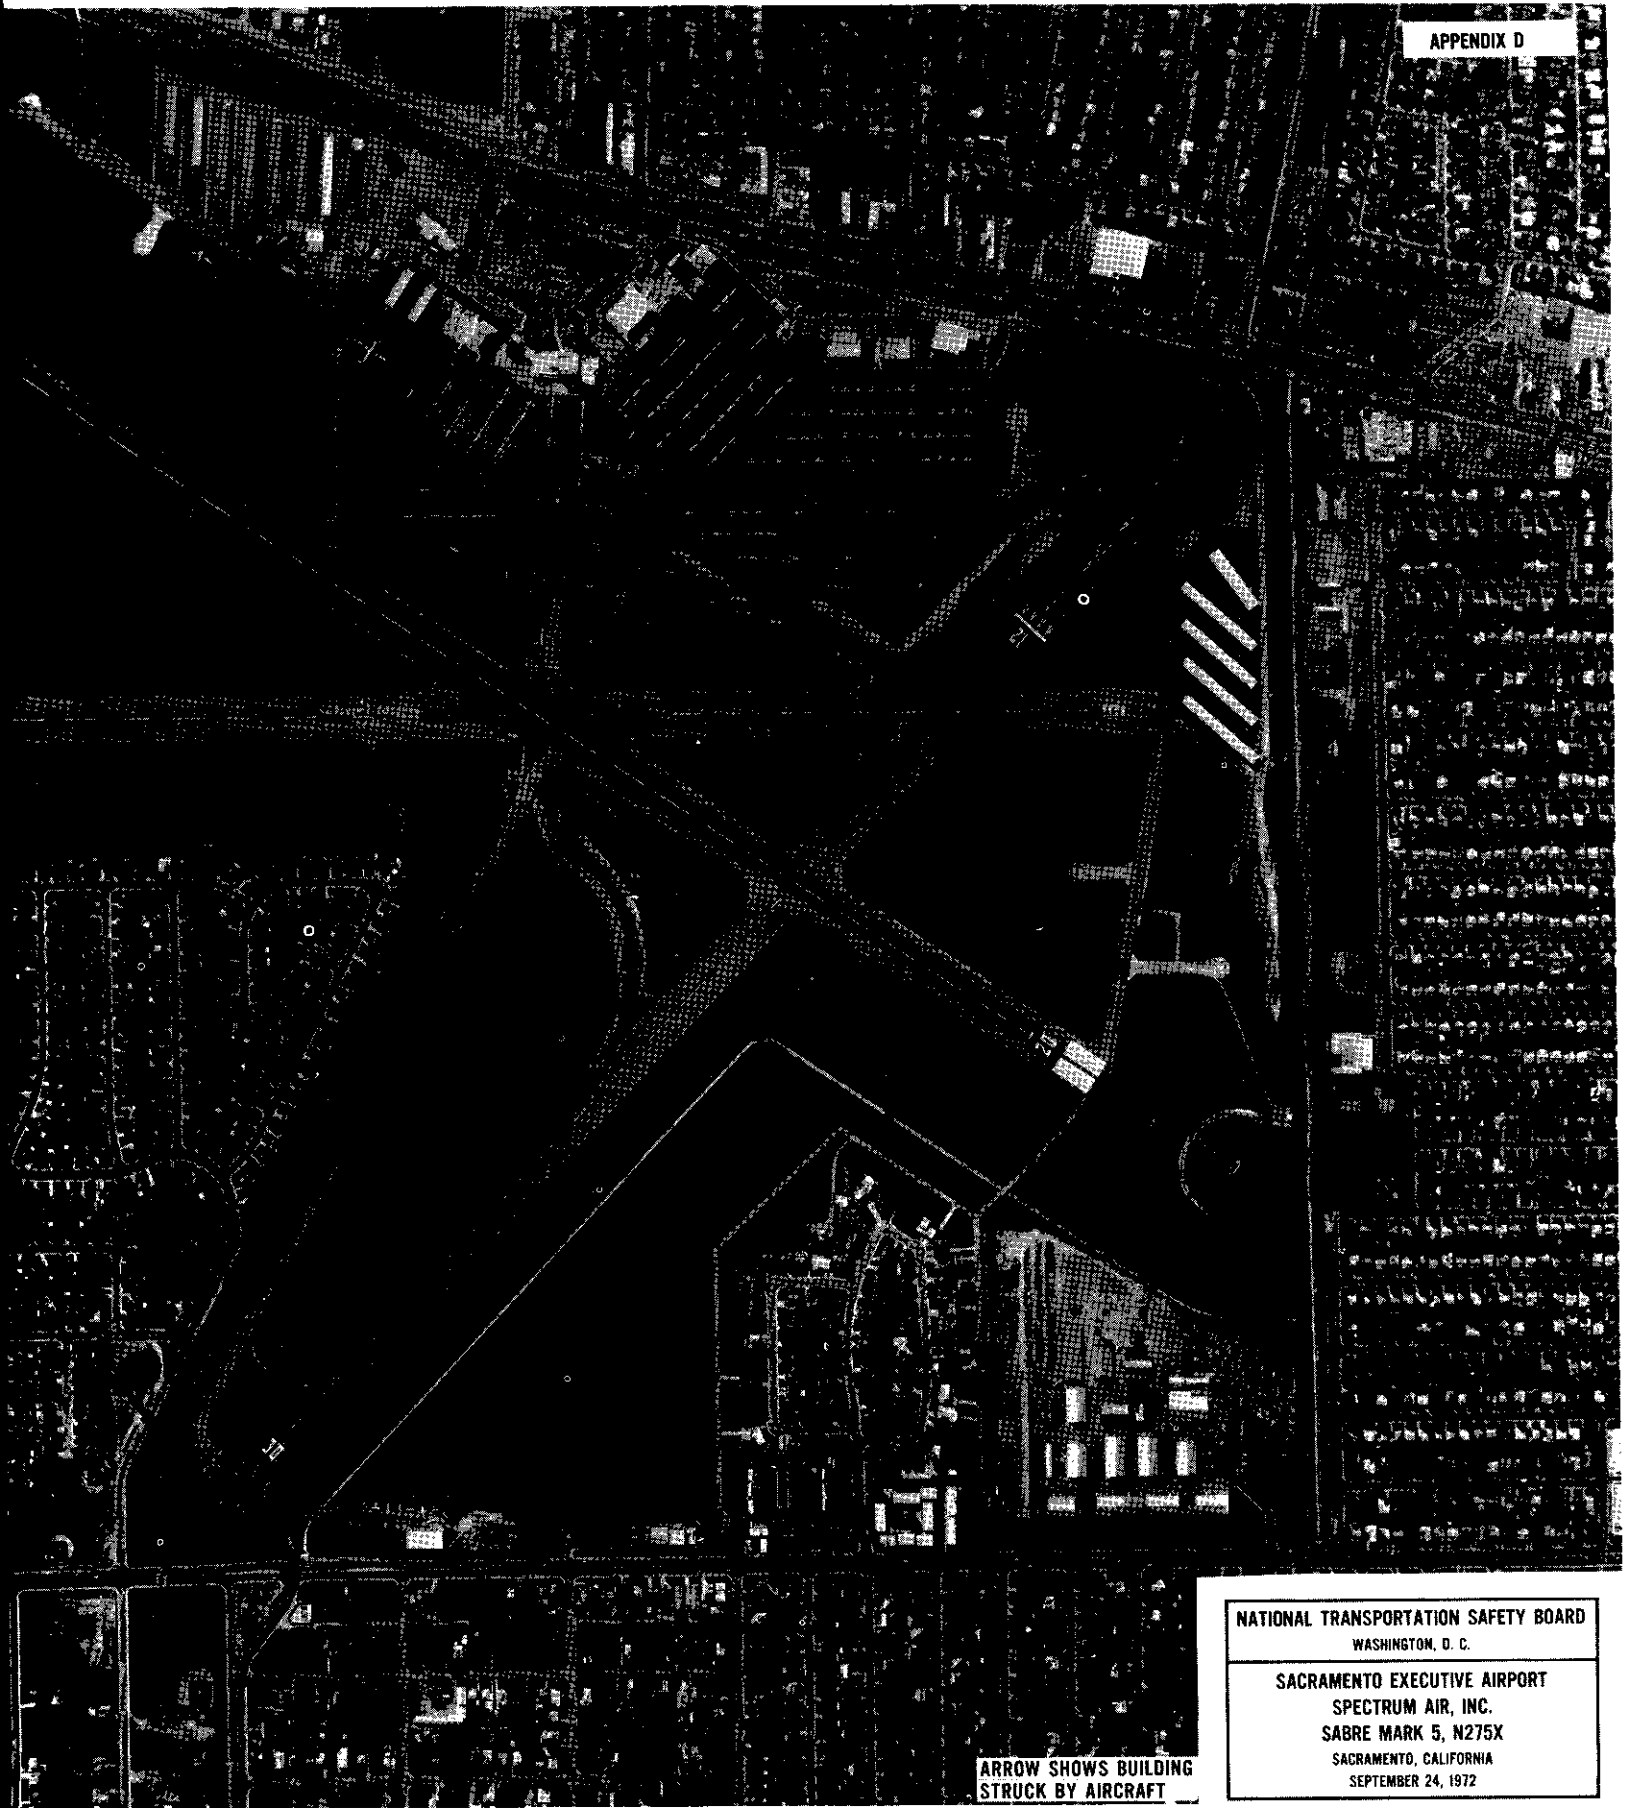
ARROW SHOWS BUILDING
STRUCK BY AIRCRAFT
