**Factual Report, Aviation, NTSB Form 6120.4**

**FACTUAL REPORT  
AVIATION  
ACCIDENT/INCIDENT**

FTW-88-M-A109

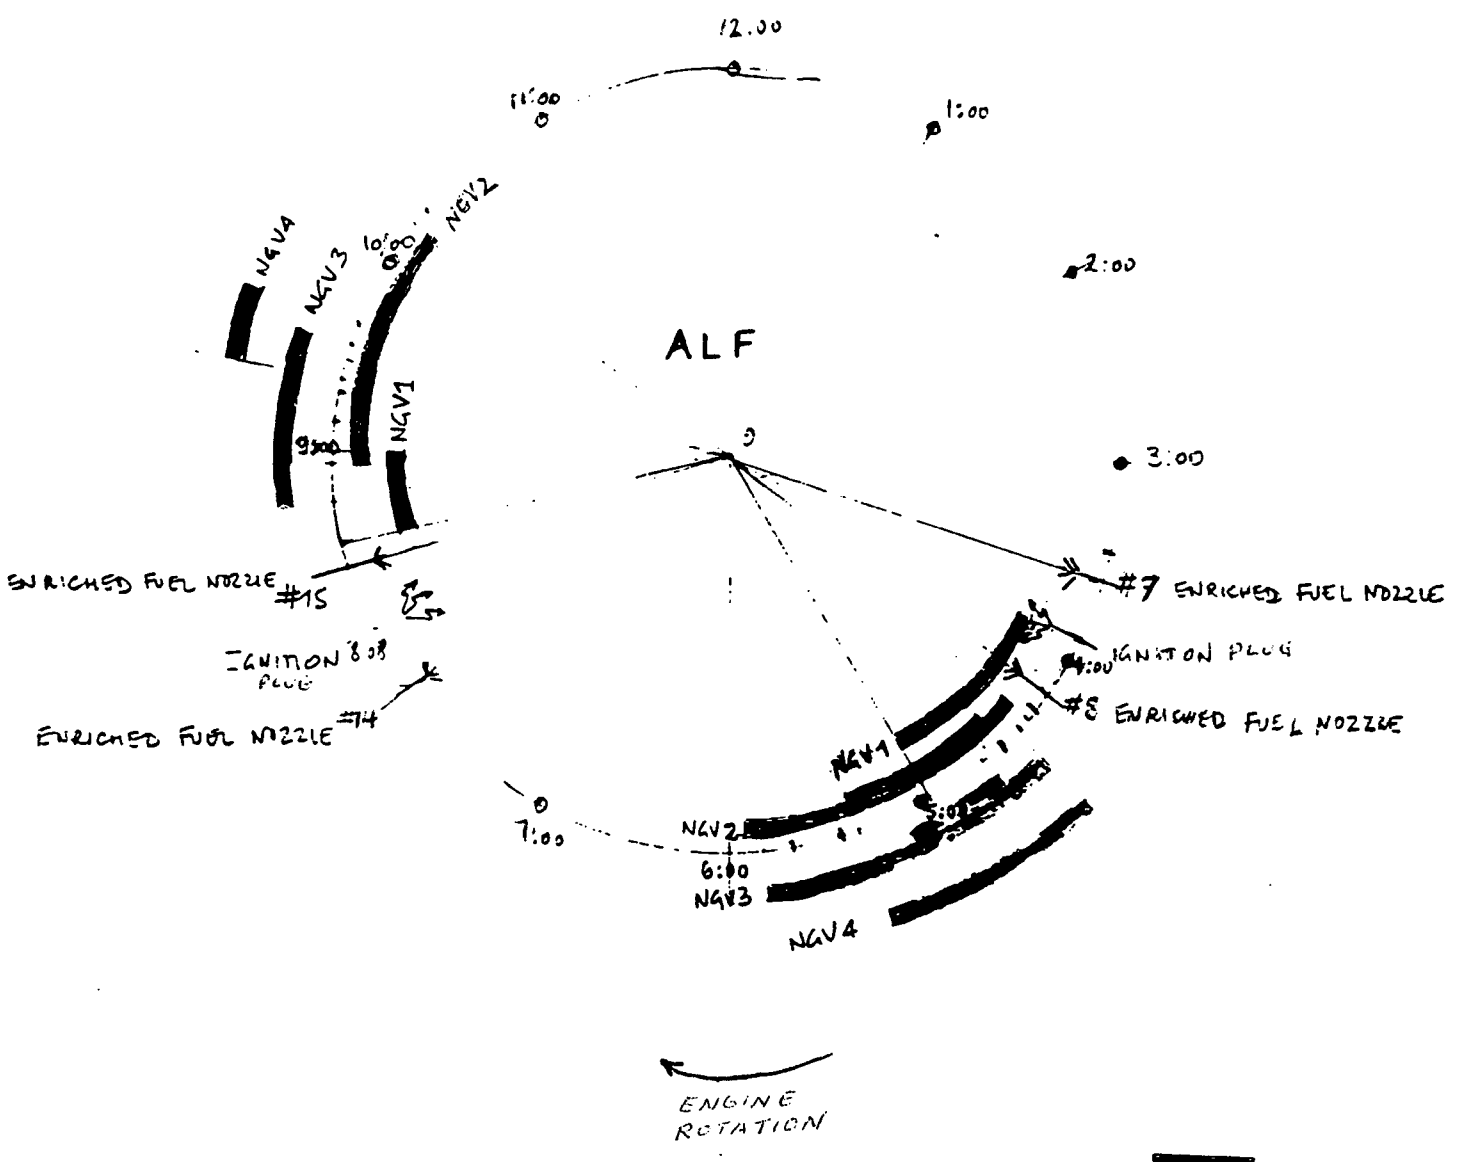
~~XXXXXXXXXX~~  
 RANGE OF NGV  
 OVERTEMPERATURE DAMAGE  
 LOW PRESSURE TURBINE

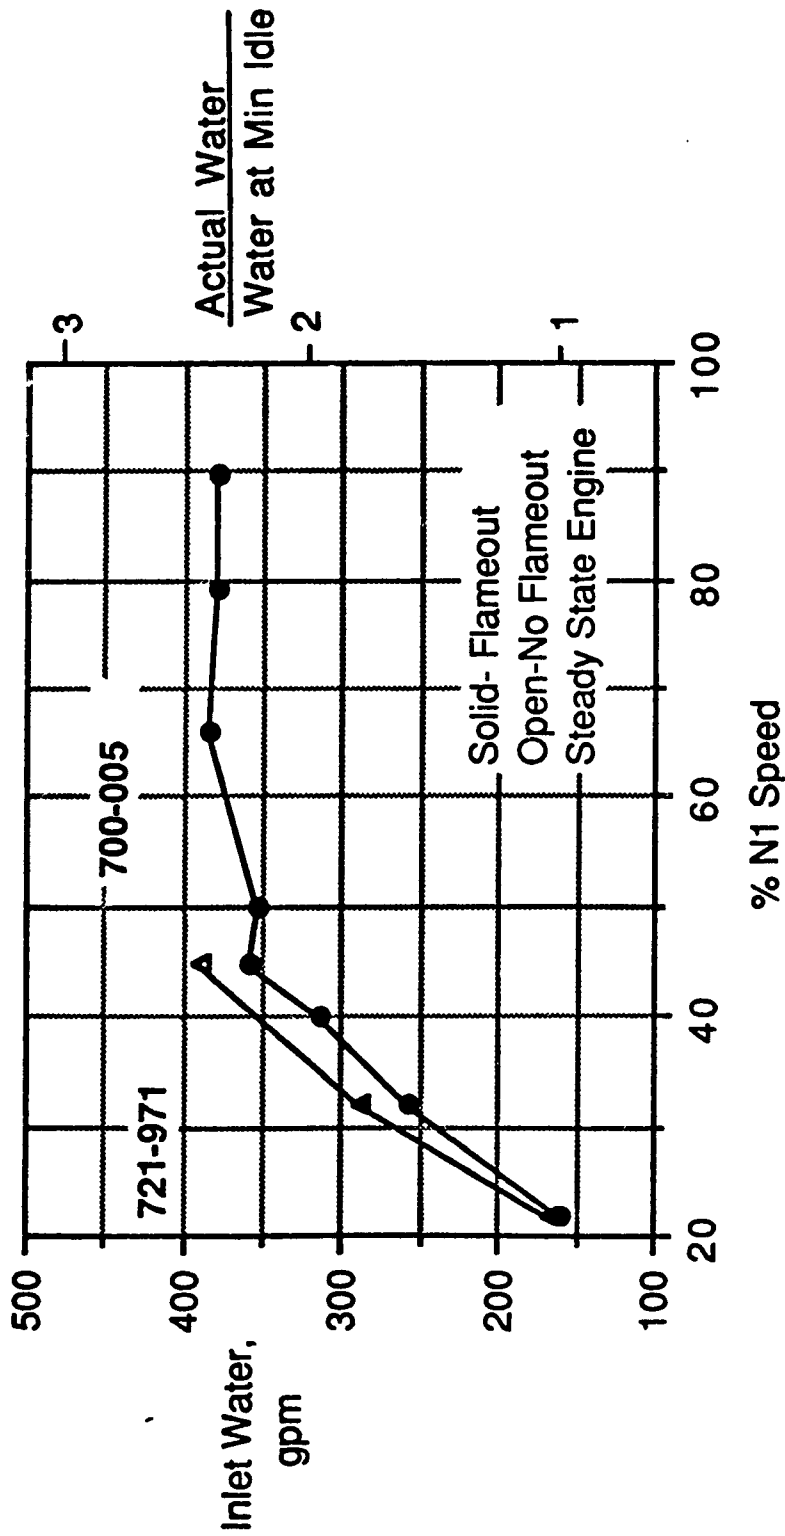
0 INCREASE STEADY STATE N1 FROM MIN IDLE TO 45% N1 IMPROVES WATER INGESTION CAPABILITY BY FACTOR GREATER THAN 2.

0 SUBSTANTIATES AIRWORTHINESS DIRECTIVE FOR SELECTION OF 45% N1 IN PRECIPITATION

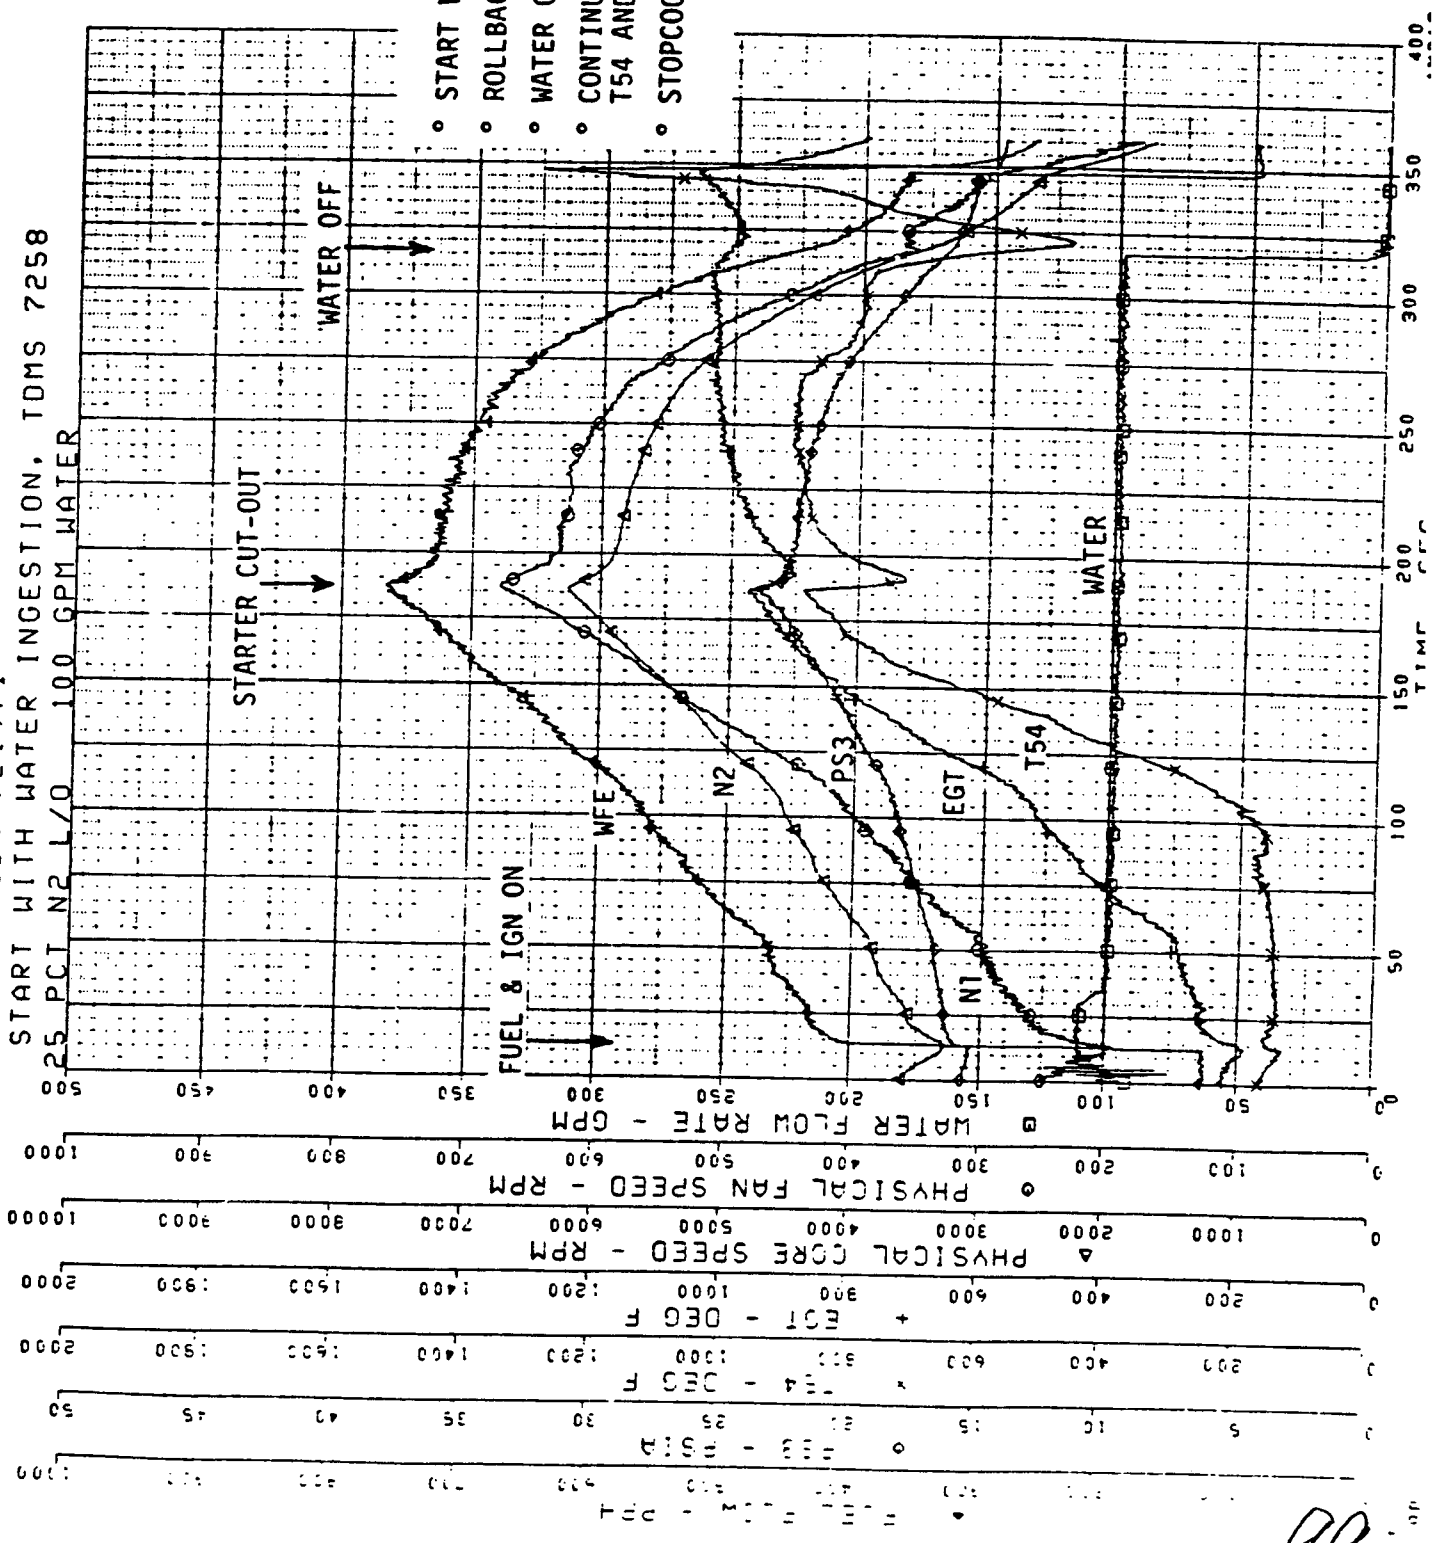
START WITH WATER INGESTION, TDMS 7258

- START WITH 100 GPM WATER
- ROLLBACK AFTER STARTER CUT-OUT
- WATER OFF AT 3600 RPM N2
- CONTINUED ROLLBACK WITH INCREASE IN T54 AND EGT
- STOPCOCK AT 2600 RPM N2

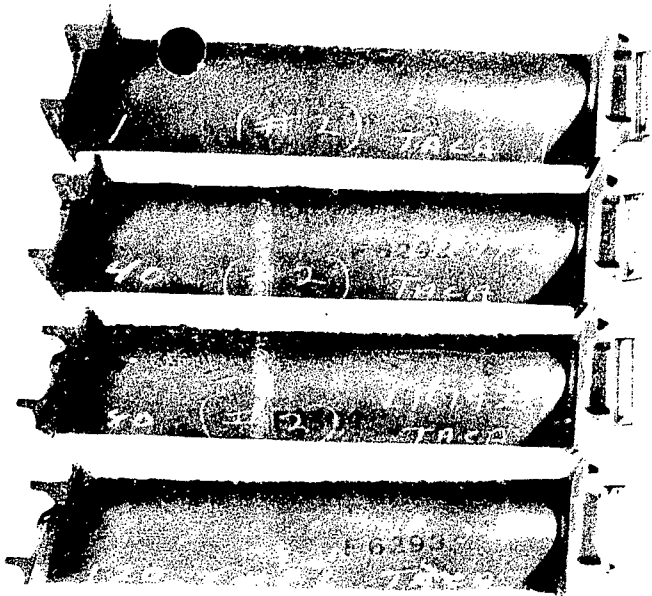
1. The 2nd and 3rd stage LP turbine blades showed airfoil microstructures of higher than normal operating temperatures (1150 and 1050°C respectively) but had not been overheated per current inspection standards established by CFMI.
2. The 4th stage LPT blades showed no changes in airfoil microstructure.

Fig. 1 - 2nd stage blades from engine S/N 721973.

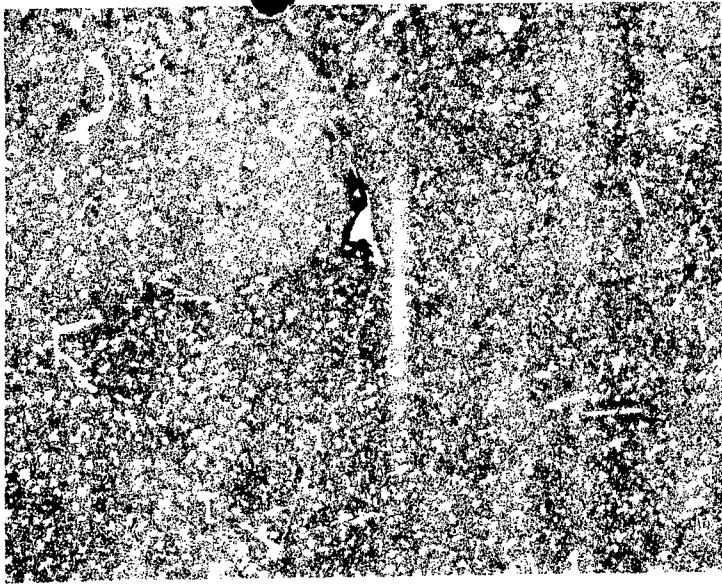
Fig. 4 - Airfoil microstructure  
of 2nd stage blade #1.

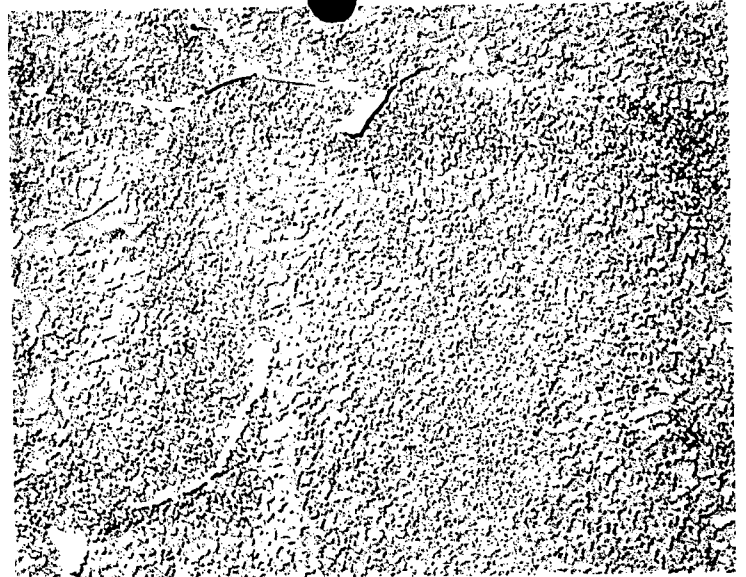
Fig. 5 - Root microstructure of  
2nd stage blade #1.

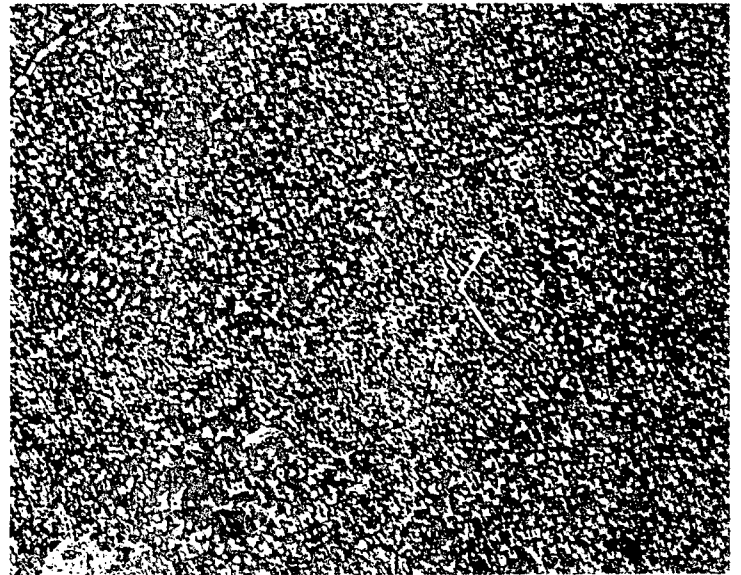
Fig. 7 - Root microstructure of  
2nd stage blade #40.

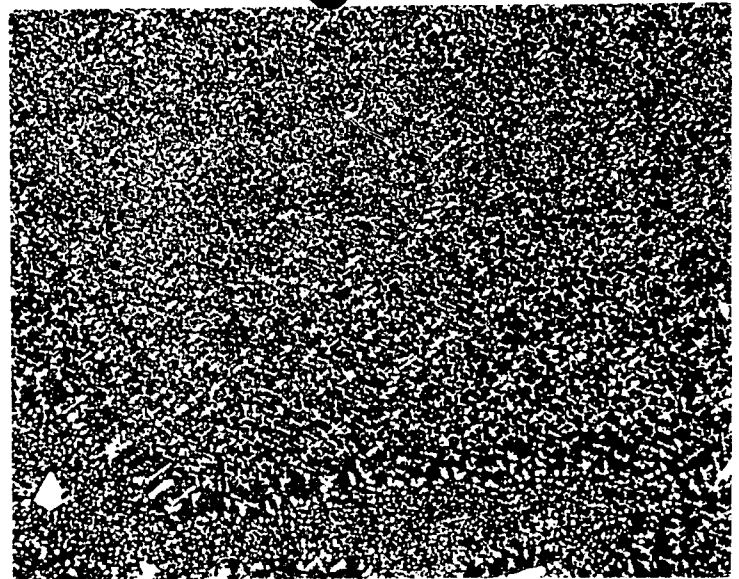
Fig. 9 - Root microstructure of  
2nd stage blade #80.

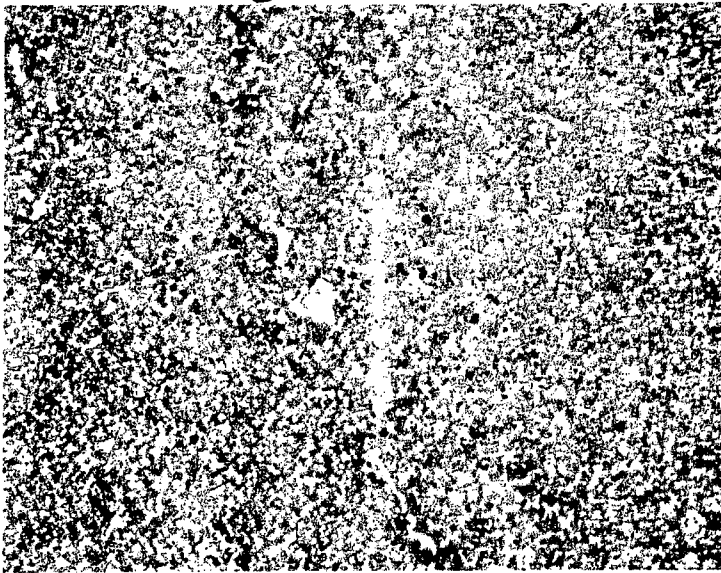
Fig. 12 - Airfoil microstructure  
of 3rd stage blade #1.

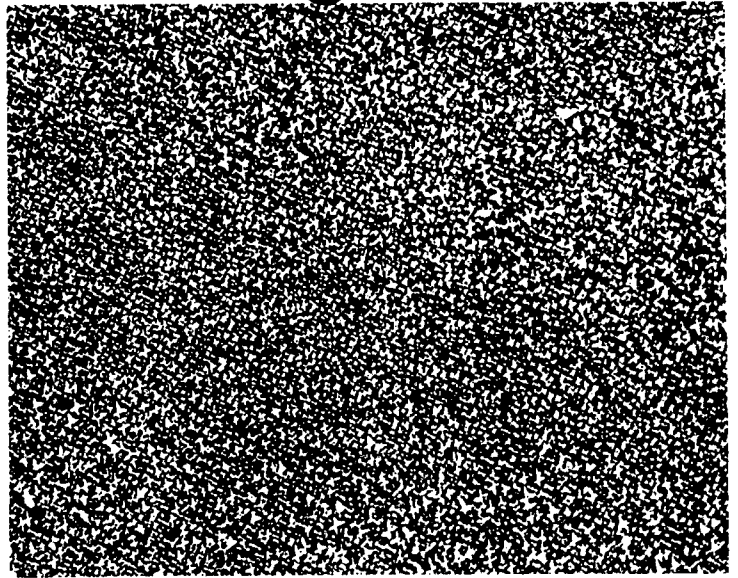
Fig. 13 - Root microstructure of  
3rd stage blade #1.

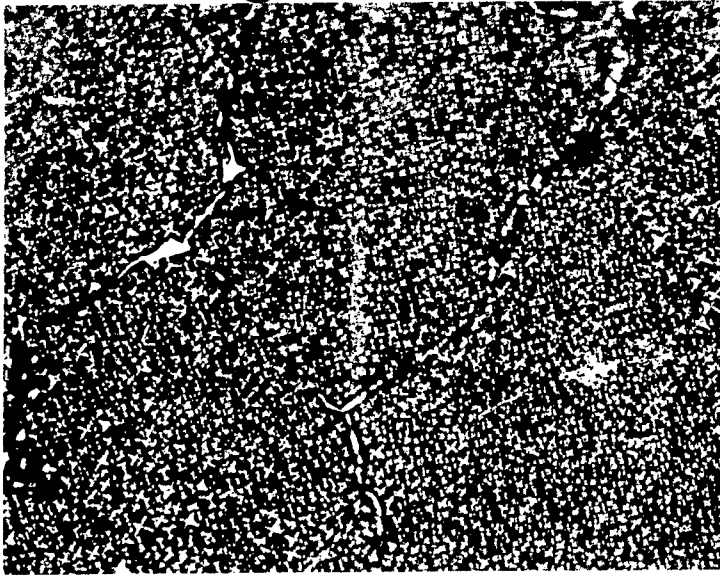
Fig. 16 - Airfoil microstructure  
of 3rd stage blade #78.

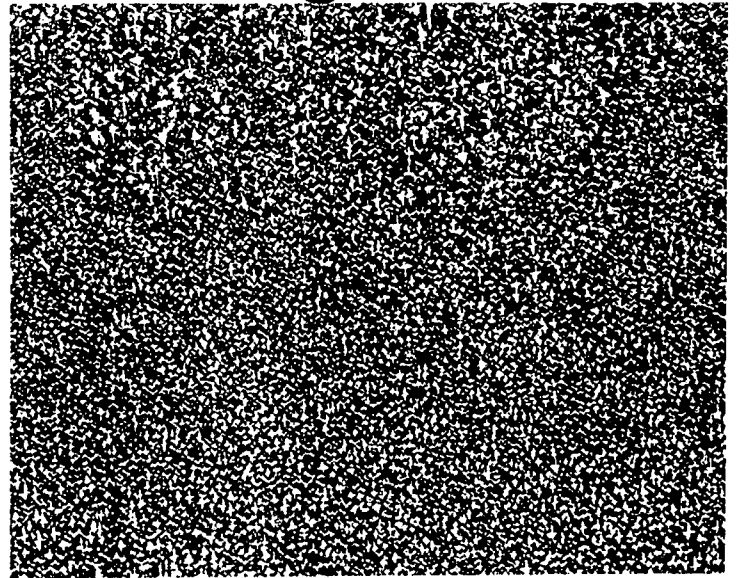
Fig. 17 - Root microstructure of  
3rd stage blade #78.

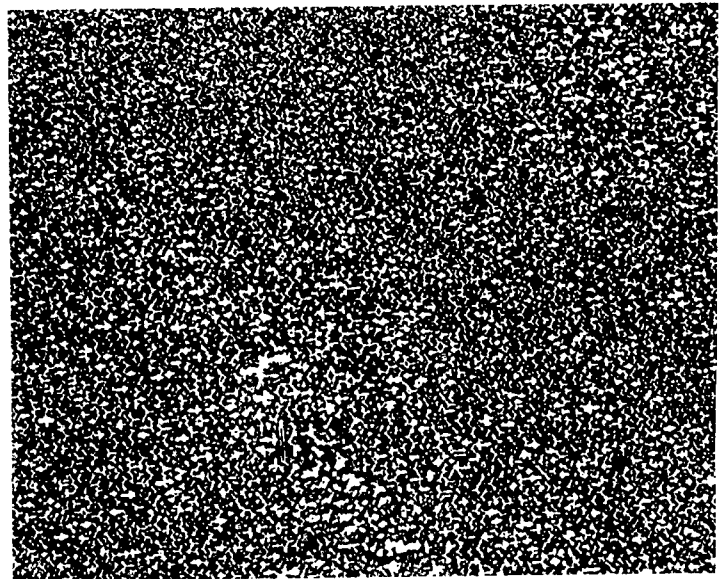
Fig. 19 - Root microstructure of  
3rd stage blade #117.

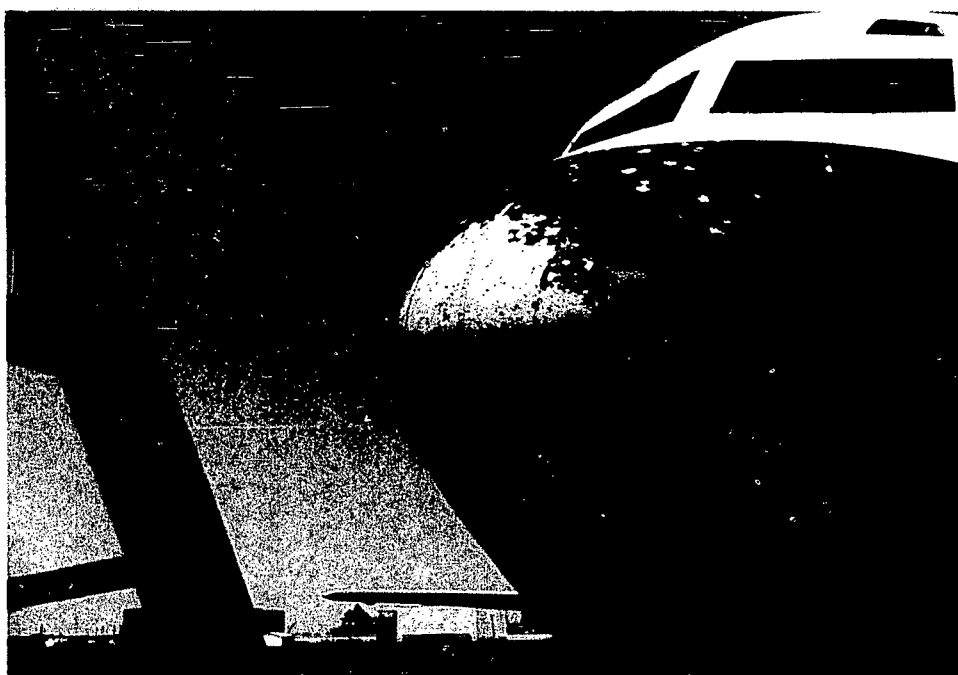
The airplane received minor hail damage to the radome, nose paint, and the leading edges of both horizontal stabilizers as a result of the encounter with the thunderstorm. The number 2 engine turbine section was severely damaged as a result of over temperature conditions which occurred during the attempted air restarts and operation in a stalled condition during the descent. The number 1 engine had no visible damage either due to hail or exposure to over temperature conditions for a prolonged period.

7. Radome and nose paint were heavily damage by hail.

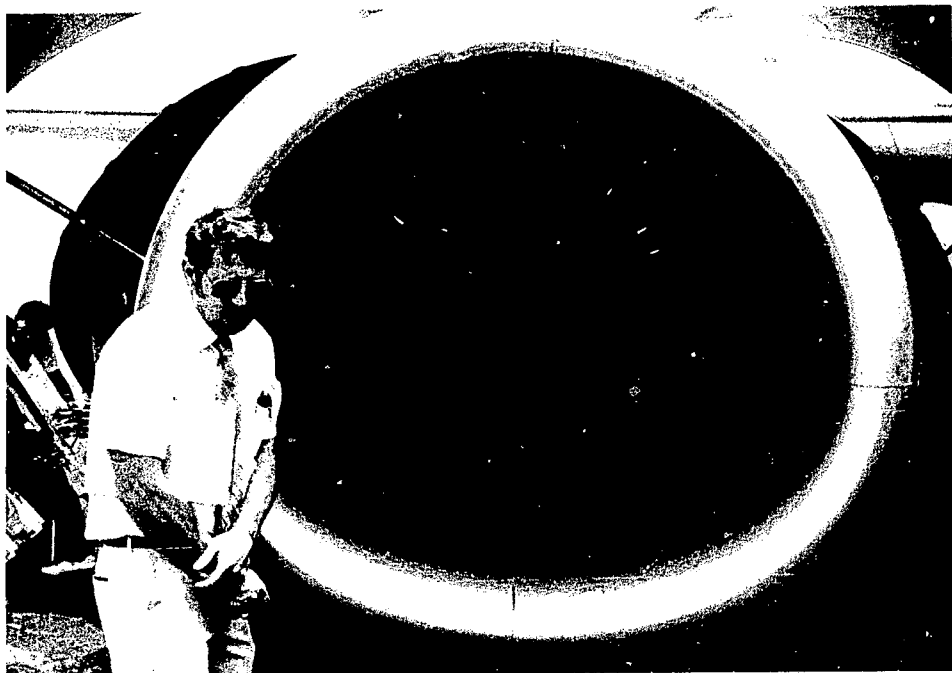
14. Due to internal thermal damage, a locked rotor start and idle check was performed on the #5 engine.

Complete aircraft systems checks and examinations were conducted. No discrepancies or damage were noted other than the damage previously discussed. Following an engine change at the number 2 position and takeoff power runs on both sides, the airplane was taken off from the private road.
