UMTA-MA-06-0156-86-1
DOT-TSC-UMTA-86-8

Water Intrusion Problems in Transit Tunnels

Paul Parks and Associates, Inc.
Engineering & Management Consultants
100 Boylston Street
Boston MA 02116

September 1986
Final Report

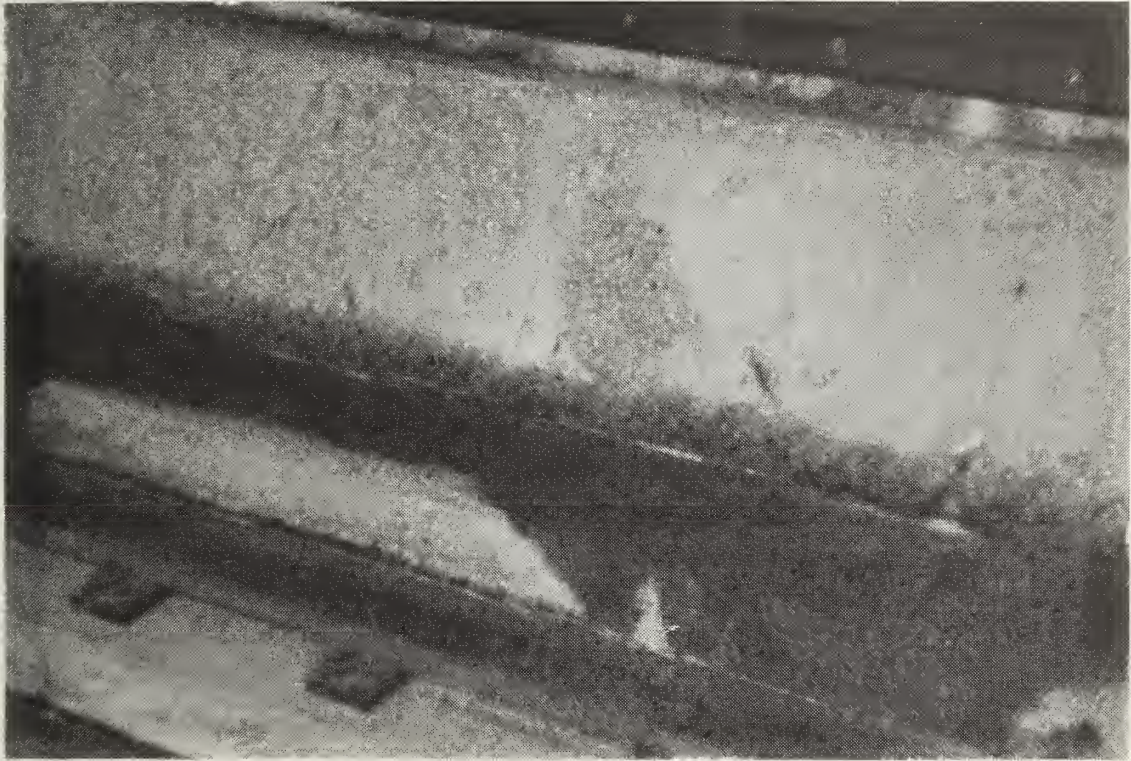
FIGURE 5.3 LEAKS ONTO TRACKBED

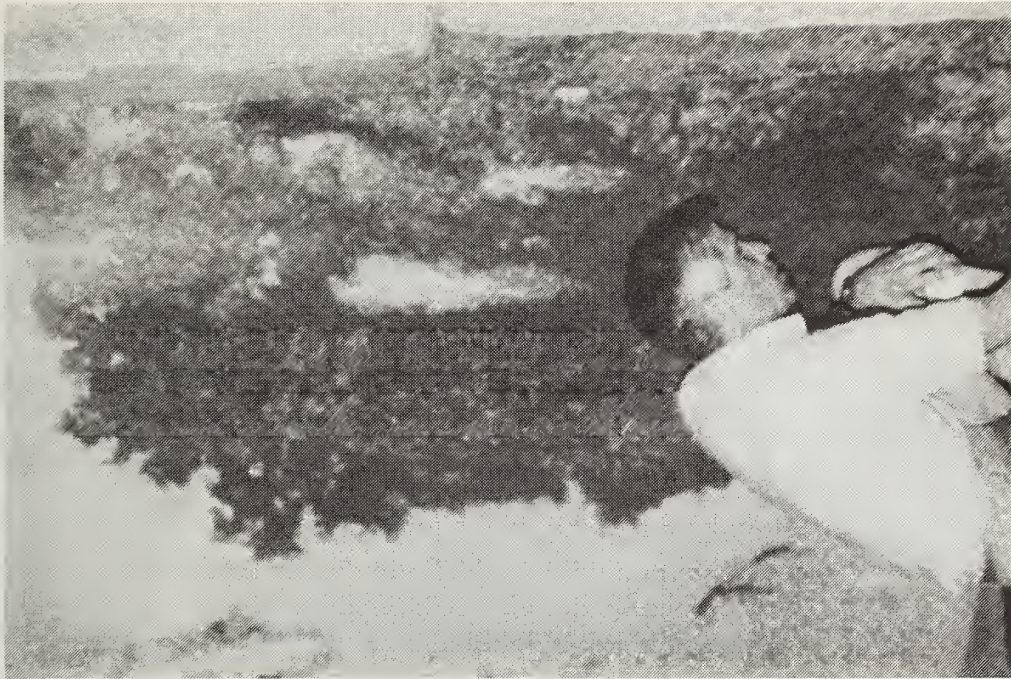
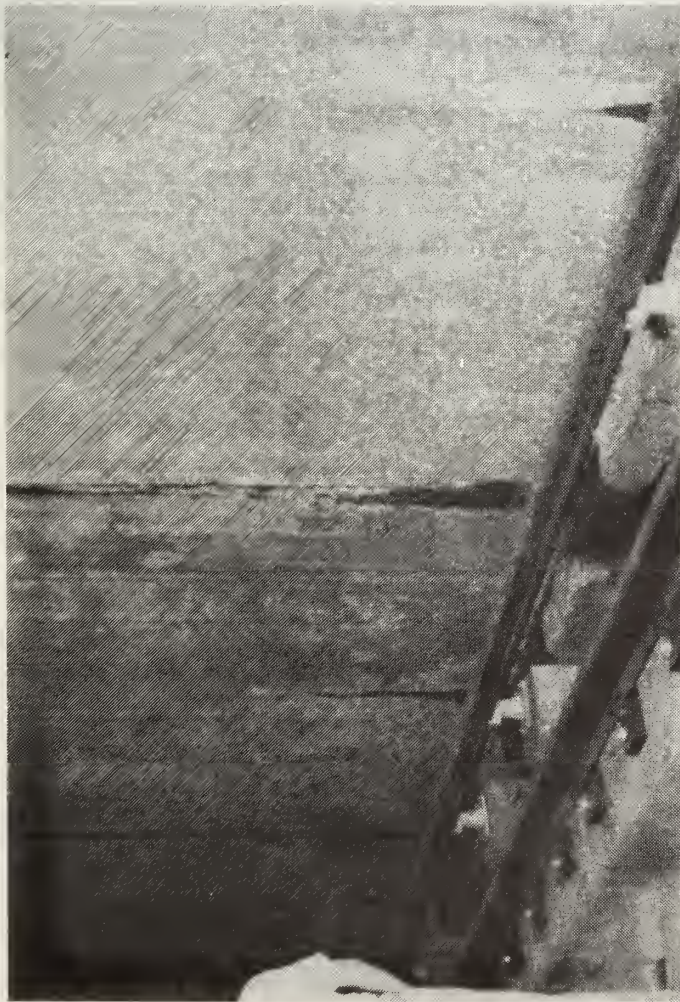
FIGURE 6.4 WATER INFILTRATION THROUGH THE WALLS

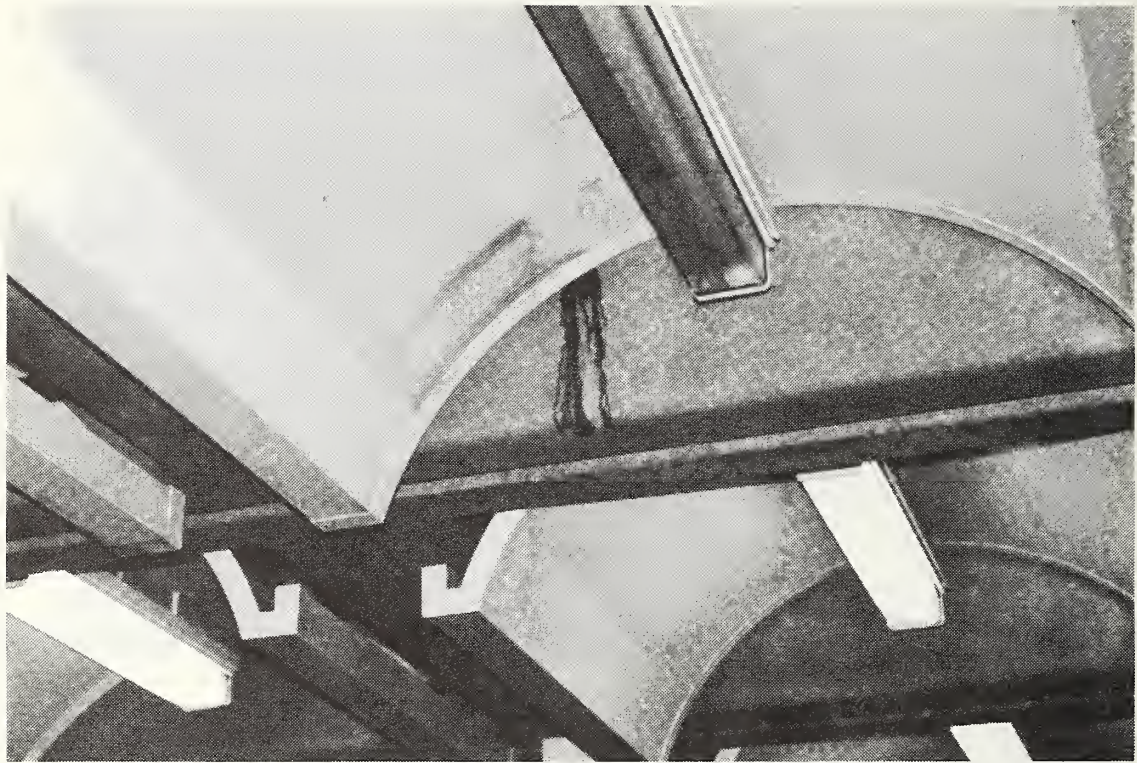
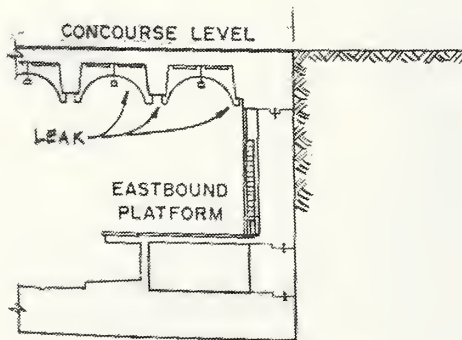
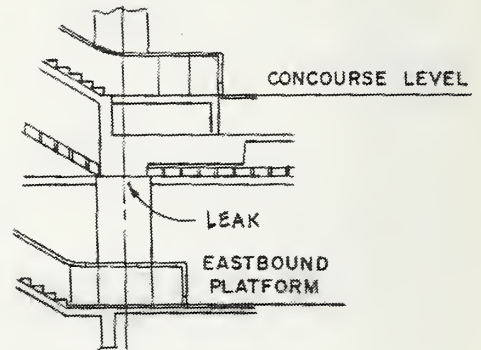
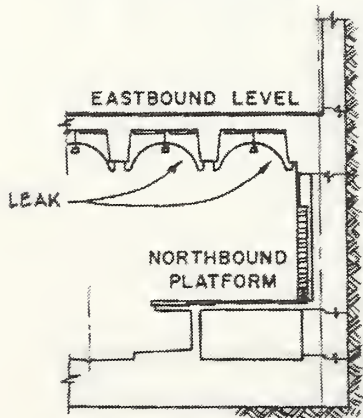
Figure 6.5 demonstrates typical leaks through the station roof. This type of leakage results in significant deterioration of both structural and architectural elements of the stations. It also has a deteriorative effect on functional components of a subway system. For example, the stray currents seek the path of water or dampness, thereby concentrating electrochemical attacks on rails, which results in severe corrosion of rail structures.

FIGURE 6.5 WATER INFILTRATION THROUGH THE STATION ROOF

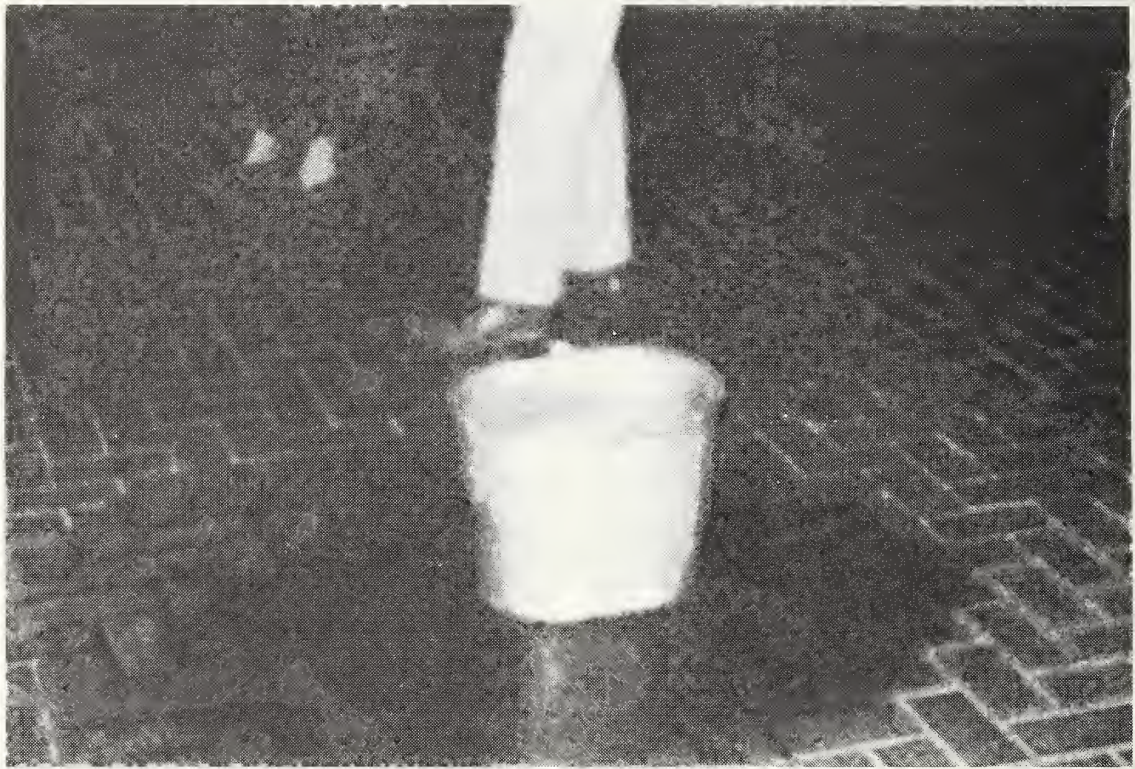
FIGURE 6.6 SAFETY HAZARD DUE TO WATER INTRUSION THROUGH STATION CEILING

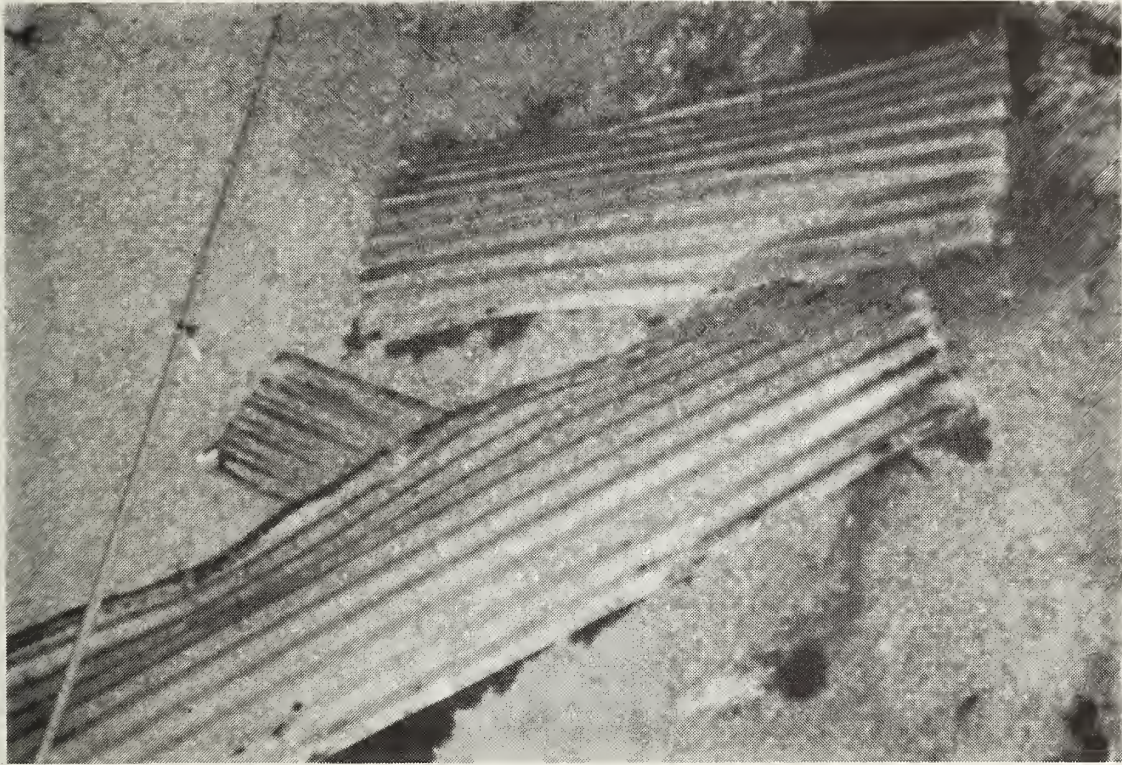
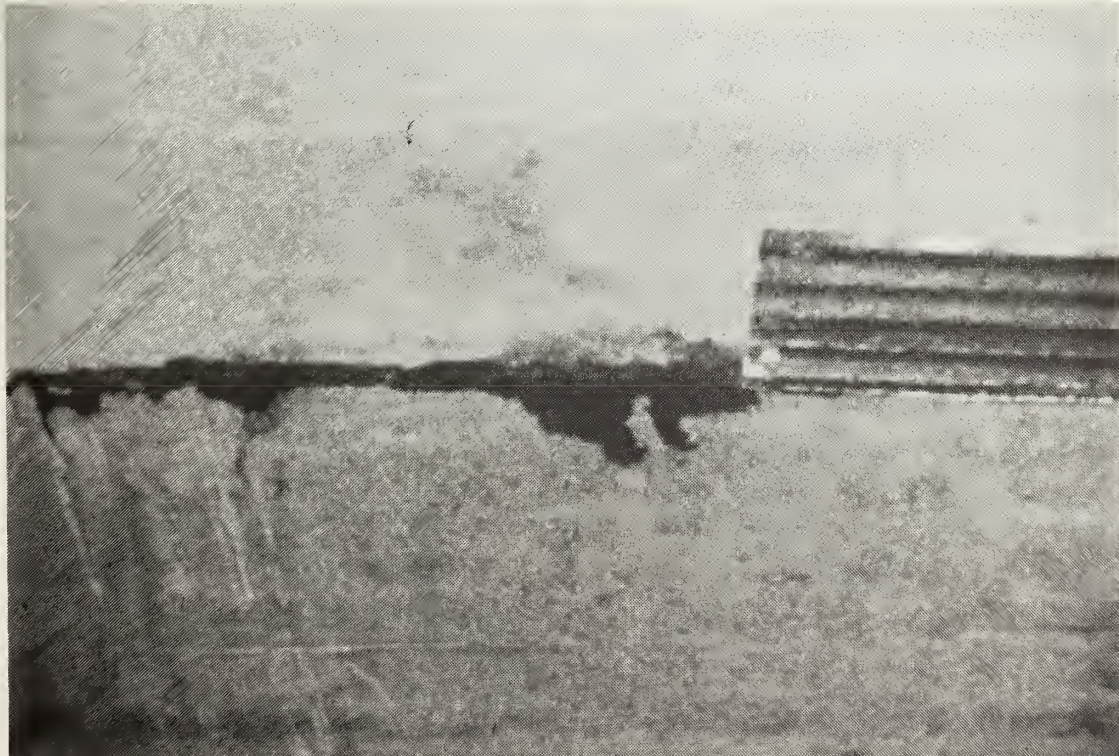
FIGURE 6.7 LEAKS AT FIVE POINT STATION

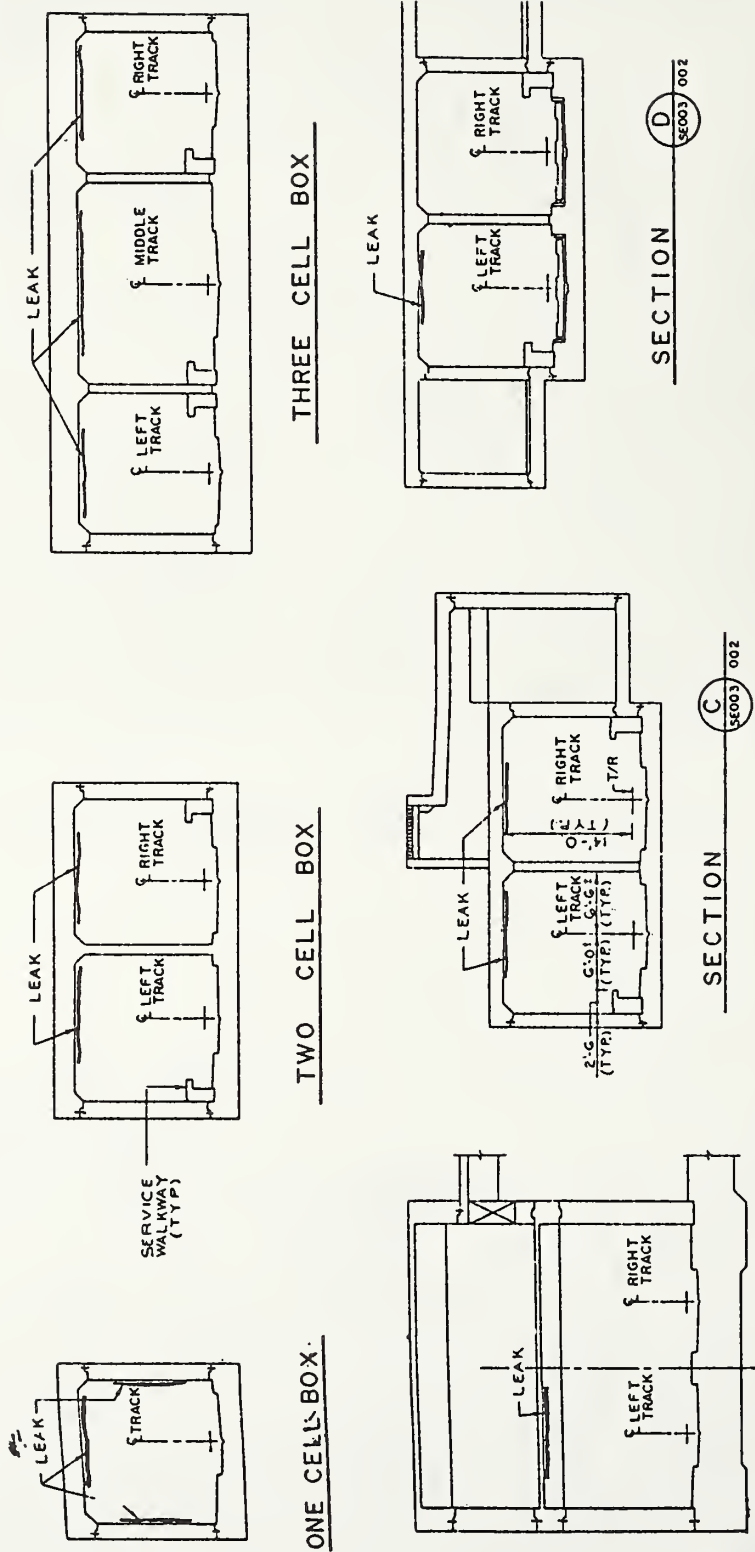
FIGURE 6.8 LEAKS AT SUBWAY STRUCTURES IN WEST LINE

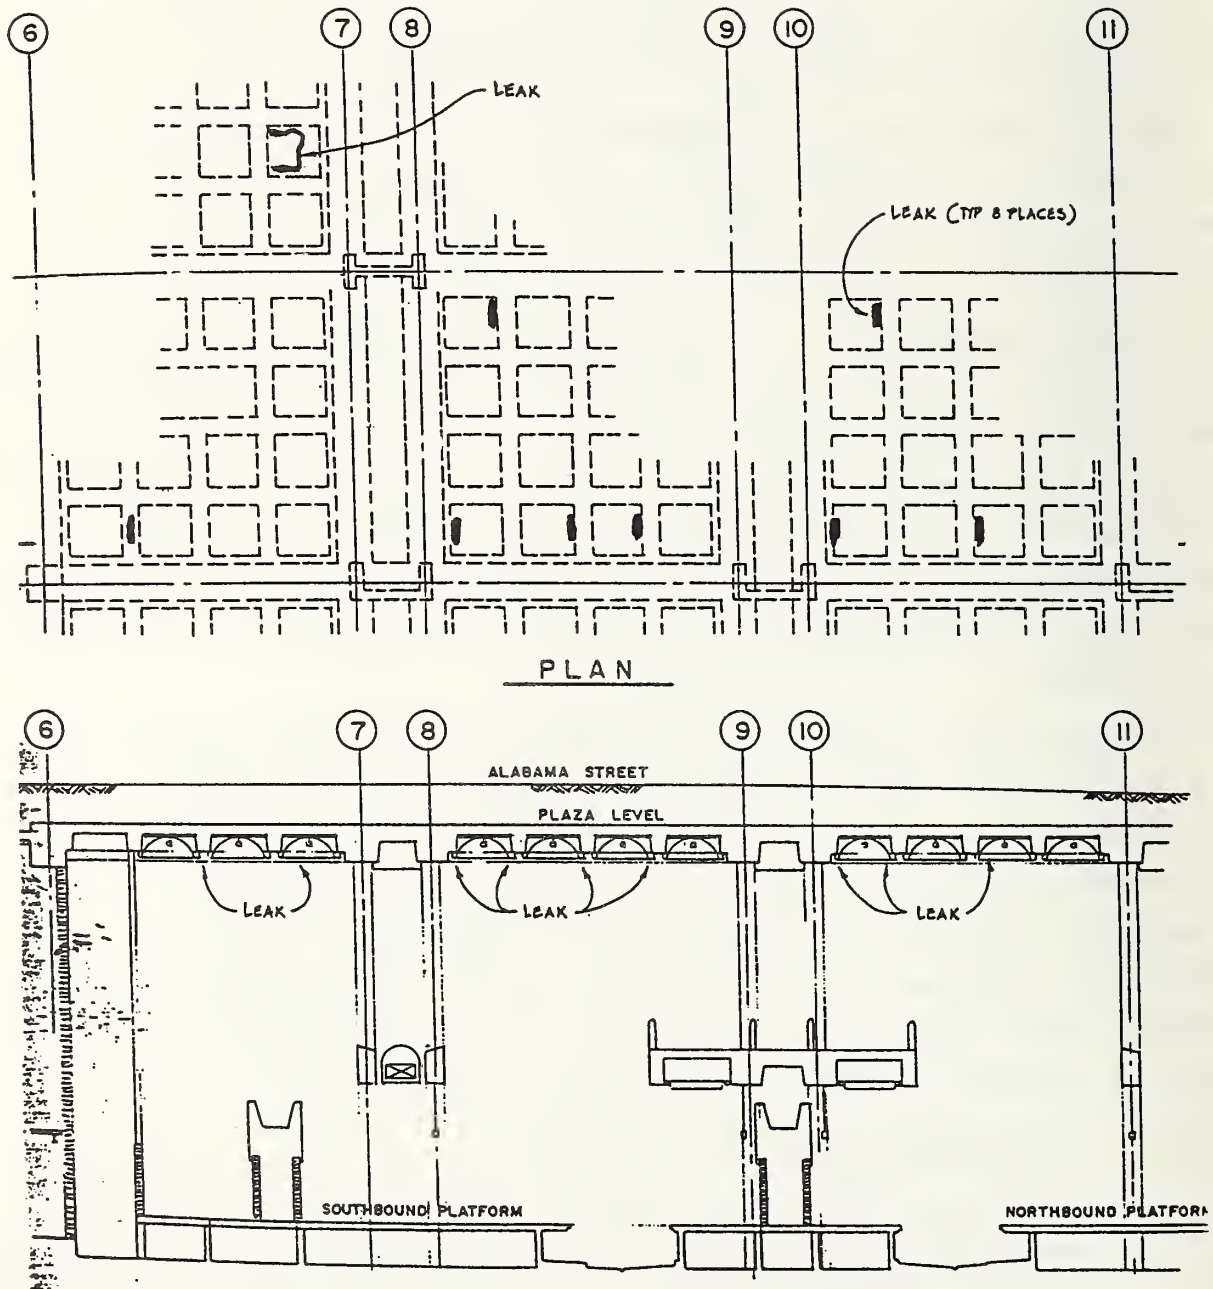
FIGURE 6.9 INTERCEPTING OF LEAKAGE (REMEDIAL MEASURES)

- o Intercepting and collecting the water flow and channeling it to the pumps by means of galvanized steel plates installed directly against water leaks, thereby diverting wall and ceiling water leaks from rail structures;
- o Installation of steel lining consisting of concrete arches with steel pans, for diverting the water (this measure was taken at construction time as well as during post-construction maintenance);
- o For many leaks that were emerging from the base of the emergency cat walk, "toe bench cutting" was used. This procedure entails cutting a small trough adjacent to all second pours that were lower than the

adjacent "toe benches". The trough was cut about 2 in. wide and 1-1/2 in. deep and run to the nearest drainage chase between second pours. The leaking water would then go into an undertrack drain.

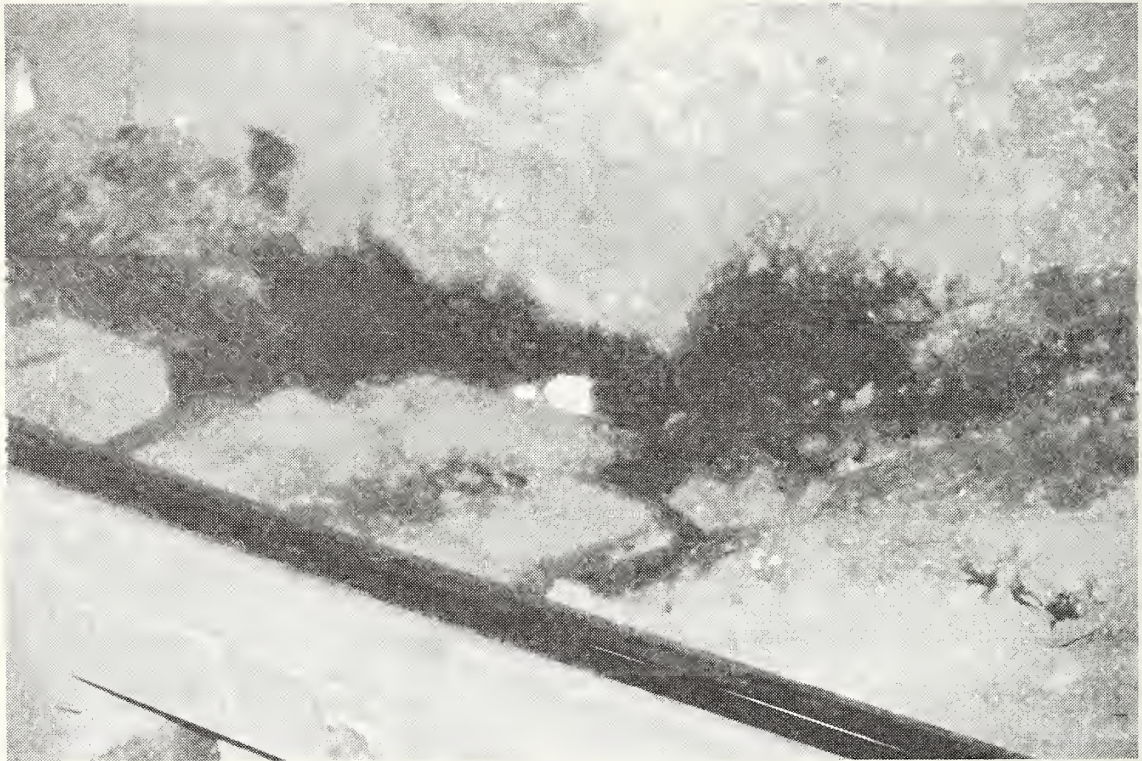
Leakage such as water streams emerging from the base of the track bed creates a specific problem by washing ballast away, as can be noted in Figures 7.2 and 7.3, where large segments of the washed-out ballast are shown.

FIGURE 7.2 BALLAST WASHED OUT BY STREAMS OF RUNNING WATER
(RED LINE, SOUTH STATION)

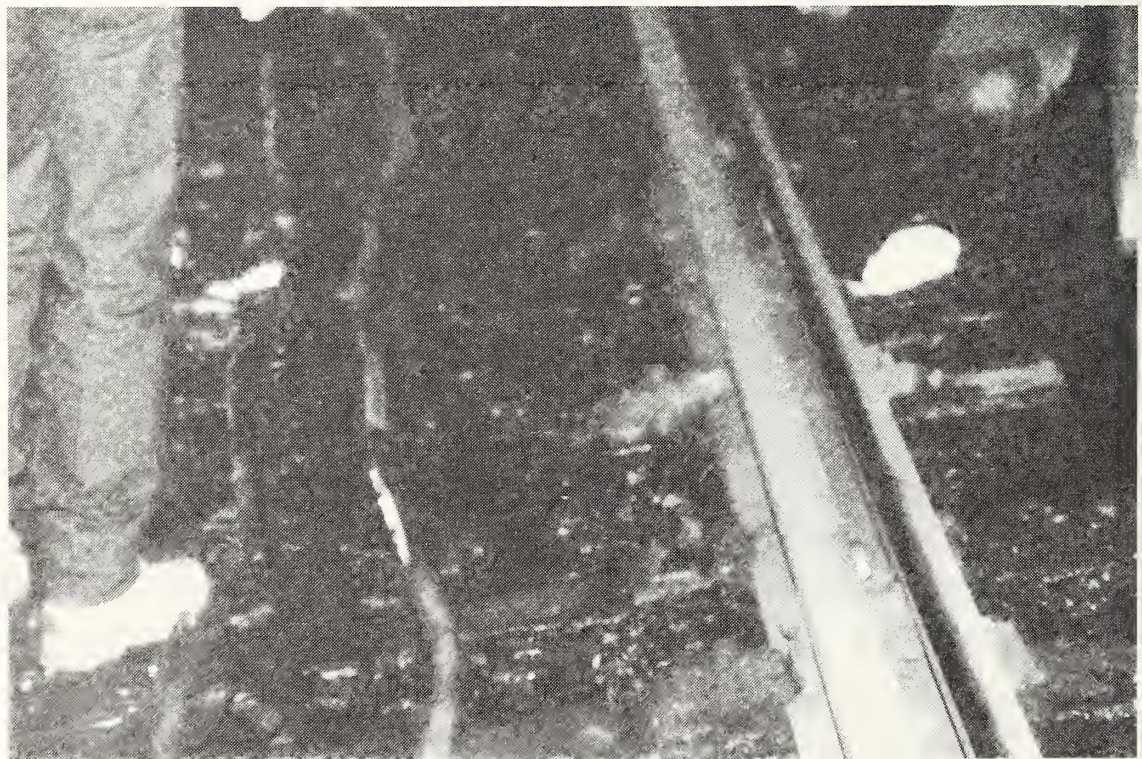
FIGURE 7.3 STANDING WATER IN THE TRACKBED (RED LINE, SOUTH STATION)

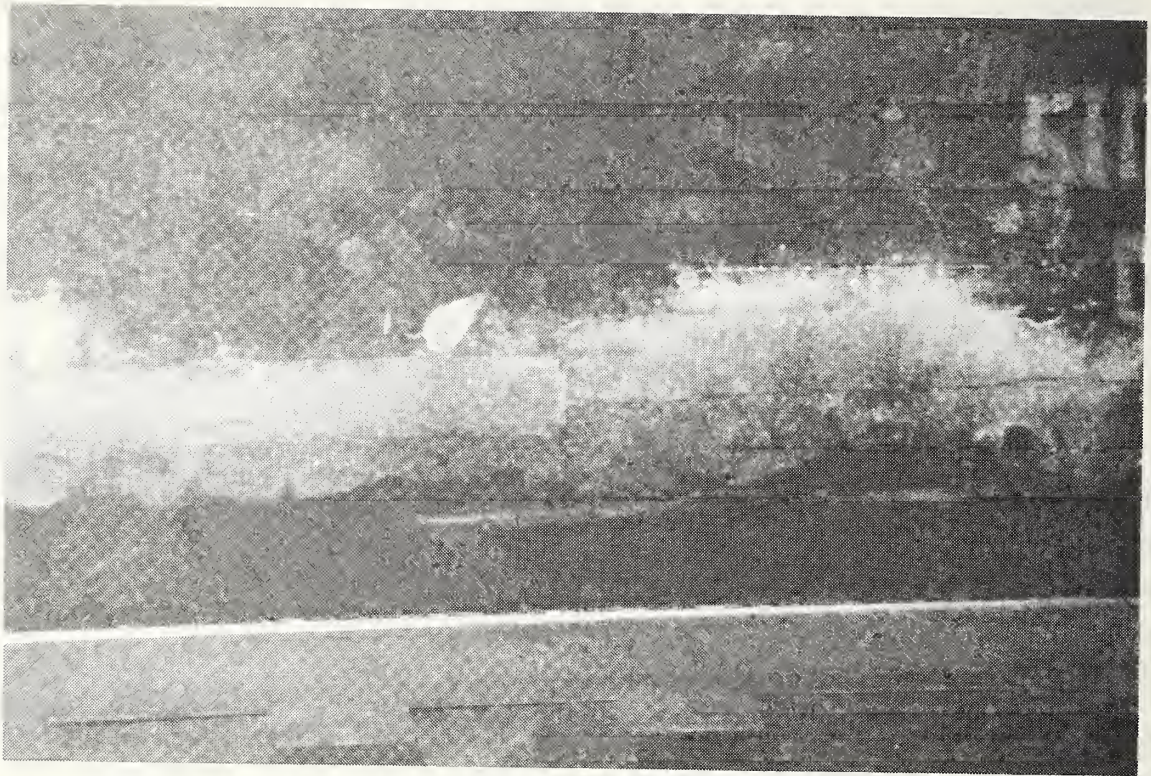
Figure 7.4 shows a wide area of calcification around shrinkage cracks in concrete. The calcification was caused by water leaks which also resulted in standing pools of water in the track area.

FIGURE 7.4 CALCIFICATION AROUND A SHRINKAGE CRACK (RED LINE, SOUTH STATION)

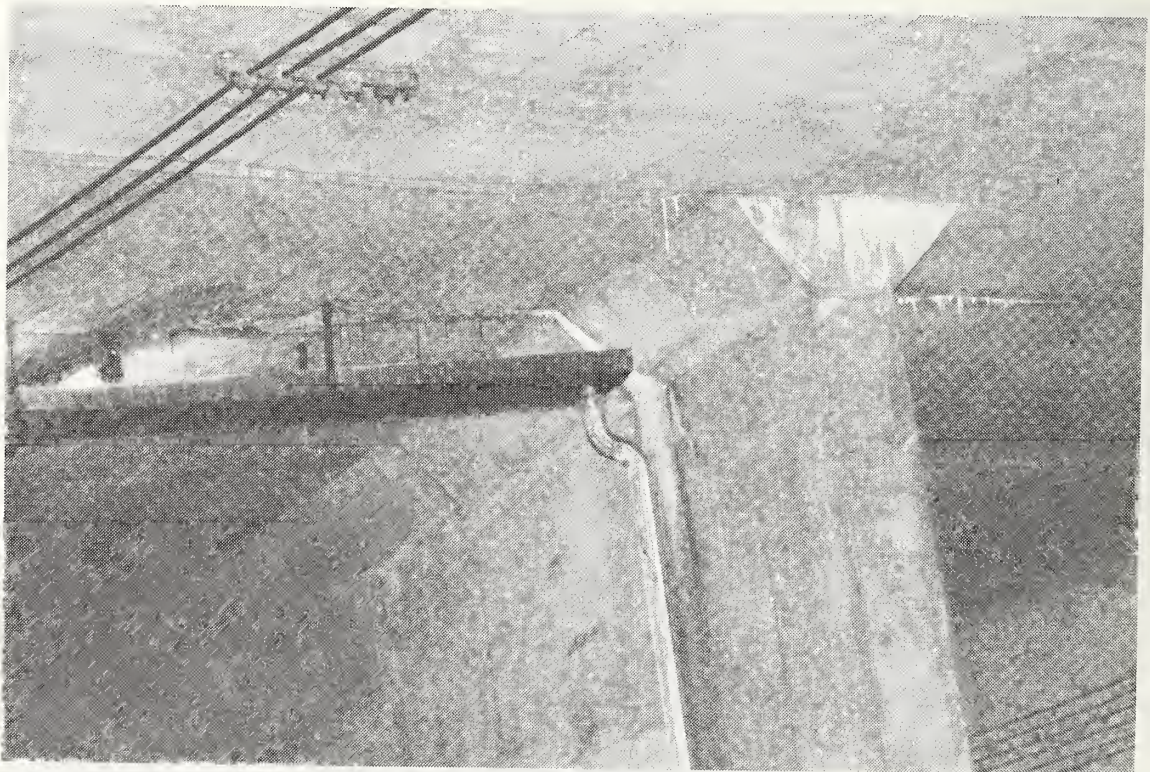
FIGURE 7.5 CHANNELING OF THE WATER (RED LINE, SOUTH STATION)

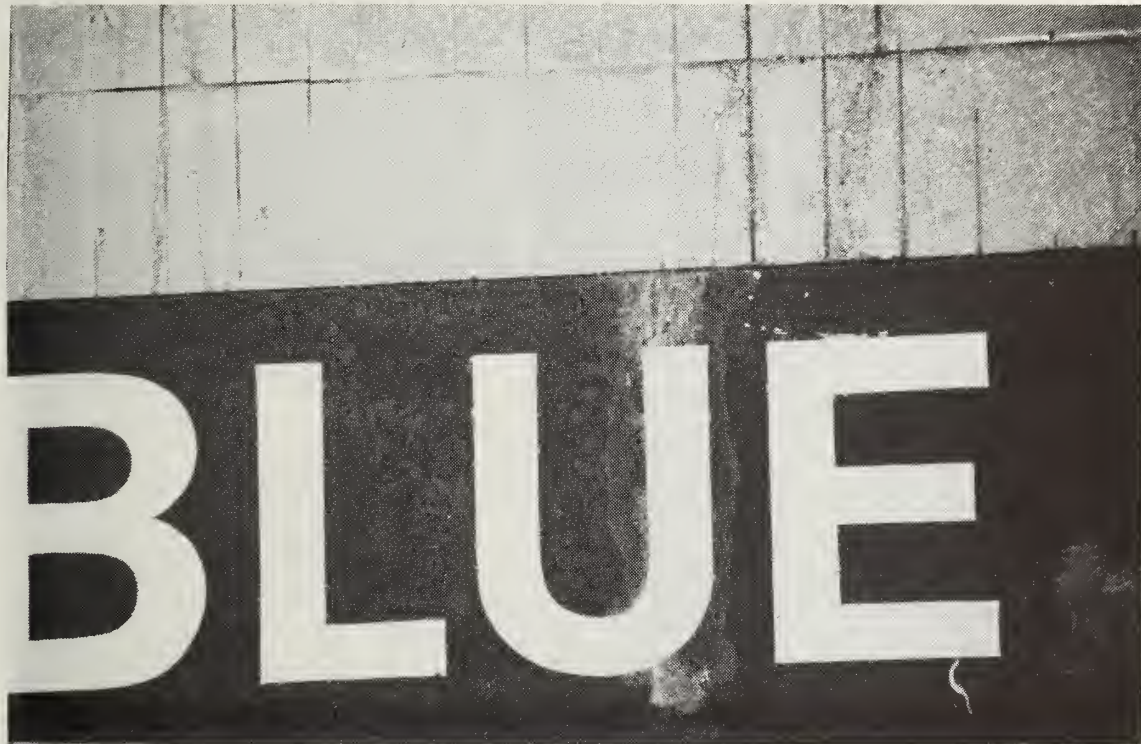
FIGURE 7.6 DETERIORATION OF PAINT (BLUE LINE, AQUARIUM STATION)

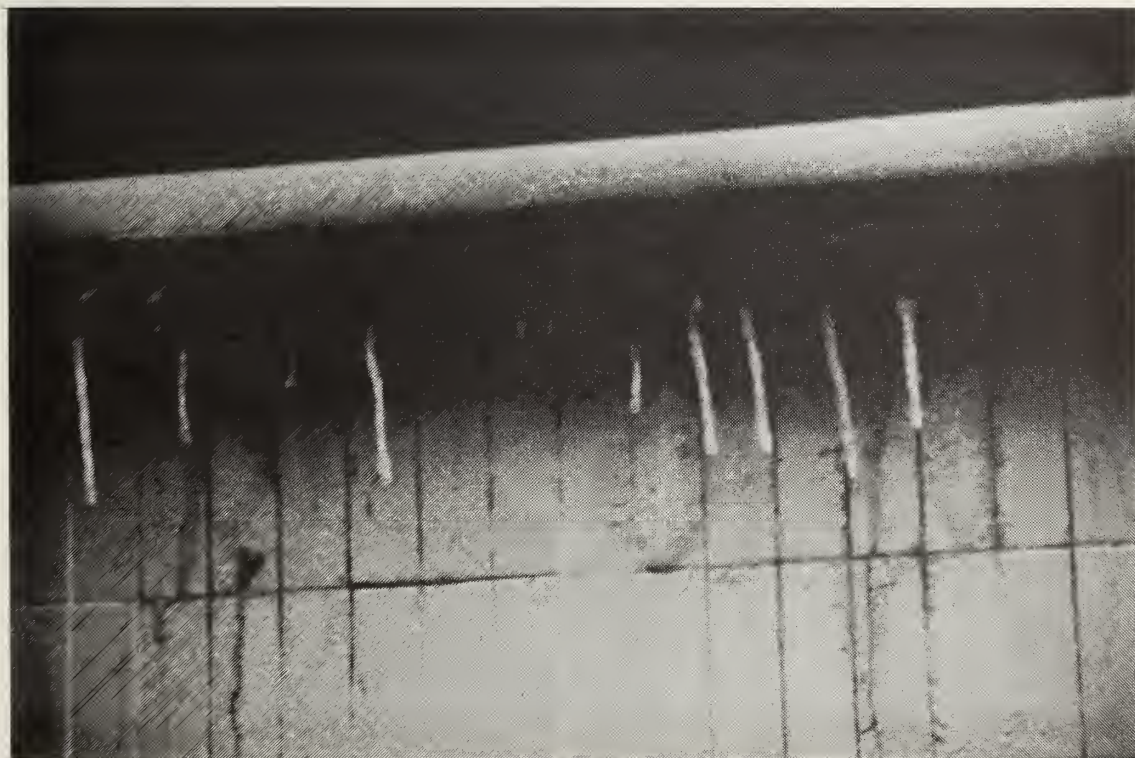
FIGURE 7.7 STALACTITES GROW (BLUE LINE, AQUARIUM STATION)

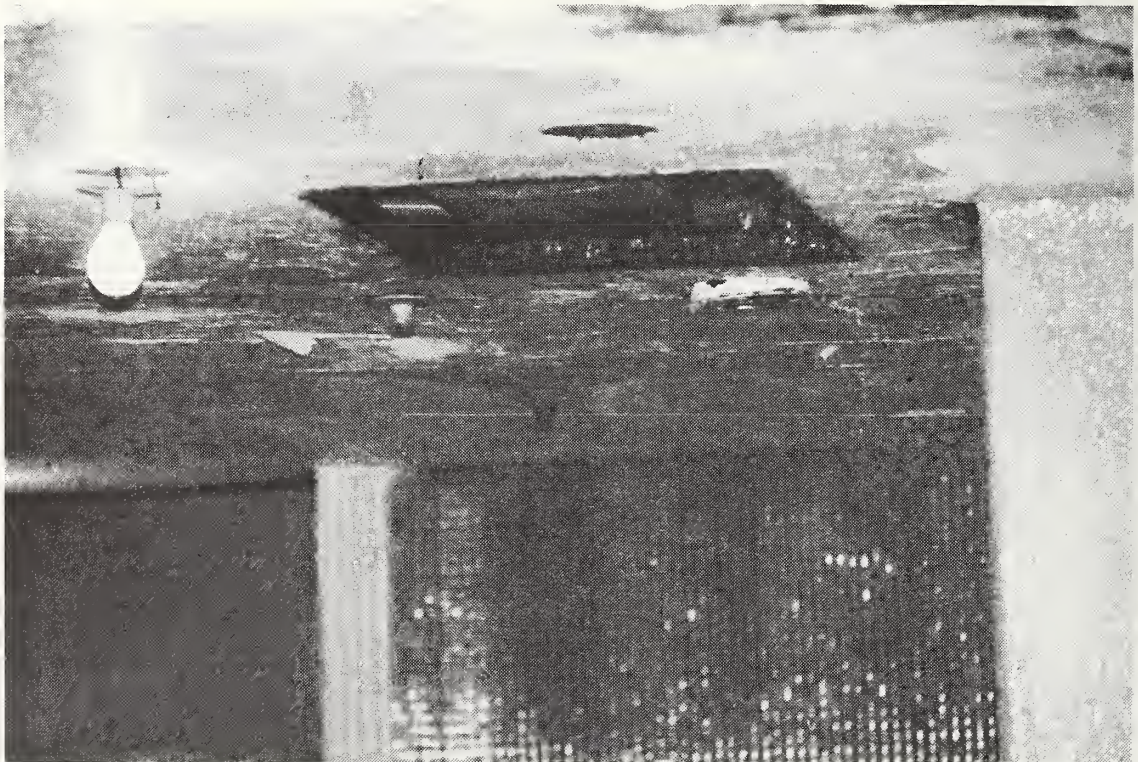
FIGURE 7.9 CEILING SECTION REMOVED FOR INVESTIGATION OF MAIN ROOF LEAKS (BLUE LINE, AQUARIUM STATION)

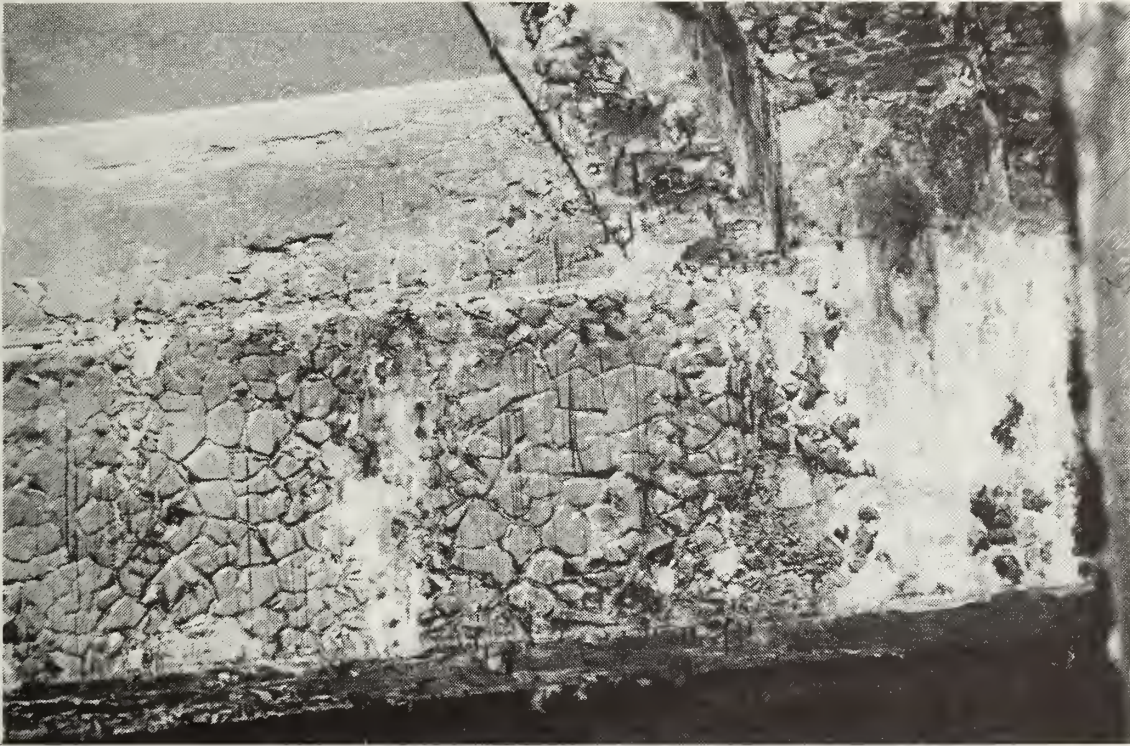
Figure 7.10 shows a large area of calcification on the wall finish caused by the water infiltrating through the walls and ceiling of the concrete lining. Such structural and architectural deterioration requires extensive repair work.

FIGURE 7.10 CALCIFICATION OF THE WALL FINISH (BLUE LINE, AQUARIUM STATION)

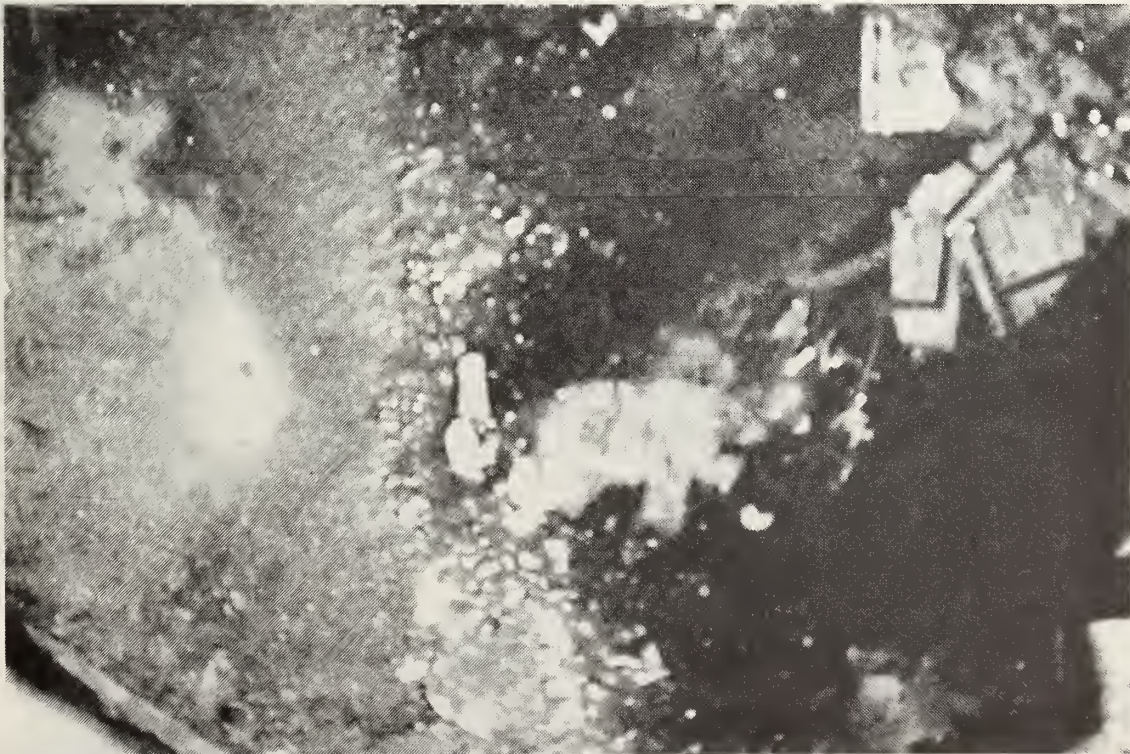
FIGURE 7.11 STANDING POOL OF WATER WITH FLOATING DEBRIS IN TRACKBED AREA (BLUE LINE, AQUARIUM STATION)

Figures 7.11, 7.12, and 7.13 also depict the deteriorative effect of water on the trackbed. There are some zones where ballast has been completely washed out.

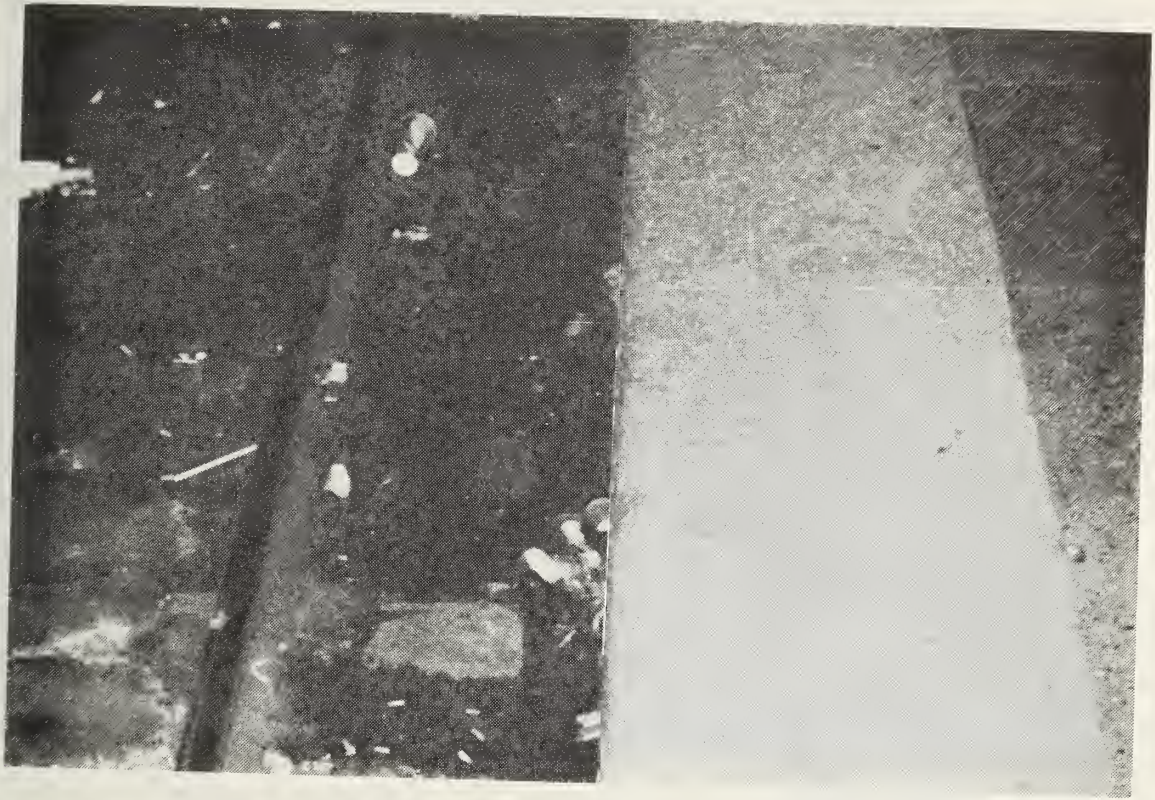
FIGURE 7.12 WATER STREAM IN TRACKBED (BLUE LINE, AQUARIUM STATION)

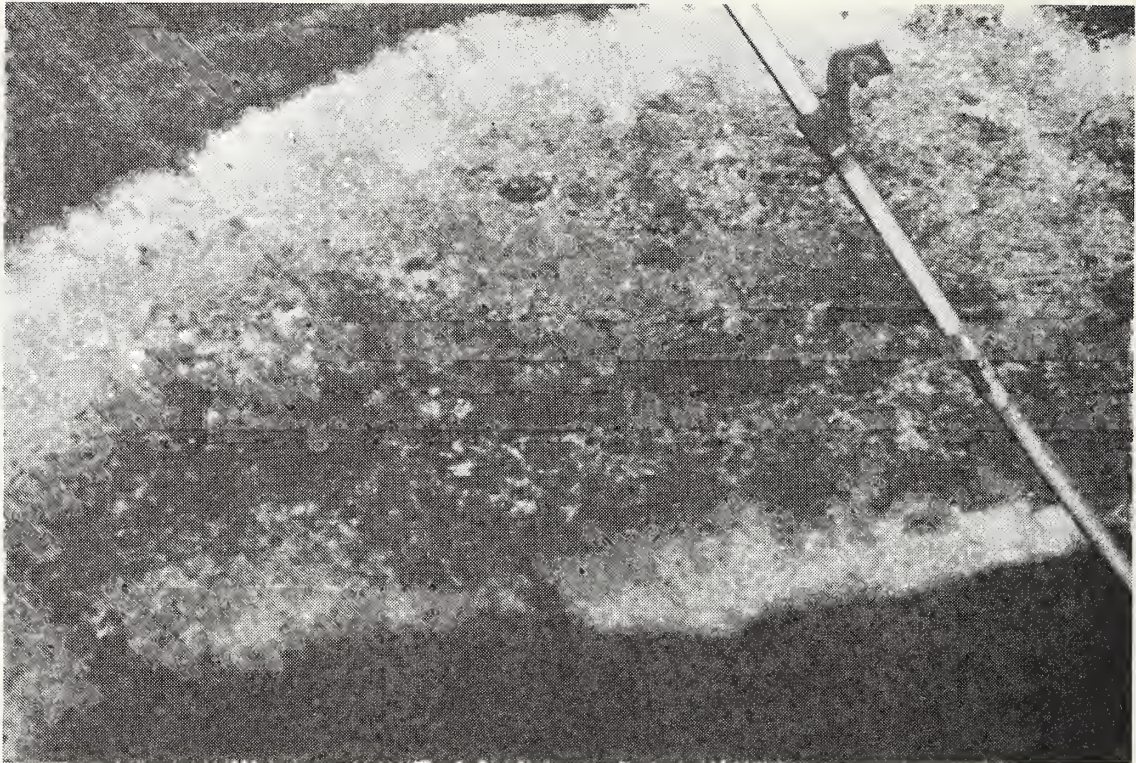
FIGURE 7.14 ZONE OF CALCIFICATION AND STALACTITES AROUND A CRACK (GREEN LINE, BOYLSTON-ARLINGTON TUNNEL)

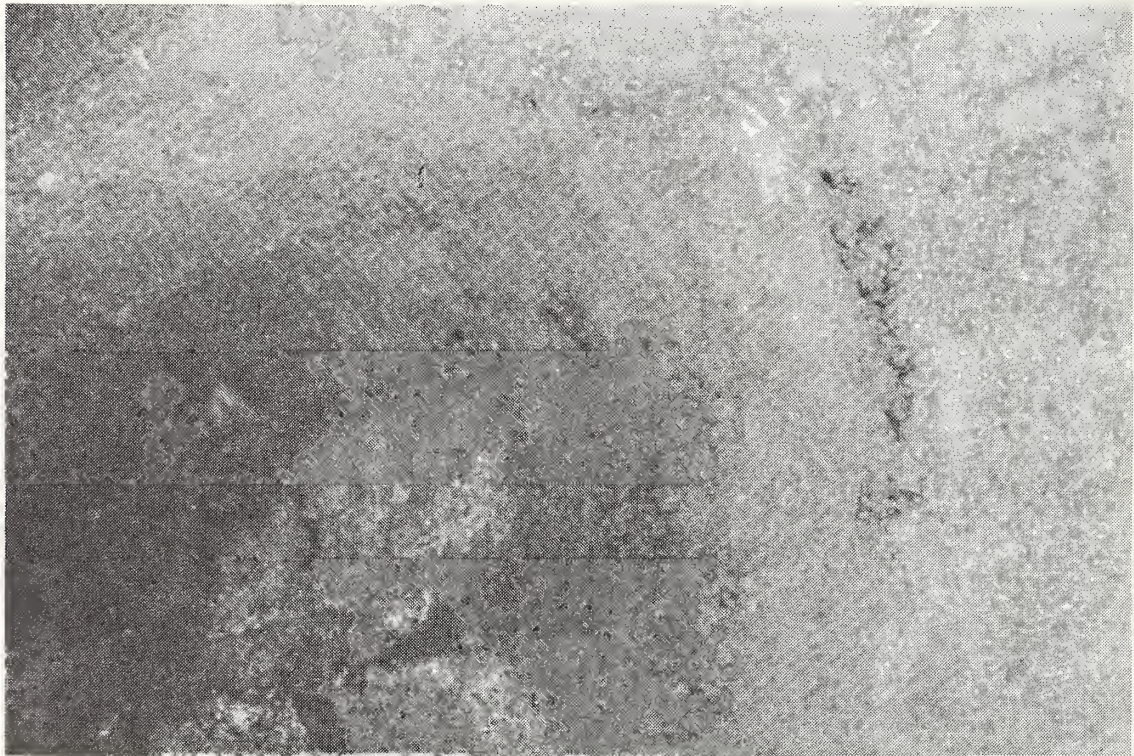
FIGURE 7.15 AREA OF MASSIVE CALCIFICATION (GREEN LINE, BOYLSTON-ARLINGTON TUNNEL)

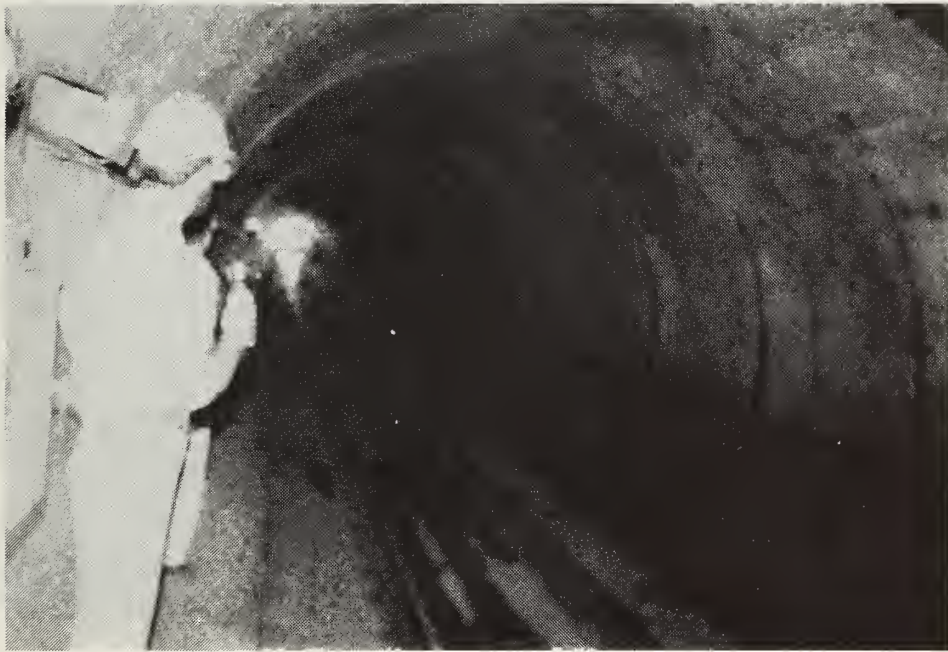
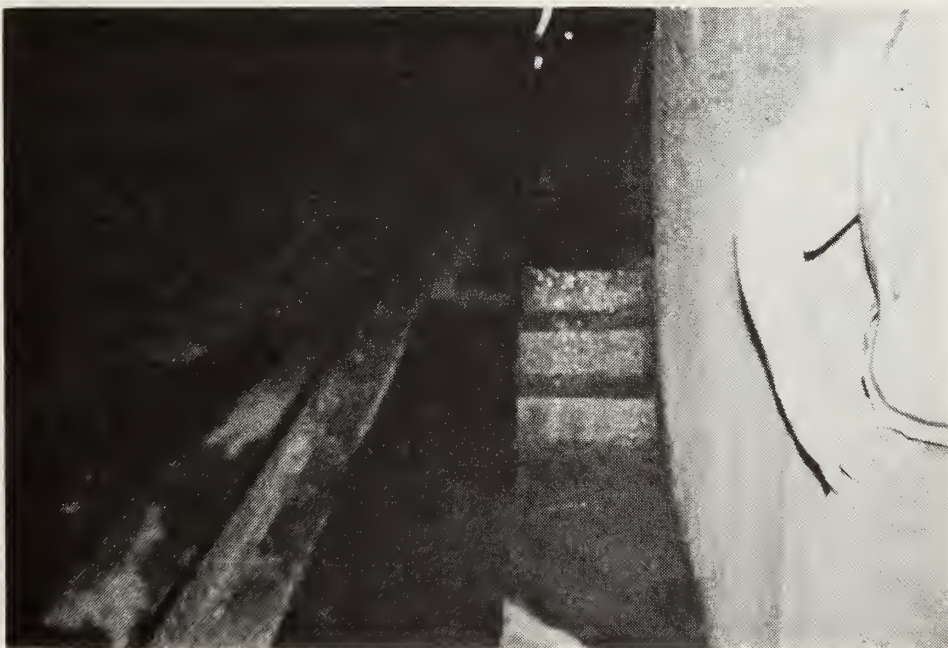
FIGURE 8.2 WATER LEAKS ON RAIL SUPERSTRUCTURE

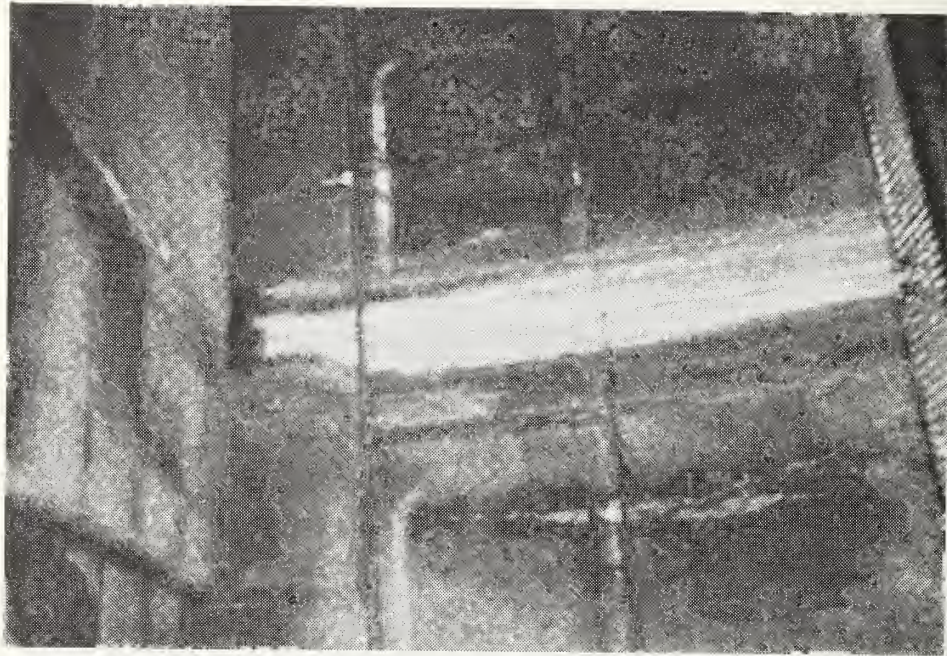
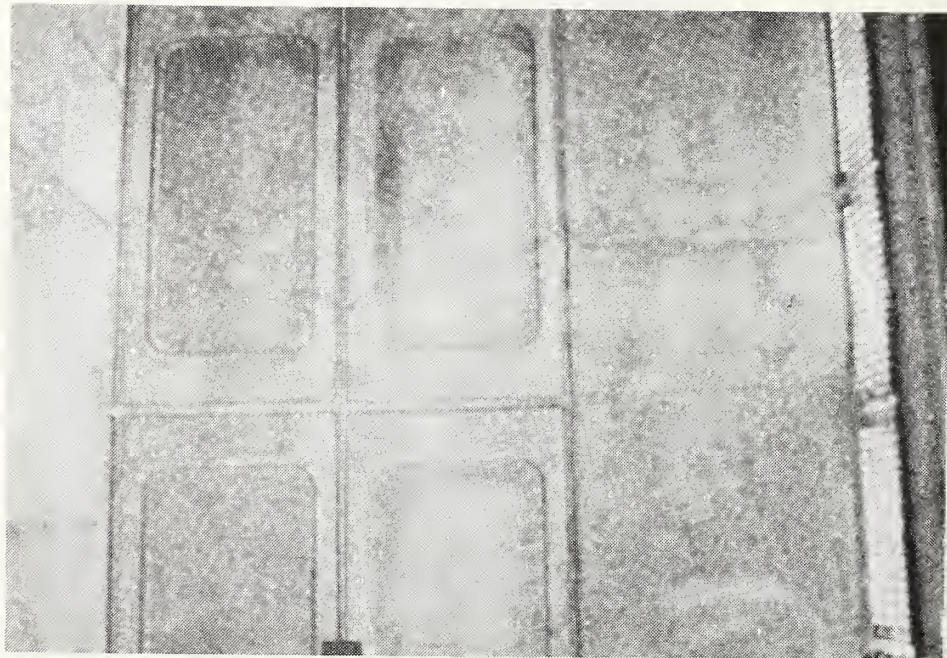
FIGURE 8.3 STONE WALLS DAMAGED BY WATER INTRUSION
