UMTA-MA-06-0156-86-1
DOT-TSC-UMTA-86-8

Water Intrusion Problems in Transit Tunnels

Paul Parks and Associates, Inc.
Engineering & Management Consultants
100 Boylston Street
Boston MA 02116

September 1986
Final Report

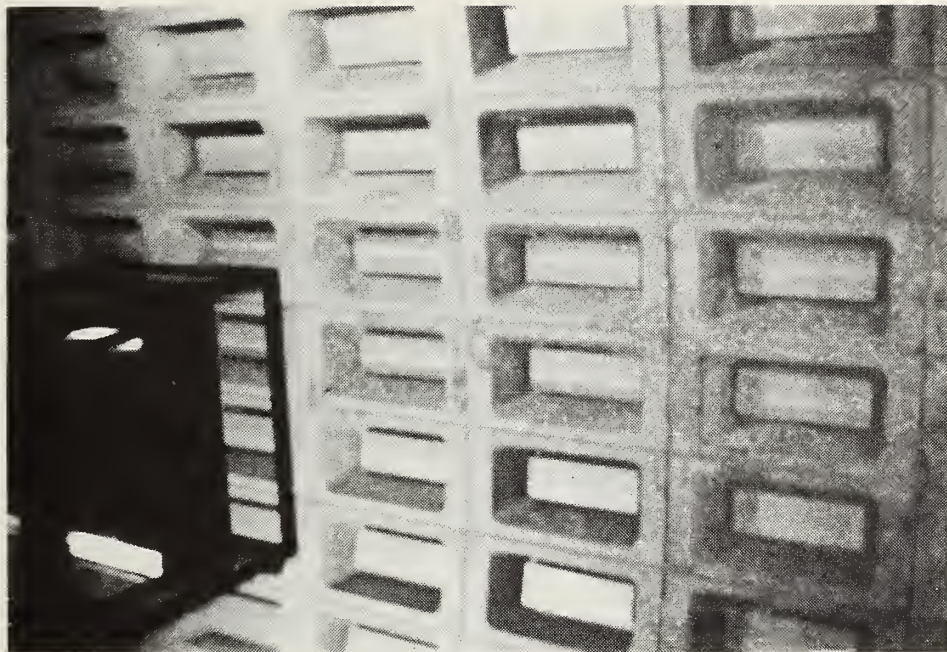
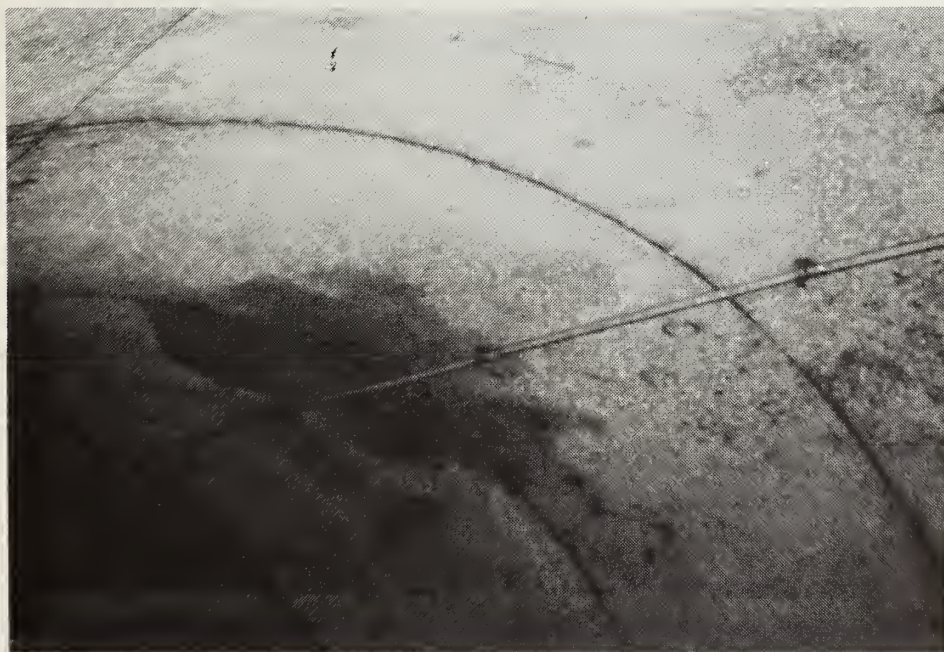
FIGURE 8.4 LEAKS THROUGH PRECAST AND CAST-IN-PLACE CONCRETE WALLS

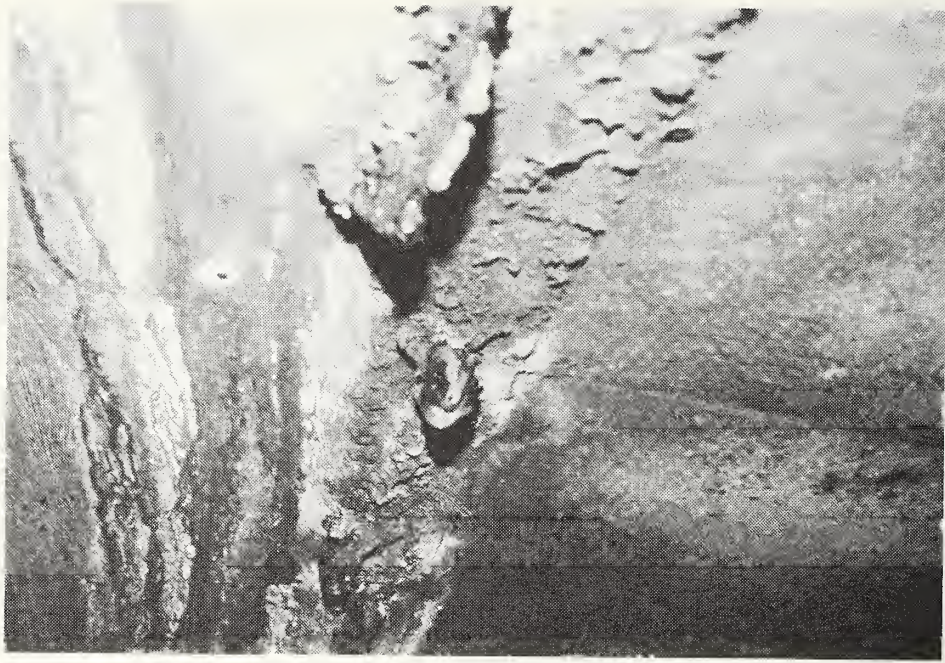
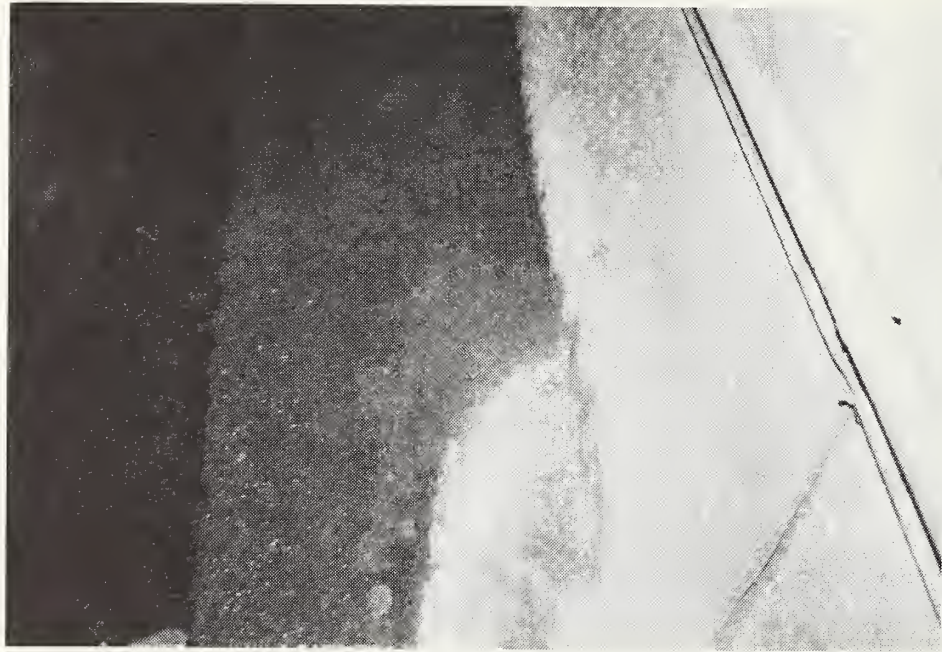
FIGURE 8.5 CALCIFICATION AND PRECIPITATIONS CAUSED BY LEAKING WATER

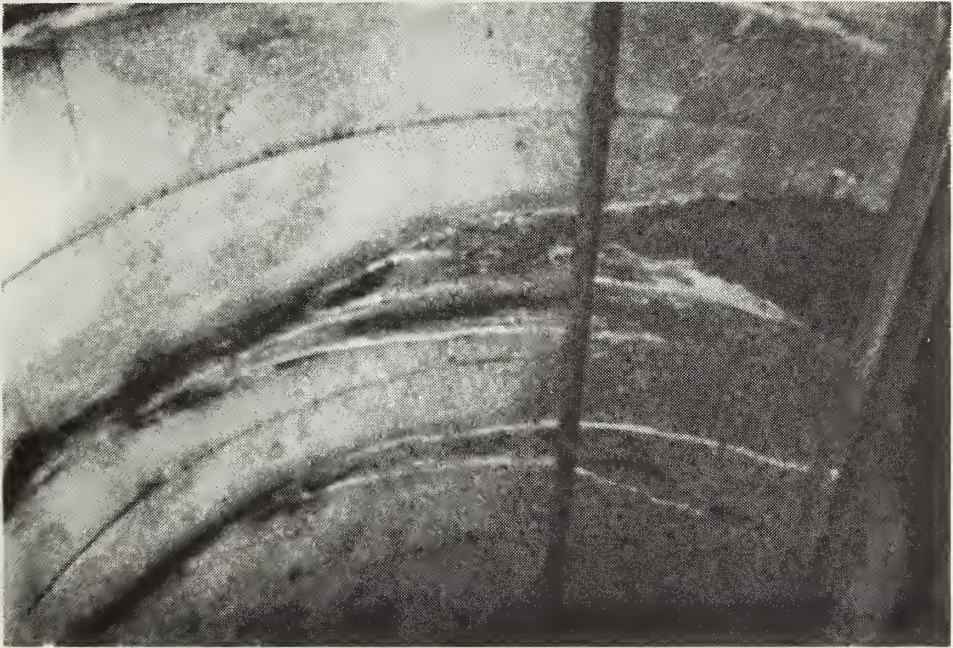
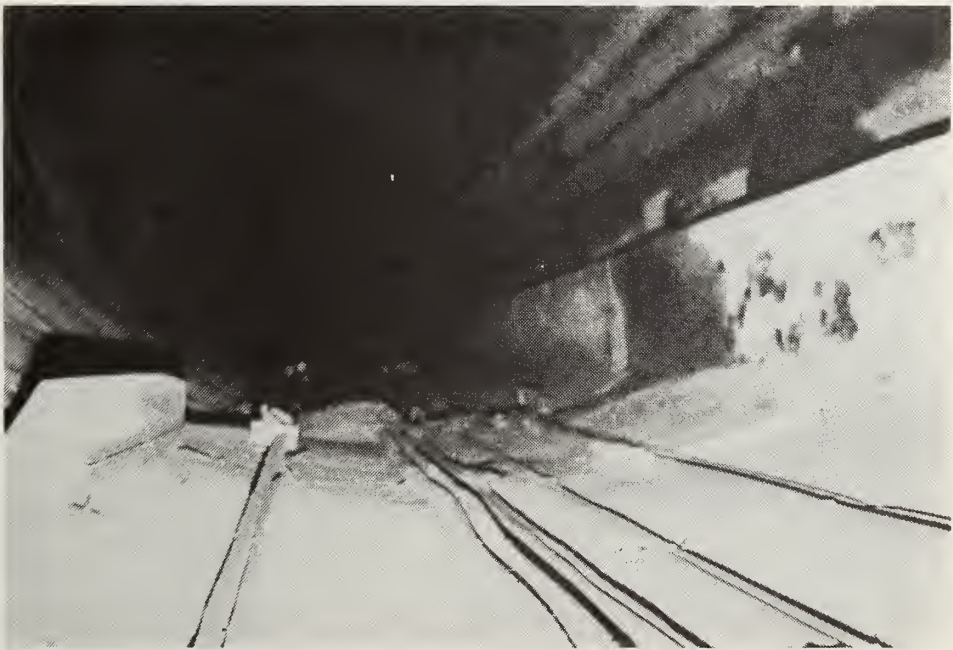
FIGURE 8.6 SHRINKAGE CRACKS IN CONCRETE LINING

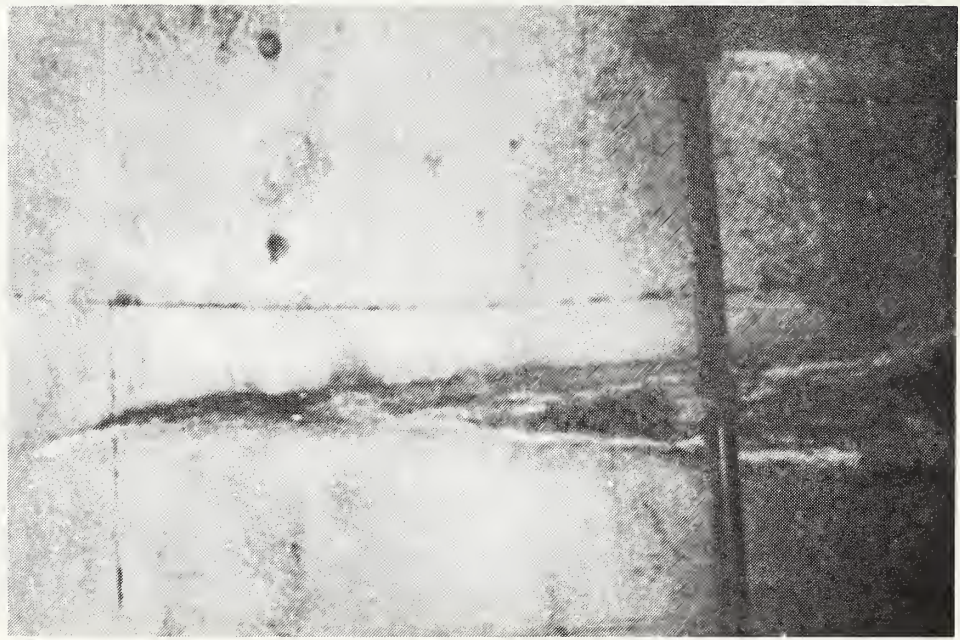
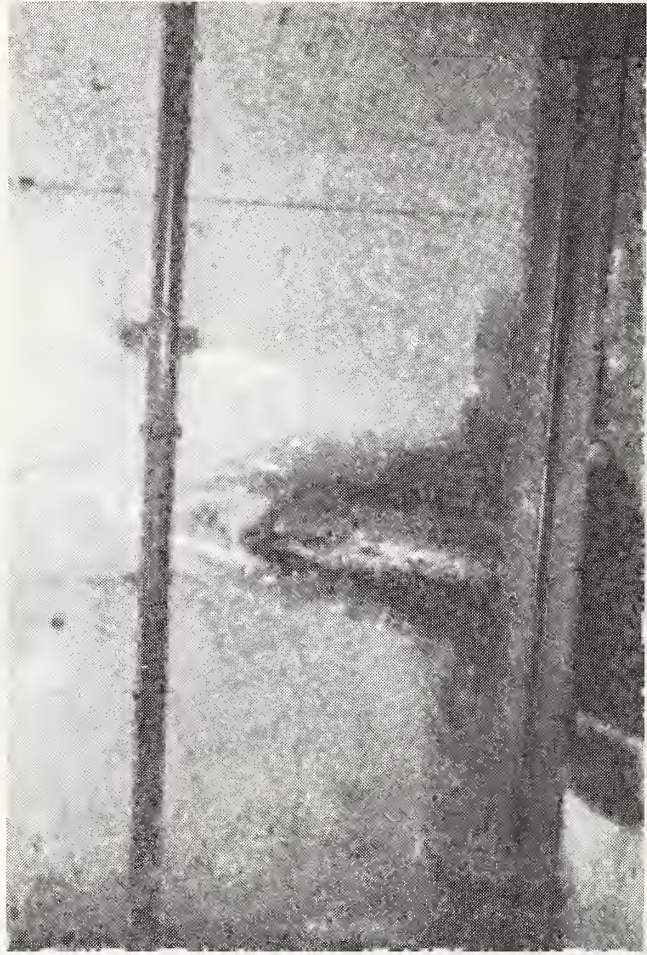
FIGURE 8.7 LEAKS THROUGH THE SHRINKAGE CRACKS IN CONCRETE LINING

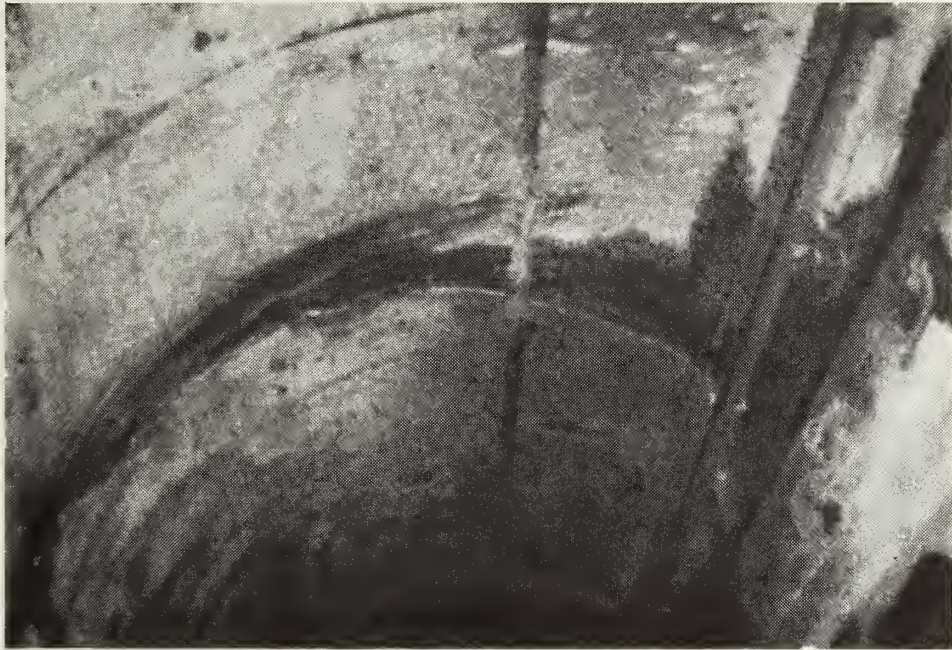
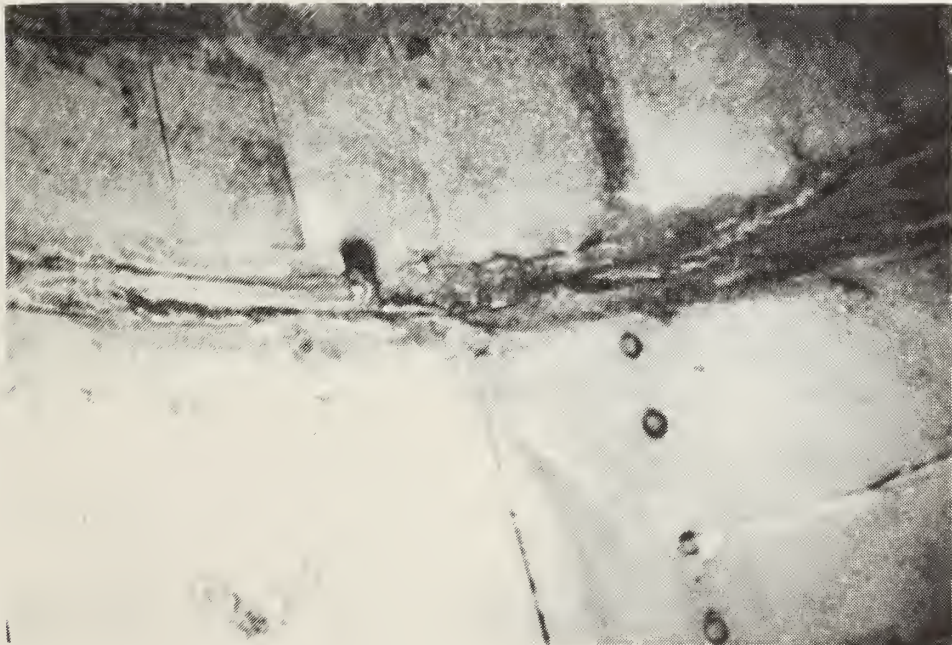
FIGURE 8.8 LEAKS THROUGH THE STRUCTURAL JOINTS IN CONCRETE LINING

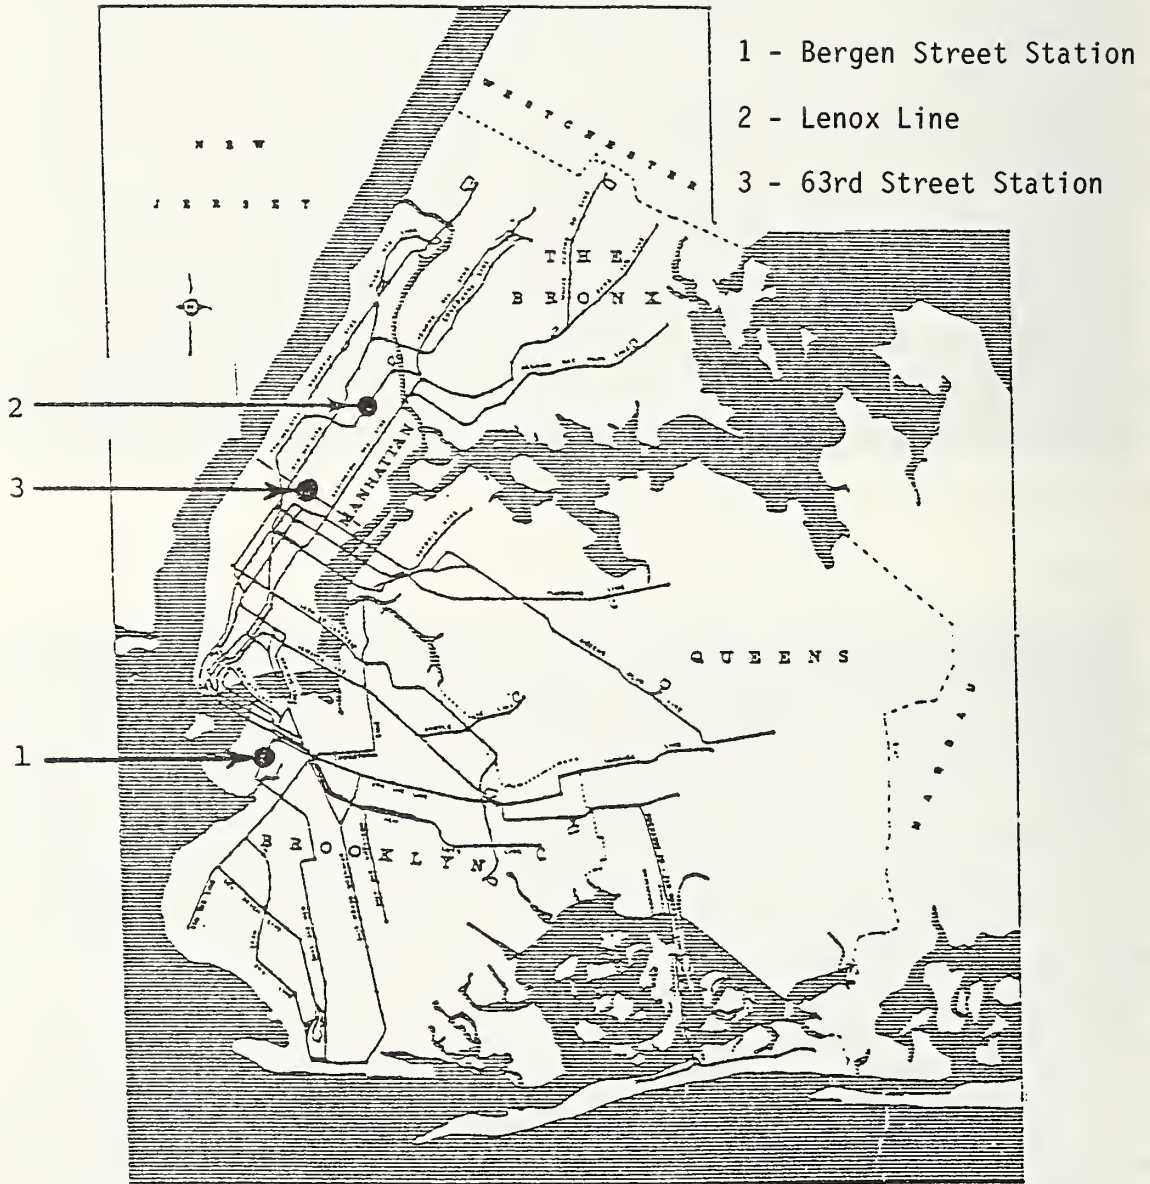
The general scheme of the NYCTA Subway System is shown in Figure 9.3. Figure 9.3 also shows the sites of the most intensive water leaks. Arrows 1, 2, and 3 point to the underground subway site locations that were visited by the site-visit team. Those sites are the most affected and are undermined by the infiltration of ground water.

FIGURE 9.3 SITES OF INTENSIVE WATER LEAKS

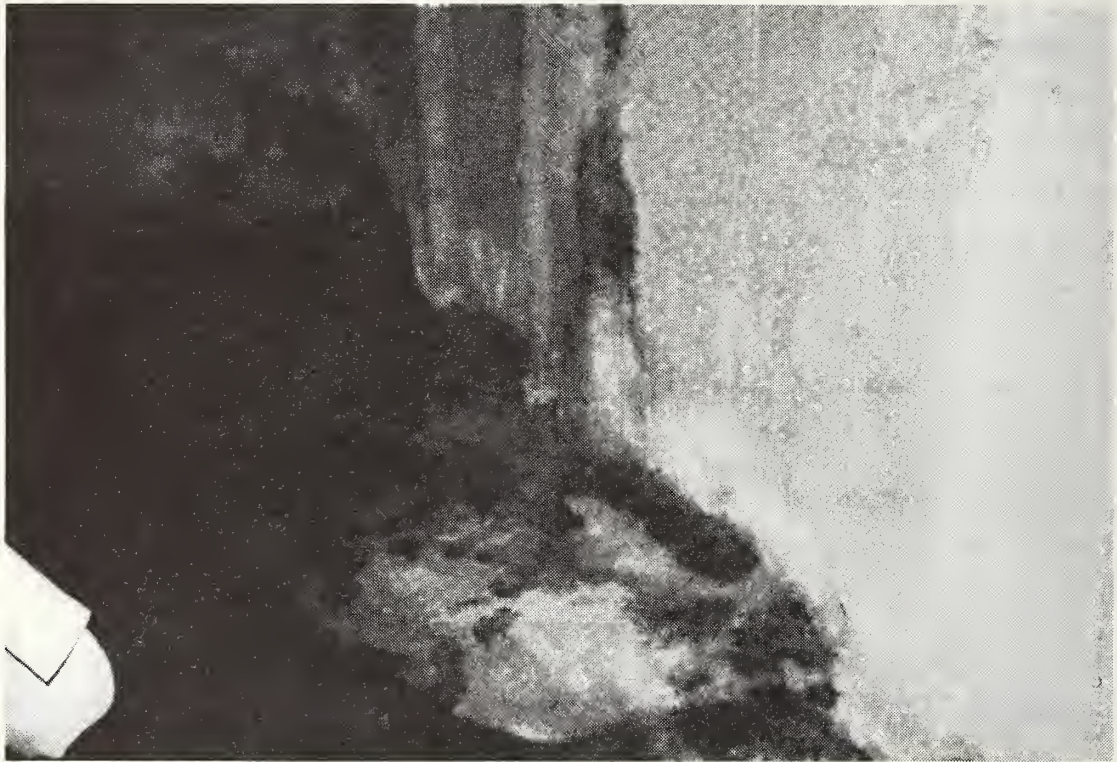
FIGURE 9.4 WATER INFILTRATION (BERGEN STREET STATION)

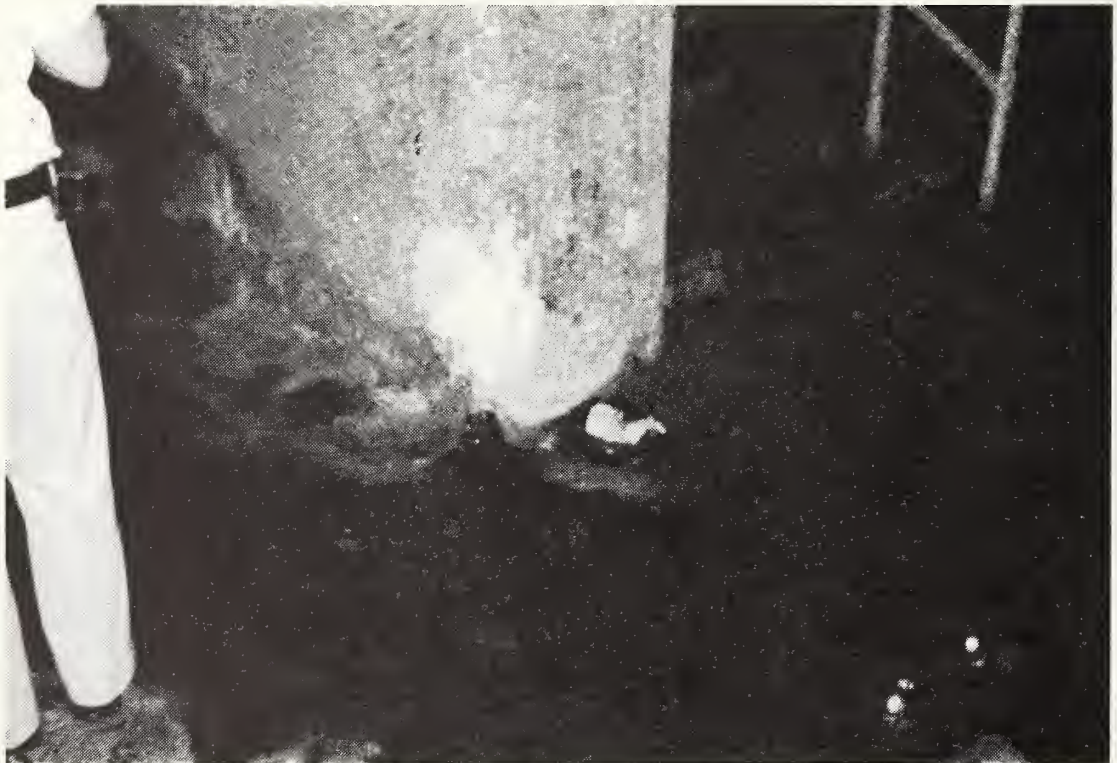
FIGURE 9.5 WATER INFILTRATION (BERGEN STREET STATION)

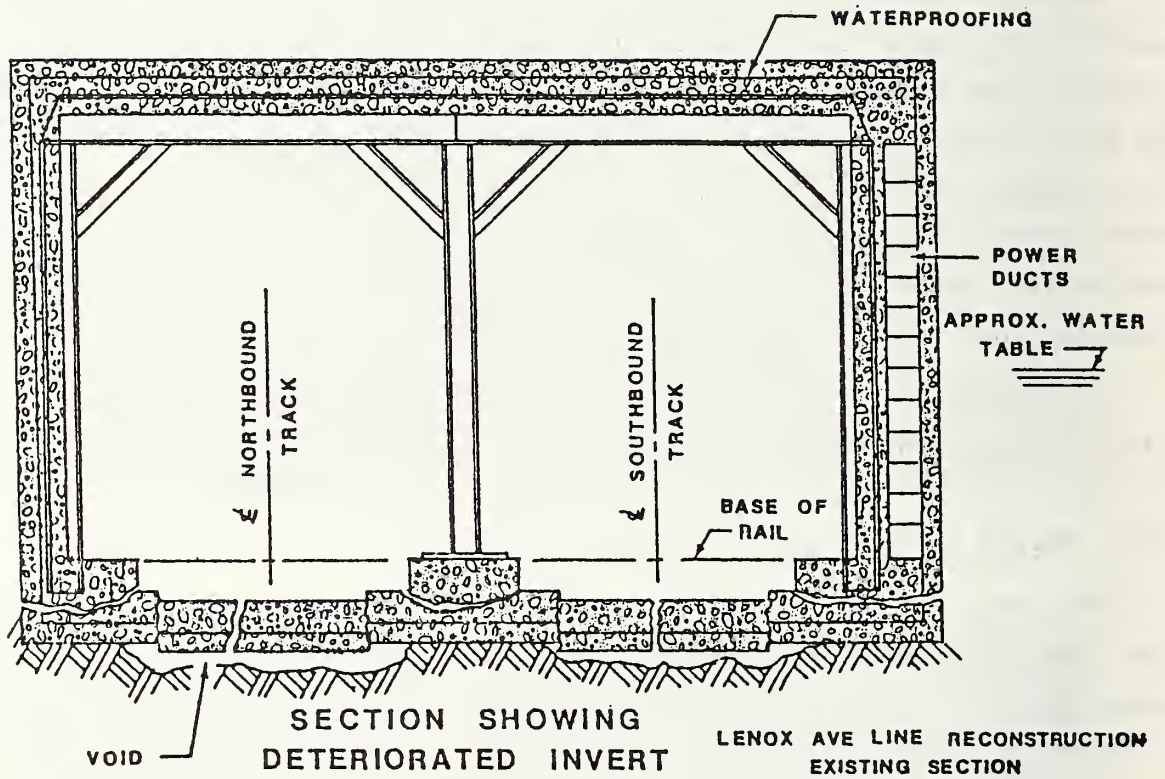
There are also a number of leaks along the ventilation system and sewer lines. However, the most extensive and dangerous type of leakage in tunnels occurs when the water can infiltrate through partially destroyed tunnel concrete walls and floors, as previously described. Figure 9.6 shows an example of such deteriorated structures.

FIGURE 9.6 WATER INFLOW BETWEEN THE BLOCKS OF DESTROYED TUNNEL FLOOR

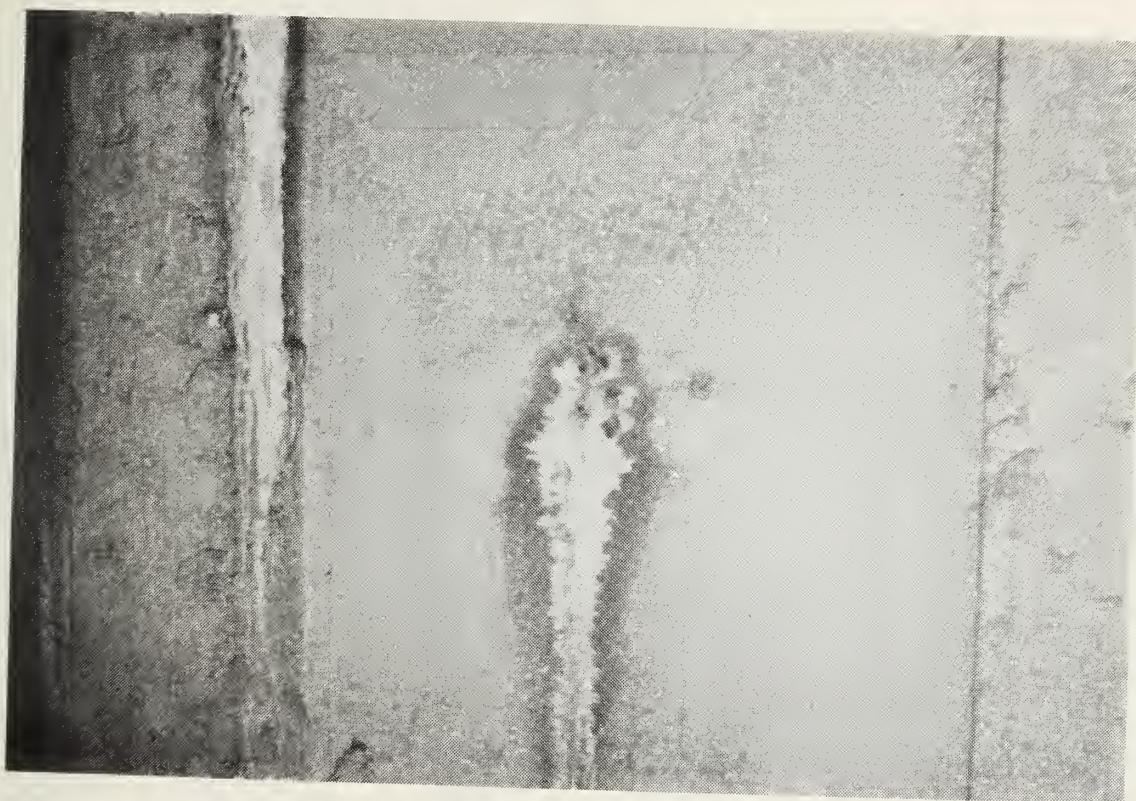
FIGURE 9.7 LEAKS THROUGH SHRINKAGE CRACKS

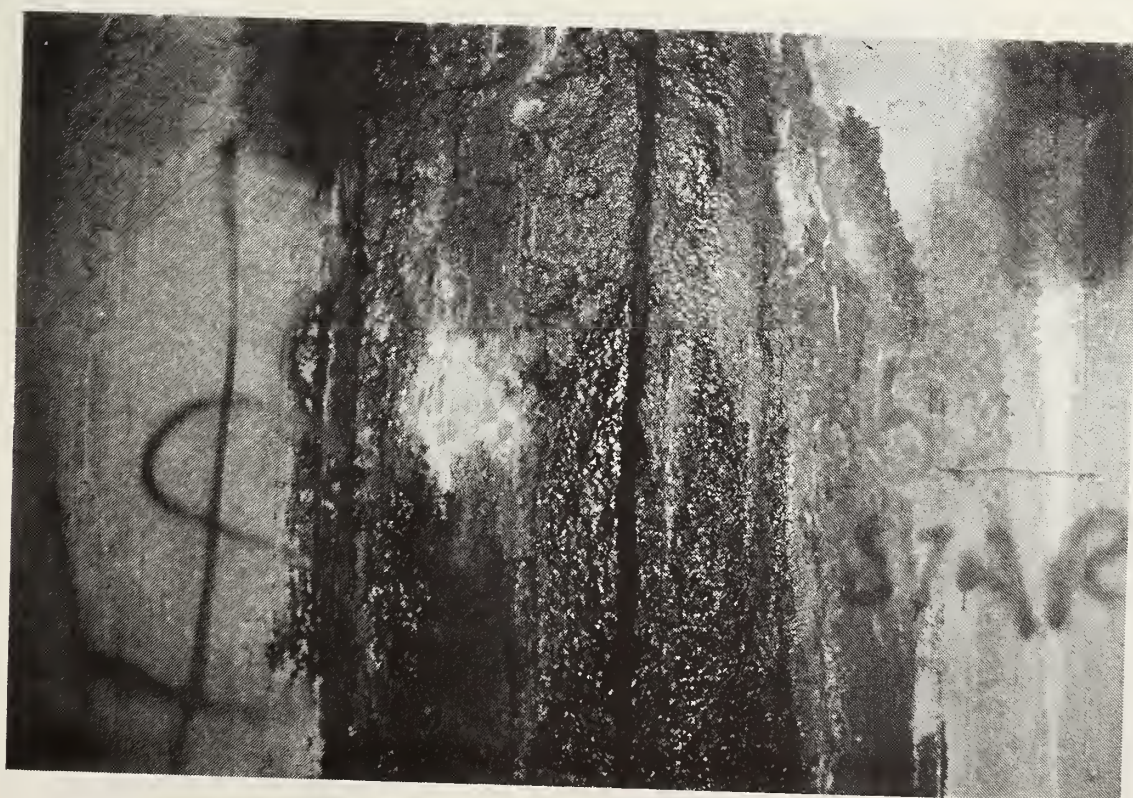
FIGURE 9.8 LEAKS THROUGH WALL JOINTS

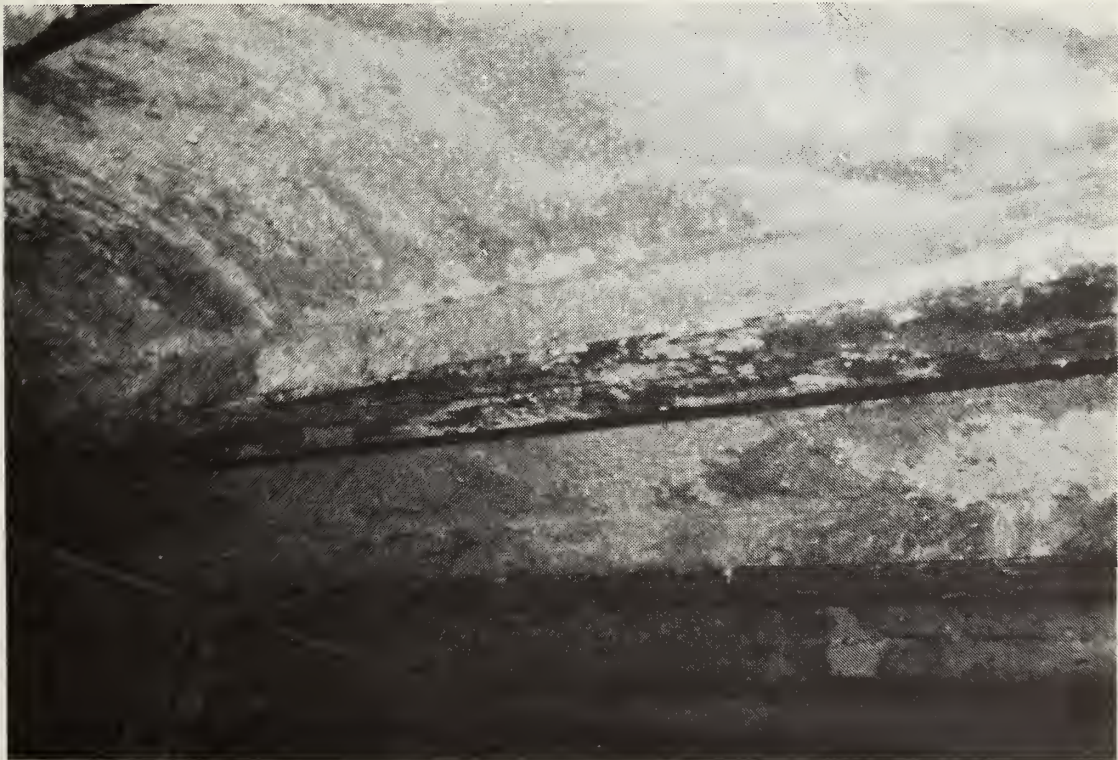
Figures 9.10 and 9.11 show a water inflow onto rail tracks and a corrosion of the arch beams.

FIGURE 9.11 CORROSION OF ARCH BEAMS (BERGEN STREET STATION)

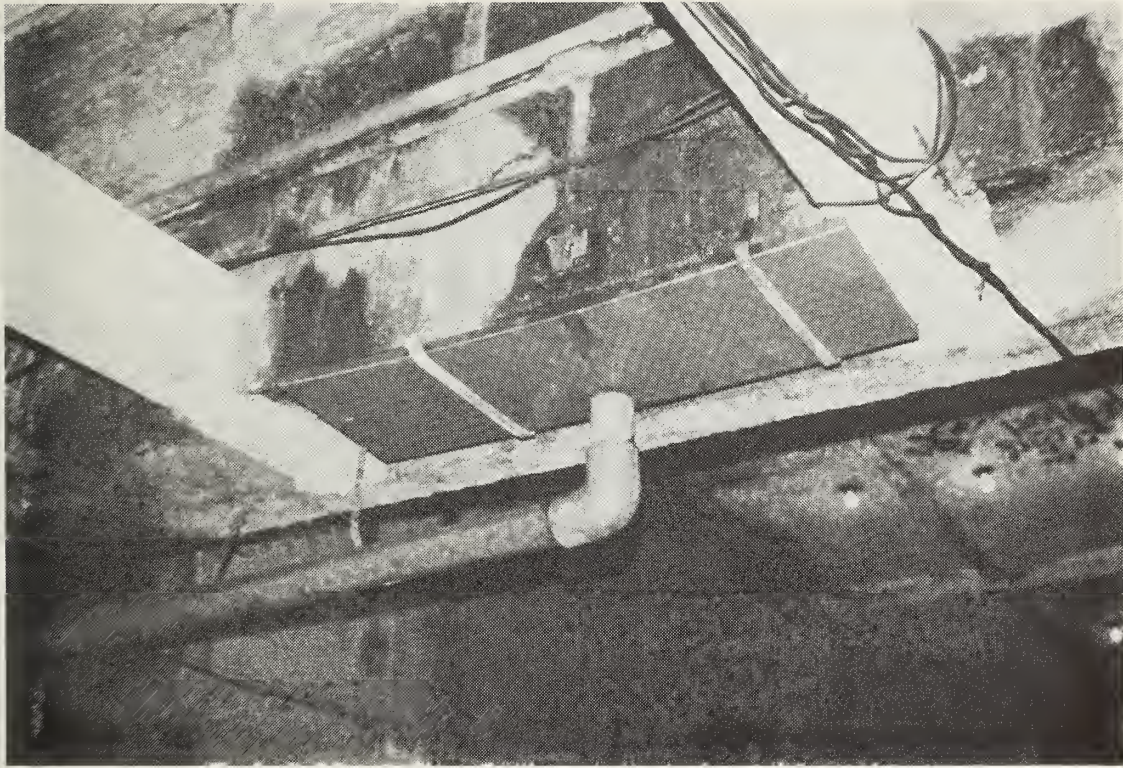
FIGURE 9.12 WATER CHANNELING (BERGEN STREET STATION)

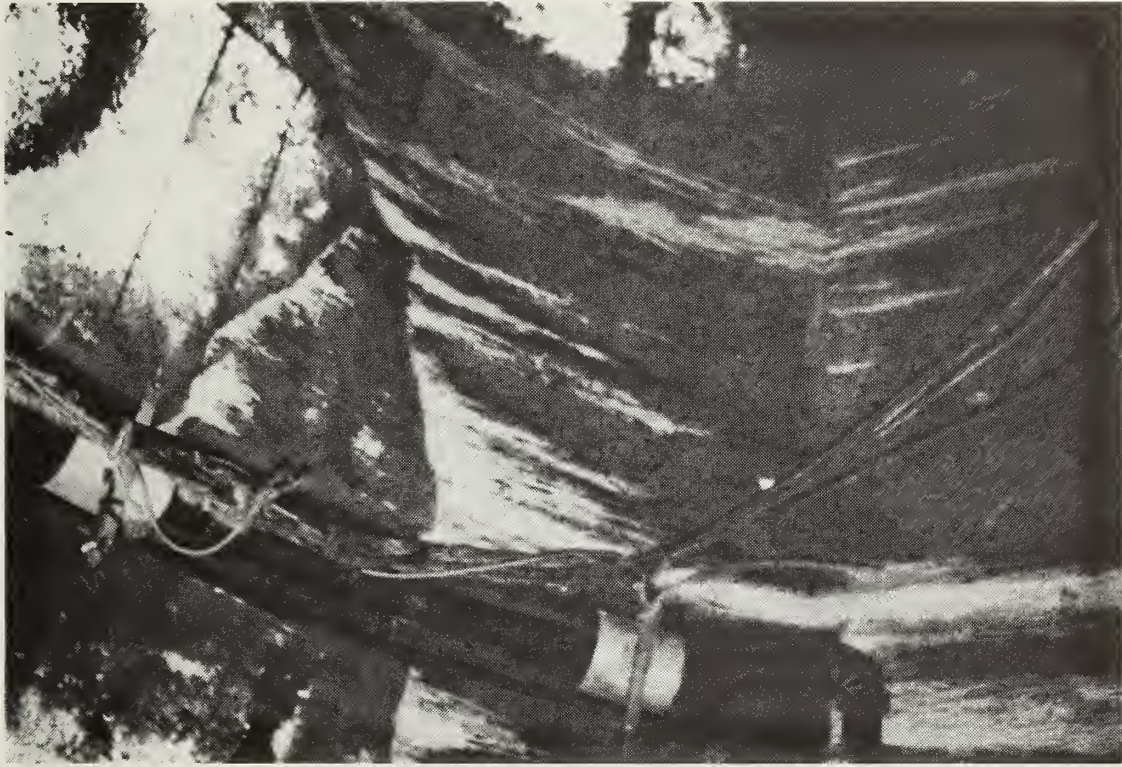
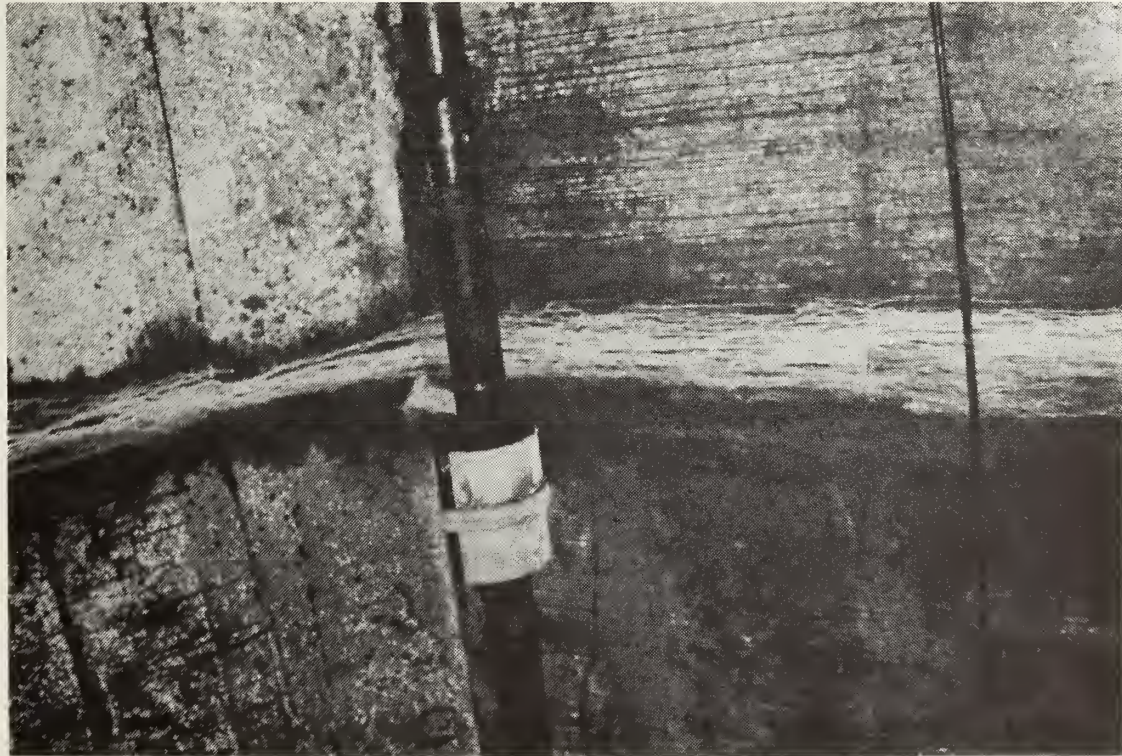
FIGURE 9.16 WATER INFILTRATION THROUGH CONSTRUCTION JOINTS

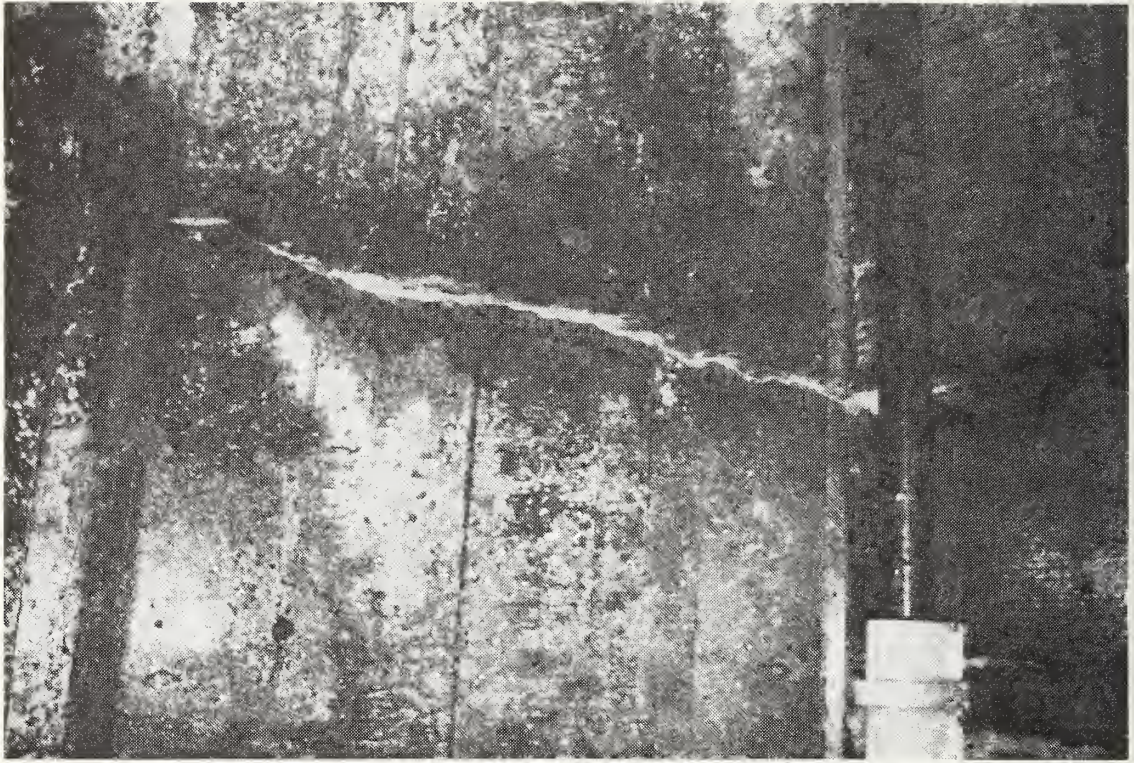
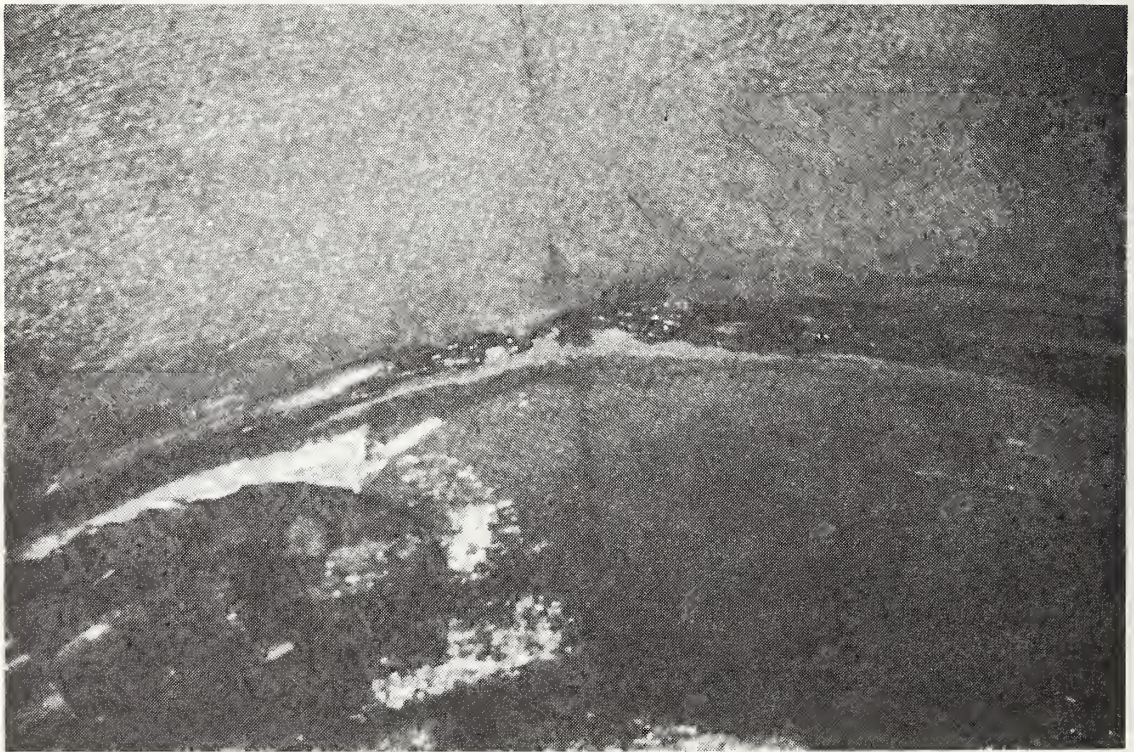
FIGURE 9.17 SHRINKAGE CRACKS (ROUTE 131-A)

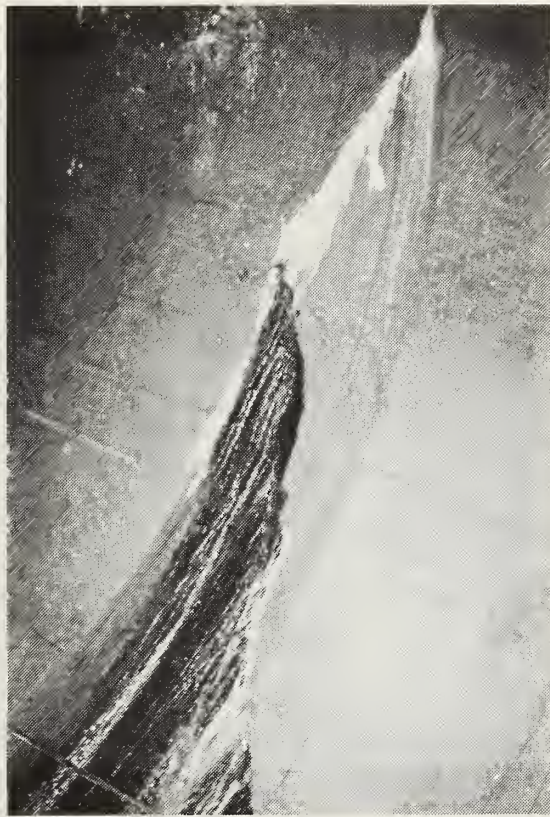
FIGURE 9.18 CALCIFICATION AROUND THE CRACKS (ROUTE 131-A)

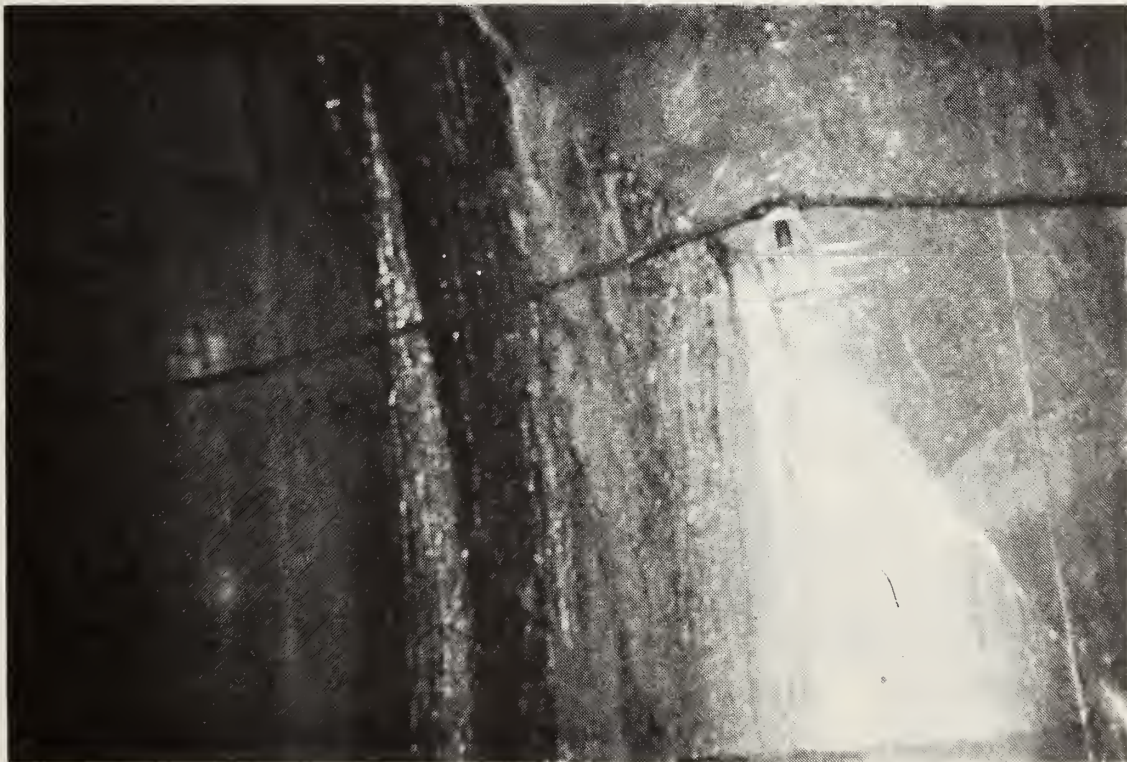
FIGURE 9.19 CALCIFICATION AND SETTLEMENTS AROUND THE CRACK AREA (ROUTE 131-A)

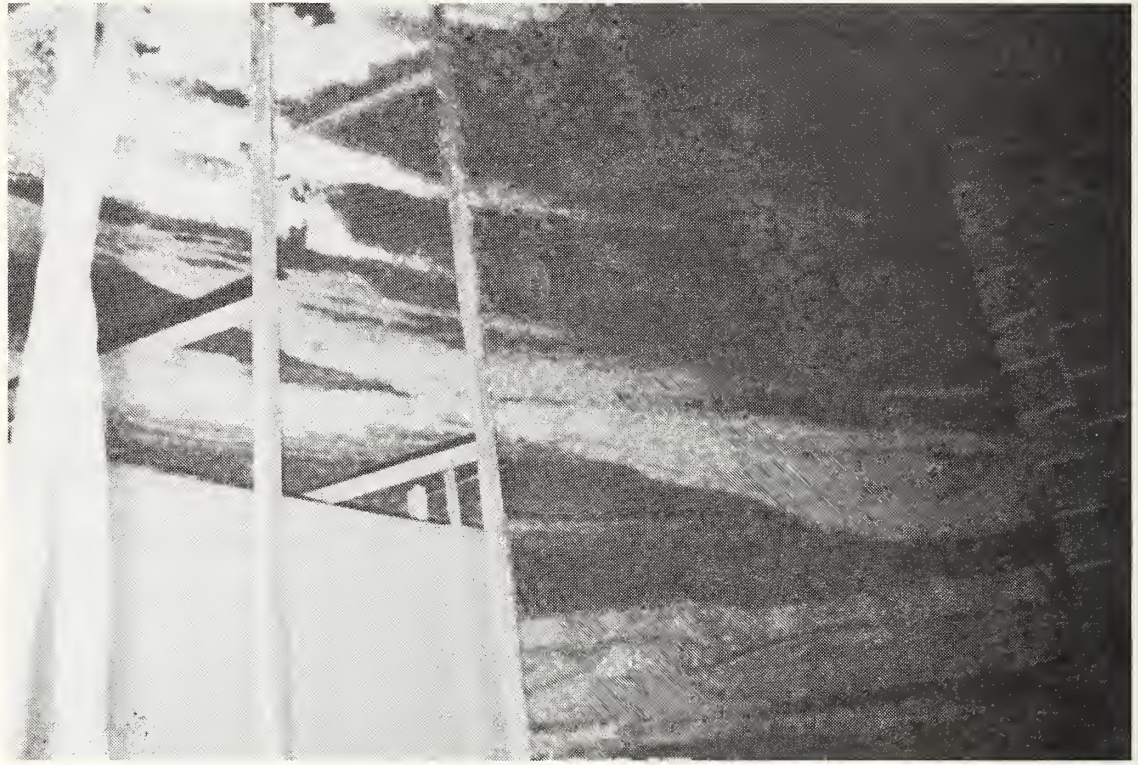
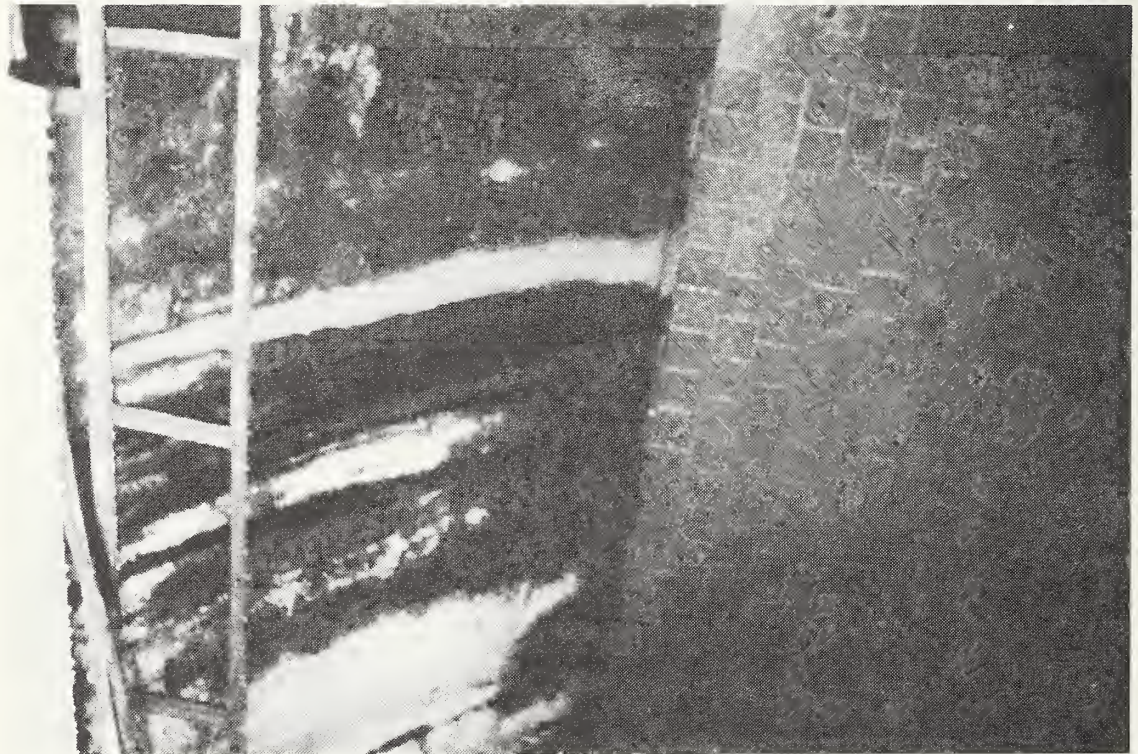
FIGURE 9.20 LEAKS THROUGH THE SHRINKAGE CRACKS BEHIND THE ARCHITECTURAL COVER (TILE WALLS)
