F/A-15 - SHIBaura ENGINEERING WORKS, Ltd.

LIMITED DAMAGE INTERPRETATION #35

FUNCTIONAL ANALYSIS REPORT NO. F/A-15

TARGET: 90.17-133 - SHIBAURA ENGINEERING WORKS, LTD.

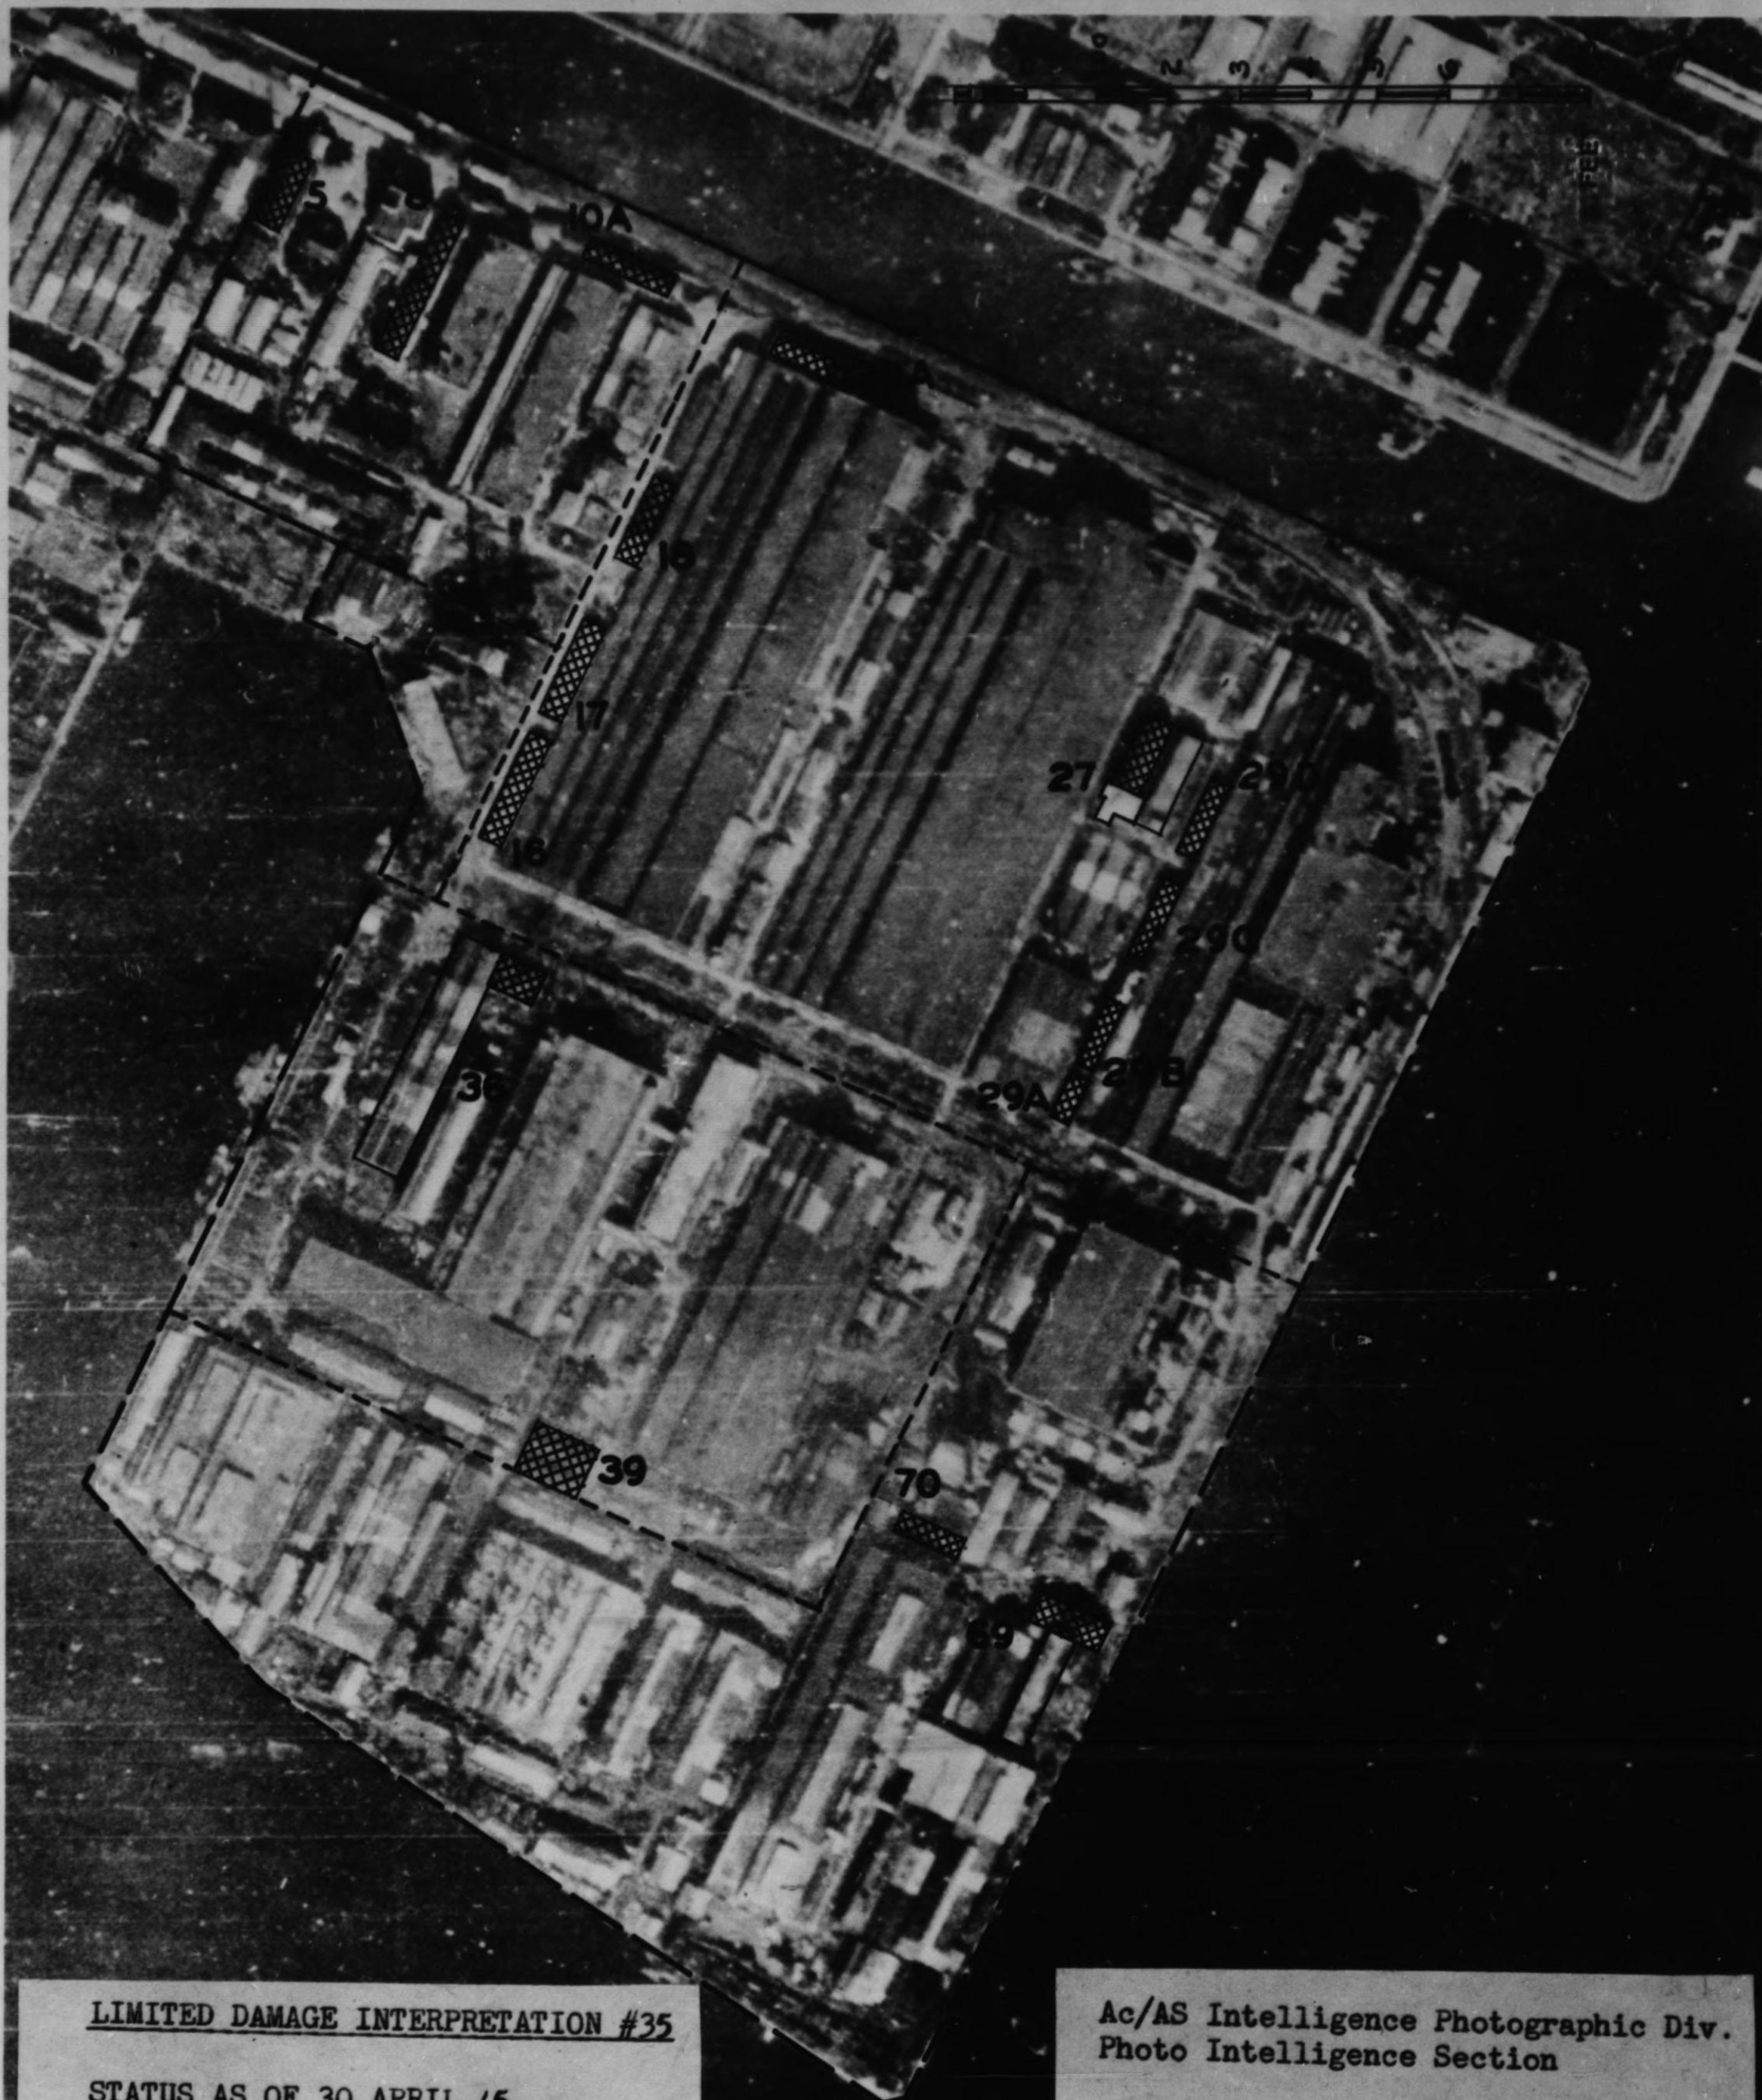
<input checked="" type="checkbox"/>	Photography is inadequate in scale	<input checked="" type="checkbox"/>	Damage is below 10% of built-up area.	<input checked="" type="checkbox"/>	Photography is inadequate in quality	<input type="checkbox"/>	Total damage is less than 50,000 sq. ft.	<input type="checkbox"/>	Stereo coverage is lacking or incomplete	<input type="checkbox"/>	Excessive time between attack and photography	<input checked="" type="checkbox"/>	Detailed interpretation is not required	<input checked="" type="checkbox"/>	Other factors as noted below
<input checked="" type="checkbox"/>	Photography is inadequate in scale	<input checked="" type="checkbox"/>	Damage is below 10% of built-up area.																		
<input checked="" type="checkbox"/>	Photography is inadequate in quality	<input type="checkbox"/>	Total damage is less than 50,000 sq. ft.																		
<input type="checkbox"/>	Stereo coverage is lacking or incomplete	<input type="checkbox"/>	Excessive time between attack and photography																		
<input checked="" type="checkbox"/>	Detailed interpretation is not required	<input checked="" type="checkbox"/>	Other factors as noted below																		
BUILDING		VISIBLE DAMAGE		DESCRIPTION OF DAMAGE																	
REF. NO.	AREA	STRUCT'L	SUPERF'L																		
5	4.6	4.6		<p>NOTES: This report shows less damage than that reported on U/DA report. Discrepancy is due to inadequate photography in both cases. The amount of damage shown hereon is considered to be accurate as shown, although other damage may exist within the target to a minor extent. The cause of all damage is believed to be fire.</p> <p>The built-up area shown hereon is as accurate as available photography allows, but will be subject to revision through later structural analysis. The percentage of damage is, therefore, approximate.</p>																	
8	7.7	7.7																			
10	A 4.6	4.6																			
16	5.8	5.8																			
17	5.3	5.3																			
18	4.6	4.6																			
20	A 3.0	3.0																			
27	13.0	5.0																			
29	A 1.8	1.8																			
29	B 2.5	2.5																			
29	C 2.4	2.4																			
29	D 2.9	2.9																			
36	26.3	3.5																			
39	7.1	7.1																			
69	11.7	4.9																			
70	3.0	3.0																			
		68.7																			
TOTALS (CUMULATIVE)				APPROVED BY: <i>Lee W. Kilgore</i> Lee W. Kilgore, Major AC Chief, Evaluation Branch Photographic Division AC/AS Intelligence																	
SITE	SITE AREA																				
	BUILT-UP AREA		1688.5																		
	% OF SITE BUILT-UP																				
DAMAGE	AREA OF DAMAGE		68.7																		
	% OF BUILT-UP AREA		4.0%																		
ALL AREAS ARE PLAN AREAS IN THOUSANDS OF SQUARE FEET

ALL DAMAGE IS STRUCTURAL
