REPORT OF THE CIVIL AERONAUTICS BOARD

Of the investigation of an accident
involving civil aircraft of the United
States NC 16086 which occurred near
Centerville, Utah, on November 4, 1940.

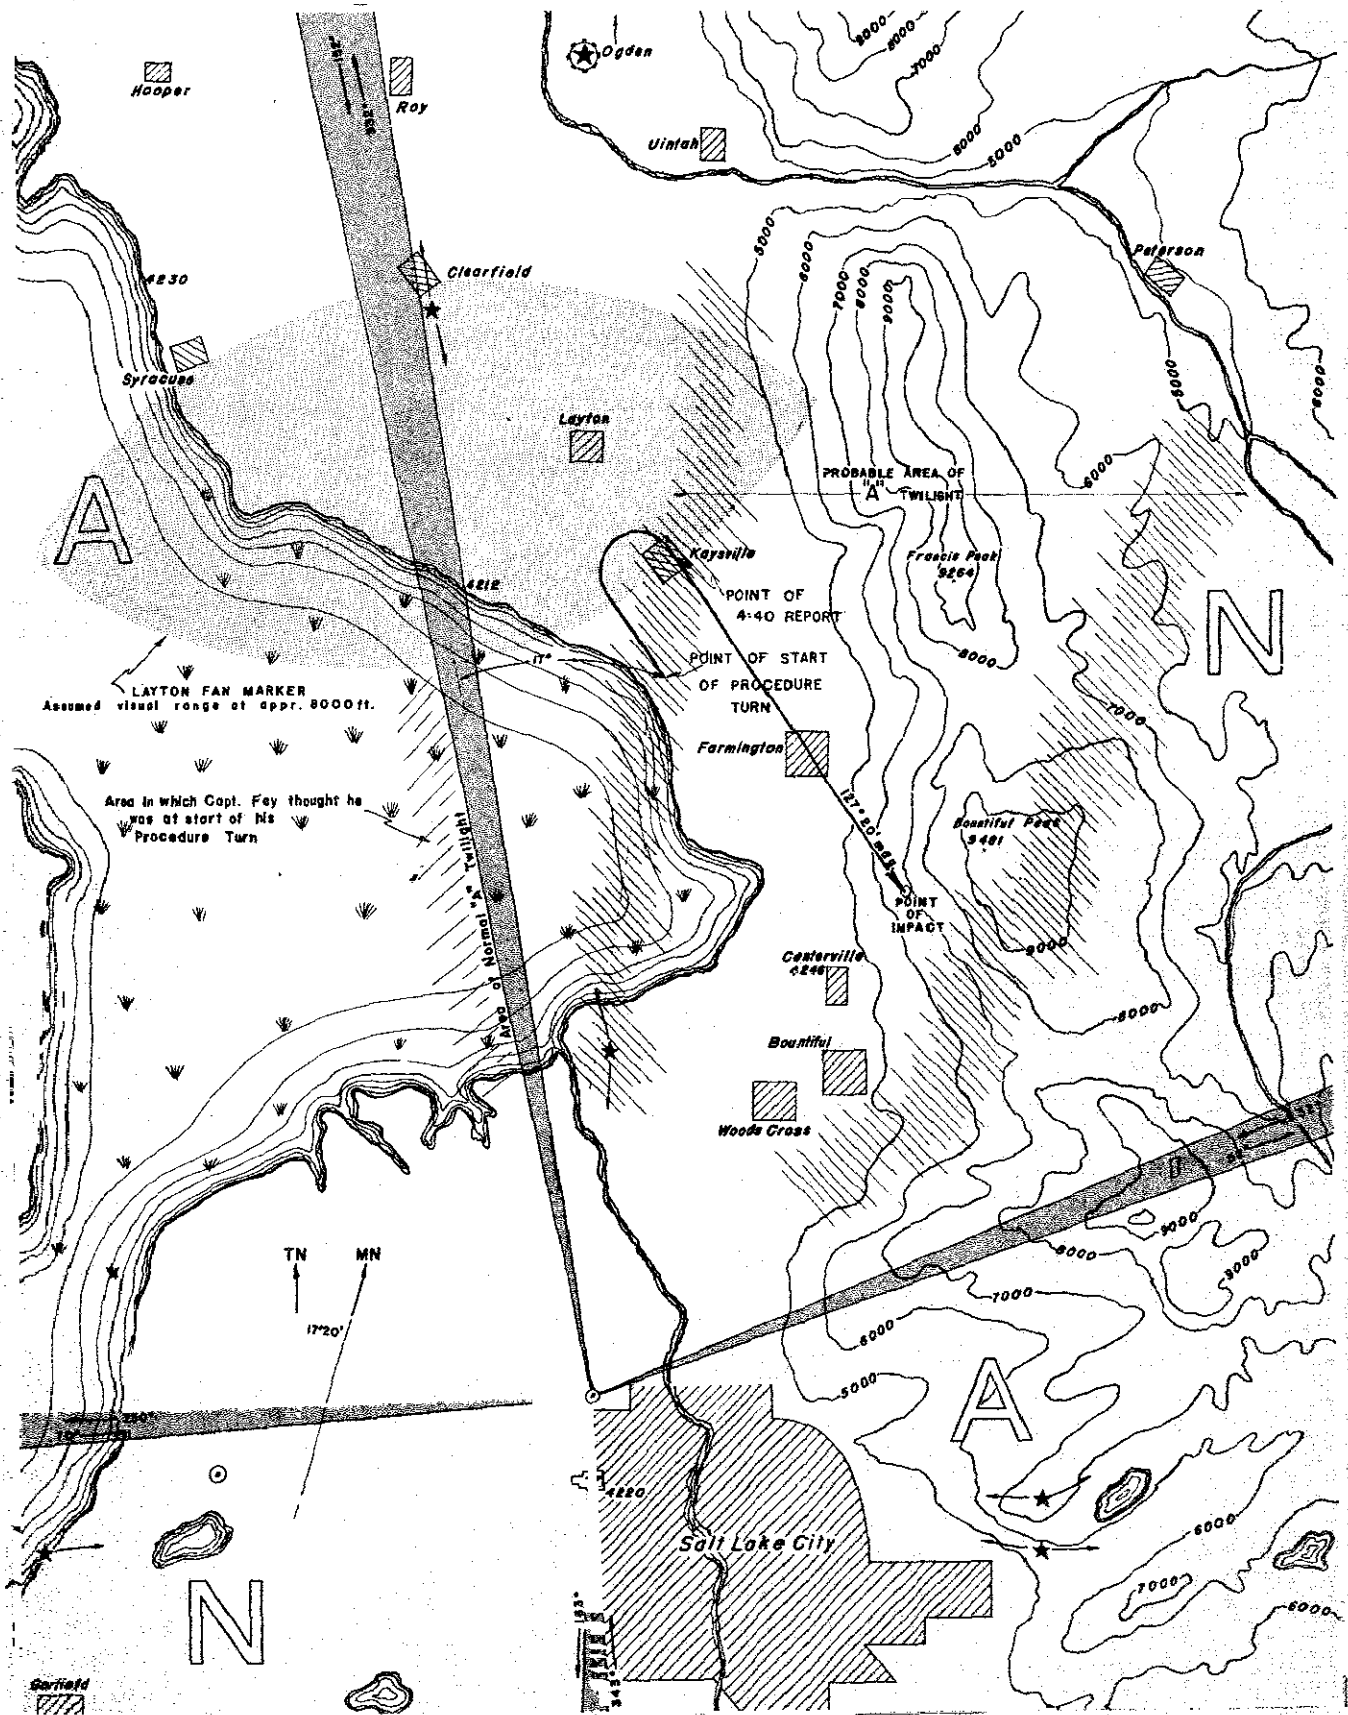
FIGURE 'A'

Since an examination of Figure A will show that the shortest distance between the limits of the visual signal of the Layton marker and the scene of the accident is about $8\frac{1}{4}$ miles, Trip 16 must have made good a ground speed of at least 165 miles per hour between the time the report "over Layton" was made and the time the airplane crashed. Moreover, the evidence would indicate that this ground speed is probably the highest ground speed that we could reasonably assume to have been made in the area in which Trip 16 was flying. According to the let-down procedure prescribed by United for Salt Lake City,

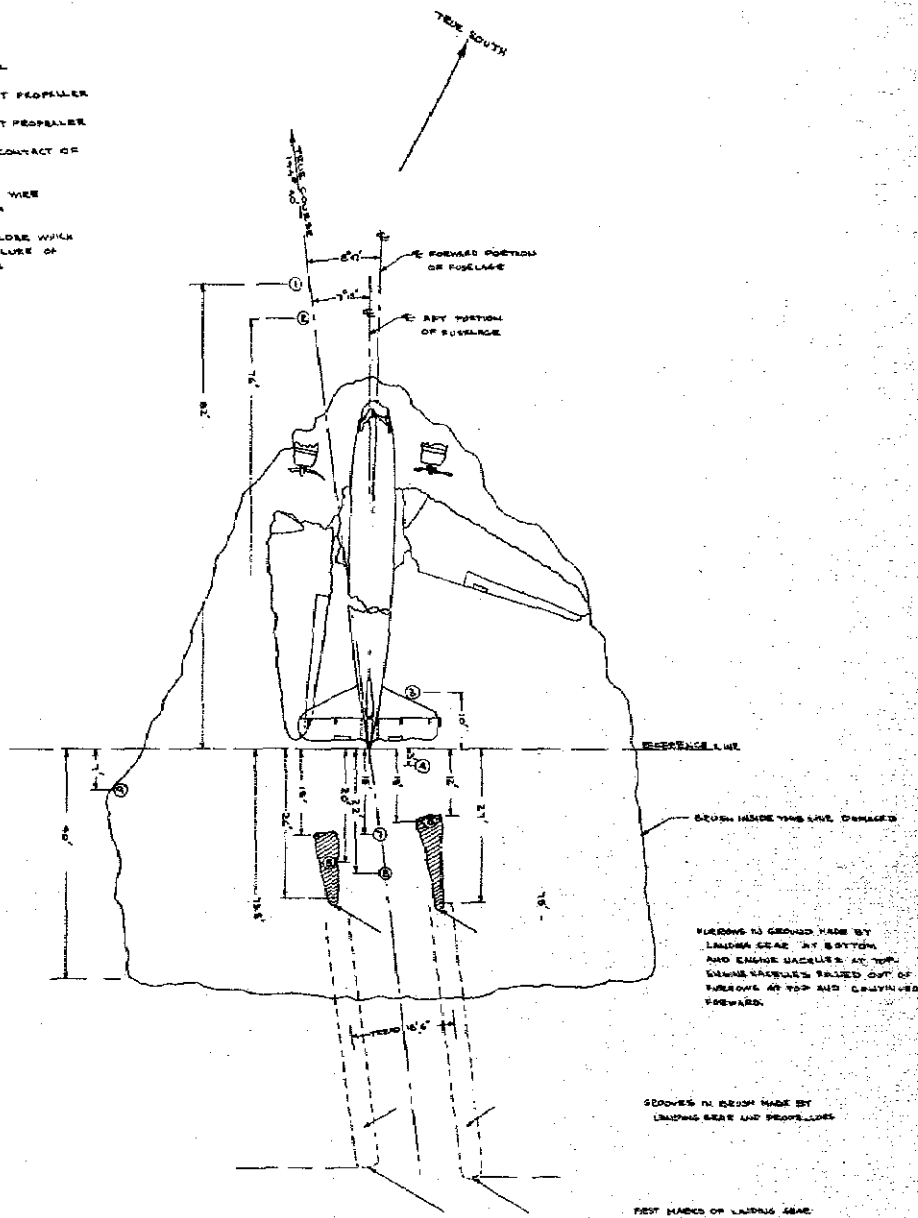
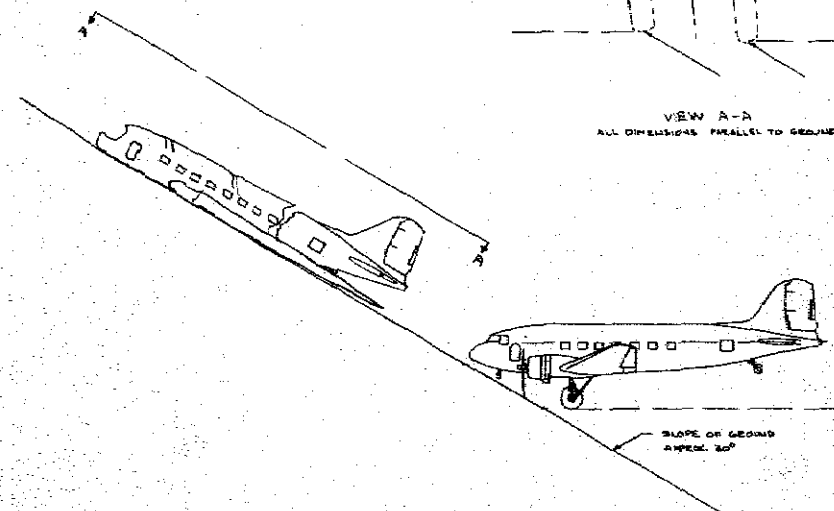
SKETCH OF ACCIDENT TO
U.S. AIRPLANE NE-16086
NEAR SALT LAKE CITY, UTAH NOVEMBER 4, 1940

- ① CAPTAIN
- ② FIRST OFFICER
- ③ RIGHT OIL COOLER
- ④ RIGHT OIL COOLER COWL
- ⑤ ONE BLADE FROM LEFT PROPELLER
- ⑥ ONE BLADE FROM RIGHT PROPELLER
- ⑦ APPROXIMATE POINT OF CONTACT OF FUSELAGE W/GRND
- ⑧ SPRING, INSULATOR AND WIRE FROM BELLY ANTENNA
- ⑨ HEAVY BUSH AND BOULDER WHICH CAUSED COMPLETE FAILURE OF WING CENTER SECTION

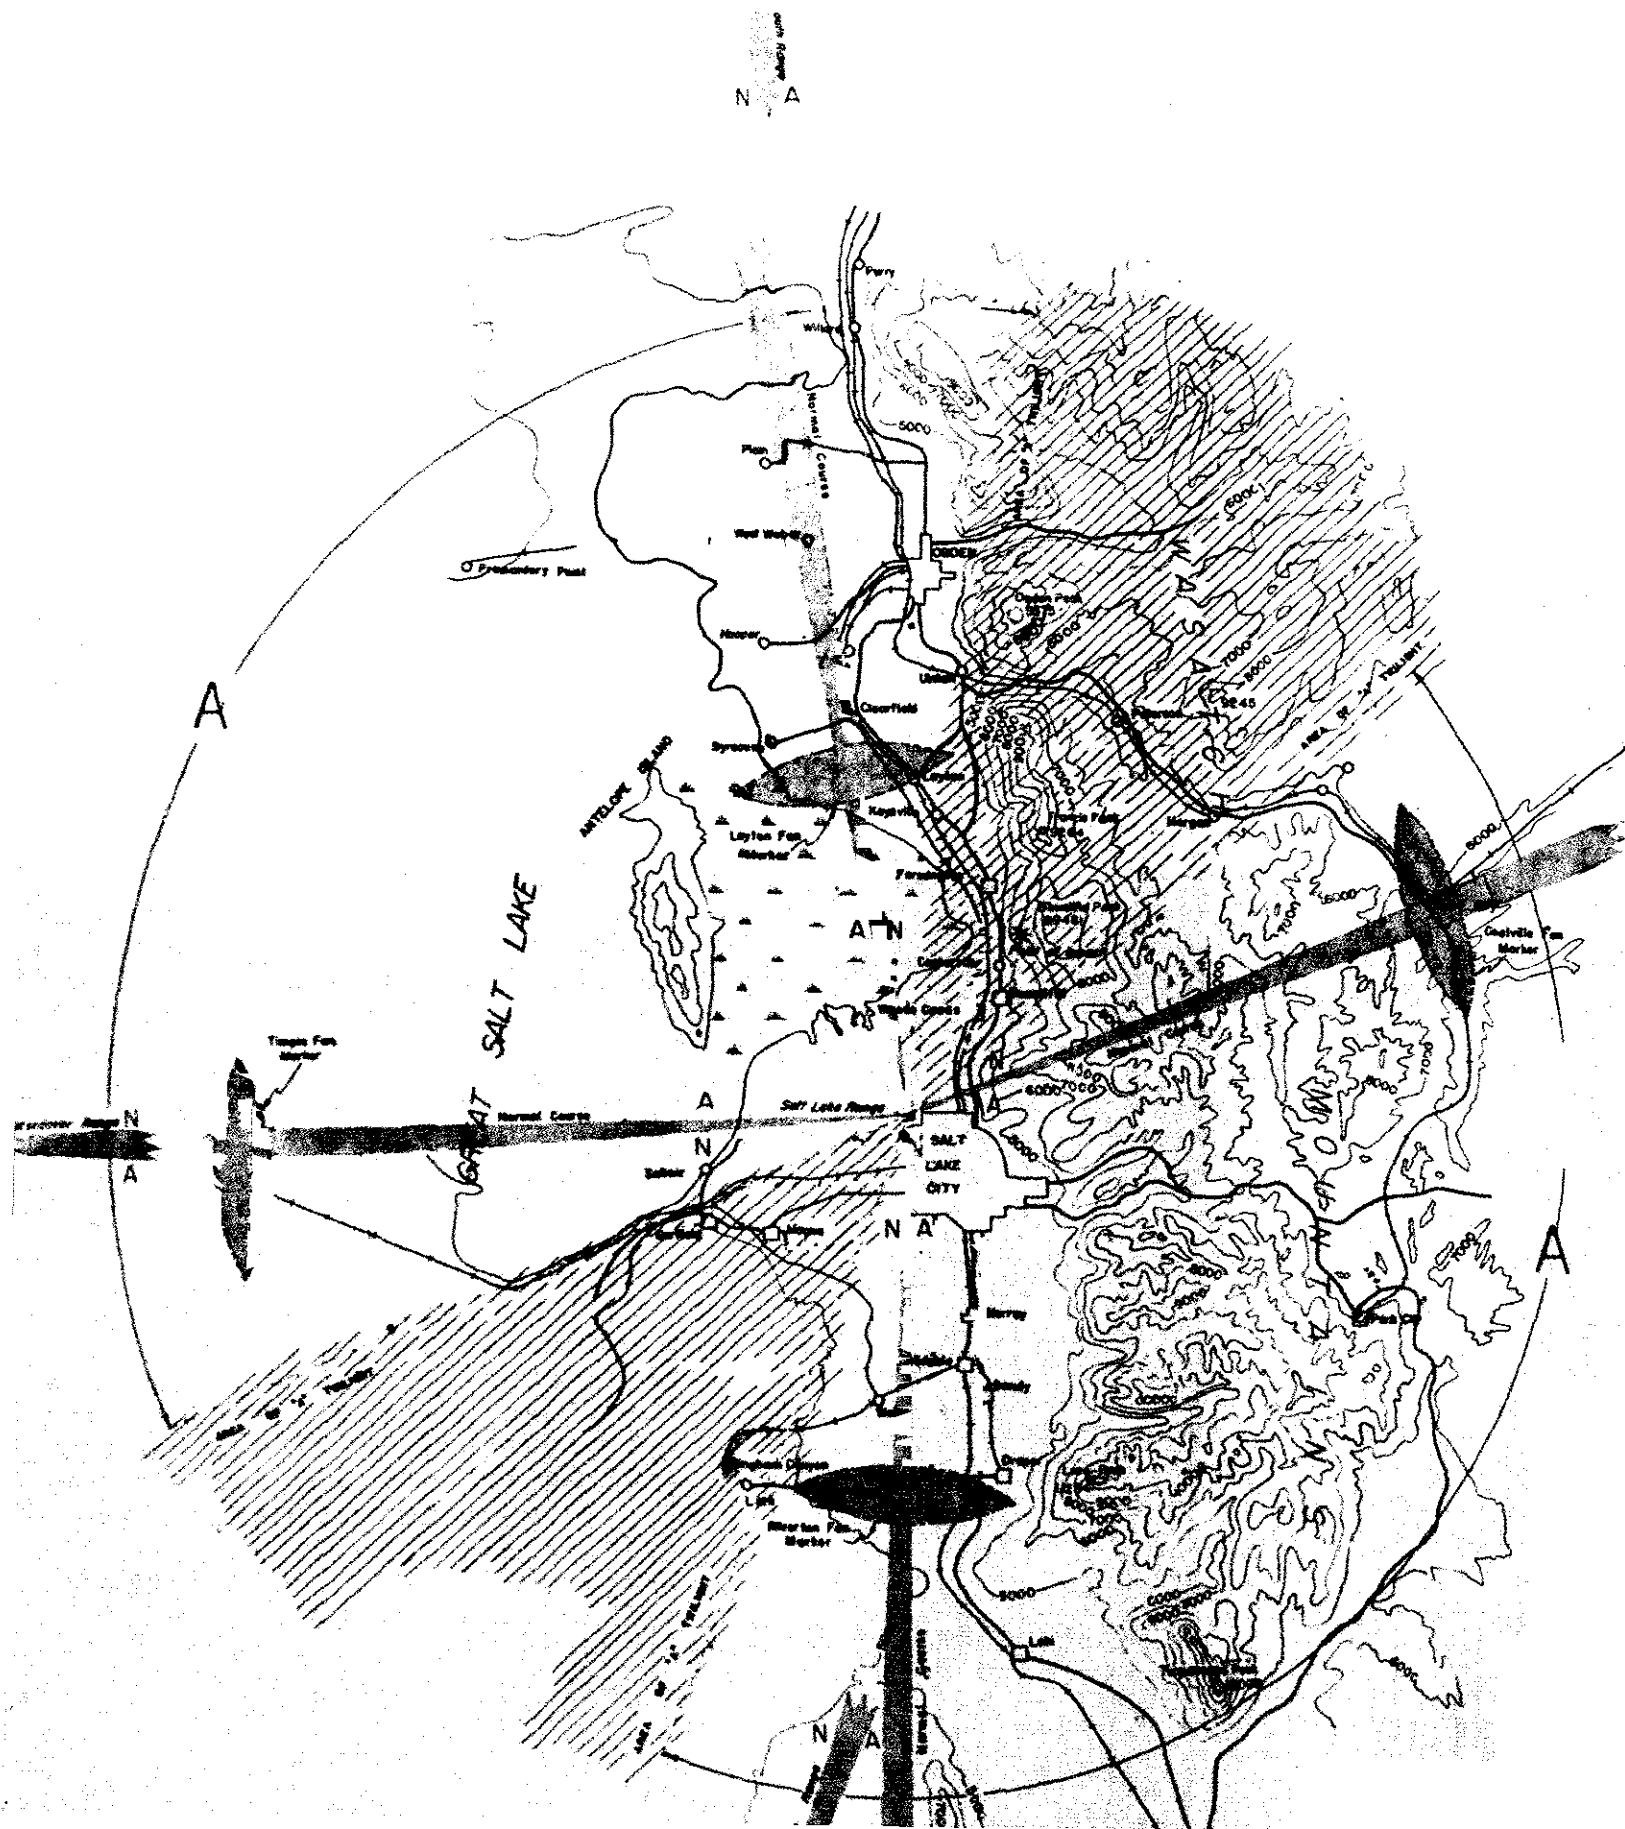
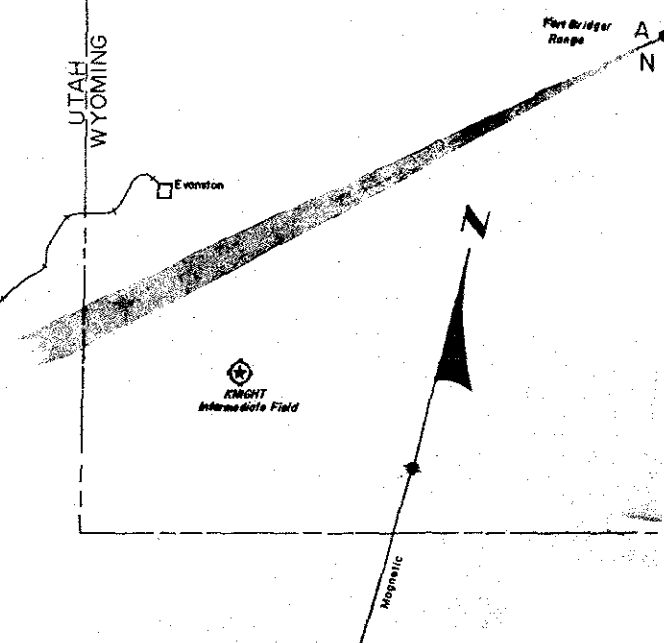
SALT LAKE AREA

SHOWING NORMAL PATTERN OF SALT LAKE RANGE AND THE PROBABLE PATTERN AT TIME OF ACCIDENT TO NC 16086
