# Aviation Investigation Preliminary Report

<b>Location:</b>	Freeland, WA	<b>Accident Number:</b>	DCA22MA193
<b>Date &amp; Time:</b>	September 4, 2022, 15:09 Local	<b>Registration:</b>	N725TH
<b>Aircraft:</b>	DEHAVILLAND DHC-3	<b>Injuries:</b>	10 Fatal
<b>Flight Conducted Under:</b>	Part 135: Air taxi & commuter - Scheduled

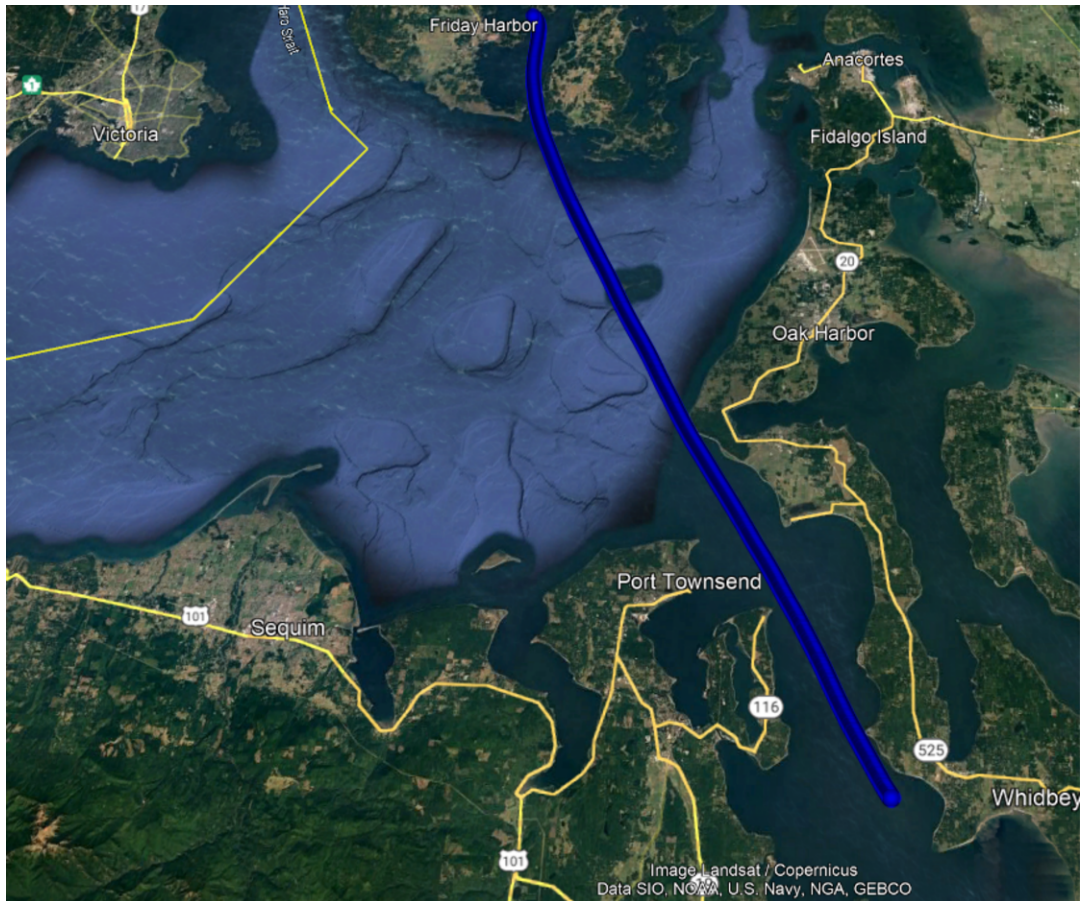
Figure 1 - FAA Tracking Data - Accident Flight Leg

The accident occurred during the pilot's second trip of the day; each trip involved multiple flight legs. A review of Federal Aviation Administration (FAA) tracking data revealed that the accident flight departed from Friday Harbor Seaplane Base (W33), Friday Harbor, Washington, about 1450 with a destination of Renton Municipal Airport (RNT), Renton, Washington. The track data indicated the airplane flew a southerly heading before turning south-southeast. The en route altitude was between 650 and 975 ft above mean sea level (msl), and the groundspeed was between 115 and 125 knots. At 1508:43 the altitude increased to 1,125 ft, and the groundspeed reduced to 109 knots. At 1508:49, the altitude decreased to 875 ft and the groundspeed reduced to 100 knots. The tracking data ended at 1508:51, at an altitude of 700 ft and groundspeed of 55 knots.

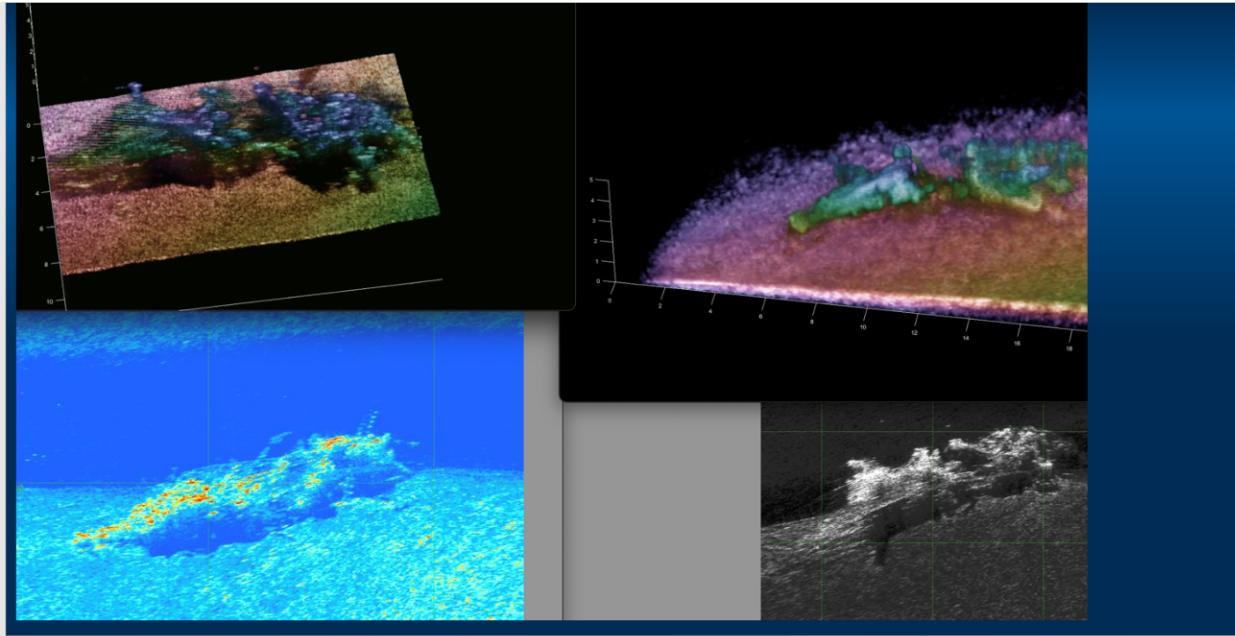
Figure 3: Images from University of Washington Applied Physics Lab Multi-Sensor Towbody (MuST) – including 3D processed data of main wreckage

A sonar survey of the accident area located the main wreckage and debris field at a depth of about 190 ft.
