ADVANCE REPORT
on the
SEDIMENTATION SURVEY OF MISSION LAKE
HORTON, KANSAS

April 15 to May 6, 1937

Sedimentation Studies
Division of Research
SCS-SS-22
July, 1938

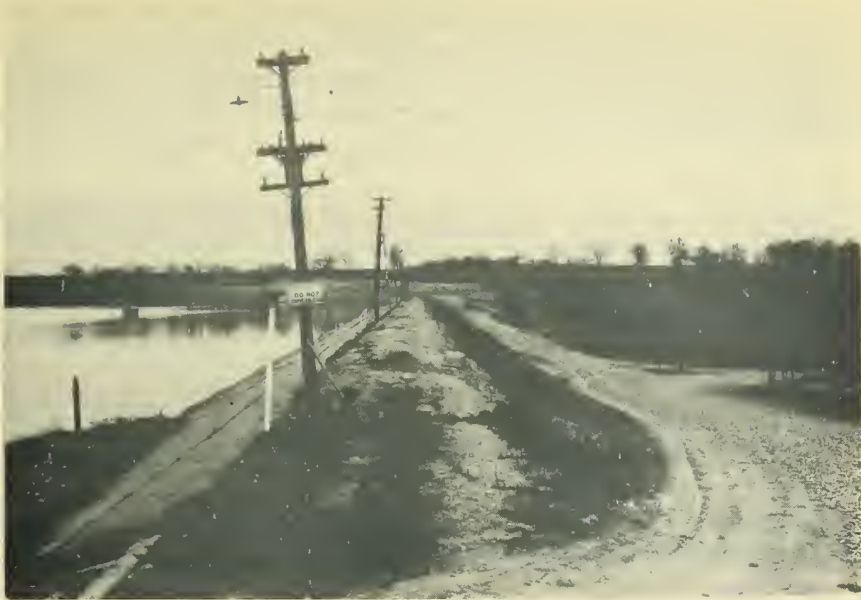
Description of dam: Mission Lake dam (fig. 2) has a total length of 1,170 feet and extends in a northwest direction across Mission Creek valley. It is an earth-fill structure with a maximum height of 34 feet and top and bottom widths of 10 feet and 145 feet, respectively. The earthen embankment is made watertight by a puddled core extending from crest level to the natural valley bottom and Wakefield wooden sheet piling extending to bedrock. The upstream face is covered with 6-inch reinforced concrete slab with expansion joints at 25-foot intervals, and has a slope of 3:1. The downstream face has a slope of 2:1.

.Figure 2.--View of the dam of Mission Lake from the west end.

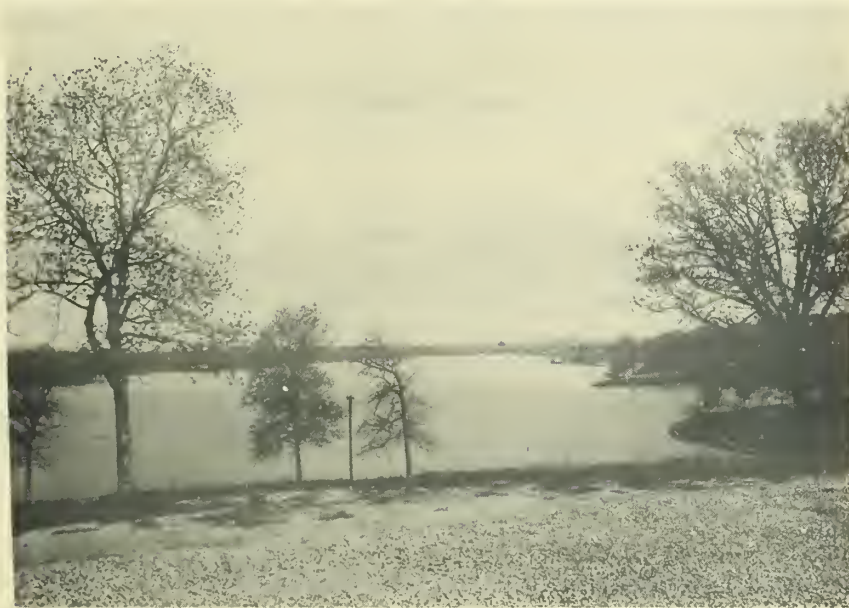
Figure 3.--View along the east shore of Mission Lake from the dam, showing rock riprap.

Submerged slopes are in general moderately steep, and descend about 14 feet from crest level to the valley bottom within a horizontal distance of 200 feet. A riprap of loose rock, extending 2.5 feet below and 1 foot above crest, has been placed along the shore line of the lower part of the lake to prevent wave erosion (fig. 3).

Littoral zones, including wave-cut banks 1 to 4 feet in height just above crest and thin gravel and sand terraces below crest, have formed along approximately 40 percent of the shore line below range R16-R17. In a few places this has occurred in spite of a protective riprap of loose rock and concrete blocks along the shore.

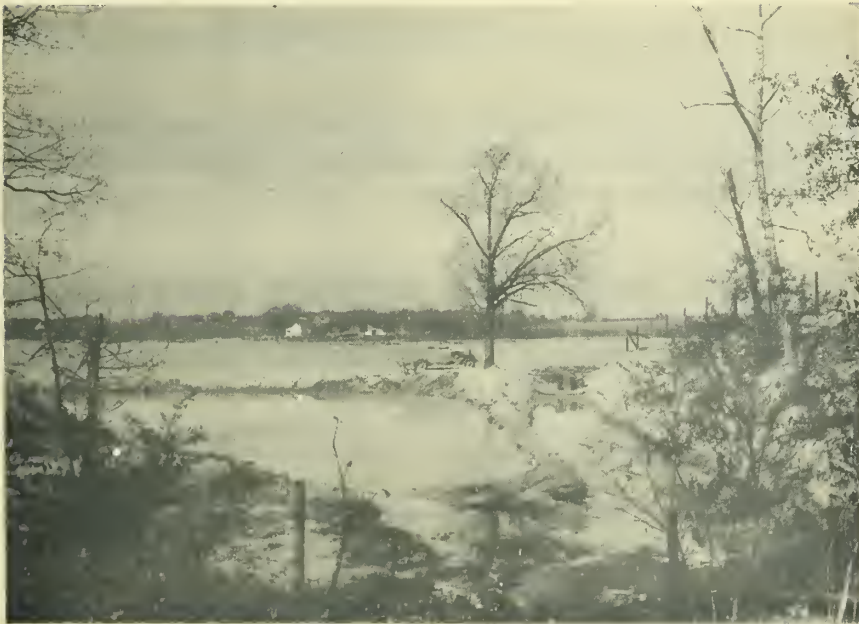
Figure 7.—Silt trap or settling basin behind road fill on east side of Mission Lake.

Estimates of the amount of sediment in the small silt-trap basins behind the road fills around the lake (fig. 7) were made during the course of the survey.

An estimated total of 2.32 acre-feet of sediment has accumulated in the check basins behind the road fills. In the absence of the silt traps nearly all of this sediment would have been deposited in the reservoir basin. Figure 7, (following p. 7) illustrates one of the road-fill basins on the east side of the lake.

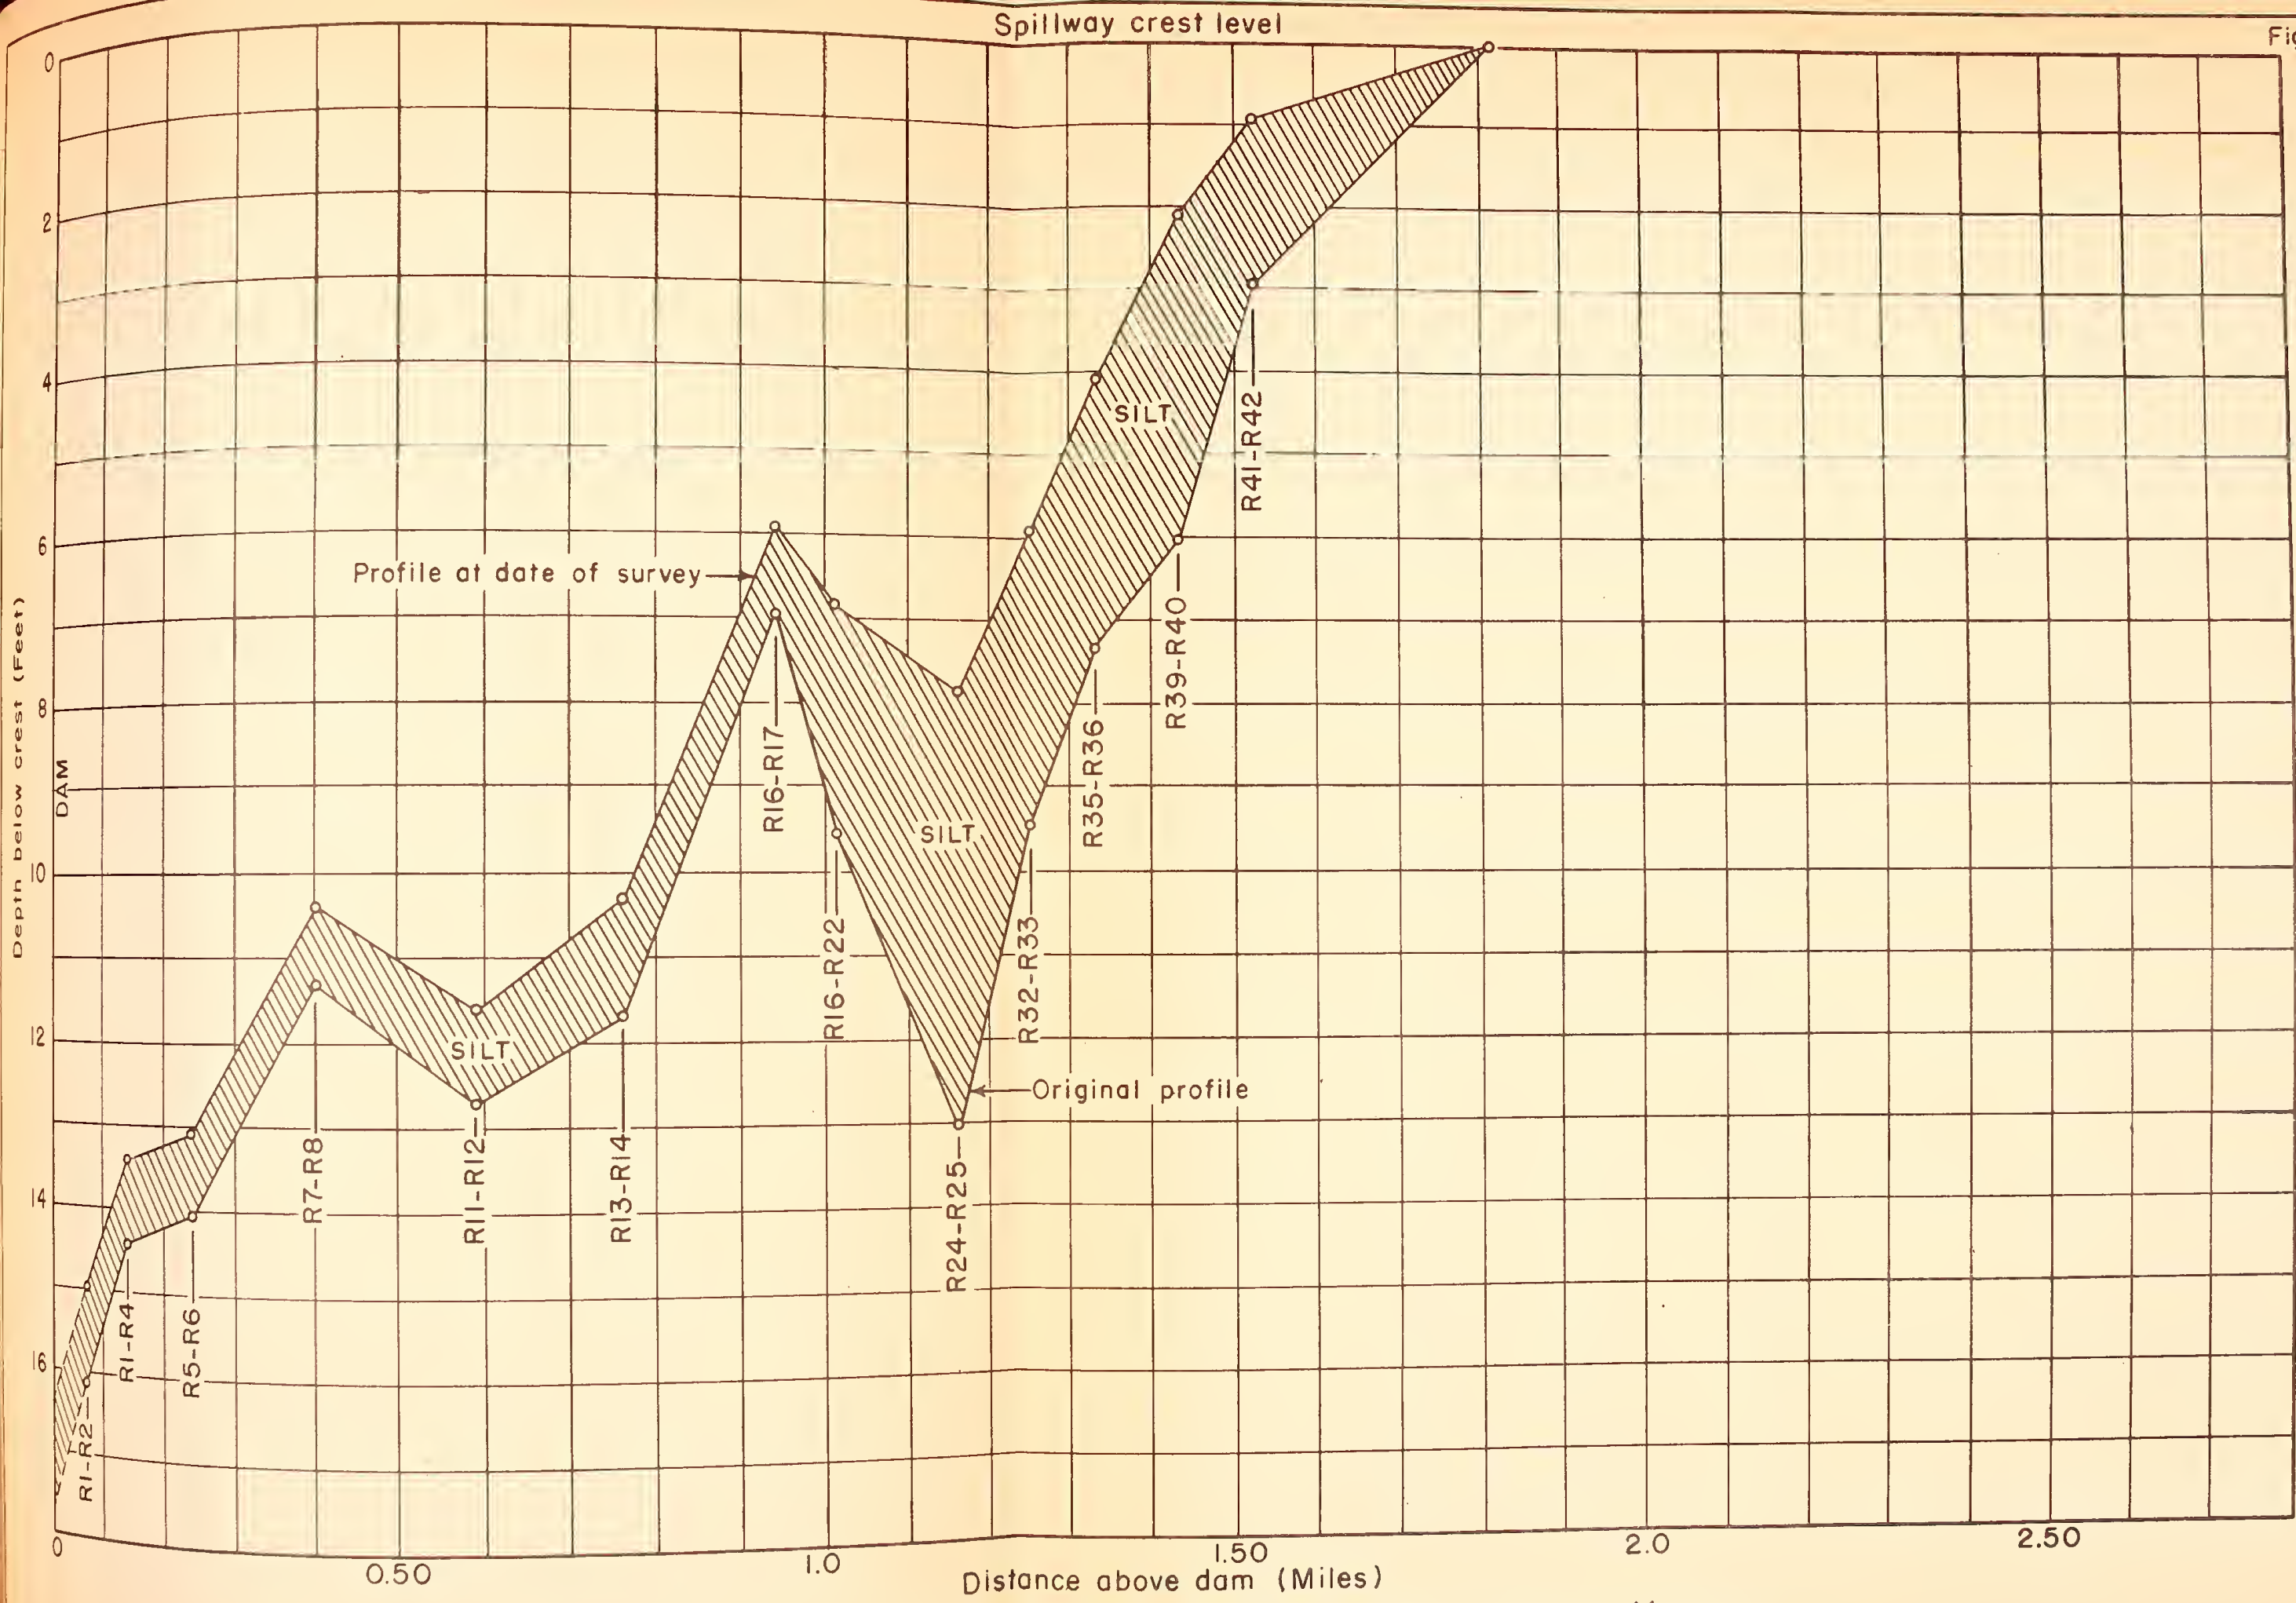
FIGURE 9. Average-depth profiles, Mission Lake, Horton, Kansas.

The general distribution of sediment is illustrated in figure 9. The thickest deposits have accumulated in the lower portions of the main tributary arms in segments 16, 17, 18, 21, 22, 23, and 25 (fig. 4). In this area the currents of water entering the wider portion of the lake from the smaller arms encounter deeper water and are sharply retarded, with resulting deposition of much suspended

sediment. The sediment thicknesses in segments 16, 17, and 18 illustrate this effect. On ranges R26-R27 and R28-R29 the maximum thickness of sediment in the channel is approximately 10 feet, and the average thickness on the 2 ranges is nearly 6 feet. On range R23-R24 the maximum and average thicknesses are 8 feet and 2.4 feet, respectively. The original stream channel has been completely filled in this part of the reservoir. Comparable deposits have accumulated in all the other important arms above segment 11.
