MARINE CASUALTY REPORT

MOBILE OFFSHORE DRILLING UNIT (MODU) OCEAN RANGER, O.N. 615641, CAPSIZING AND SINKING IN THE ATLANTIC OCEAN, ON 15 FEBRUARY 1982 WITH MULTIPLE LOSS OF LIFE

REPORT NO. USCG 16732/0001 HQS 82

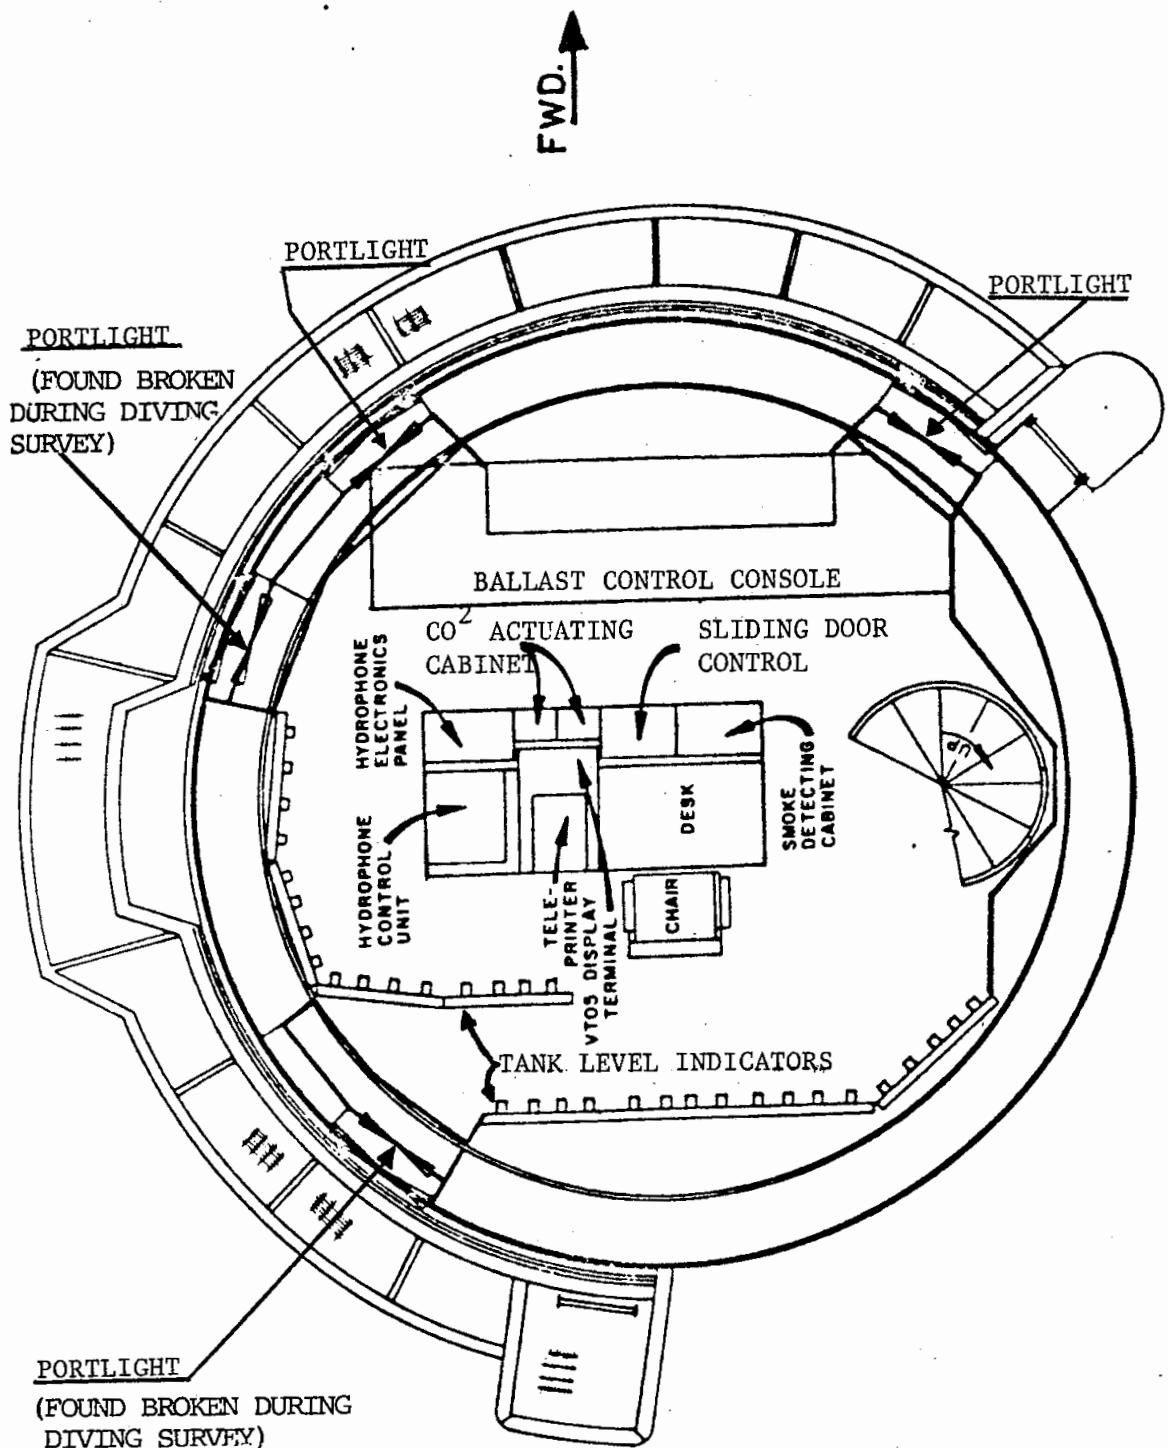
figure 9

BALLAST CONTROL ROOM ARRANGEMENT

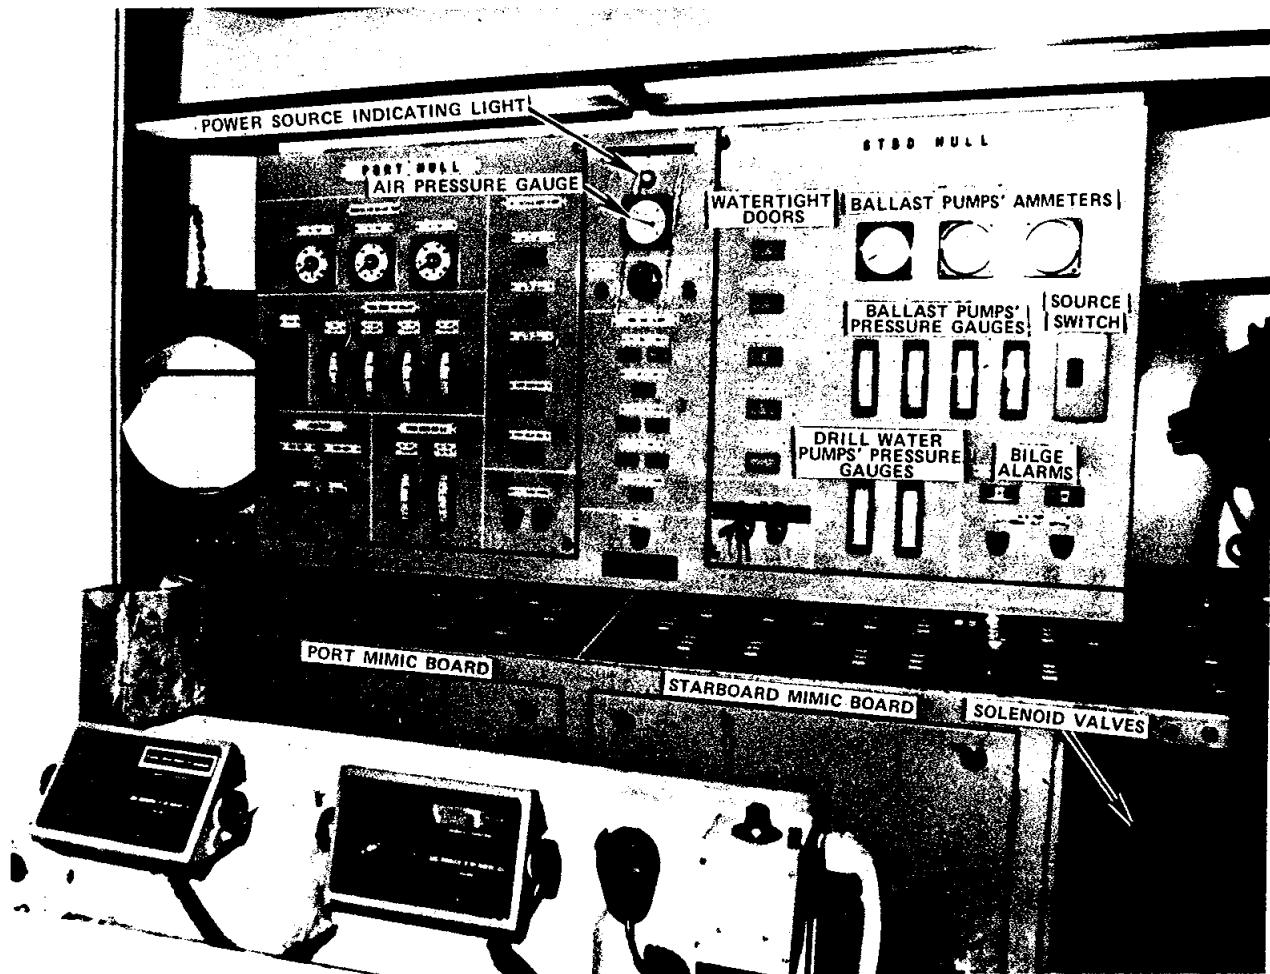
BALLAST CONTROL ROOM

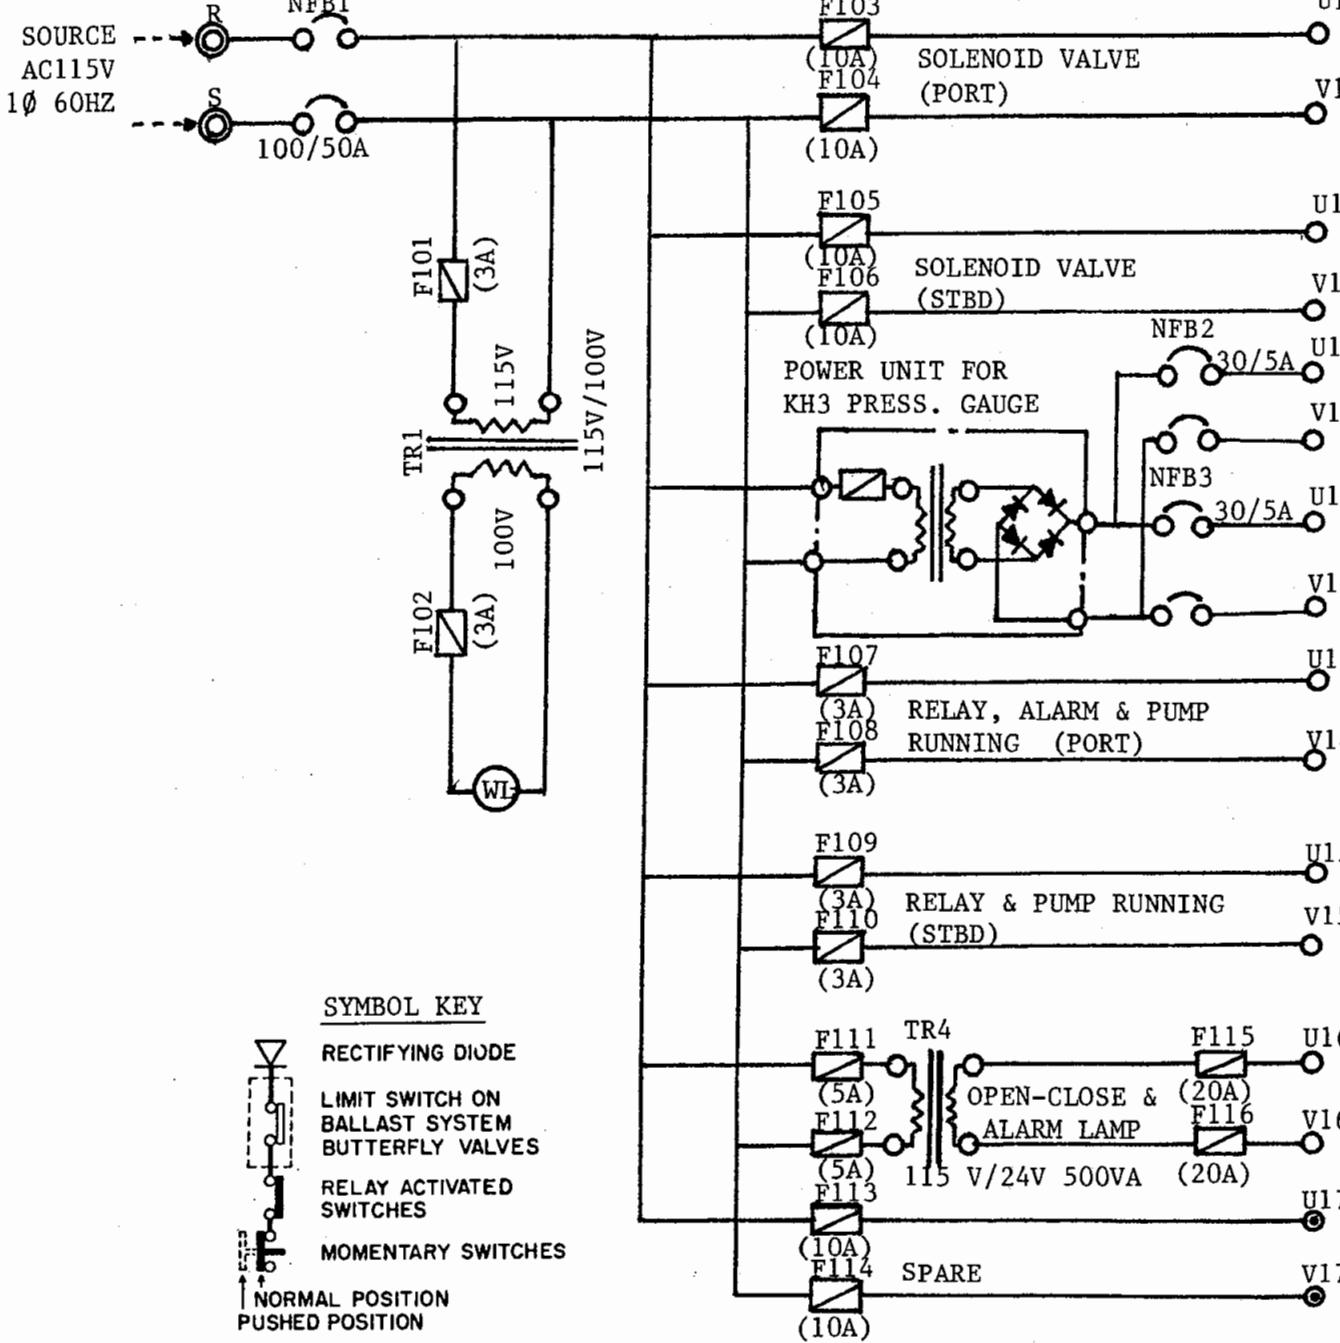
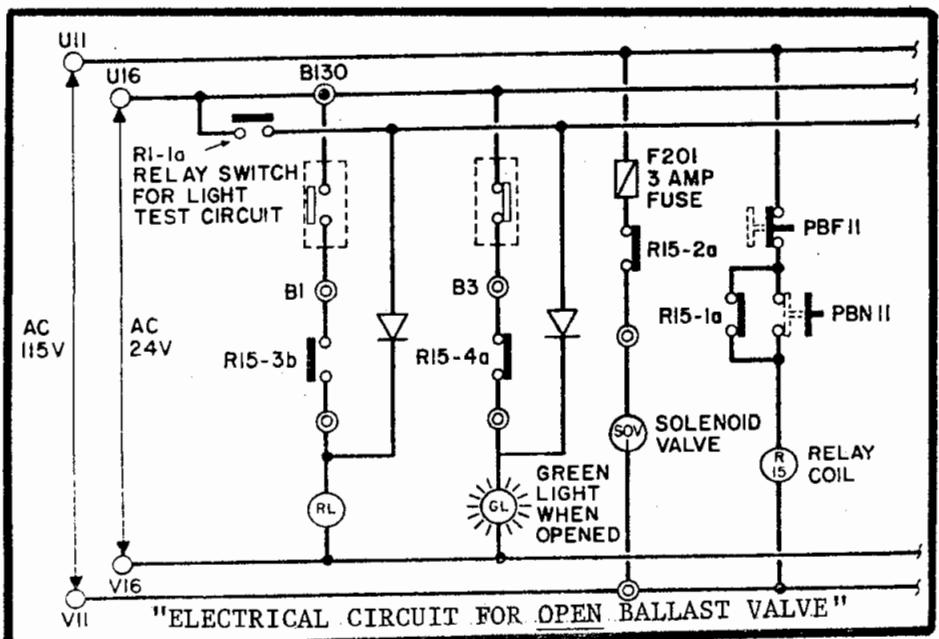
FIGURE 11

POWER LINE CIRCUIT FOR BALLAST CONSOLE

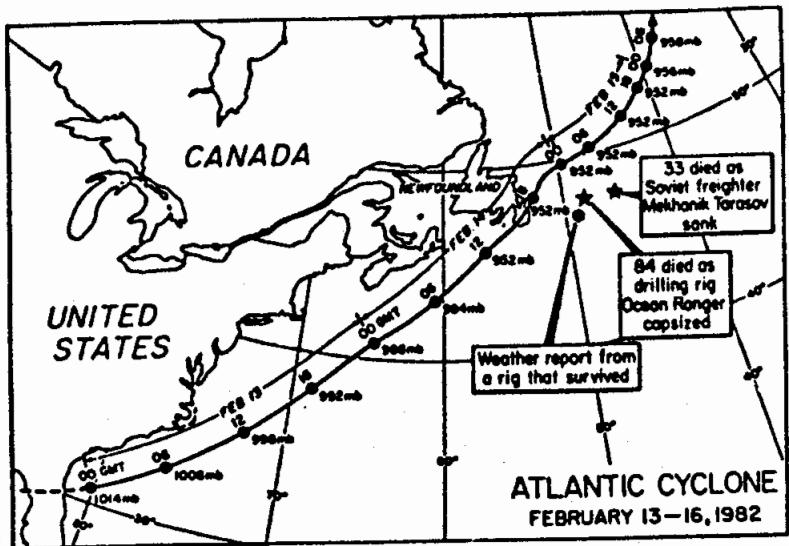
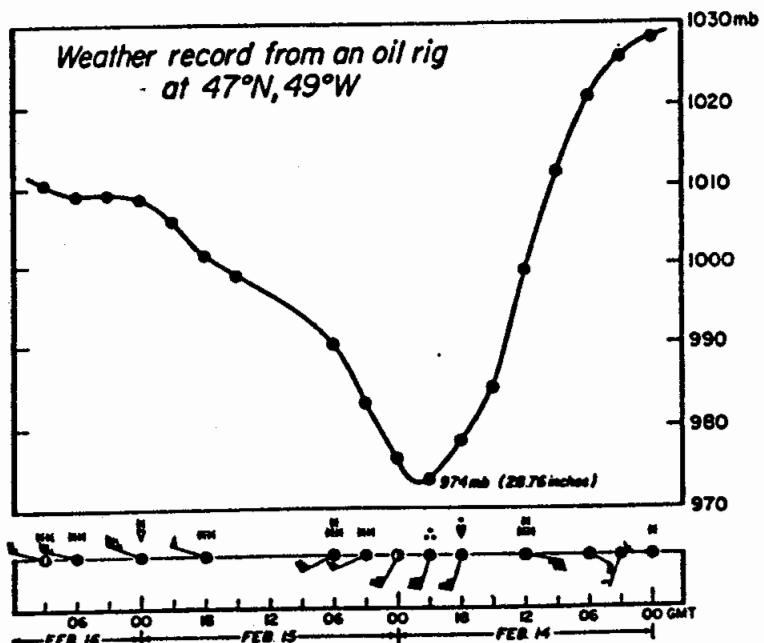
The storm associated with the OCEAN RANGER casualty was a major Atlantic cyclone. Figure 13 shows the storm track and the on-scene weather at the site of the casualty.

Figure 38.—The track of this vicious storm with 6-hr pressures, and the weather record from a nearby oil rig (47°N , 49°W). A total of 117 deaths resulted from this storm. From Storm Data, Feb. 1982, prepared by Prof. ██████████, University of Chicago.

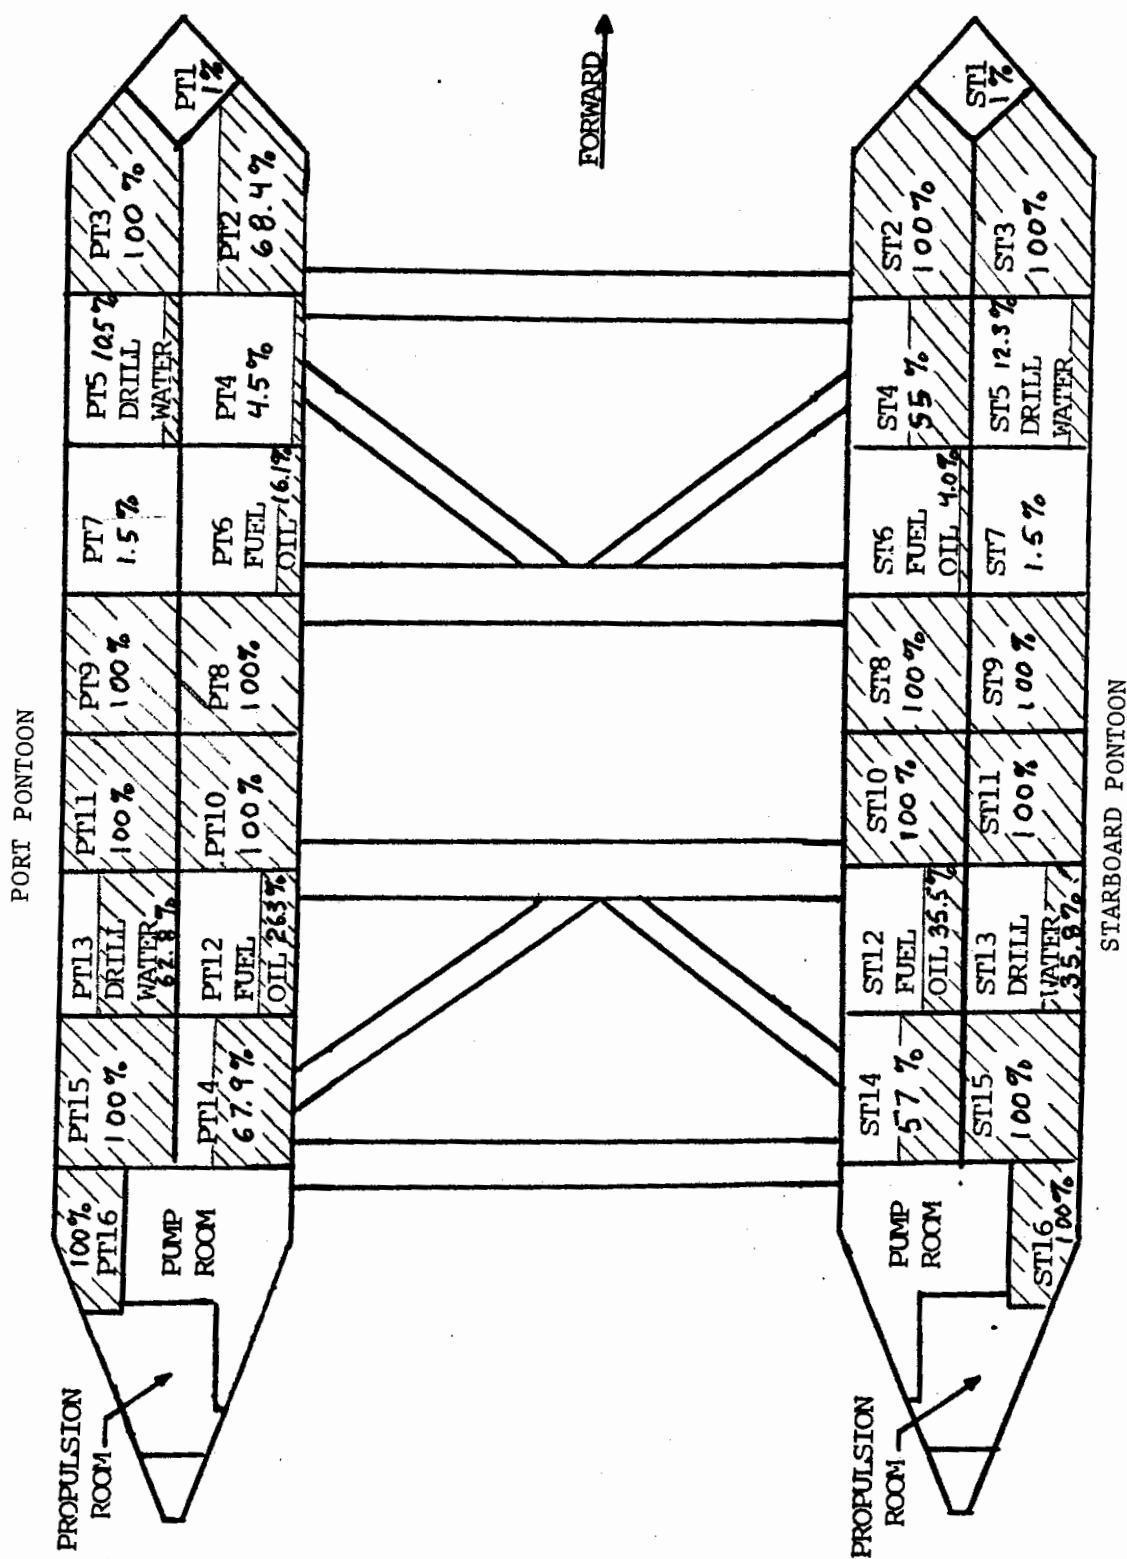
Figure 15 depicts the liquid levels in the ballast tanks on 14 February 1982 as indicated in the weekly ballast report work sheets recovered from the OCEAN RANGER. The report indicated that the after ballast tanks used for adjusting trim, PT 14 and ST 14 were respectively 67.9% and 57.0% of capacity. The ullage provided a potential moment to correct trim of 58,000 foot/long tons (F/LT). During the evening, the control panel was doused with sea water entering a broken porthole causing an actual or perceived panel malfunction. At the time of malfunction or when personnel attempted to correct the malfunction, the OCEAN RANGER either took water into the ballast tanks or water shifted to the forward tanks, or both, causing a list by the bow. At some point, the crew had taken the measure of closing the two manually operated sea inlet gate valves. Evidence indicates the rig may have had a 10 degree list for a period of time which the crew believed had stabilized. An approximate moment of 17,000 (F/LT) was required to cause a 10° trim by the bow.

Figure 15: PERCENTAGE OF LIQUIDS IN OCEAN RANGER PONTOON TANKS,
MORNING OF 14 FEBRUARY 1982

This moment is equivalent to the transfer of 80 LT of water from ballast tank PT 16 to ballast tank PT 1. More likely, the list was caused by the simultaneous transfer of water from several of the full tanks aft to forward empty tanks that provided the 27,000 F/LT moments. Later the list was reported to be 10 to 12 degrees and the last report list before abandoning the rig the list was reported to be 12 to 15 degrees. It was also apparent that manual control of the solenoid activated air valves in the control panels was attempted as a means of opening the ballast valves. Figure 16, page 112, shows the solenoid valves and the extent that the brass rods were used at the time they were recovered by divers. No specific logic can be attributed to the position of the brass rods except that their use indicated the control panel electric circuits were not useable or perceived to be unuseable and an attempt was being made to pump ballast. However, none of the rods were in a position to activate the ballast pump manifold valve or ballast pump discharge valves. It is also possible that brass rods were being inserted in the solenoid valves in preparation to use the pumps. Seventeen of the rods were screwed in all the way against the solenoid valve plunger which would have opened the air valve allowing activation of a ballast valve unless control air had been purposely cutoff. One rod was screwed partway in. Given the ballast control room operator's, Master's, and electrician's inexperience, they may not have realized how far to screw in the rods without opening the solenoid valve. A practiced sense of feel would have been required to do this properly. The opening of the 17 solenoid valves would have resulted in gravitation of ballast to the bow increasing the list to the severe condition which caused the OCEAN RANGER personnel to abandon the rig. It is not known if they operated any of the butterfly valves manually in the pump room. This procedure would have depended on the P.A. system or walkie talkie for communication.
