Air Conditioning Modifications for the GMC RTSII Series 01 Coach (Model TH-8201)

Prepared by:
Transportation Systems Center
Urban Systems Division

October 1982
Final Report

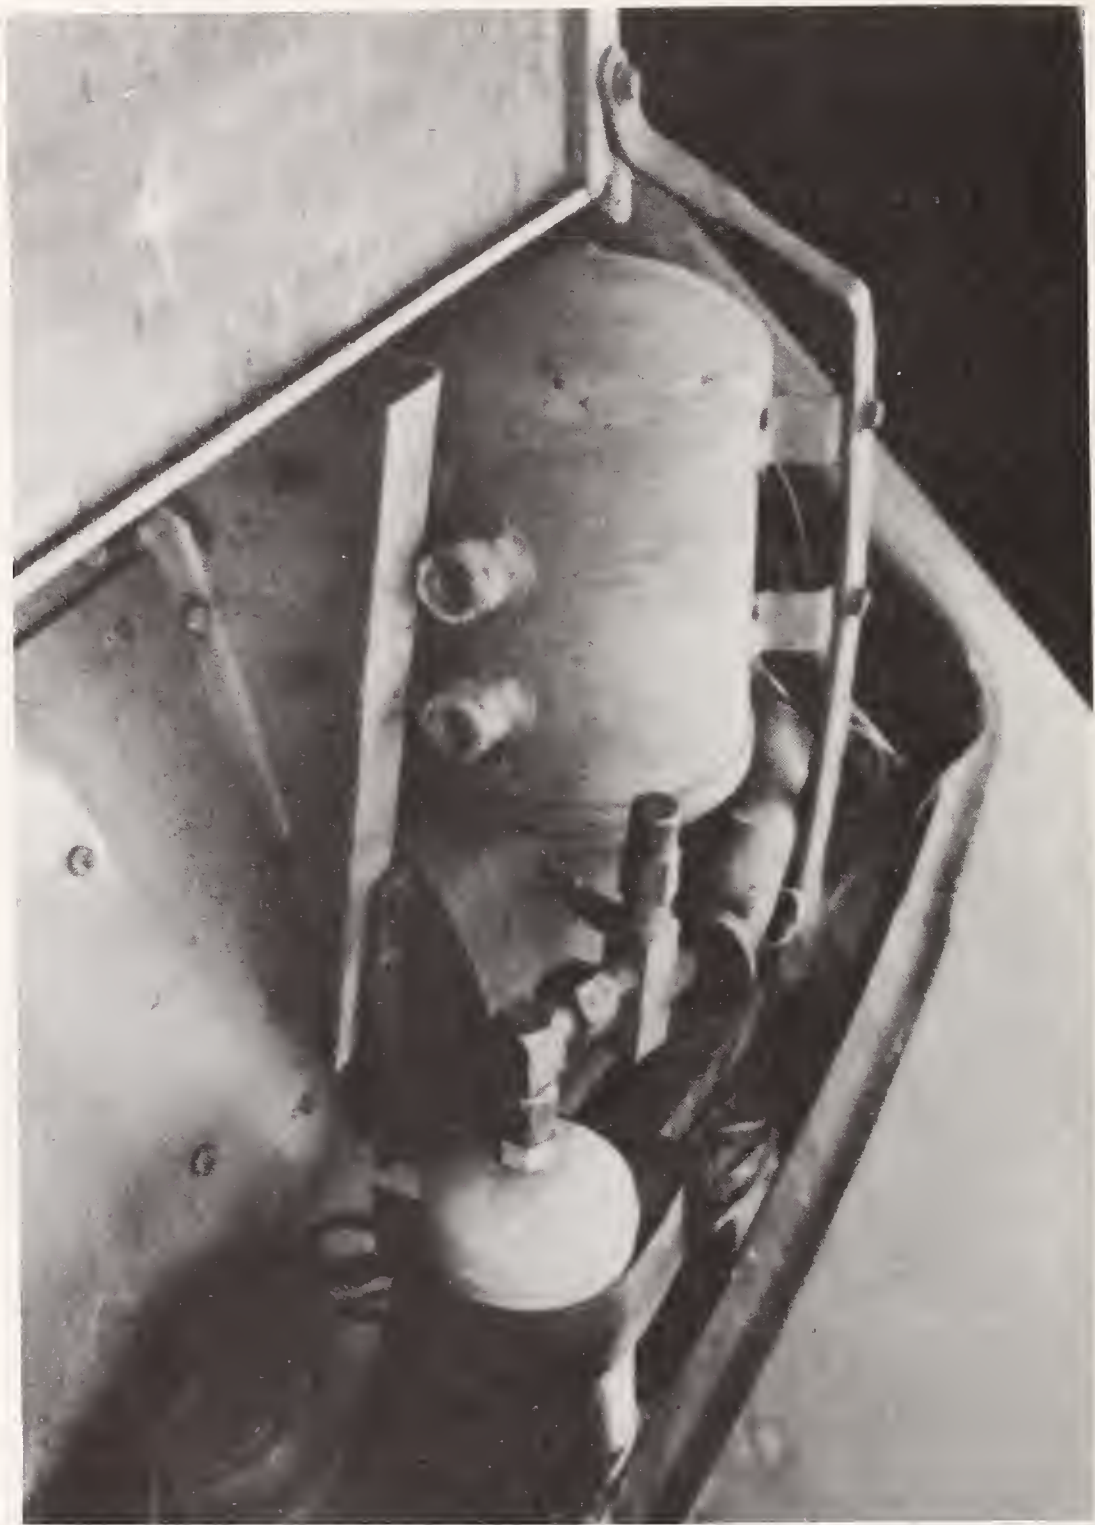
FIGURE 14

The refrigerant liquid receiver and dryer are both relocated from the engine compartment to a location below the replacement condenser in the upper right rear corner of the bus. These components are shown installed in Figure 14.

Relocated Liquid Receiver and Dryer

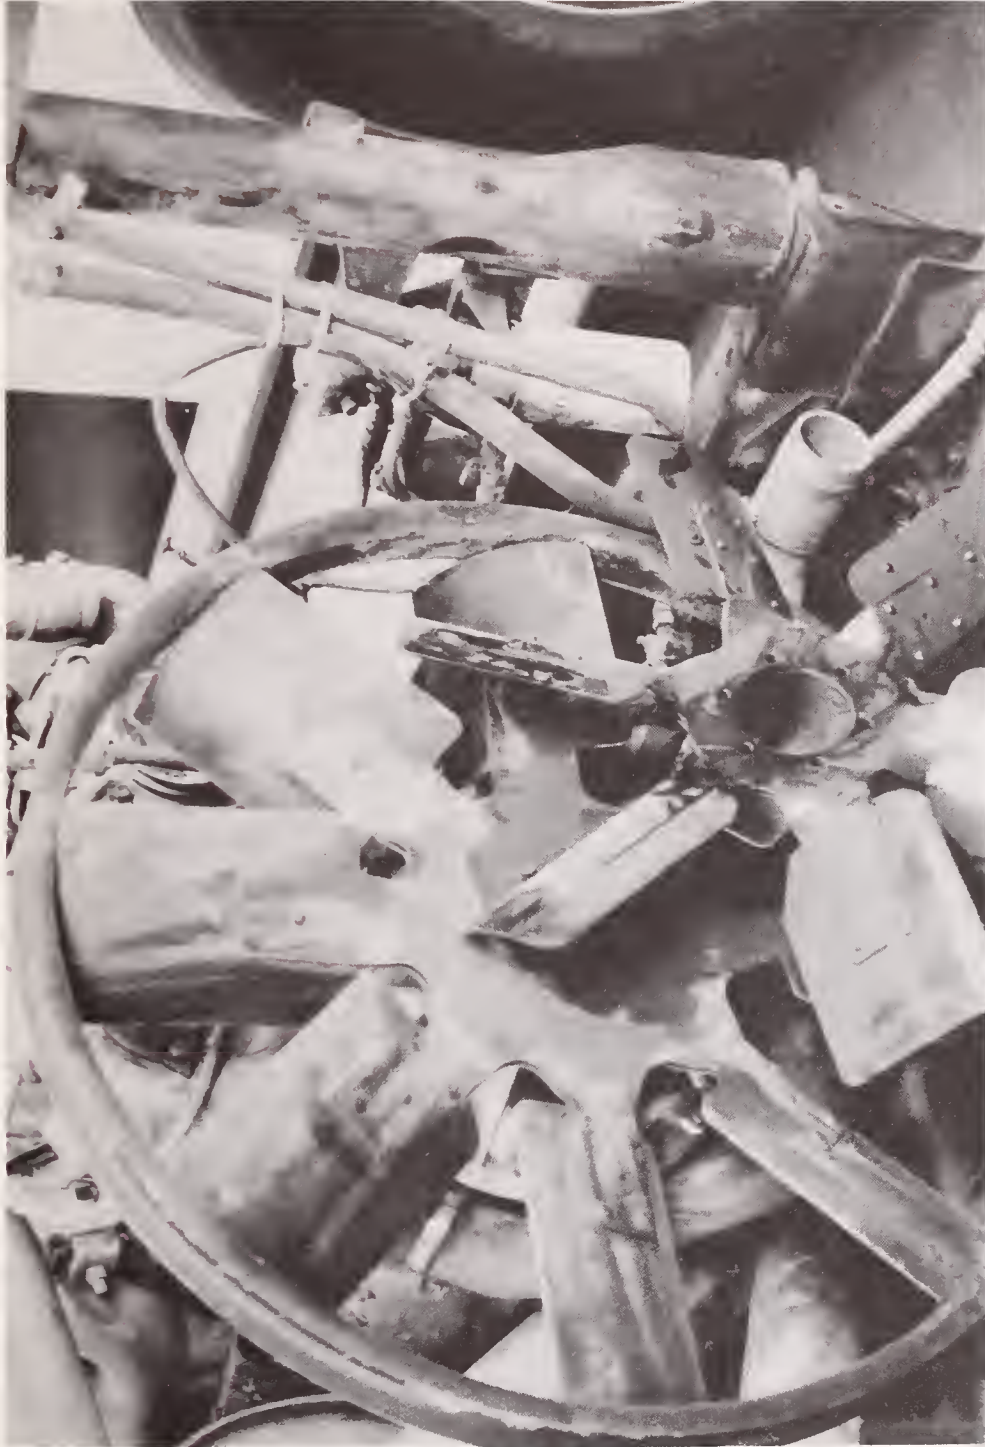
FIGURE 18
Eight-Blade Original and Six-Blade Replacement
Engine Cooling Fans

The engine cooling fan is replaced with one of smaller diameter (26 inches) than the original fan (34 inches). The new fan, a stock item, reverses the direction of air flow through the radiator, blowing the heated air out the left side of the coach. The fan has six blades, two fewer than the larger fan. The two fans are shown in Figure 18.

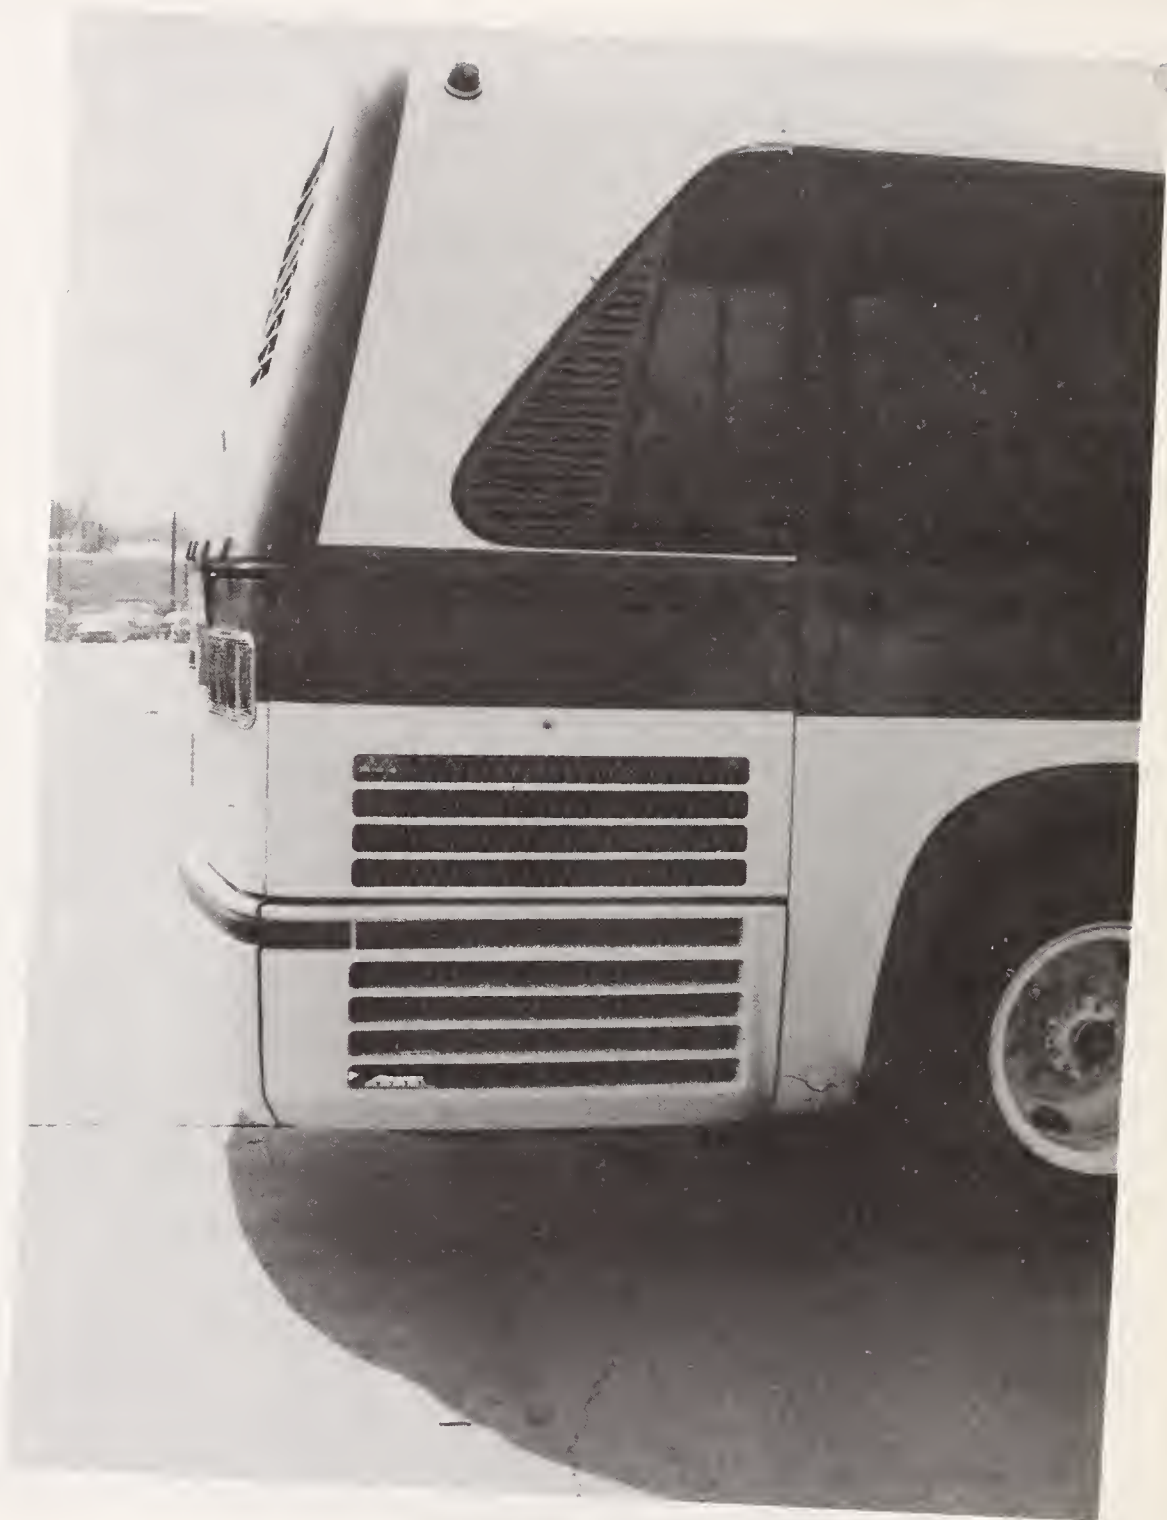
FIGURE 20
Modified Right Side Air Intake Vents

engine compartment past the transmission and the air conditioning compressor. The metal plate(s) are replaced with an expanded metal grill, shown in Figure 20. Noise levels are reduced because of the combined effects of decreased fan size, thermostatic control, and air flow direction.
