NIST-IR 6118

Metallurgy of the *RMS Titanic*

Tim Foecke
Metallurgy Division
National Institute of Standards and Technology

February 4, 1998

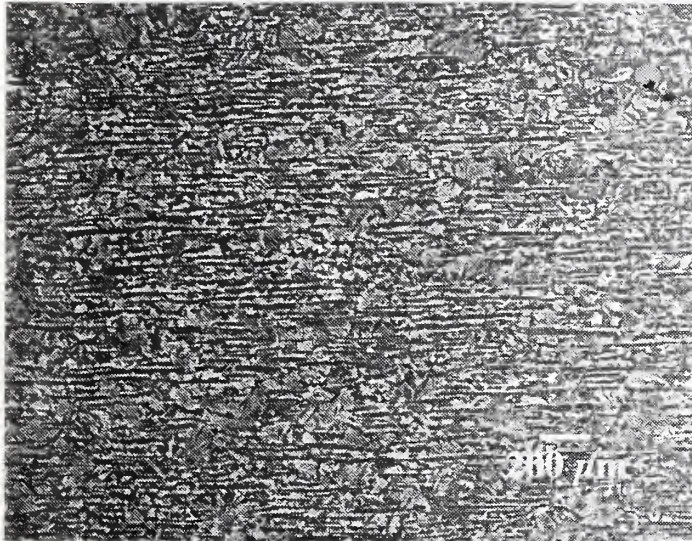
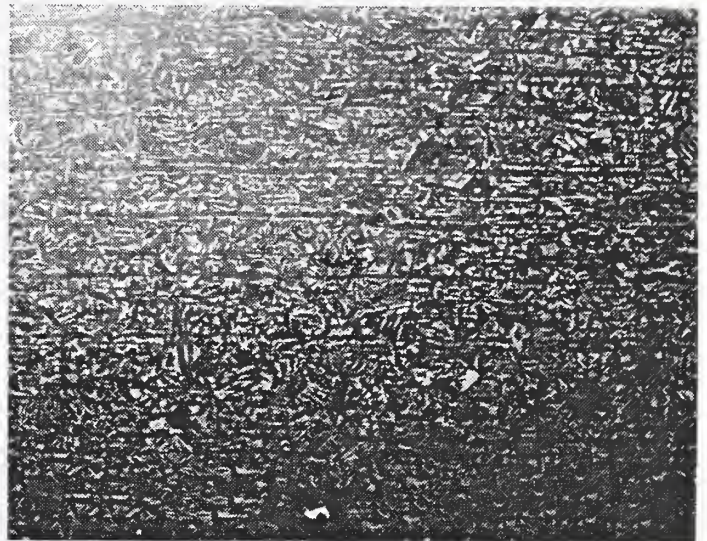
Steel samples of all three orientations orthogonal with respect to the rolling plane were polished and etched to reveal the microstructure. A ferrite-pearlite microstructure was seen, with large ferrite grains (ASTM number = 4-5, 100 μm to 130 μm equivalent diameter) and large, coarse pearlite colonies (roughly 0.2 μm lamella thickness, but quite variable). The microstructure shows a large amount of banding in the rolling direction. MnS and oxide particles are evident throughout the material, and were quite large, occasionally exceeding 100 μm in length. The MnS particles were deformed into lenticular shapes instead of being melted into stringers. Given the lack of rare-earth additions to increase the sulfide melting point (see table 2), this indicates a low rolling temperature. The large grain size and coarse pearlite are consistent with air-cooling of the rolled

A comparable modern steel grade is AISI 1018, which has a similar chemistry and does not possess a specialized microstructure. Micrographs of a modern 1018 steel show a finer grain size, much finer pearlite, and smaller and less numerous rare-earth doped MnS particles. This microstructure is typical of that produced in a modern high-speed mill, followed by a quench and normalization treatment.

Figure 1: Scanning electron microscope image of the polished and etched longitudinal sections of steel from the hull of the *Titanic*, and for comparison a modern hot-rolled 25 mm (1") AISI 1018 plate. Note the differences in grain size, pearlite lamella spacing, and MnS particle sizes.

A finer microstructure, both in terms of grain size and in pearlite lamella spacing, would have exhibited a significantly higher transition temperature at this composition. This could have been obtained by rolling the steel at a higher speed and temperature, then subjecting the plate to a quench and normalization anneal. However, the concept of notch sensitivity of iron-based alloys was little understood, and the first quantitative ways to begin to evaluate the fracture toughness of a material, among them the Charpy V-notch test [21], was only devised in the five or so years before the
