FDD #6 NAKAJIMA MUSASHINO (9)

Pack 3 PHOTO LOG - NAKAJIMA - MUSEUM

PHOTO LOC - NAKAJIMA - MUSEUM -

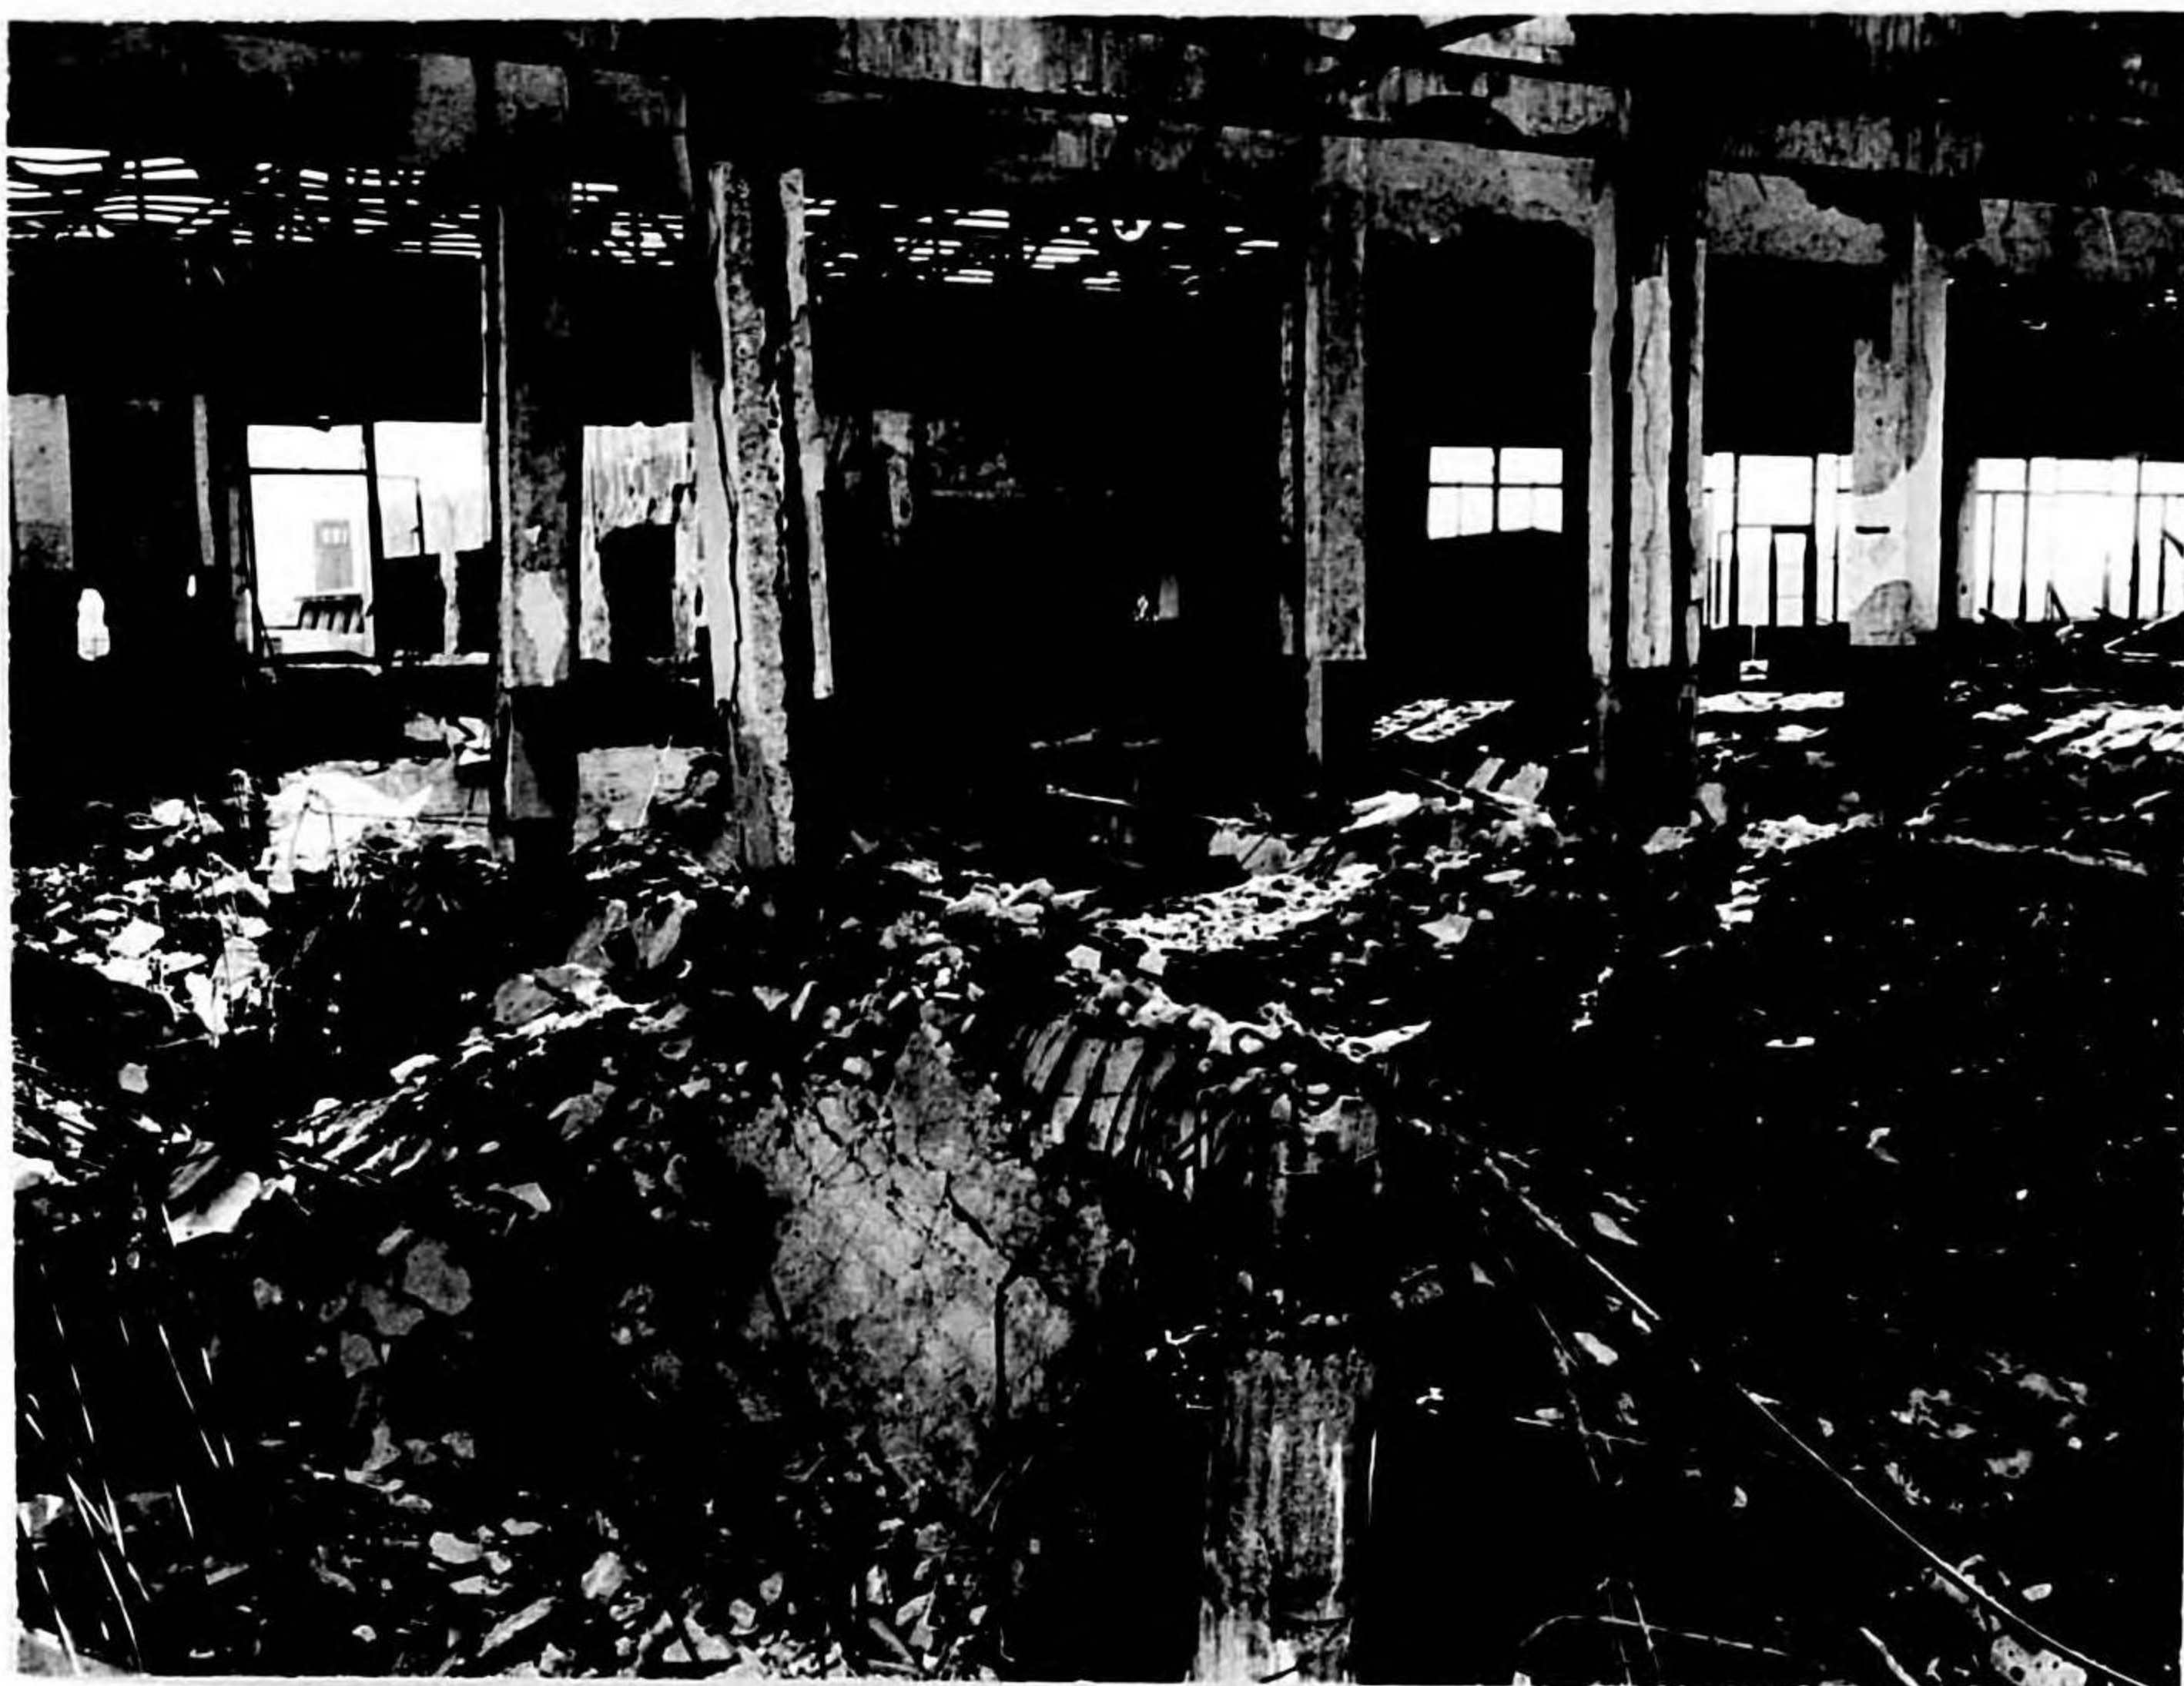
Photo 2

View on fourth floor showing damage to slab from
bombs 2 and 3. *Bldg. 11, center section.*

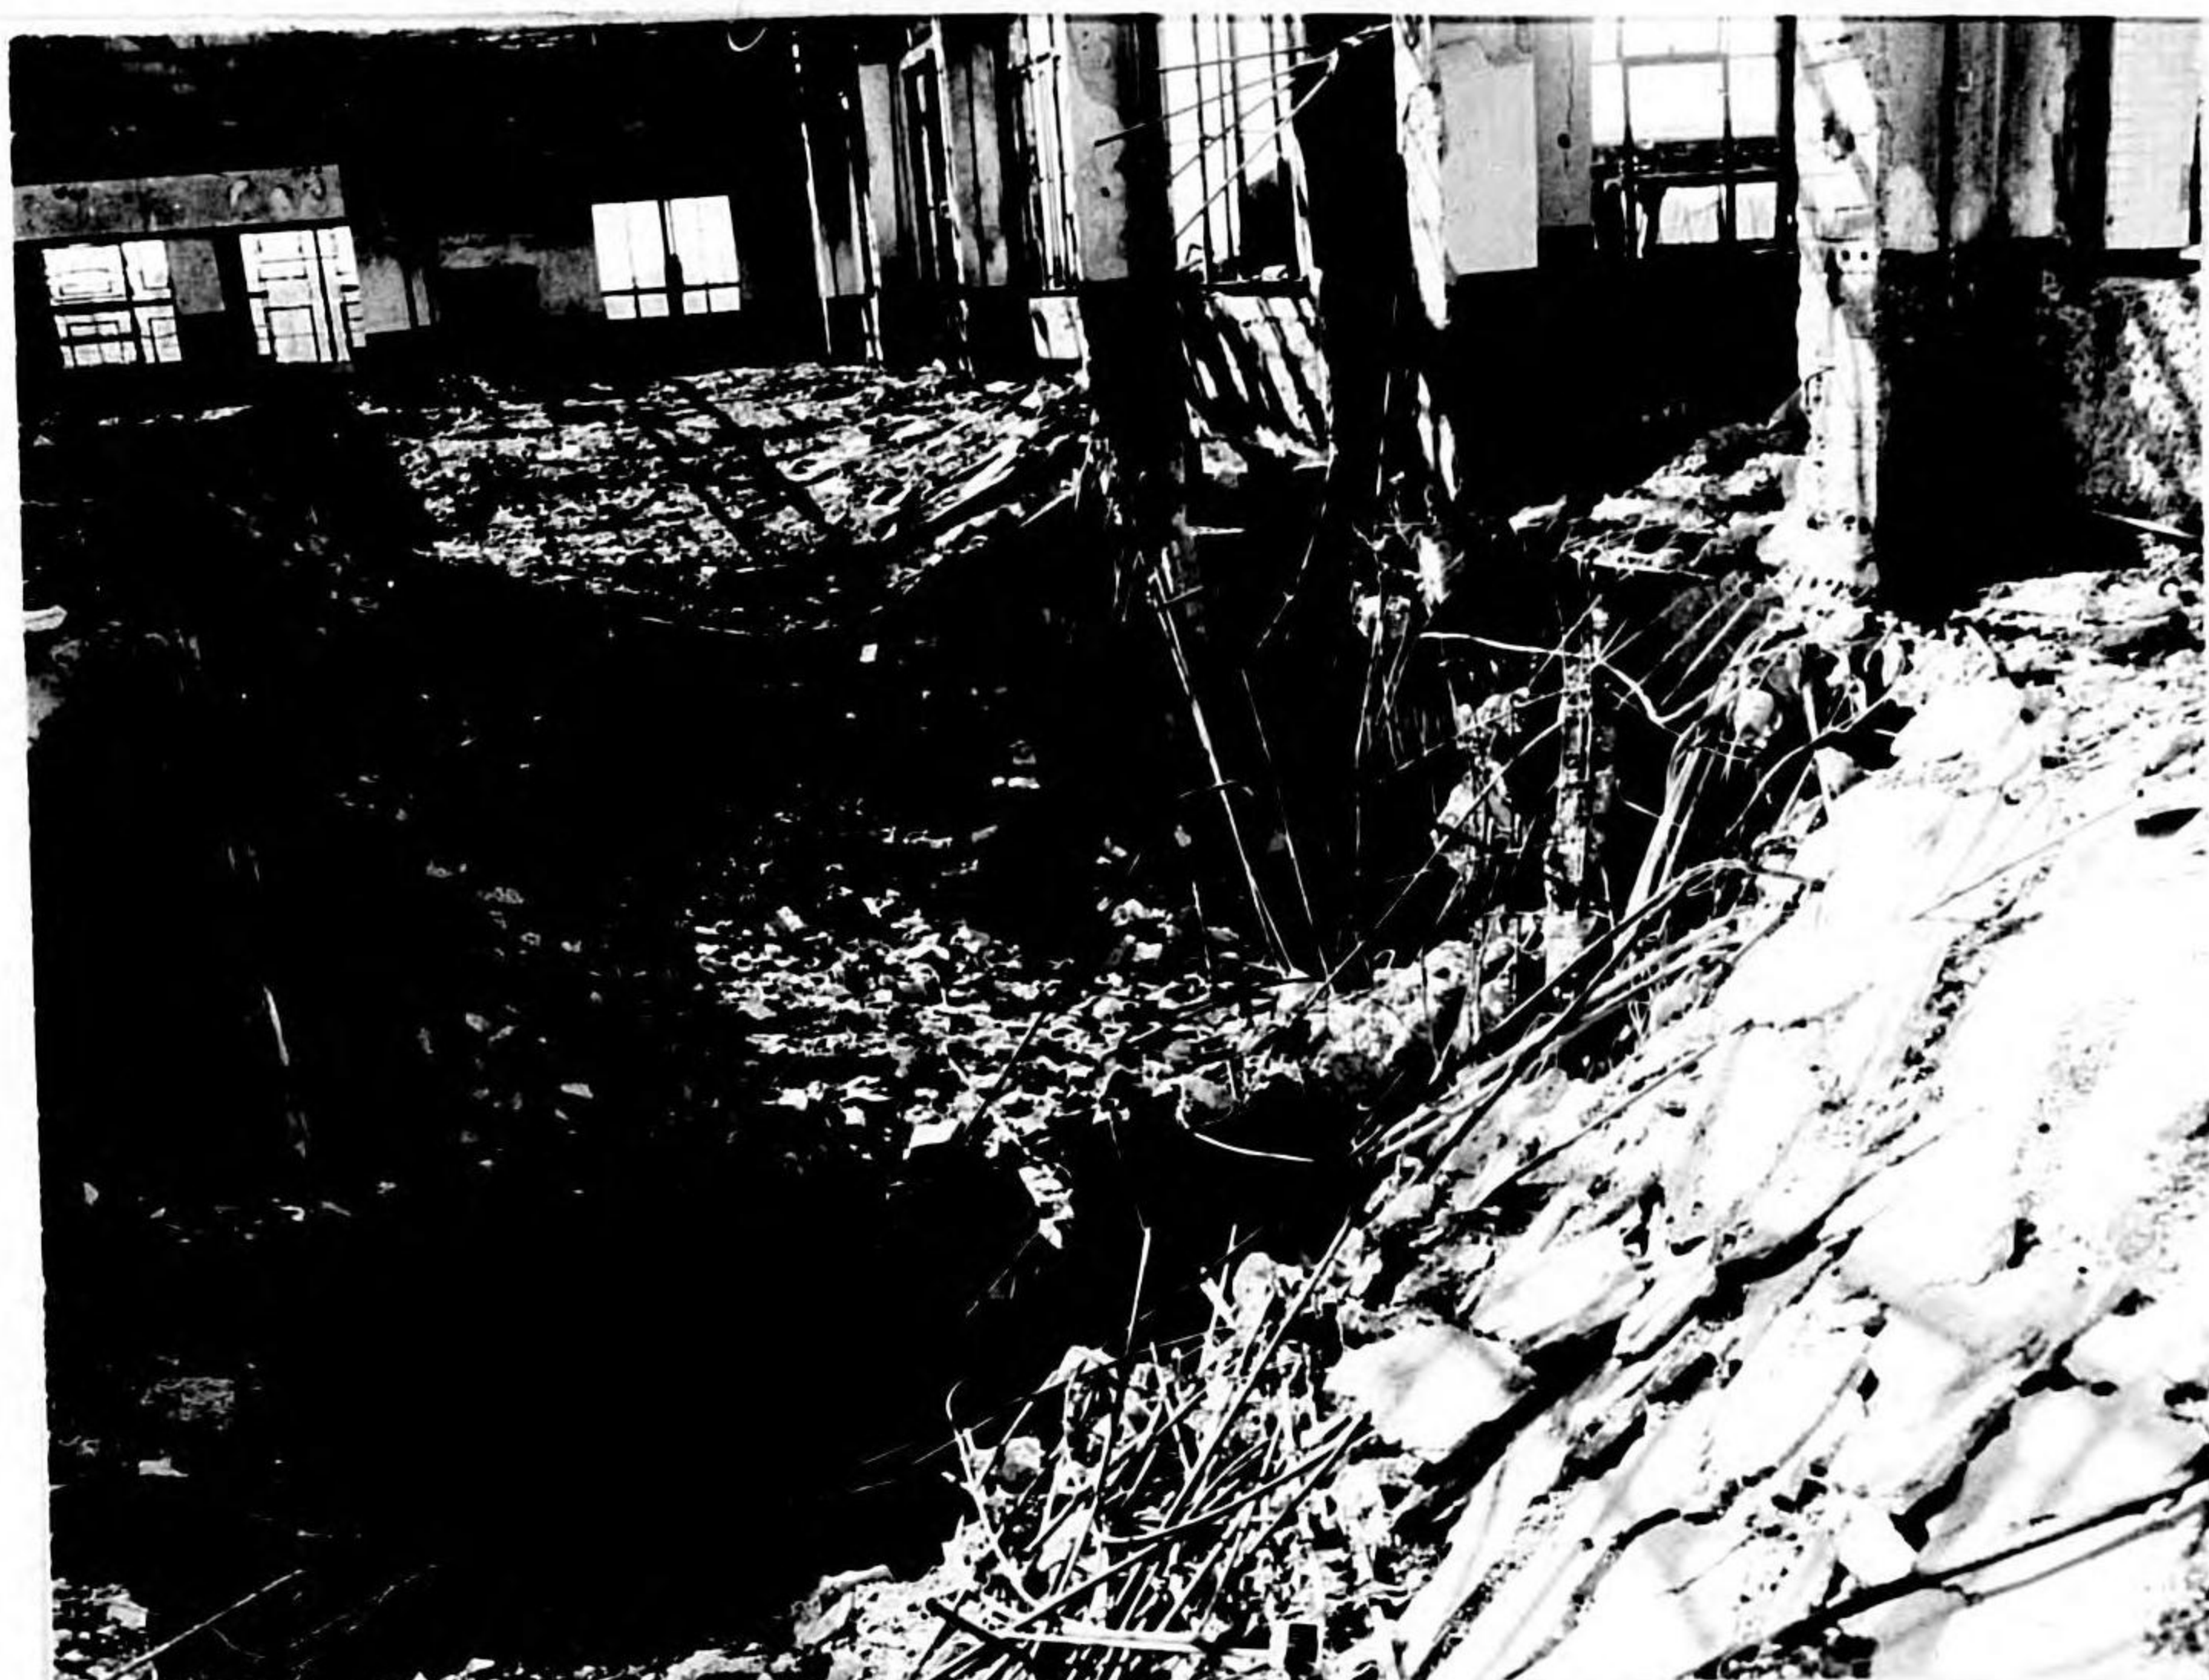
Photo 3

View showing damage to third and fourth floors from
Bomb 1. *2/9/11, center section*

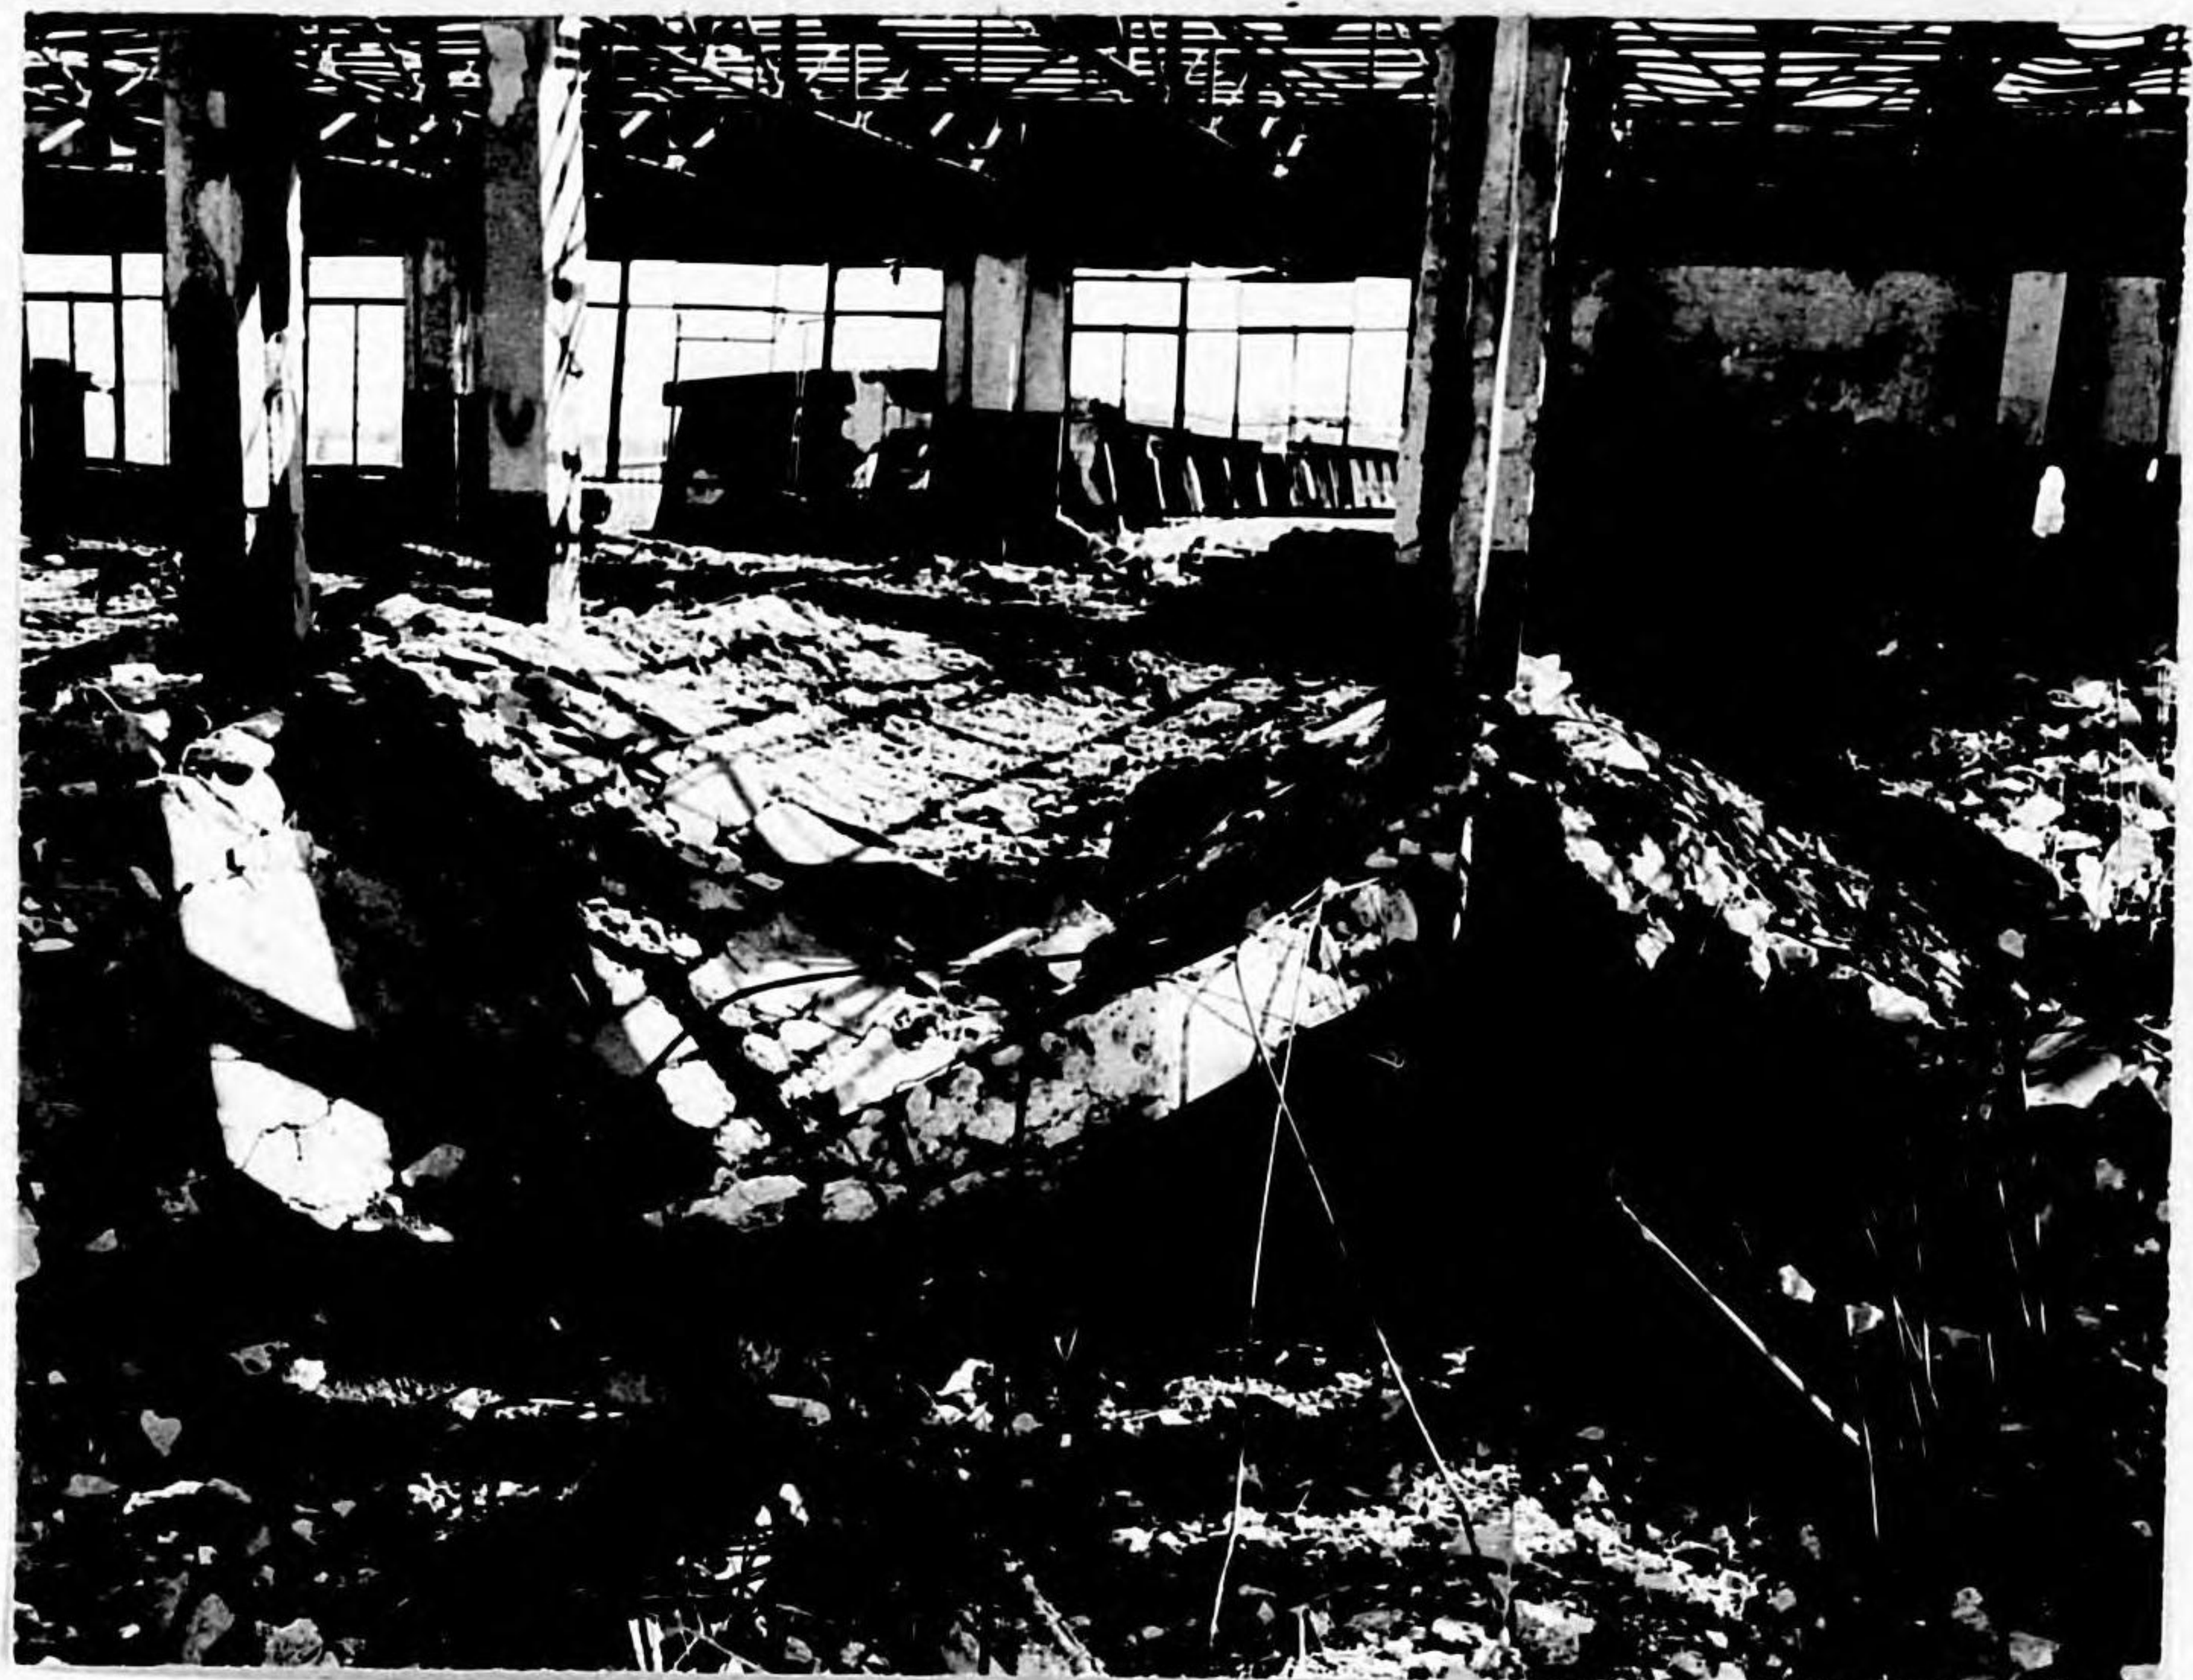
Photo 4

View showing damage to fourth floor slab.
Bldg. 11, Center Section.

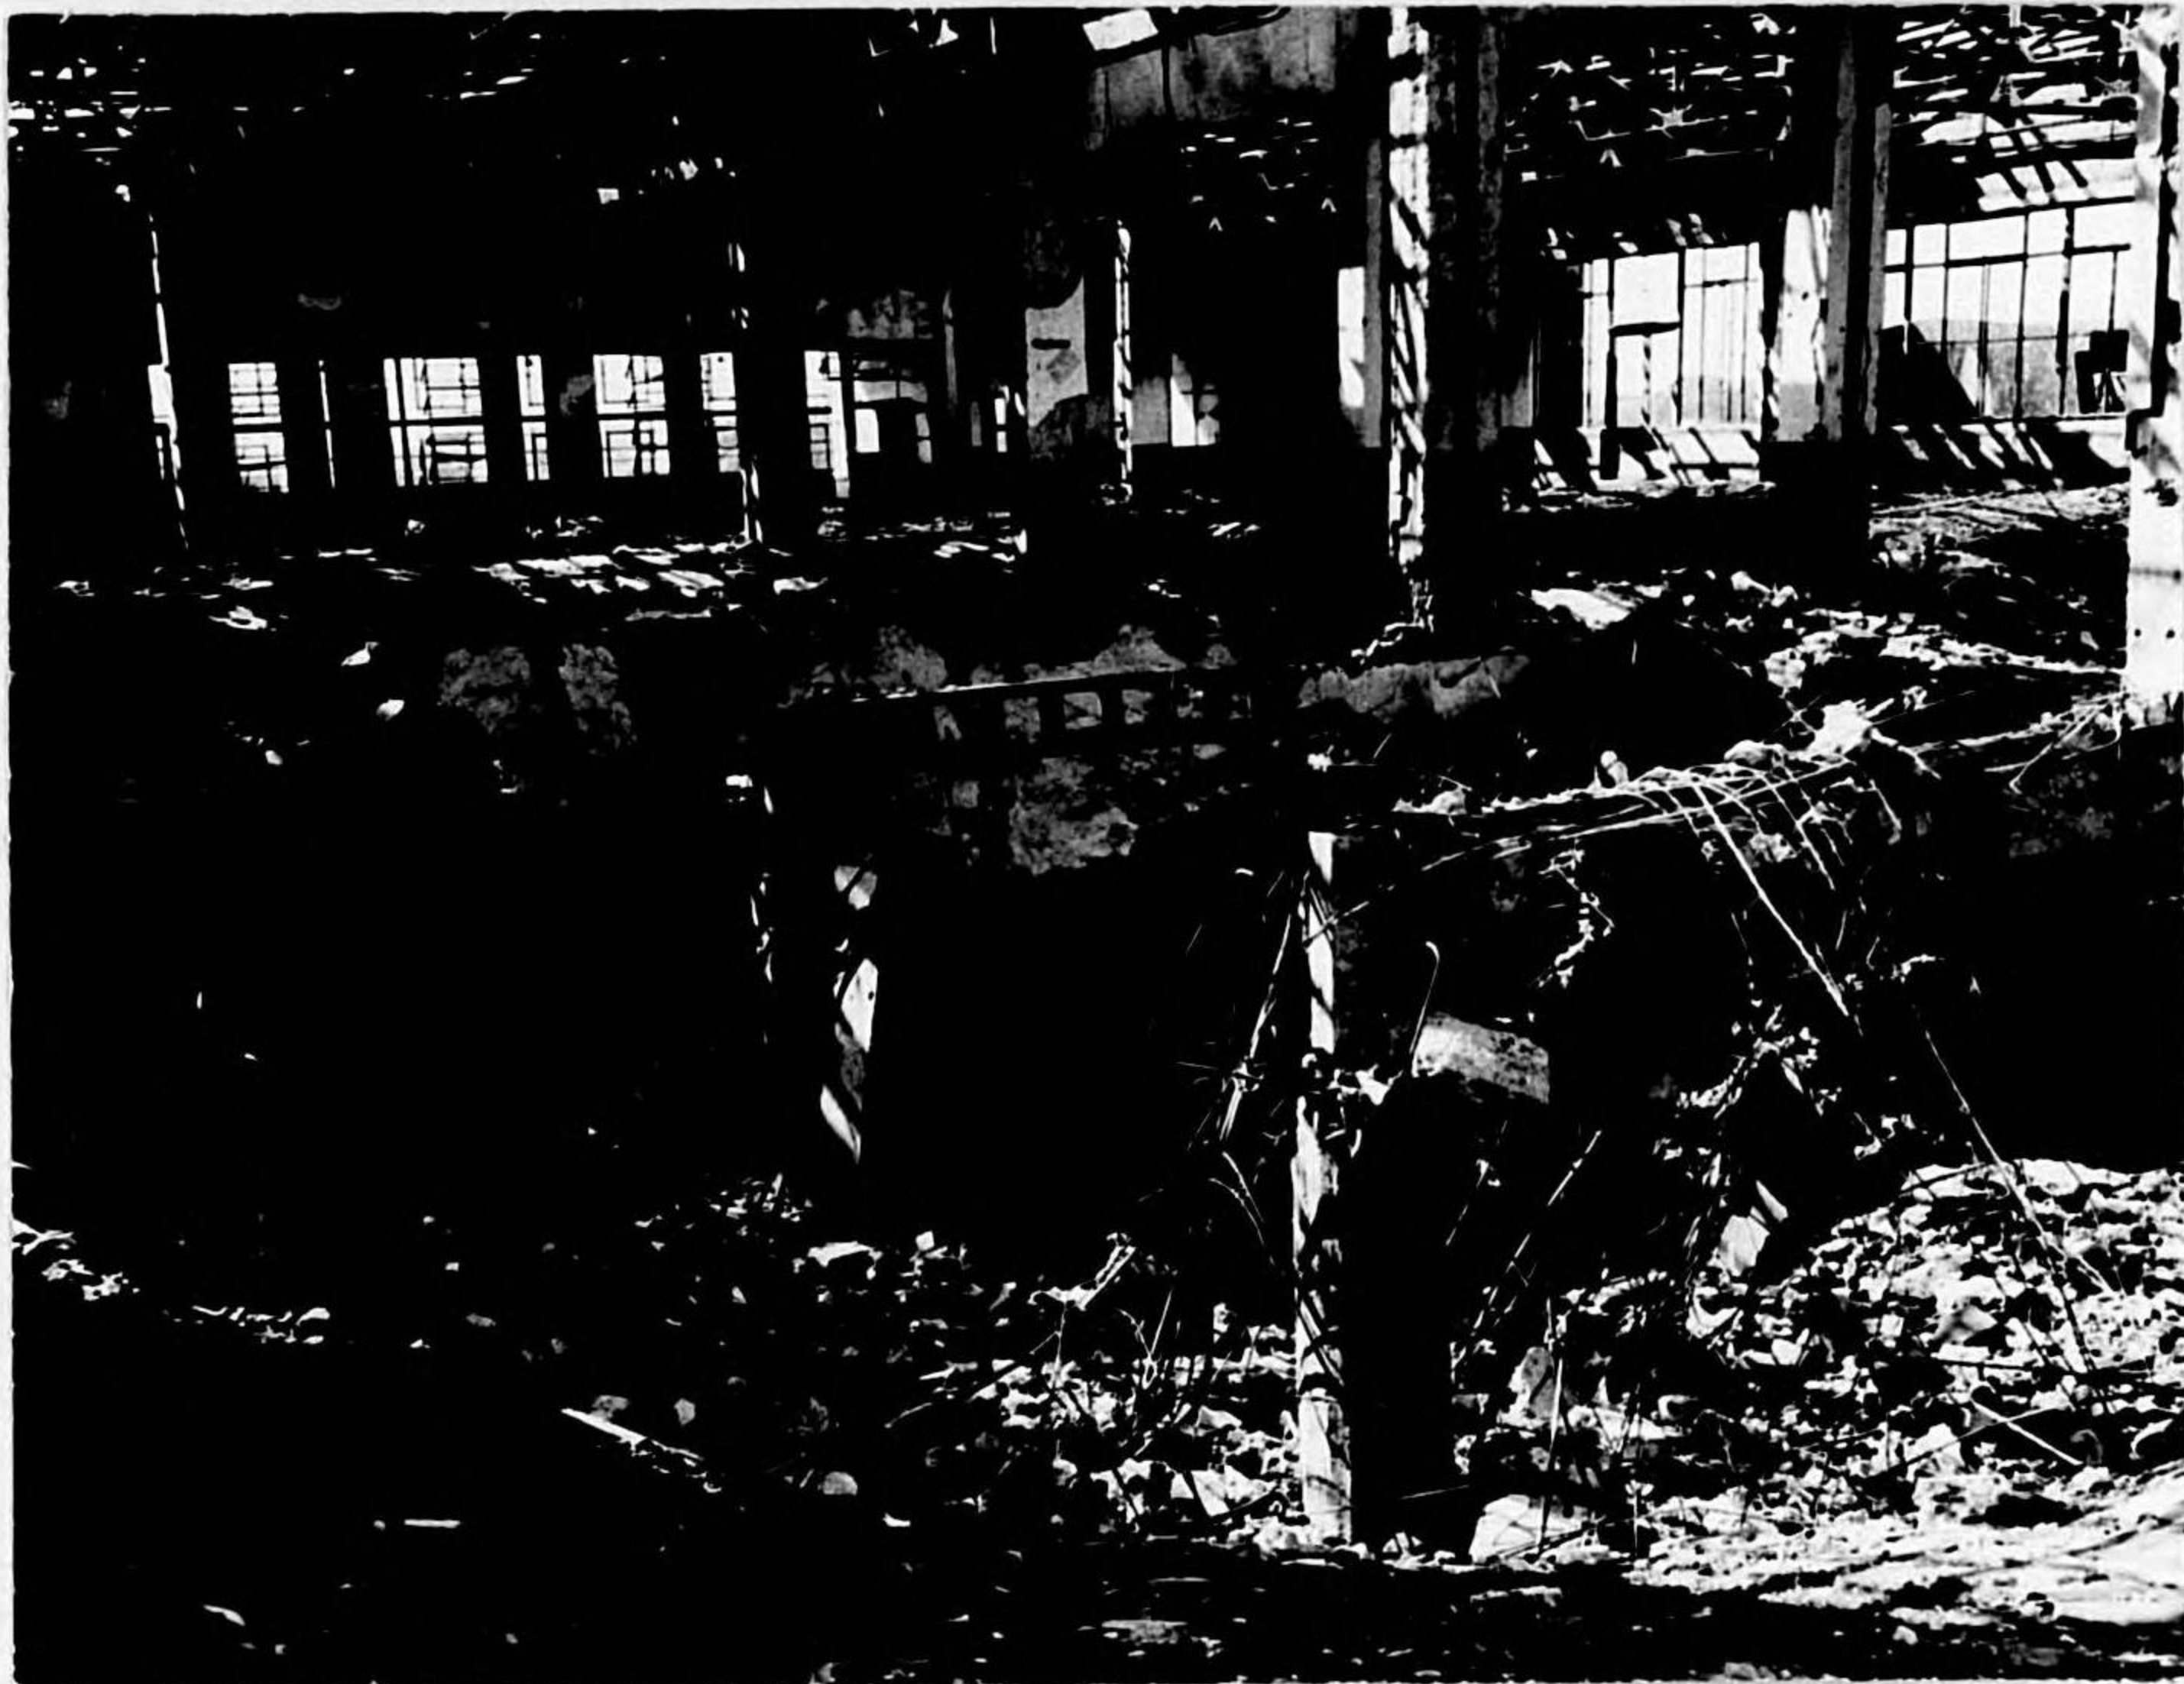
Photo 6

View of damage to fourth floor slab, ^{that} Note center columns supporting roof are not continuous, but bear on fourth floor structural steel beams.

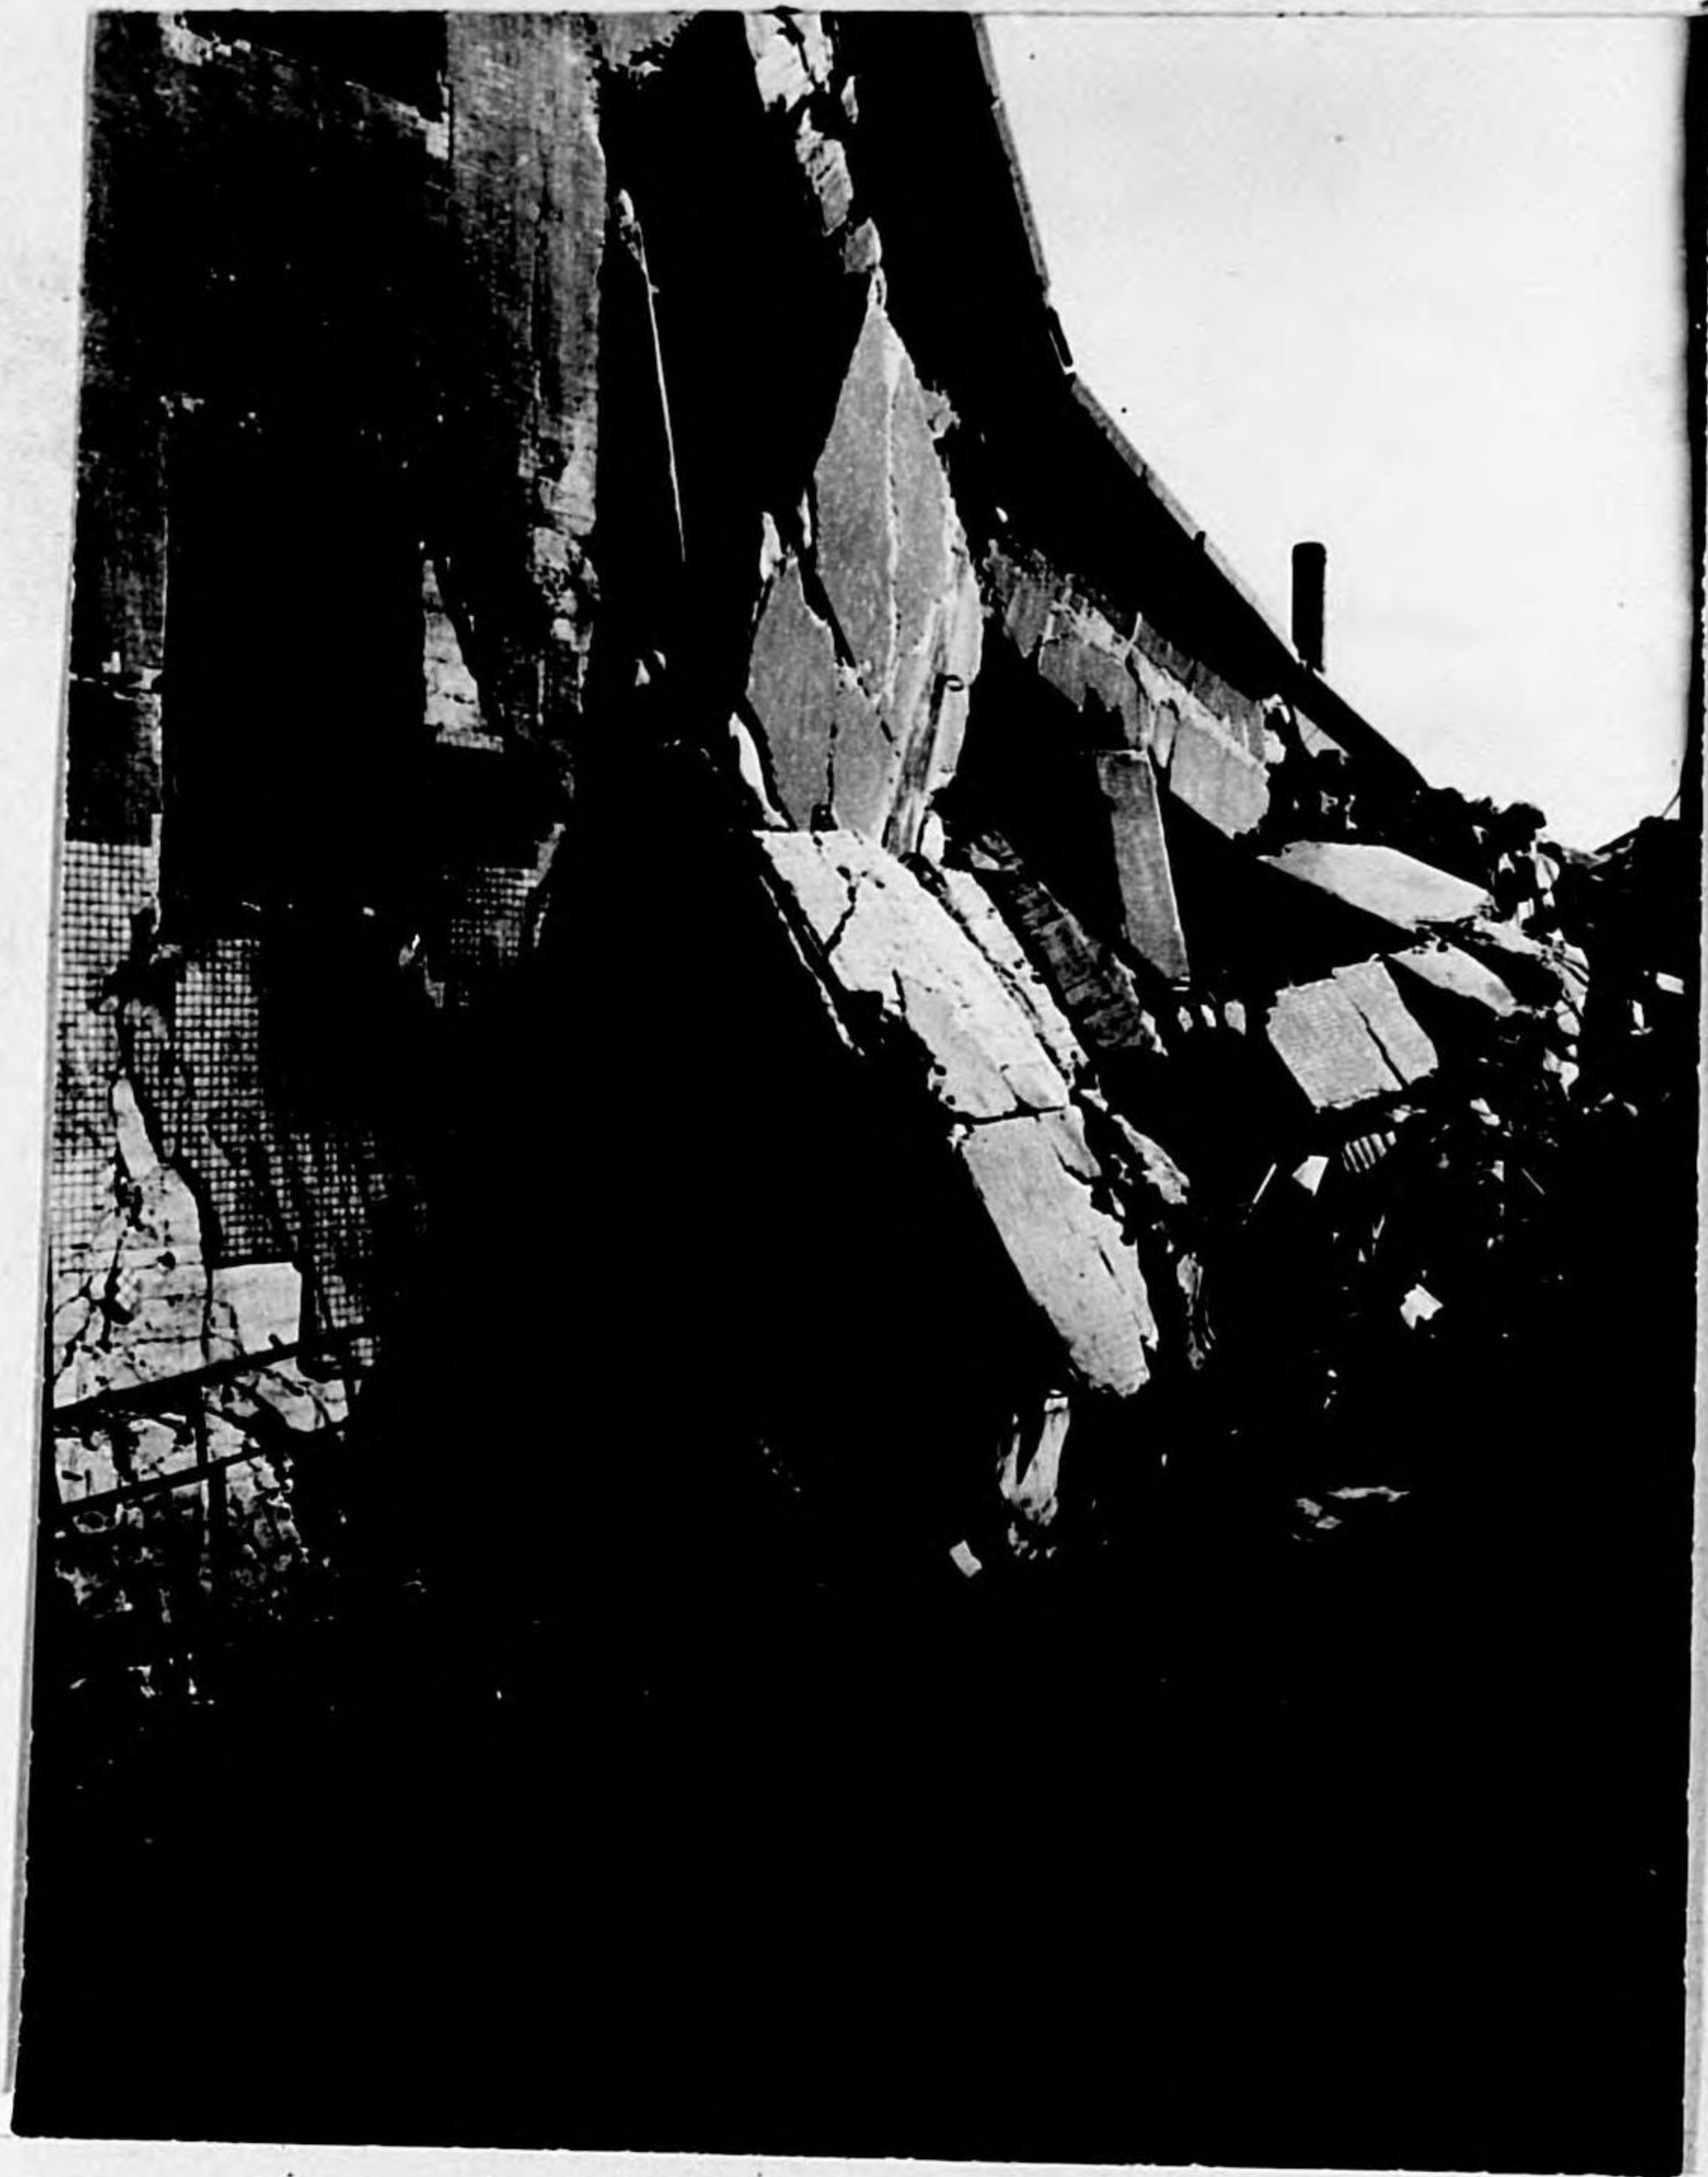
Photo 15

Section of south wall of building 11-E collapsed by bombs 7 and 8. The hole at ground level in the wall in left foreground is entry point of Bomb 7.

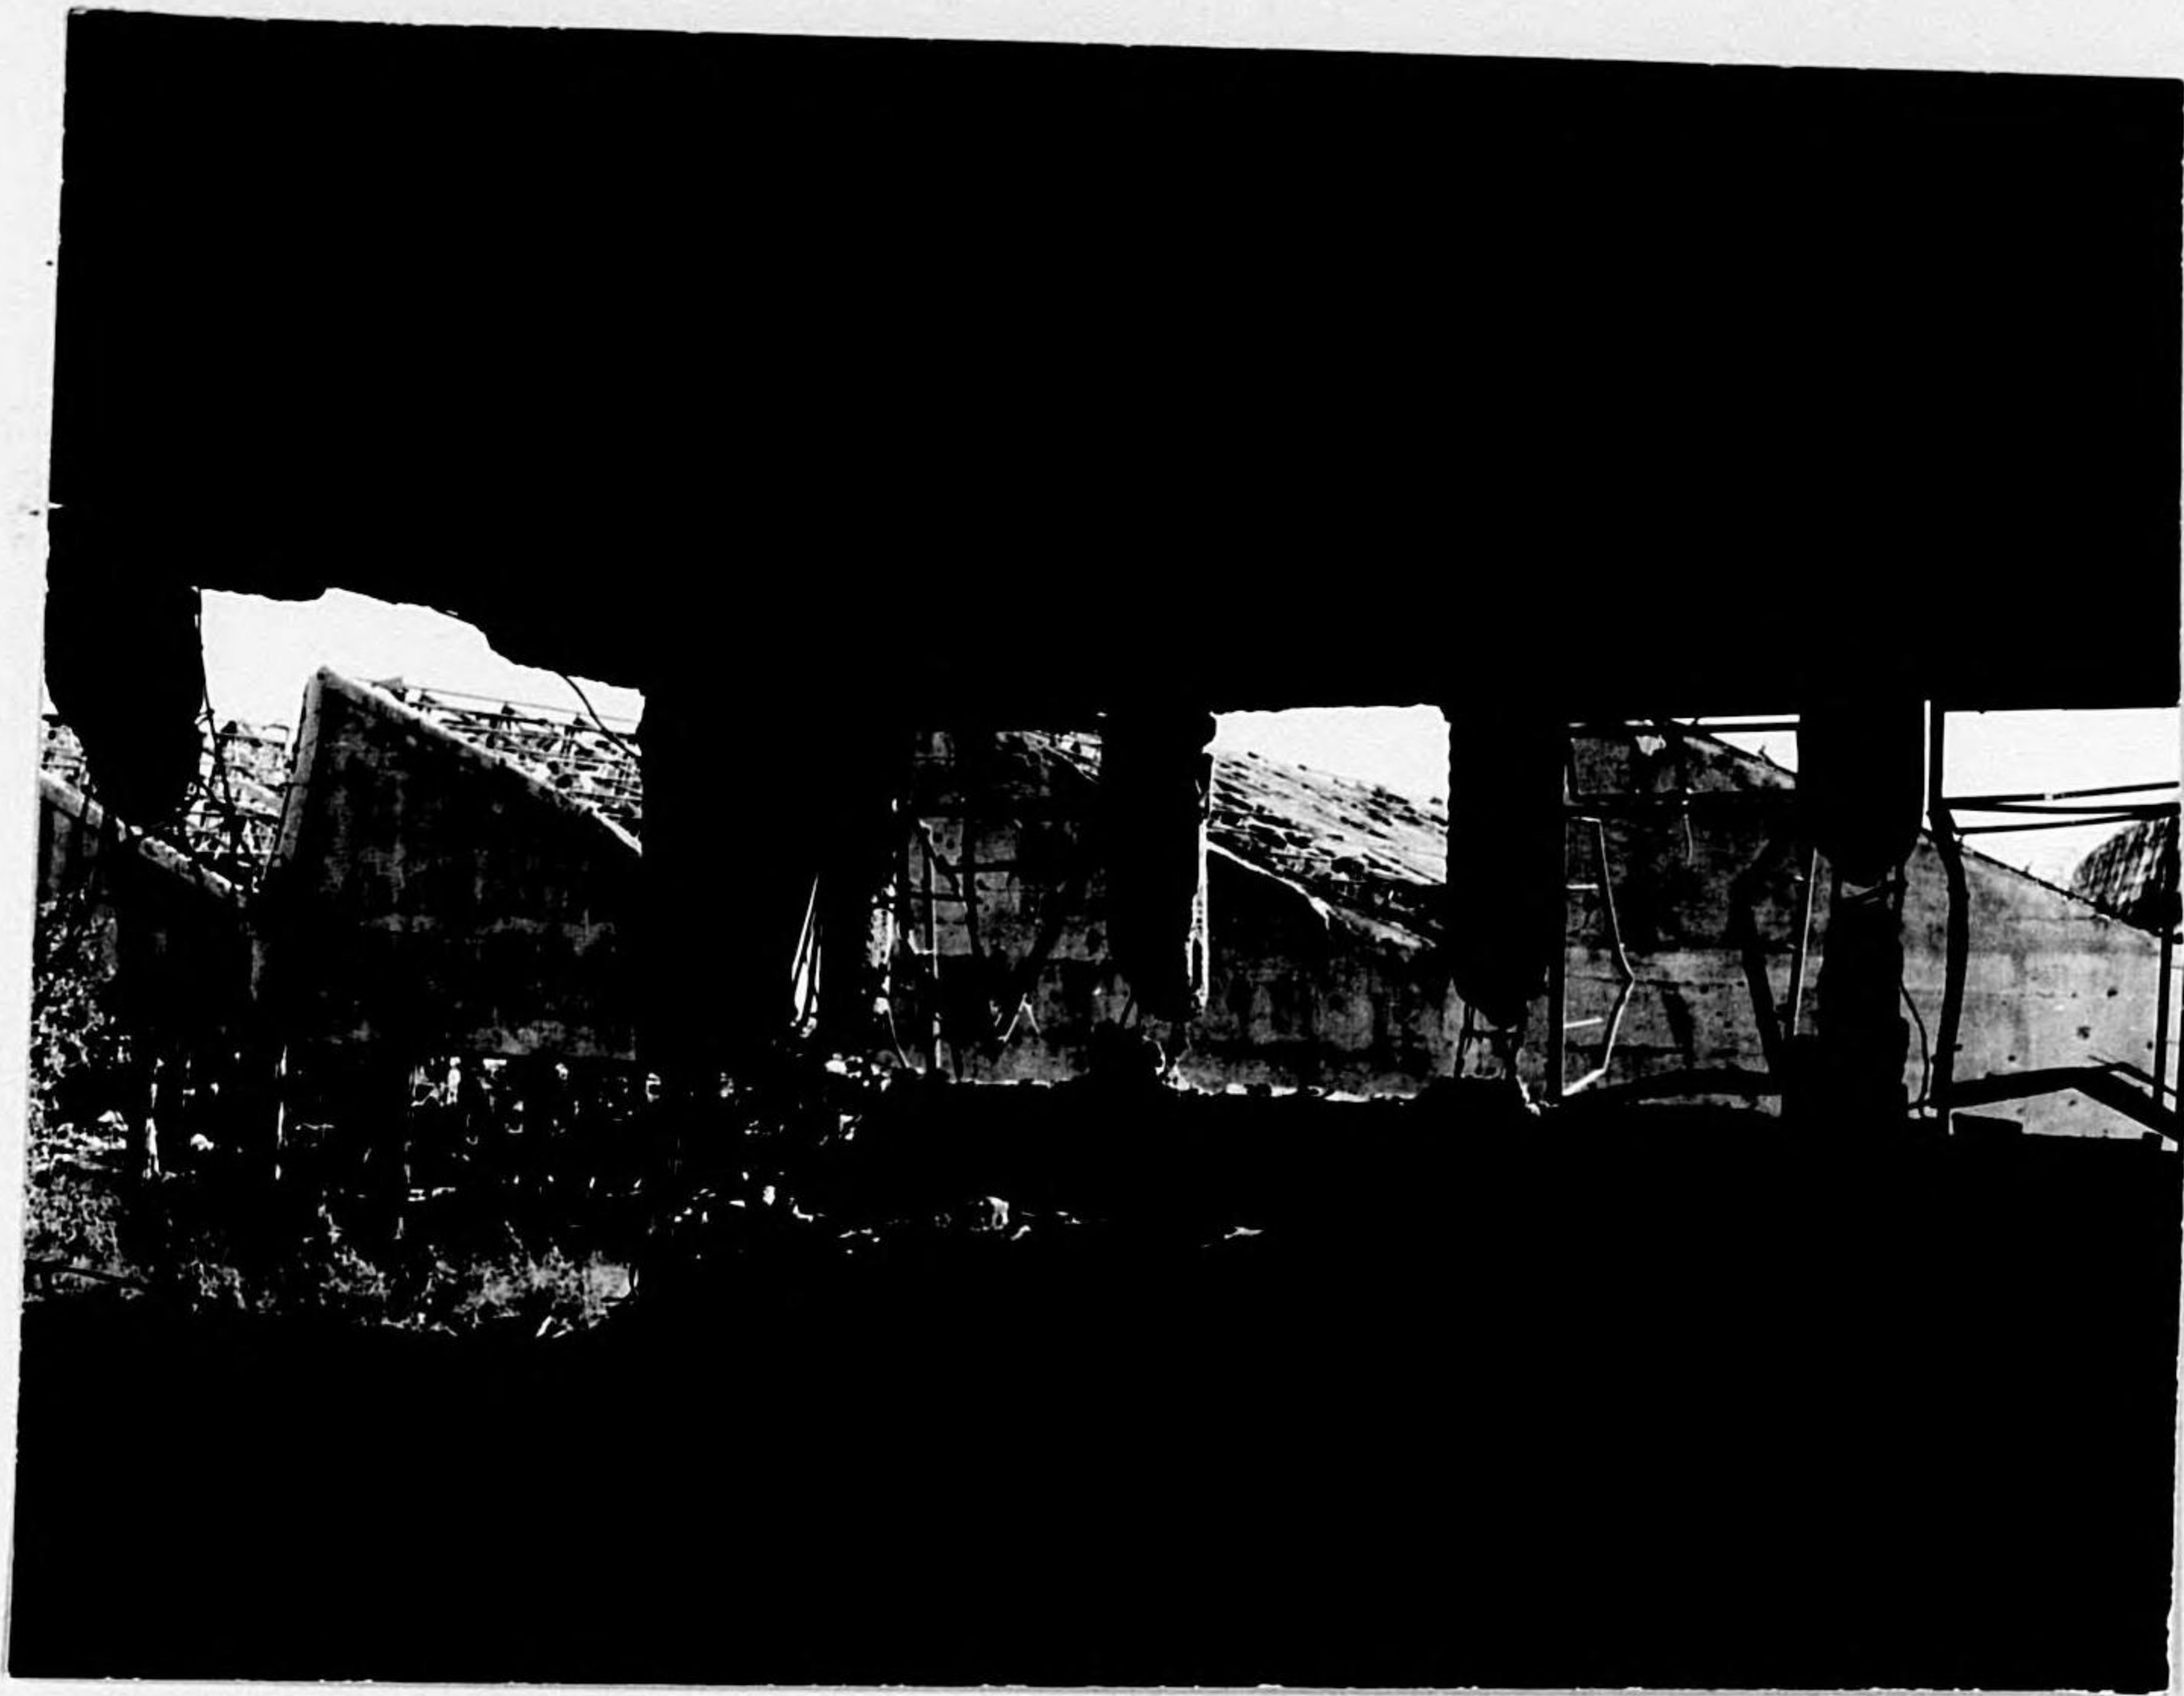
Photo 24

Inside view of N.E. corner of Building 28 showing damage from Bomb 11.
