FDD #6 NAKAJIMA MUSASHINO (9)

Pack 3 PHOTO LOG - NAKAJIMA - MUSEUM

PHOTO LOC - NAKAJIMA - MUSEUM -

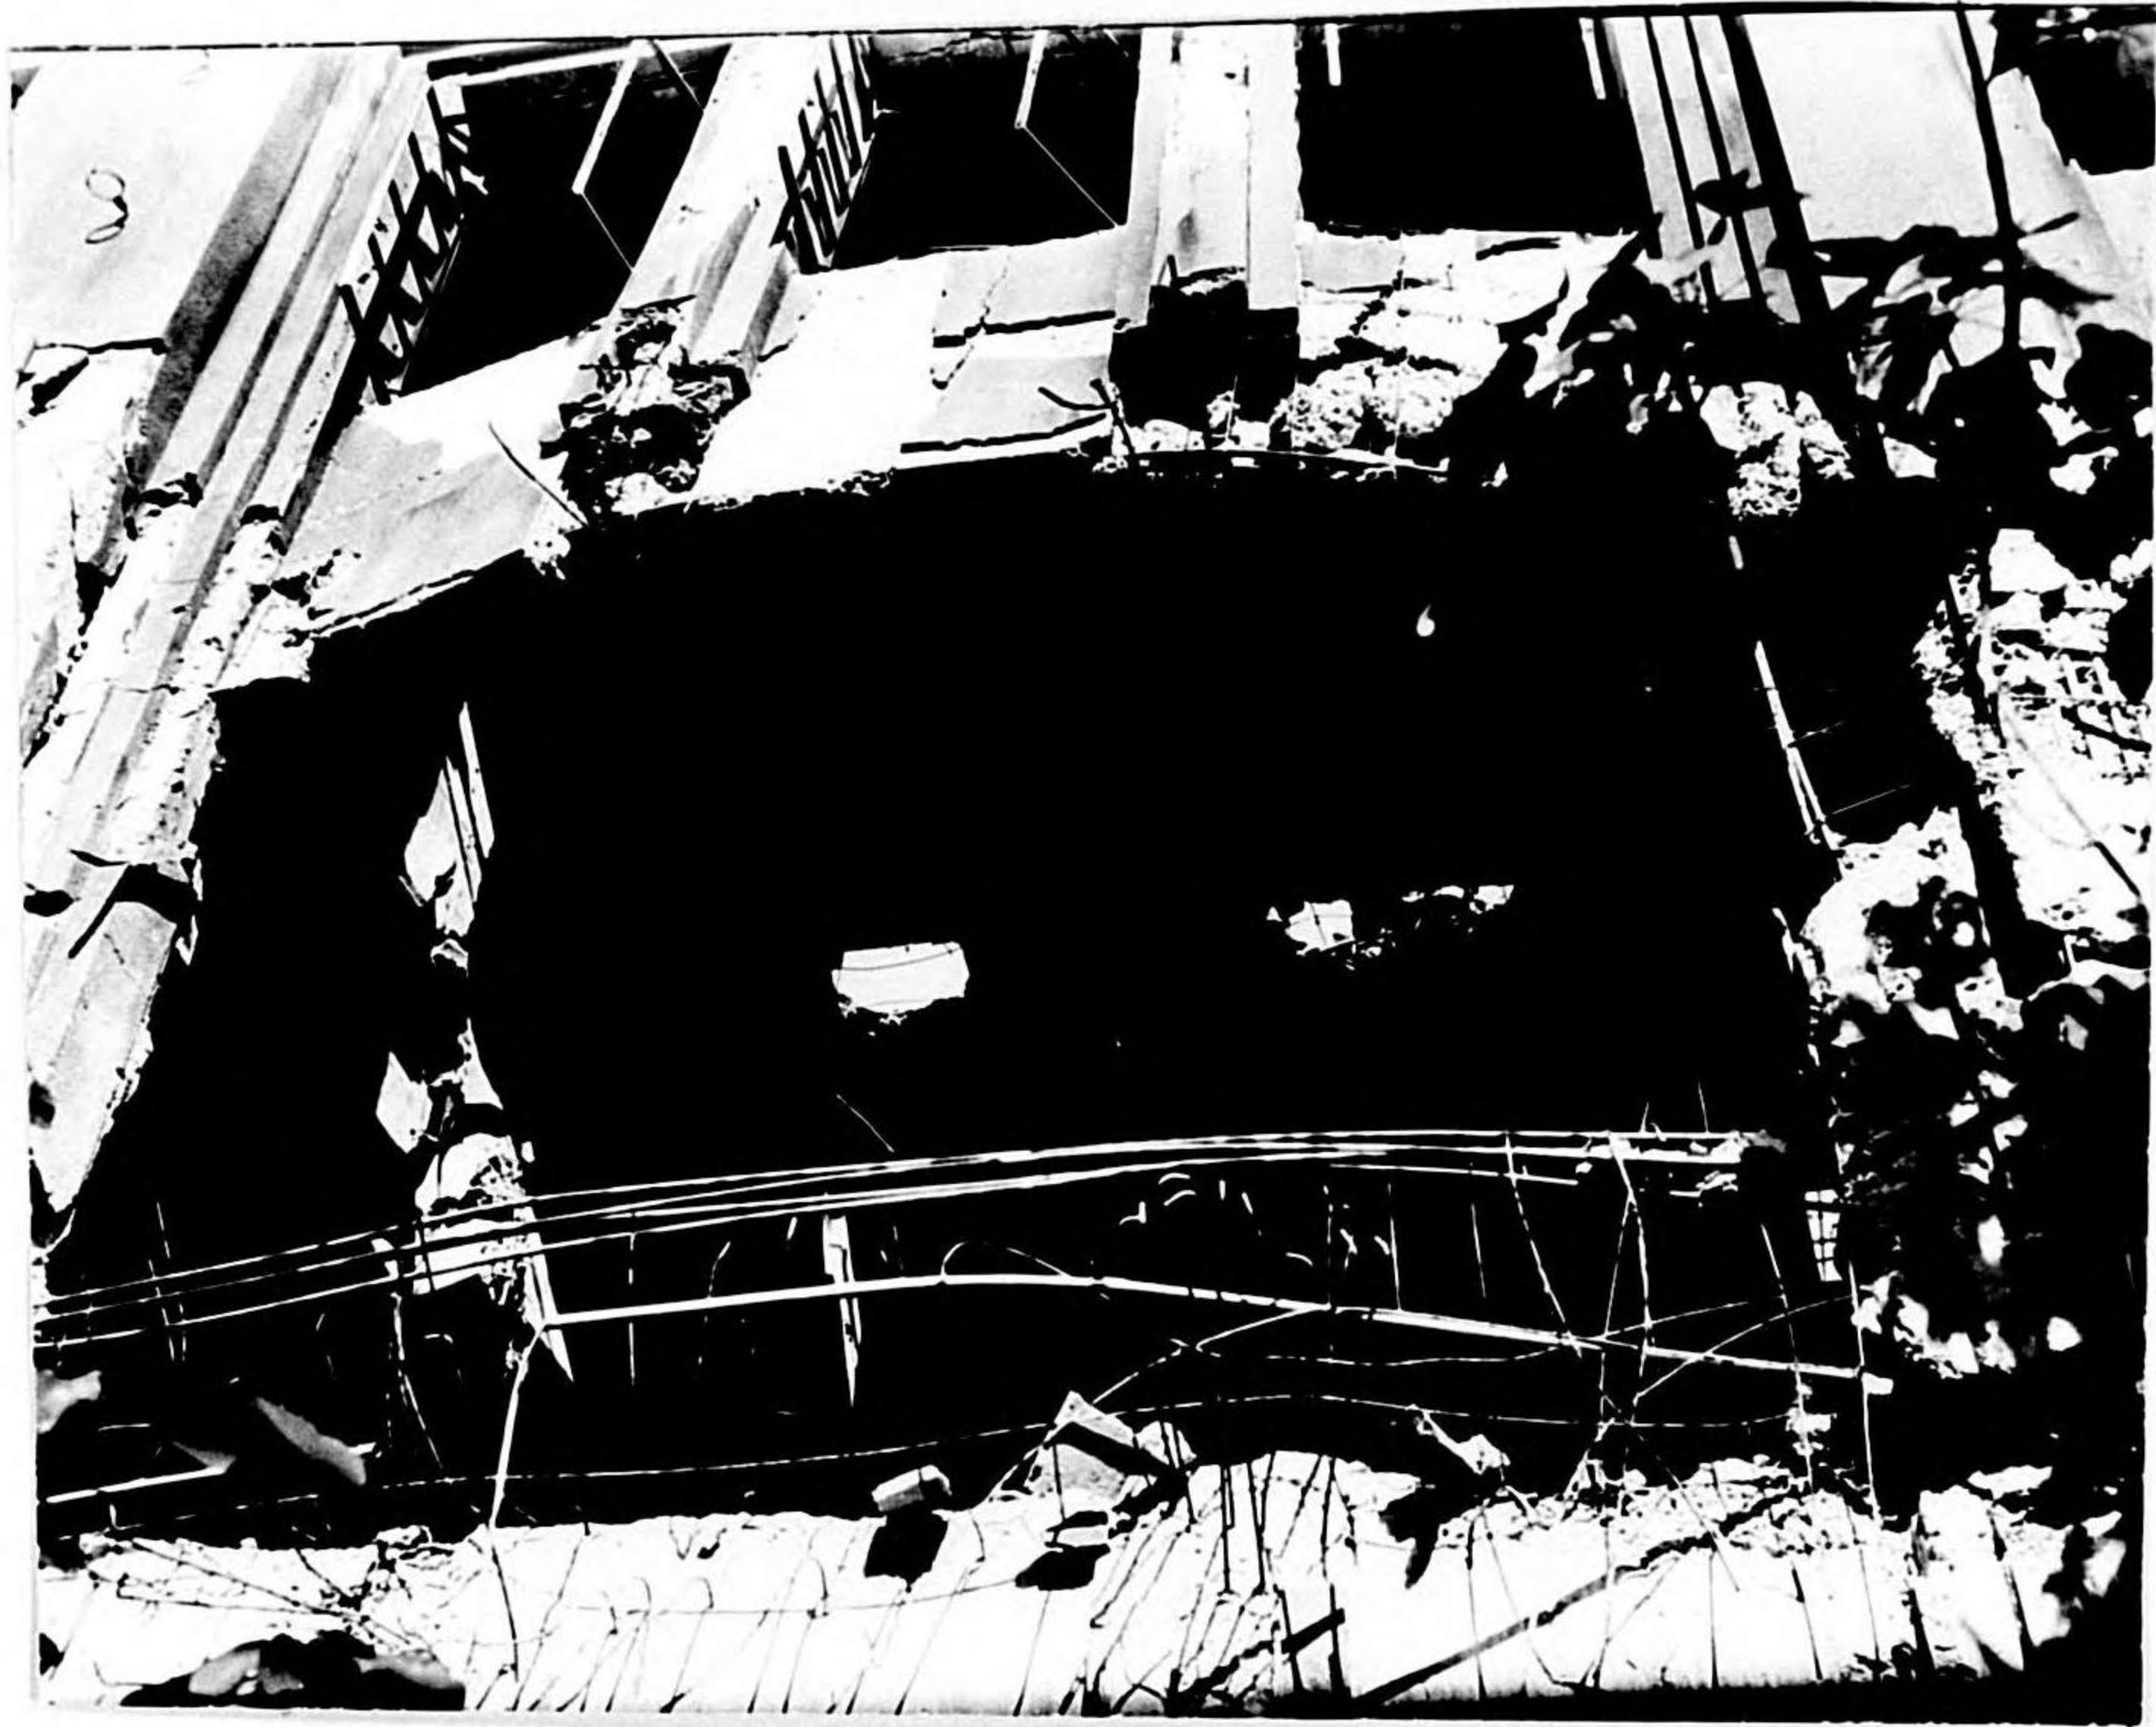
Photo 28

View of entry point of Bomb 12 from outside building through blasted opening in south wall of Building 28.

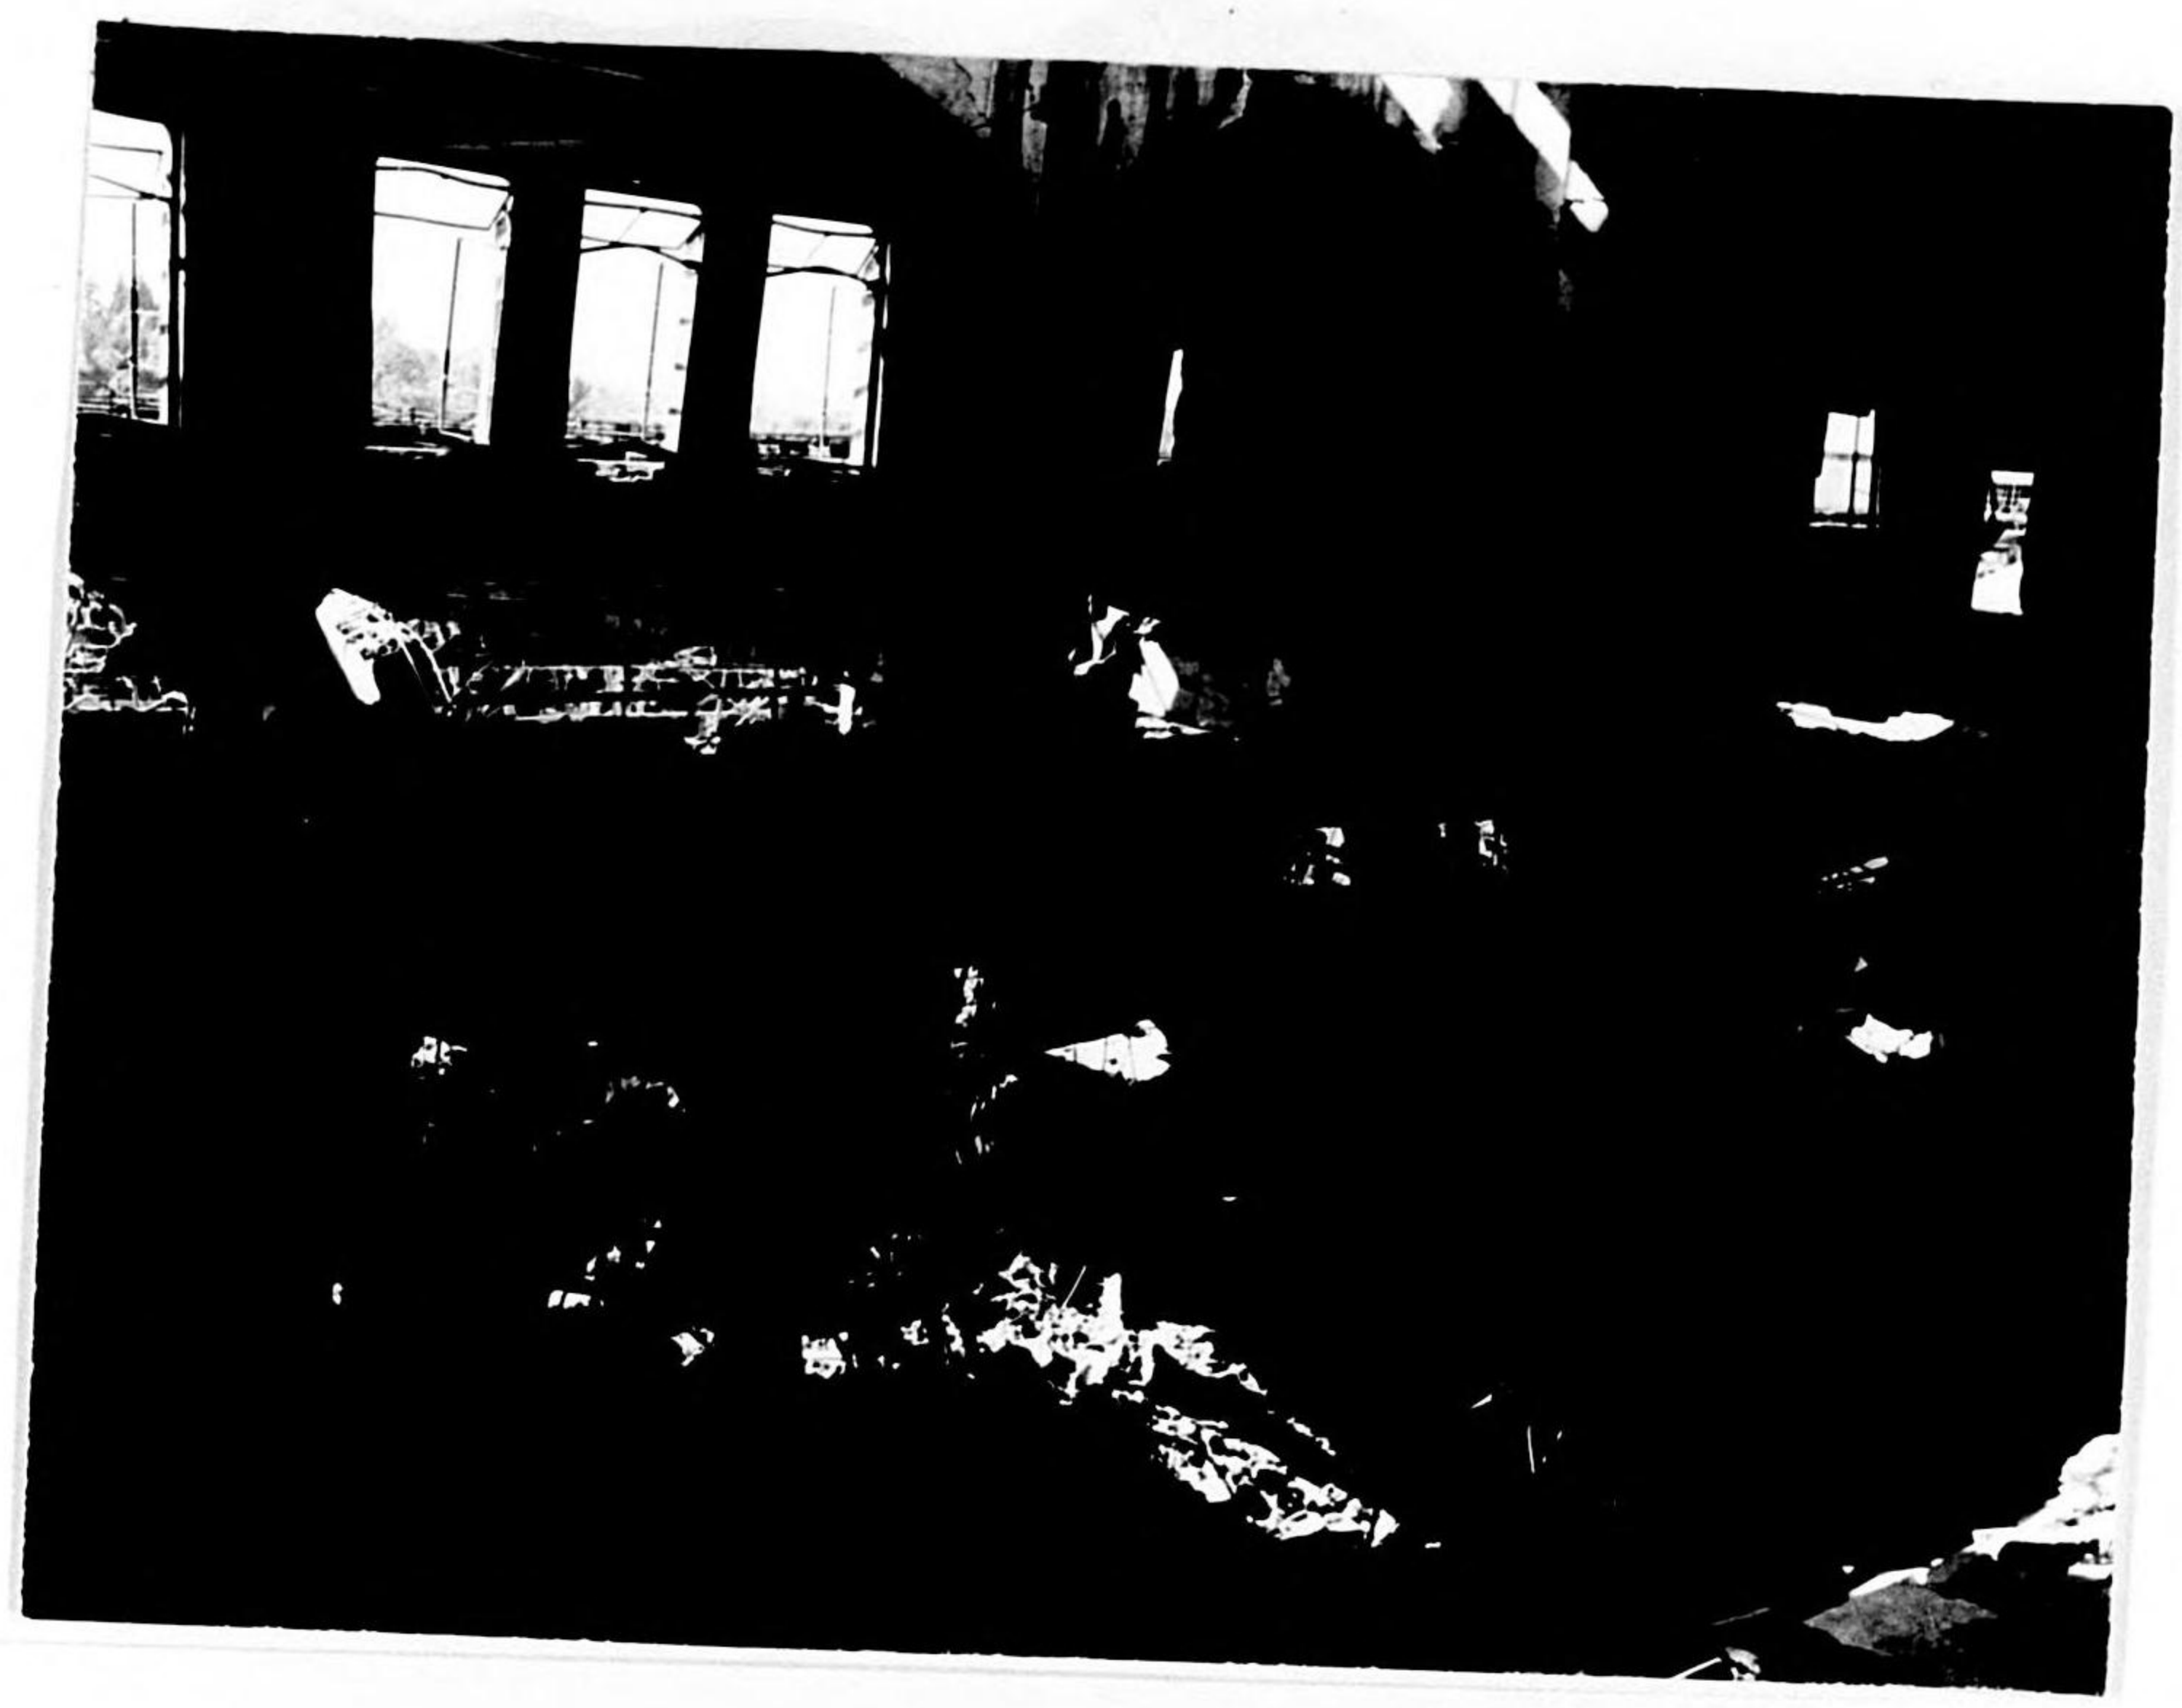
Photo 29

View of damage to third floor of building 28 caused by Bomb 12.

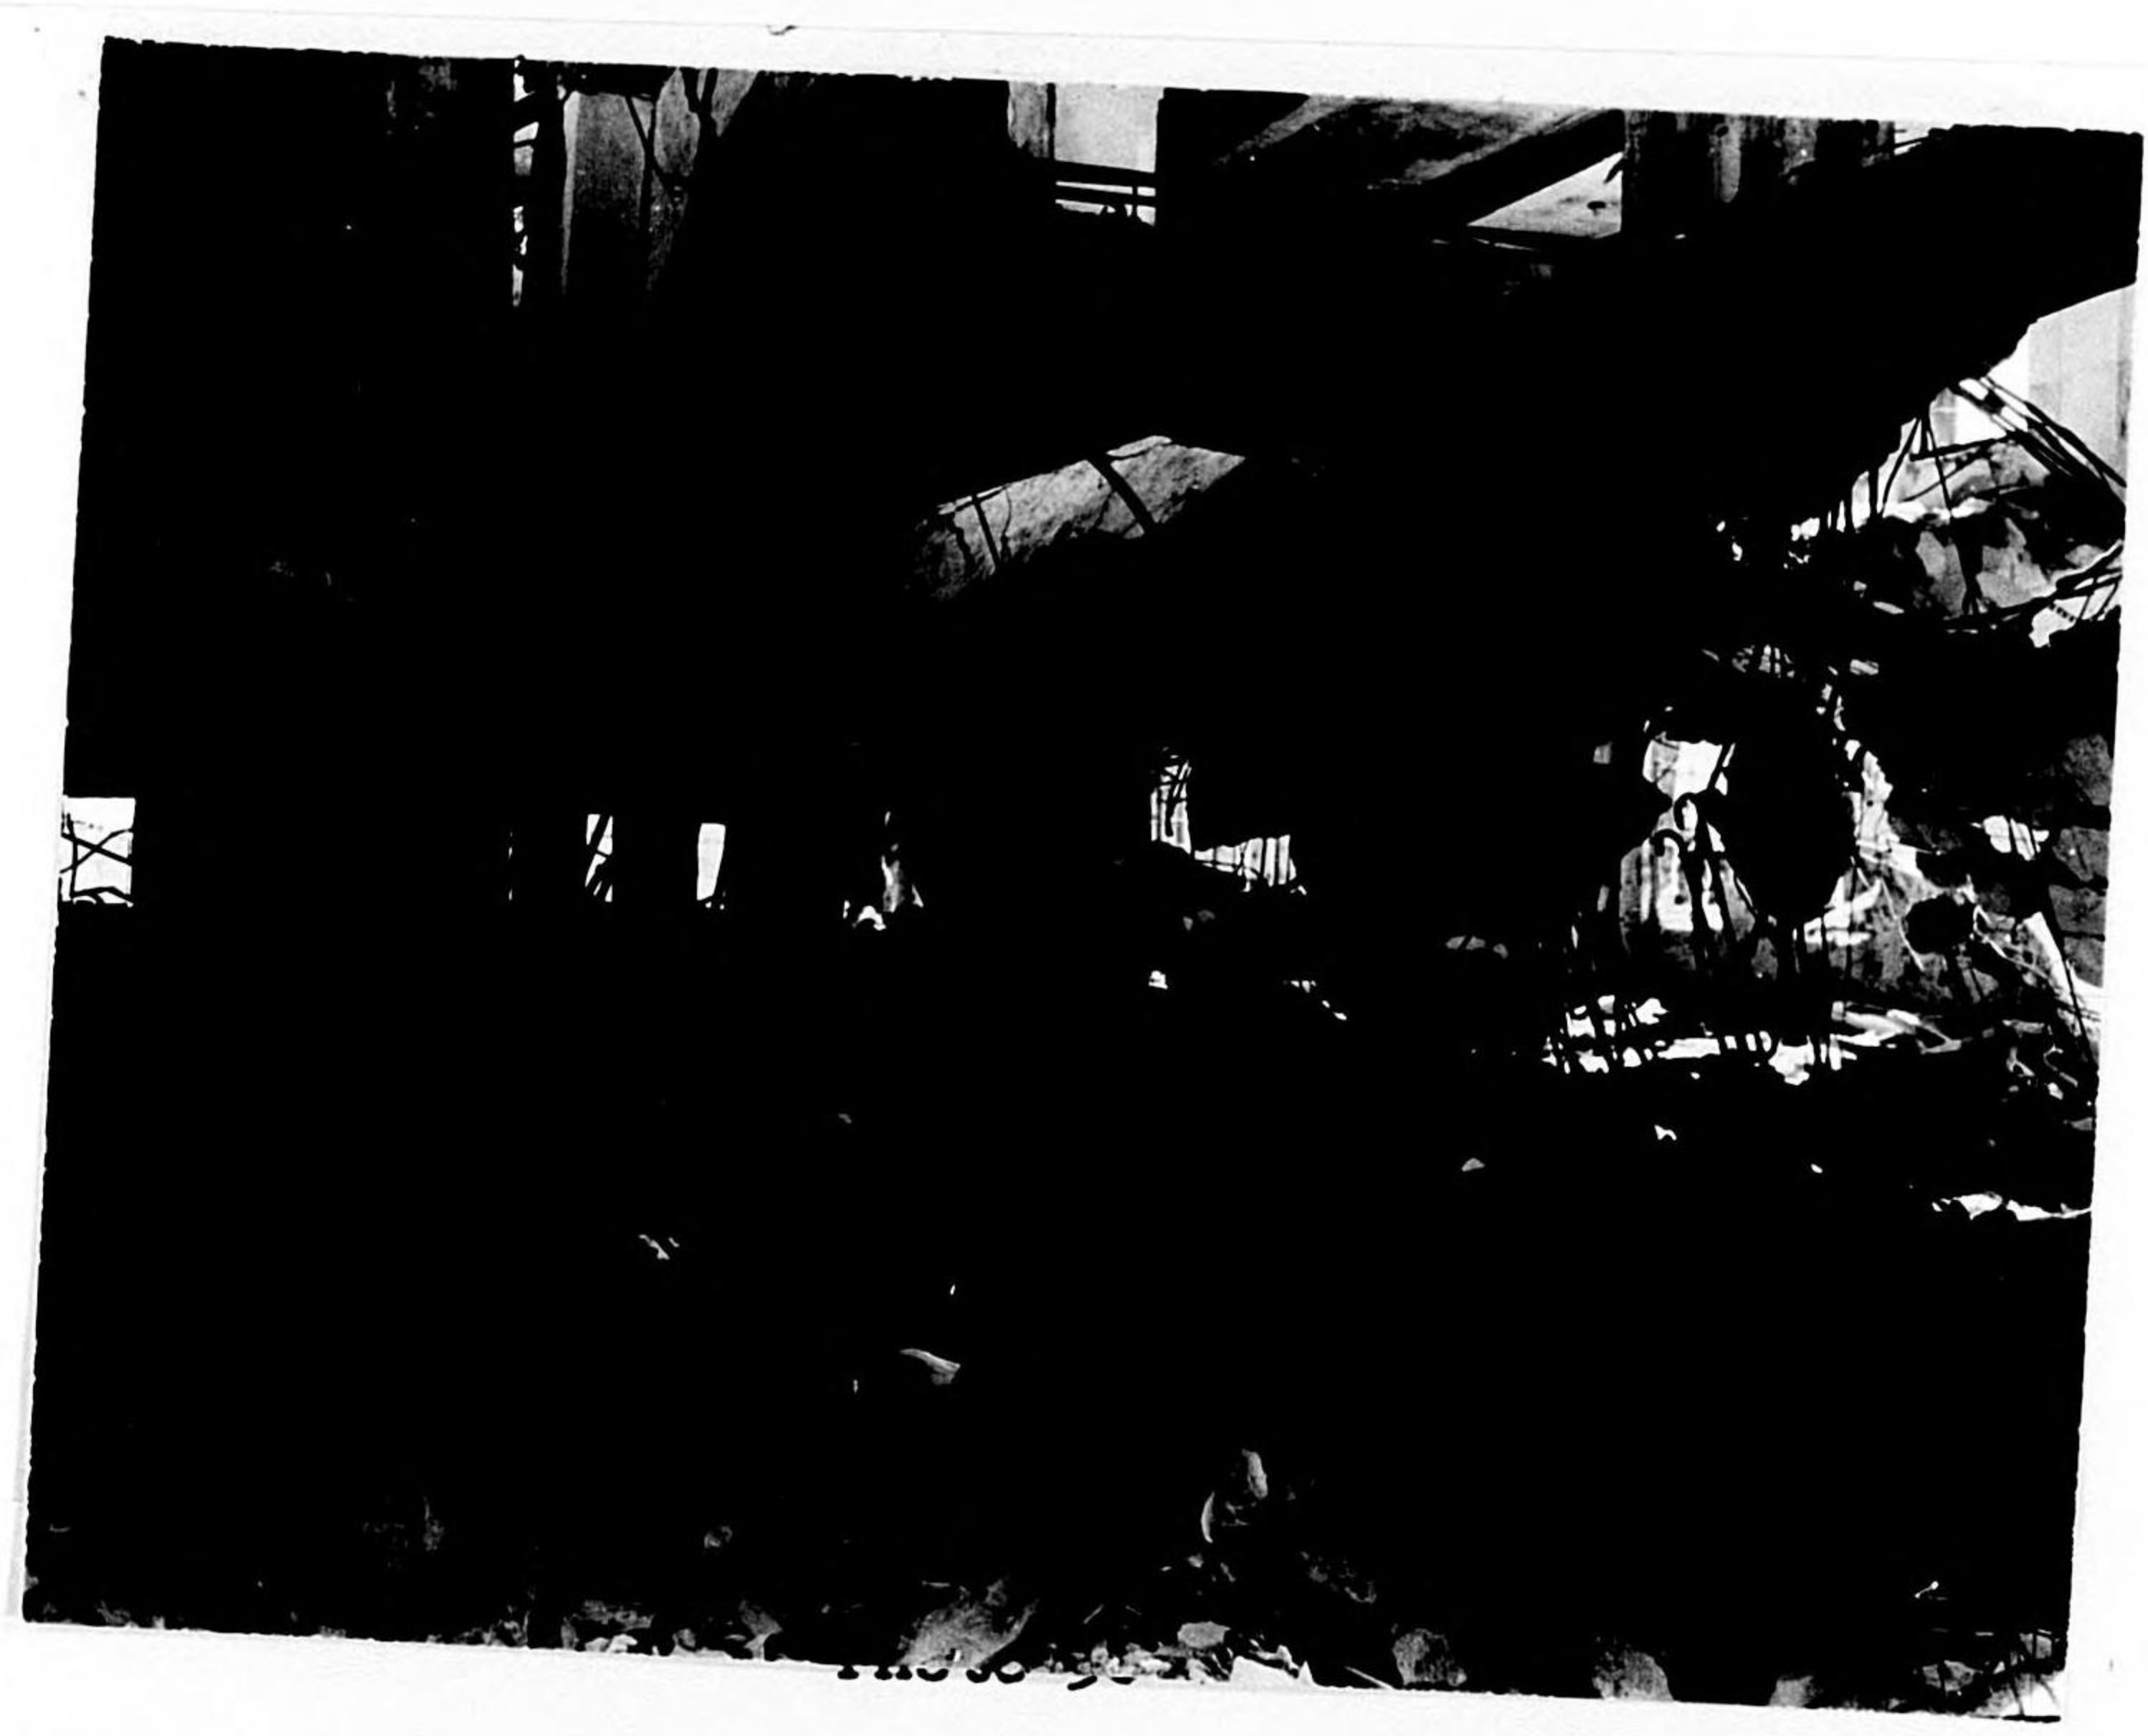
View of damage to columns in second floor. Note that roof is apparently not affected by lack of support. Also of interest is the staggered splicing of column reinforcing steel.

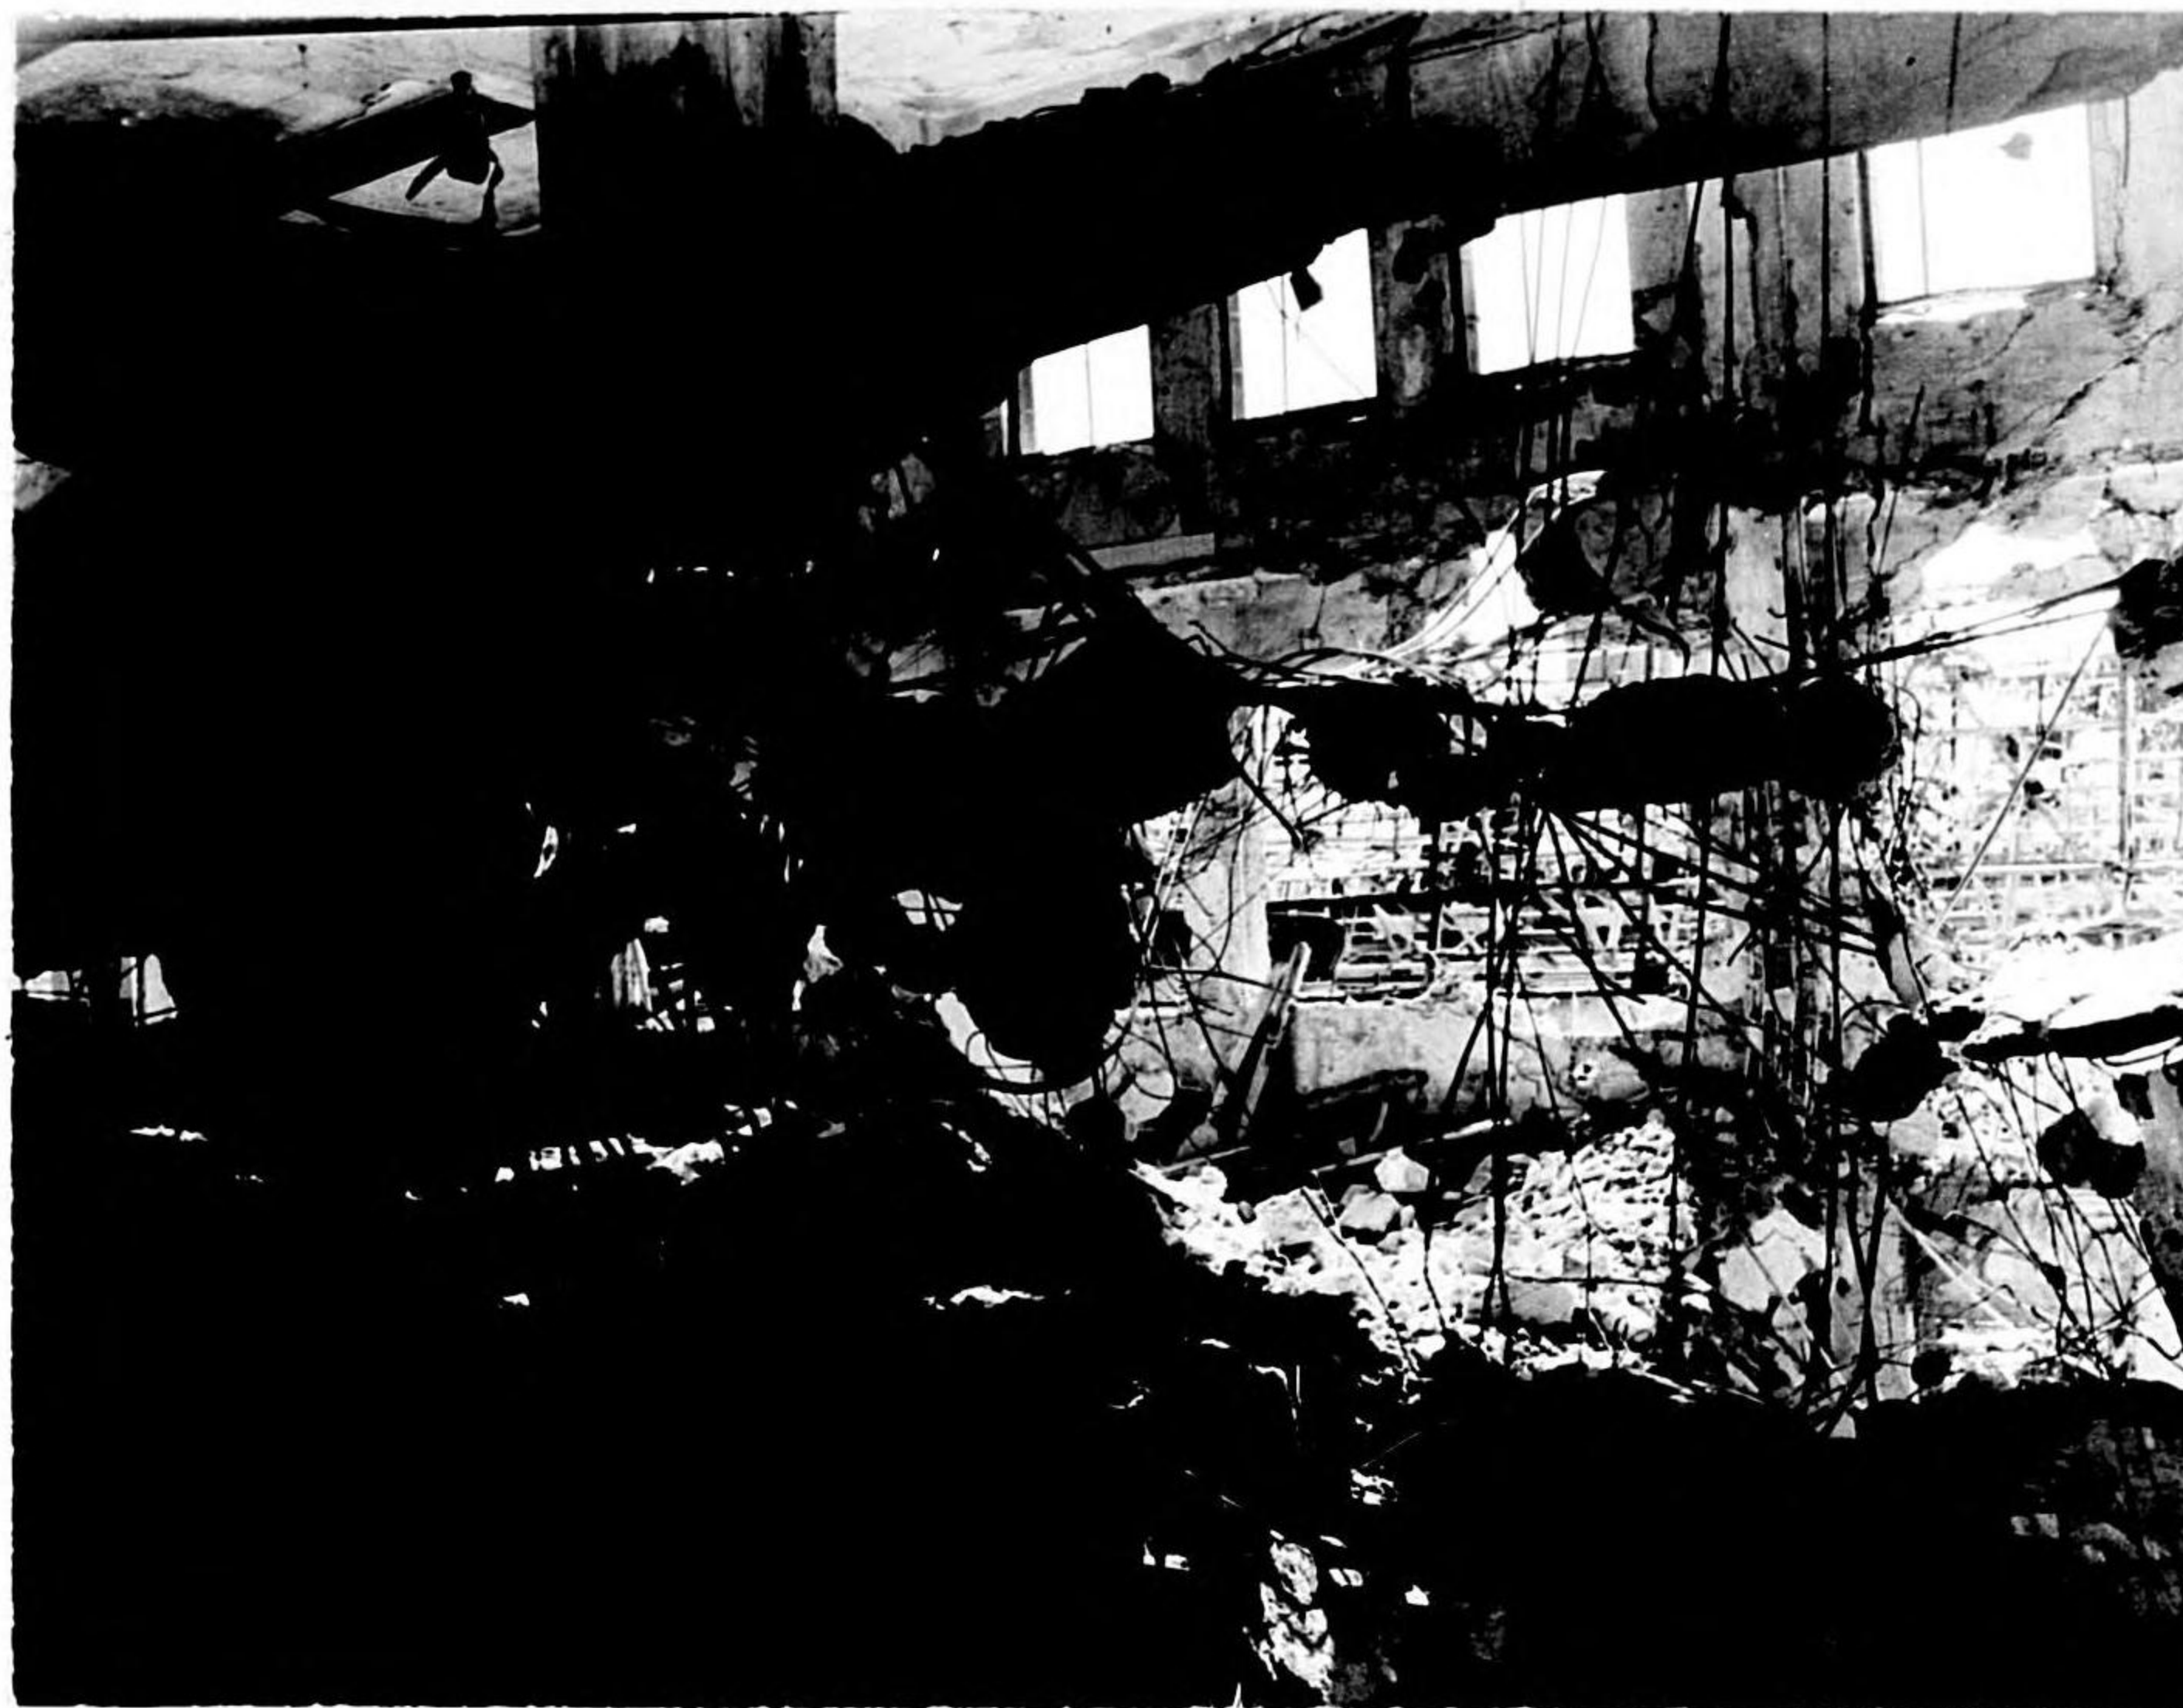
Photo 31

View of same column shown in Photo 30, with south wall of building in background.

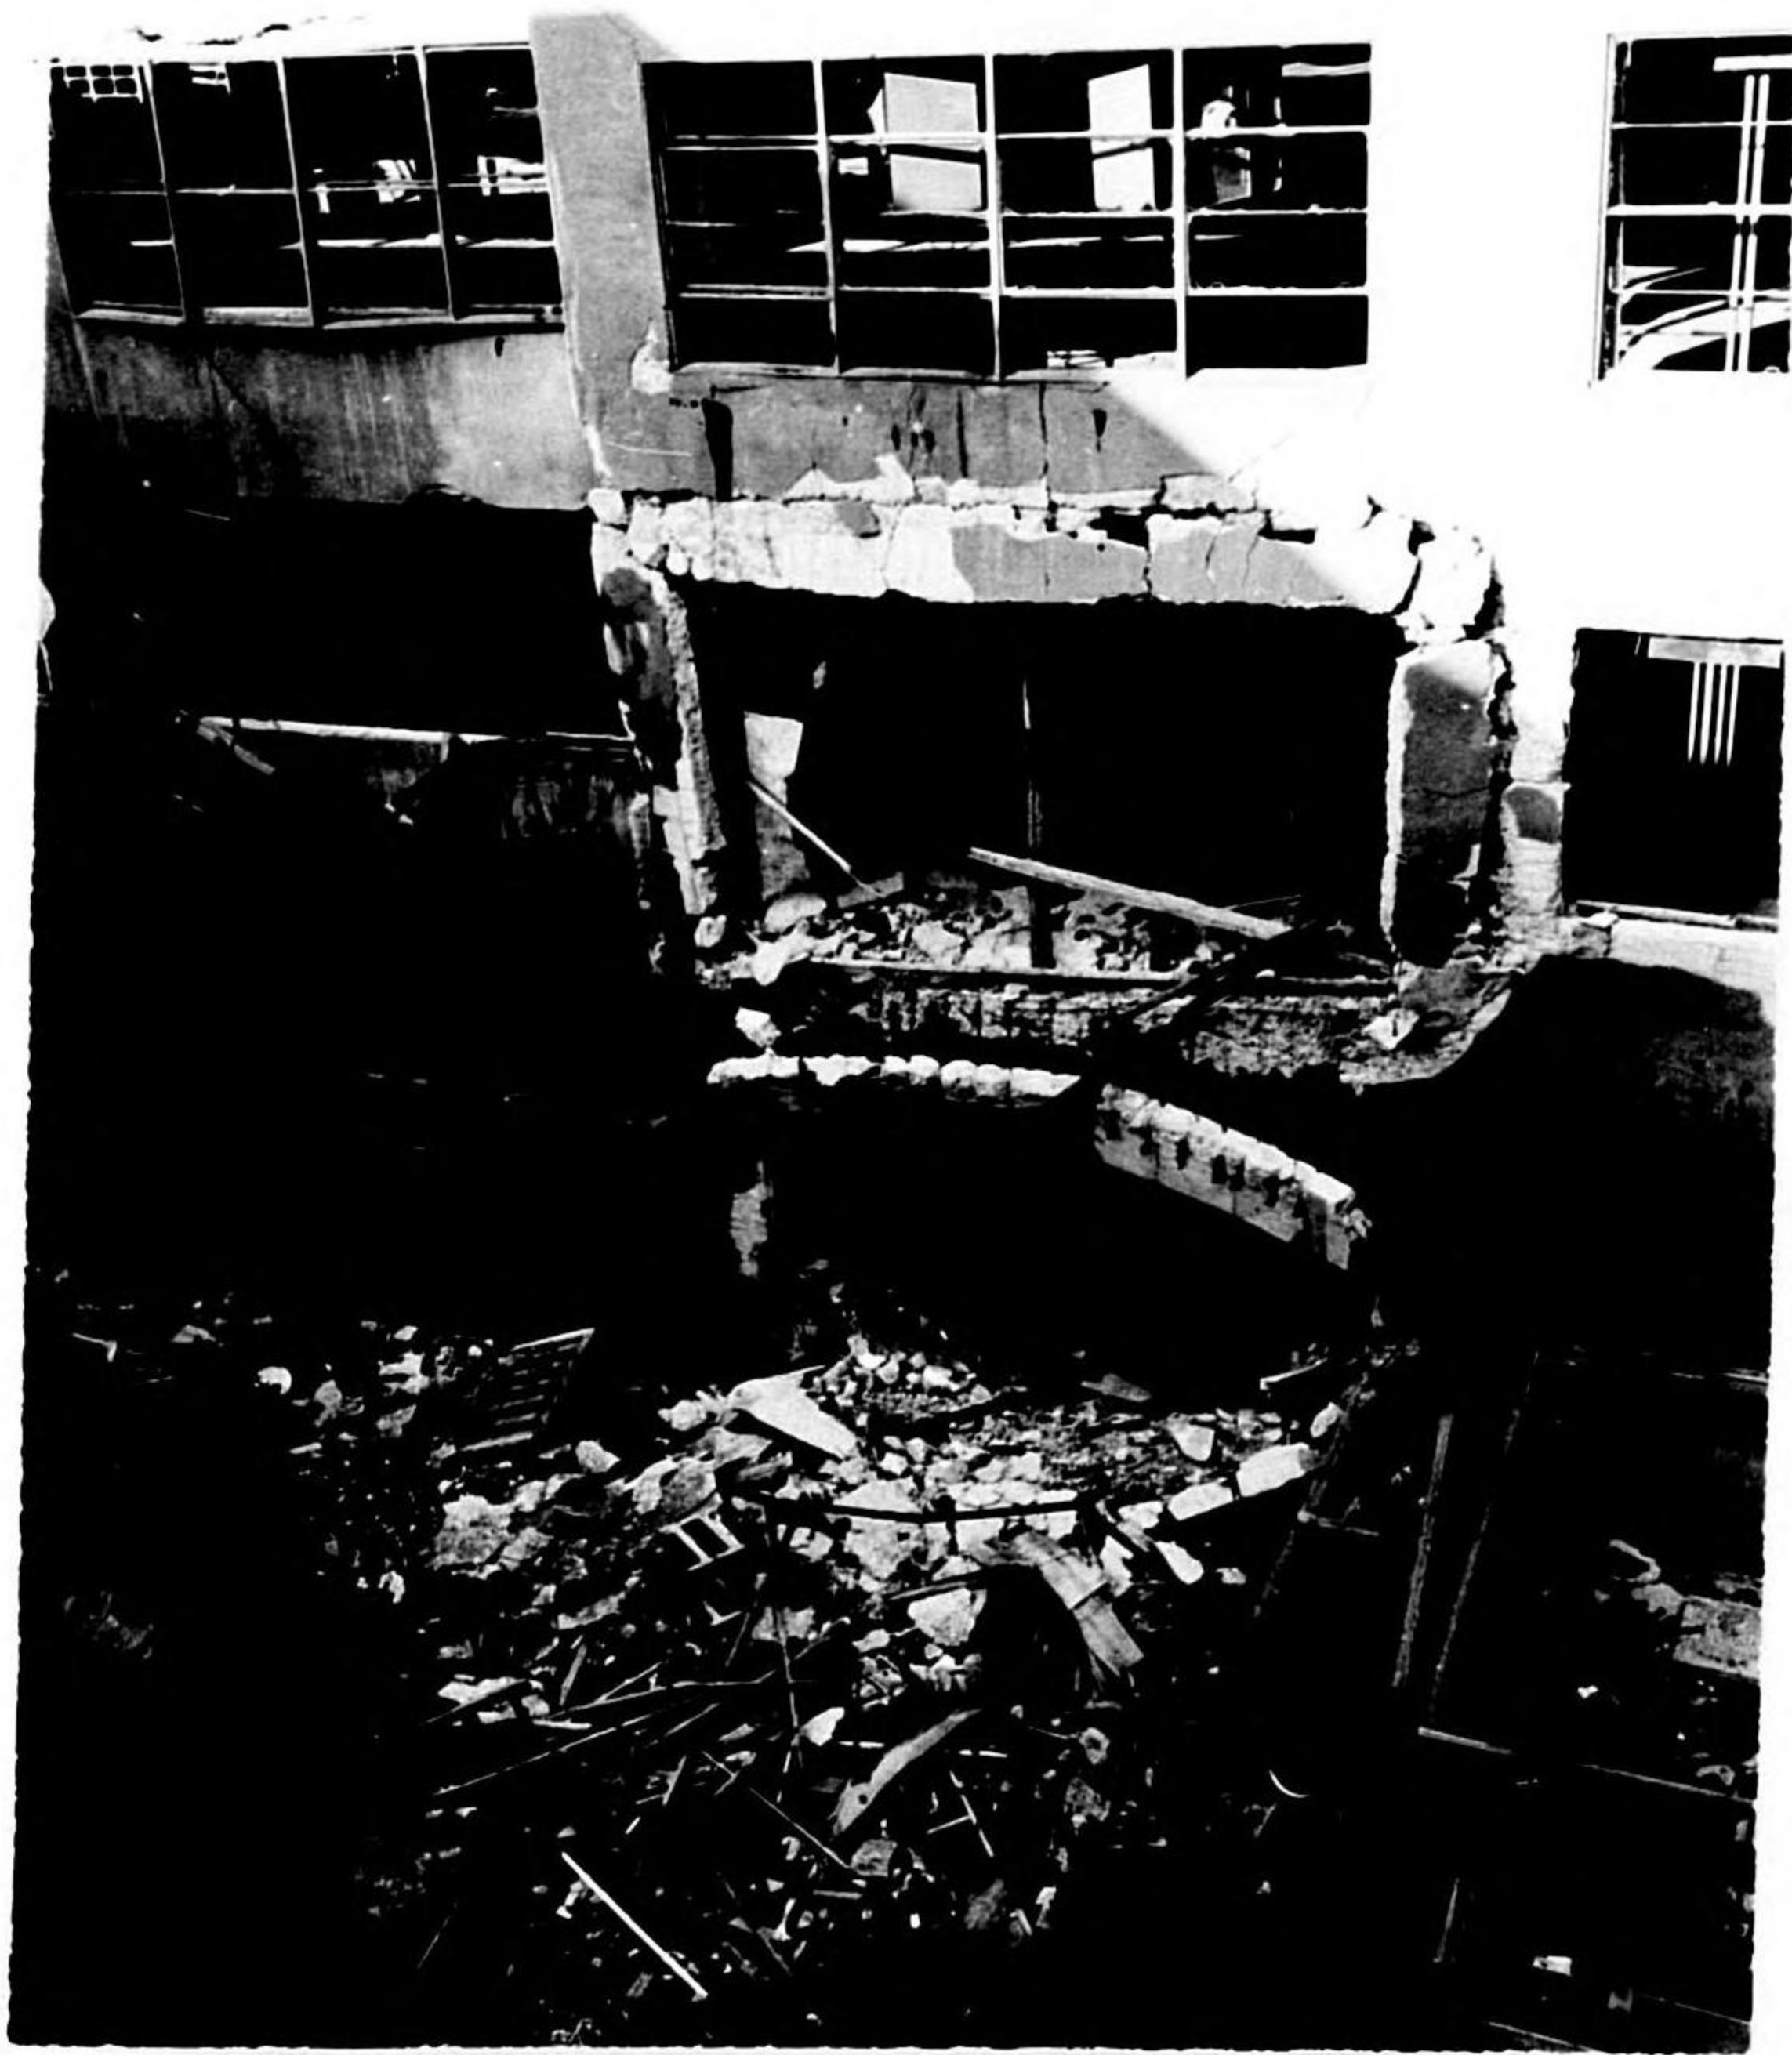
Photo 39
Exterior view of damage by Bomb 14.

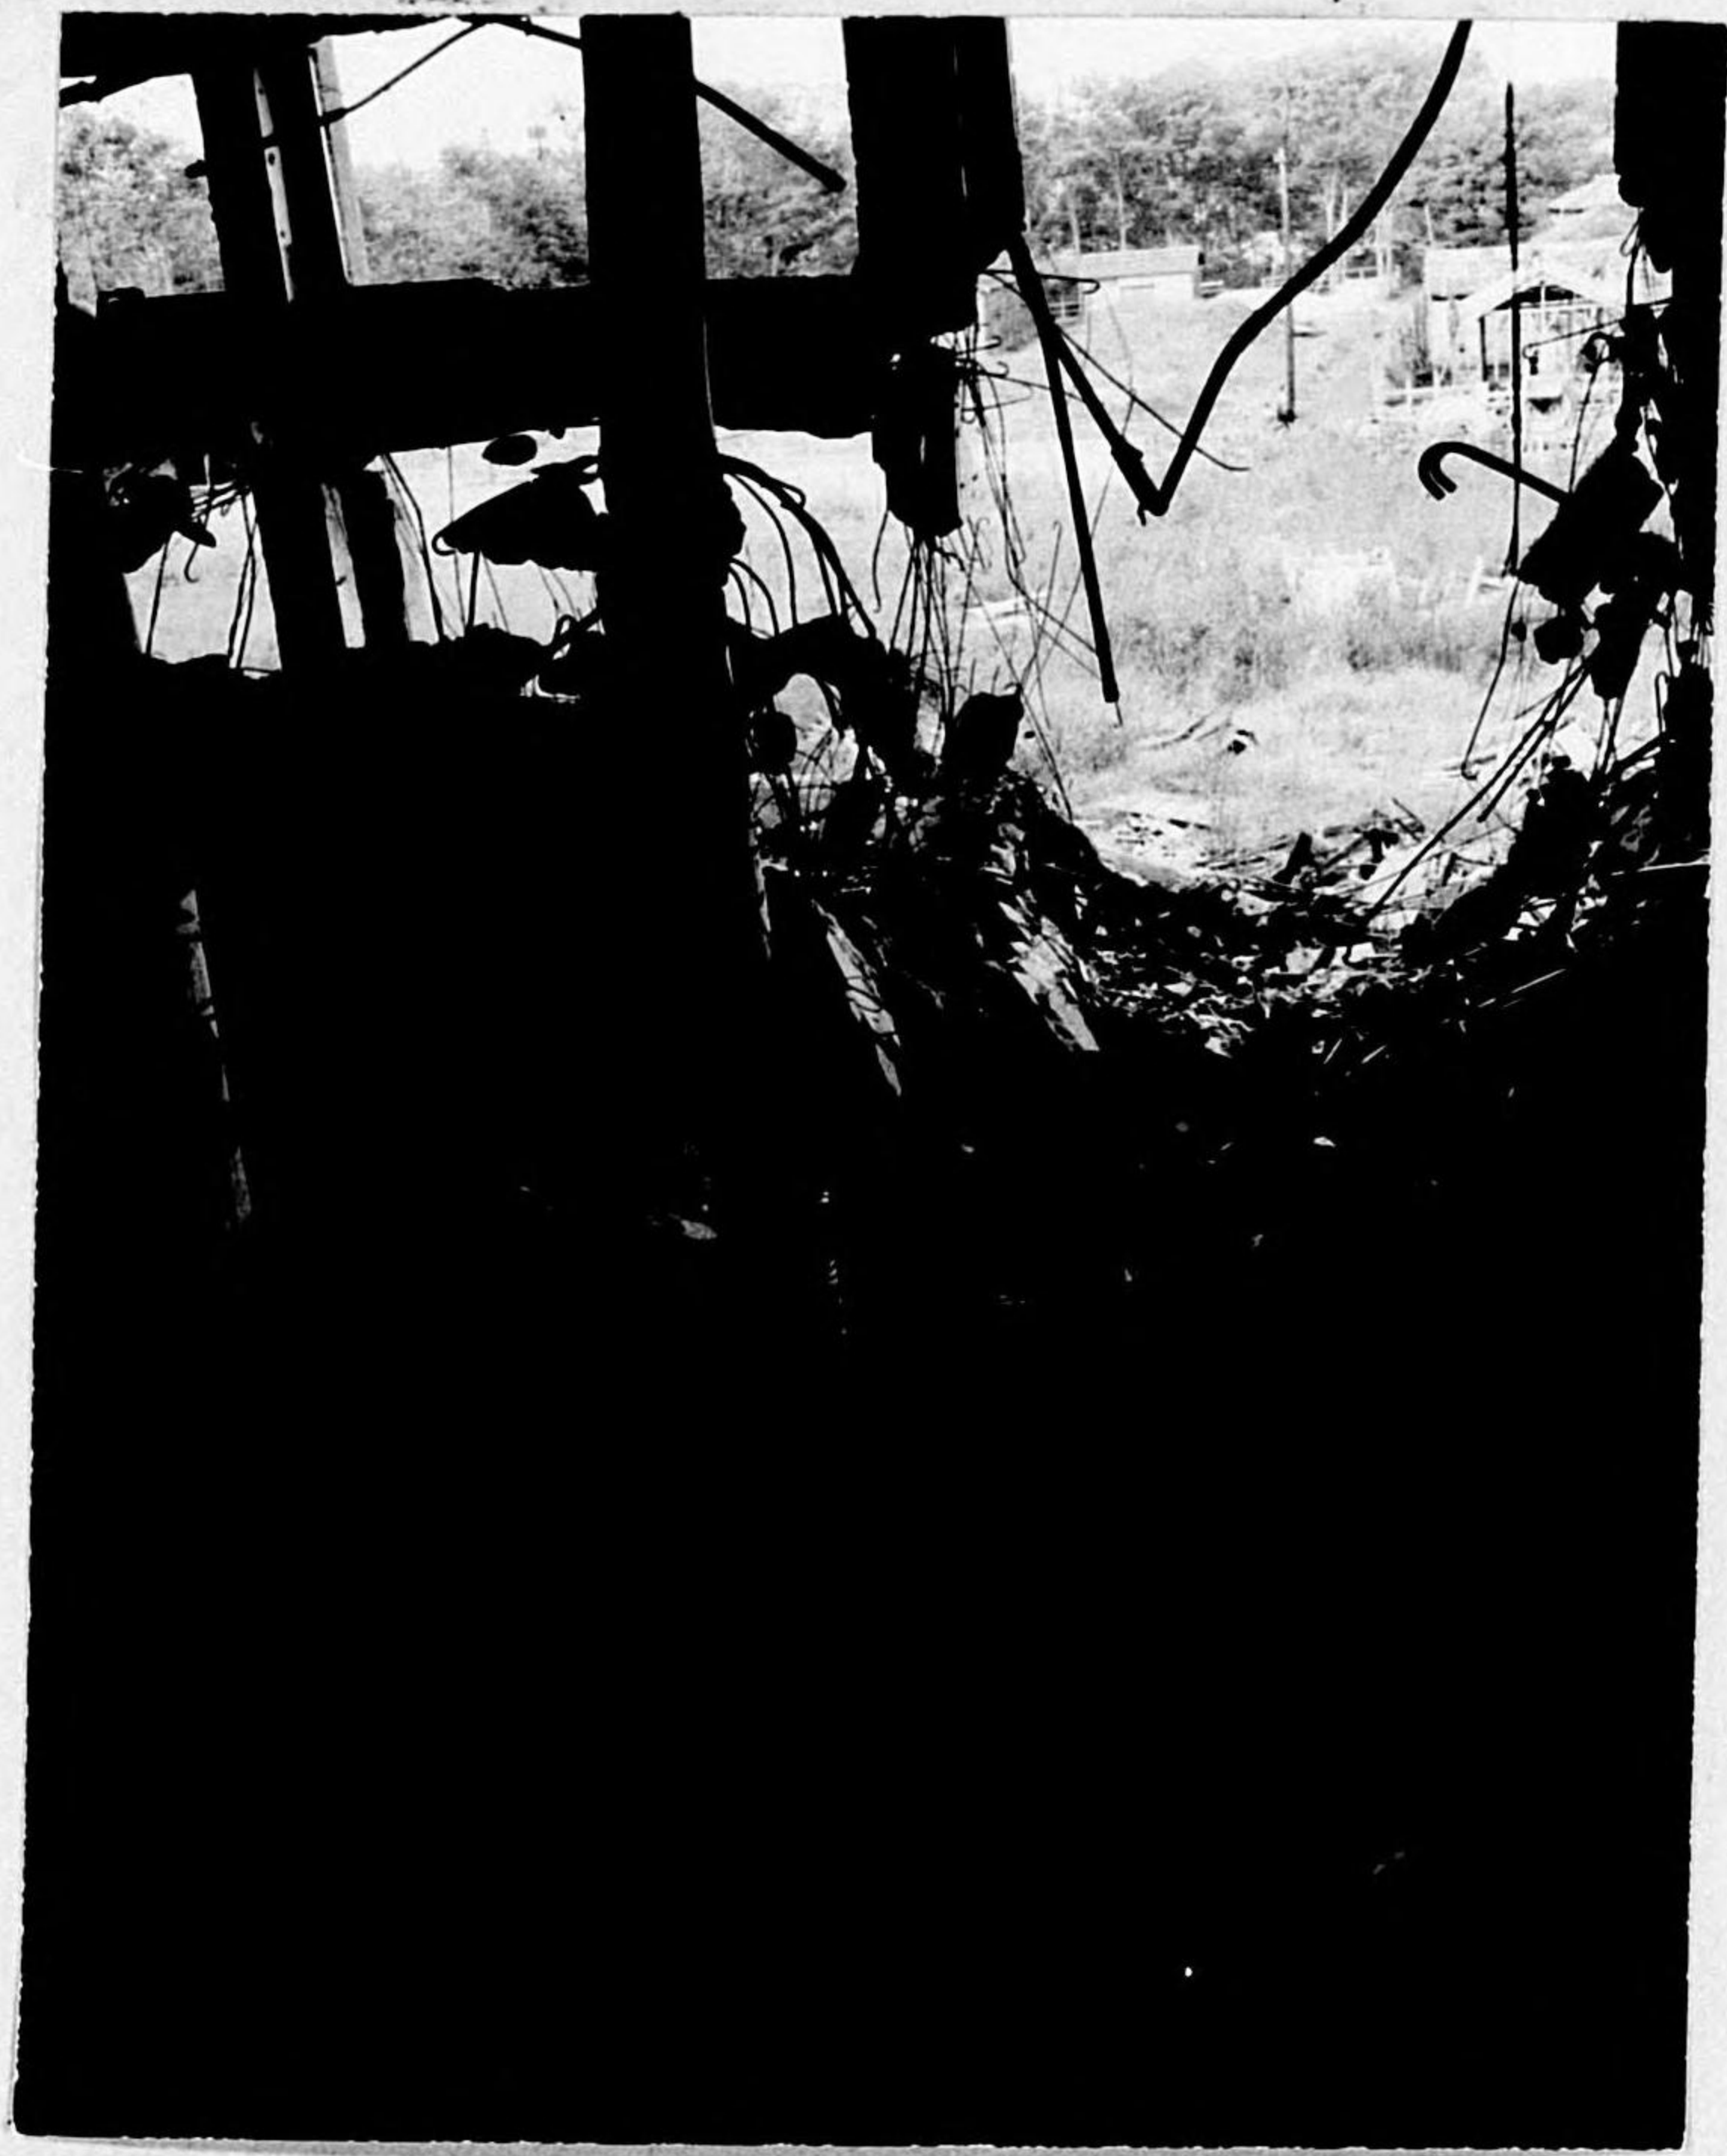
Photo 41

Interior view of damage by Bomb 13, third floor,
Building 35.
