FDD #6 NAKAJIMA MUSASHINO (9)

Pack 3 PHOTO LOG - NAKAJIMA - MUSEUM

PHOTO LOC - NAKAJIMA - MUSEUM -

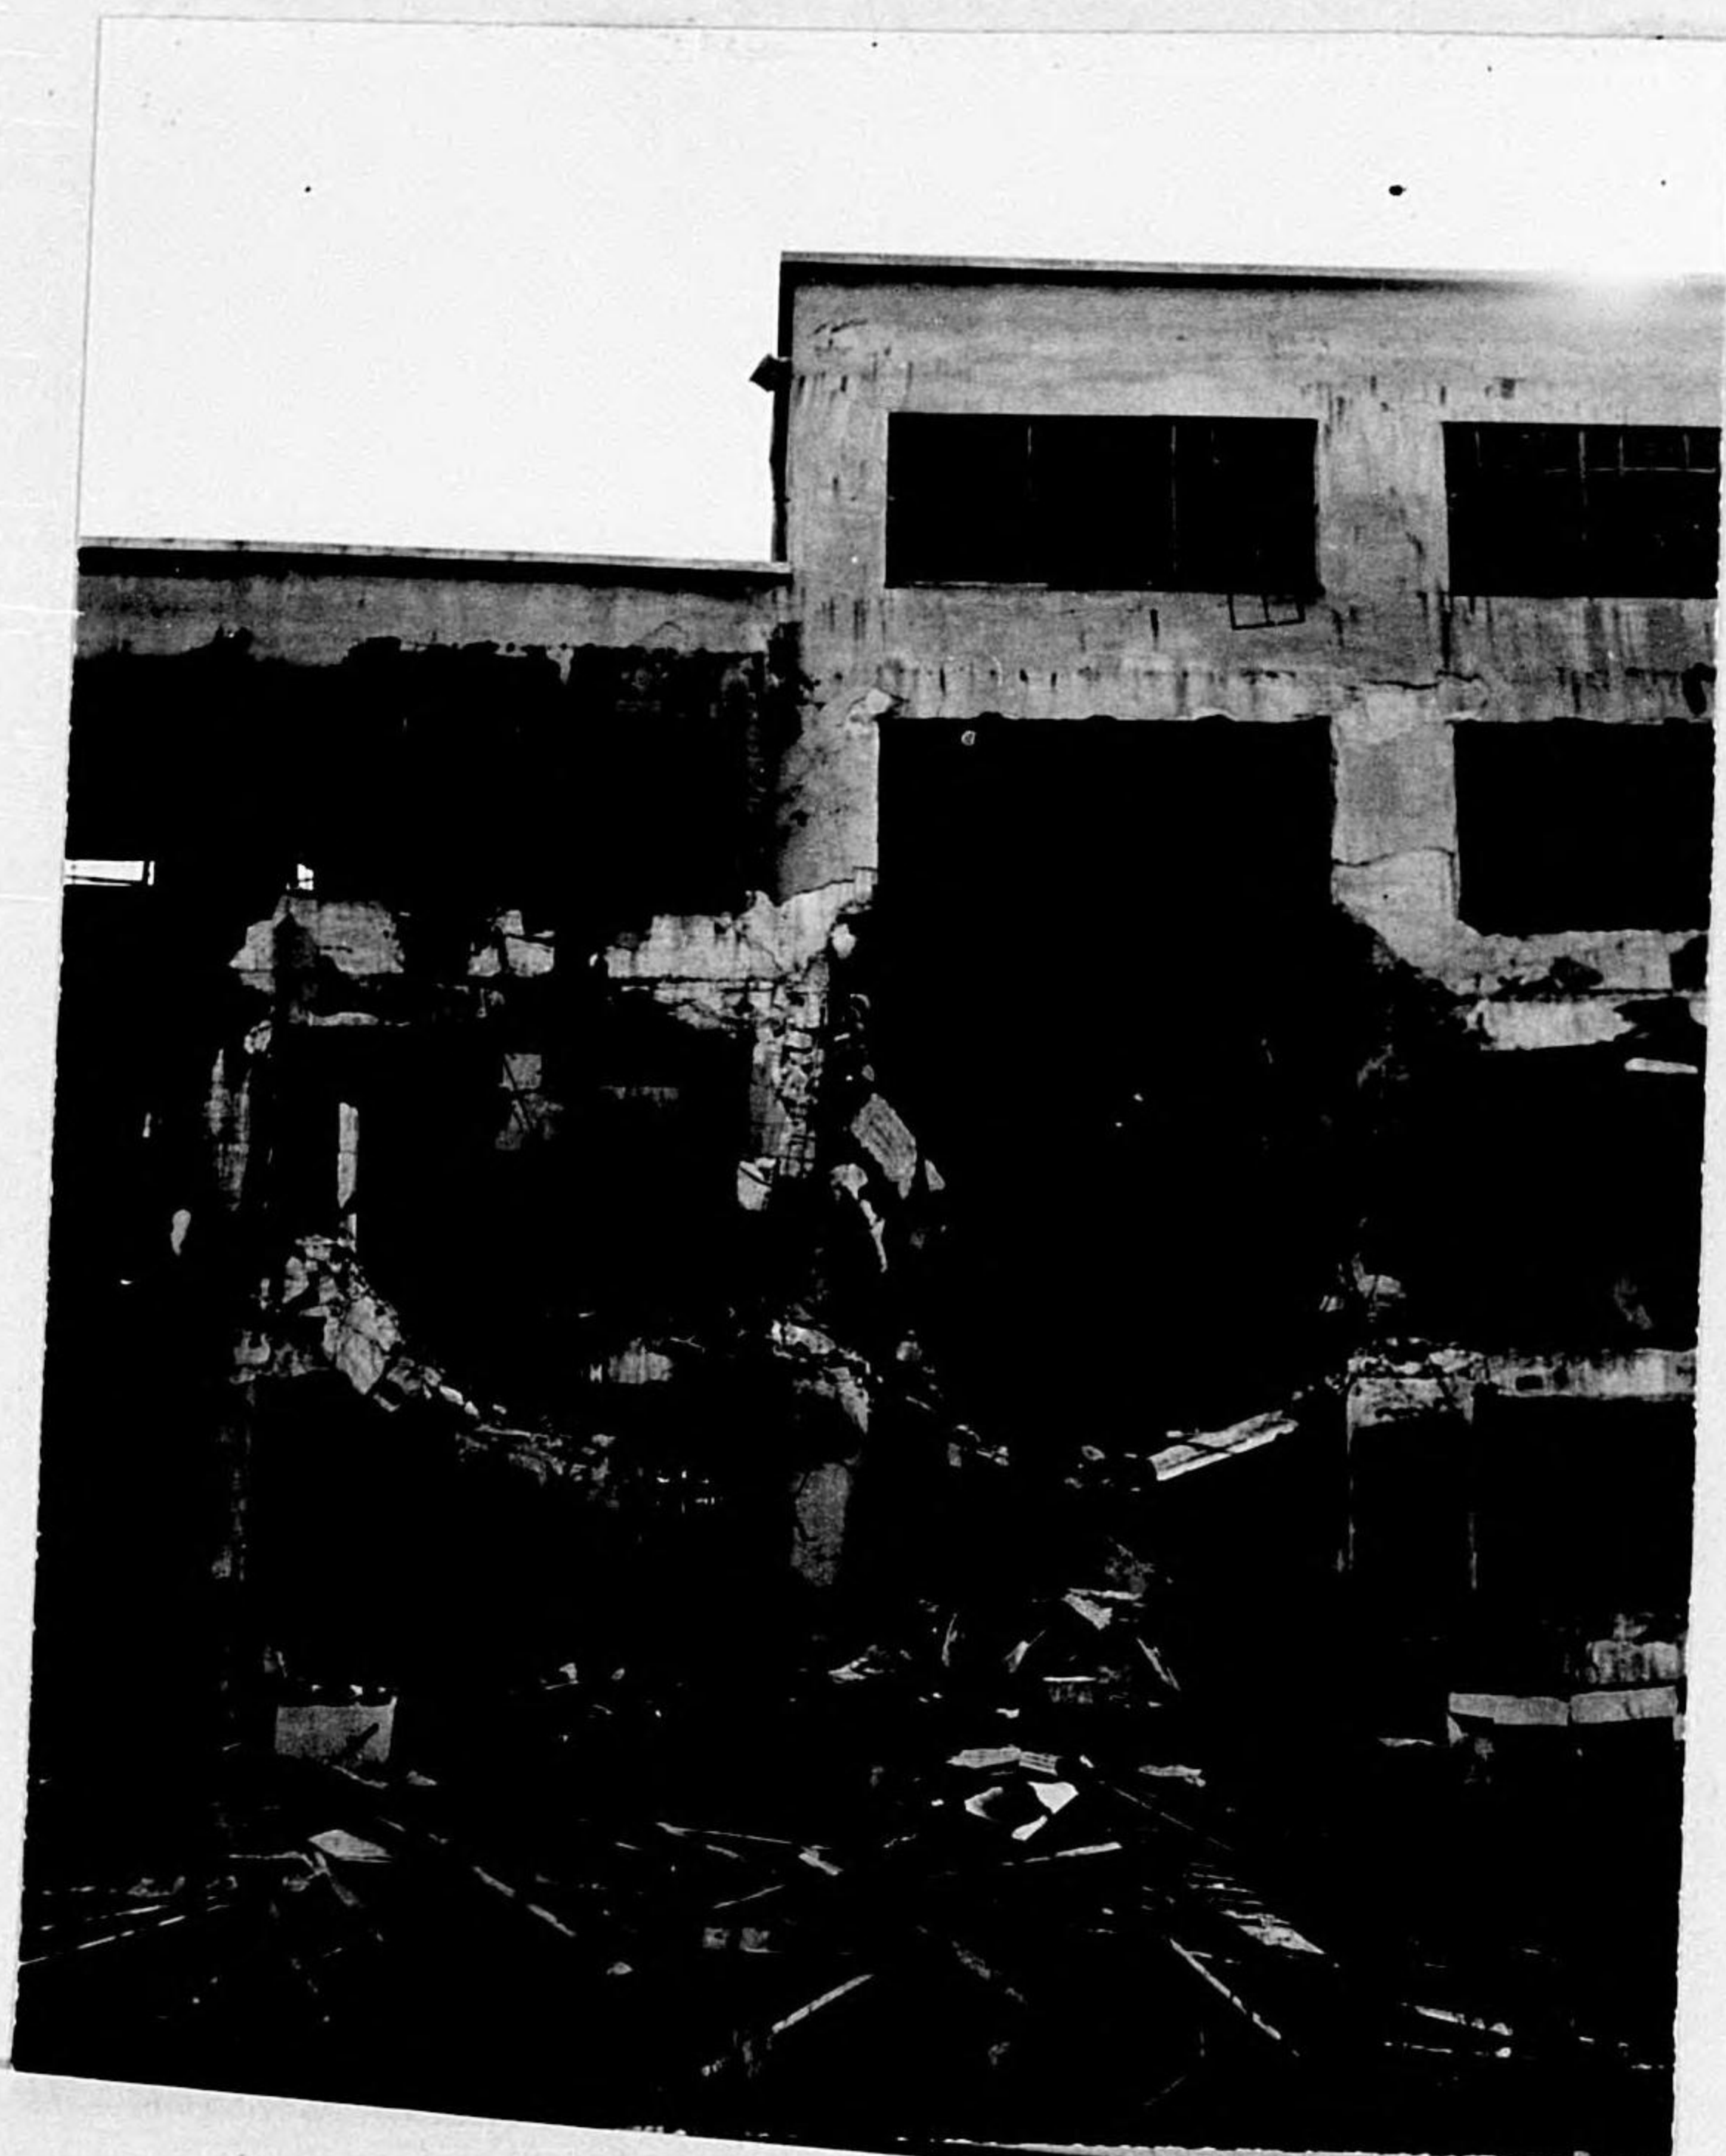
Photo 42
Exterior view of damage by Bomb 13.

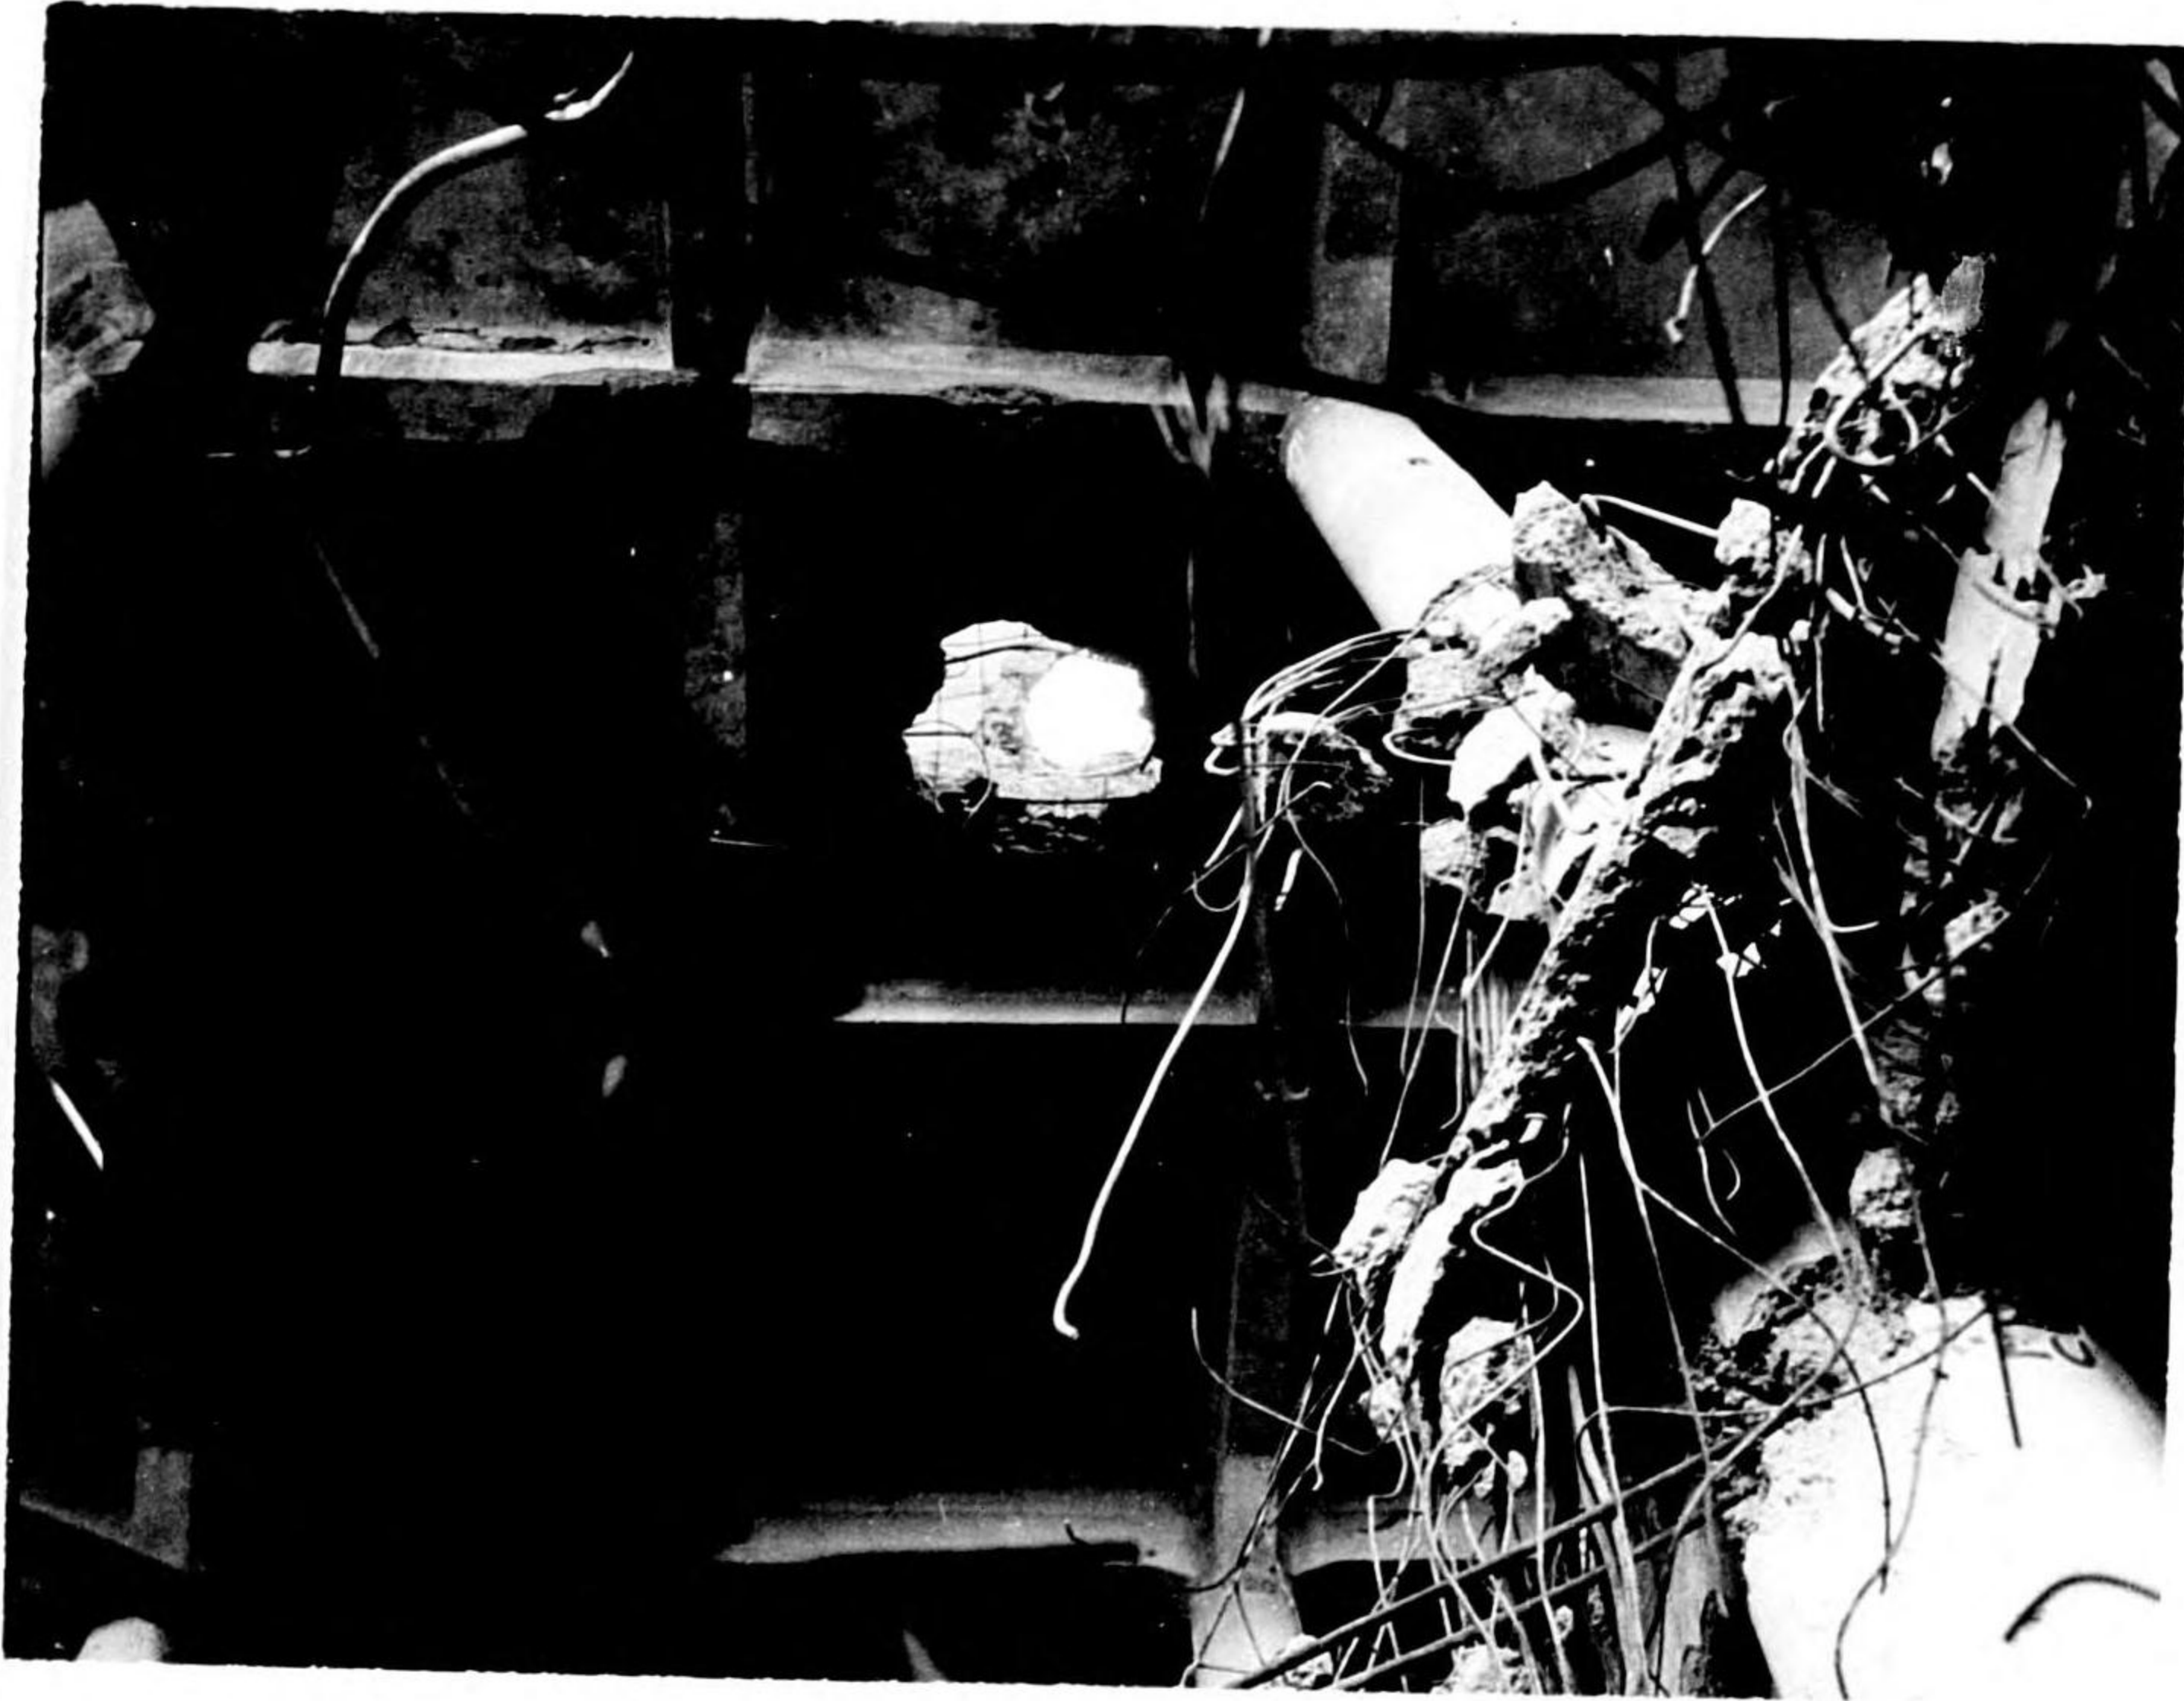
Photo 43

Looking up through Bomb 13 passage hole from basement,
Building 35.

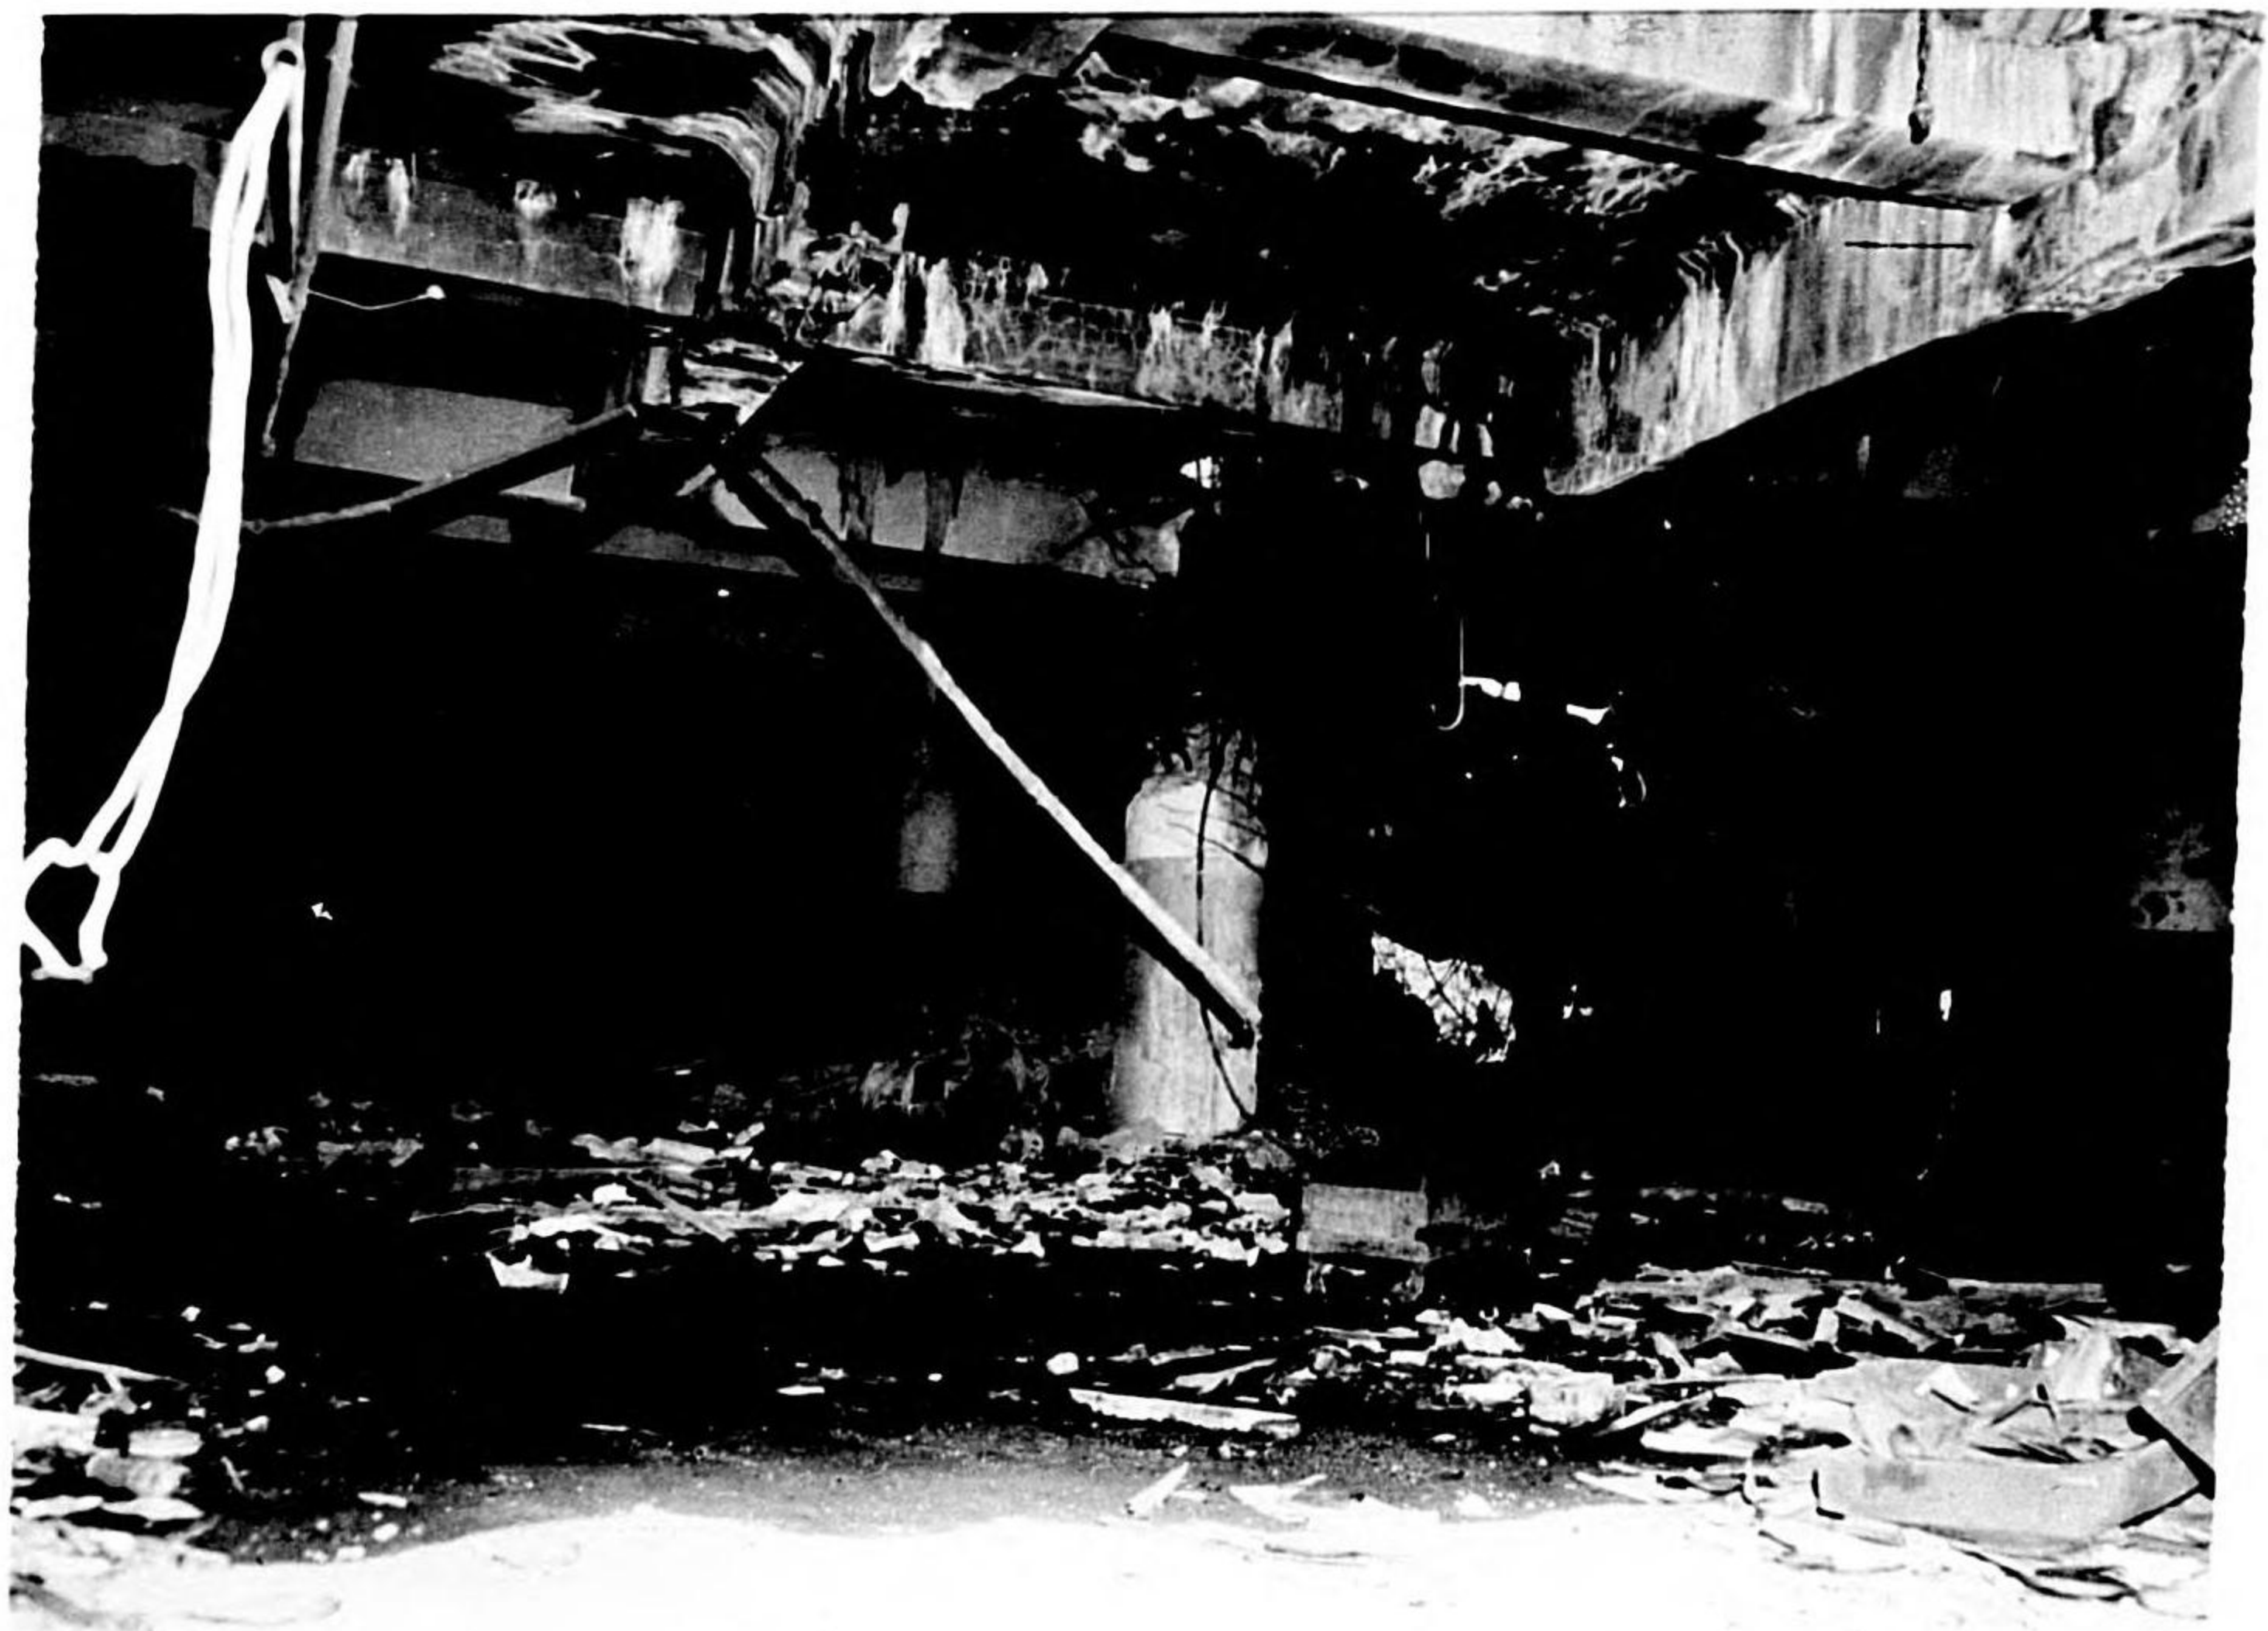
Photo 44

Interior view of Bomb 13 damage to third floor,
Building 35.

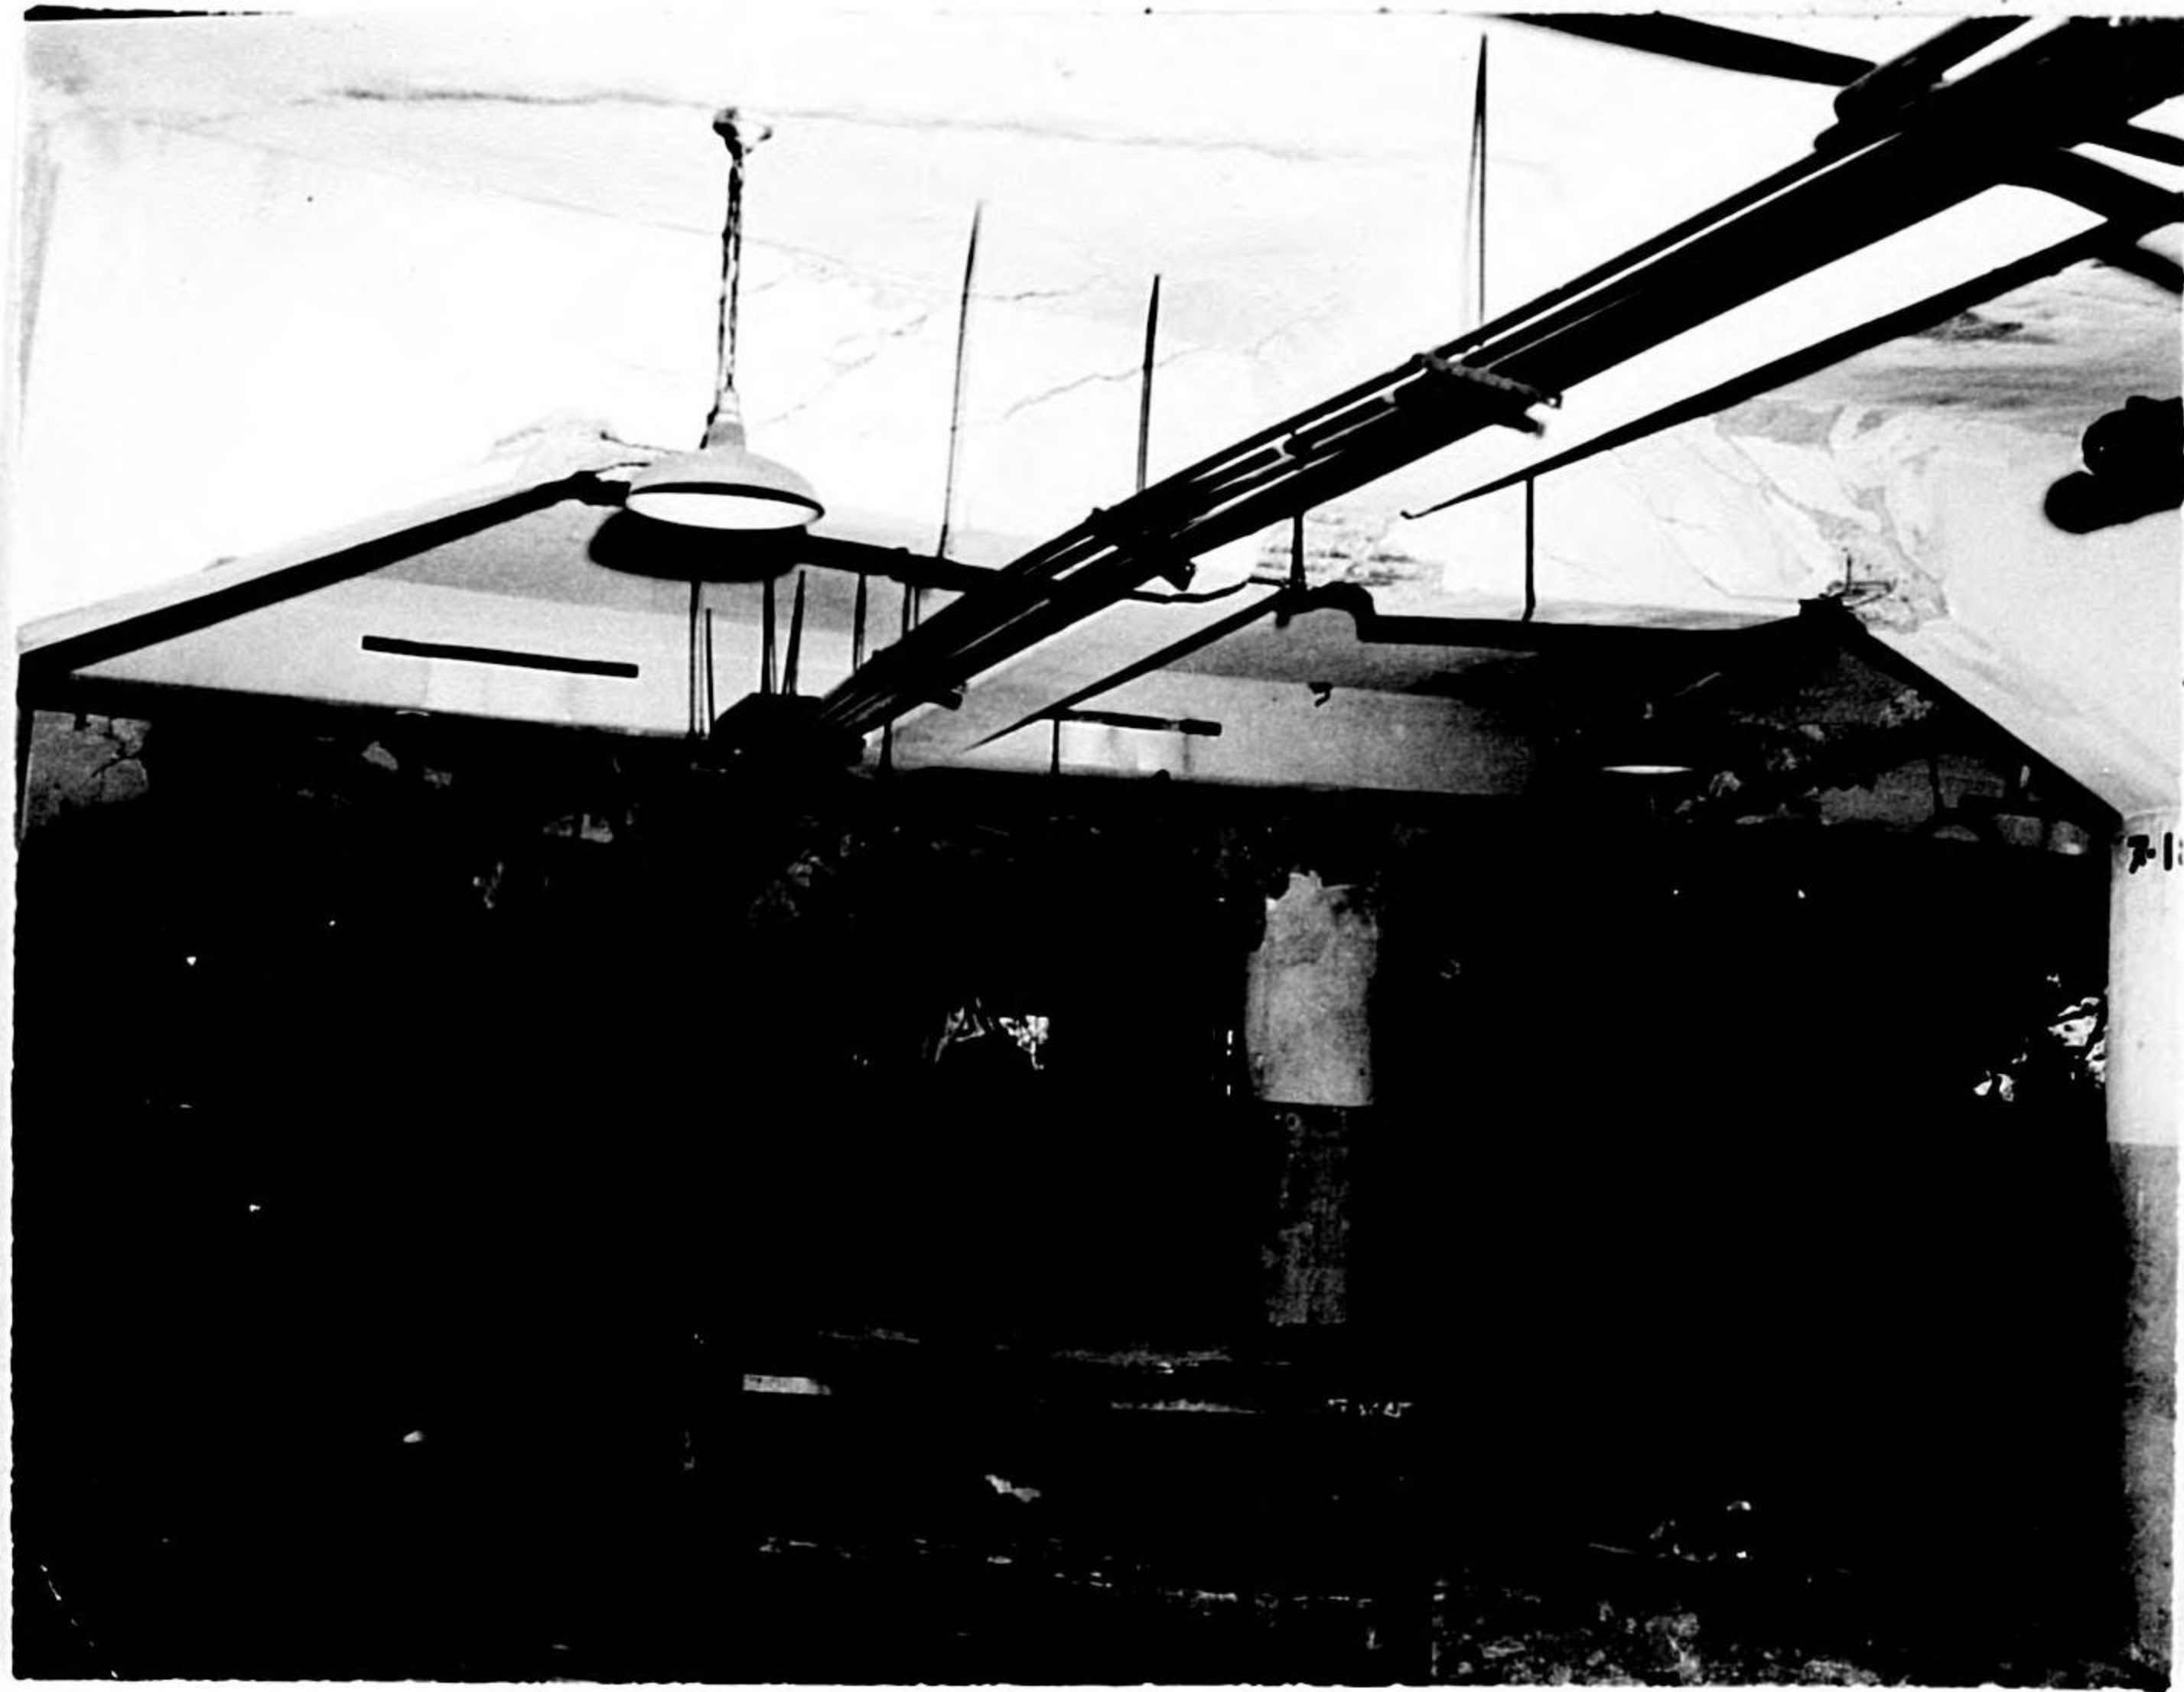
Photo 45

Interior view of Bomb 13 damage to first floor, Building 35. Note rupture of concrete members caused by racking of structure.

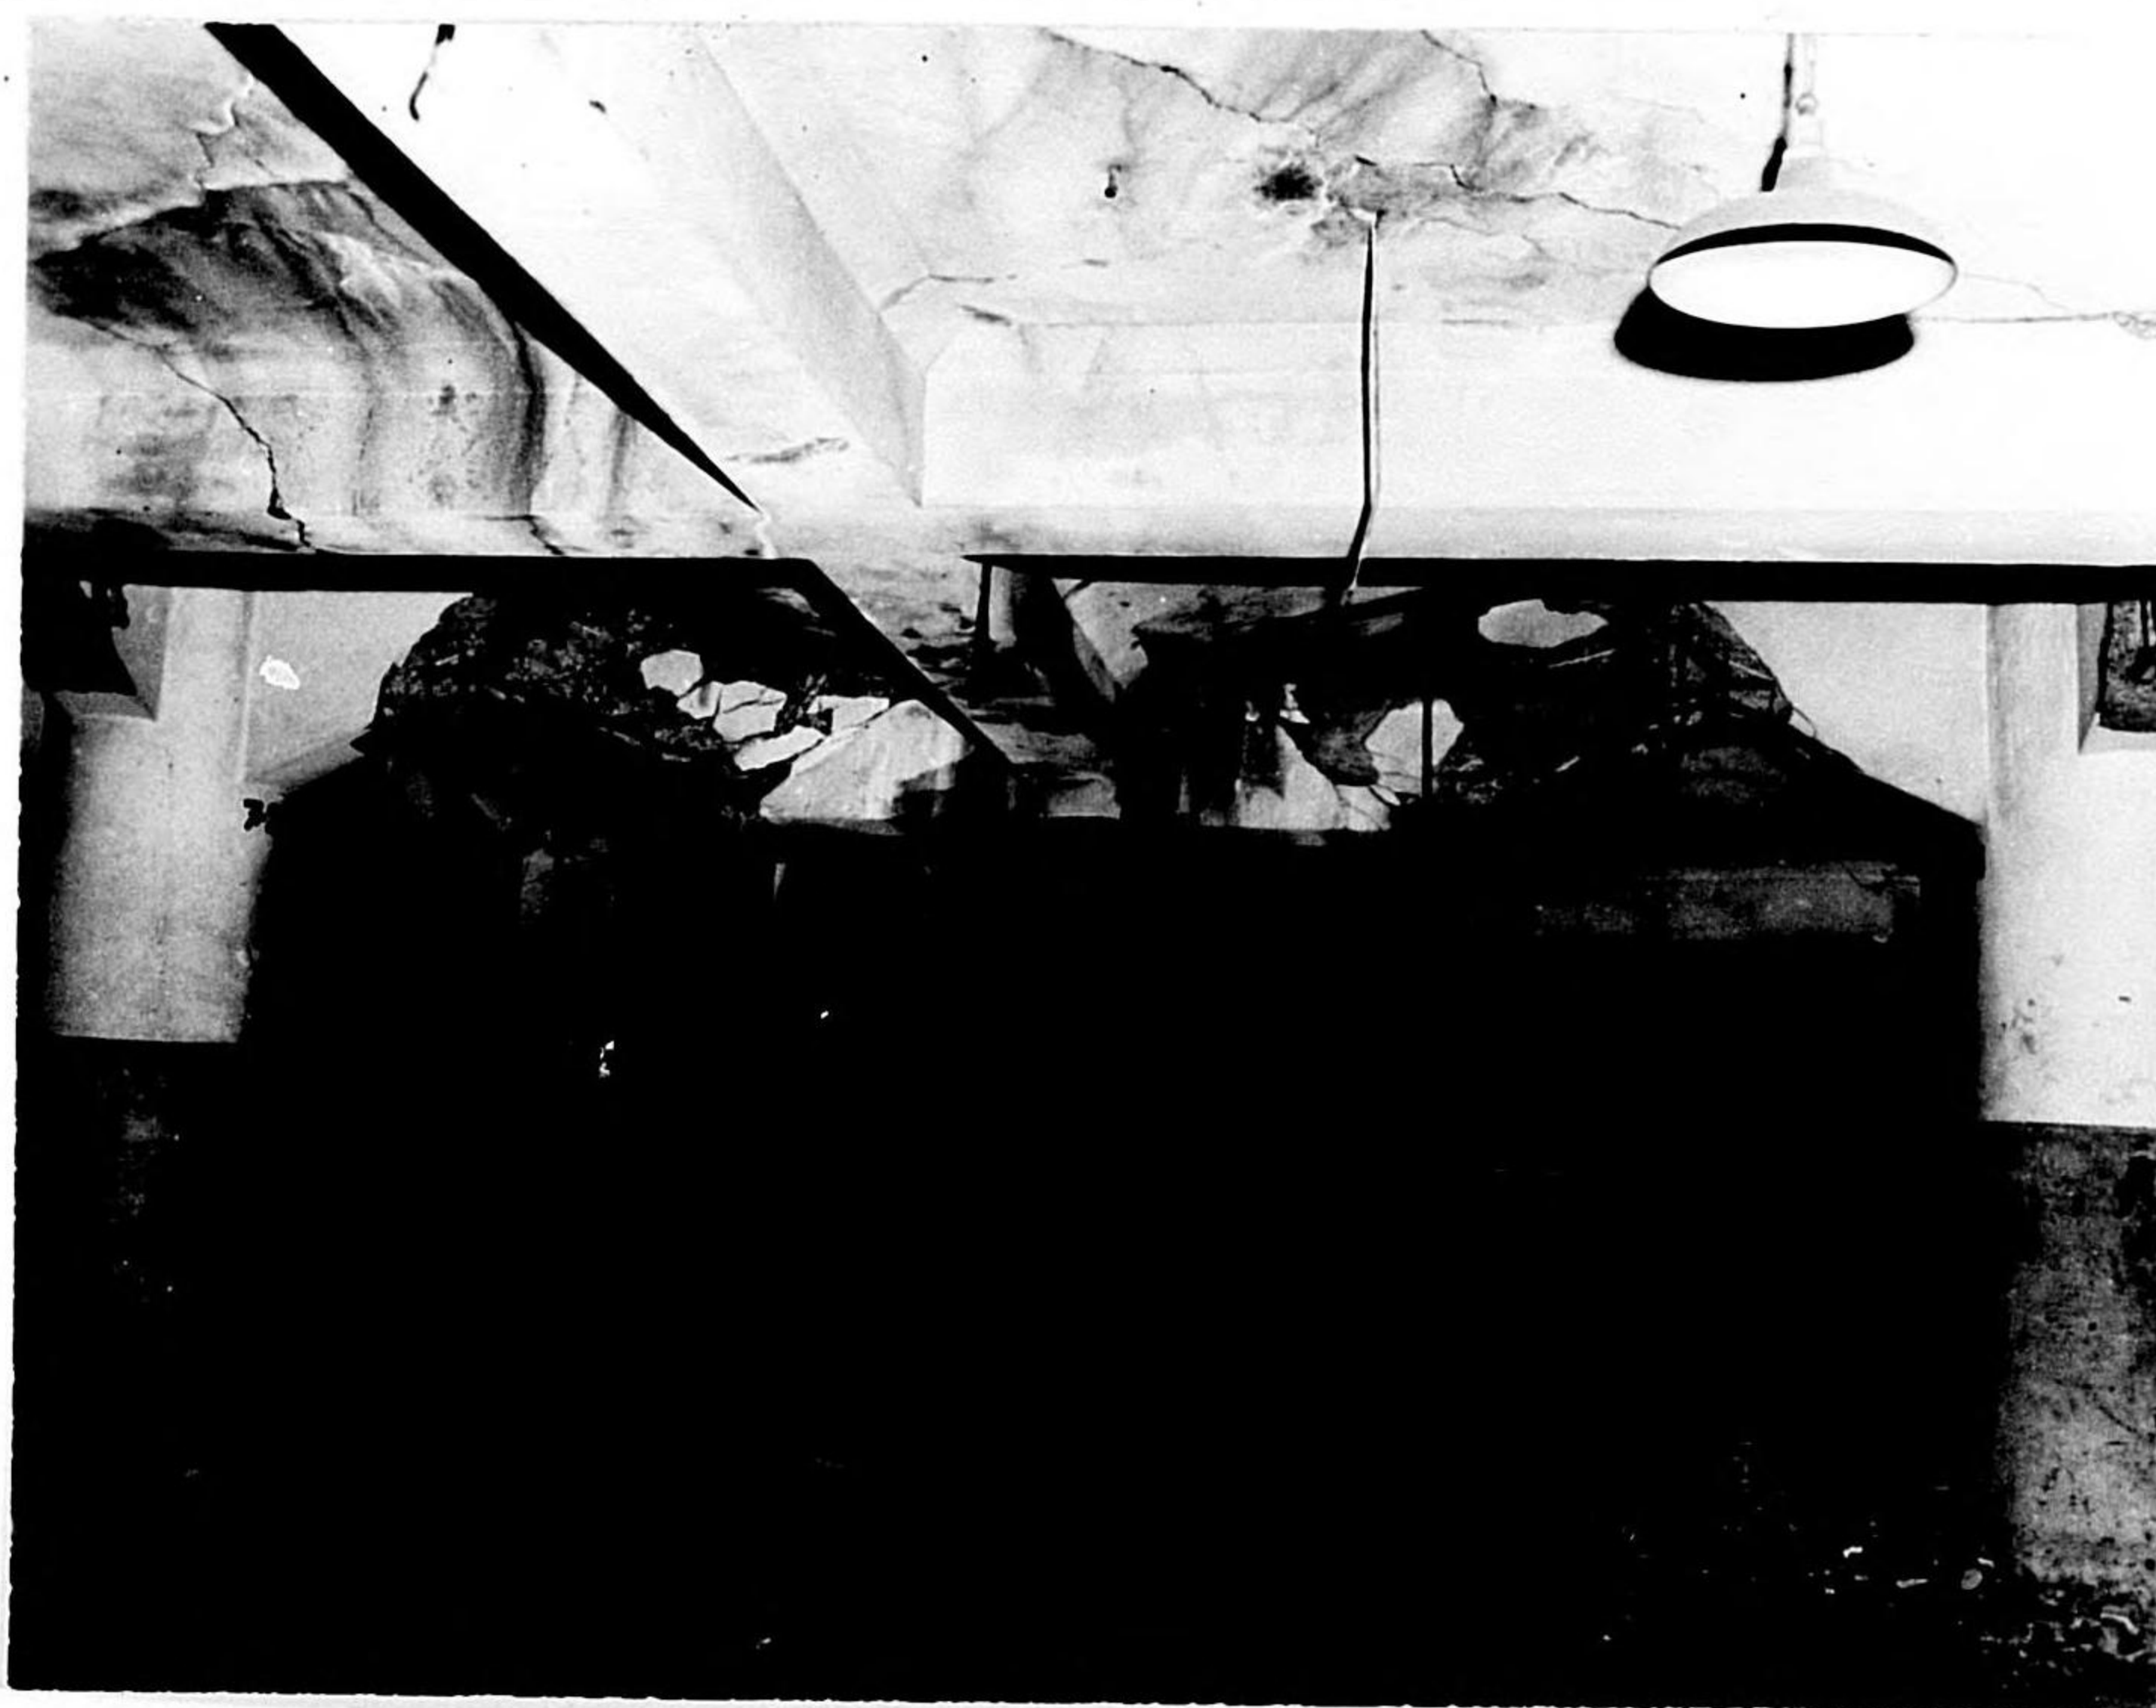
Photo 46

Interior view of Bomb 13 damage to first floor, Building 35.
