## CIVIL AIRCRAFT ACCIDENT

Report of the Second Independent Review  
appointed to consider the Accident to  
Elizabethan Aircraft G-ALZU at Munich  
on 6th February 1958 and to Report whether blame for  
the Accident is to be imputed to Captain Thain

1969

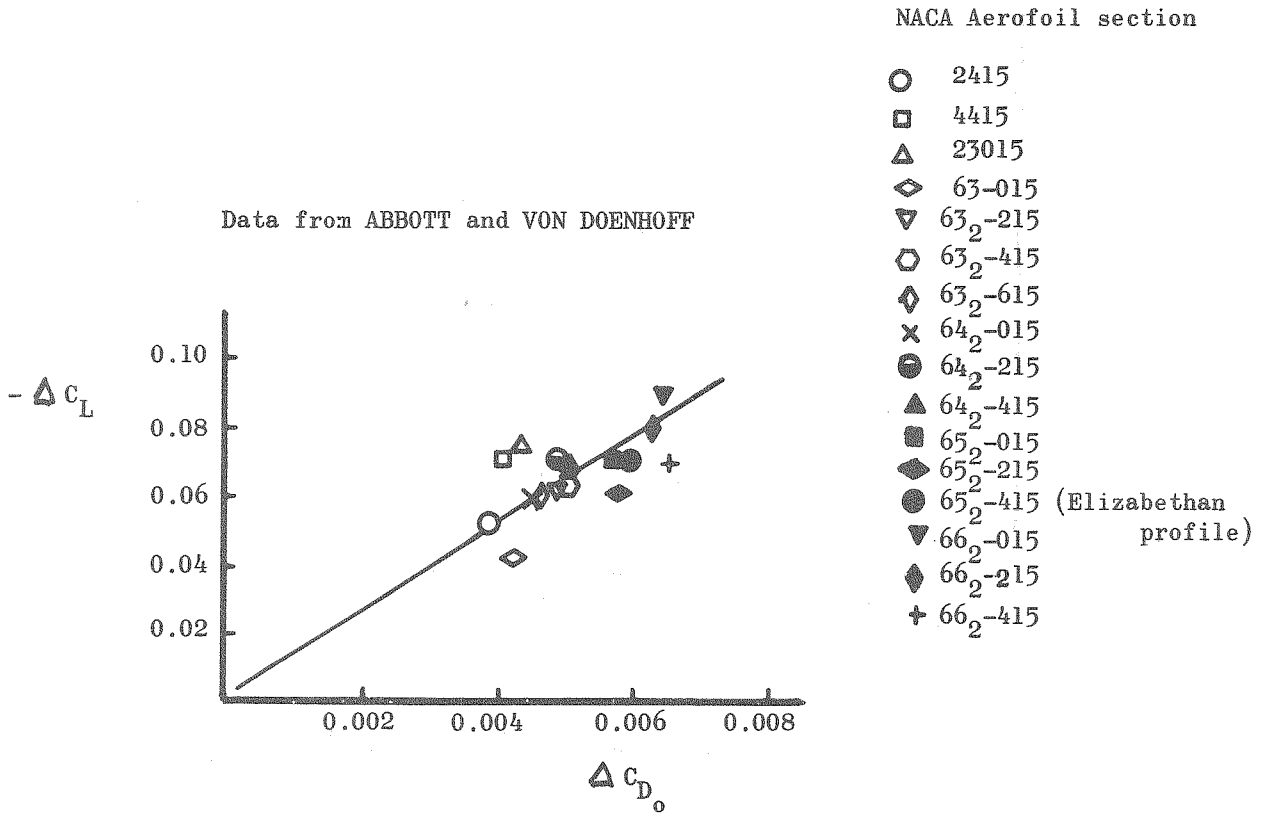
The fall in  $C_L$  from a  $C_L$  of 1.0 due to roughening the leading edge with grains corresponding to  $k_s/c = 4.6 \times 10^{-4}$  (approximately 1.5 mm on the Elizabethan).

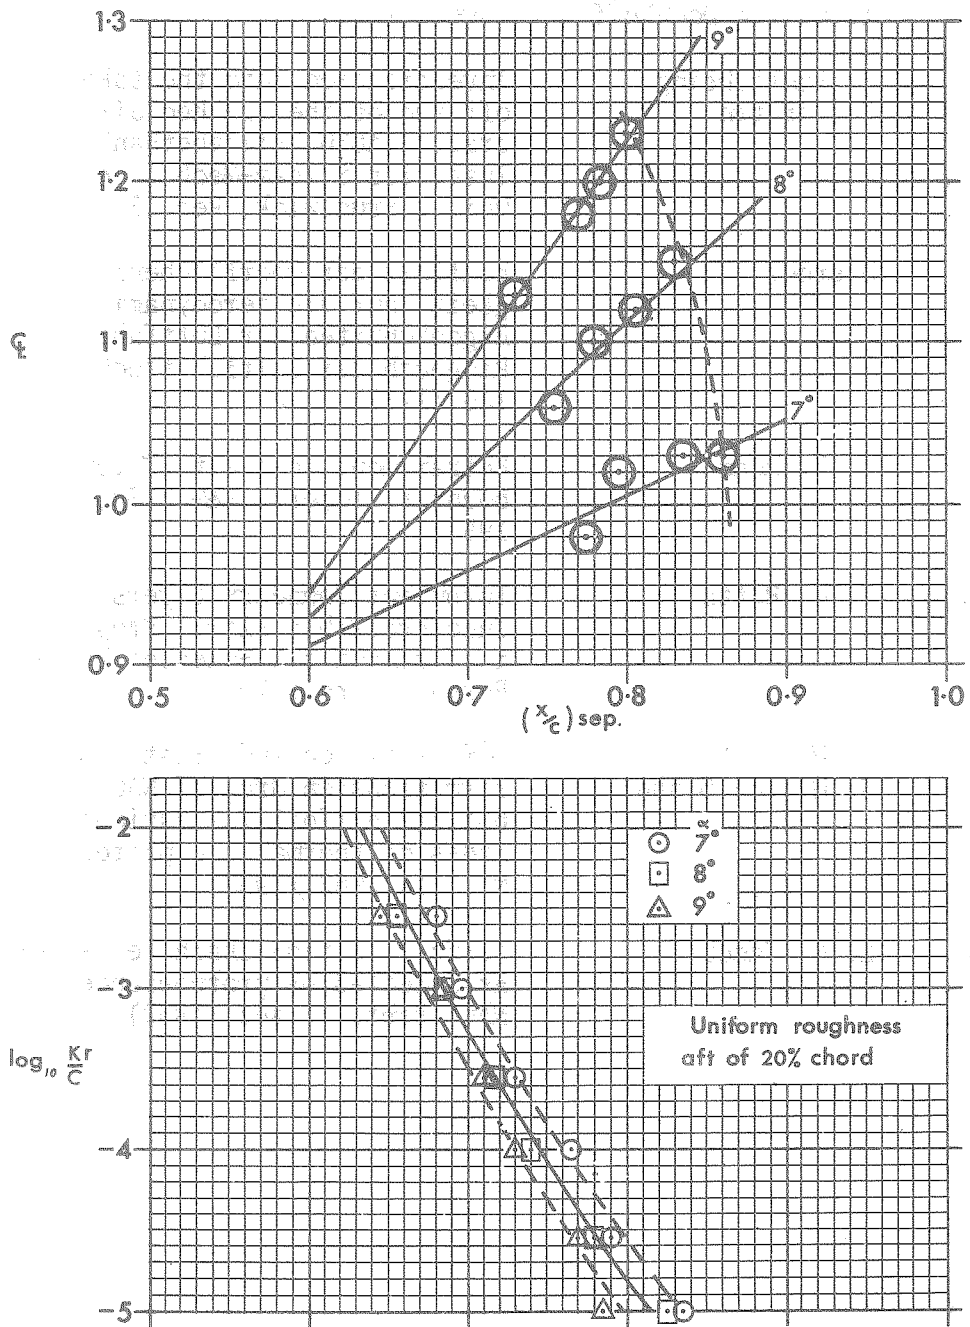
FIG.1 Correlation of calculated separation point against observed  $\xi$  and roughness height. (Aerofoil section NACA 65,-415)

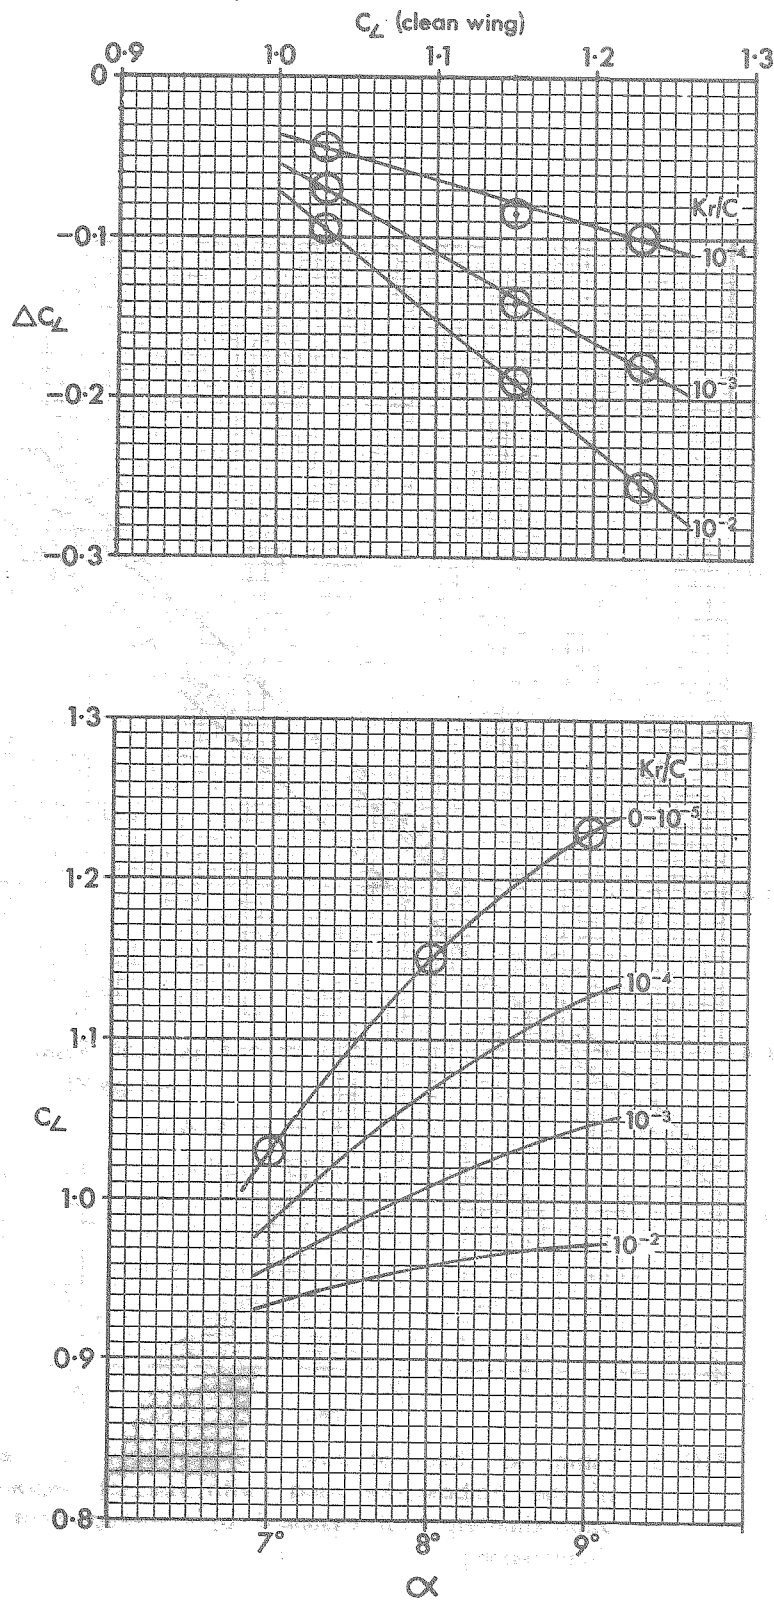
FIG. 2 The estimated effect of roughness (aft of 20% chord) on the lift of aerofoil section NACA 65<sub>2</sub>-415

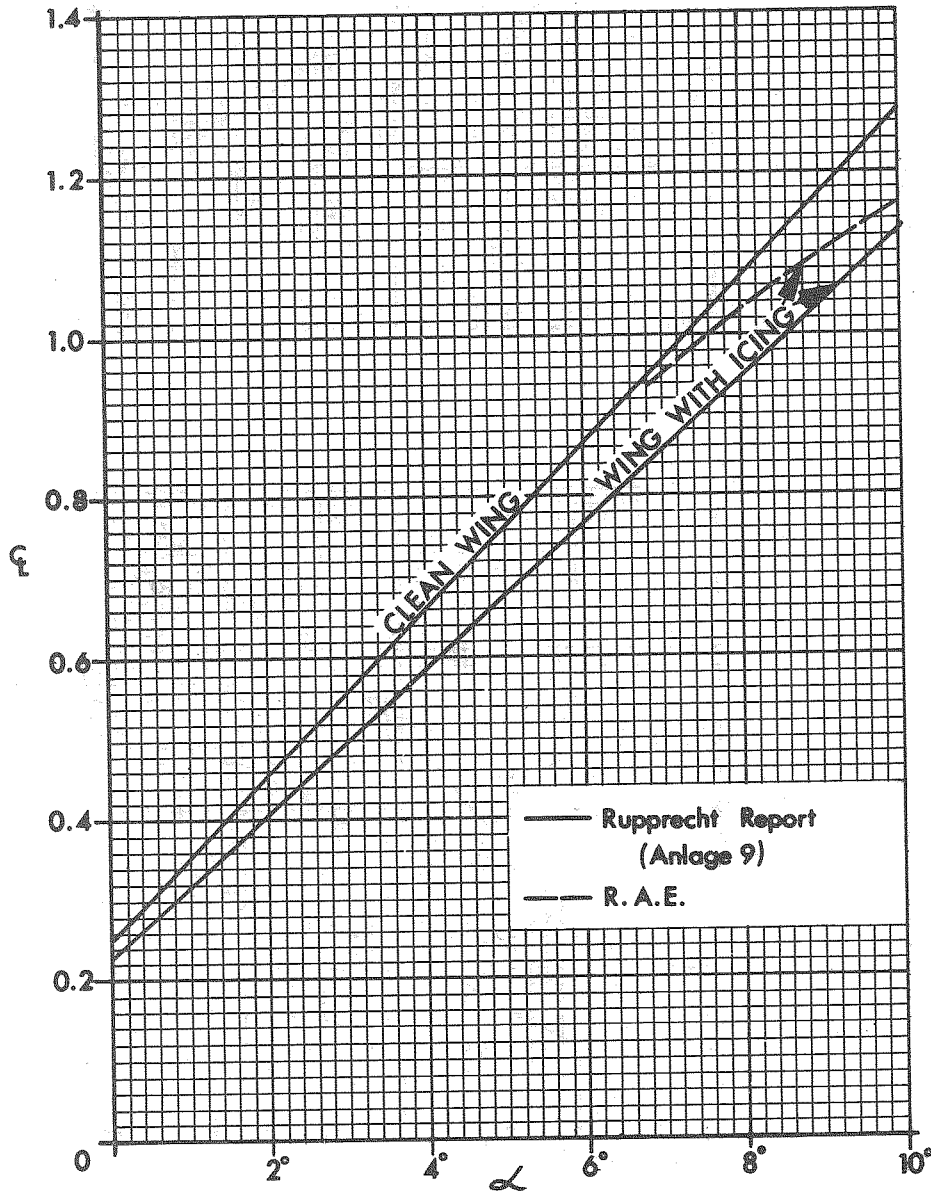
FIG. 3 Estimated effect of icing (5mm. thick) on the lift of the Ambassador wing (with the ice deposit approximately that assumed by the Rupprecht Commission)
