EXPLOSION AT CONSOLIDATED SCHOOL
NEW LONDON, TEX.

INVESTIGATION OF EXPLOSION AT
CONSOLIDATED SCHOOL, NEW LONDON, TEX.

MARCH 18, 1937

Prepared by
DAVID J. PRICE
Principal Engineer in Charge
Chemical Engineering Research Division
Bureau of Chemistry and Soils
U. S. Department of Agriculture
Washington, D. C.

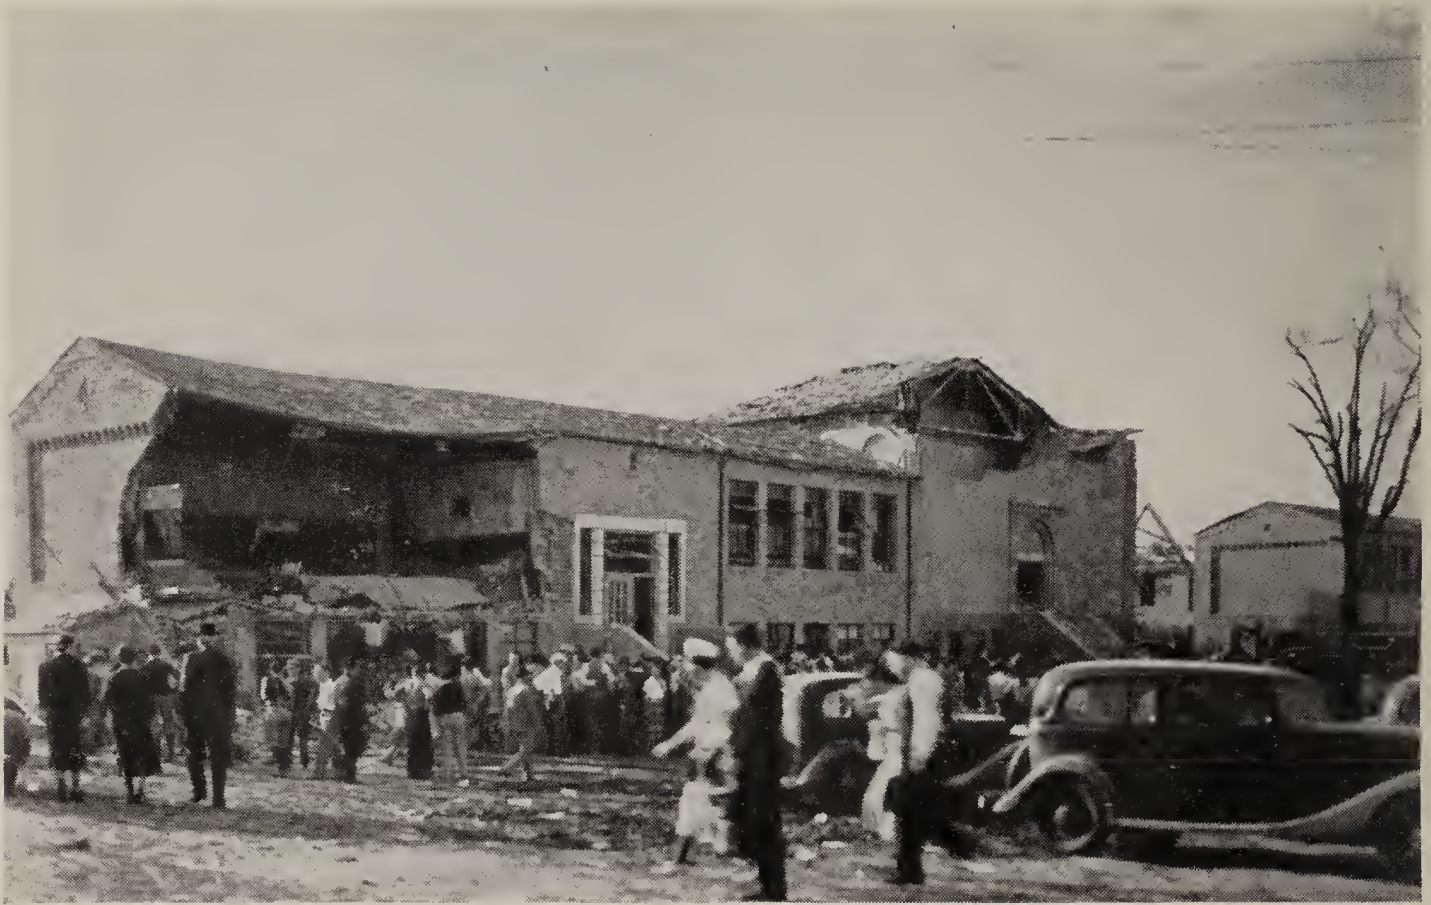
View of graded school and auditorium after explosion on March 18, 1937; approximately 300 children were killed in this section of the building.

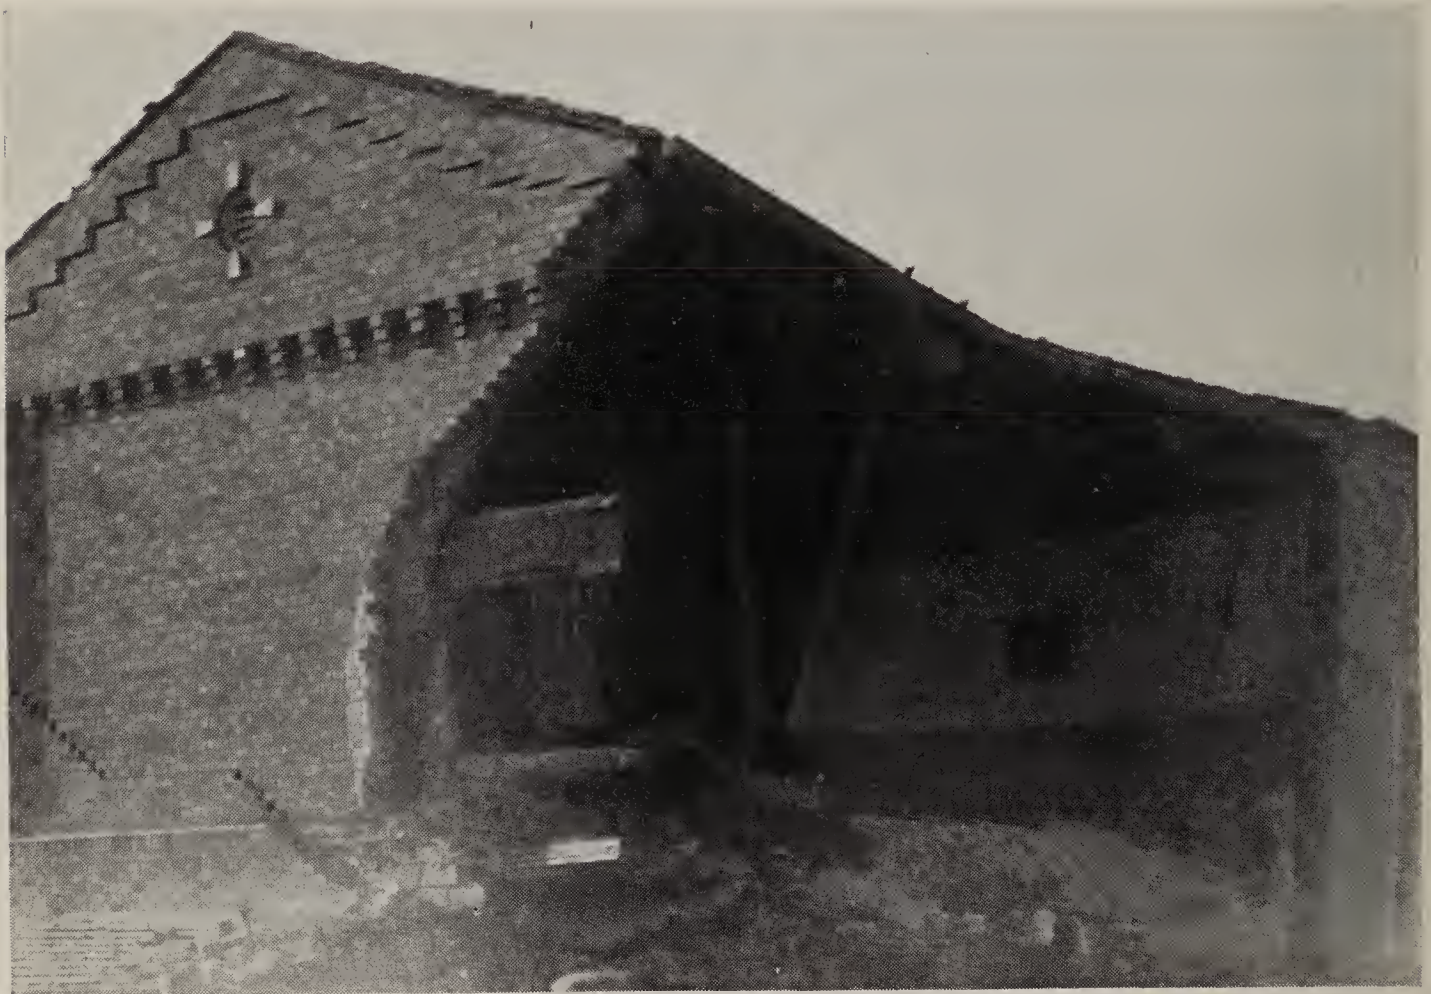
Close-up view of second floor of graded school at southeast corner of building.

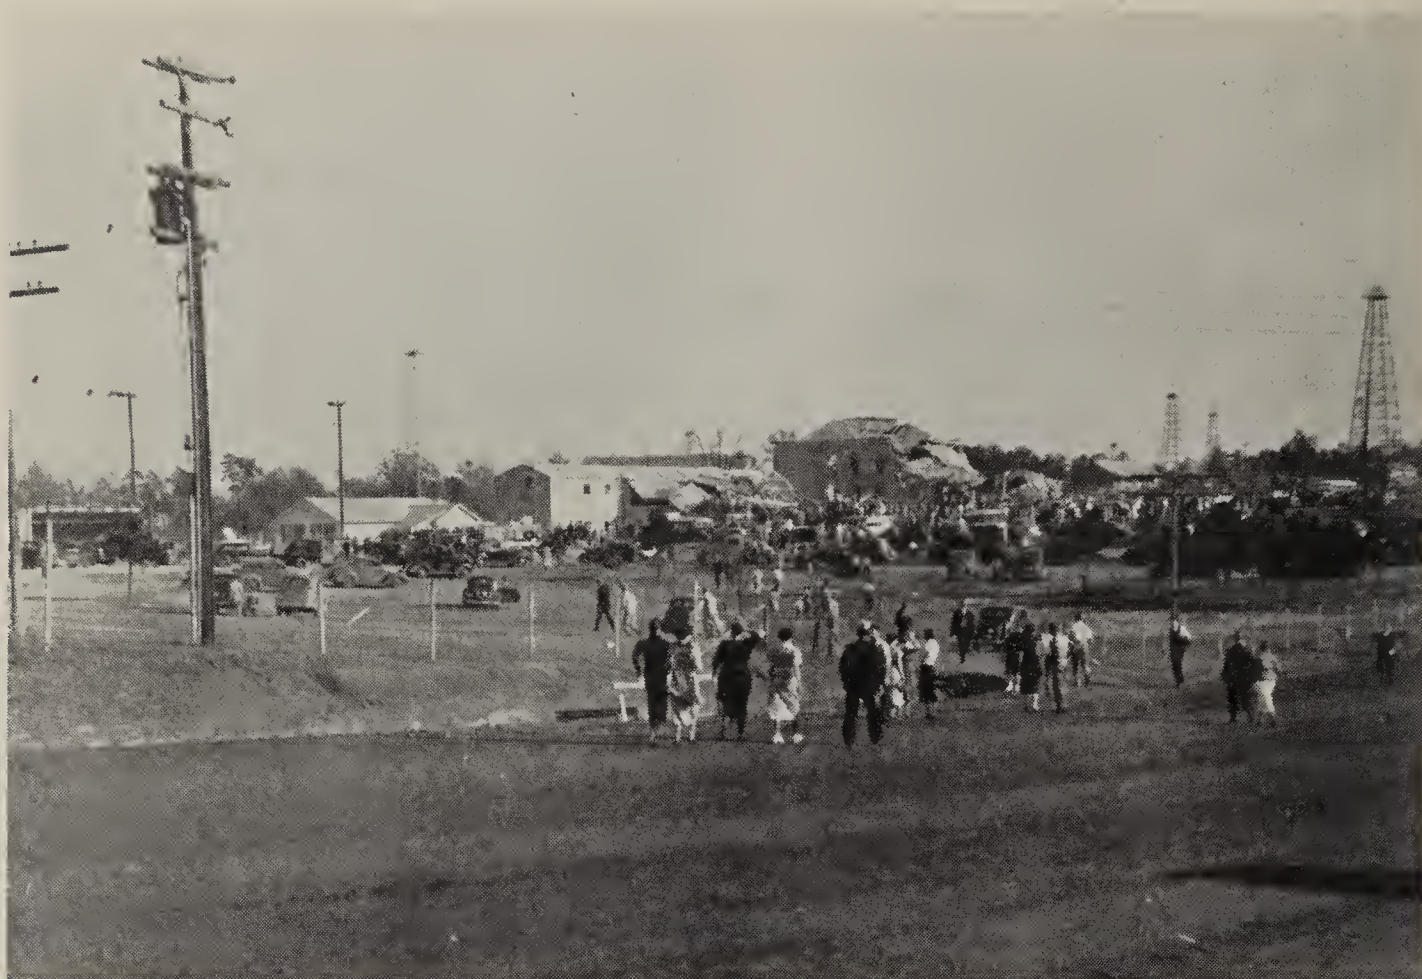
General view approaching school property. Wrecked high-school building on left, auditorium in center, graded school at right. Note oil and gas wells adjoining school property.

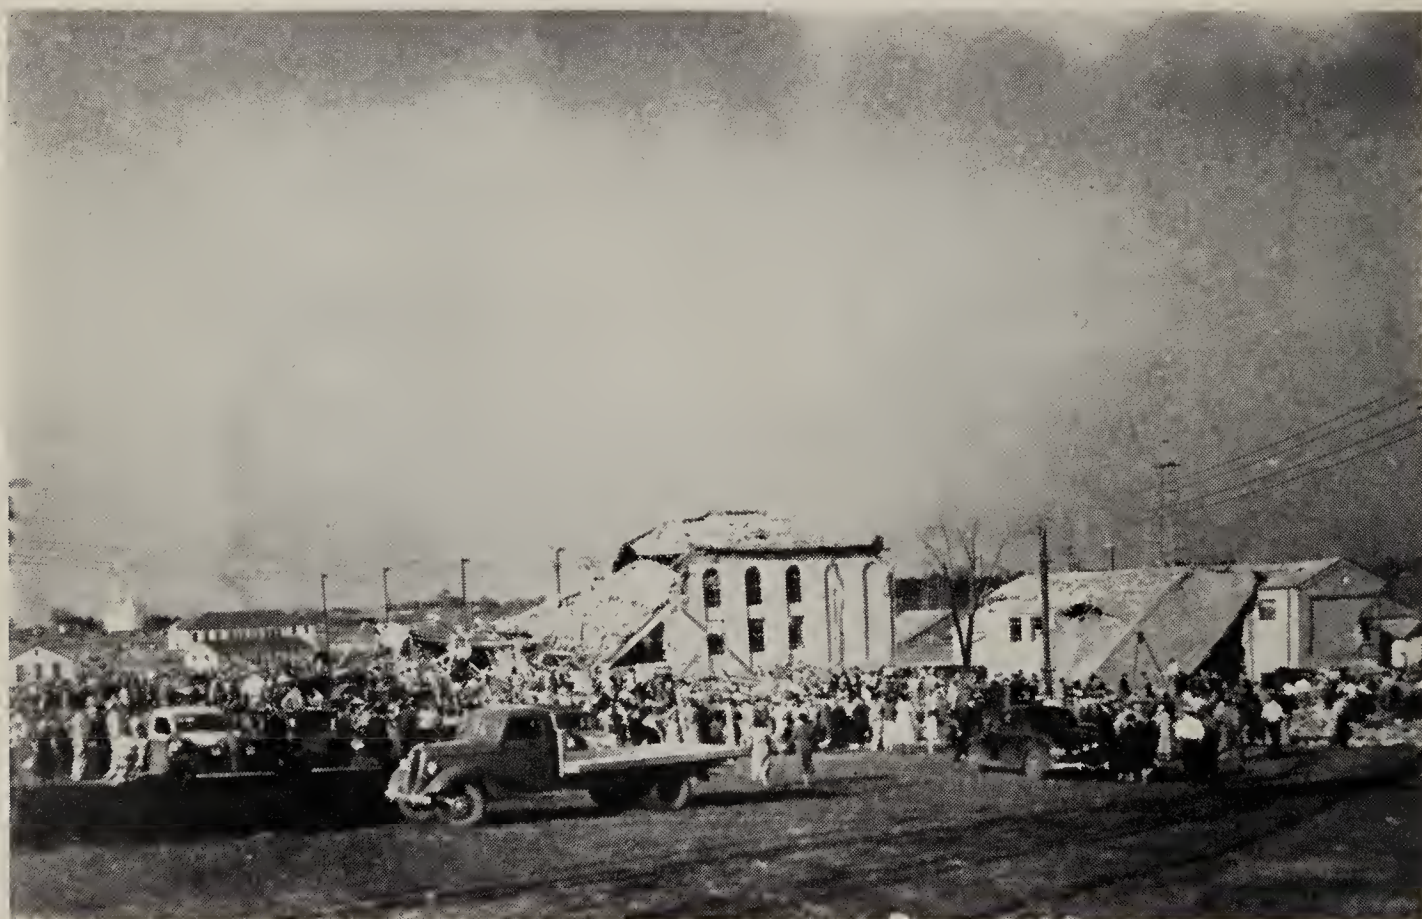
View showing damage to auditorium in center and graded school on right. Note near-by oil and gas wells and athletic-field stadium back of auditorium.

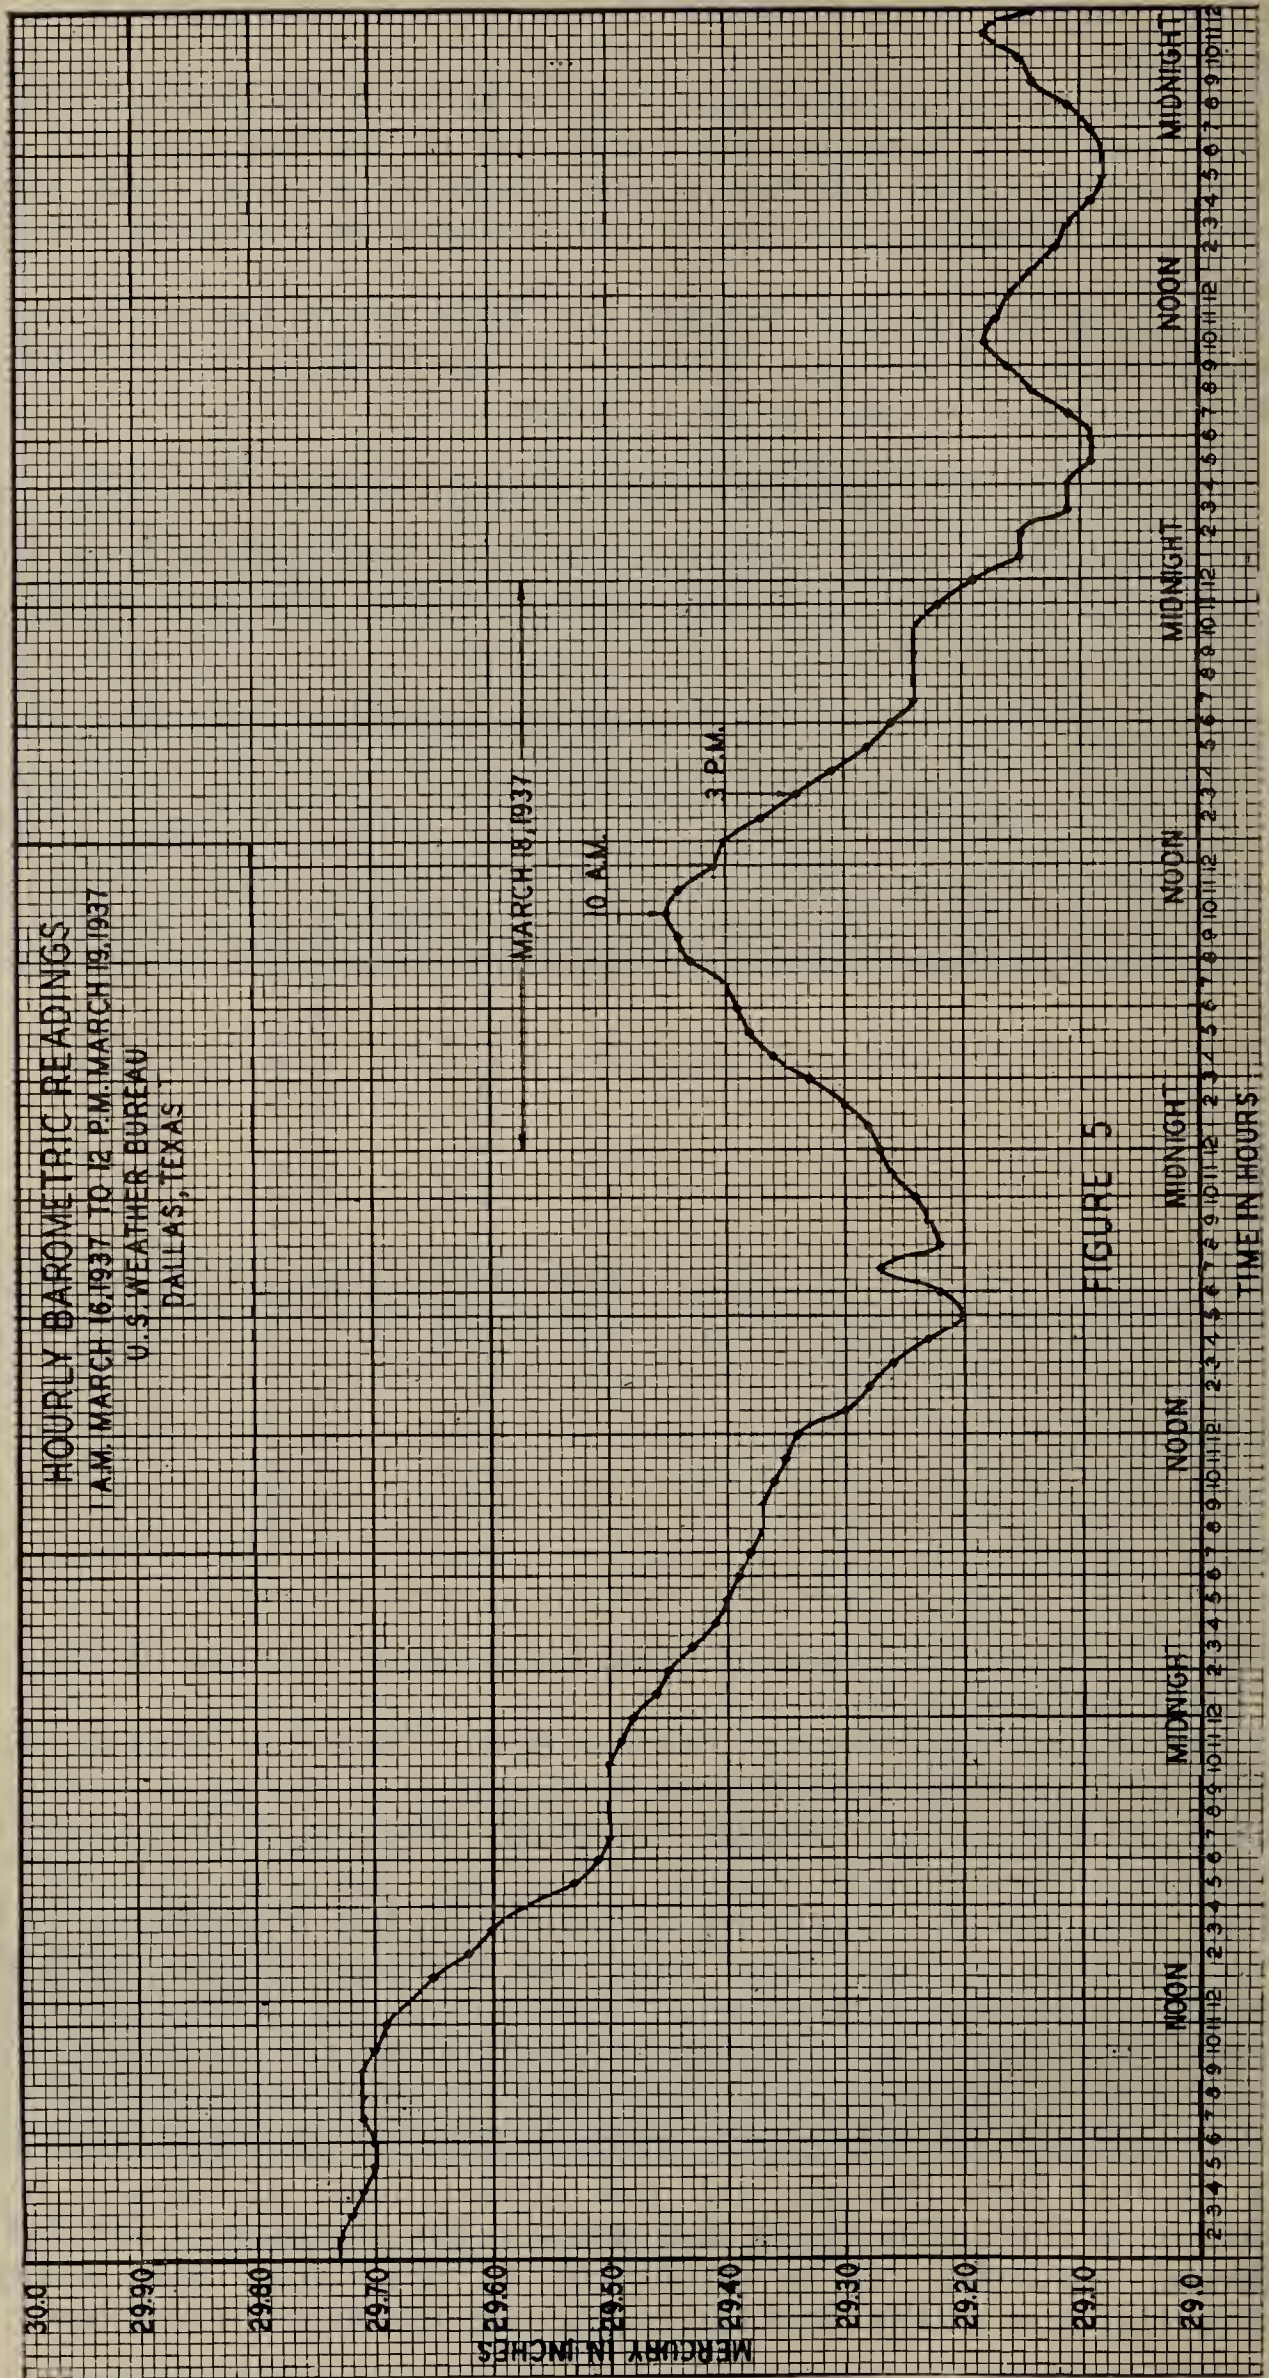
Figure 5 shows the graph of these barometric readings by hours for the 4-day period.

It will be observed that the barometer for Thursday, March 18, was high at 10 a. m. with a reading of 29.45 and that at 3 p. m.; about the time of the explosion, the barometer had dropped to 29.34 and continued to fall for some time later.

The fact that the explosion occurred during a period of falling barometer is important for at least two reasons. In the first place, it may explain how it happened that one of the school employees, entering the open area underneath the floor at the southeast corner about 10 a. m. to remove some stored material, was able to strike several matches at this point without causing an explosion. It is very evident that the gas had not accumulated sufficiently for an explosion at this point up to 10 o'clock in the morning of the day the explosion occurred. It is important to note that this workman entered this area at the time the barometer was high for the day.

In the second place the gas would probably escape more readily and therefore accumulate in larger quantities as the barometer was falling. It is quite likely therefore that during the 5 hours of falling barometer from 10 a. m. to 3 p. m., the approximate time of the explosion, a large amount of gas had collected in the open area under the first floor.

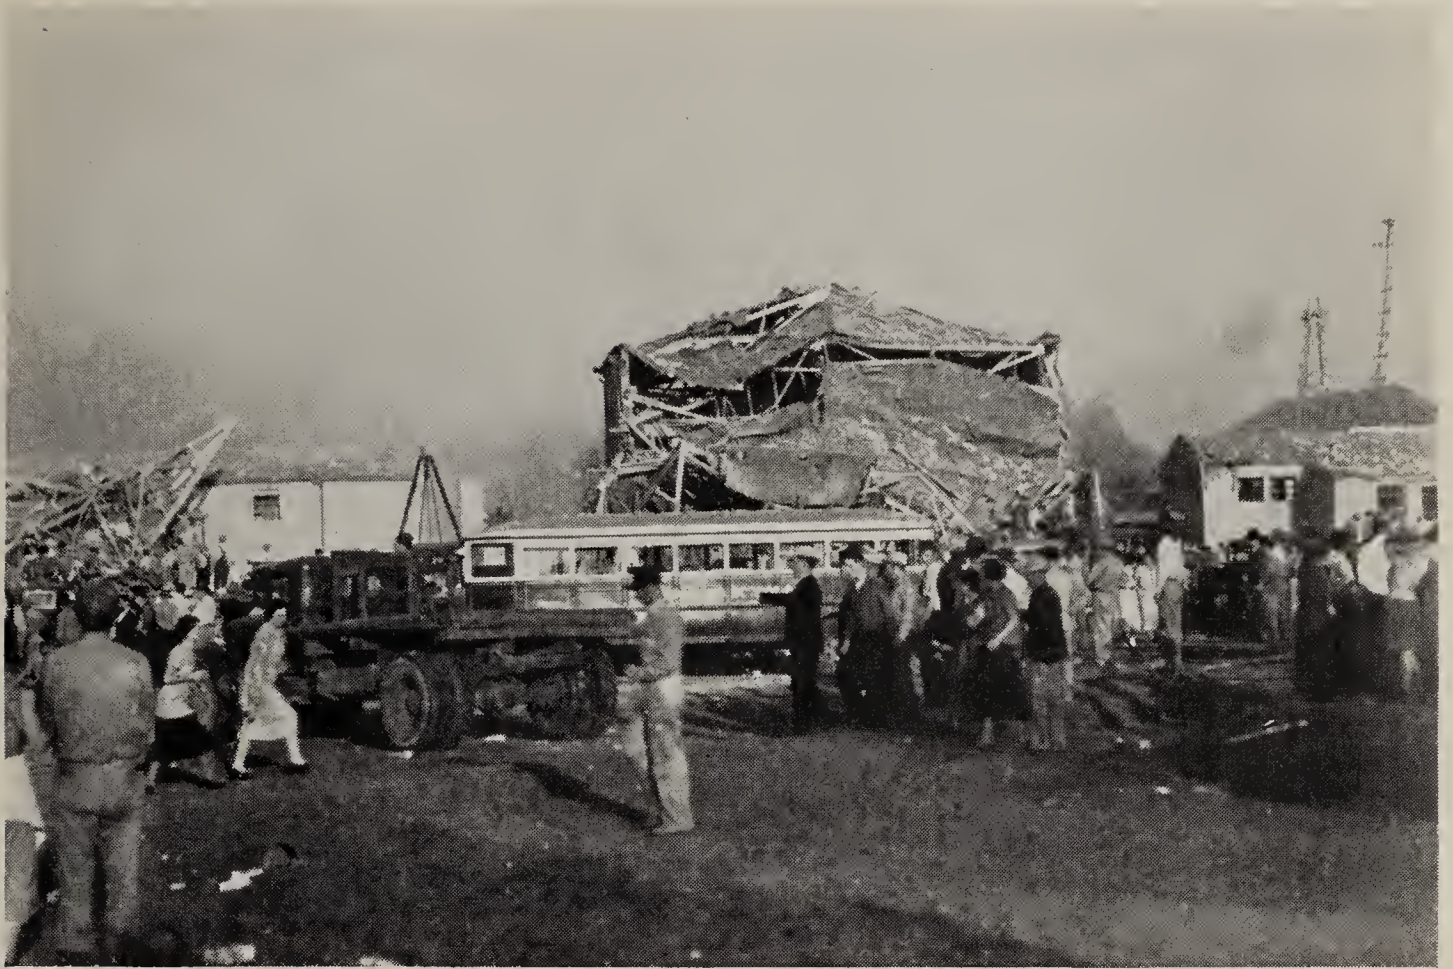
Another view, showing damage to auditorium. Note one of the busses of the London independent school district used to bring the students from surrounding points.

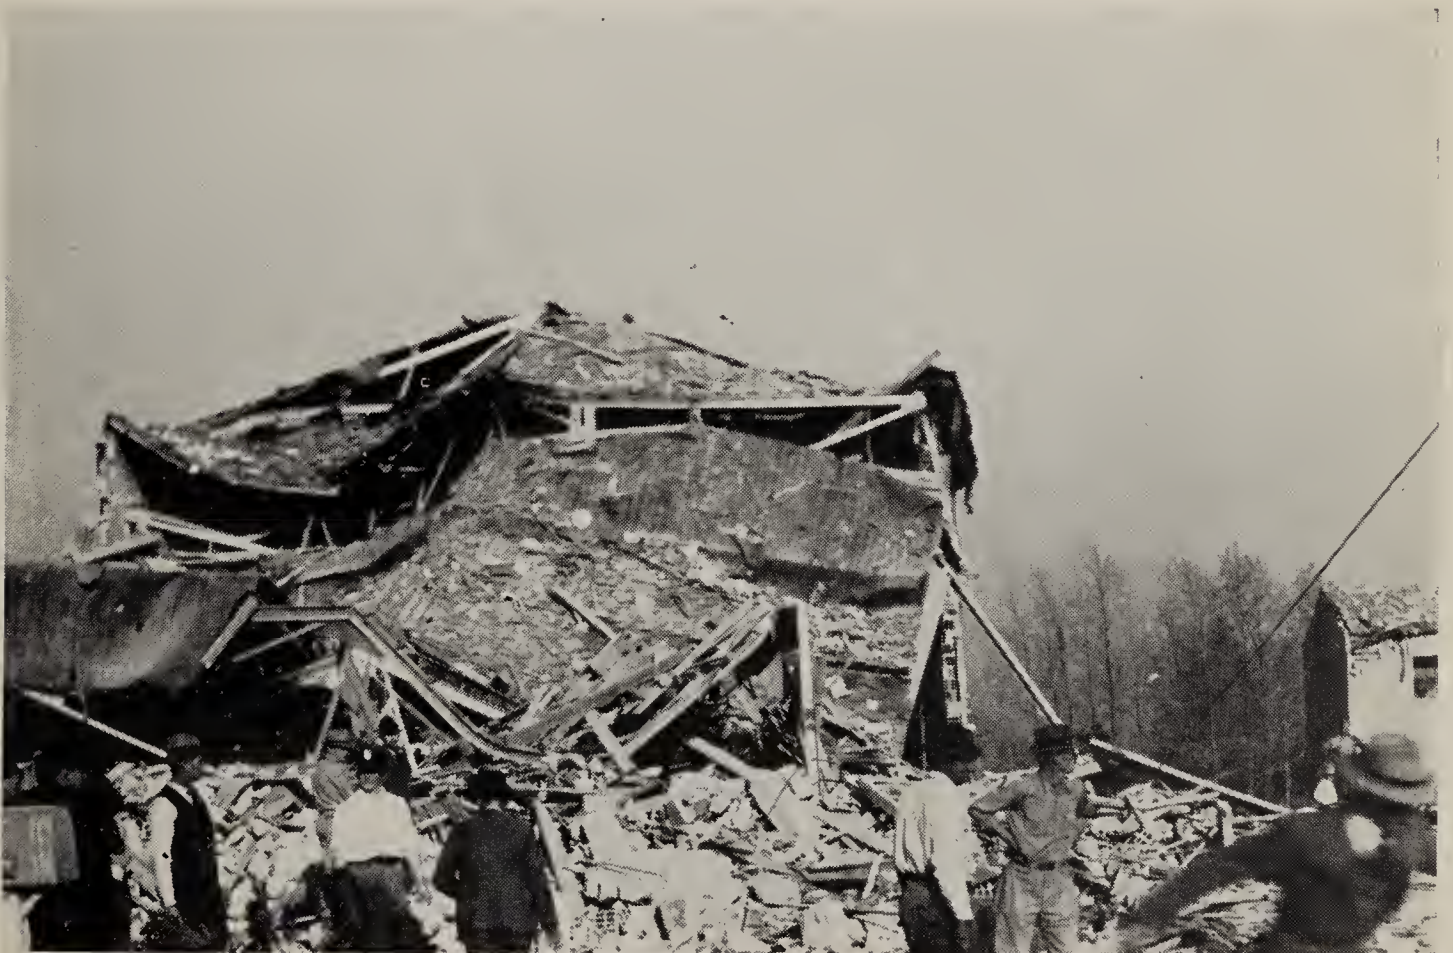
Close-up view showing debris from wrecked auditorium. Note steel girders, brick, and tile.

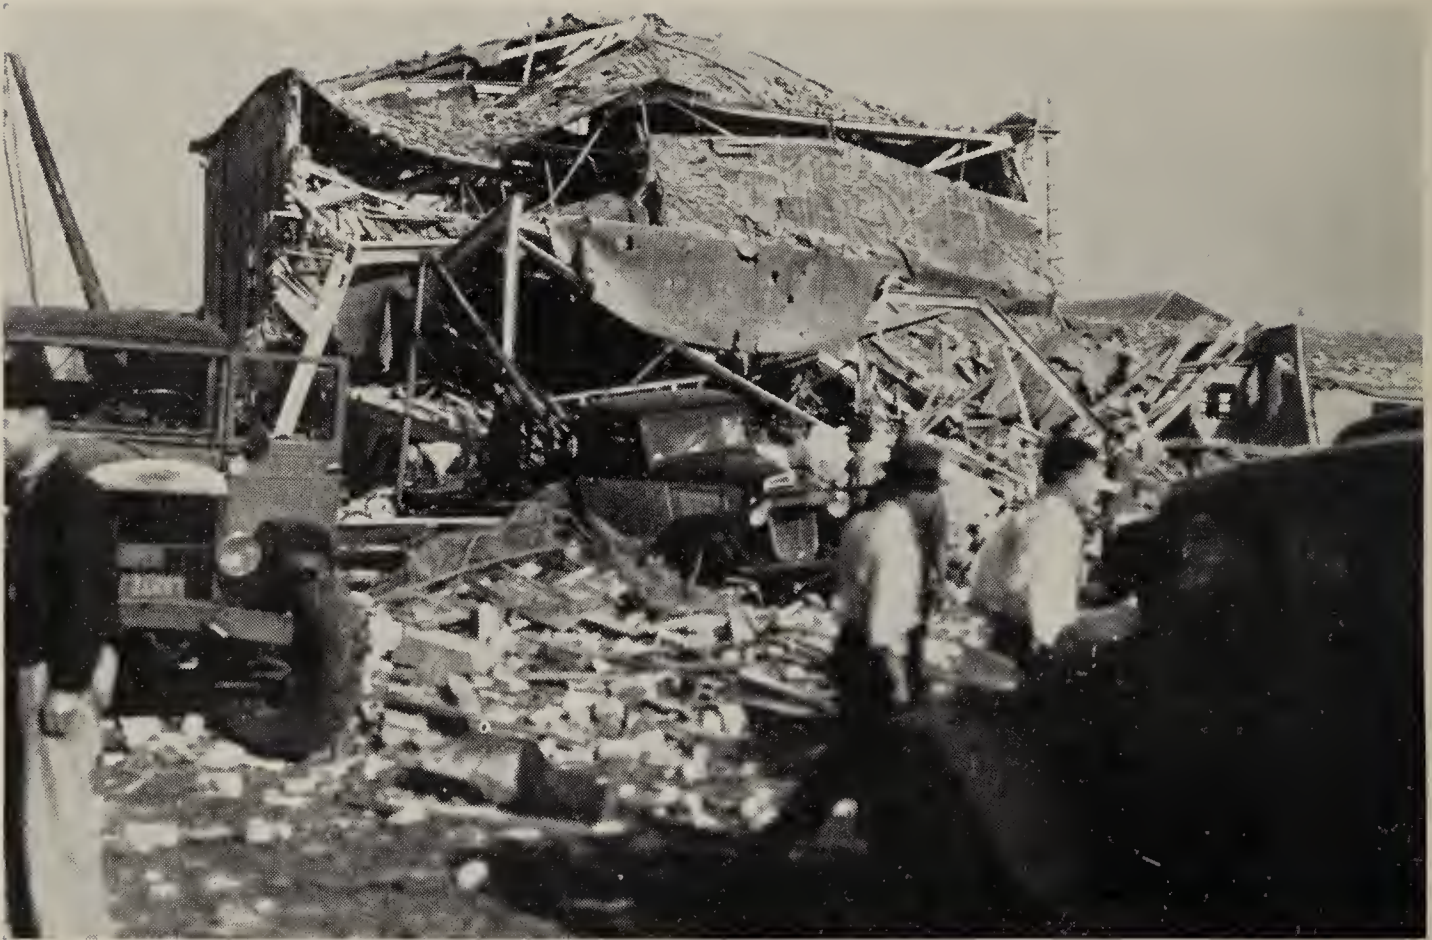
Another view of auditorium while recovery work was in progress. Many bodies were buried in the debris.

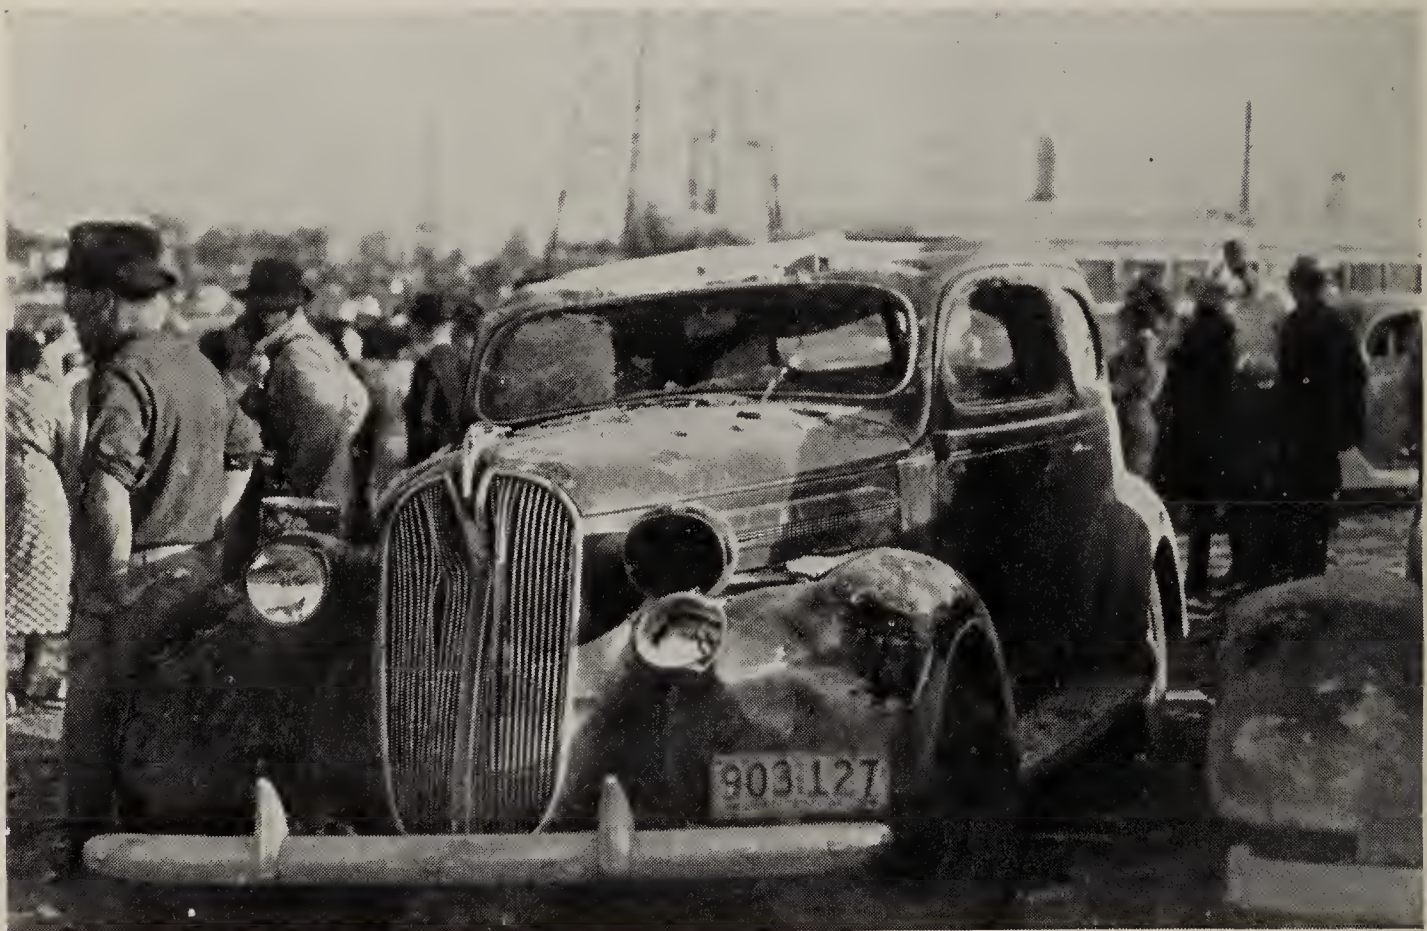
Damaged automobile parked about 125 feet from southeast corner of building.
