PHYSICAL PROTECTION WORKBOOK

dittert site

SEPTEMBER, 1978

DITTERT SITE
(AR-NM-02-085)

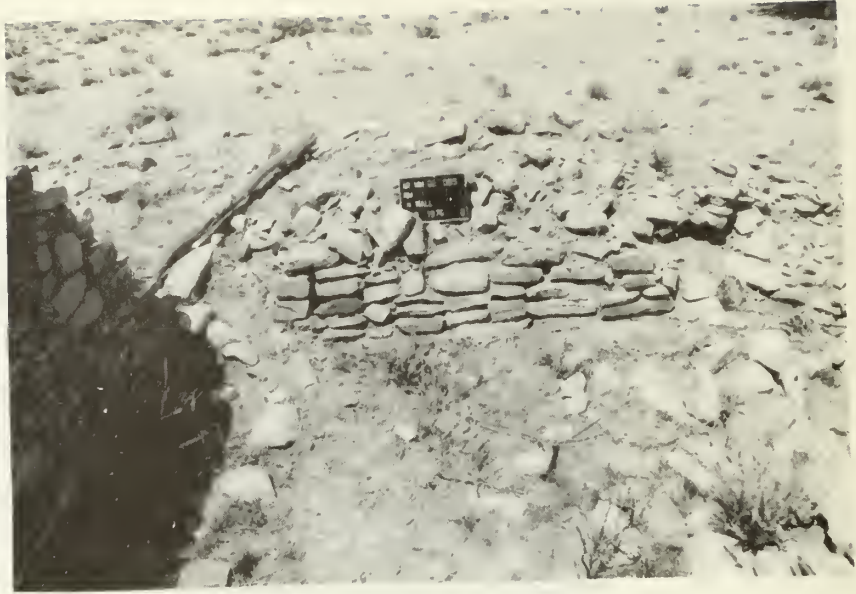
Room 1, north wall: before
stabilization

All four walls in this room were cleared of loose material then capped and grouted. The south wall was reconstructed where it once caved in. The north wall was leaning and the northeast corner of the room was caved in before stabilization procedures began. Special attention was given to all walls in Room 1. Unfortunately, there was not adequate time to completely excavate the room, and therefore, the north wall, as completed, is still in a leaning position. It was found that if the wall were straightened, it would destroy all fabric, and the wall would have to be completely reconstructed. The decision was made to leave the wall in it's leaning position, and adequately backfill on both sides of the wall to insure sufficient stability.

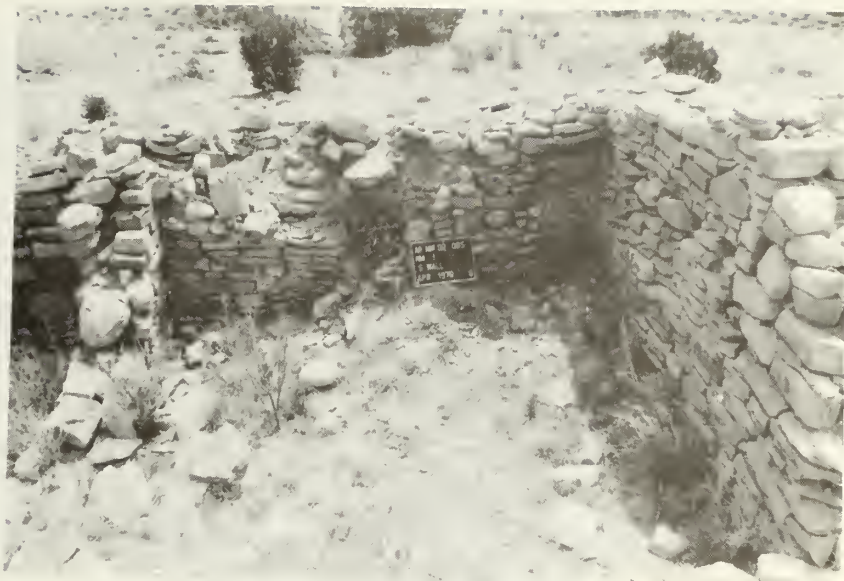
Room 1, south wall: before
stabilization

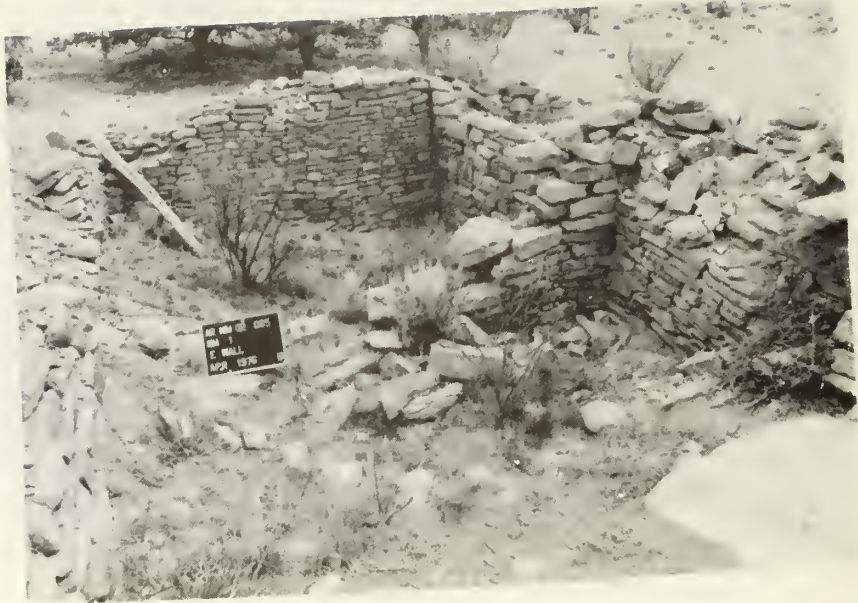
Room 1, east wall: before
stabilization

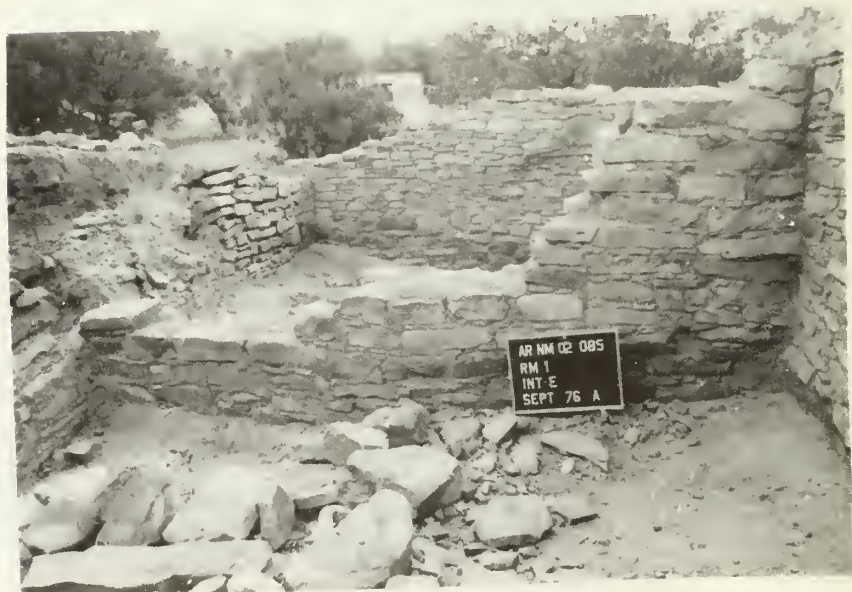
Room 1, east wall: after
stabilization

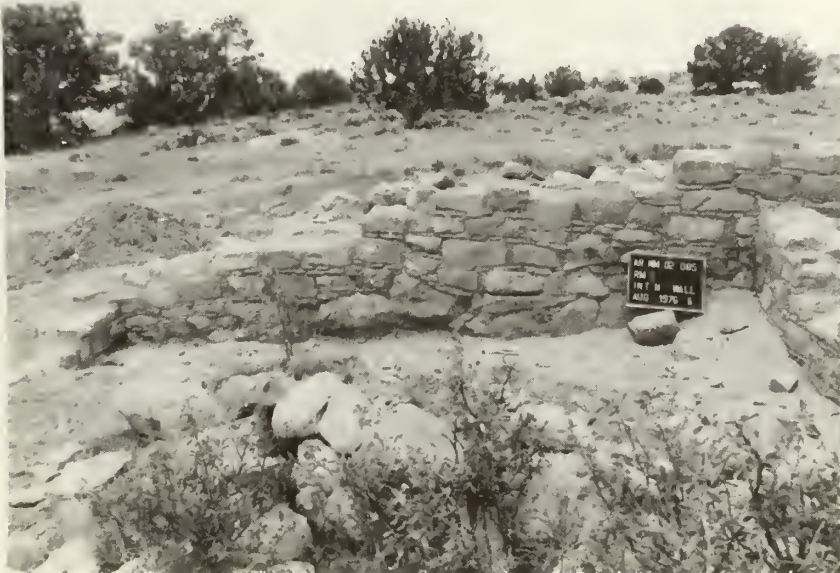
Room 2, north wall: after
stabilization

Note strange masonry blocks at base
of wall.

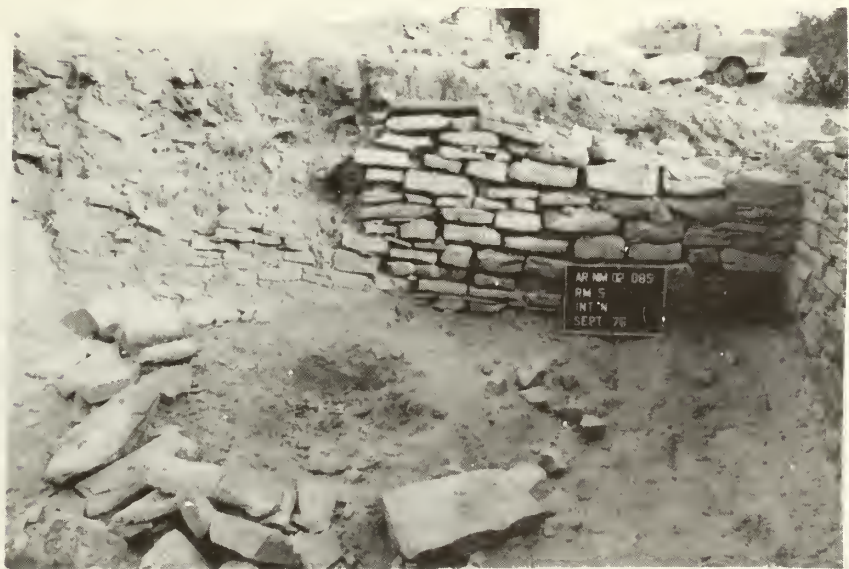
Room 5, north wall: after digging
trenches to expose wall.

No photo taken of stabilization
completed.

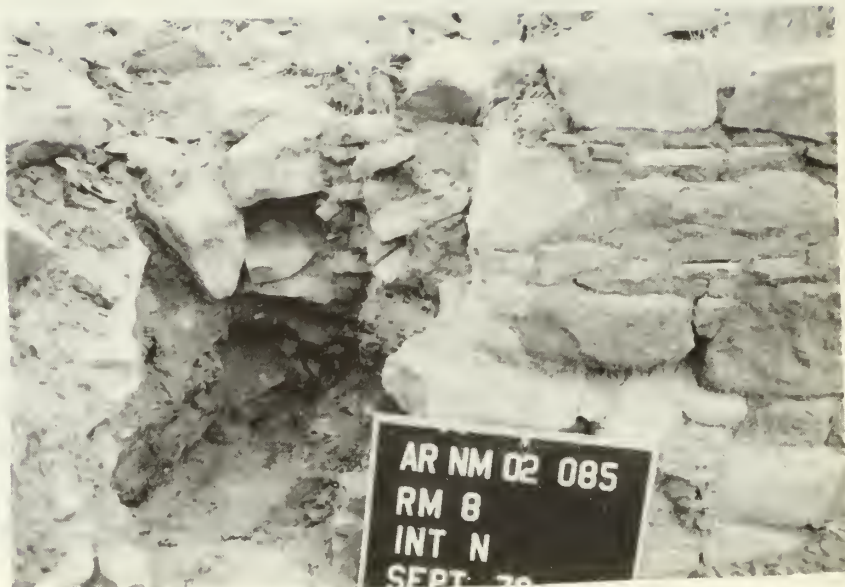
Room 8, north wall: looks like a
roof beam, we have no notes.

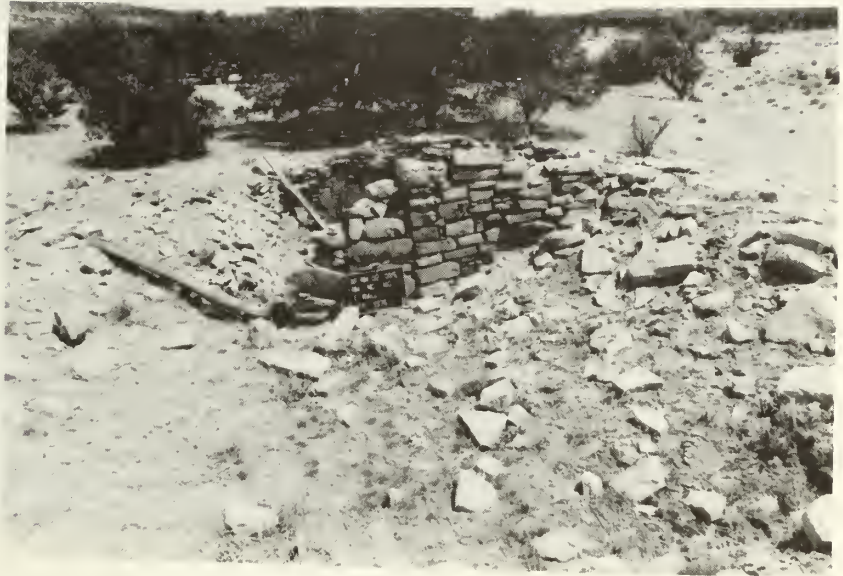
Room 12, east wall: before
stabilization

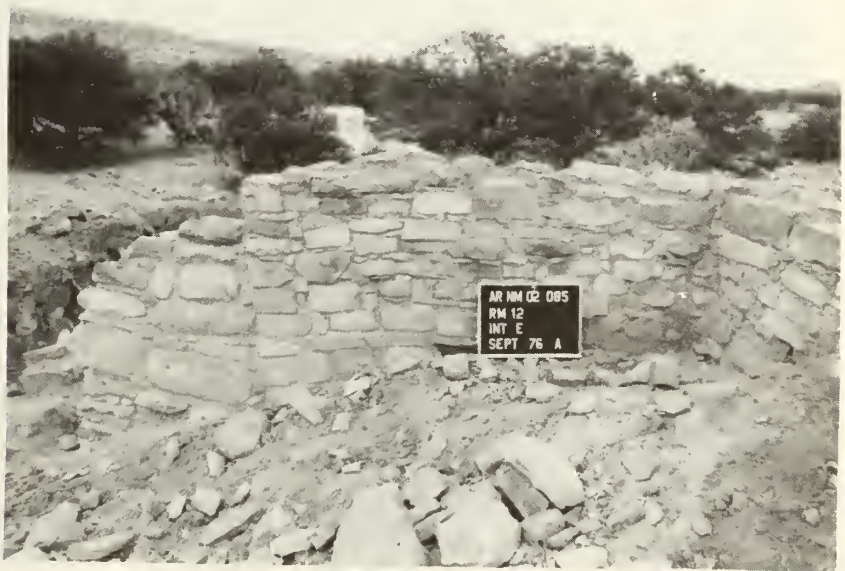
Room 12, east wall: after
stabilization

Note that plugged doorway, visible in
top photo, somewhat obscured below.

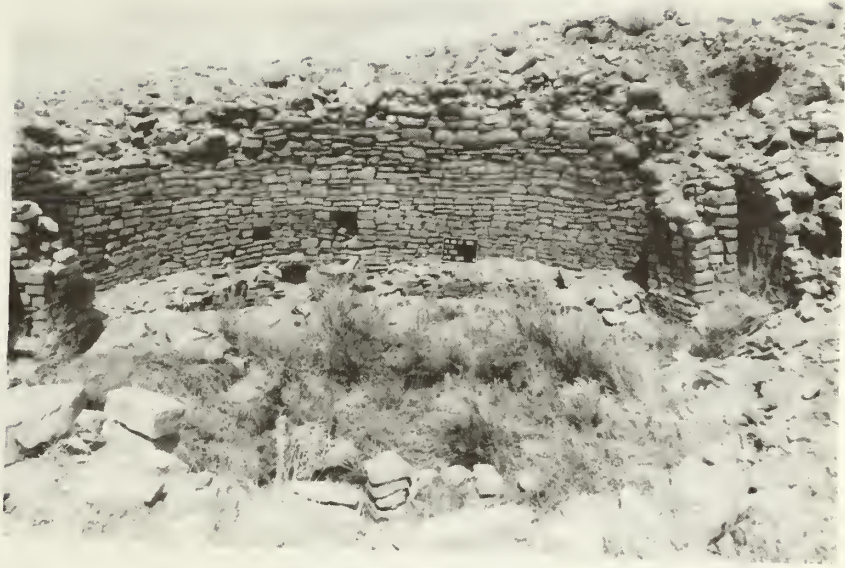
Kiva, north wall: before
stabilization

The northern section of the kiva bench was cleared of all loose material and was capped and grouted leaving a level surface. The hole at the base of the northern section of the kiva was repaired with sandstone and adobe mortar to match the existing masonry.

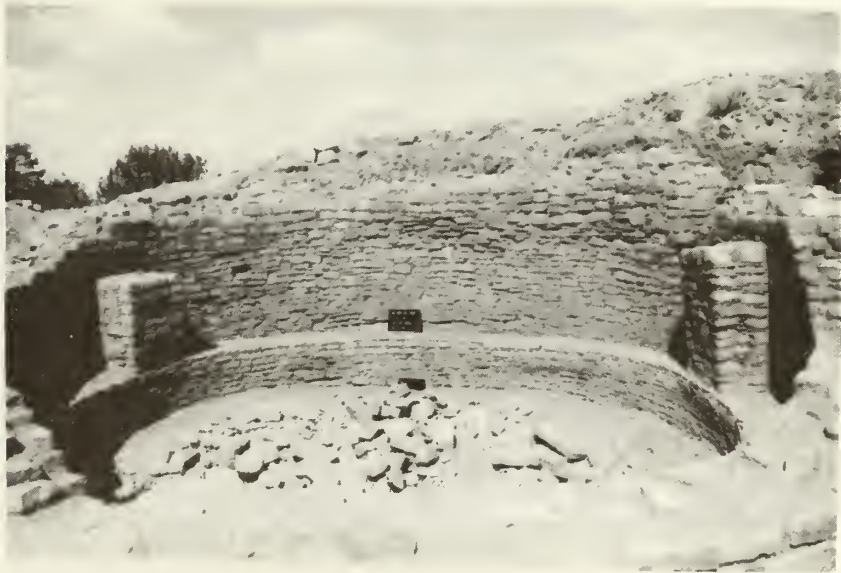
Kiva, north wall: after
stabilization

Note that there is one niche at the base of the stabilized kiva bench. Dittert found two. This error could have been avoided, if the site were studied in detail before field work began.

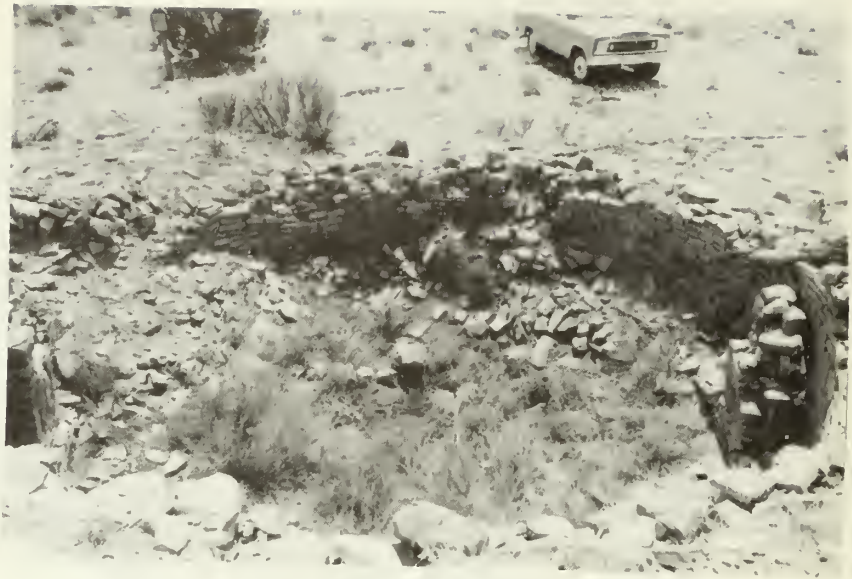
Kiva, south wall: before
stabilization

The hole at the base of the south wall was probably a ventilator shaft, though no testing was done to make a final determination before the kiva was backfilled. No hole outside the kiva was found. The decision was made to repair the hole without further testing. A deflector was found as material in the kiva was being removed. It was lying near the base of the east bench, and was left leaning against the east wall when backfilling operations began.
