THESIS

A CASE STUDY OF THE USS *DWIGHT D. EISENHOWER*
COLLISION AND ITS IMPLICATIONS

Patrick J. Dennison

September 1993

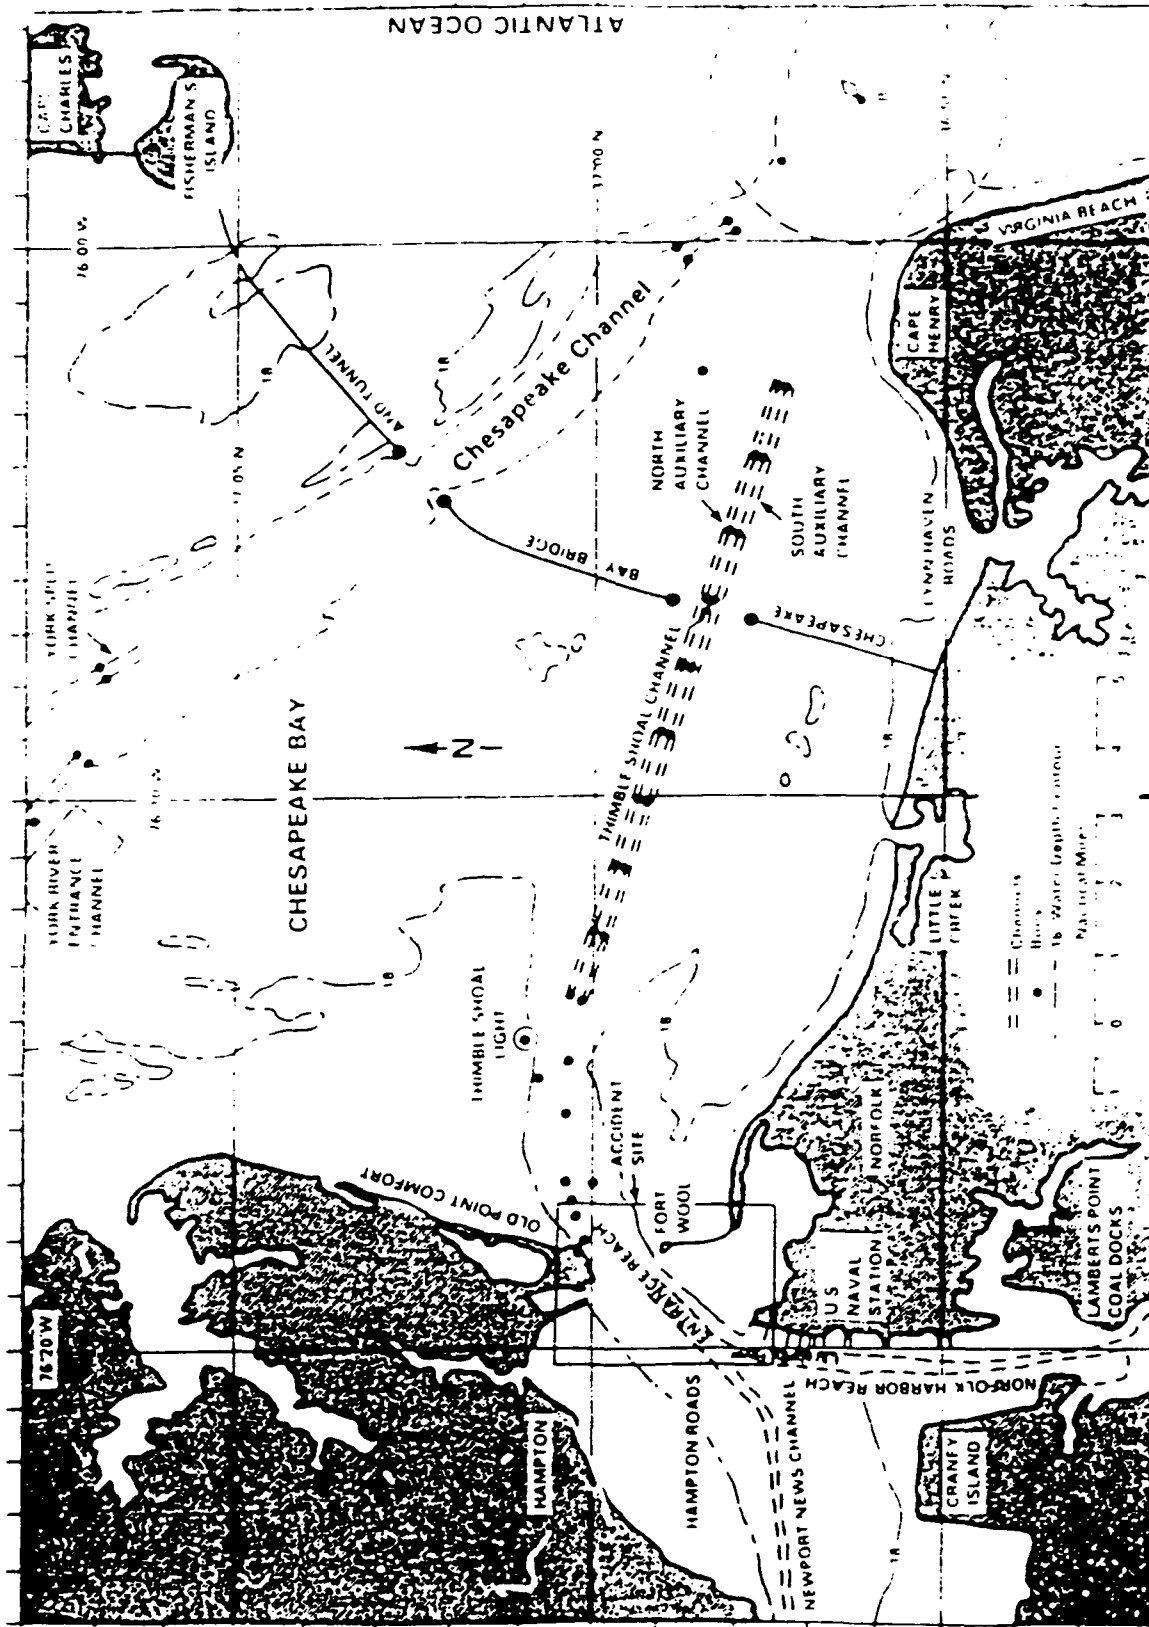
Figure II-1. Chart of the accident site

On 29 August 1988, at approximately 0821, the USS *DWIGHT D. EISENHOWER* (CVN 69) collided with the Spanish bulk carrier, *URDULIZ*. The *EISENHOWER* was returning from her first extended deployment in almost three years, and was transiting the recently narrowed Entrance Reach Channel. The *EISENHOWER* sustained over two million dollars damage to her number 2 aircraft elevator and along the starboard side where the impact took place. The *URDULIZ* damage totalled over 350 thousand dollars and was confined to the bow. There were no injuries to personnel on either ship, nor did the collision render either ship unseaworthy. [Ref. 2:p. v] **Figure II-1** displays a chart of the accident site.

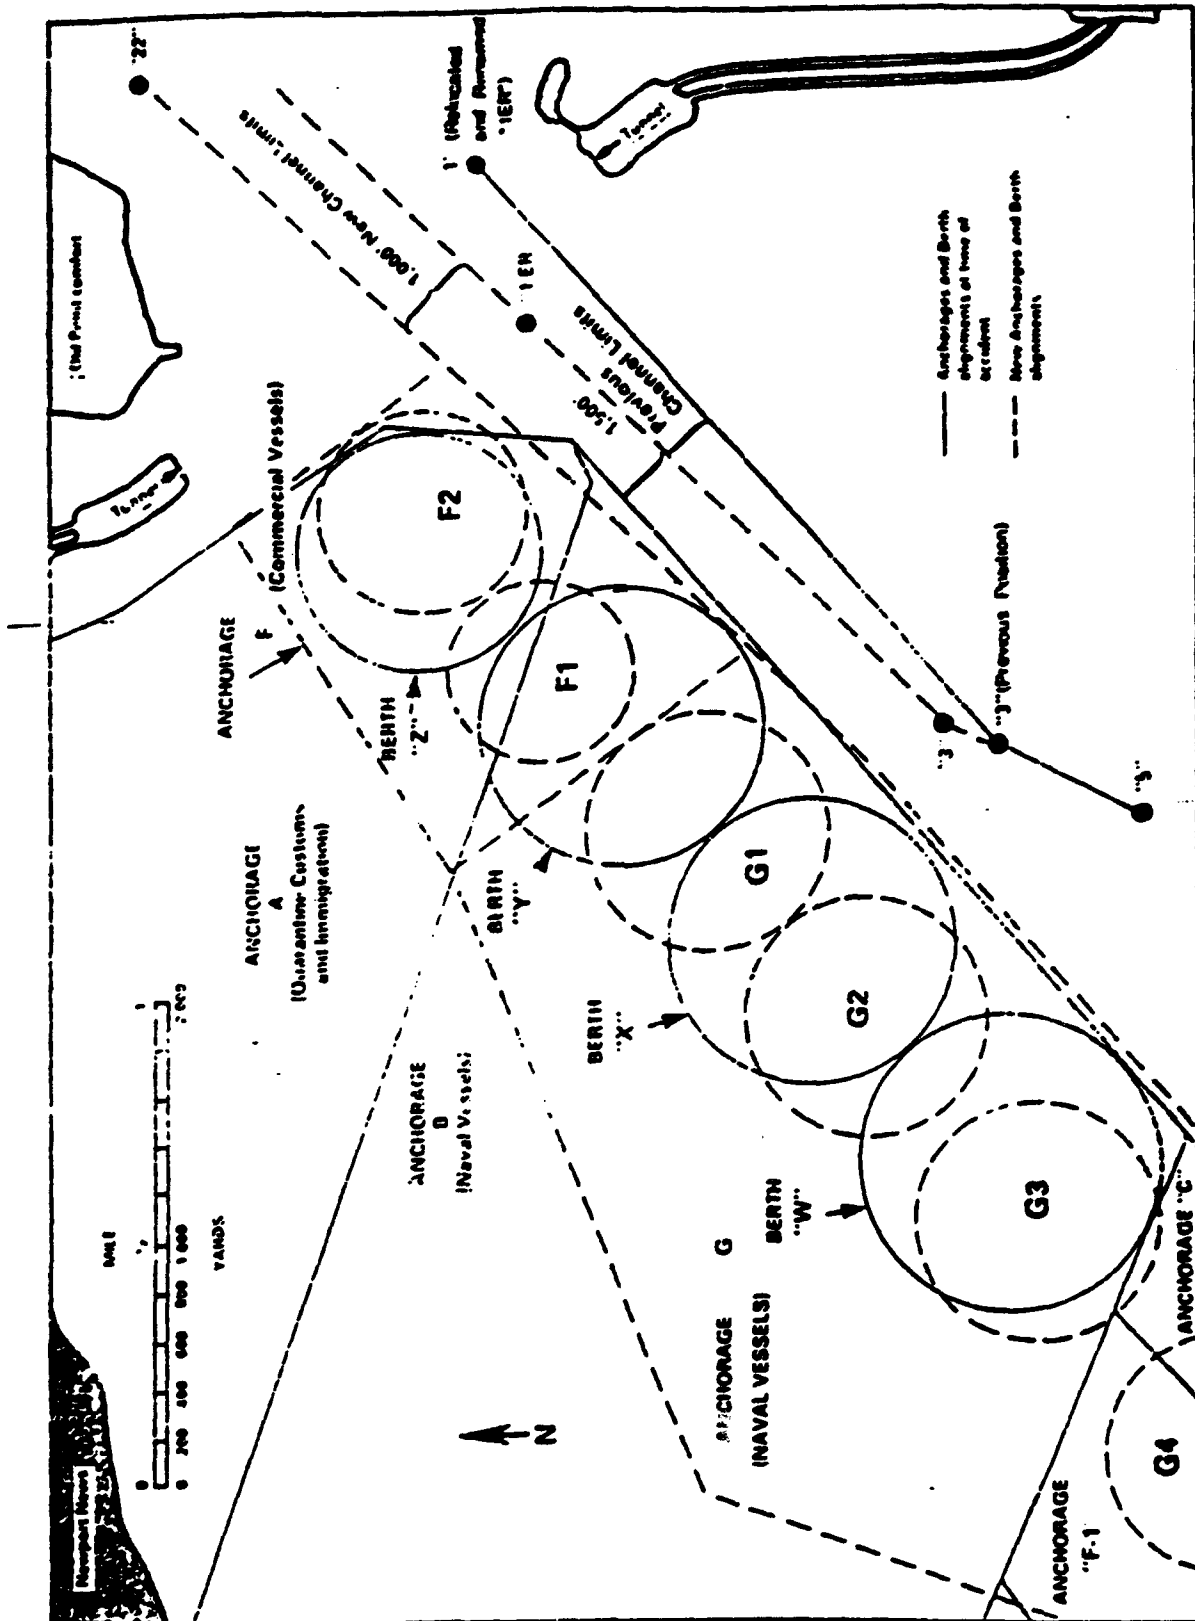
Figure II-2. Anchorages adjacent to Entrance Reach Channel

The *EISENHOWER's* track through Entrance Reach Channel was intentionally laid by the Navigator along the northwest edge of the charted reach to compensate for the new position of Elizabeth River Buoy 1. The *EISENHOWER's* new track passed within 200 yards of anchorage ZULU (where the *URDULIZ* was anchored) and was tangent to *X-RAY* and *YANKEE* anchorages 250 yards from the center of the channel (all anchorages are shown in Figure II-2).

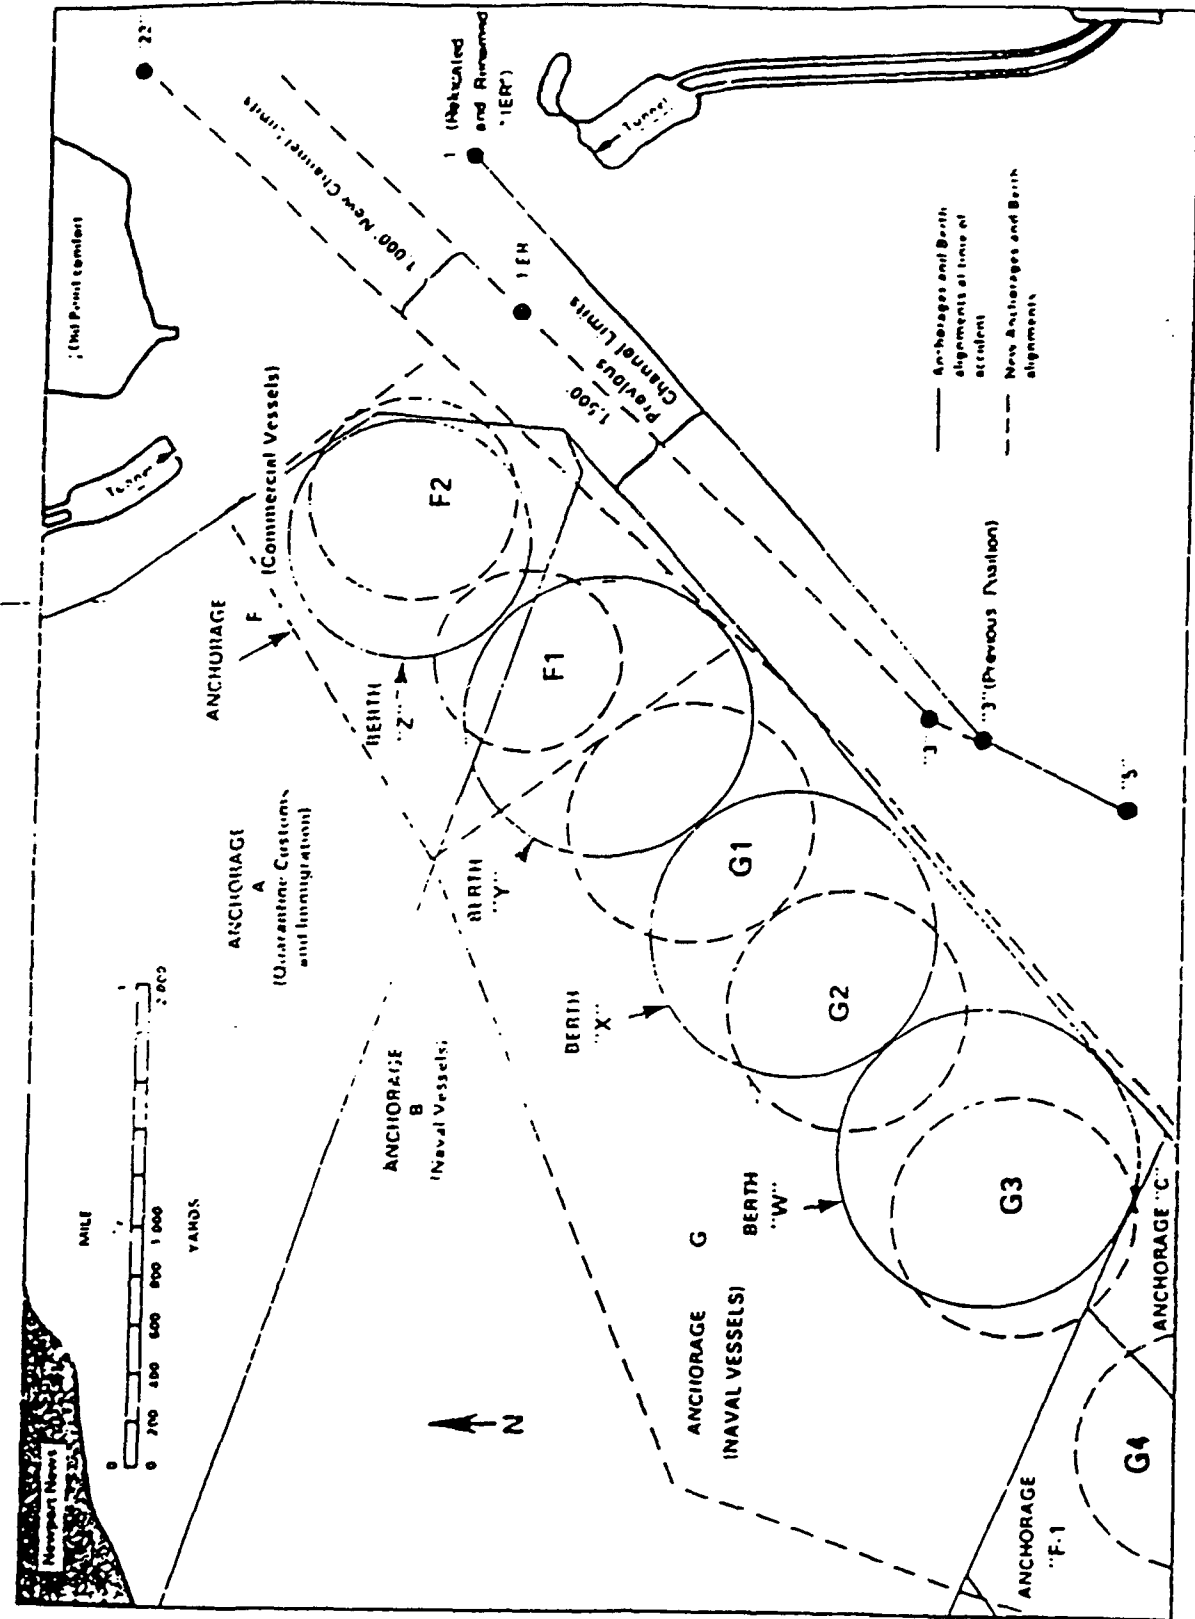
Figure III-1 Anchorages adjacent to Entrance Reach Channel

The pertinent anchorages in the Entrance Reach Channel at the time of the collision are labelled as shown in Figure III-1. Anchorage "A" was the Quarantine, Customs, and Immigration Anchorage for commercial vessels and was also used by deep drafts waiting to load or unload their cargo. The sizable anchorage included the 1,500 foot - radius berth "Z" in which URDULIZ was anchored. The southern edge of berth "Z" was located 600 feet north of the northern edge of Entrance Reach Channel before the channel was narrowed. After the channel was narrowed, the southern edge was only 300 feet from the channel edge. In fact, the southern boundary of Anchorage "A" was also the northern edge of the previous Entrance Reach Channel, yet was not marked by any navigational buoys. The explanation for the Coast Guard's decision not to place buoys near the anchorage was explained as follows: "...when you put buoys near an anchorage they get run over and serve only as a hazard to navigation" [Ref.2:p. 34].

In 1984, the Coast Guard had proposed intended changes for the Hampton Roads waterways around the Norfolk Naval Base. These modifications were necessary due to the construction of the Newport News Bridge-Tunnel. To accommodate this construction, the widening and deepening of the channel was initiated in 1987. This widening of the channel precipitated the adoption of new buoy and channel alignments. Subsequent to these changes, the Coast Guard renamed a segment of Anchorage "A" to "F" and berth "Z" to "F2". [Ref. 2:p. 21] As shown in Figure III-1, the southern edge of Anchorage "F" was moved north and aligned with the new, northern edge of Entrance Reach Channel. Also, the southern boundary of new berth "F2" was nearly the same as the previous berth "Z". These changes to the affected anchorages became effective on 08 February 1989. The Coast Guard intended these changes to widen the channel, yet in the end, the most travelled stretch of Entrance Reach Channel (around the anchorages) was narrowed by repositioning the present buoy alignment.

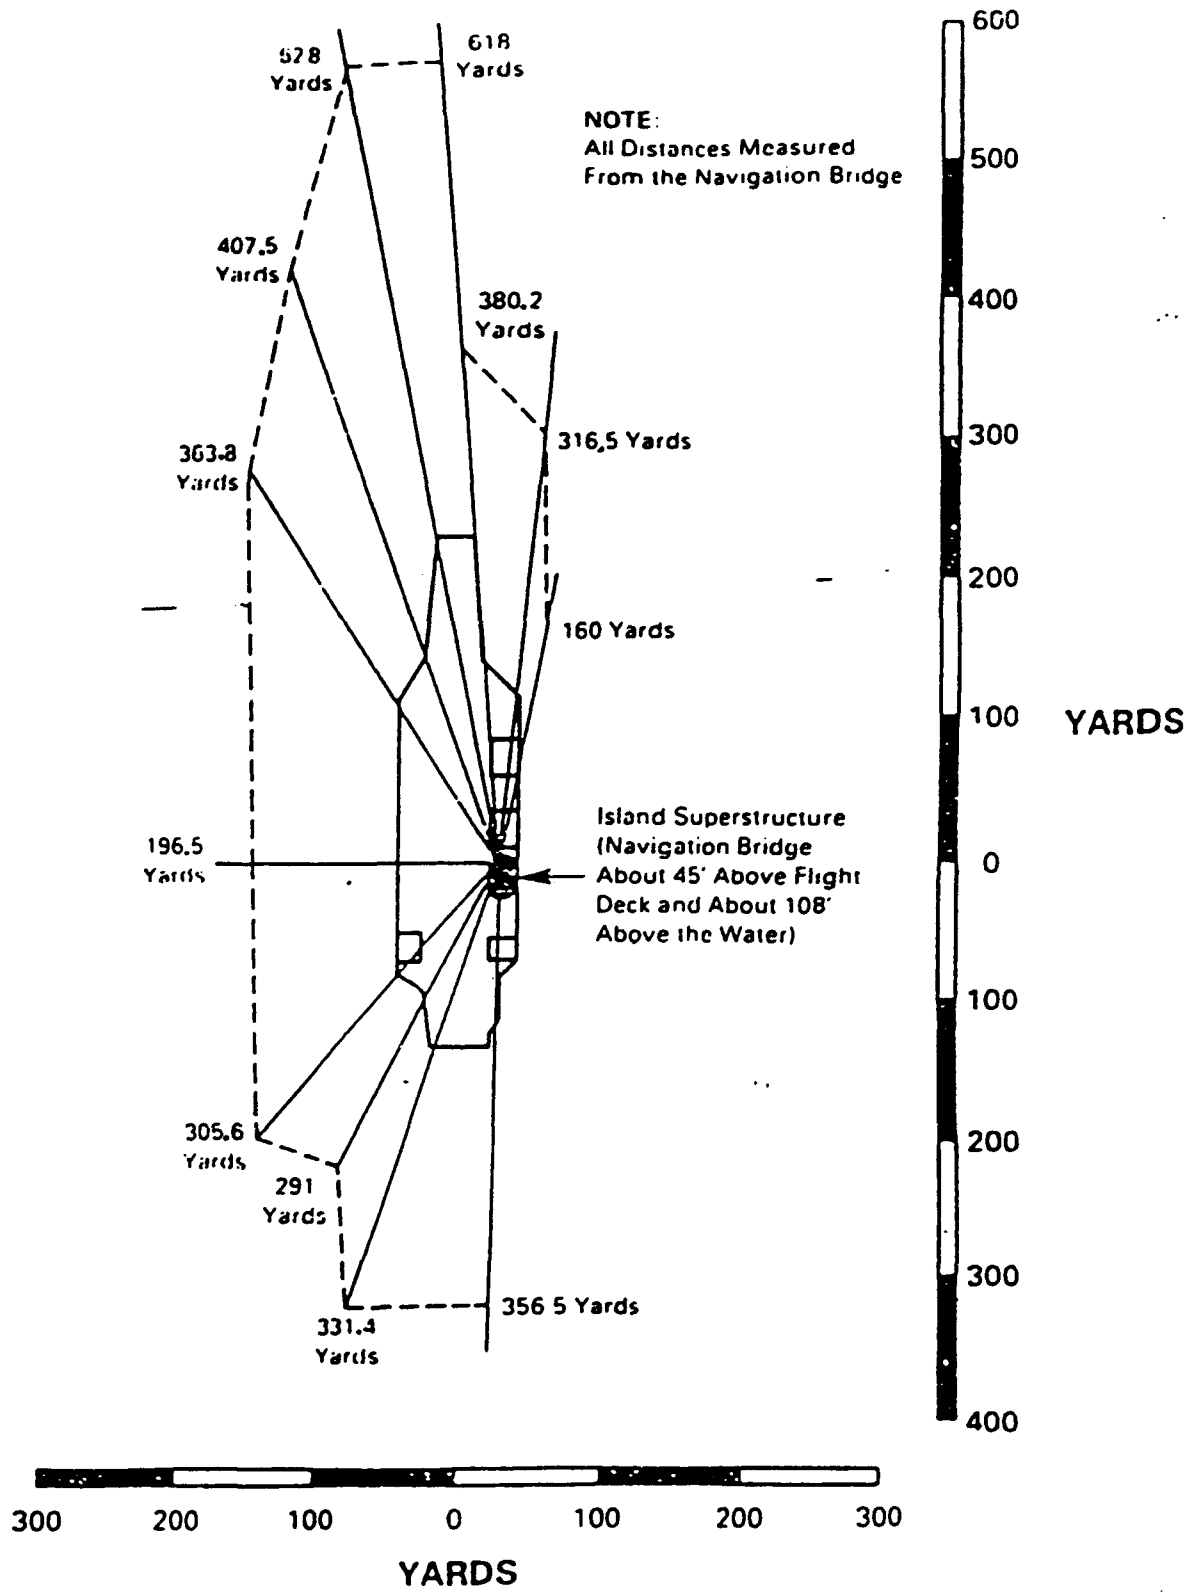
Figure III-2 Shadow zones measured from the bridge of the EISENHOWER

This is particularly important because of the *EISENHOWER*'s "shadow zones" and her 36 foot draft. The shadow zones created by the *EISENHOWER*'s size are depicted in Figure III-2. The inability of the bridge team to continually monitor the port-to-port passage of the *LIPSCOMB* factored in the collision. According to the investigation,

If the *EISENHOWER* had followed its planned track, with its bridge on the northern edge of the old Entrance Reach Channel (700 feet wide at buoy 1ER after the changes) its flight deck would have "shadowed" approximately 590 feet of channel on its port beam, leaving about 110 feet of the channel visible from the navigation bridge to buoy 1ER and the southern side of the new Entrance Reach Channel. Had the submarine followed a trackline of about 100 - 150 feet to the left of buoy 1ER, the large shadow zone on the port side of the *EISENHOWER* prevents a continuous view of a vessel with a low profile or a small vessel, if it passes too close, especially a vessel such as a submarine.
[Ref. 2:p. 21]

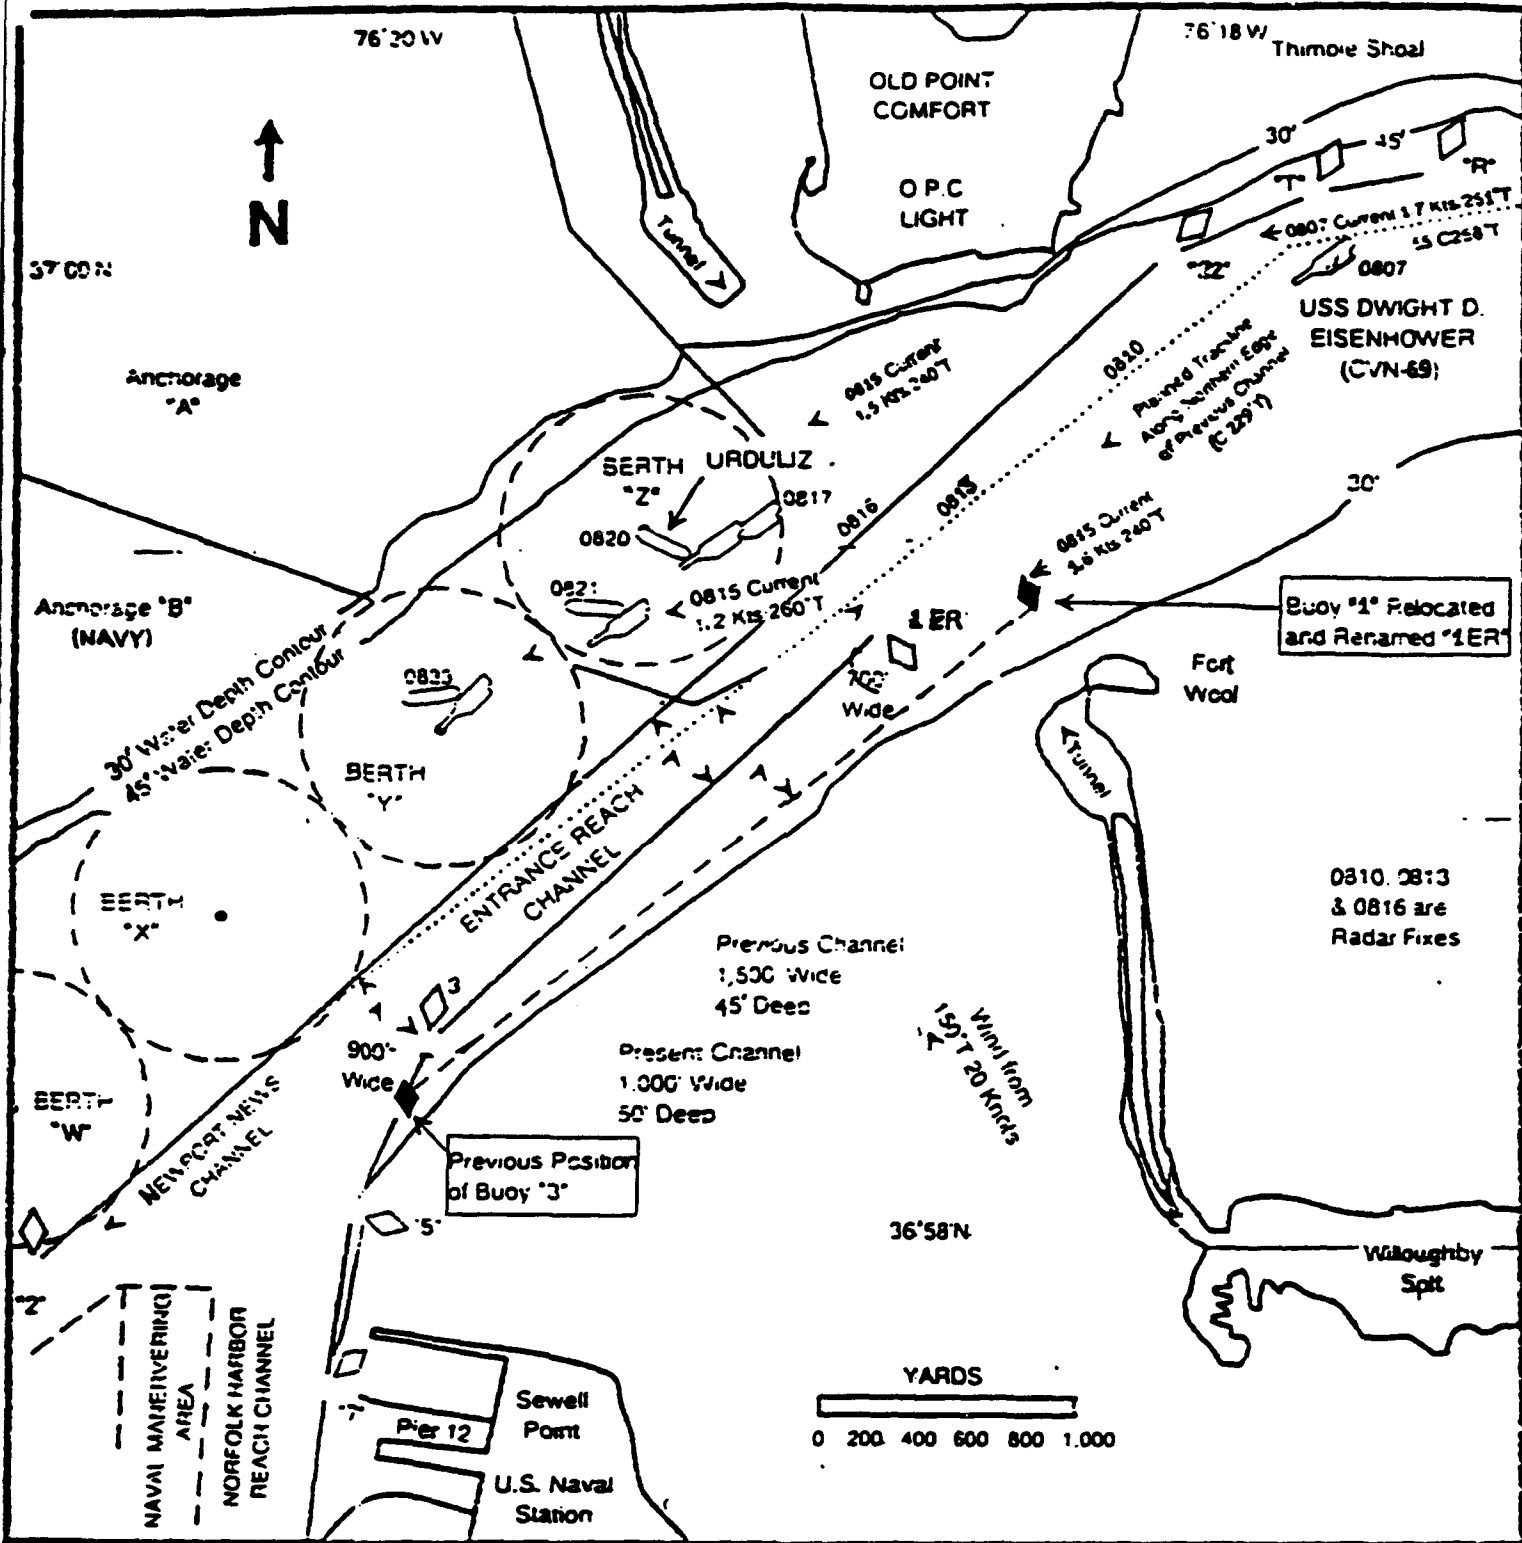
Figure III-3 Detailed chart of the accident site

Entrance Reach Channel is located between Old Point Comfort and Fort Wool on the east and Sewells Point in the west. The southern side of the channel used to be marked with Elizabeth River Channel Lighted Horn Buoy (LHB) "1" (buoy 1) near Fort Wool and the Elizabeth River Channel Lighted Buoy "3" (buoy 3) northwest of Sewells Point (This is depicted in **Figure III-3**). A line drawn between the two buoys (1 and 3) delineated the southern edge of the channel.

The northern side of the channel was located at the southern edge of Anchorages "A" (berth "Z") and "B" (berths "X", "Y", and "W") and on a line between the Naval Ordnance

Lighted Buoy (buoy "T") east of Old Point Comfort and the Newport News Channel Lighted Buoy "2" (buoy 2). This was a distance of approximately 3.5 nautical miles (nm).

In early 1988, the Thimble Shoal Lighted Buoy "22" (buoy 22) was repositioned close to the eastern side of Old Point Comfort. This created a "hole" in the system; now, there were no buoys between buoy 22 and buoy 2 on the "new" northern side of Entrance Reach Channel, a distance of 3.2 nm. When the Coast Guard was asked why this was permitted, the witness replied, "...when you put buoys near an anchorage, they get run over and they serve only as a hazard to navigation." If an arriving ship followed a course on the northern side of the channel that corresponded to a line drawn between buoys 22 and 2, it would encroach the southern edge of Anchorage "A" and "B", thereby transiting through the anchorage. [Ref. 2:p. 19]

The investigation did not agree with the Coast Guard's rationale that placing buoys near an anchorage resulted in increased hazards to navigation. The NTSB believed that the northern boundary of Entrance Reach Channel must be marked with additional buoys to assist conning crews of ships in determining the movement of their ship and the channel's limits. [Ref. 2:p. 35]

The NTSB also recommended that the Coast Guard "...establish additional buoys on the northern side of Entrance Reach Channel to delineate the channel limits." [Ref. 2:p. 40]
