PB92-916301
NTSB/RAR-92/01

RAILROAD ACCIDENT REPORT

**DERAILMENT AND COLLISION OF
AMTRAK PASSENGER TRAIN 66 WITH
MBTA COMMUTER TRAIN 906
AT BACK BAY STATION
BOSTON, MASSACHUSETTS
DECEMBER 12, 1990**

ADOPTED: FEBRUARY 25, 1992

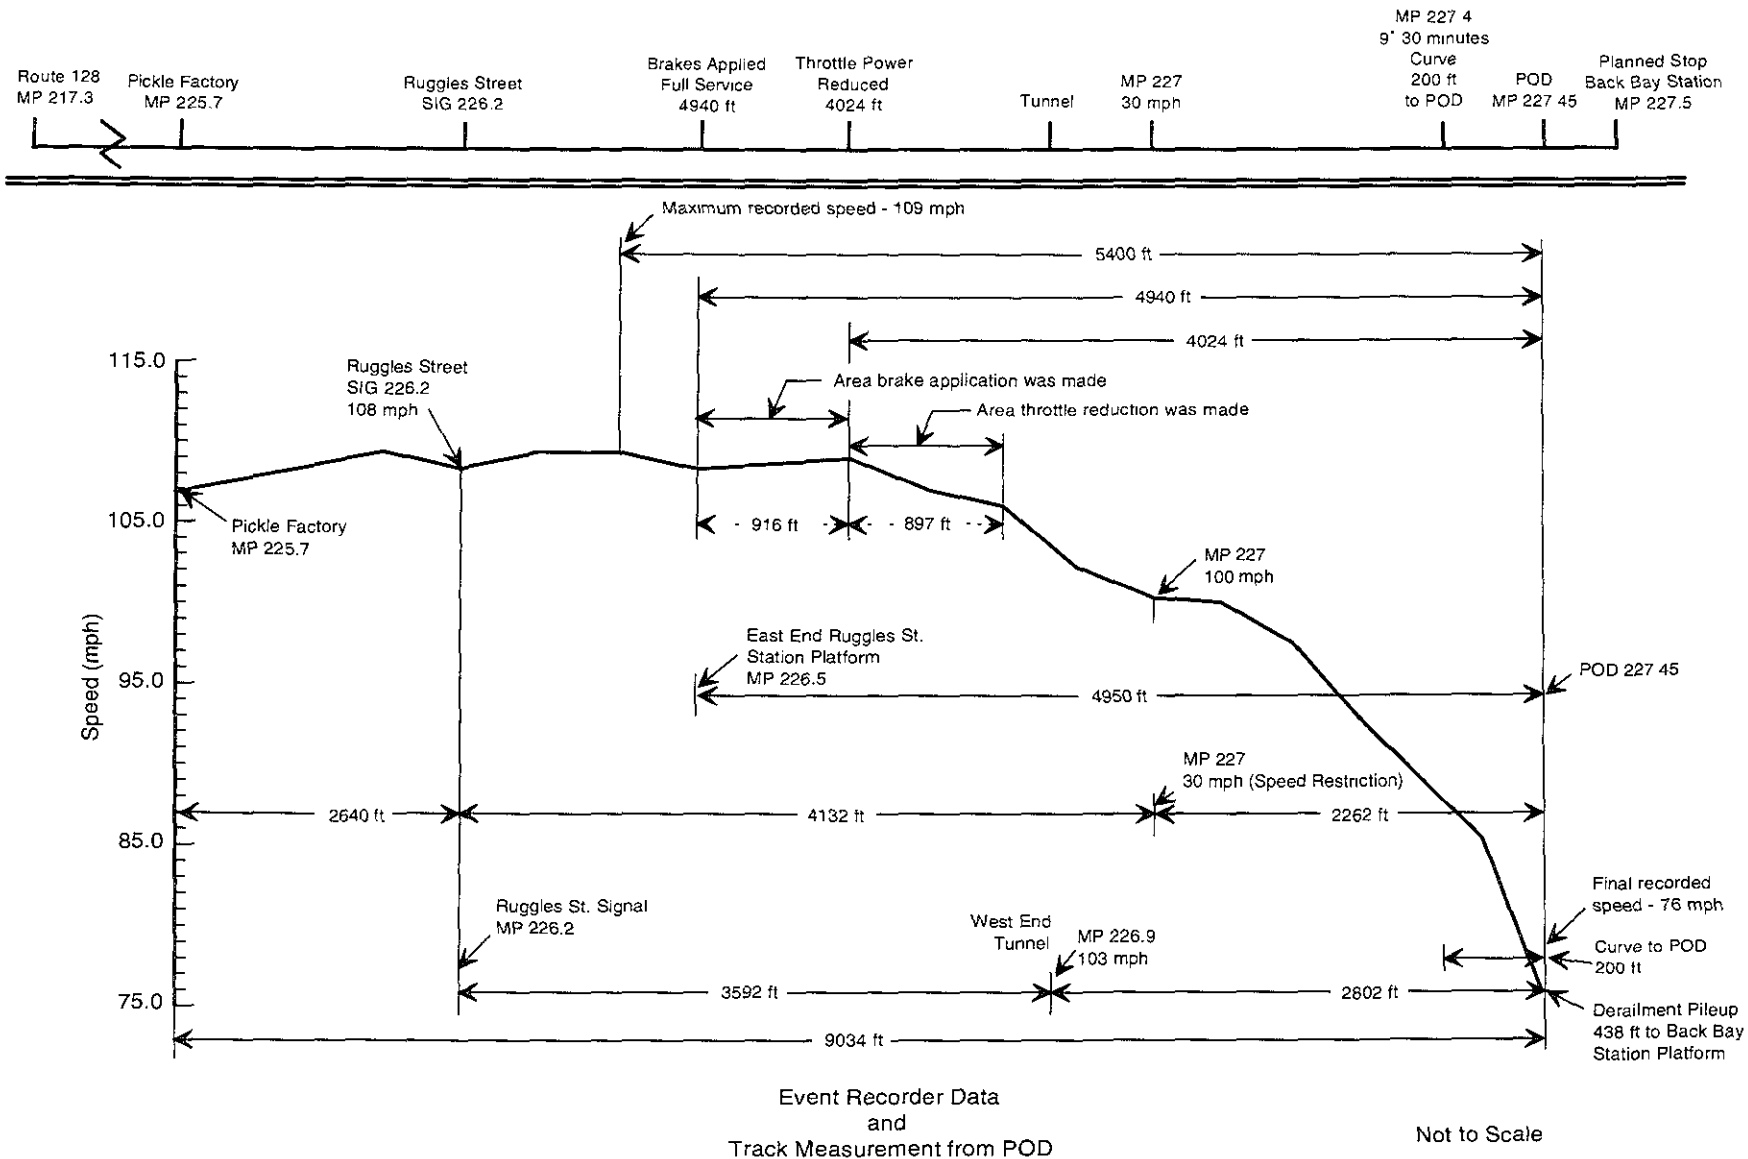
Figure 2 --Diagram of Amtrak train 66 speed and distance travelled.

According to the locomotive engineer, he instructed the apprentice engineer to initiate the braking sequence for Back Bay station near the west end of the Ruggles Street station platform (MP 226.2). However, the event recorder data indicate that braking was not initiated at that location. Even if the instructions had been issued there, they would have been issued too late to slow the train to comply with the 30-mph speed restriction at MP 227. The locomotive engineer stated that a 10- to 12-psi first-service reduction was made, but the train failed to slow as much as usual. The event recorder data do not show that a 10- to 12-psi reduction was made.

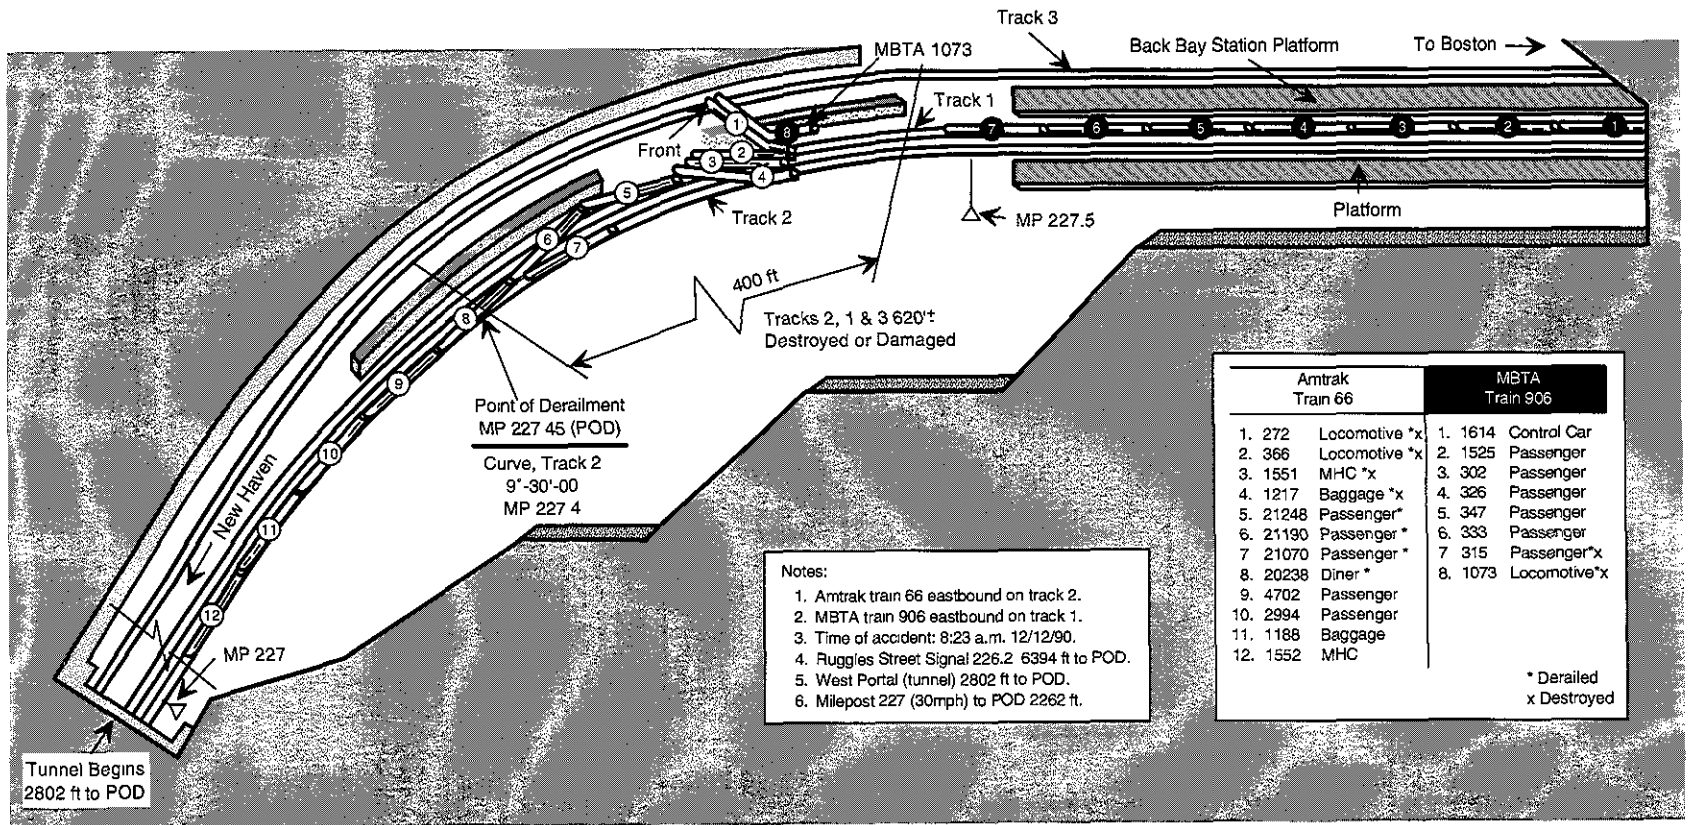
Figure 3 --Diagram of derailment site.

At the initial derailment marks on track 2, both rails remained undisturbed on the ties. Beginning 250 feet before the POD, the track was forced approximately 1 inch out of alignment for 62 feet to the south. The track immediately east of the POD was heavily damaged for approximately 30 feet; beyond this area, the track was undisturbed for approximately 120 feet leading into the area where the cars came to rest on track 2.

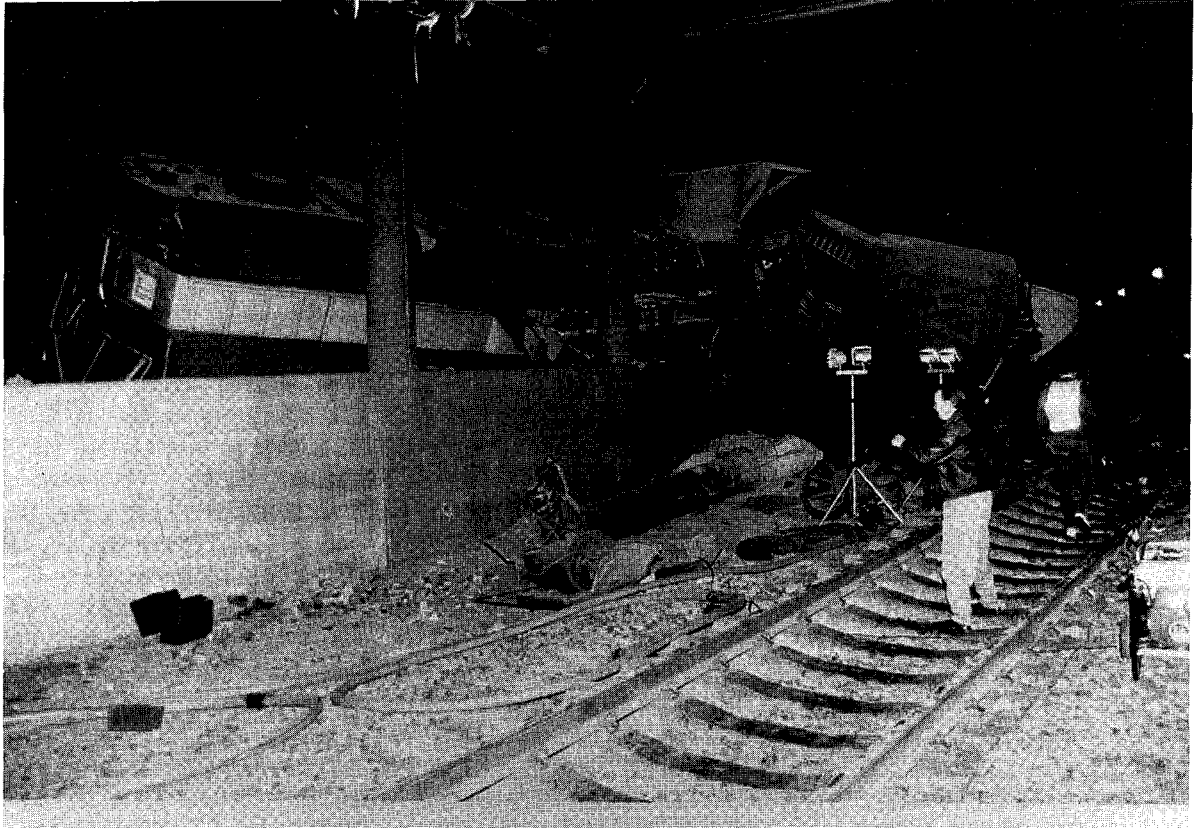
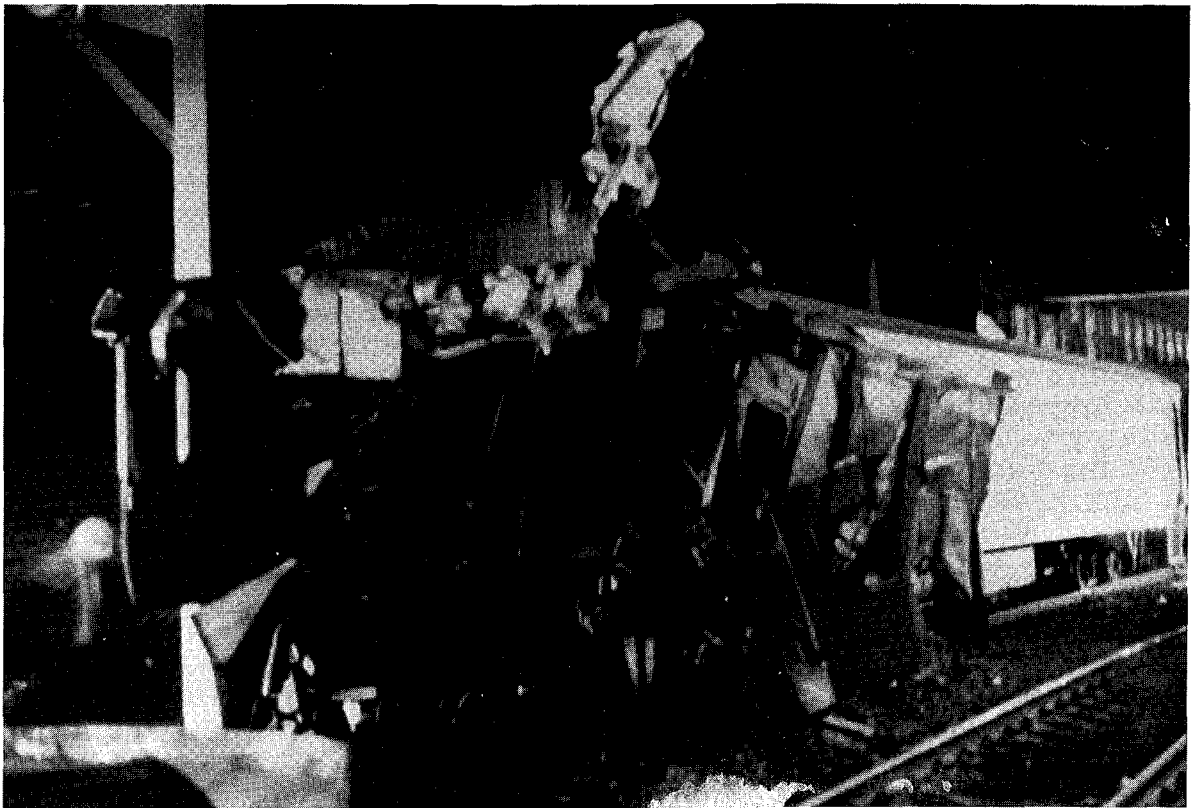
MBTA Train 906 Exits --Control car 1614 (lead car) and passenger cars 1525, 302, 326, 347, and 333 did not derail following the collision. The passengers exited from the doors at both ends of the cars. All wheels on passenger car 315 had derailed, and the car sustained massive damage. It remained upright against the stairwell housing between tracks 1 and 3. All emergency windows were removed. The west end of the car was crushed and the exit door blocked; at the east end of the car, the exit door to the platform was opened. The unoccupied locomotive 1073 was destroyed. (See figure 4.)

Figure 4.--MBTA train 906 wreckage.

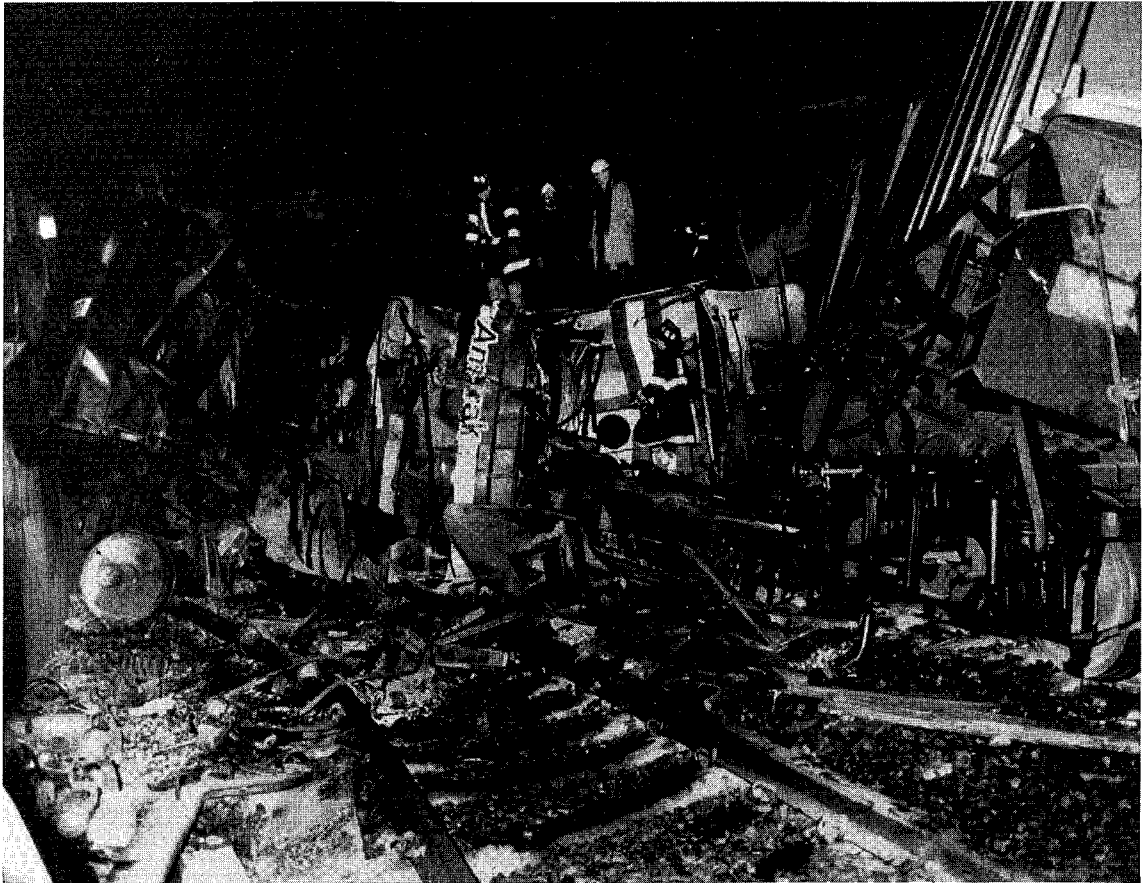
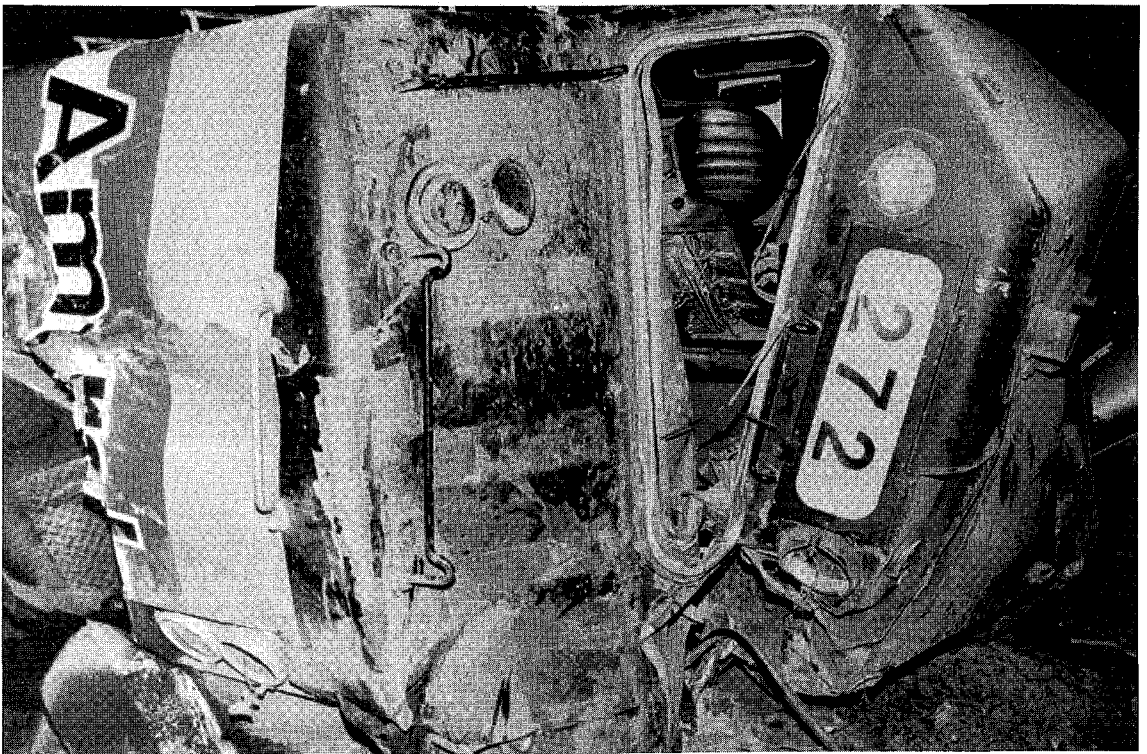
Both trains sustained massive equipment damage. The fuel tank on Amtrak locomotive 366 broke loose, and a diesel fuel fire ensued. The fire department quickly extinguished the fire, but moderately heavy smoke and minor fire damage resulted. Exhaust fans in the tunnel reduced the smoke and removed it completely after the fire was extinguished.

Figure 5.--Amtrak train 66 wreckage.

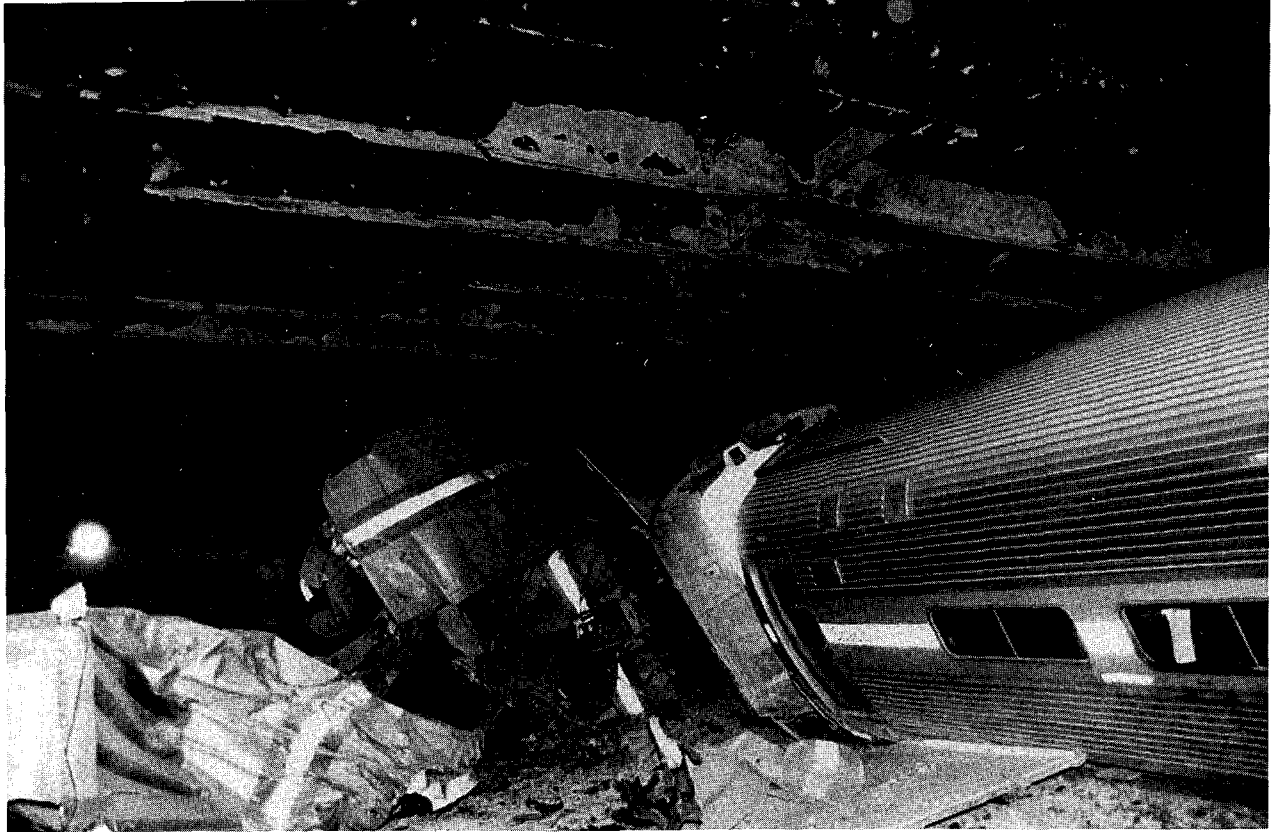
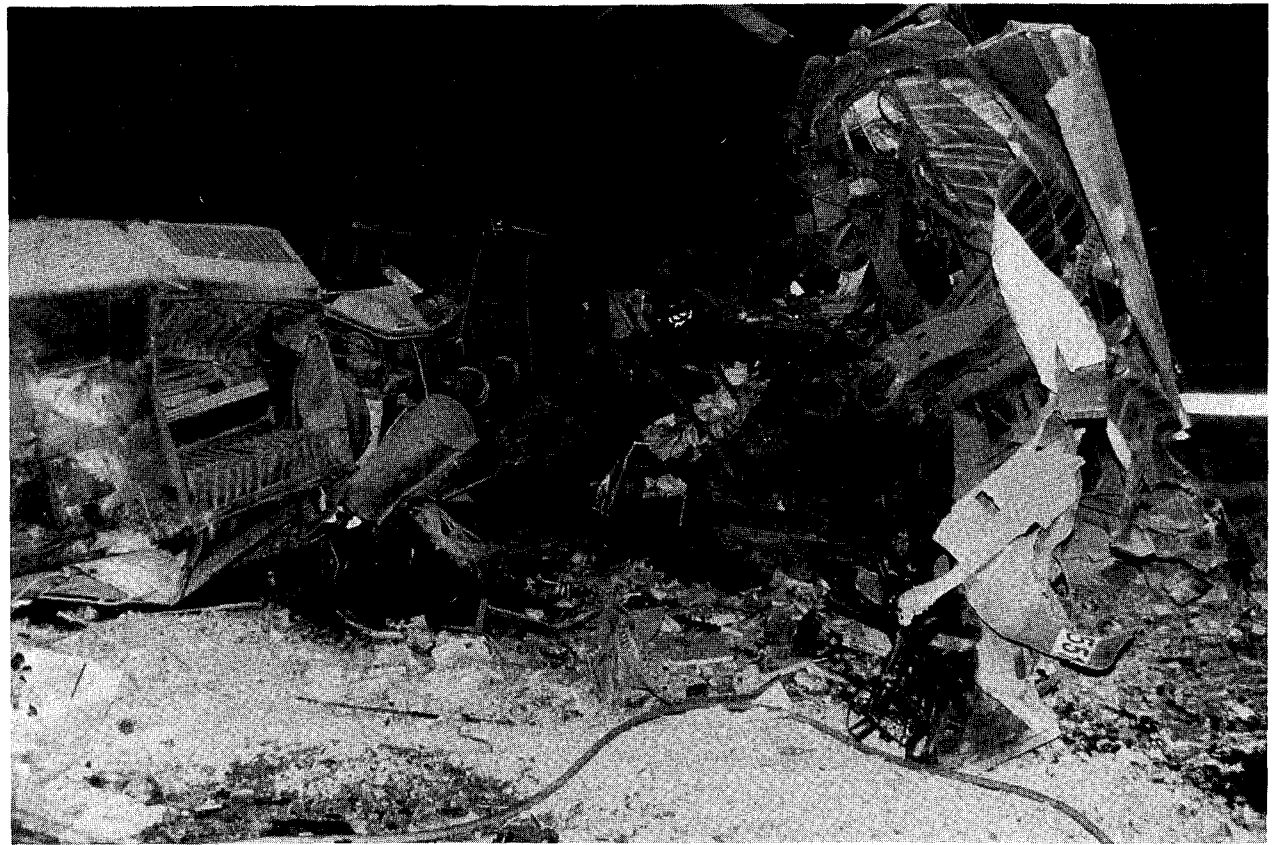
Figure 6.--Amtrak train 66 wreckage.

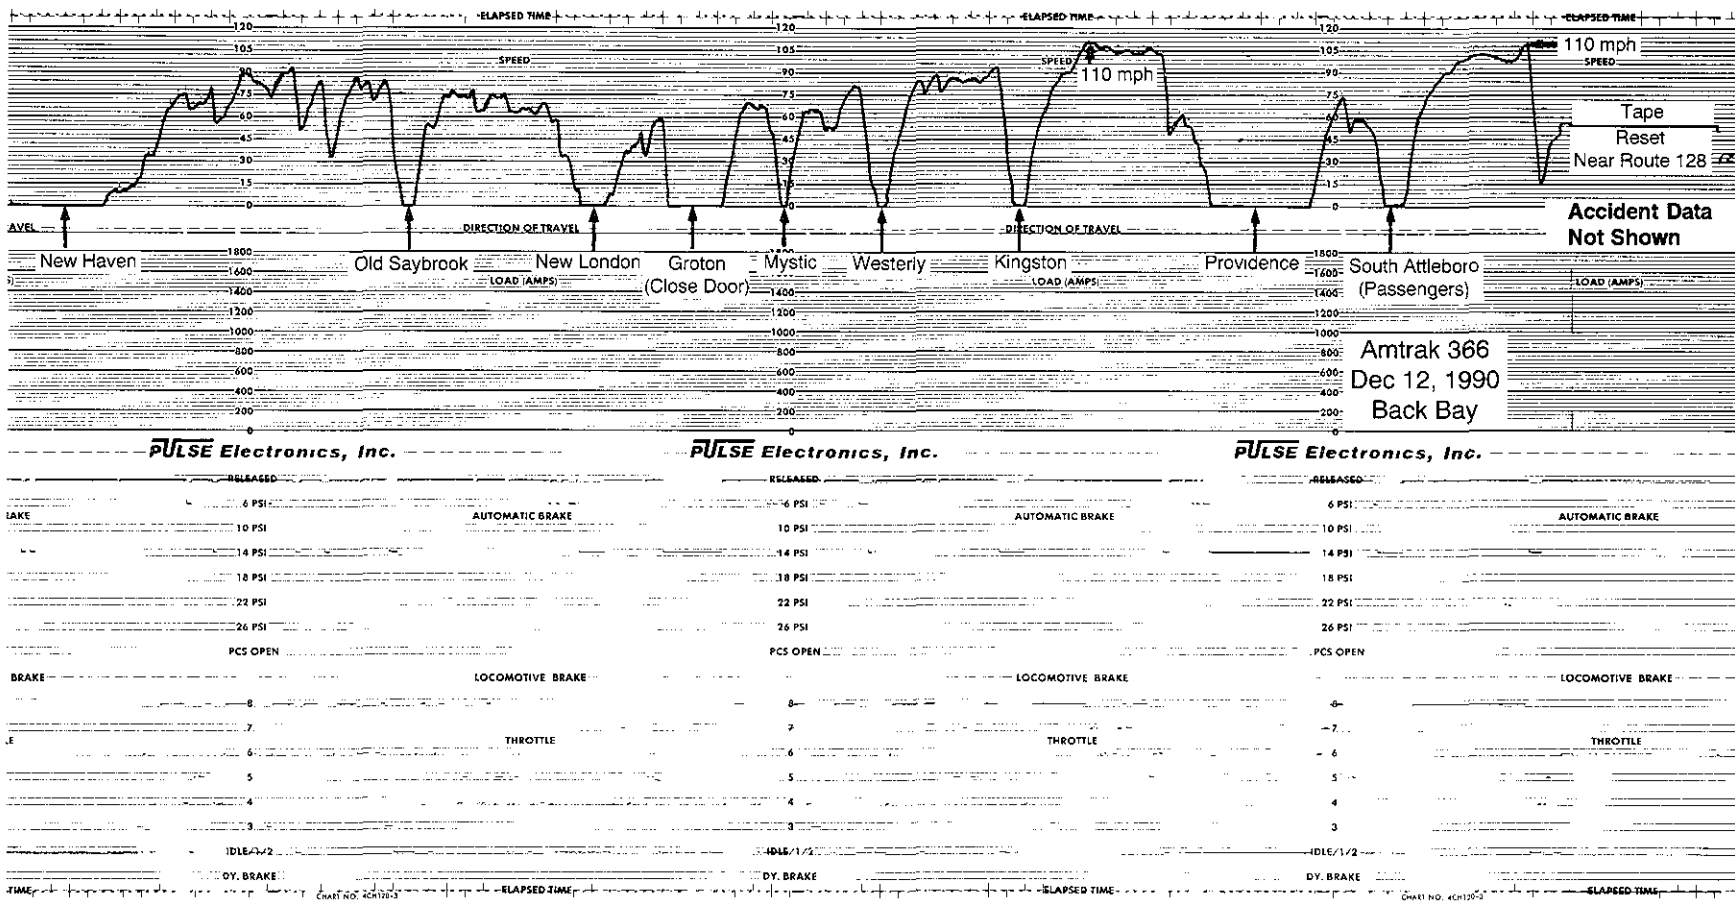
Event Recorder Tests --The Safety Board laboratory received the Pulse data pack from Amtrak locomotive 366 for readout and evaluation on December 13. The laboratory's Pulse readout machine generated a strip chart of the data recovered. Data from the event recorder, which recorded information about every 5 3/4 seconds, showed no signs of accident damage. Safety Board engineers found an electronic end-of-tape mark⁵ on the magnetic tape that prevented strip chart output of data from Route 128 to just beyond the accident. Data before the end-of-tape mark indicated that the train had operated at speeds up to 110 mph between Kingston and Providence and between South Attleboro and Route 128. (See figure 7 for the Pulse magnetic tape event recorder strip chart.)

Safety Board laboratory engineers found that the end-of-tape mark on the magnetic tape was 13.6 minutes long, 2.2 minutes longer than the minimum 11.4-minute end-of-tape mark that usually exists after a readout. Also, this end-of-tape mark began at Route 128 (MP 217.3) and ended just beyond the accident (MP 227.45) data. Given the safeguards designed into the Pulse event recorder system components, the end-of-tape mark over the most recently recorded data should not have occurred.

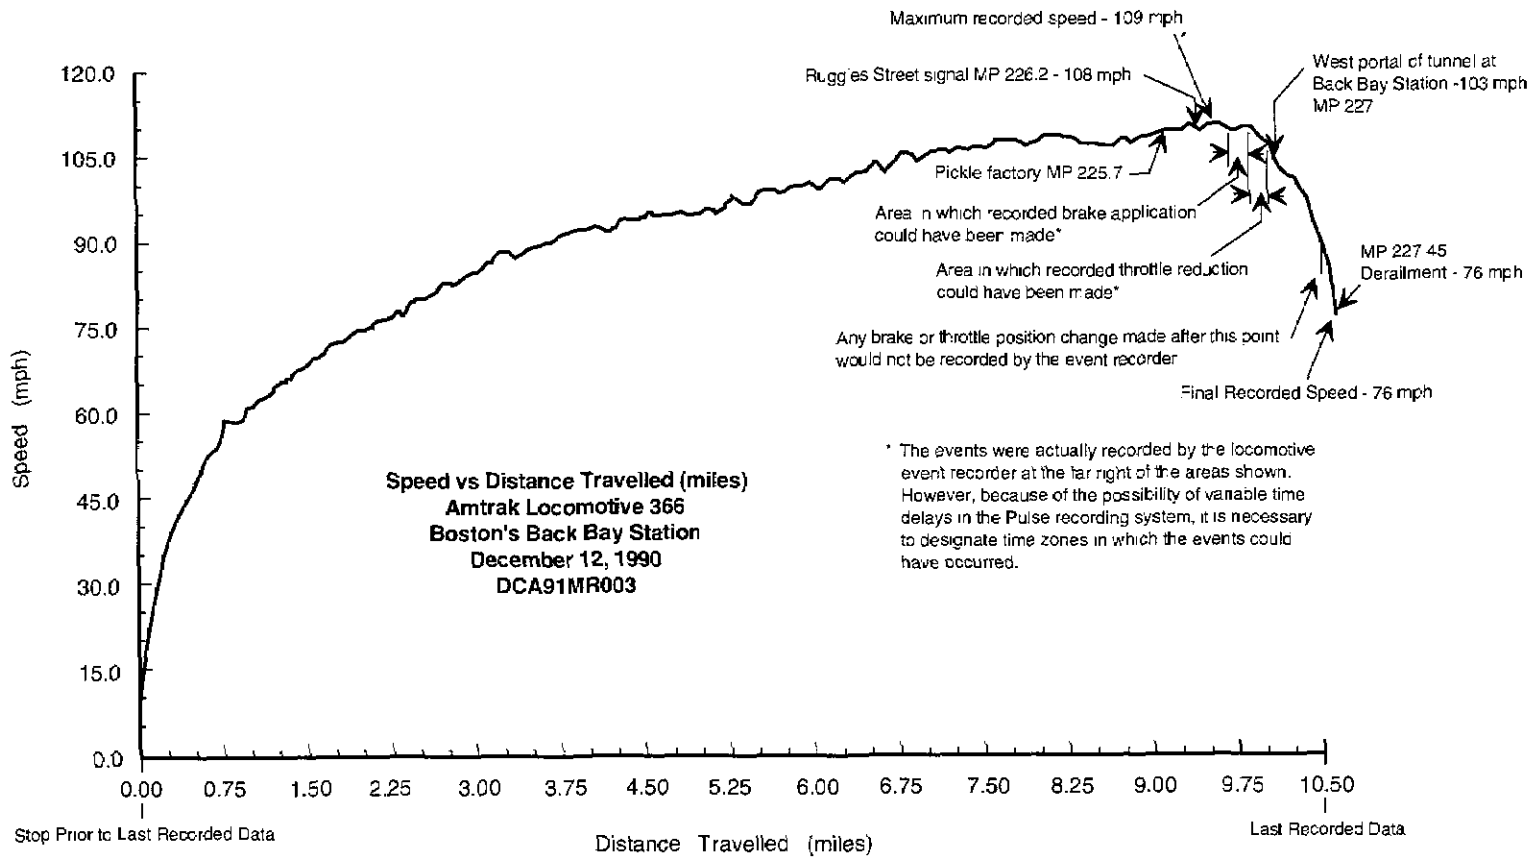
Figure 8.--Event recorder data recovered from Amtrak train 66.

Additional conditions for each test were determined from the Pulse event recorder data and the reported operating procedures of the train's locomotive crew. According to the locomotive engineer and the recovered event recorder data, the apprentice engineer began braking Amtrak train 66 at the west end of the Ruggles Street platform (about 4,950 feet before the POD). Event recorder data show a maximum recorded speed of 109 mph approaching Ruggles Street.
