# NATIONAL TRANSPORTATION SAFETY BOARD

REAR-END COLLISION OF  
AMTRAK PASSENGER TRAIN 94, THE COLONIAL  
AND CONSOLIDATED RAIL CORPORATION  
FREIGHT TRAIN ENS-121,  
ON THE NORTHEAST CORRIDOR  
CHASE, MARYLAND  
JANUARY 4, 1987

NTSB/RAR-88/01

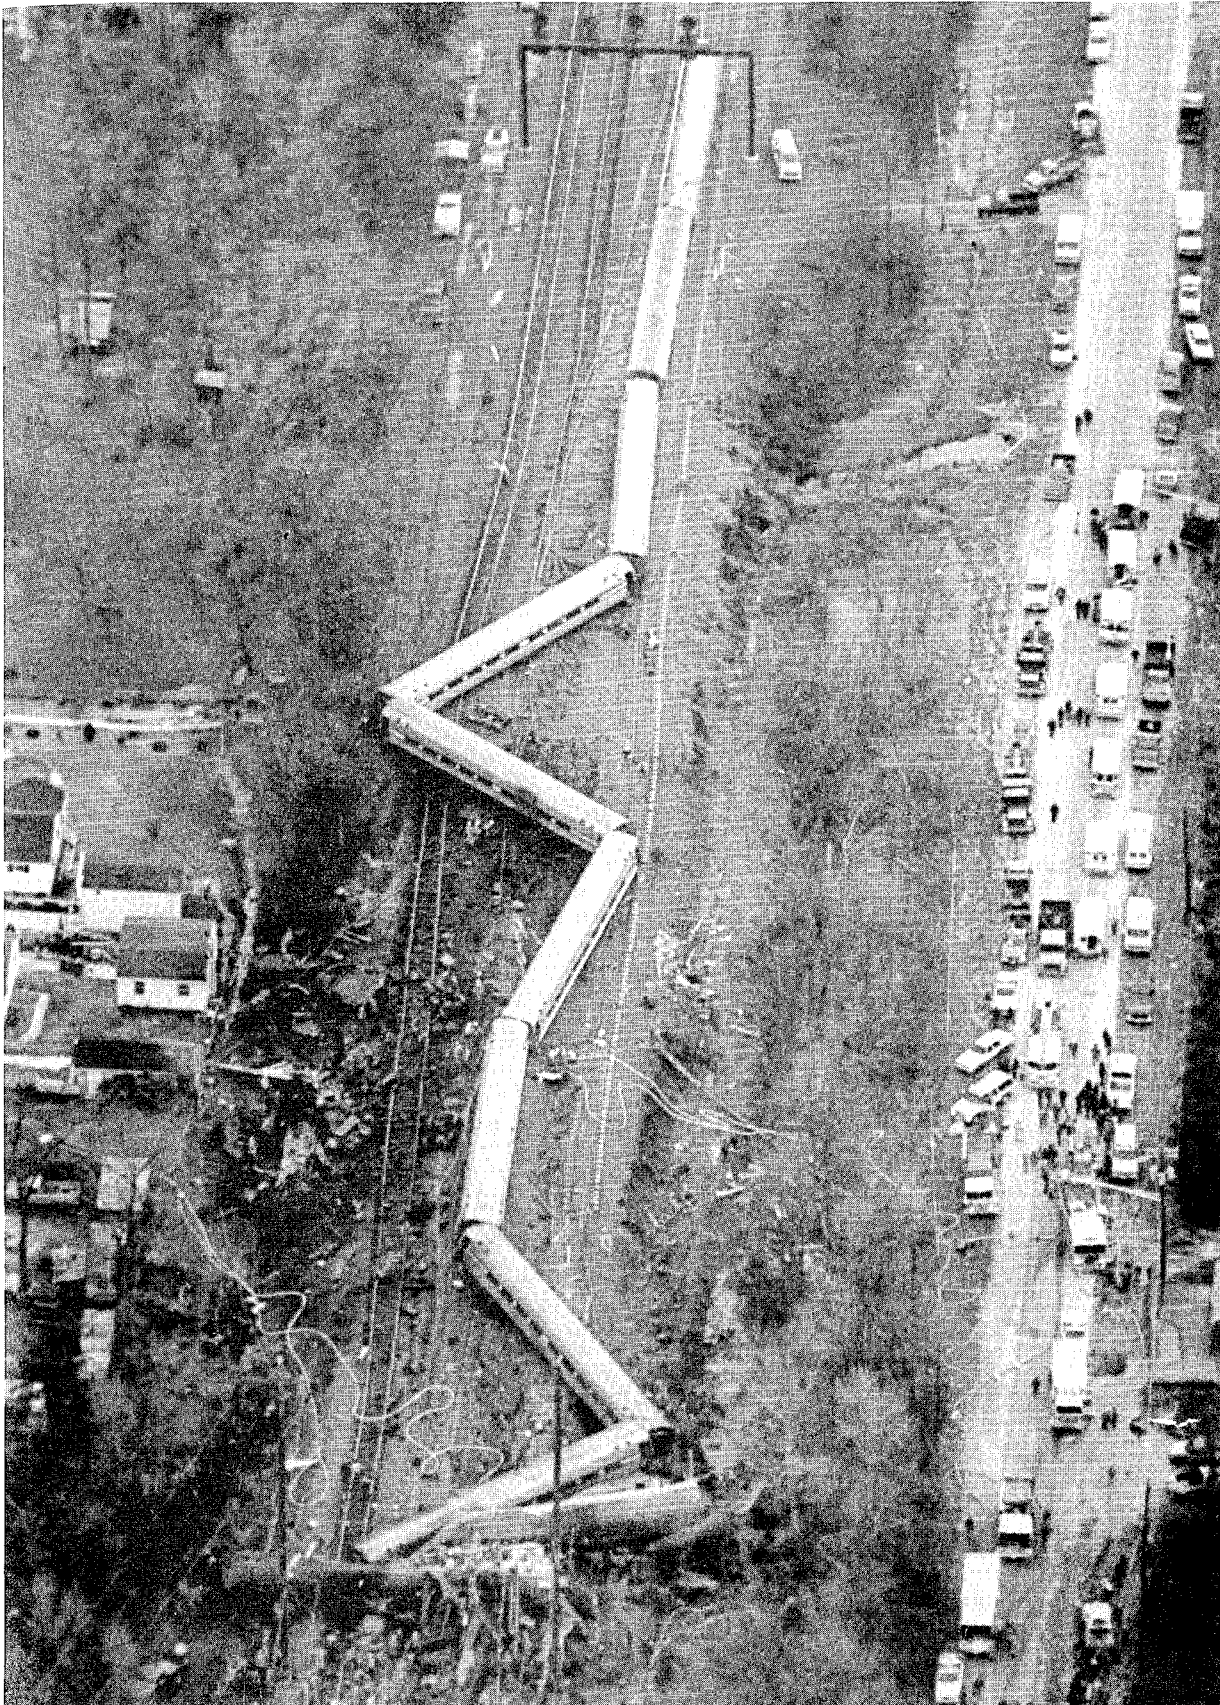
Figure 3. Aerial view of the accident site.

The forward cab and superstructure of the lead Amtrak locomotive unit was crushed downward and inward to the underframe. Separated from the trucks, the remains of the car body came to rest west of the tracks about 400 feet north of the collision point. The trailing Amtrak unit remained in line with the track, although separated from its trucks, and came to rest leaning about 45° to the right at a point about 450 feet north of the collision point (see figure 3).

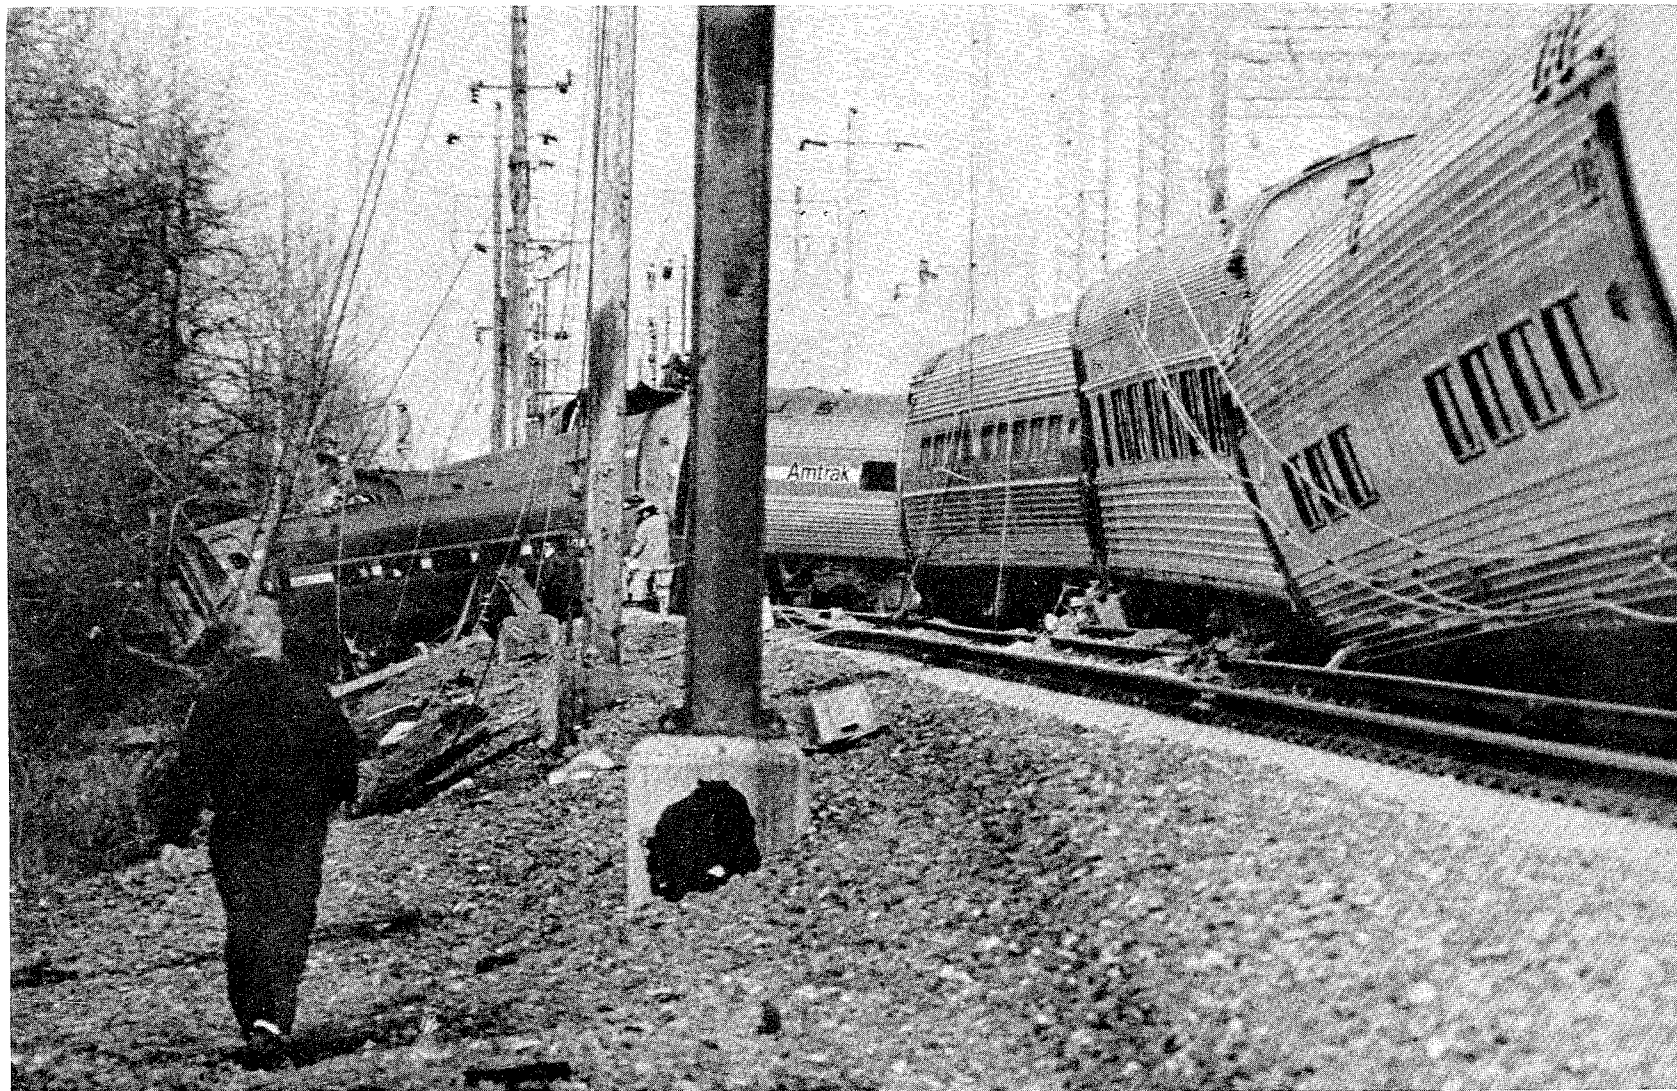
The head car of the passenger train, an unoccupied food service car, came to rest behind the trailing Amtrak locomotive. After passing over the food service car, the second car came to rest on its side on top of the rear of the trailing Amtrak locomotive unit. It was more or less perpendicular to the track, badly deformed and bent or crimped downward in the middle at an angle of about 30° (see figure 4). The third car stopped diagonally to the track, leaning to one side, on top of the crushed food service car. One end was crushed between the second and fourth cars. The fourth car stopped diagonally to the track, upright and with the car body essentially intact. The 5th through 12th cars remained coupled and upright, although the 5th, 7th, 8th, and 9th cars had jackknifed and stopped diagonally to the track. The other derailed cars remained in line with the track (see figure 5).

Figure 5. View from west side of the tracks facing north and showing derailed passenger cars of train 94. The car at the extreme right was the rear car of the train, and the car ahead of it was the second car from the rear. The poles in the middle held up the catenary wires. Fallen catenary and high-voltage transmission lines are on both sides of the poles.

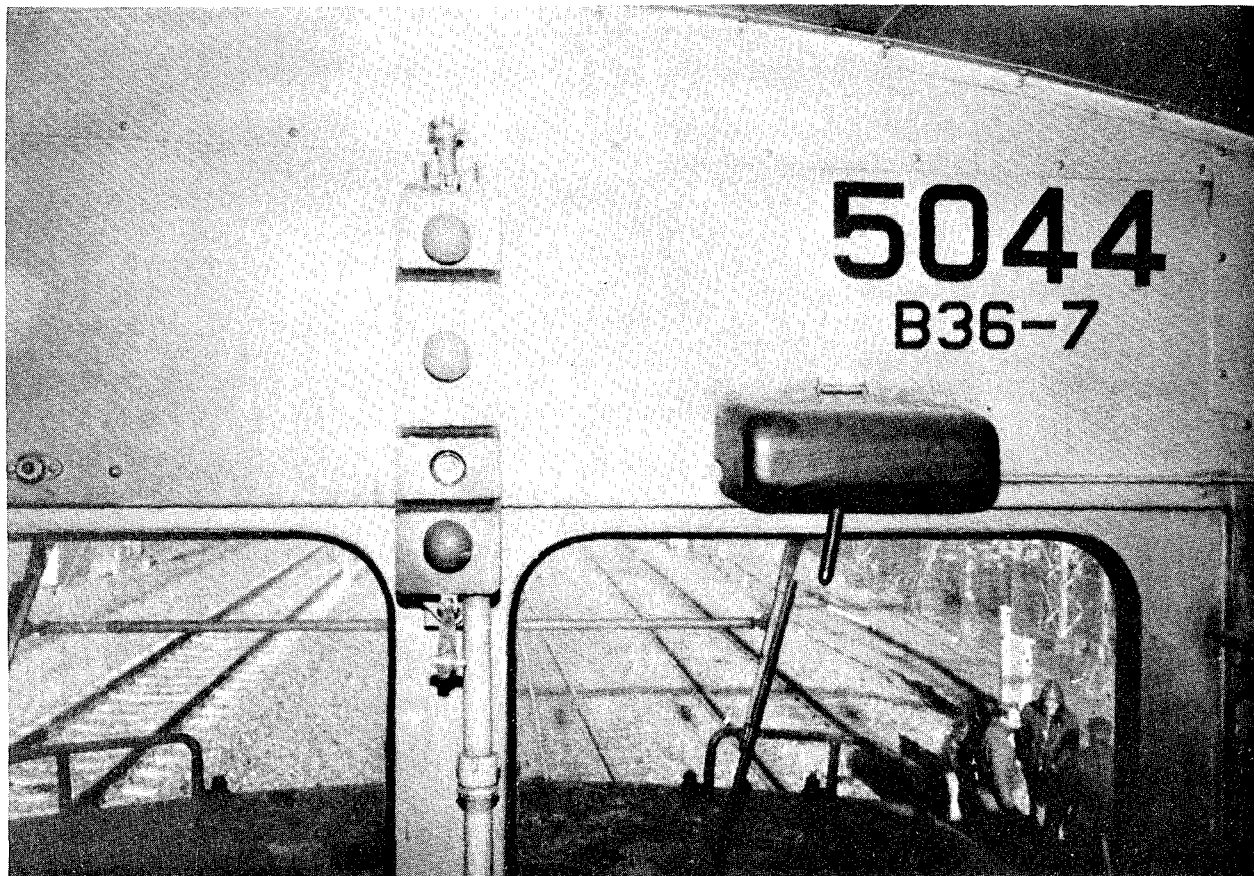
The four-aspect cab signal of unit 5044 was of the same configuration as the Amtrak AEM-7 locomotives; it was mounted in the middle of the forward cab bulkhead at the top of the windshield. The hinged cover had two sets of aspect ports set at oblique angles so that one could be viewed from each side of the cab. The top port was the "clear" aspect, the next two below were the "approach medium" aspect, the next below was the "approach" aspect, and the bottom port was the "restricting" aspect. There were screw-in receptacles in the signal box for four small white bulbs--one for each aspect. An examination of the signal box after the accident revealed that the bulb for the "approach" aspect was missing (see figure 13). All the other aspects had operative bulbs that were properly inserted.

Figure 13. Cab signal of Conrail unit 5044 with the cover removed; the bulb for the "approach" aspect is missing.

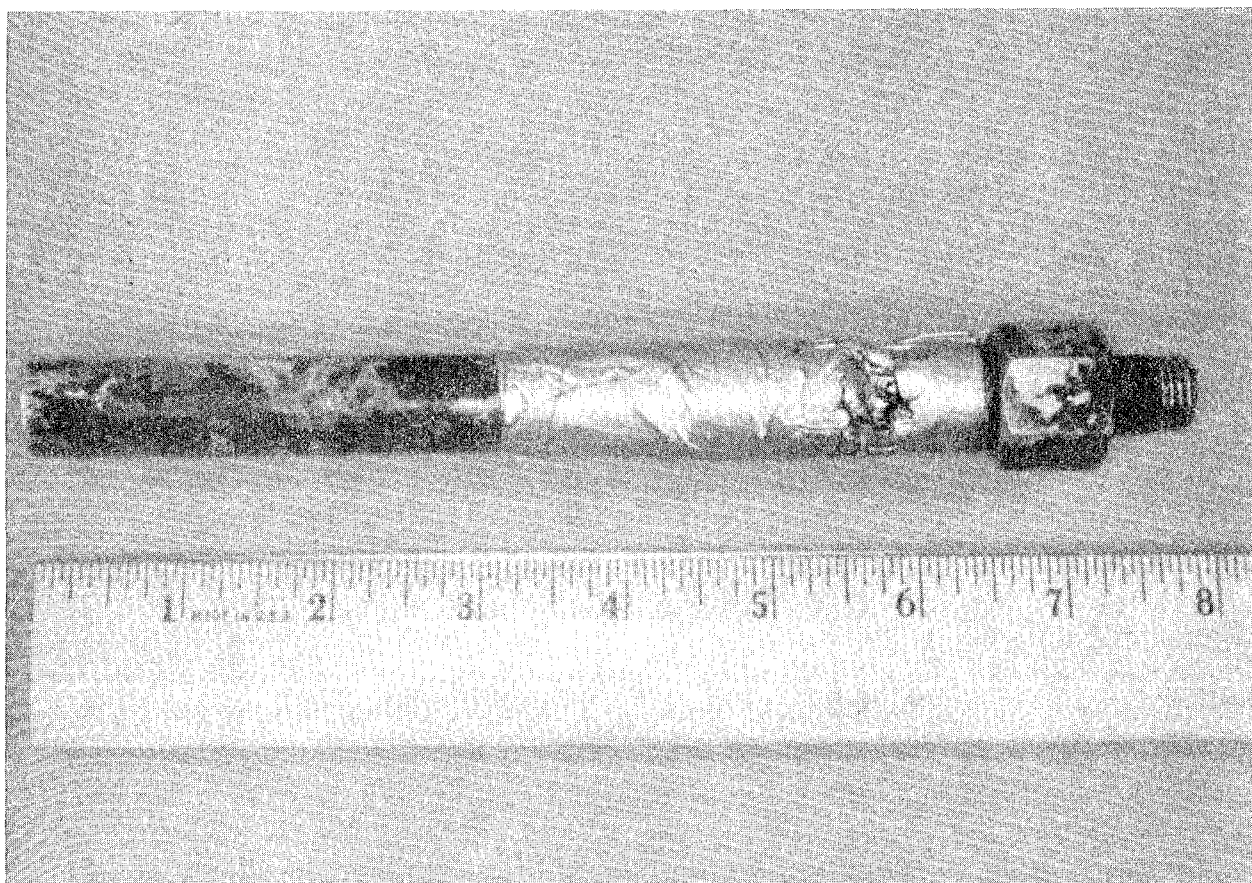
The 6 1/2-inch cab signal whistle was mounted in the airbrake control stand and could be accessed by unsnapping six latches that held the back cover in place. Following the accident, investigators removed the cover from the airbrake control stand of unit 5044 and found the port of the whistle wrapped tightly with duct tape (see figure 14). In this

Figure 14. The cab signal whistle removed from Conrail 5044 with the port covered by duct tape.

condition, no sound could be heard over the sound of the idling engine of an adjacent locomotive. When the tape was slit at the port, the whistle emitted sound at a normal 95- to 105-decibel level.

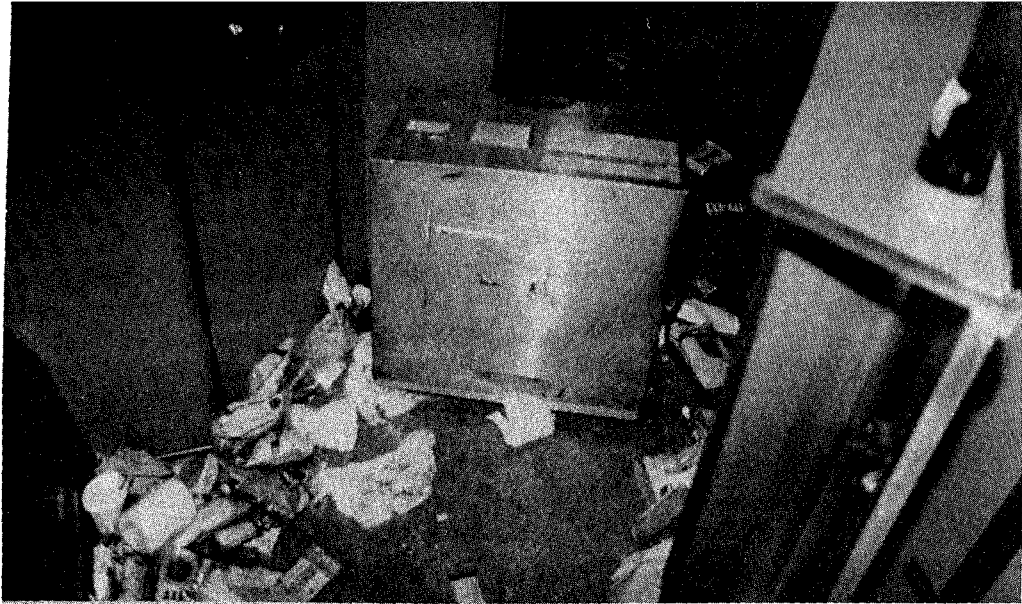
The train crewmembers related that most of the passengers remained calm and there was little panic, although the aisles of most of the coaches were blocked by fallen luggage. In the food service cars, unsecured microwave and convection ovens and other articles in the pantry sections were thrown to the floor and blocked movement through the cars (see figure 15).

Figure 15. Microwave oven and other pantry material blocking the aisle of the rear car of train 94, the food service car.

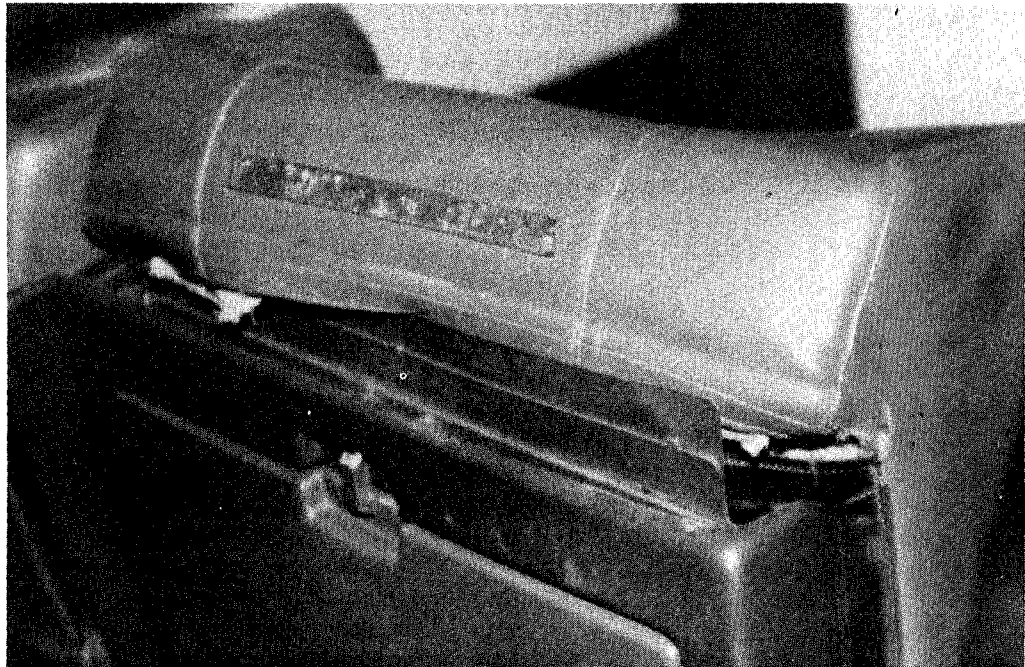
Passengers throughout the train reported that they had been struck by fallen luggage. Others stated they were injured when thrown into sheet metal seatbacks exposed by dislodged cushions (see figures 16 and 17). A number of seats had been dislodged altogether in the seventh car (see figure 18). Postaccident inspections revealed that the emergency windows in the 11th car, a rebuilt Heritage-class coach, could not be pulled inward as designed because the inside framing around them was too wide. Of the 45 passengers who were interviewed or who responded to questionnaires, 20 reported they were struck by luggage falling from overhead racks; additionally, 8 of the 45 passengers reported they had difficulty in evacuating because of fallen luggage in the aisles.

Figure 16. Edges of sheetmetal seatback frames exposed by displacement of the cushions.

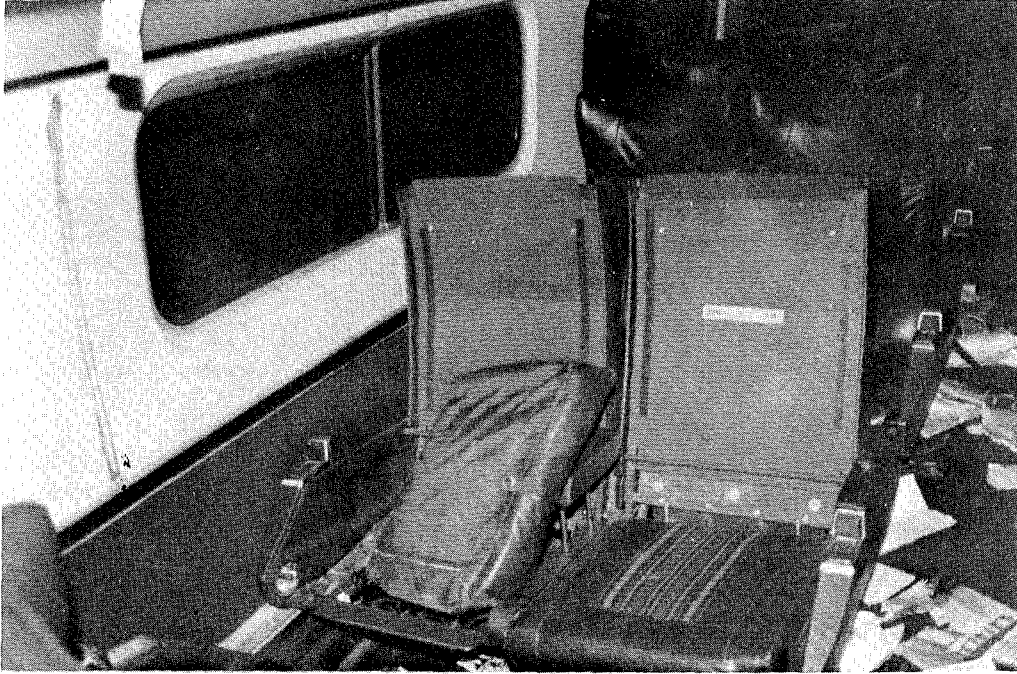
Figure 17. Missing seatback cushions and exposed sheetmetal seatback frames in a coach.

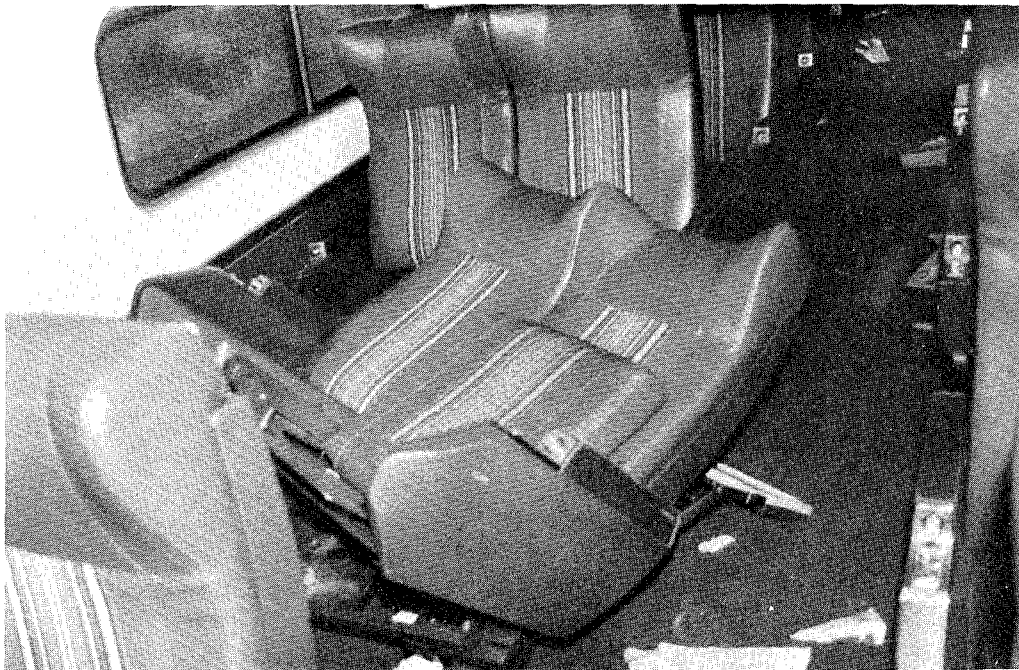
Figure 18. Seats separated from pedestals in the seventh car of train 94.

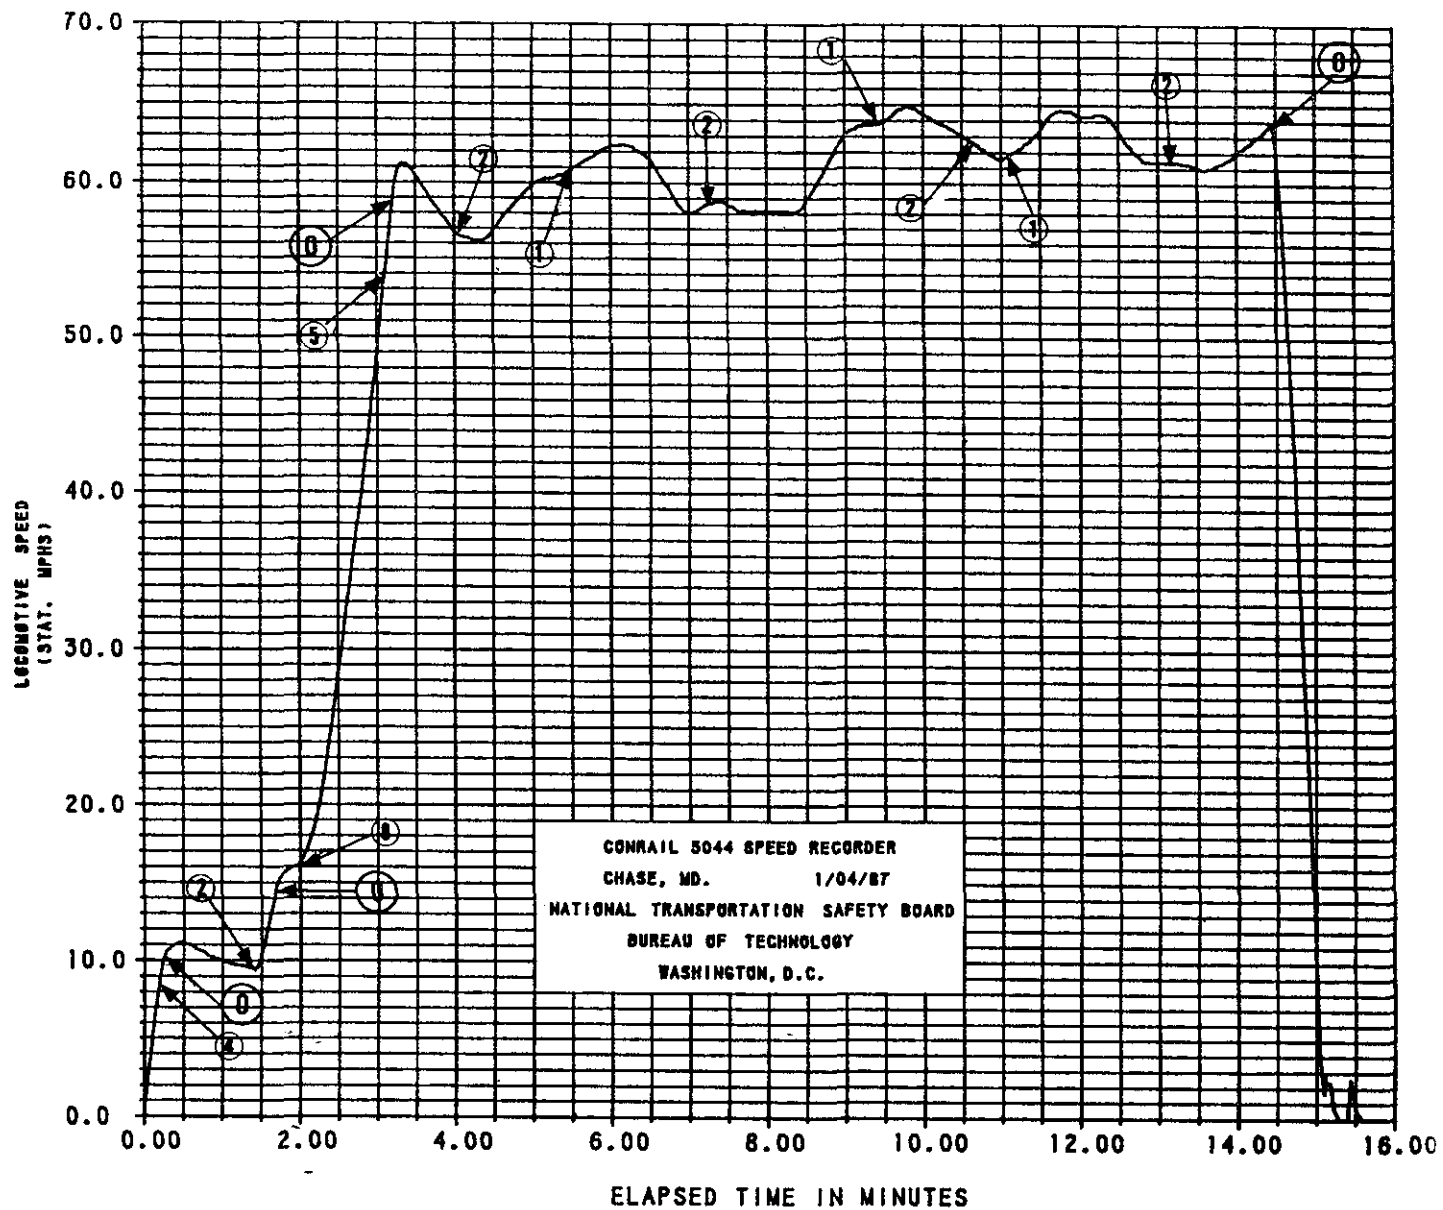
Figure 20: Speed data from the event recorder on Conrail locomotive 5044, the lead unit of train ENS-121, as reproduced in enhanced graphic form. The locations of changes in the throttle setting have been plotted on the graph. Throttle settings are 0 (idle) through 8 (fully open).

The data from the lead unit's recorder indicated that 15 minutes 15 seconds passed between the time train ENS-121 left the vicinity of Bay View yard office and the time it stopped at Gunpow. The times 1:15:15 and 1:30:30 were used as reference points for the start and stop times. At 1:17:15, 2 minutes after the start, the throttle was opened to the eighth or full throttle position; at the time, the train was moving at about 15.5 mph. At 1:18:20 and 52 mph, the throttle was reduced from the eighth to the fifth position, and 10 seconds later, at 57 mph, the throttle was reduced to idle. Acceleration ceased and deceleration began at about 60 mph; at about 56 mph, the throttle was opened to the second position.
