# AIRCRAFT ACCIDENT REPORT

**ADOPTED:** October 23, 1964**RELEASED:** October 29, 1964

DELTA AIR LINES, INC.  
DC-7, N4875C, AND  
U. S. AIR FORCE C-123B, AF 540589,  
MEMPHIS MUNICIPAL AIRPORT,  
MEMPHIS, TENNESSEE,  
JANUARY 13, 1963

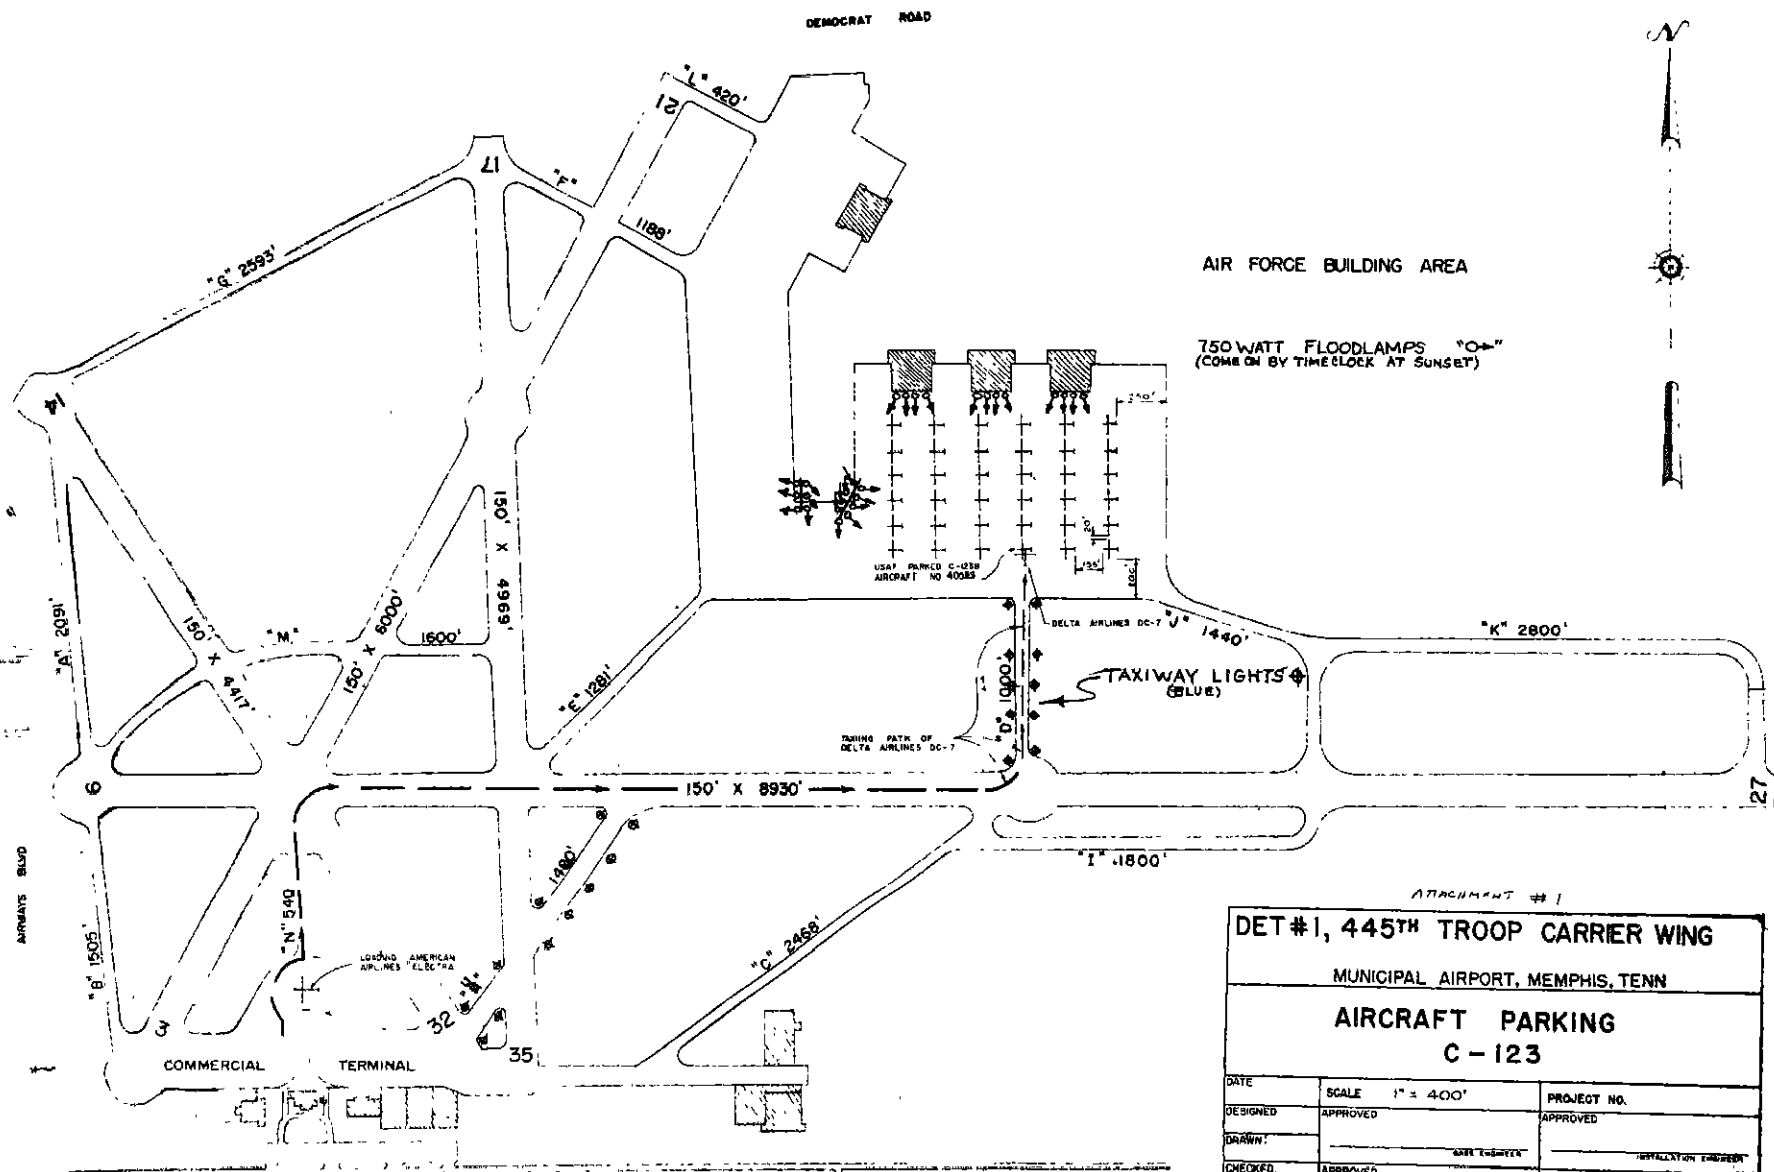
<i>Attachment #1</i>		
<b>DET #1, 445TH TROOP CARRIER WING</b>		
<b>MUNICIPAL AIRPORT, MEMPHIS, TENN</b>		
<b>AIRCRAFT PARKING</b>		
<b>C - 123</b>		
DATE	SCALE 1" = 400'	PROJECT NO.
DESIGNED	APPROVED	APPROVED
DRAWN	APPROVED	APPROVED
CHECKED	APPROVED	DRAWING NO.
APPROVED	COMMANDER	SHEET 08

Taxi instructions issued by the control tower and recorded on the tape indicate Delta 8715 was instructed to turn left at the second taxiway after passing the north-south runway. Referring to the diagram of the Memphis Airport,<sup>7/</sup> the air traffic control instruction to "turn left at the second taxiway" was misinterpreted by the captain. This placed the aircraft on Taxiway "D", in position for the subsequent collision with the C-123B.
