MILL POND RESERVOIR MAIN DAM
MA 01121

PHASE I INSPECTION REPORT
NATIONAL DAM INSPECTION PROGRAM

NEW ENGLAND DIVISION, CORPS OF ENGINEERS

JANUARY 1980

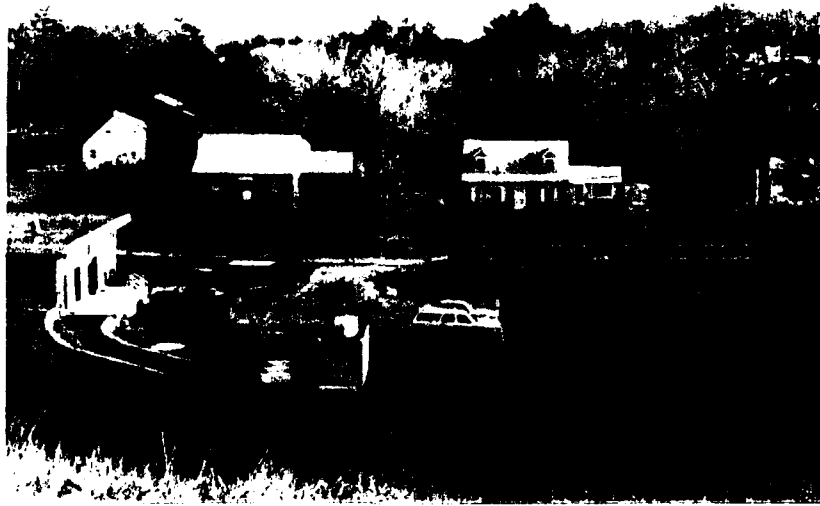
The impact area is separated into two sections which follow Maple Meadow Brook (photograph 13) and Willow Brook (photograph 14). Along Maple Meadow Brook there is substantial residential development. Much of this development has occurred since the dam was constructed. At least 65 homes would be damaged by dam failure flood water.

PHOTO NO. 13 - View of the immediate downstream area showing the Water Treatment Plant and the Maple Meadow Brook Dam Failure Impact Area. Many of the homes, upper right side of photo, are at higher elevations than those in the immediate downstream area.

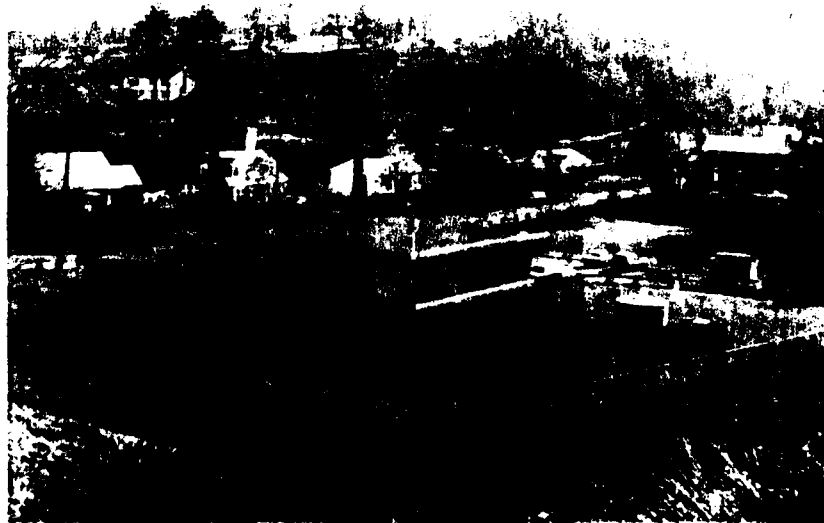
Along the Willow Brook impact area, near Winter Street, initial flood stage, within the first 500 feet of channel, will be about 15 feet. The outlet valley is narrow in this area. Continuing past Winter Street the valley leads into Willow Brook which flows towards Main Street (Rte. 38). Flood stage near Rte. 38 could be 5 feet. At least 35 homes in this area could be damaged by flood water. Most of these homes are located near the perimeter of the impact area and damage could be caused by flood water depths of 5 feet.

PHOTO NO. 14 - View of the right side immediate downstream area. Upper right side of photo shows the beginning of the Winter Street-Willow Brook-Route 38 Dam Failure Impact Area.
